# Appendix K Cultural Heritage Archival Recordings

## 9.5 Sample Set of Photographic Prints

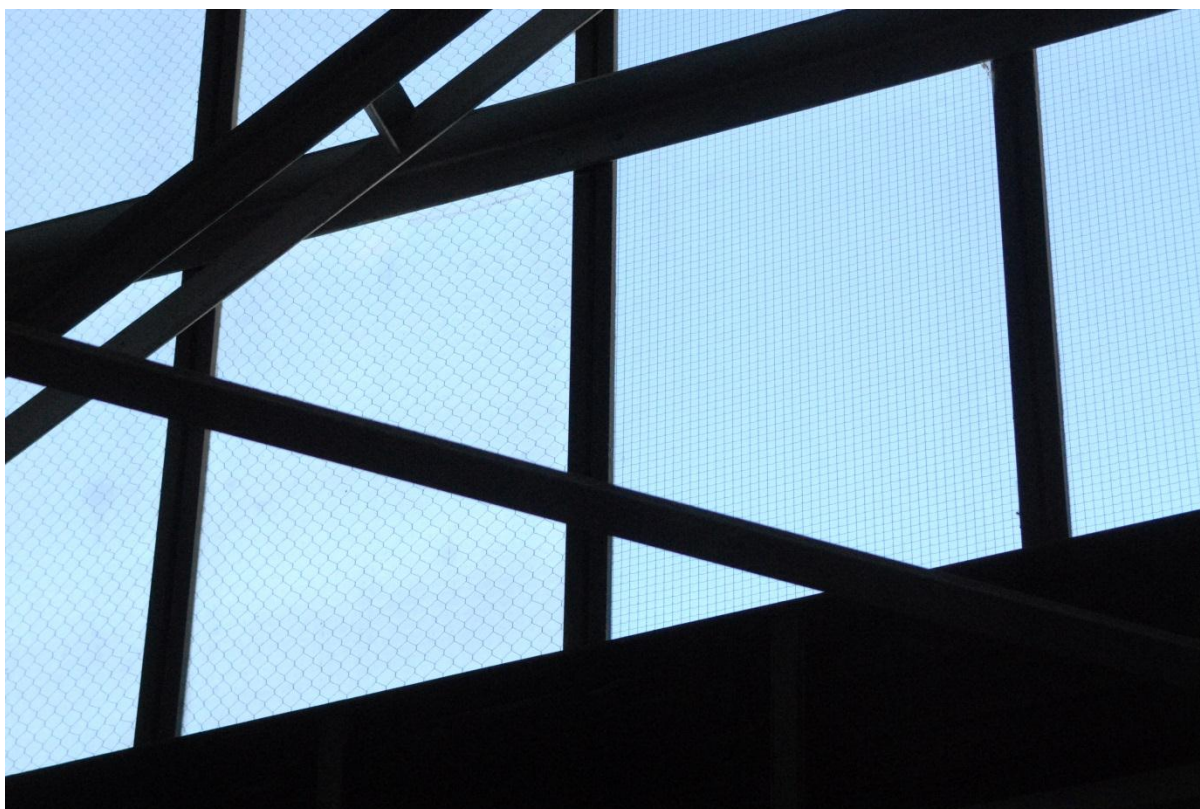
**Figure 8.48 Detail of clerestory window panes, note two varieties of mesh reinforcing, (image no. B99 0124)**

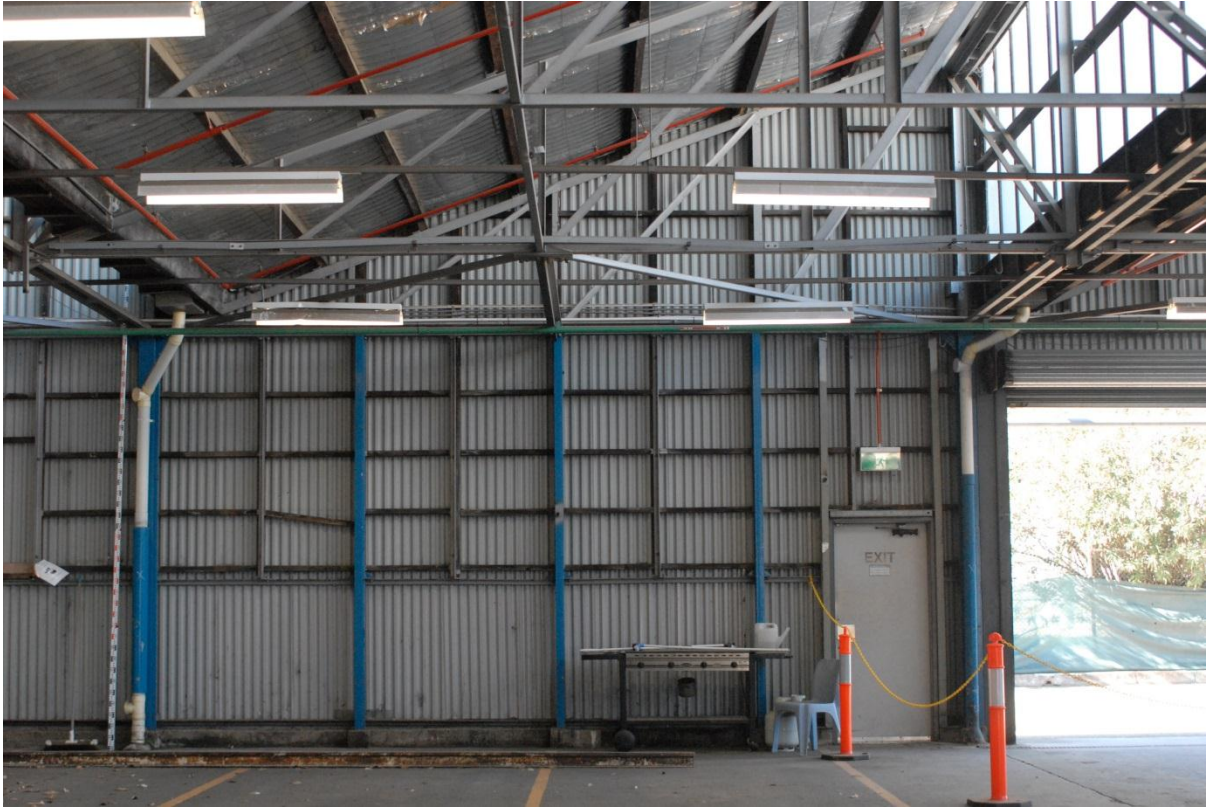
**Figure 8.49 Looking E at originally framed wall unit, with modern door insert on right, (image no. B99 0122)**

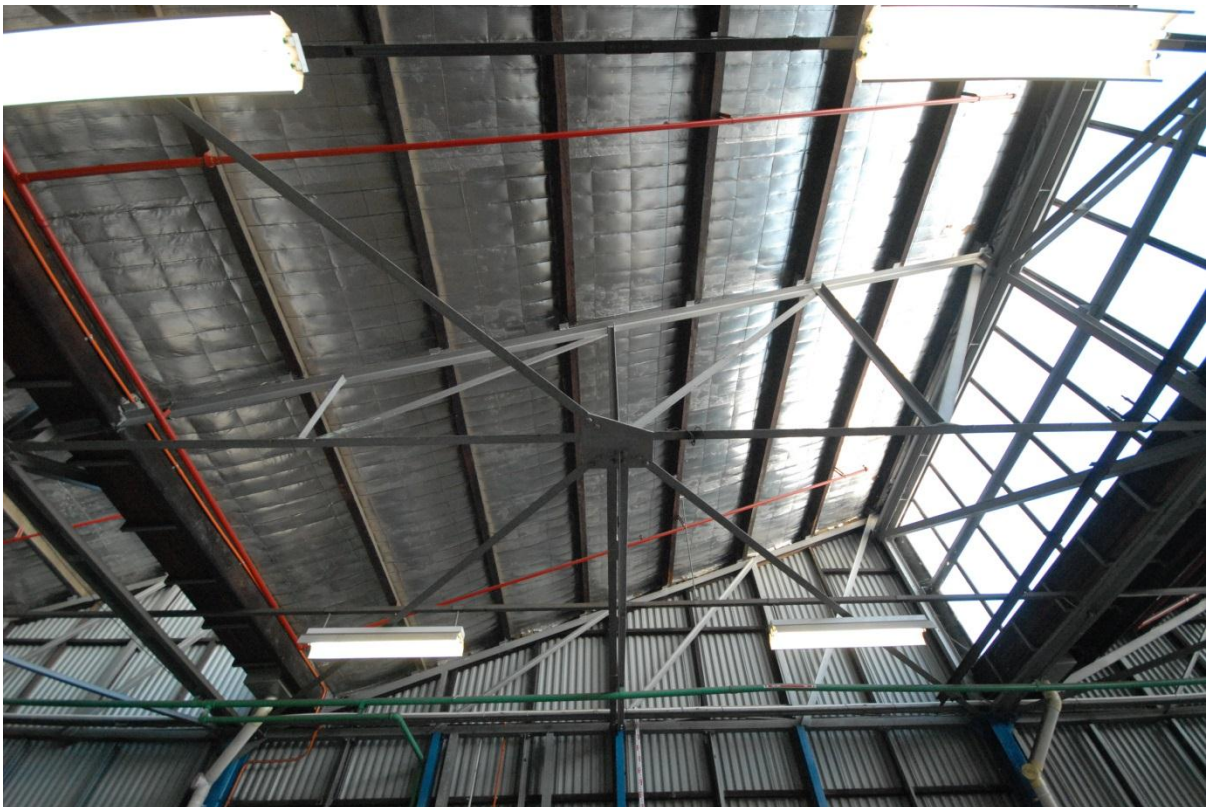
**Figure 8.50 Wide view of roof and upper wall structure, looking E, (image no. B99 0078)**

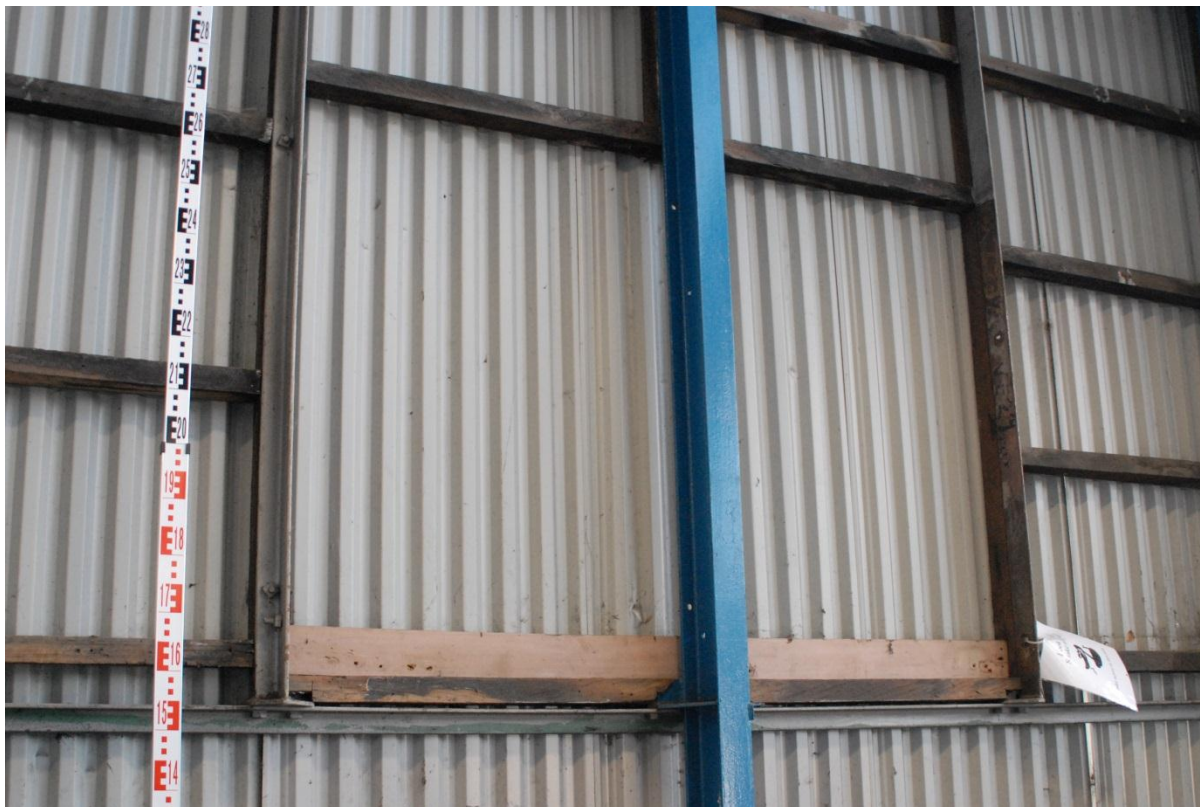
**Figure 8.51 Detail of former window aperture on E wall, as revealed by wall framing, (image no. B99 0113)**

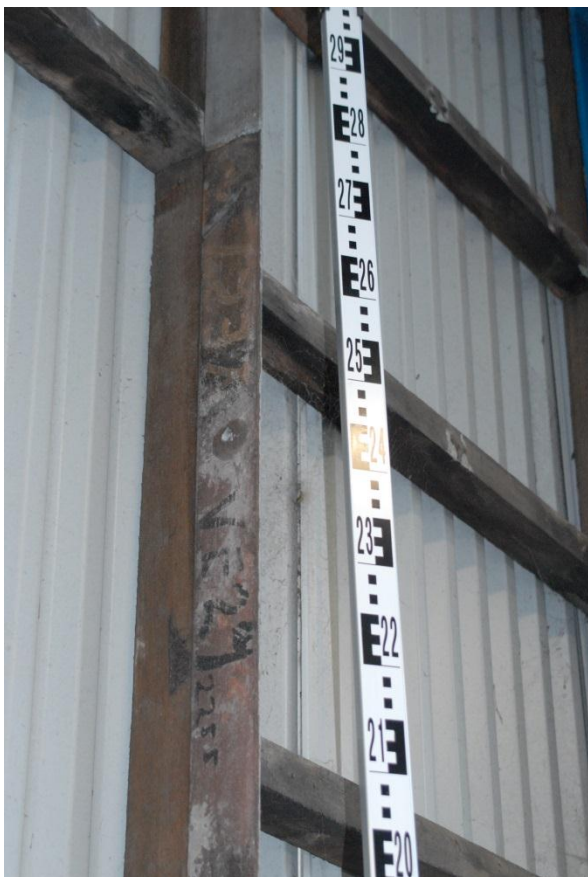
**Figure 8.52 Detail of by-hand writing in paint on metal framing (image no. B99 0116)**

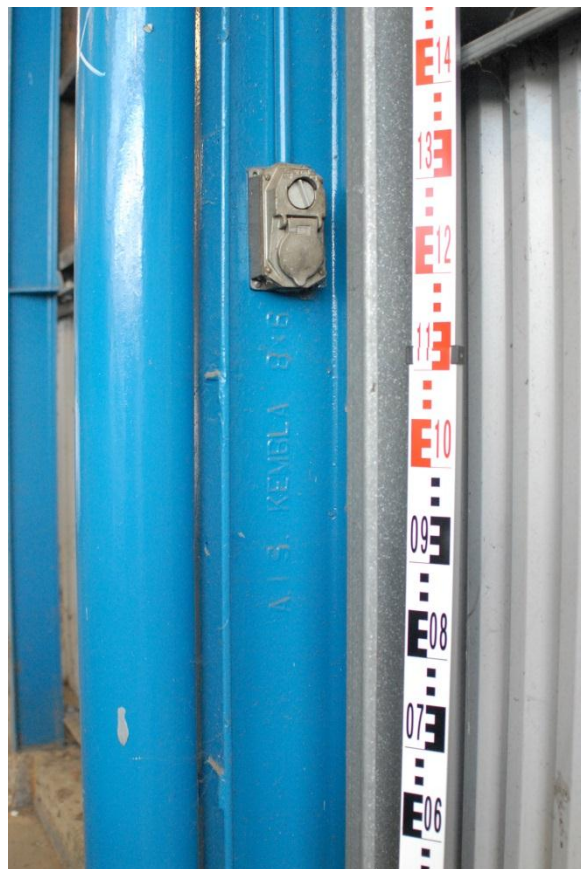
**Figure 8.53 Detail of 'I' column showing original power socket and BHP makers mark, (image no. B99 0107)**

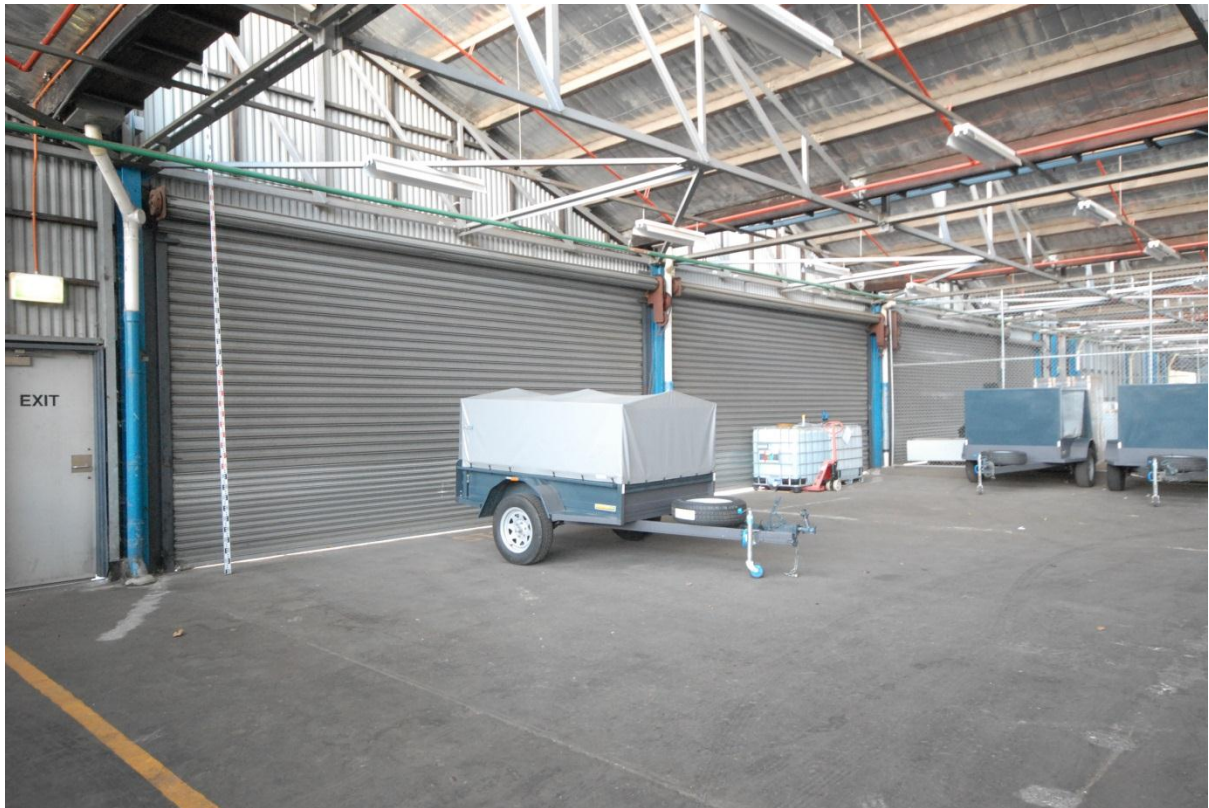
**Figure 8.54 View of W wall showing three large roller doors, looking NW, (image no. B99 0070)**

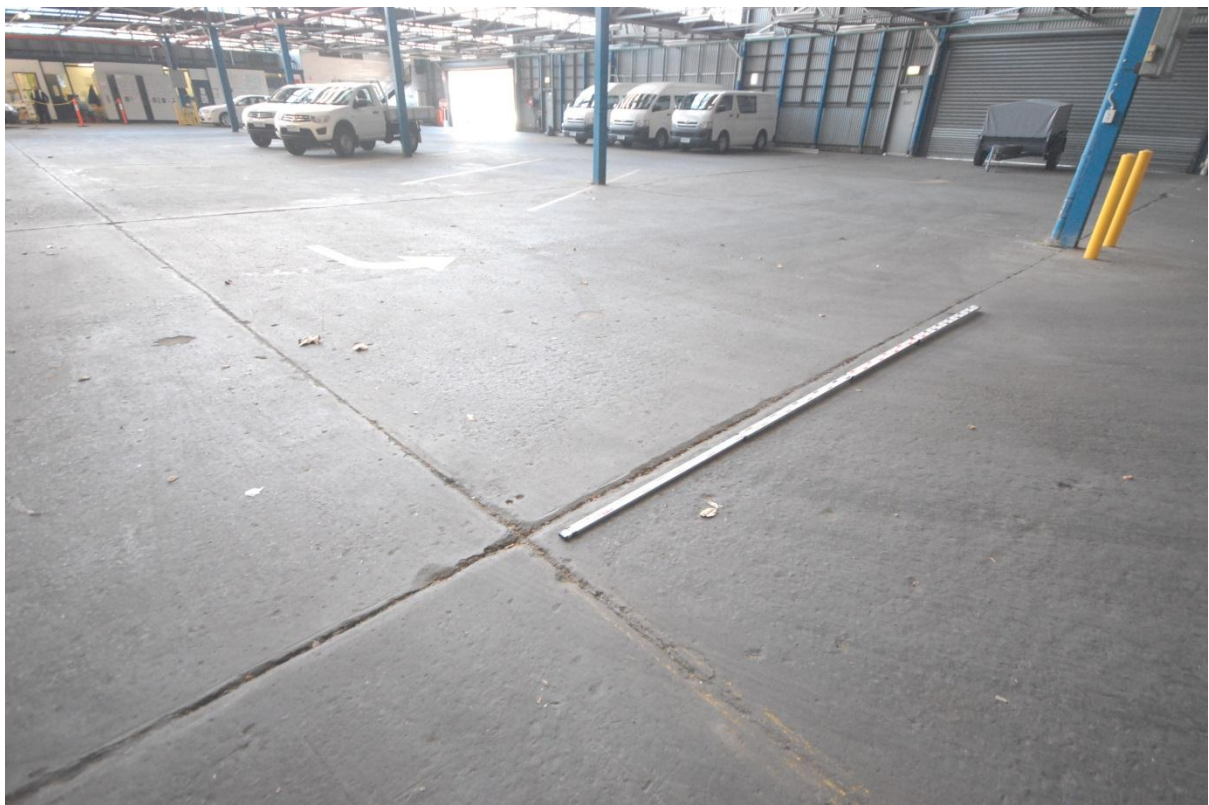
**Figure 8.55 Wide view of floor, looking SW, showing grid pattern in slab joints, (image no. B99 0073)**

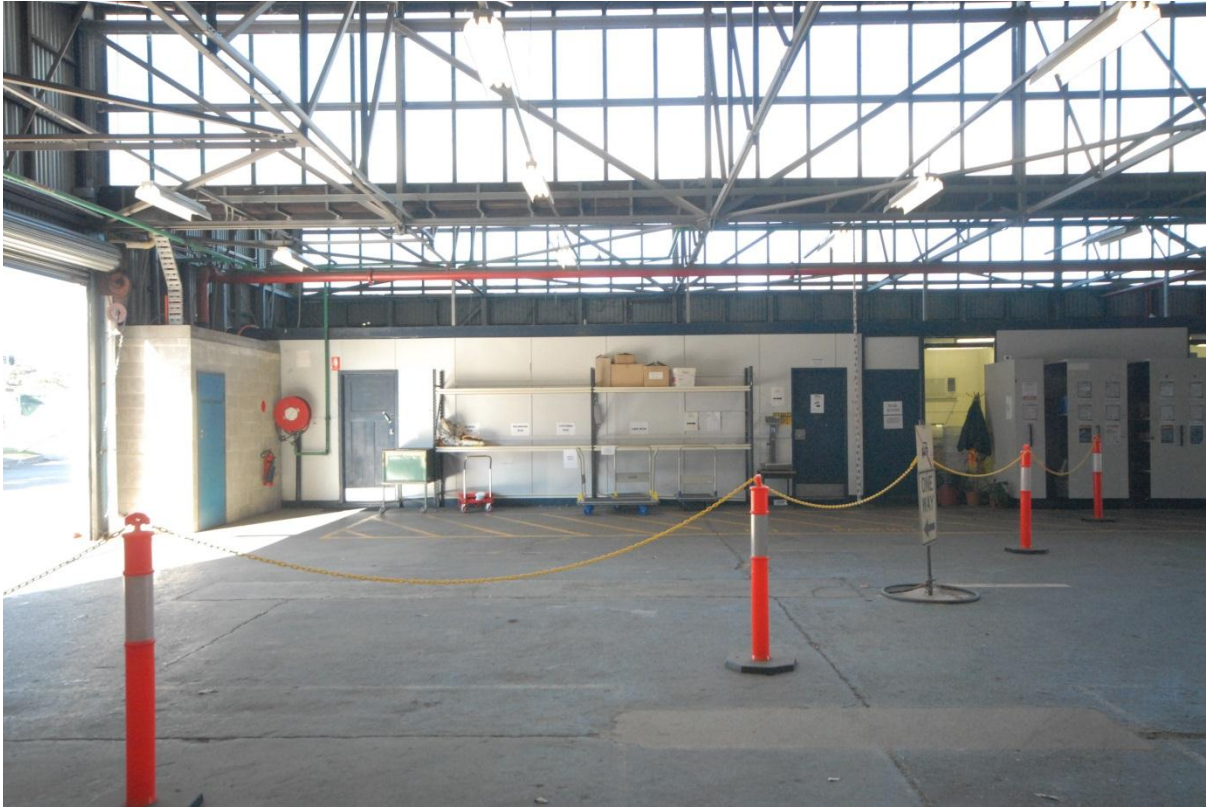
**Figure 8.56 Looking S (SE corner of building) at series of rooms and offices along S wall, (image no. B99 0052)**

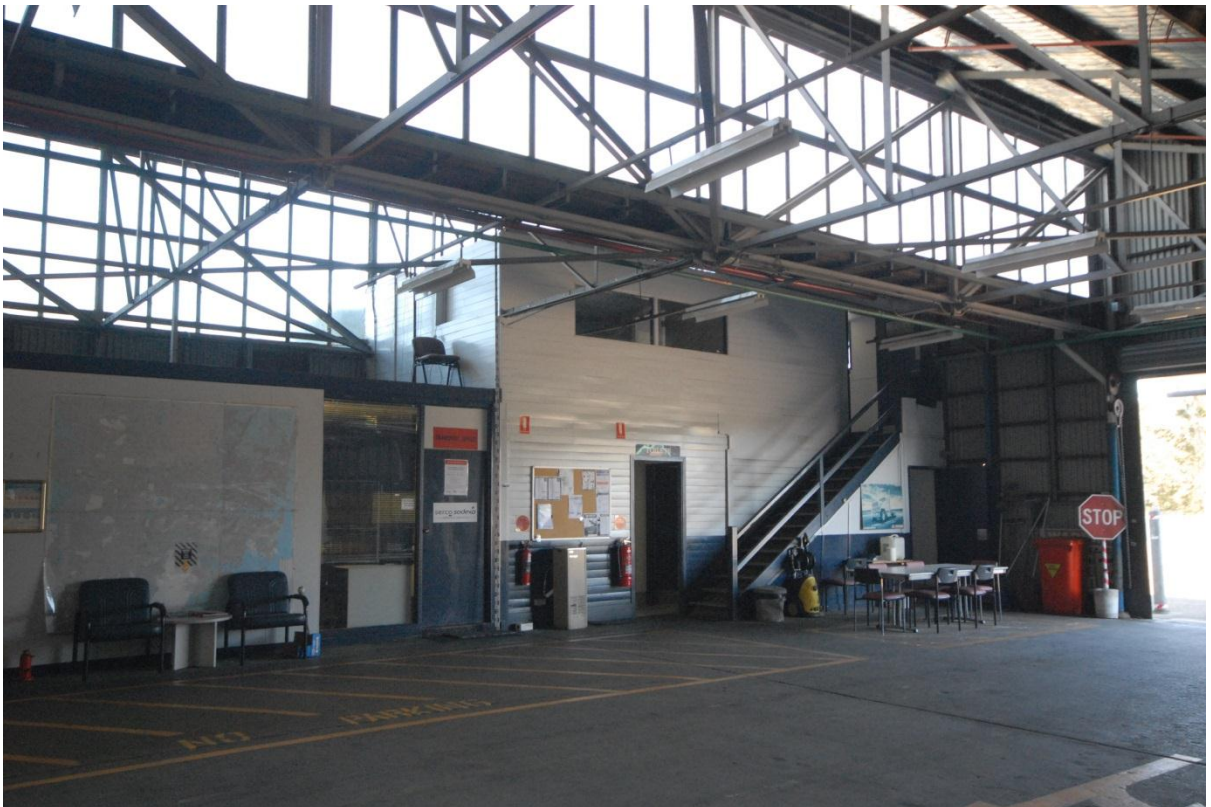
**Figure 8.57 Looking SW at recent two storey construction in SW corner of building. The roof structure was modified in order to make the upper building space available, (image no. B99 0059)**

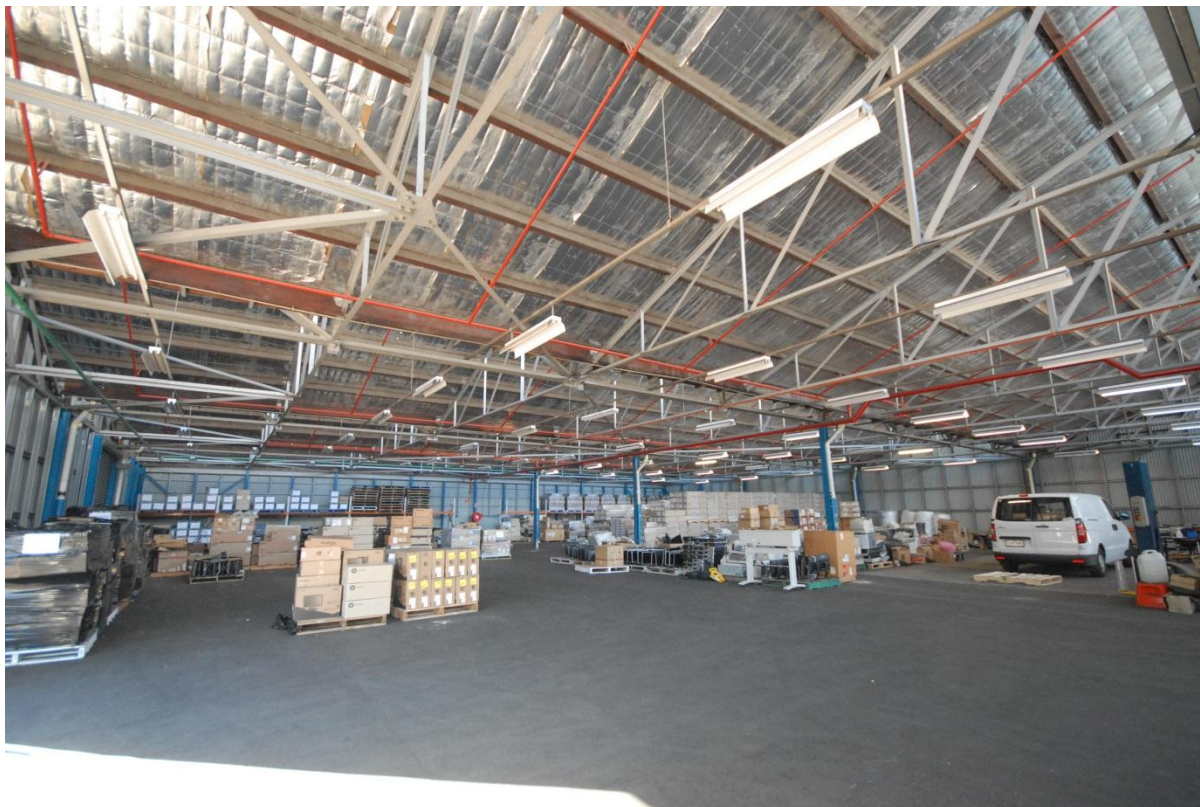
**Figure 8.58 Wide view of northern portion of building, looking NE, (image no. B99 0179)**

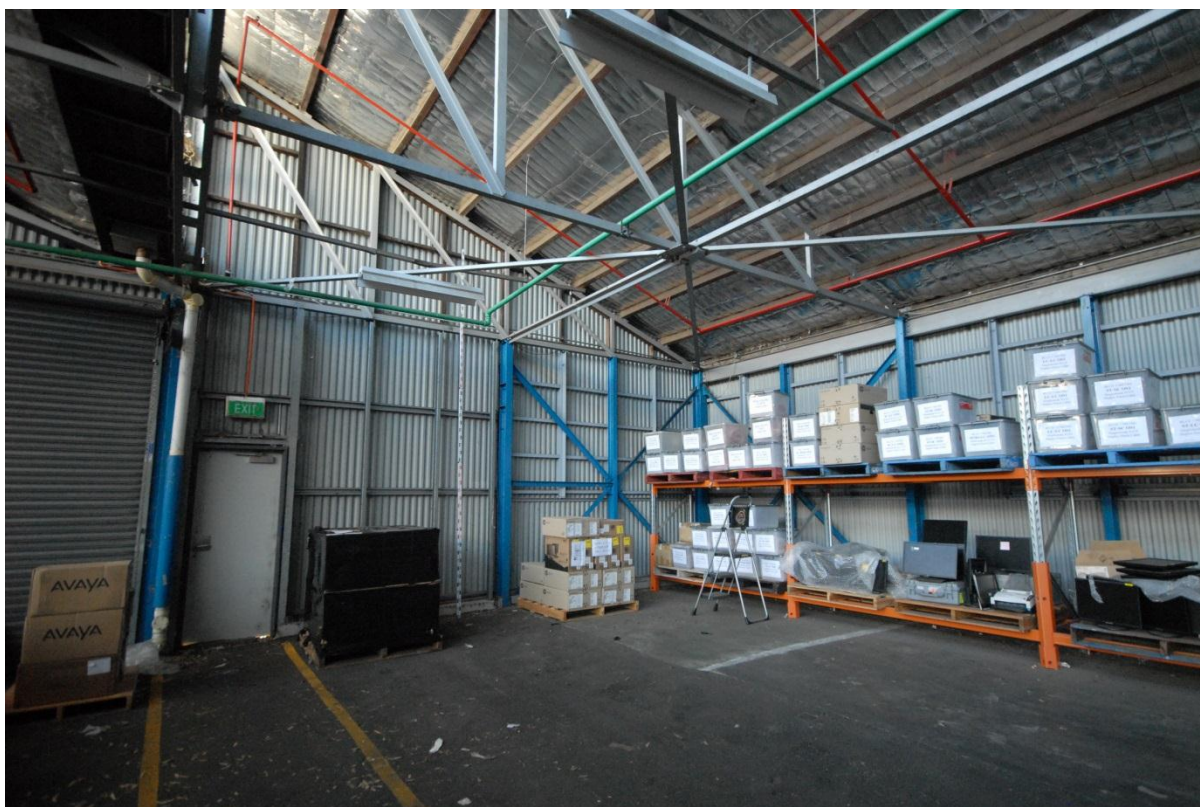
**Figure 8.59 Looking NW at NW corner of building showing wall cross bracing on either side of the corner and large supporting 'I' beam across top of N wall, (image no. B99 0170)**

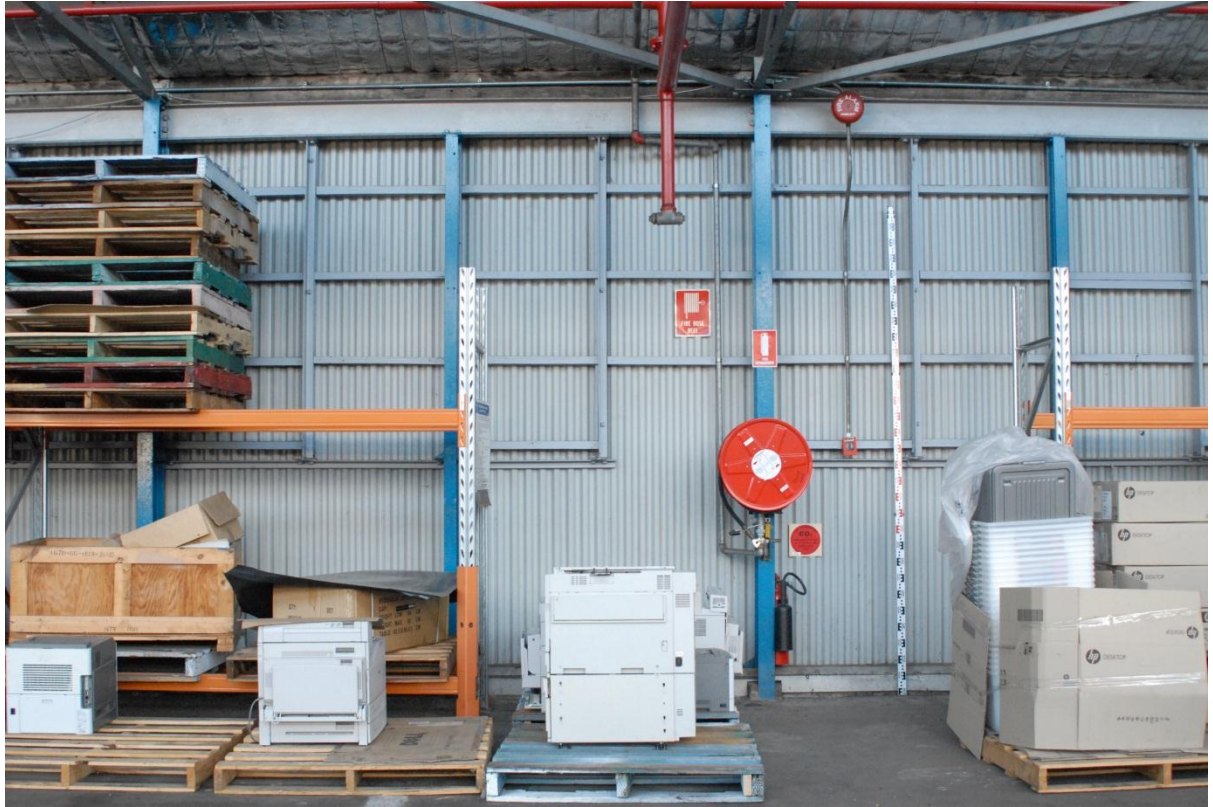
**Figure 8.60 View of N wall showing former external doorways as revealed by missing lower wall frame elements, (image no. B99 0185)**

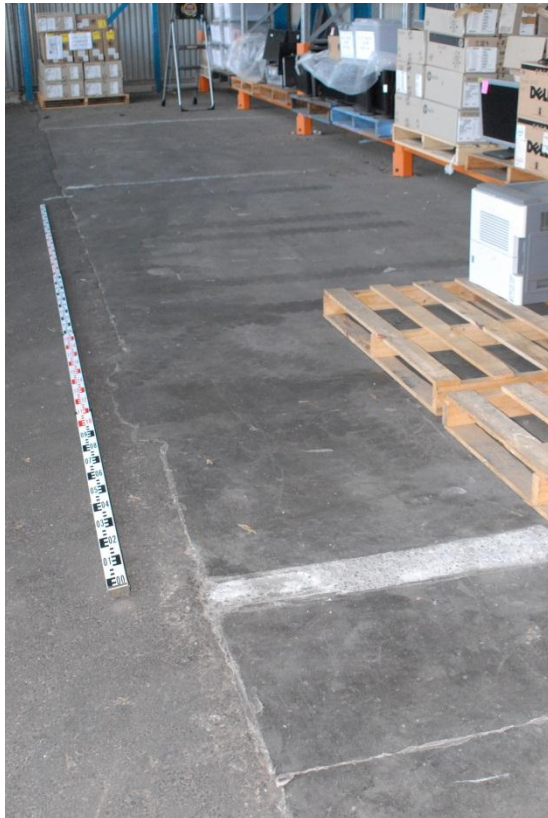
**Figure 8.61 Looking WNW at concrete floor adjacent to N wall. This formed the floor of former rooms and offices. Former walls are indicated by infilled trenches (image no. B99 0194)**

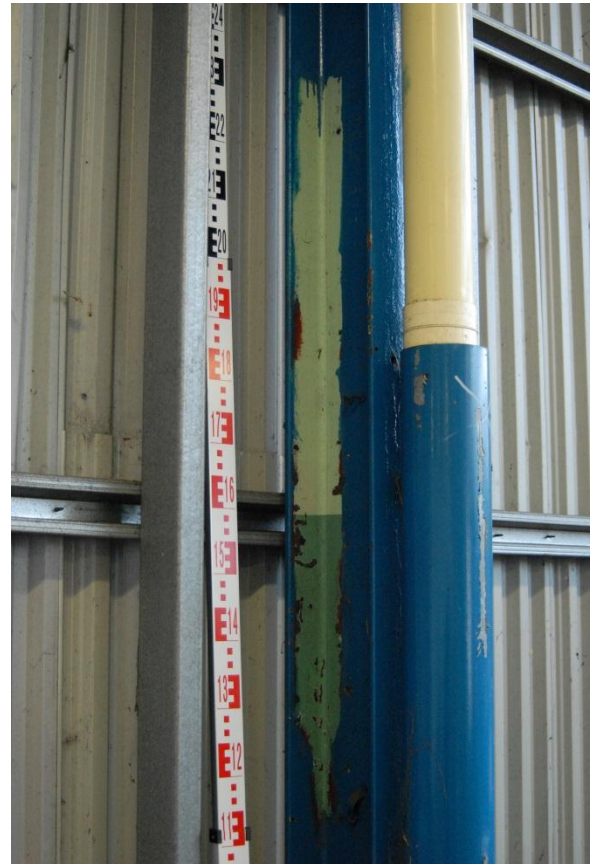
**Figure 8.62 Detail of remnant paint showing former interior two-tone green colour scheme, on column of the E wall, (image no. B99 0203)**

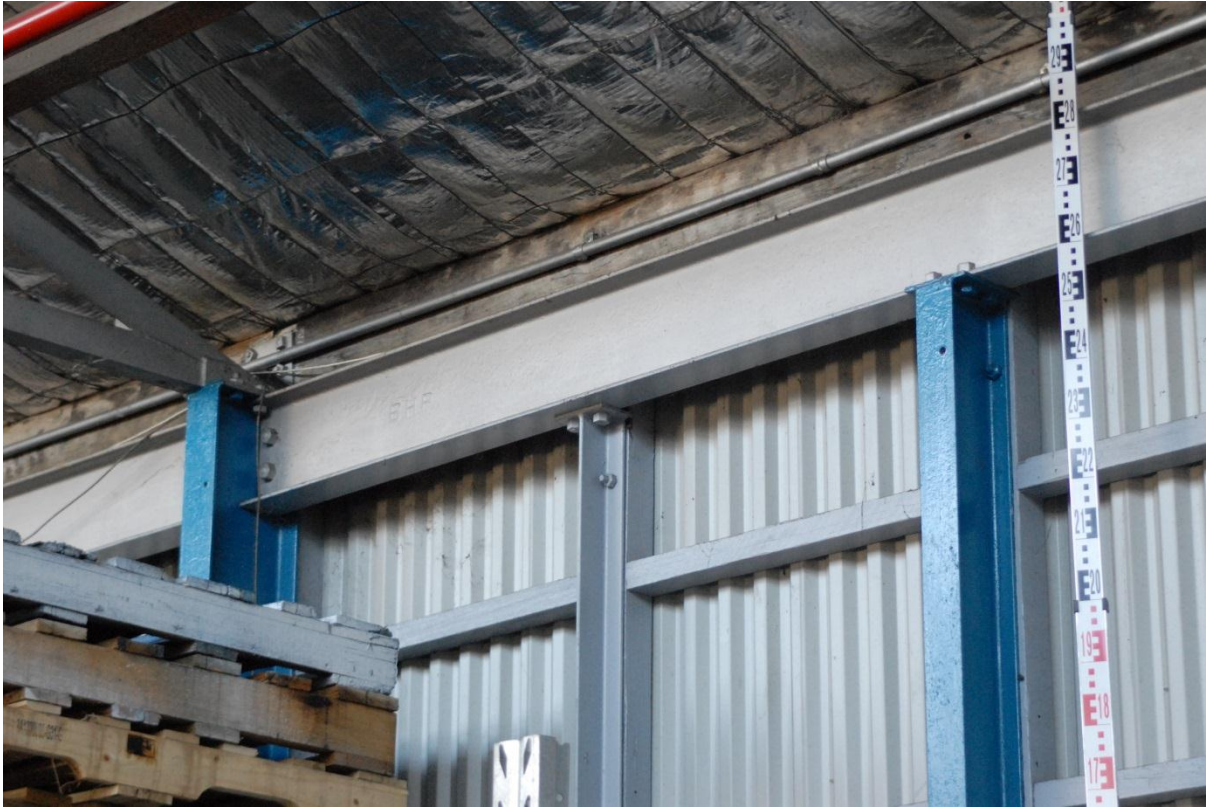
**Figure 8.63 Detail of frame jointing on N wall, (image no. B99 0188)**

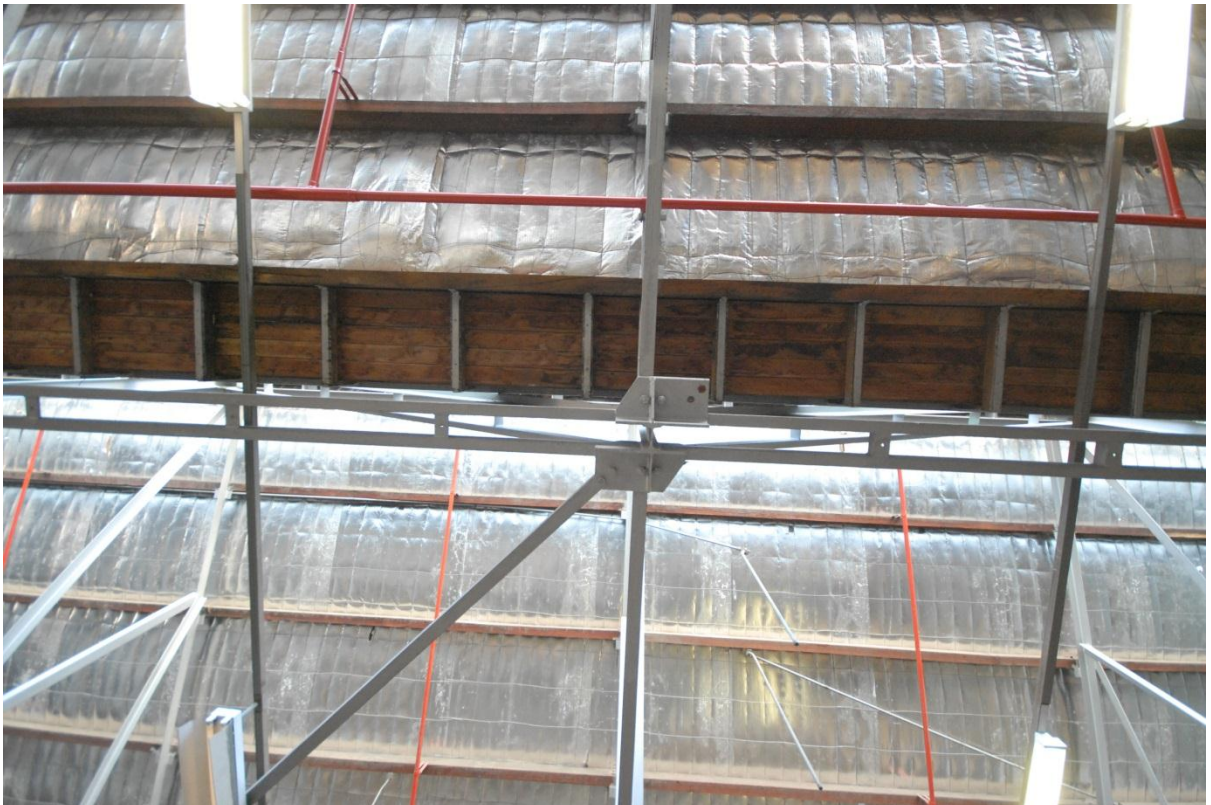
**Figure 8.64 Looking up at roof structure and joining plate adjacent to box drain, note bracing strut (top right) has been removed, (image no. B99 0199)**

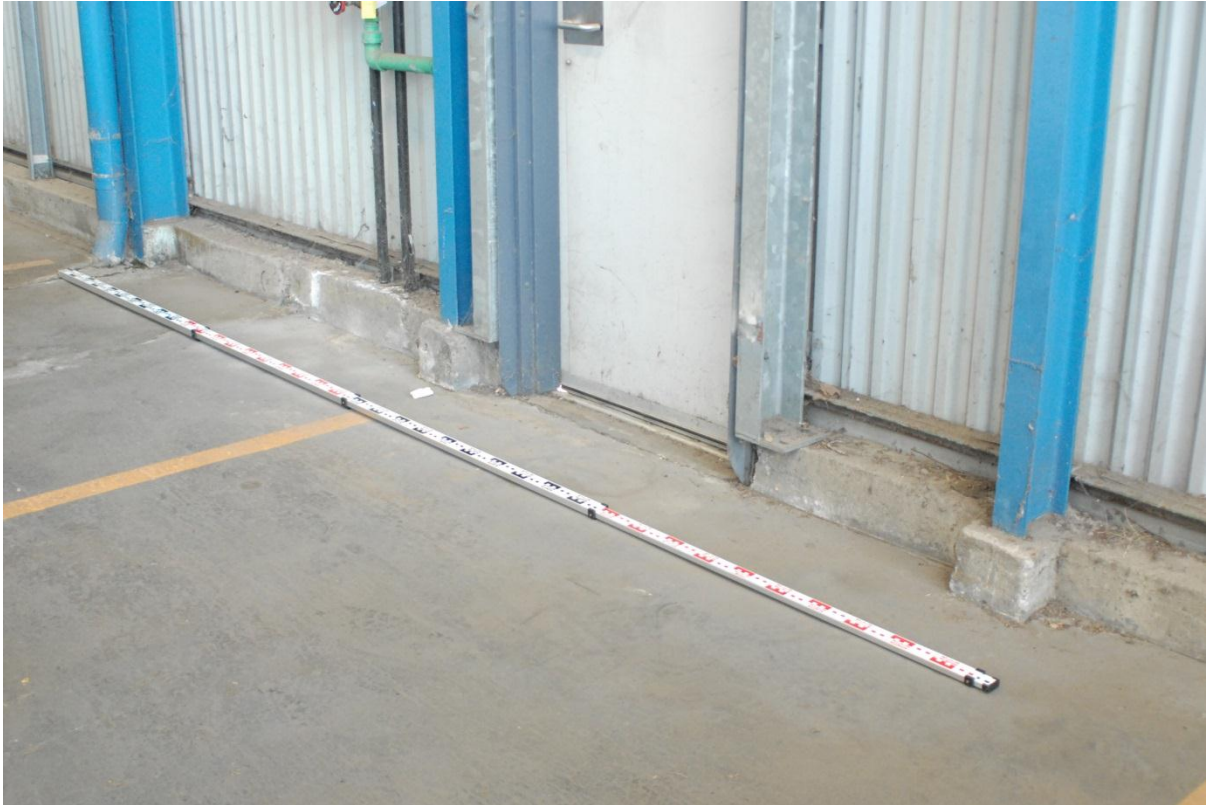
**Figure 8.65 Detail of possibly original interior floor kerbing on E wall, note modern door incision, looking NE (image no. B99 0097)**

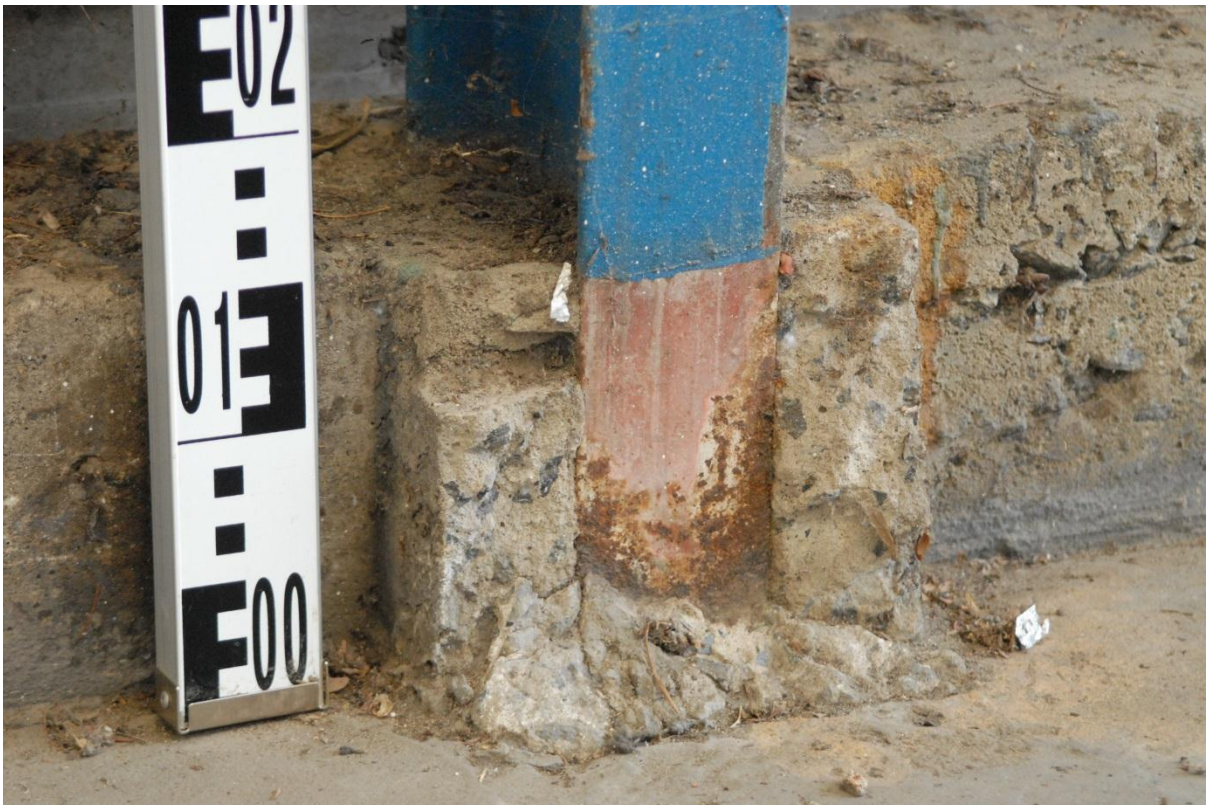
**Figure 8.66 Detail of concrete base around a wall 'I' column showing red-brown paint underneath concrete – possibly the metal primer, or an indication of a former interior colour scheme, (image no. B99 0103)**

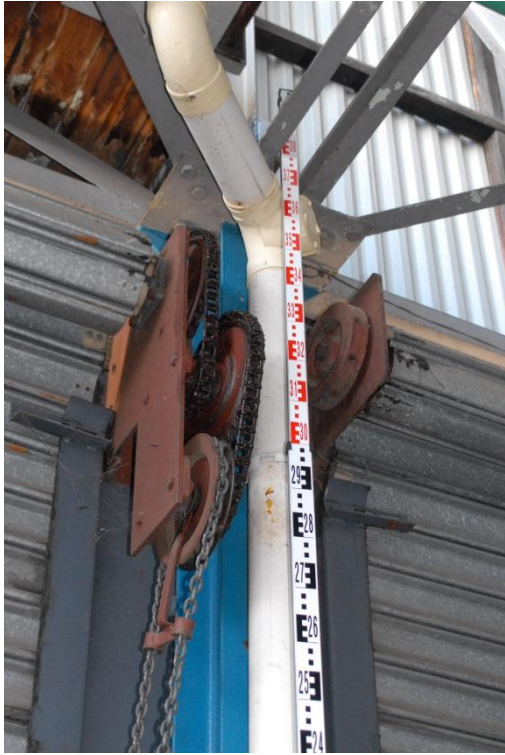
**Figure 8.67 Detail of roller door mechanism on W wall, looking NW, (image no. B99 0140)**

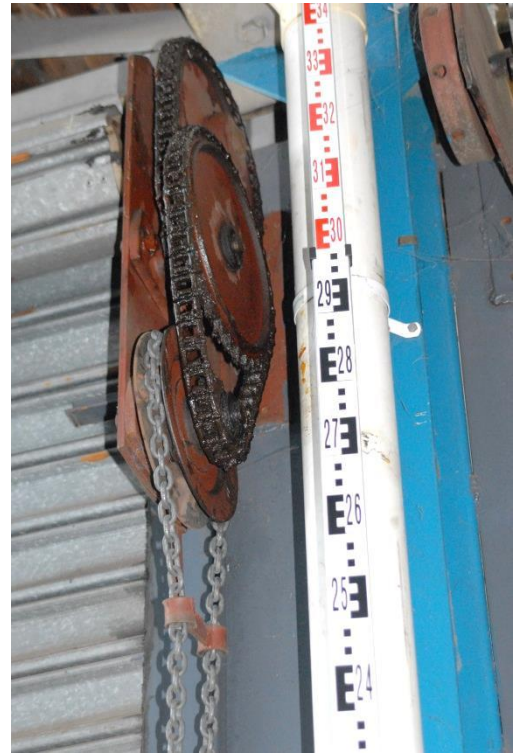
**Figure 8.68 Detail of roller door mechanism on W wall, looking SW, (image no. B99 0142)**

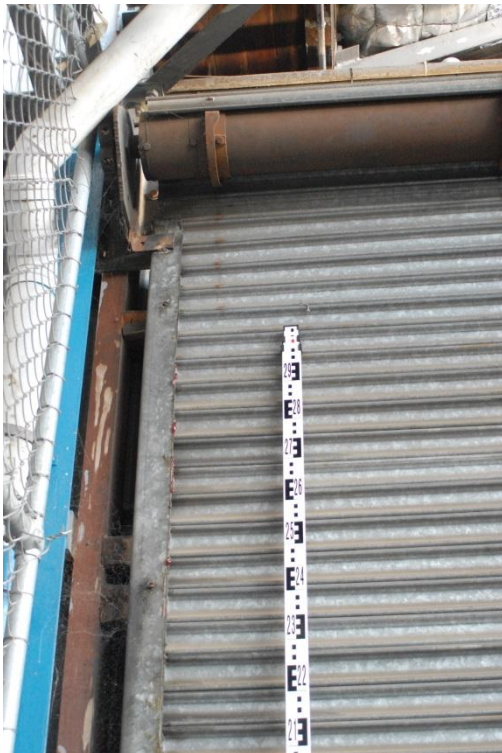
**Figure 8.69 Detail of upper left margin of (older?) roller door on E wall, looking (image no. B99 0088)**

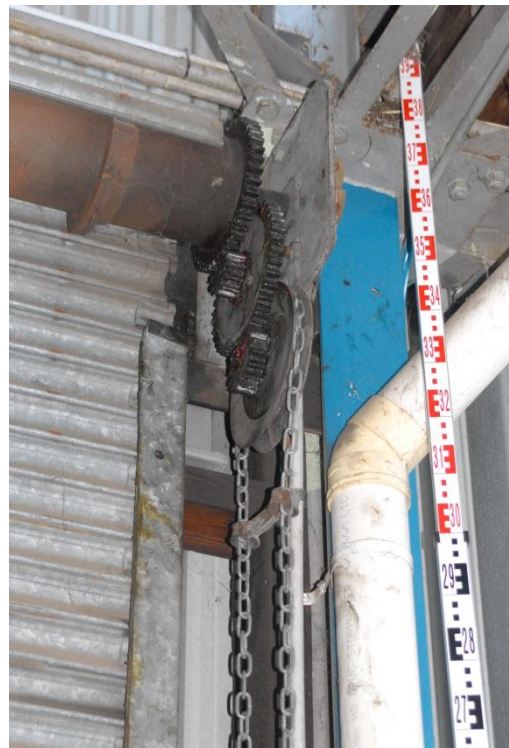
**Figure 8.70 Detail of upper right margin of (older) roller door on E wall, (image no. B99 0094)**

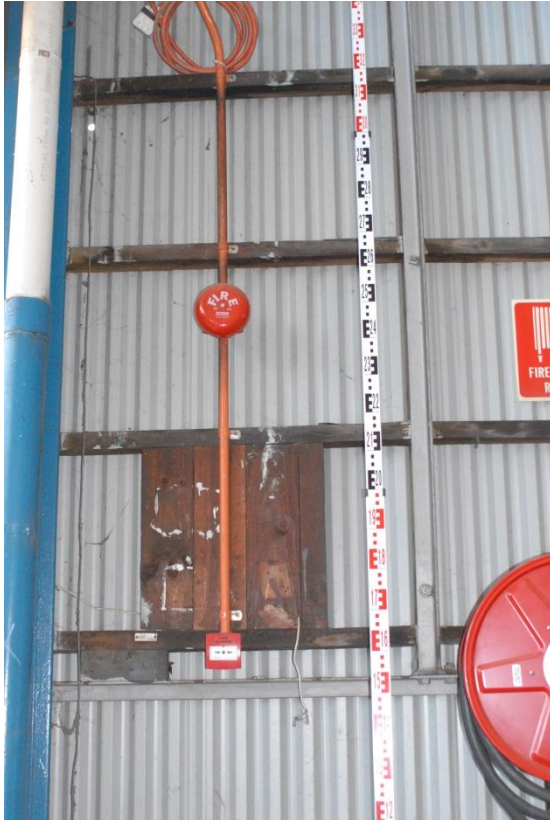
**Figure 8.71 Detail of disused internal electrical board, near SW corner of building, (image no. B99 0134)**

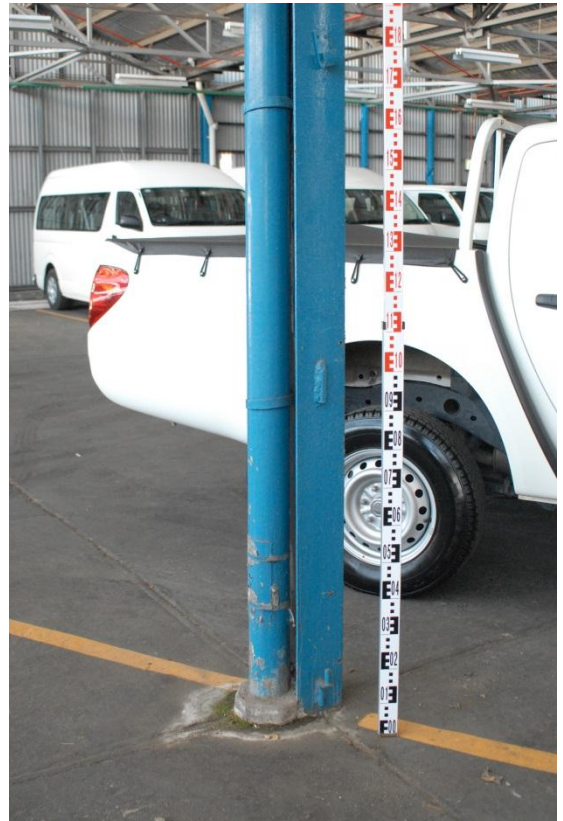
**Figure 8.72 Detail of column with welded fittings, suggesting a formerly attached gate or fence, (image no. B99 0128)**

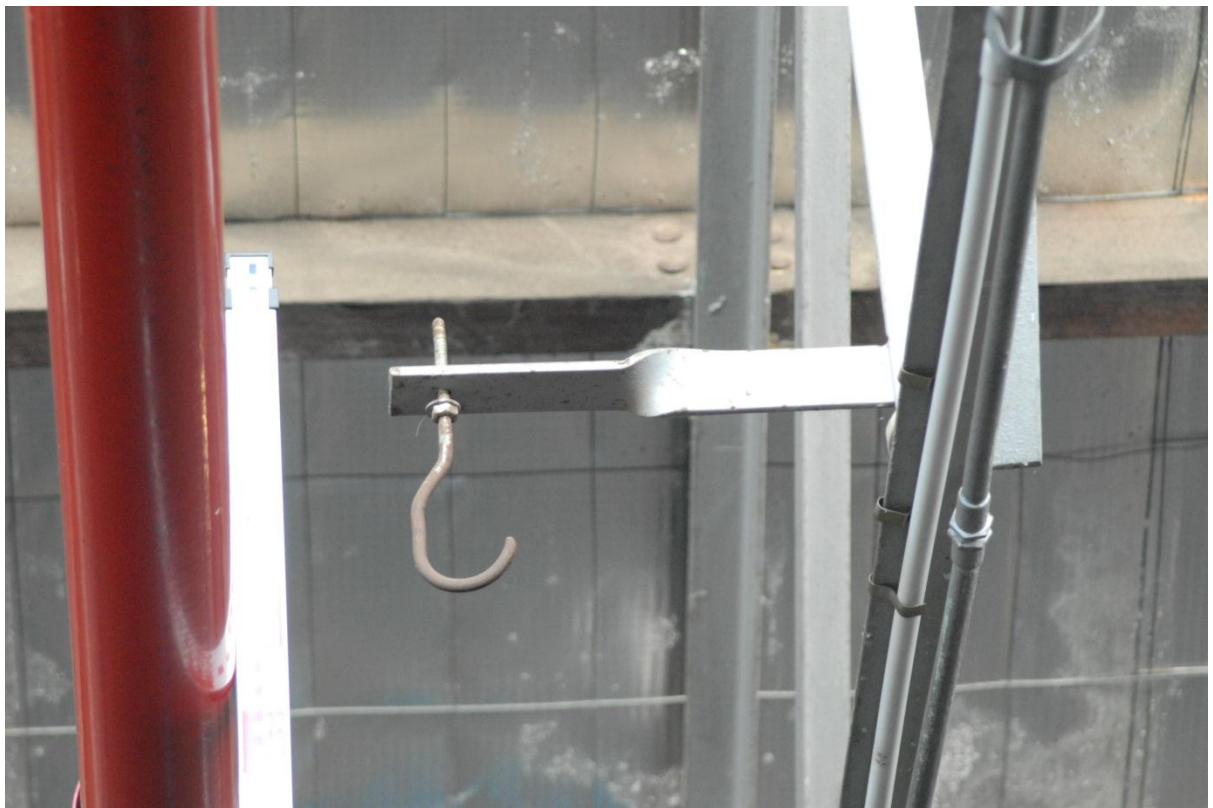
**Figure 8.73 Detail of disused ceiling hook, one of a series aligned in a N-S direction (image no. B99 0148)**

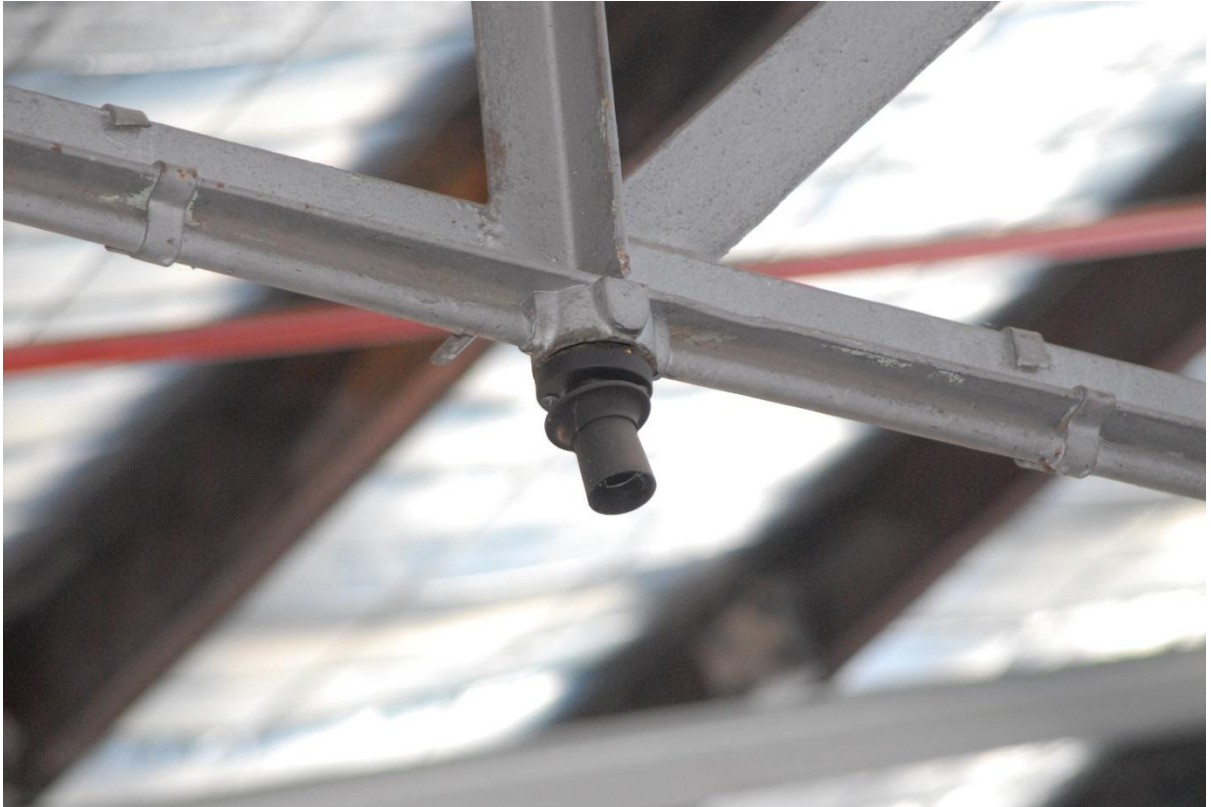
**Figure 8.74 Detail of disused electrical conduit and Bakelite bayonet light fitting, (image no. B99 0307)**

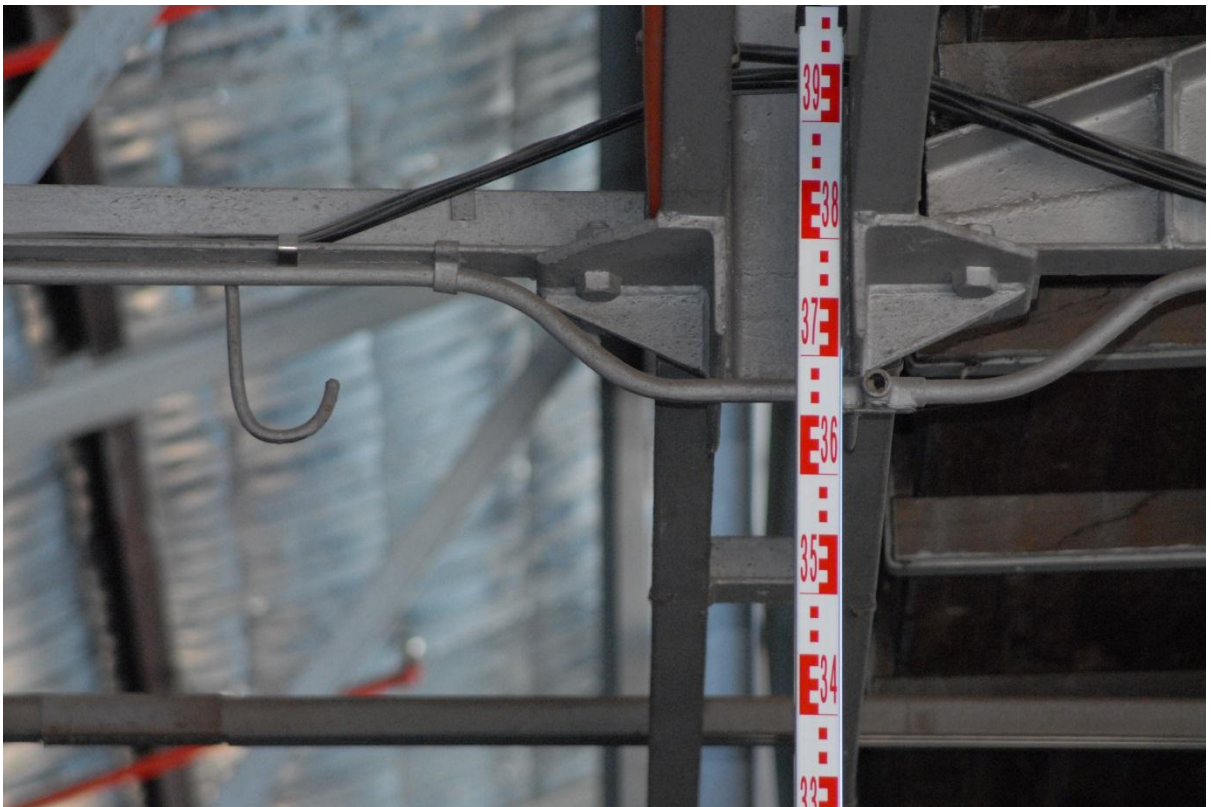
**Figure 8.75 Detail of truss join at base of clerestory window, also showing old electricity conduit and disused remnant ceiling hook, one of a series running E-W across the building, (image no. B99 0303)**
