# Appendix K Cultural Heritage Archival Recordings

## 9.5 Sample Set of Photographic Prints

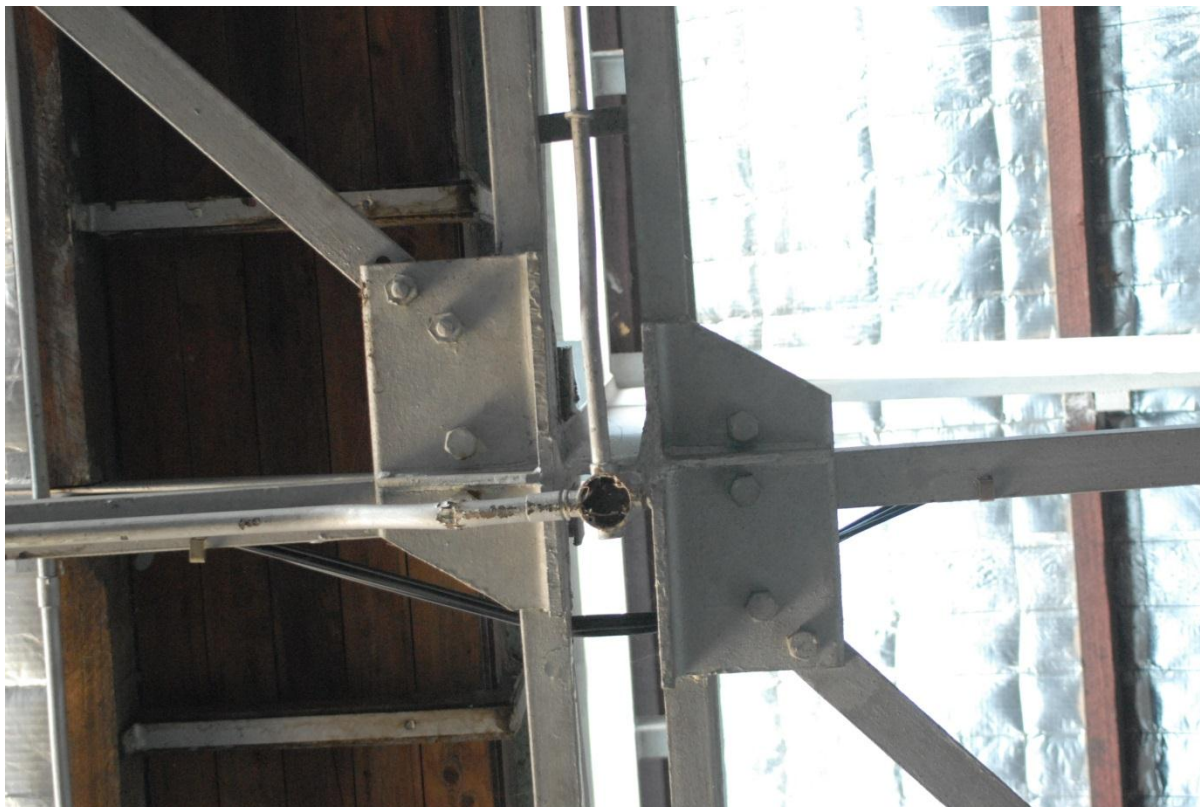
**Figure 8.76 Detail of joining plates at base of clerestory window, (image no. B99 0151)**

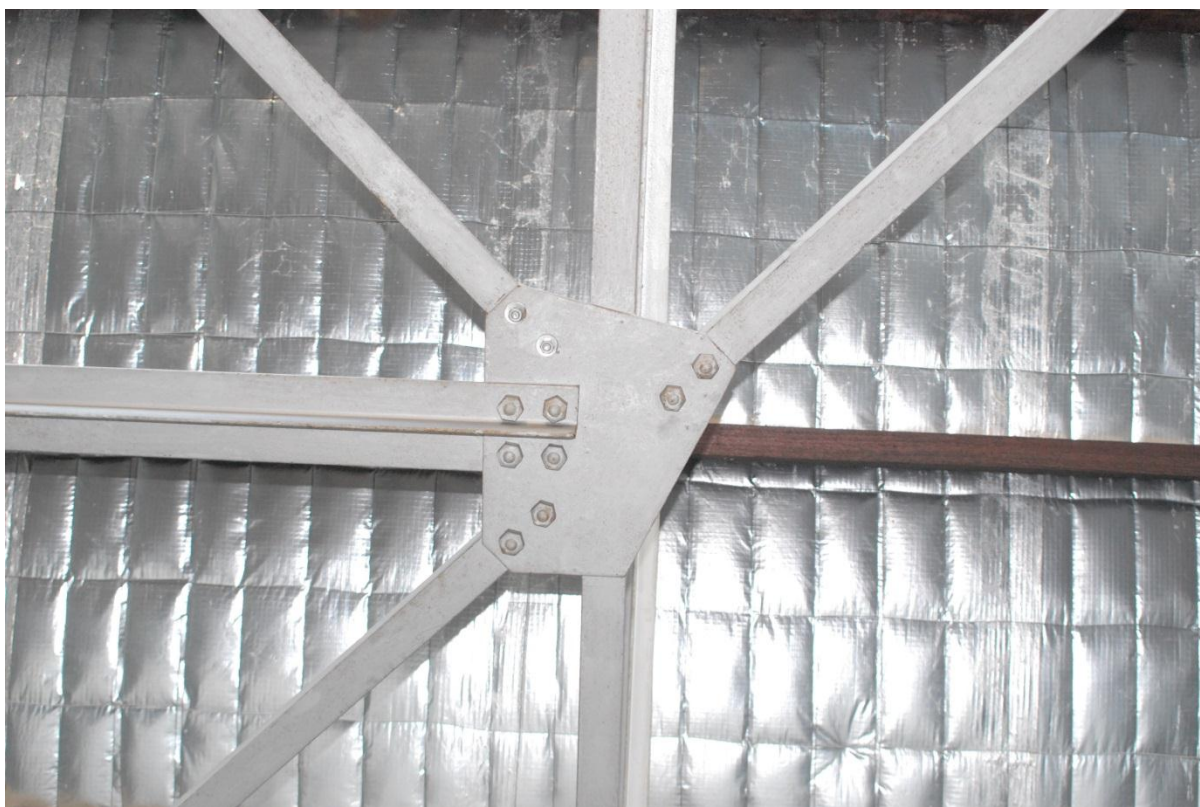
**Figure 8.77 Detail of 6-way roof join and plate, near wall, (image no. B99 0154)**

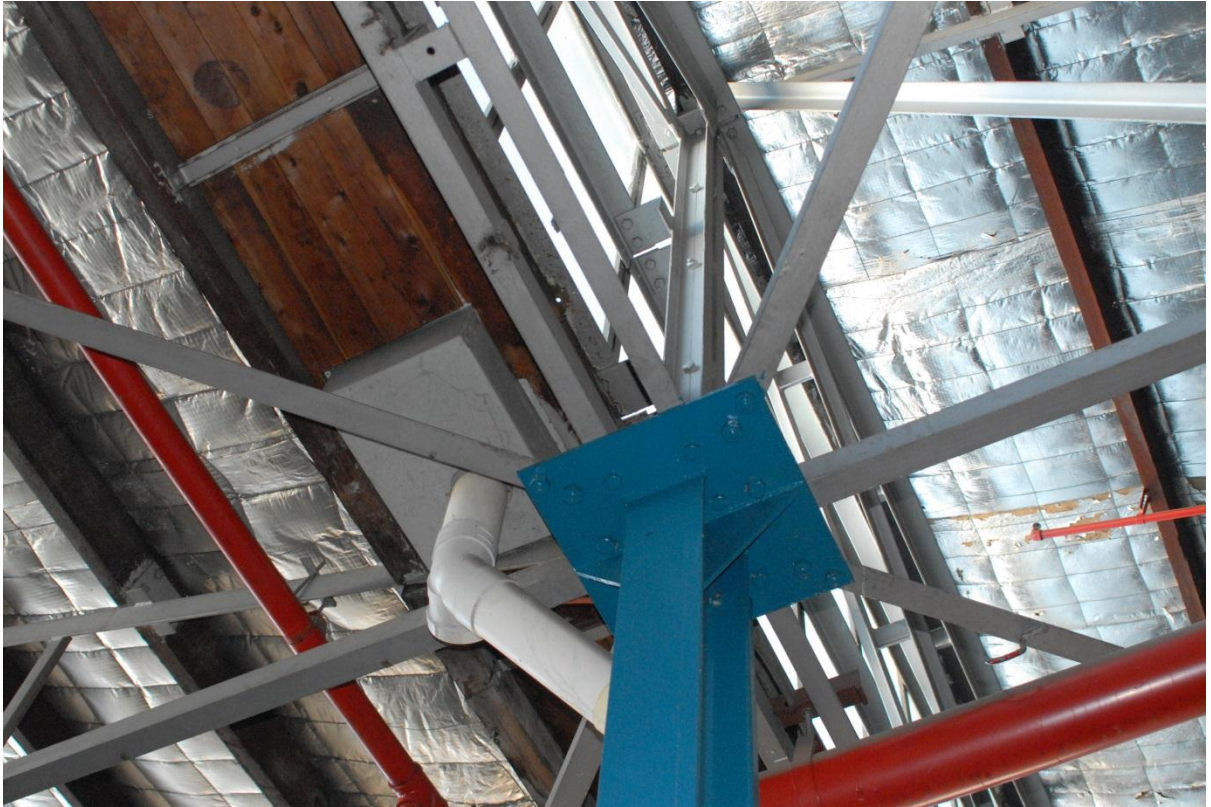
**Figure 8.78 Detail of top of central-axis roof column, situated at the point of intersection of cross bracing, showing associated jointing, (image no. B99 0159)**

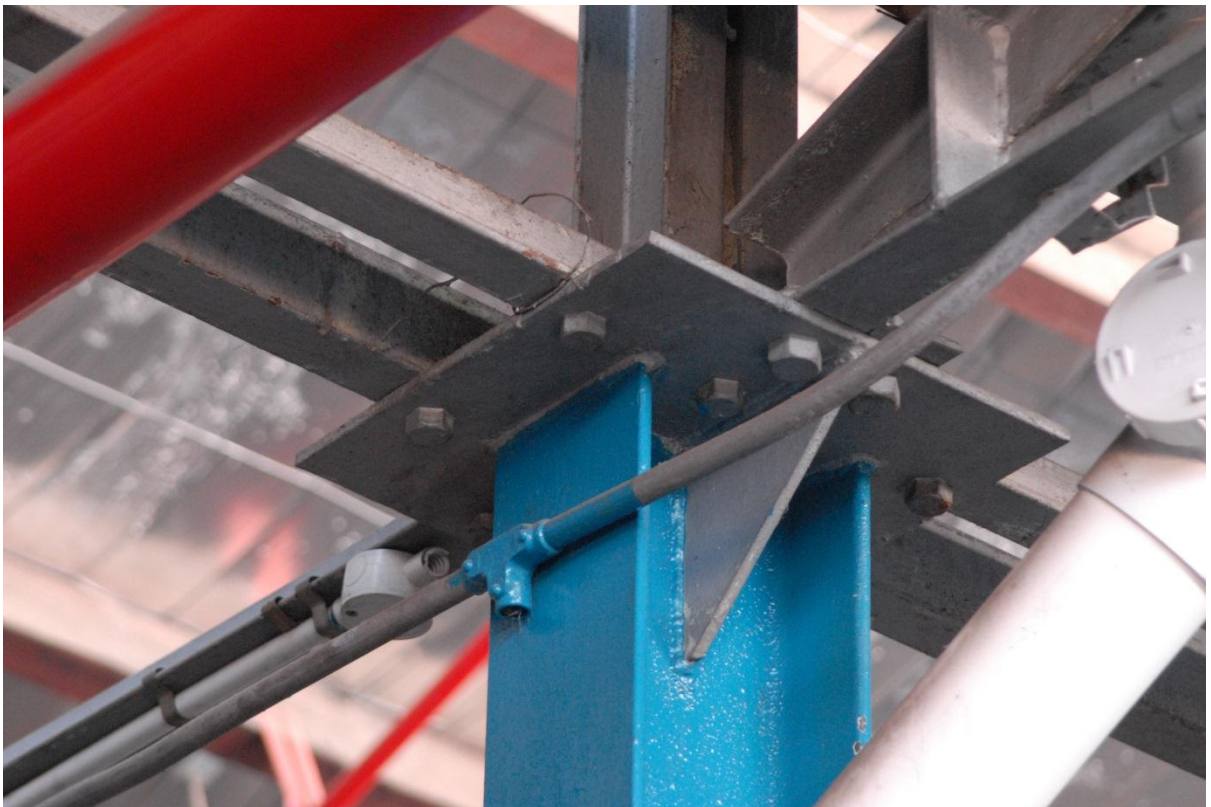
**Figure 8.79 Detail of top of column, not situated at intersection of roof bracing, (image no.B99 0164)**
