# **Lot 12 Old Maitland Road Sandgate, NSW**

*Hazardous Materials Assessment*

For Crawford's Freightlines Pty Ltd

Date - 28 March 2012

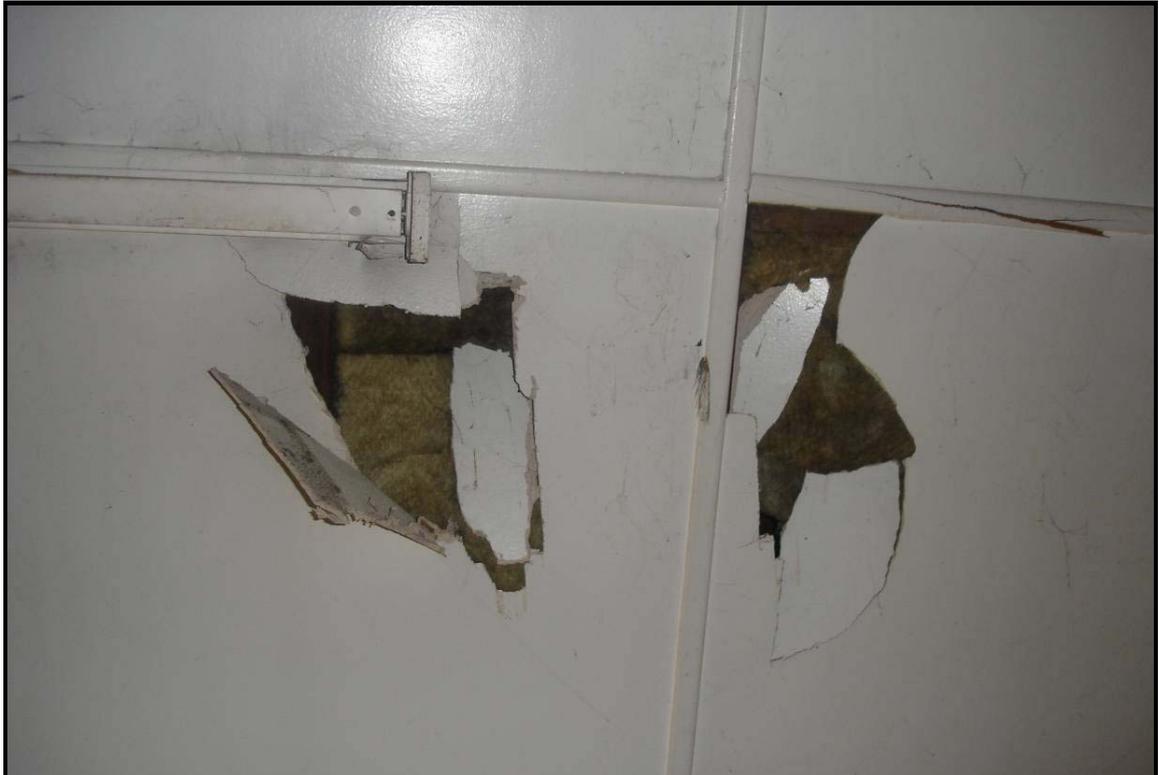
**Photograph: 1** View of broken sections of fibrous cement ACM within the Shower Block of Shed D (23 February 2012).

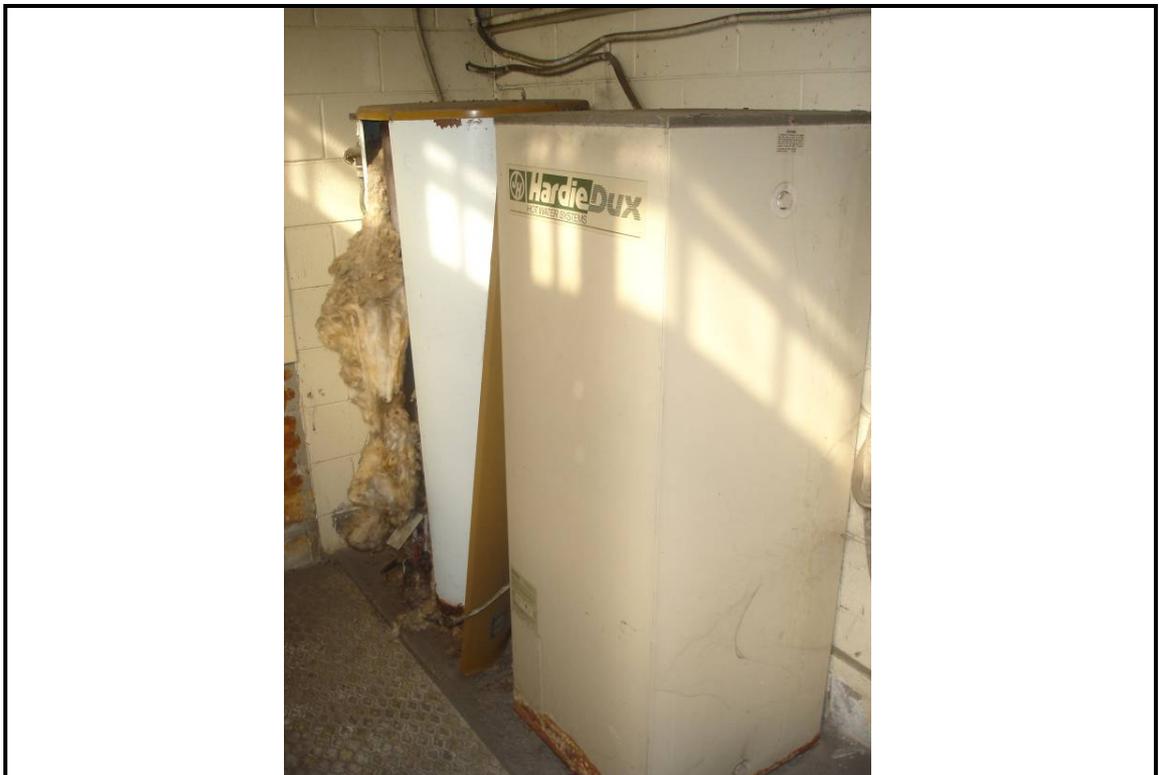
**Photograph: 2** View of water heaters with SMF insulation falling out of the water heater to the rear of shot (23 February 2012).

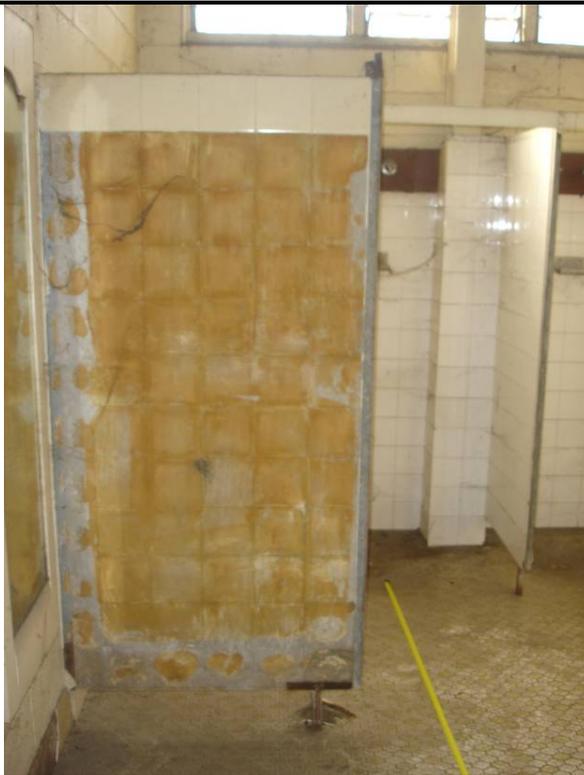
**Photograph: 3** View of shower partitions with compressed asbestos cement sheeting, partition is one of five partitions in Shower Block, Shed D (23 February 2012).

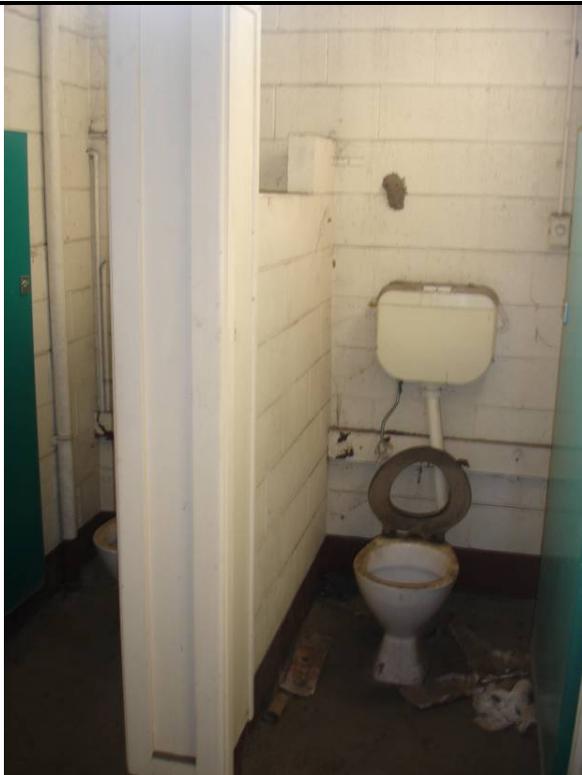
**Photograph: 4** View of fibrous cement ACM section of the partition between toilets (23 February 2012).

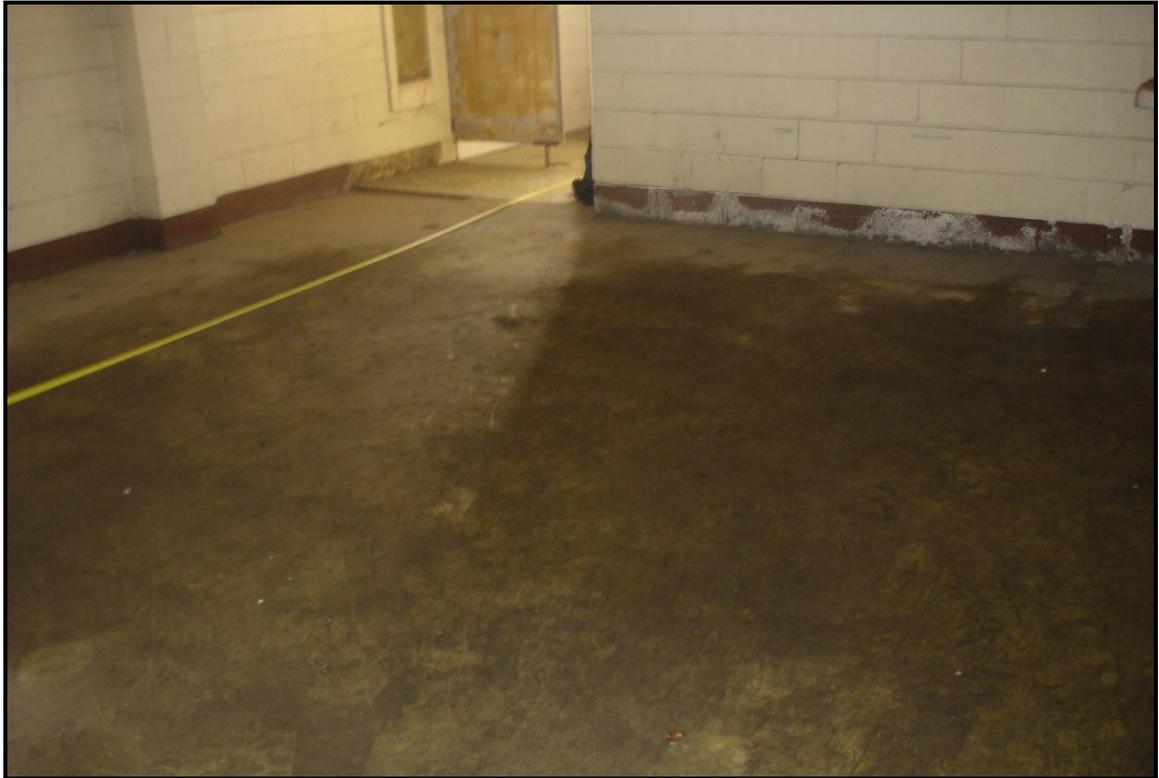
**Photograph: 5** | View of vinyl tile ACMs to floor of the Shower Block, Shed D (23 February 2012).

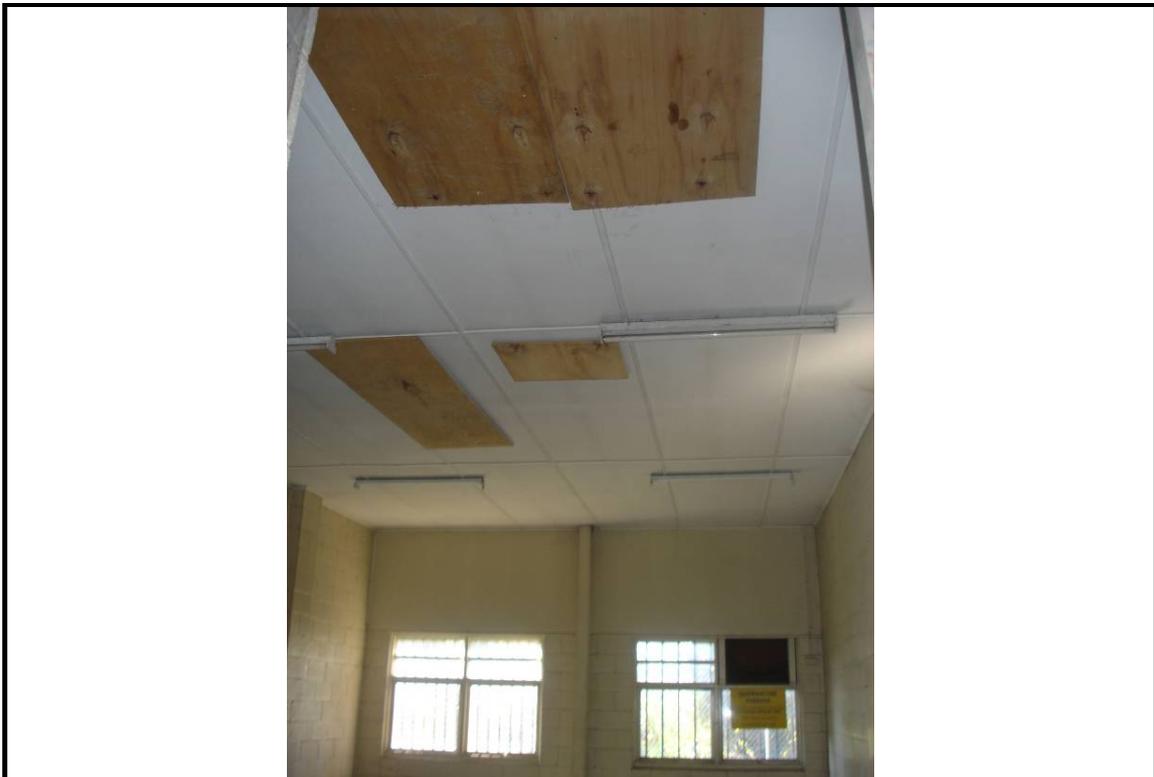
**Photograph: 6** | View of fibrous cement ACM with to ceiling with plywood sections used for repairing broken sections, Quarantine Inspection Area, Shed D (23 February 2012).

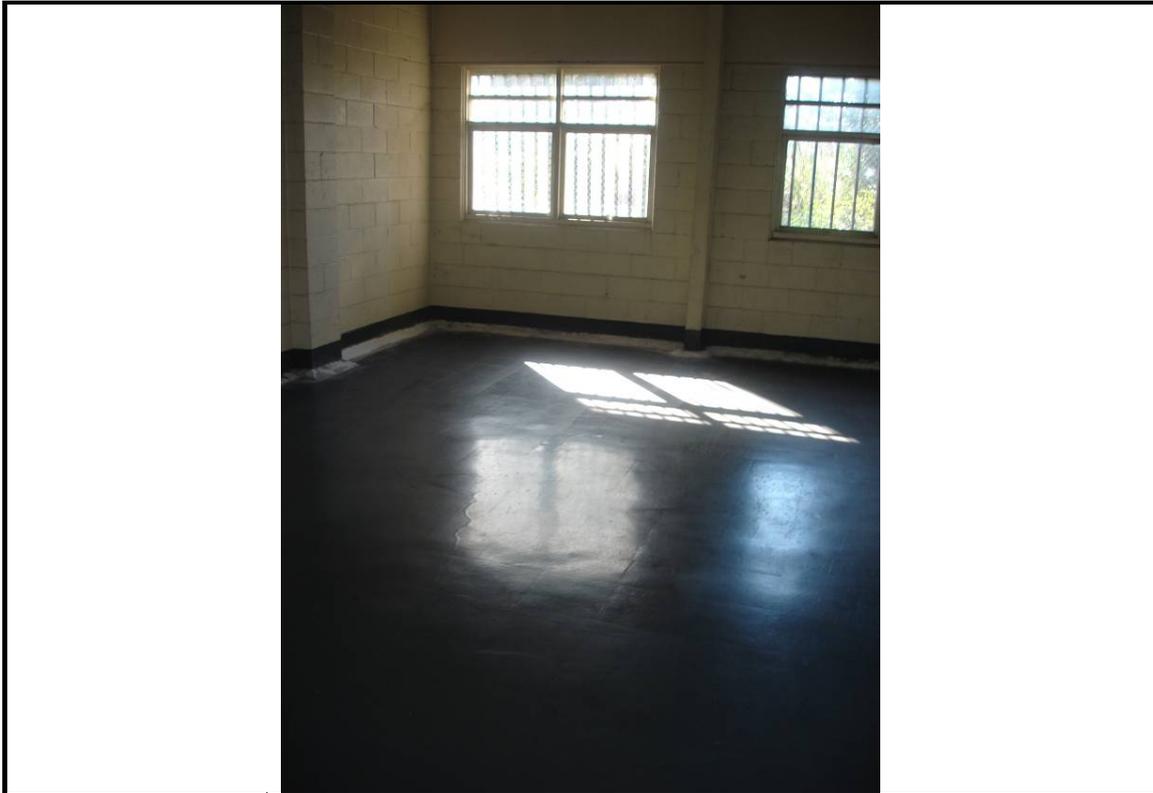
**Photograph: 7** View of vinyl floor tiles assumed to contain asbestos to Quarantine Inspection Area, Shed D(23 February 2012).

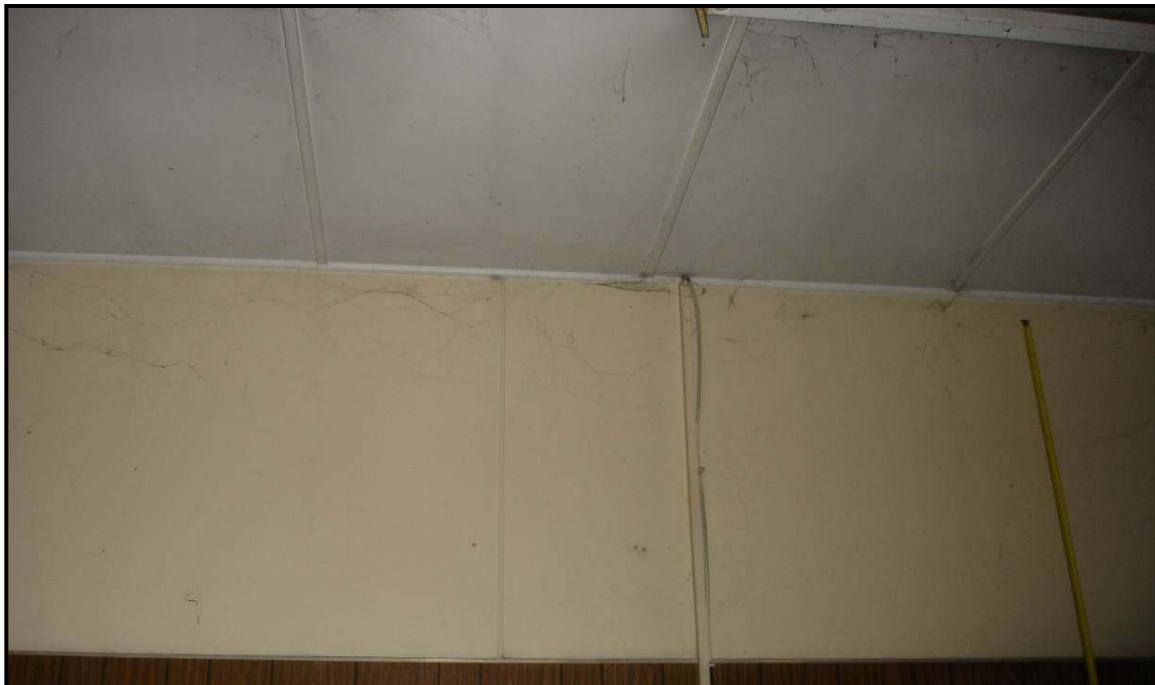
**Photograph: 8** View of fibrous cement ACM to ceiling and upper panels of dividing wall in Office, Shed D (23 February 2012).

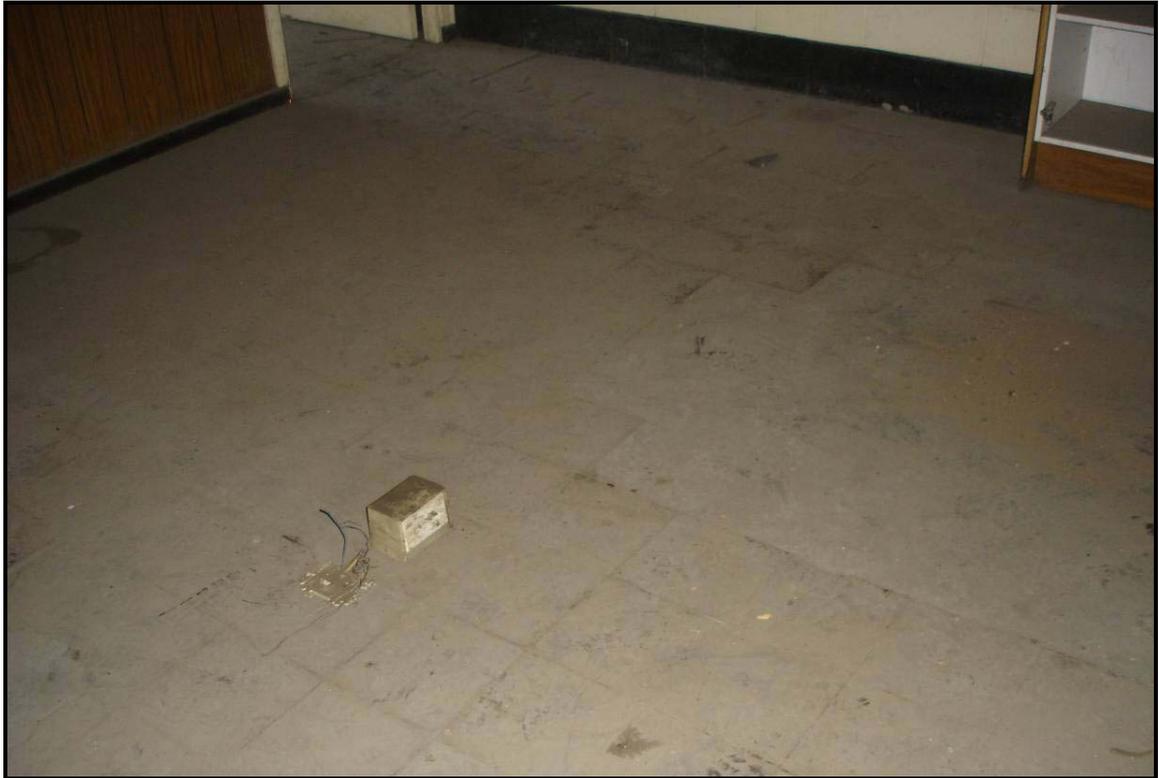
**Photograph: 9** | View of vinyl tile ACMs to floor of Office area, Shed D (23 February 2012).

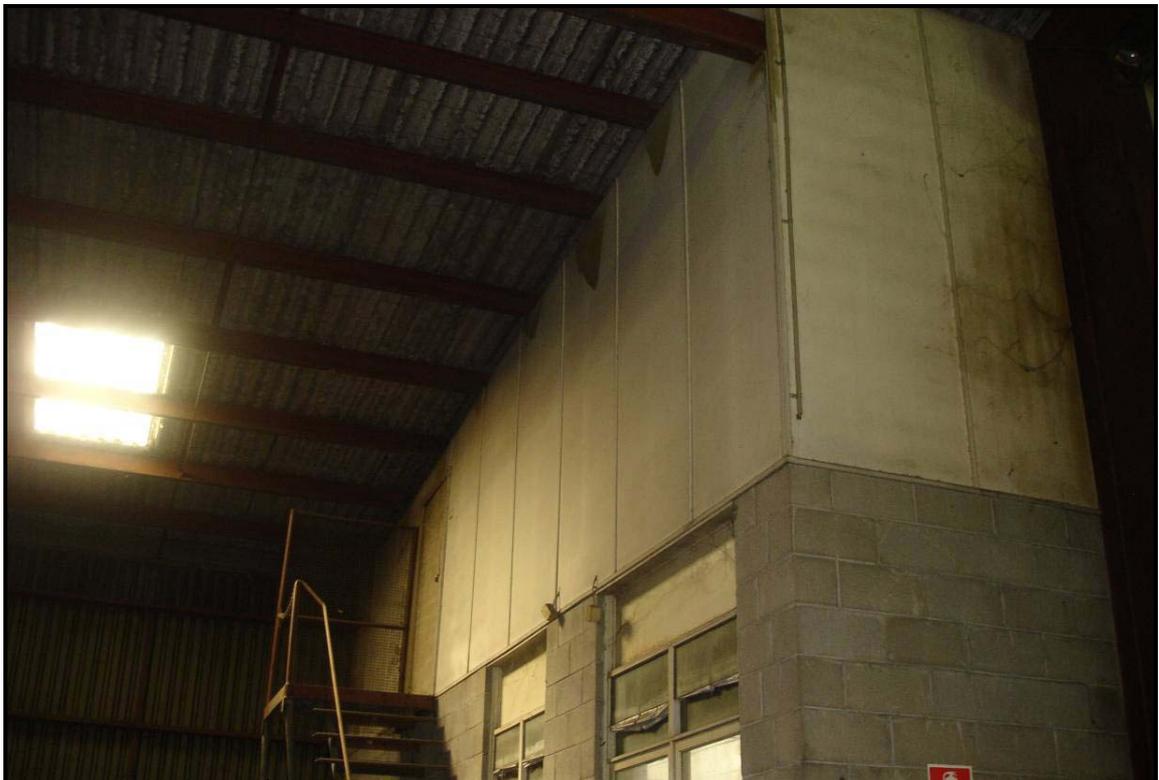
**Photograph: 10** | View of fibrous cement ACM to upper wall panels (23 February 2012).

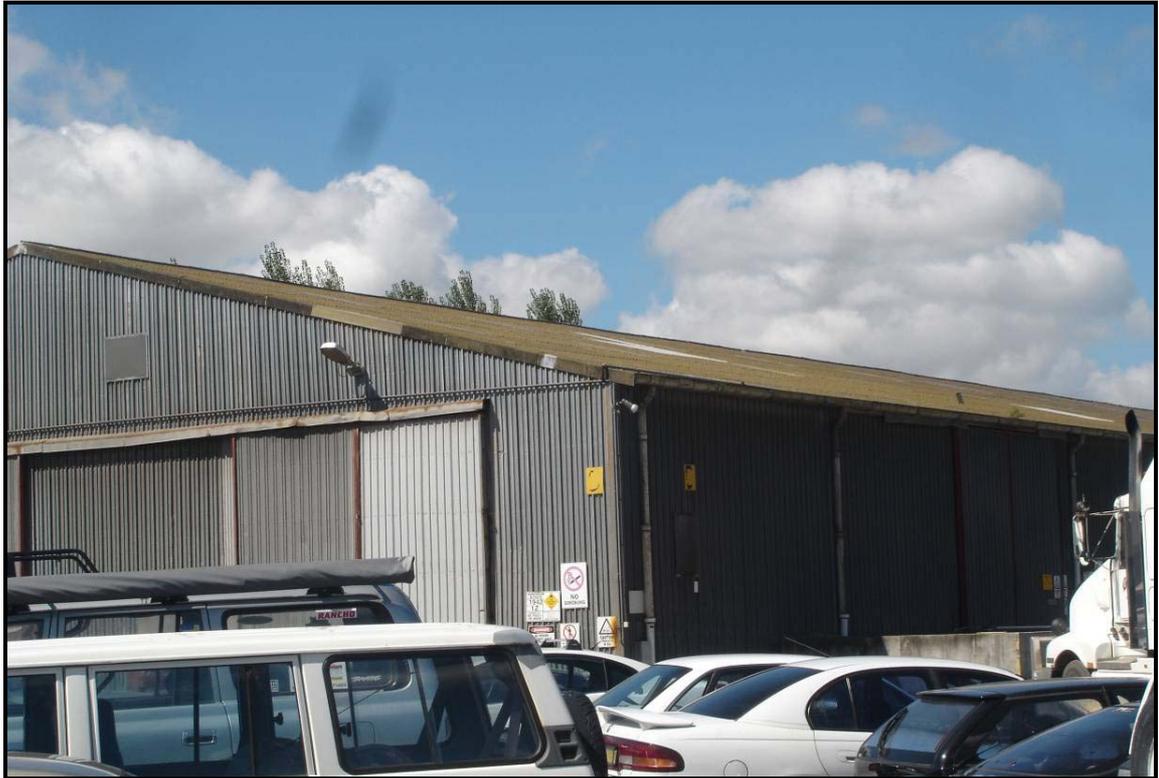
Materials regarded as a high priority for action according to their risk rating included the external ACMs to the Administration Building, Shed C and Shed D. The ACMs included the corrugated roofing sheets, gutters and roof gable capping were noted to be in a weathered and potentially degraded condition. If these materials were to further deteriorate there is potential for asbestos fibres to be released to the environment following rainfall events.

**Photograph: 11** View of Shed D with corrugated fibrous cement ACM roofing (23 February 2012).

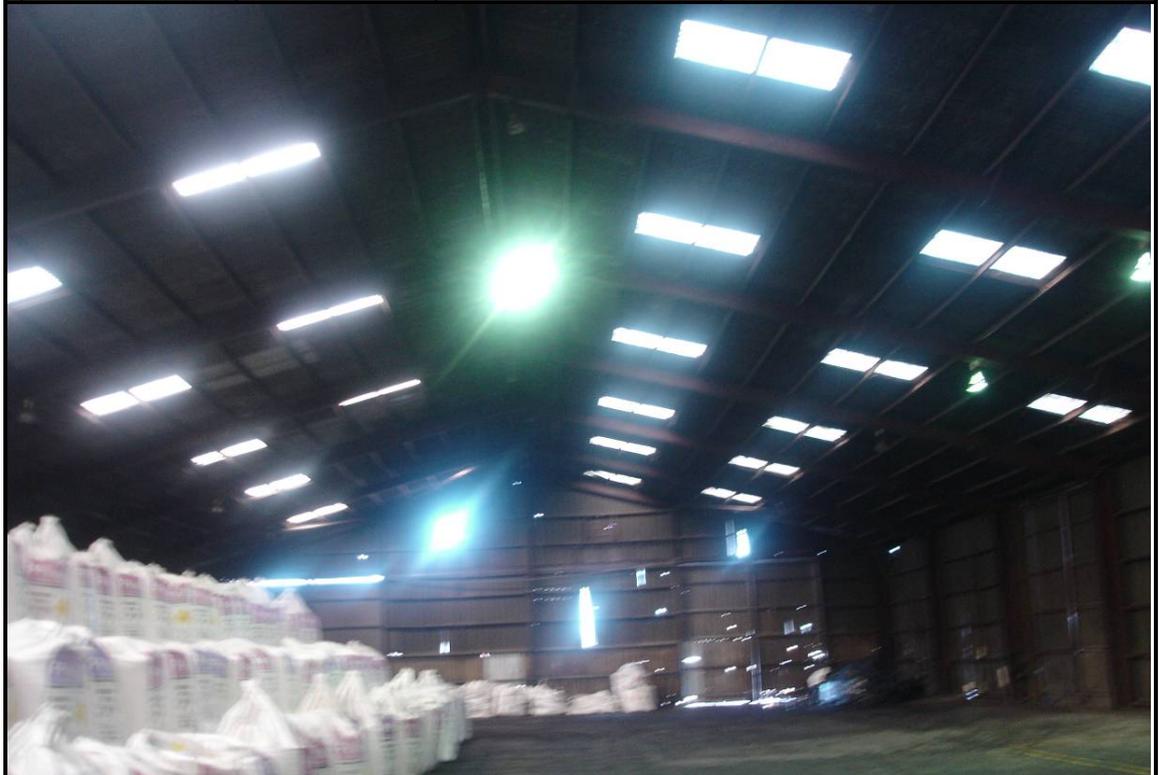
**Photograph: 12** View of internal areas of Shed D showing underside of ACM corrugated fibrous cement roofing (23 February 2012).

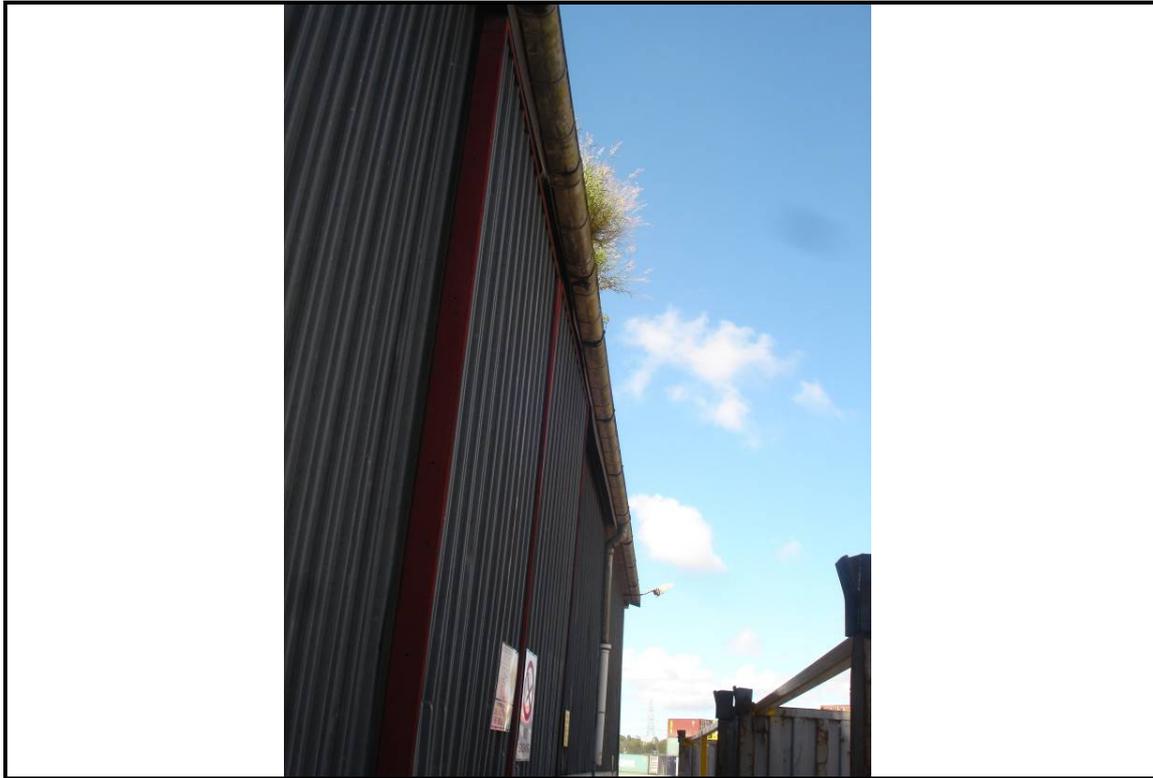
<b>Photograph: 13</b>	View of ACM roof guttering, Shed D (23 February 2012).
Crawfords Freightlines Pty Ltd. (Lot 12, DP625053)	<b>ERM</b>

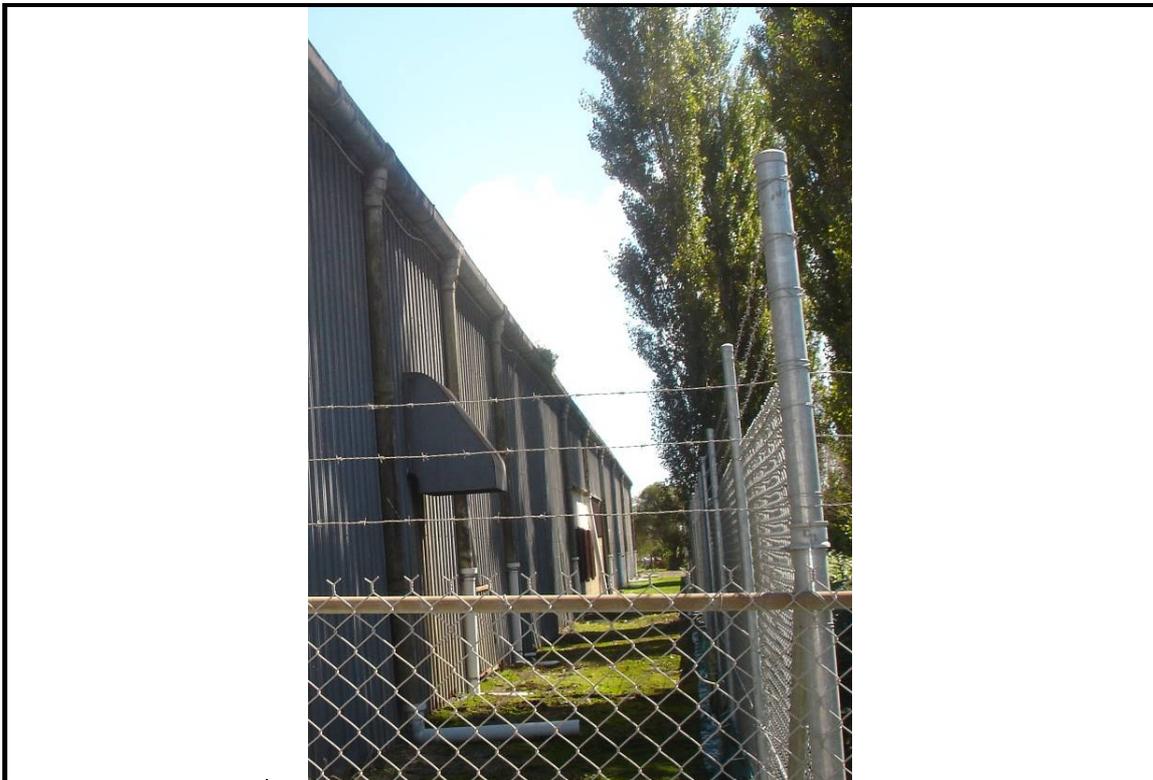
<b>Photograph: 14</b>	View of ACM guttering and down pipes emitting to surface on east side of Shed D (23 February 2012).
Crawfords Freightlines Pty Ltd. (Lot 12, DP625053)	<b>ERM</b>

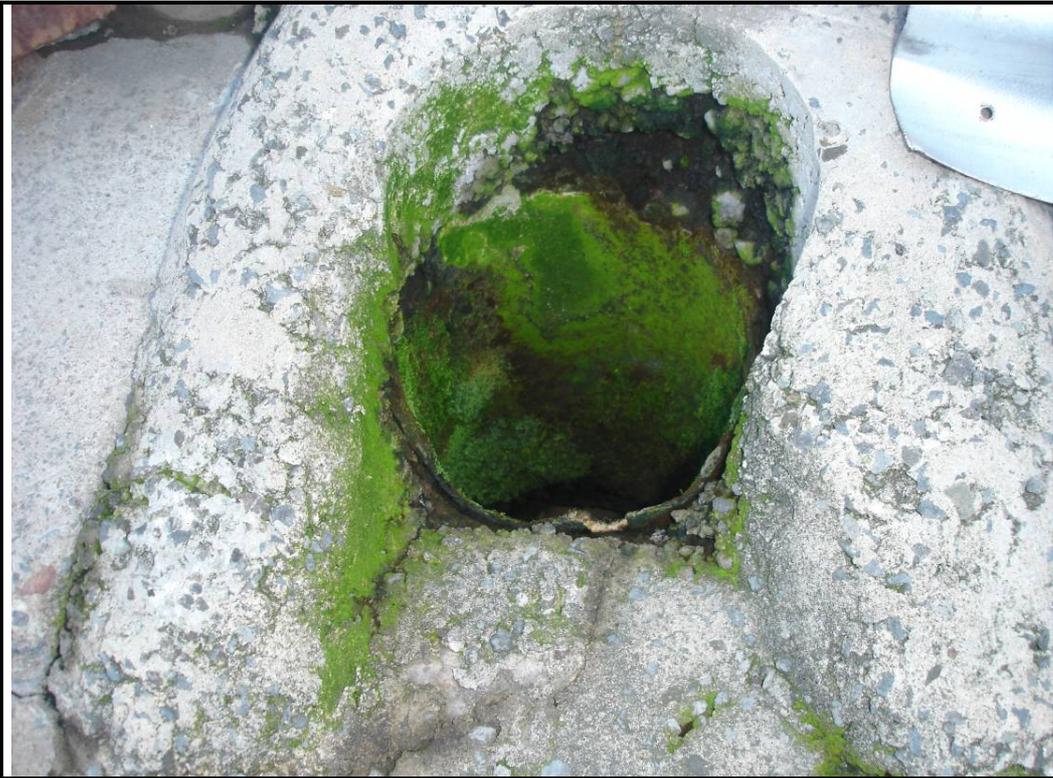
**Photograph: 15** View of former downpipe extending 0.5m below ground level and broken off at ground level. Pipe identified to contain ACM (ERM02) and located on west side of Shed D (23 February 2012).

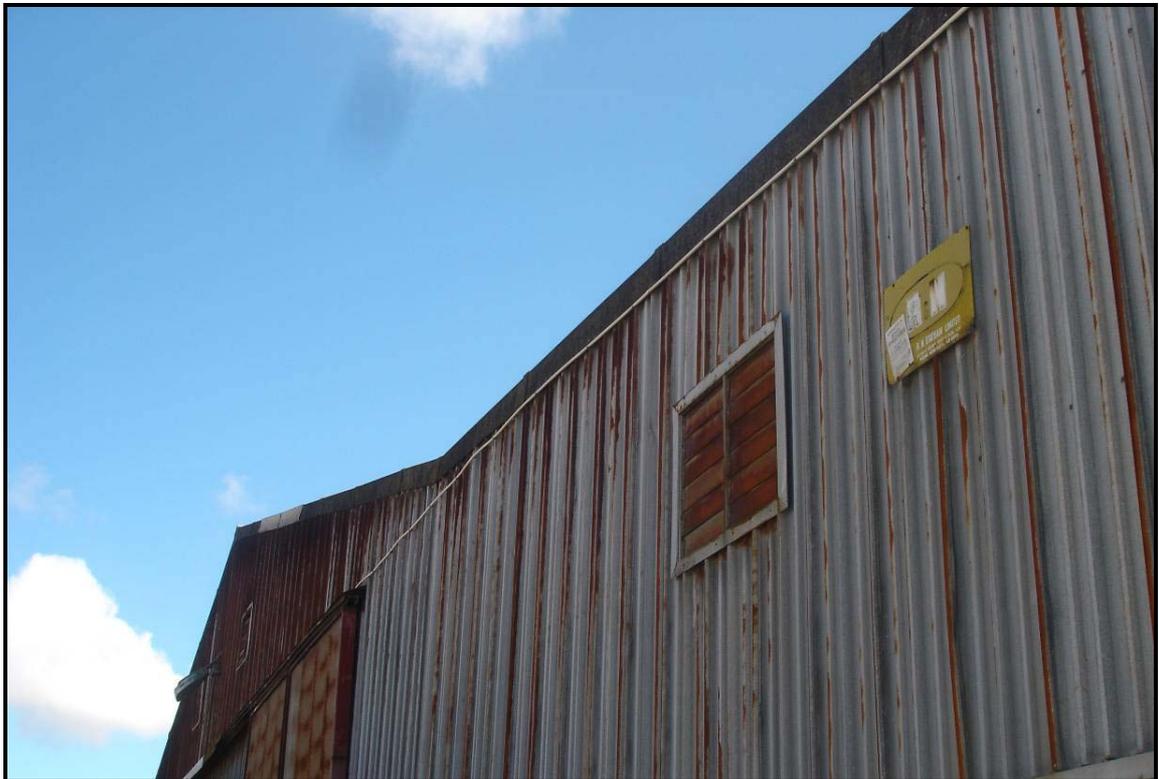
**Photograph: 16** View of gable end capping to roof, Shed D (23 February 2012).

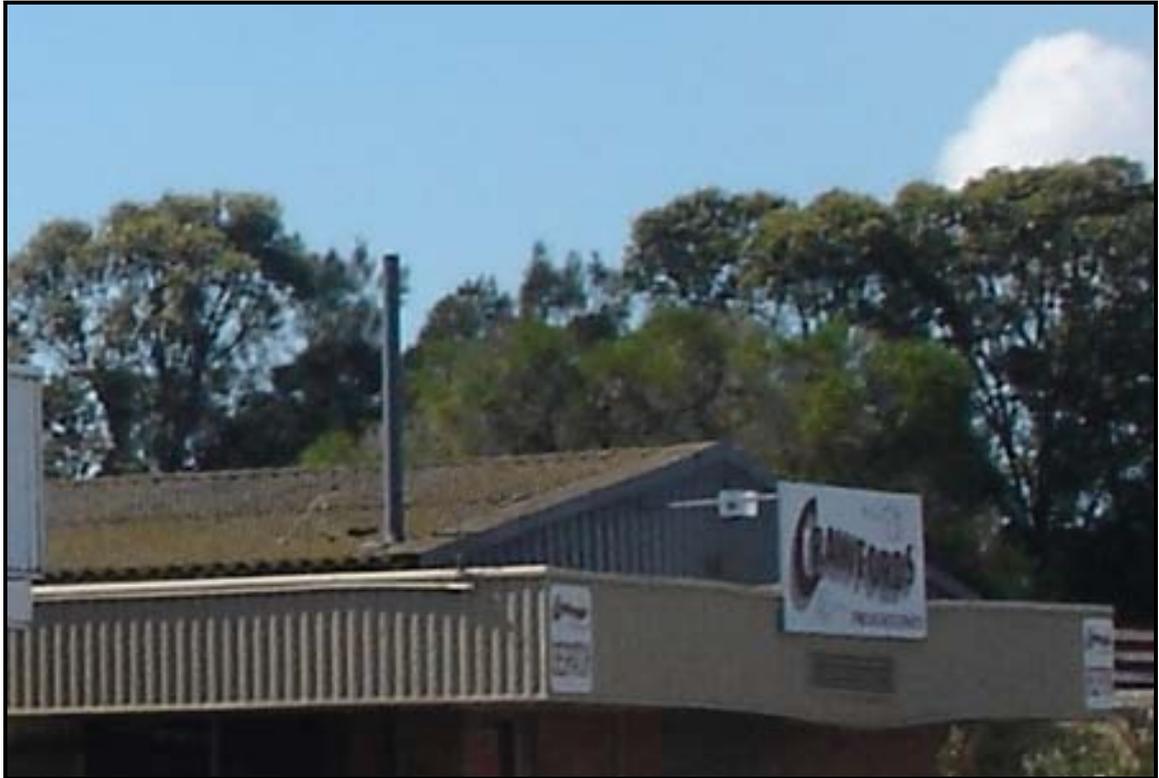
**Photograph: 17** | View of eaves and awning area to east side of Administration Building (23 February 2012).

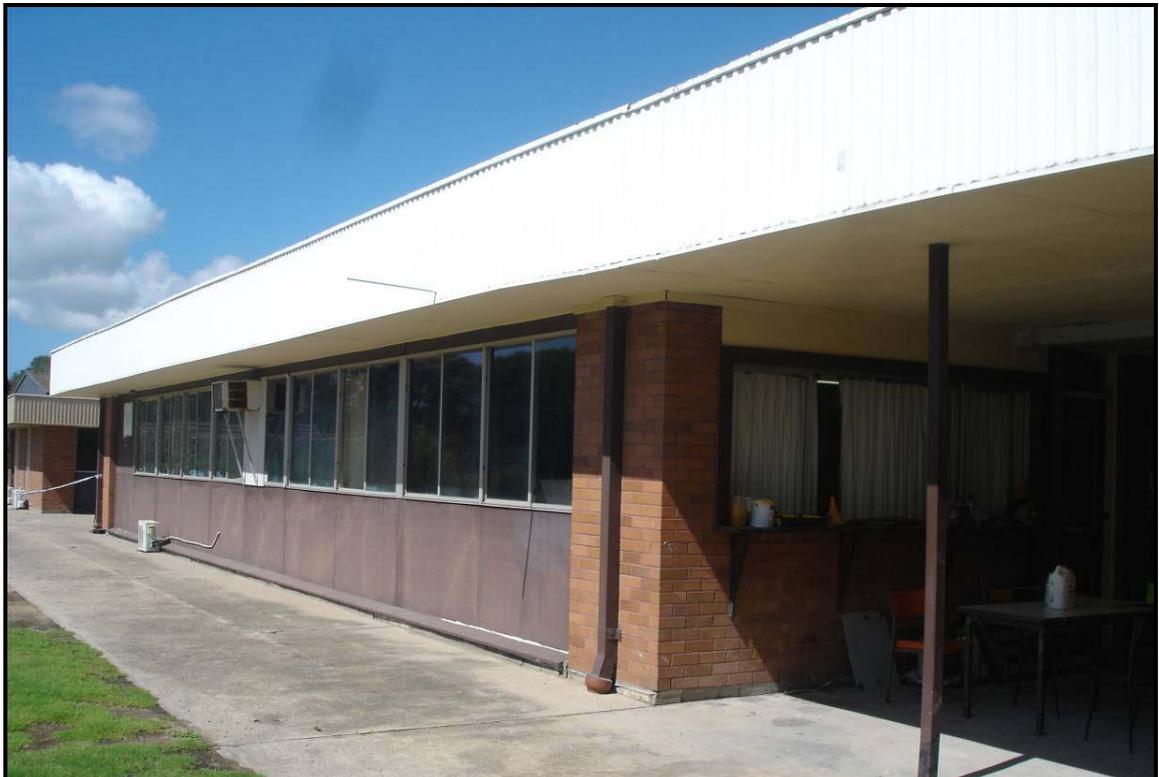
**Photograph: 18** | View of eaves and awning area to east side of Administration Building (23 February 2012).

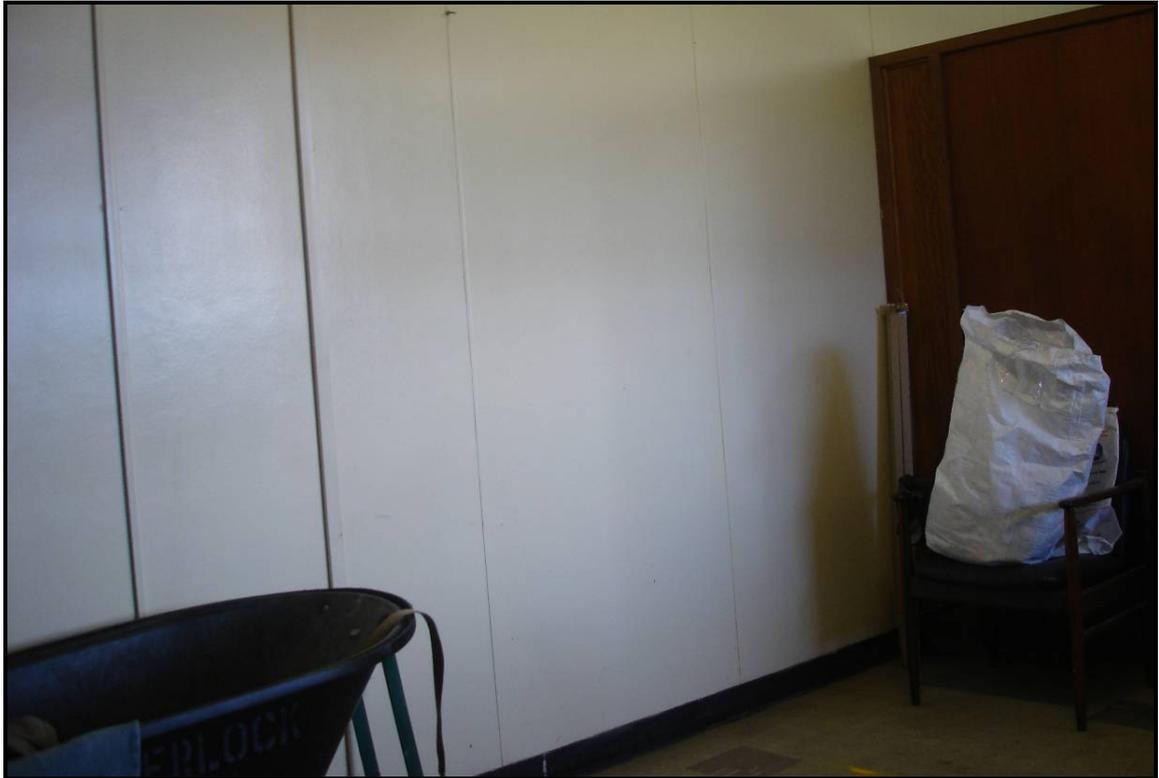
**Photograph: 19** | View of ACM wall paneling and ACM vinyl tiles (23 February 2012).

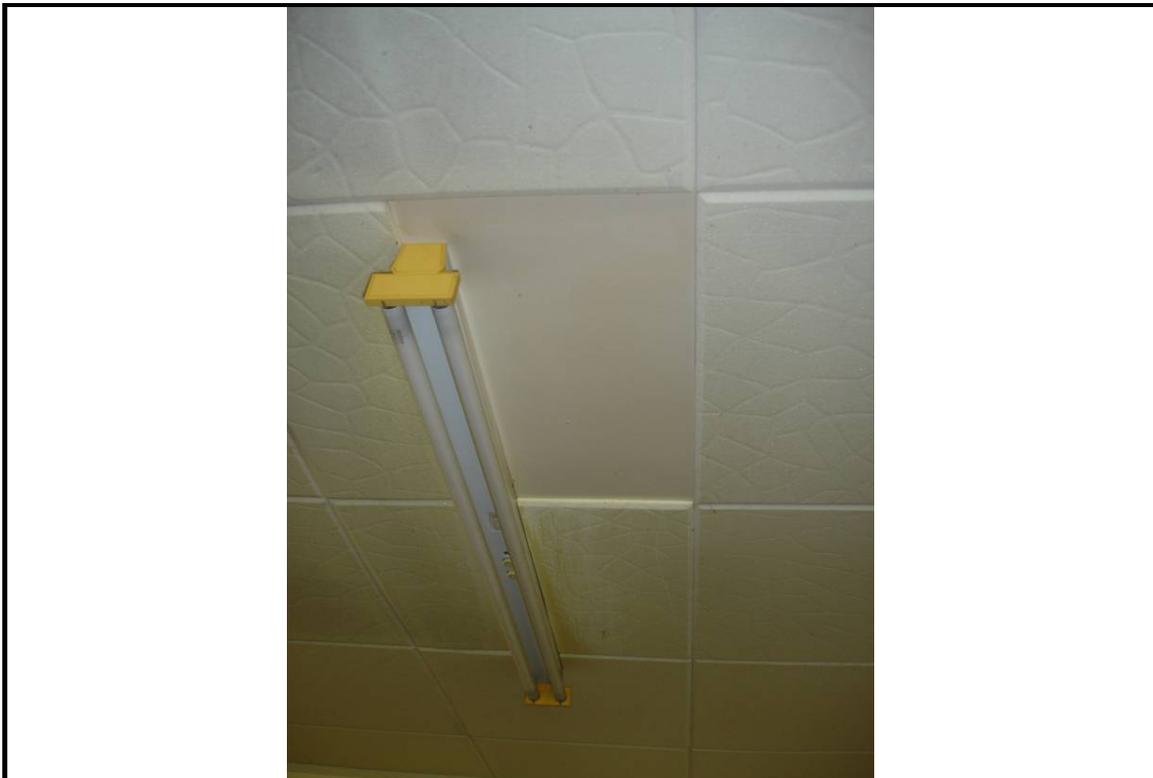
**Photograph: 20** | View of ACM fibrous cement ceiling with polystyrene tiles glued to surface, Central section offices, Administration Building (23 February 2012).

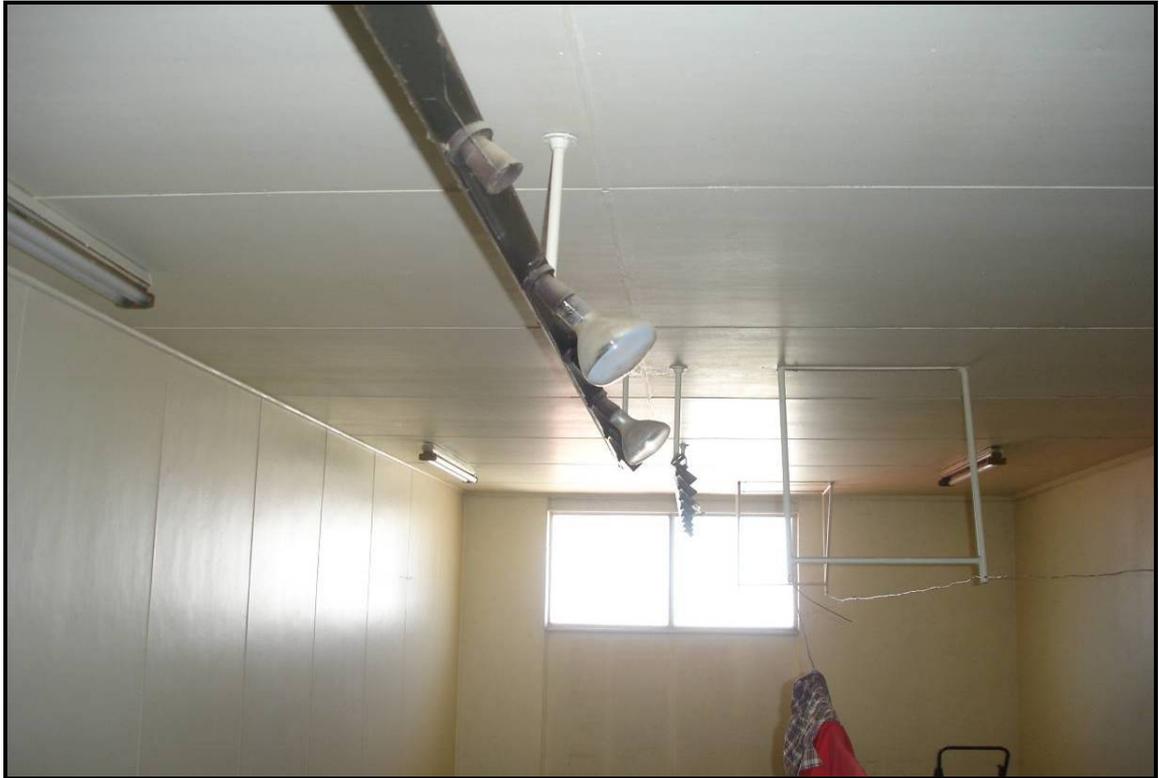
<b>Photograph: 21</b>	View of ACM to ceiling within locker room adjacent to showers (23 February 2012). South Wall non-ACM with north wall ACM
Crawfords Freightlines Pty Ltd. (Lot 12, DP625053)	<b>ERM</b>

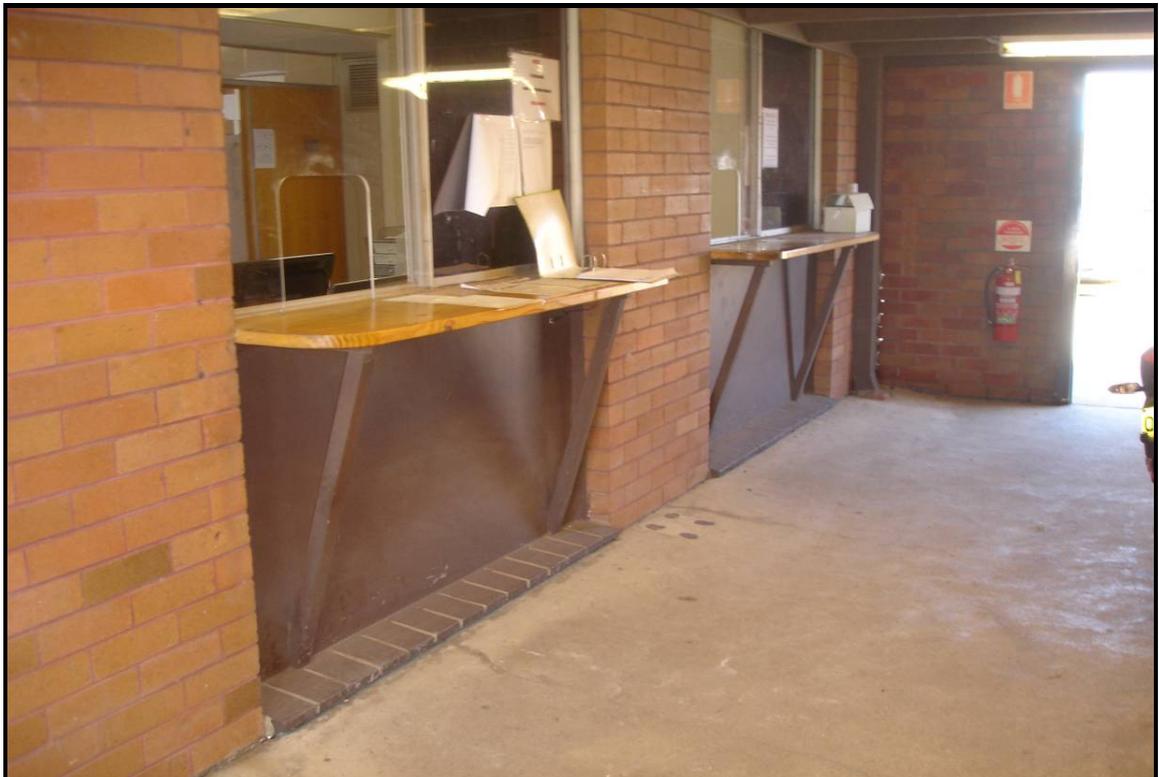
<b>Photograph: 22</b>	View of ACM fibrous cement infill panels beneath reception windows, South Administration Office (23 February 2012)
Crawfords Freightlines Pty Ltd. (Lot 12, DP625053)	<b>ERM</b>

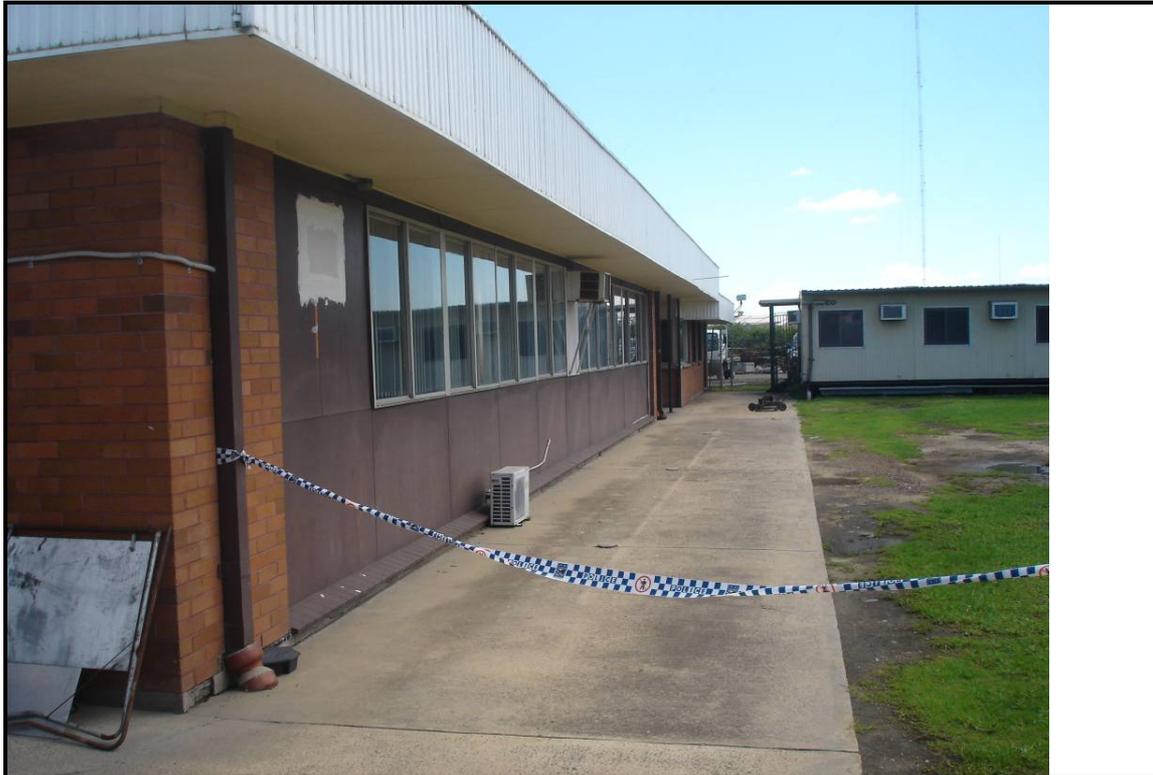
**Photograph: 23** | View of ACM eaves and window infill panels to east of the central section of the Administration building (23 February 2012).

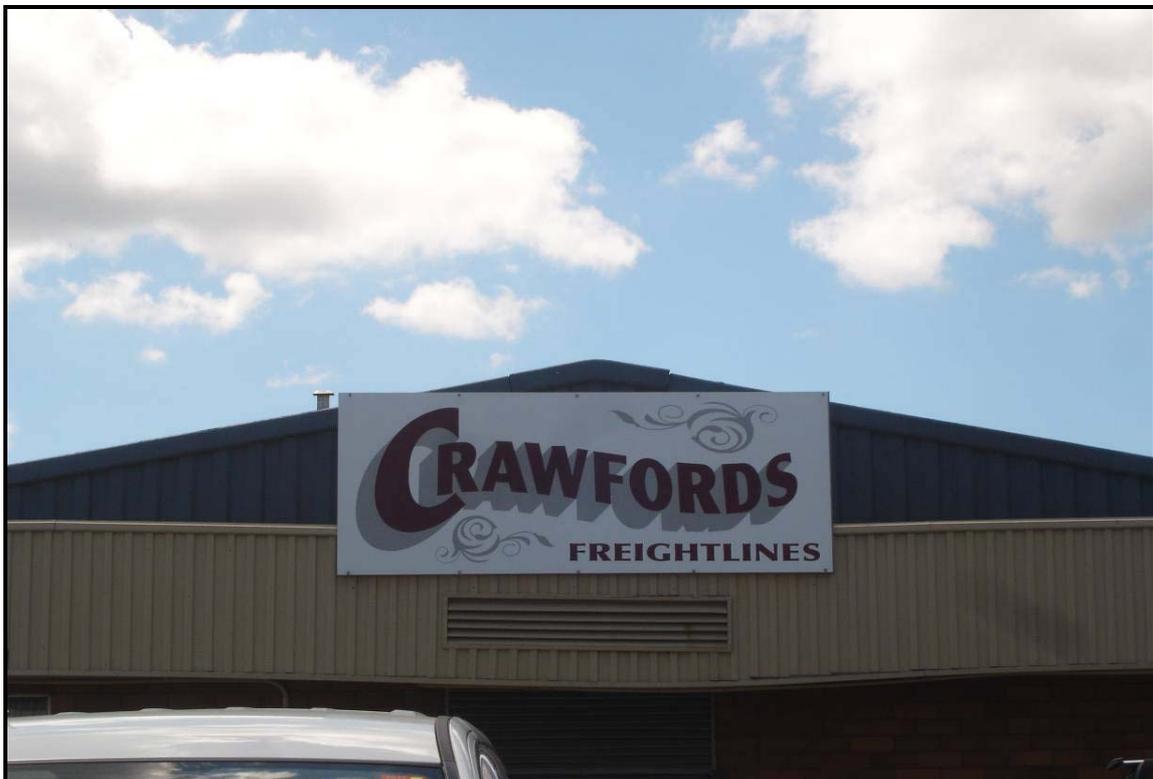
**Photograph: 24** | View of ACM corrugated facia board painted blue-grey Administration Building (23 February 2012).

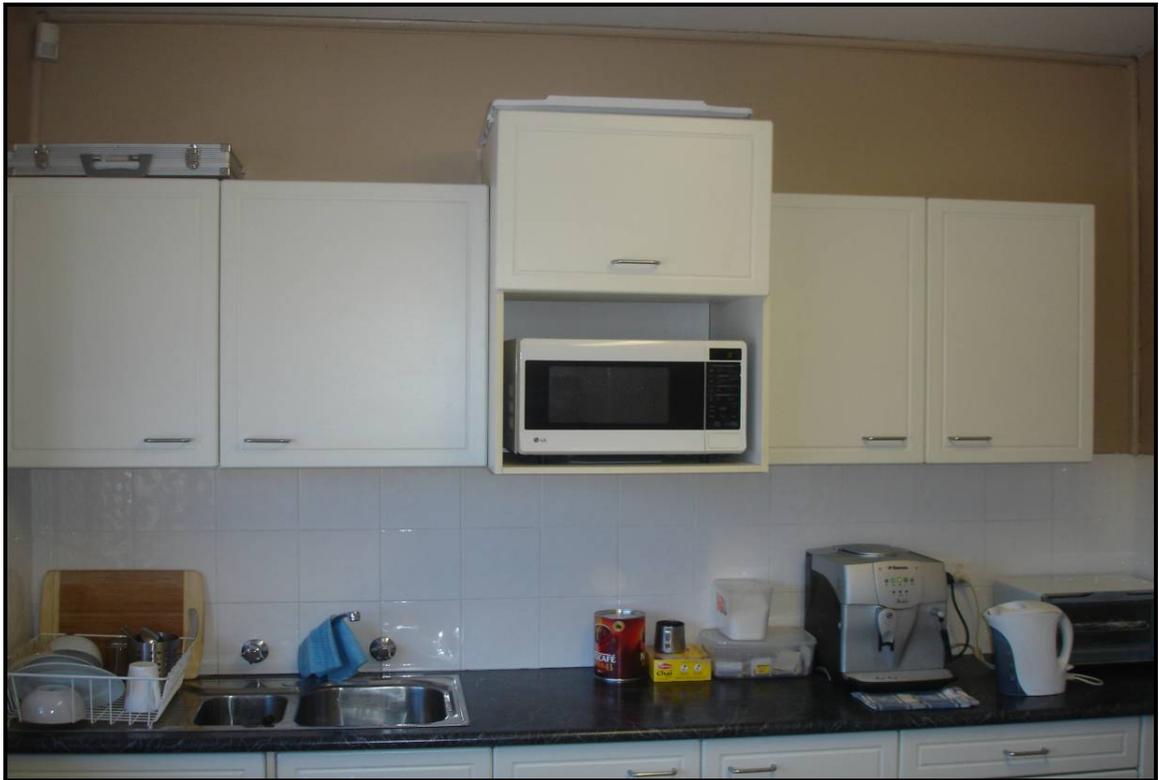
**Photograph: 25** View of ACM fibrous cement behind Kitchen cupboards (23 February 2012).
