# **Lot 12 Old Maitland Road Sandgate, NSW**

*Hazardous Materials Assessment*

For Crawford's Freightlines Pty Ltd

Date - 28 March 2012

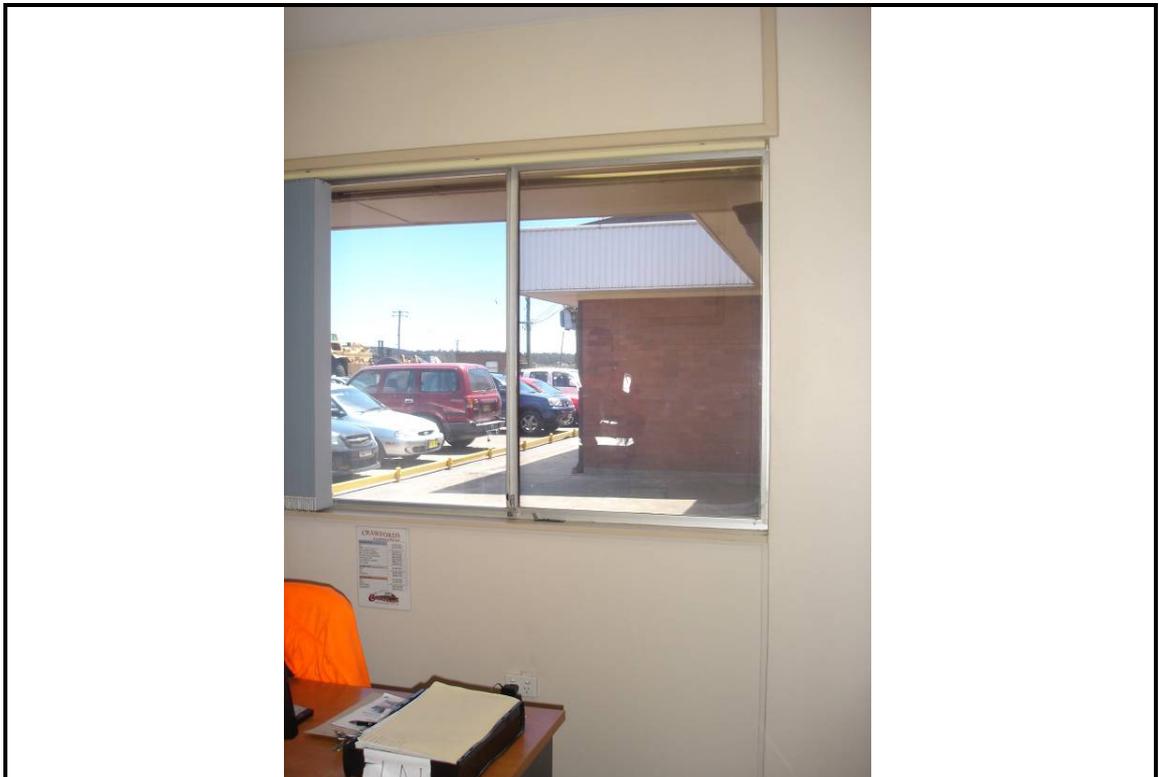
**Photograph: 26** View of ACM fibrous cement, window infill panels within western office of Administration Building (23 February 2012).

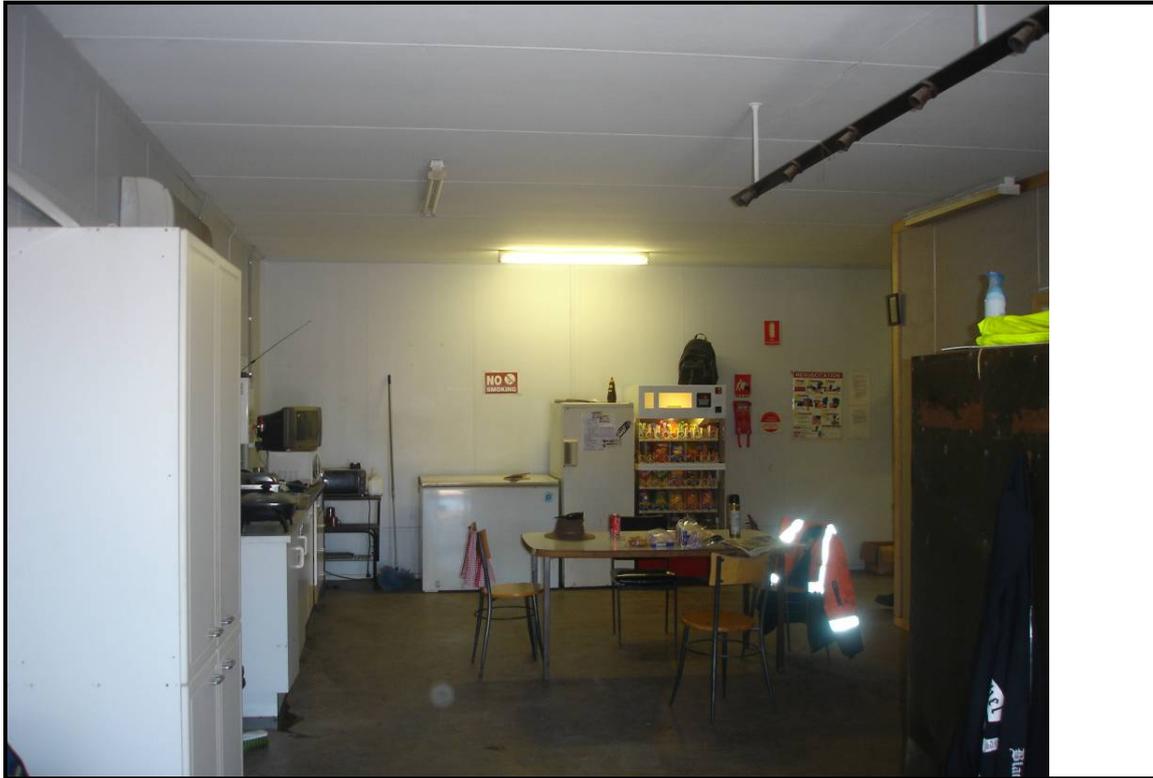
**Photograph: 27** View of lunchroom with ACM ceilings and ACM to northern and eastern walls to left and rear of shot (23 February 2012).

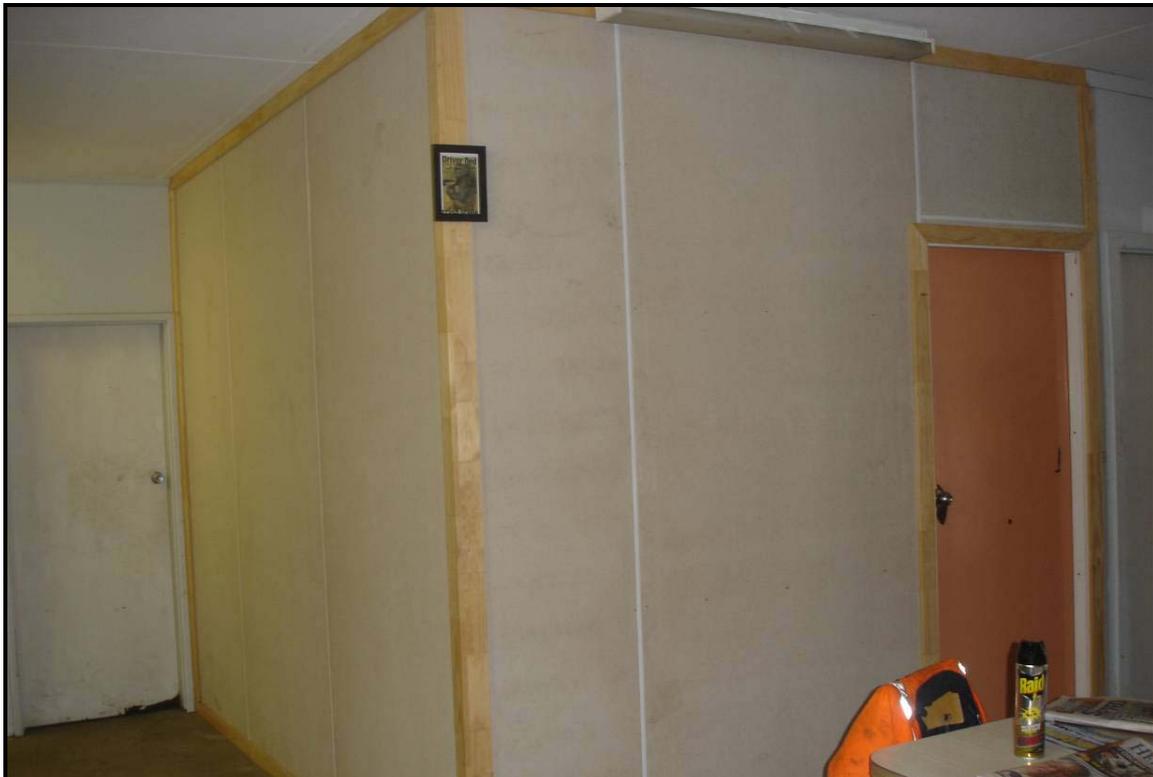
**Photograph: 28** View of new fibrous cement non asbestos to private rooms off lunchroom (23 February 2012).

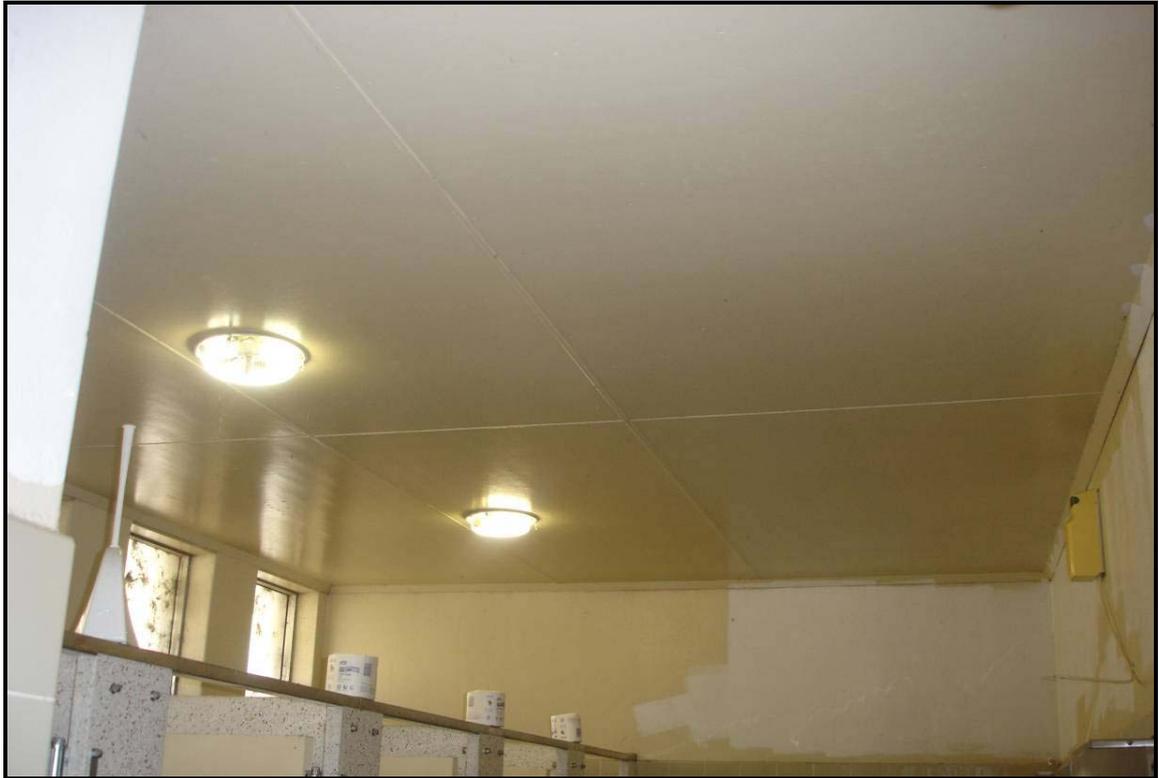
**Photograph: 29** View of ceiling to male toilets (south end) to the central section of the Administration Building (23 February 2012).

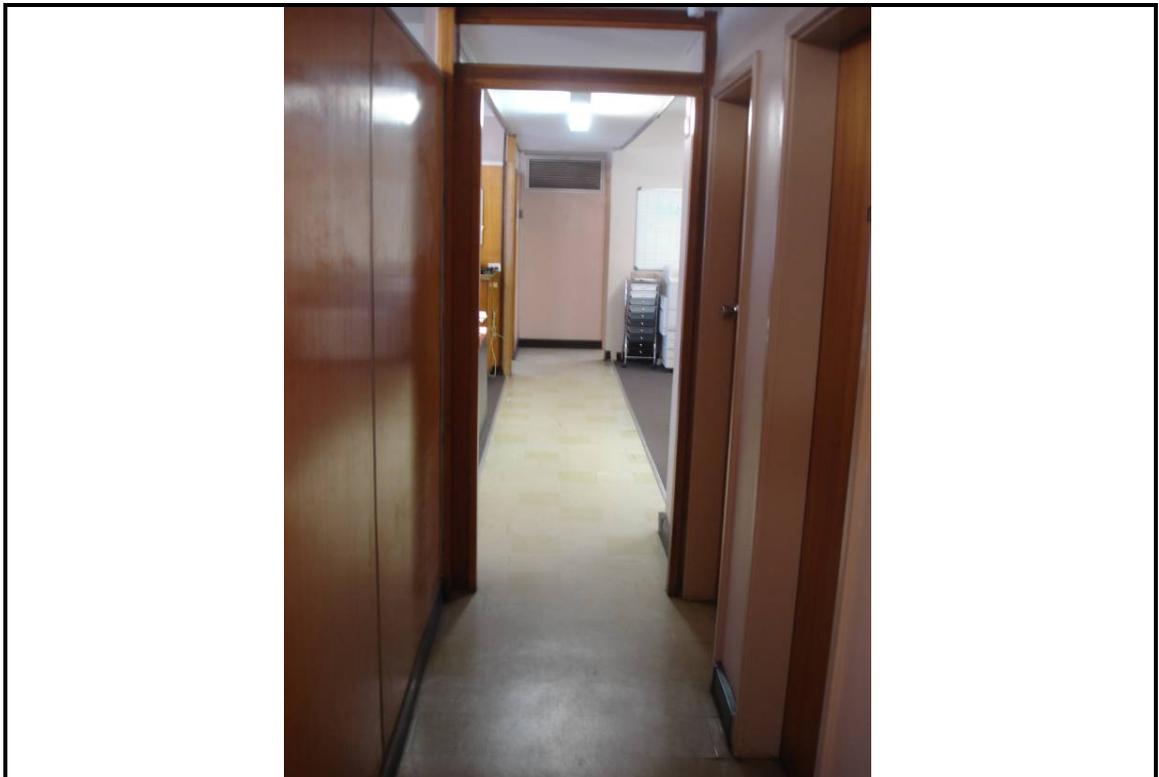
**Photograph: 30** View of vinyl tiles to flooring of southern section of the Administration Building (23 February 2012).

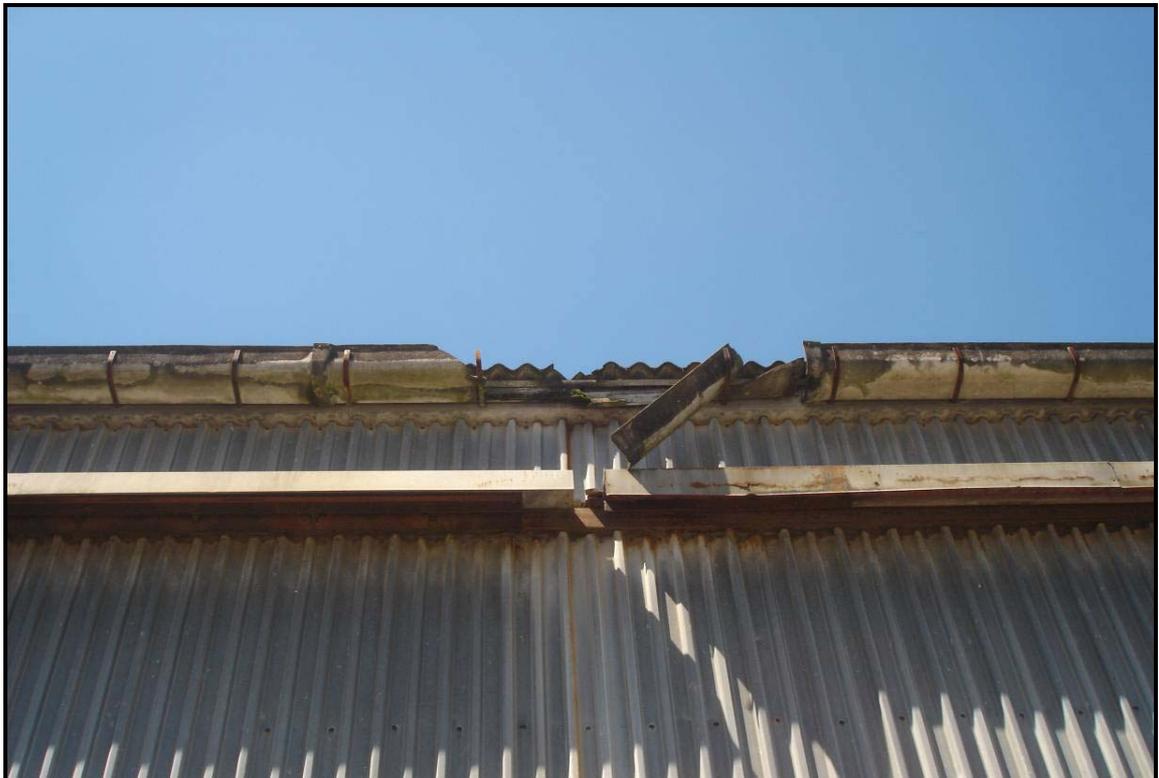
<b>Photograph: 32</b>   View of broken section of ACM guttering of Shed C (23 February 2012).		
Crawfords Freightlines Pty Ltd. (Lot 12, DP625053)	<b>ERM</b>	Lot 12 Old Maitland Road, Sandgate NSW

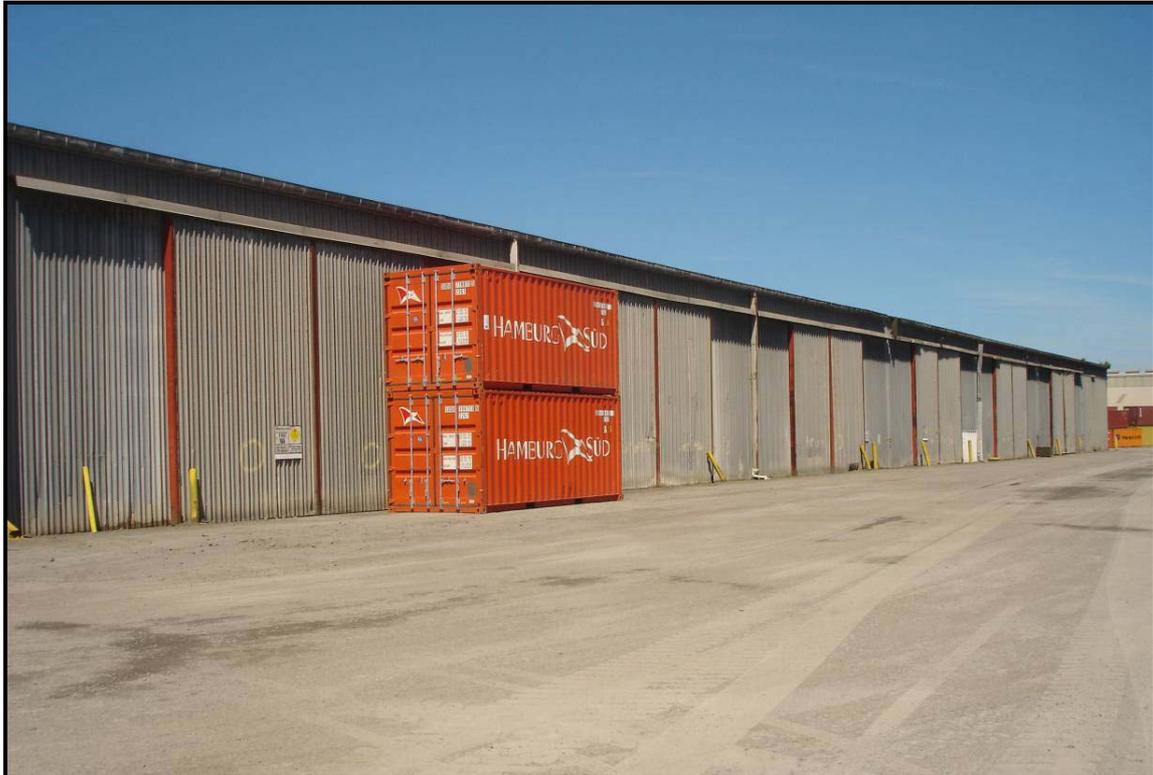
**Photograph: 33** View from west of Shed C. ACM downpipes and gutting present along west side of building (23 February 2012).

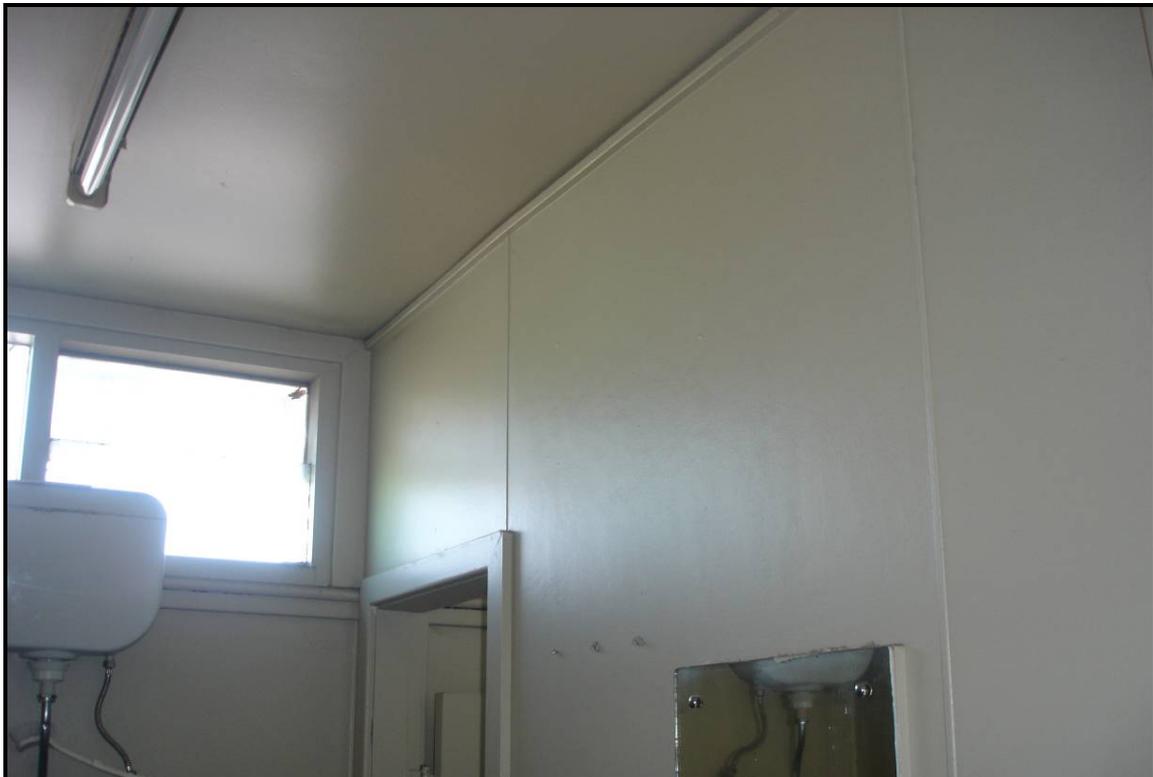
**Photograph: 34** View of ACM fibrous cement to walls and ceiling in Shed C (23 February 2012).

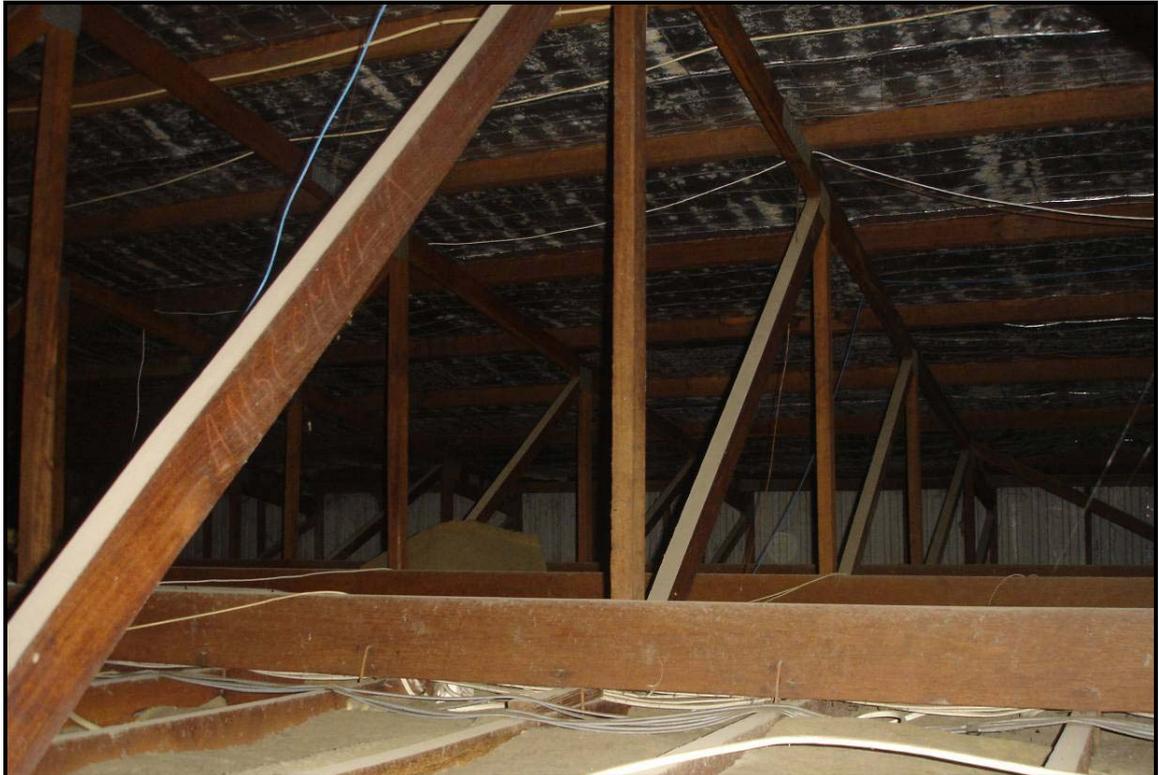
**Photograph: 35** View of insulation to the ceiling void within the Administration Building (23 February 2012).

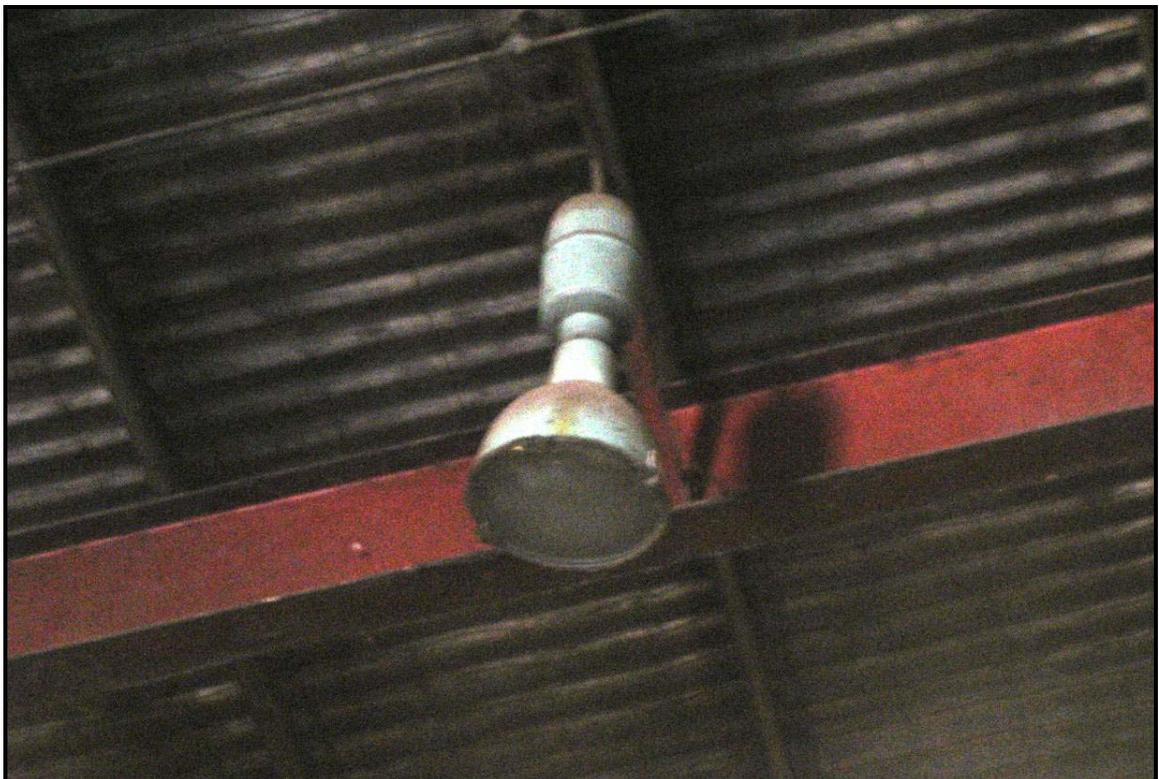
A number of old-style fluorescent and metal-halide lights were observed within the warehouse buildings (Shed C and Shed D). These lights were of an age which PCBs may have been used within the ballasts. The lights were not in operation as they appear to be have been superseded by newer metal-halide lights. Access to the ballasts was not possible due to height restrictions. When disposing of these products until confirmed otherwise these lights should be treated to as PCB containing capacitors.

**Photograph: 36** View of metal halide light and ballast which potentially contain PCB capacitors (23 February 2012).
