Report on
Hazardous Building Materials Assessment –
Early Works

Dubbo Base Hospital
Myall Street, Dubbo

Prepared for
Health Infrastructure

Project 72811.01
June 2012

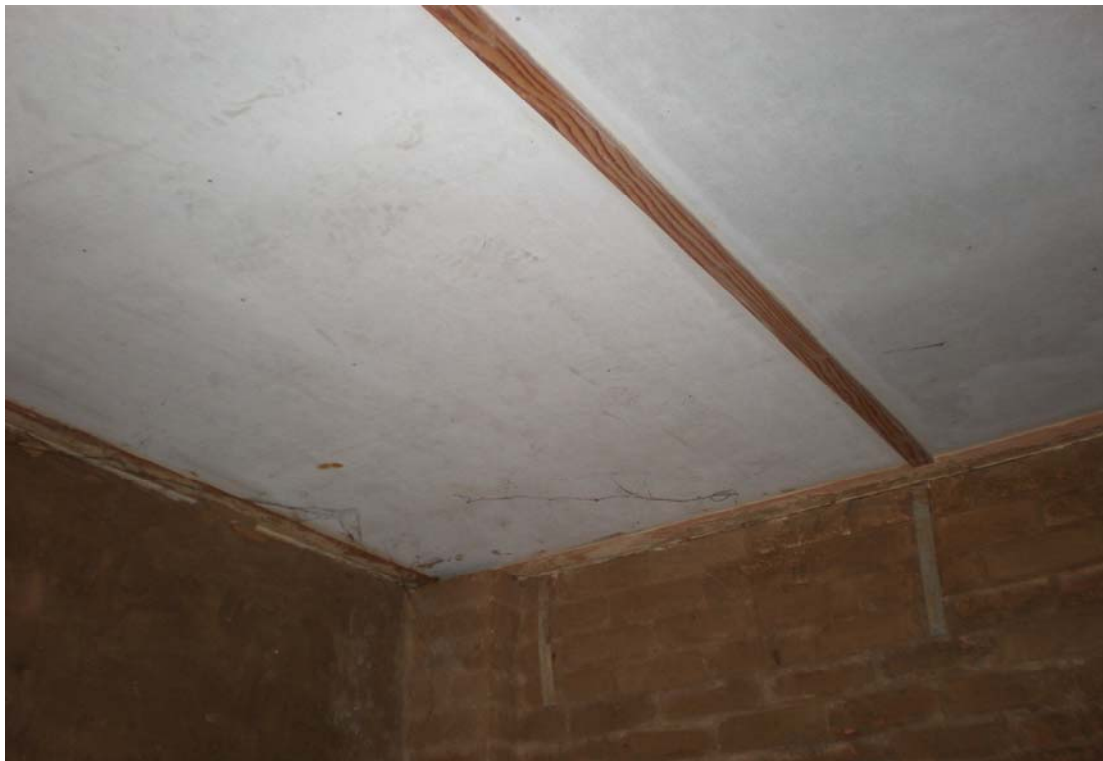
Location of ACM	Description	Bonded or Friable
Internal ceiling lining	Flat asbestos-cement sheeting	Bonded

Photo 9/2 - Bonded asbestos ceiling inside electrician's store

The removal of ACM from the impacted buildings should be carried out prior to the commencement of large-scale demolition activities and in accordance with the requirements of the WorkCover NSW and the National Occupational Health and Safety Commission (NOHSC) *Code of Practice for the Safe Removal of Asbestos 2nd Edition* [NOHSC:2002(2005)]. This work will need to be undertaken by a contractor with an appropriate asbestos-removal licence.

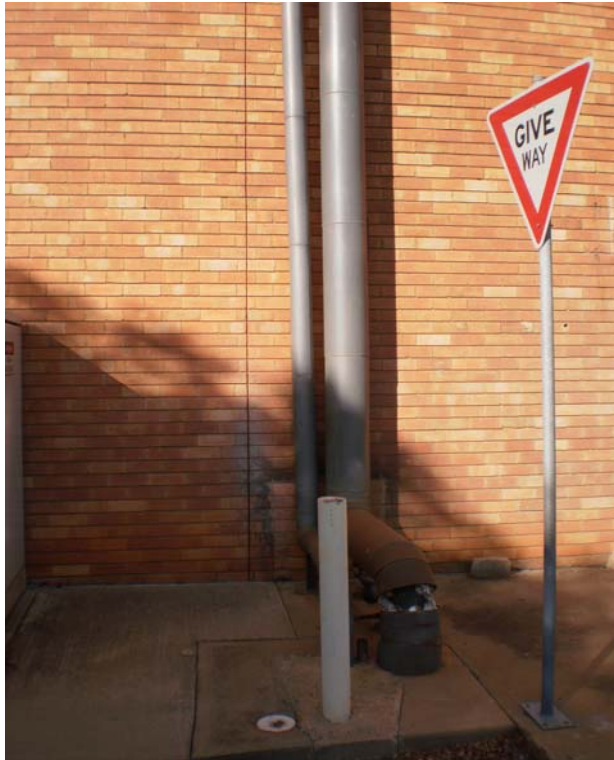
Photo 10/3 - Pipe with exposed insulation

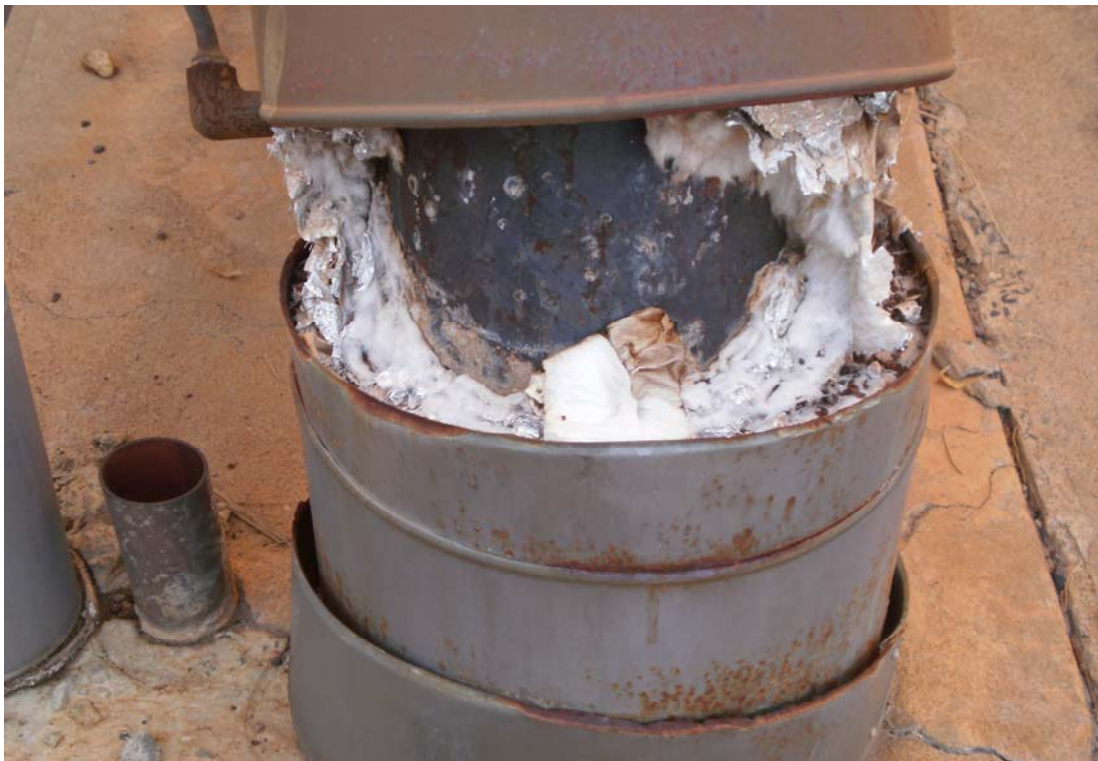
Photo 10/4 - Close up view of exposed insulation (assumed not to be ACM)

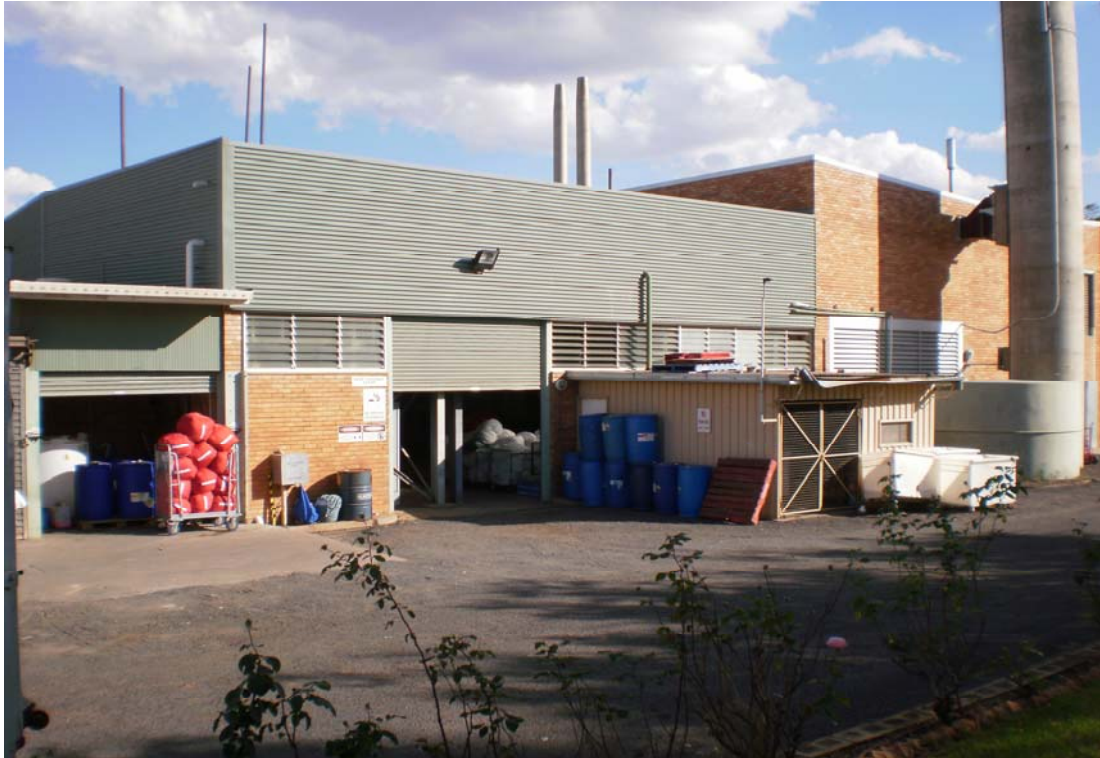
Location of ACM	Description	Bonded or Friable
Chimney	Moulded inlet pipe	Bonded
None identified within building	N/A	N/A

Photo 11/1 - Old boiler room adjacent to smoke stack (bonded asbestos pipes from building to stack)

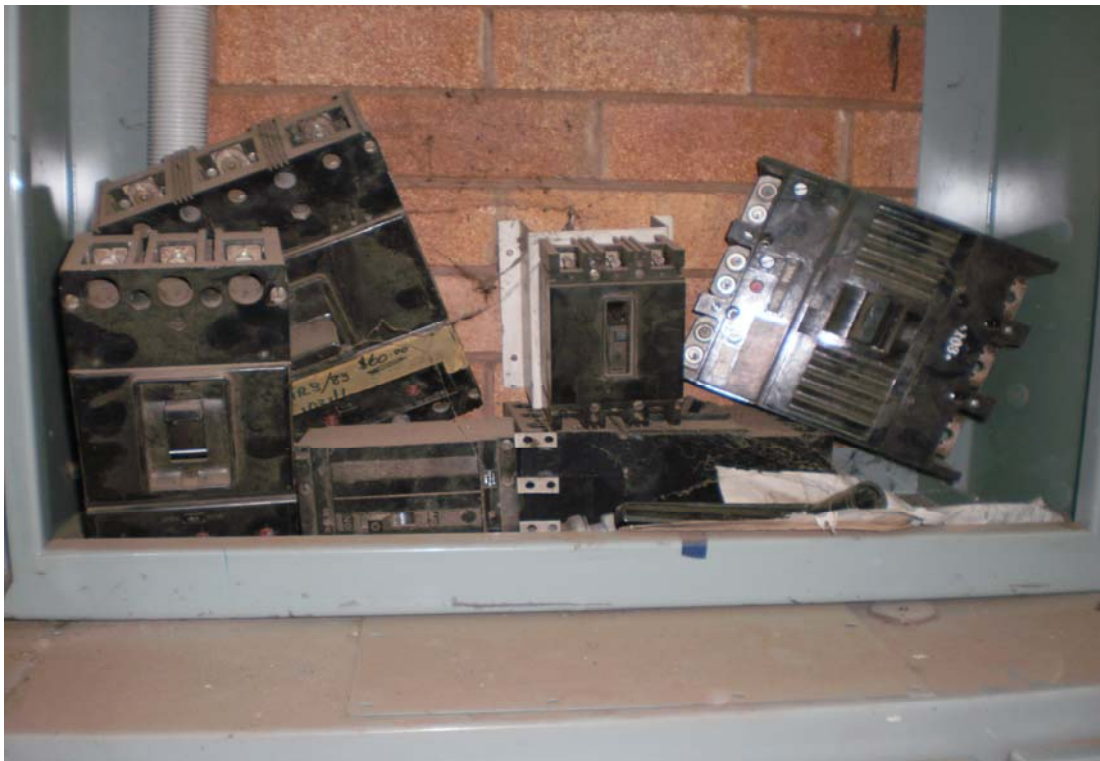
Several Bakelite light fittings were observed within the Nurses Accommodation building. Numerous Bakelite electrical switches and components were observed in the New Boiler Room and Nurses Accommodation building. These switches contain phenolic compounds and also may potentially contain asbestos fibres. These products should remain intact and be disposed of at an appropriate landfill facility. The products should not be broken, cut or damaged as the release of fibres is a potential health hazard.

Photo 12/2 - Bakelite switches (potentially bonded asbestos + phenol)

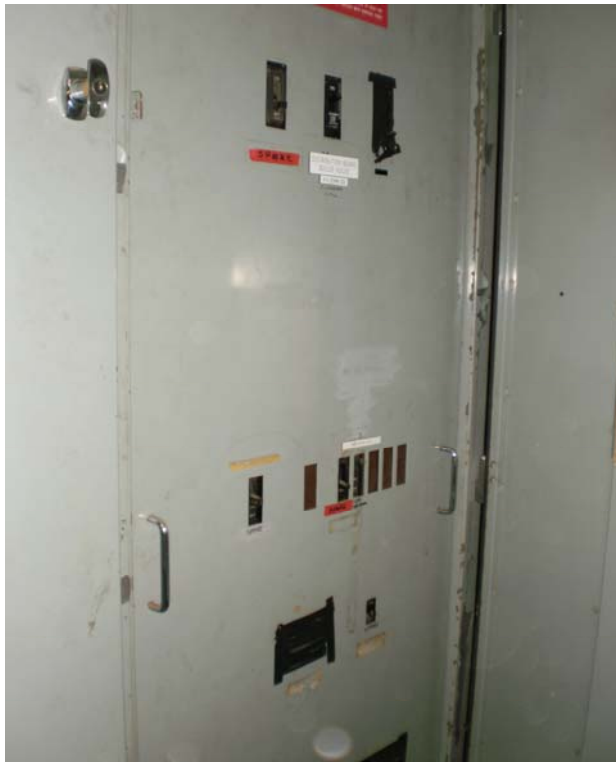
Photo 12/3 - Electrical switchboard (internal access not available)

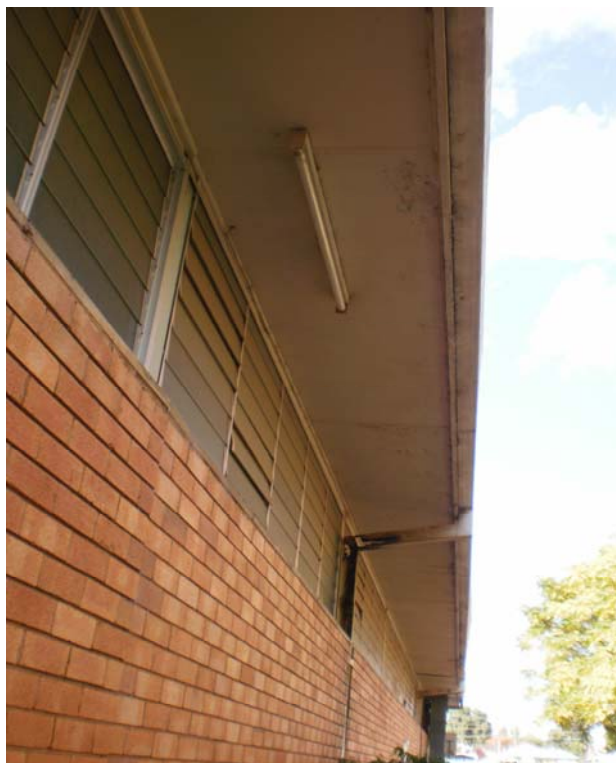
Photo 13/2 - Bonded asbestos eve lining

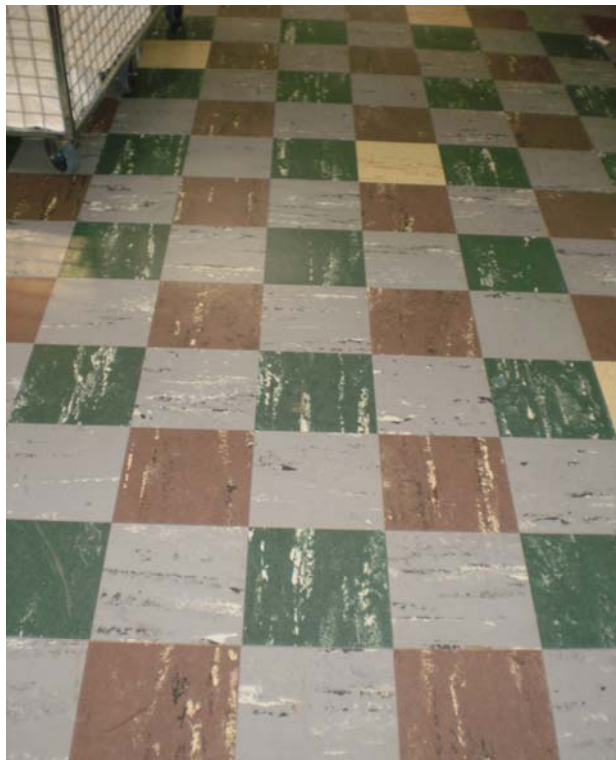
Photo 13/3 - Asbestos vinyl floor tiles

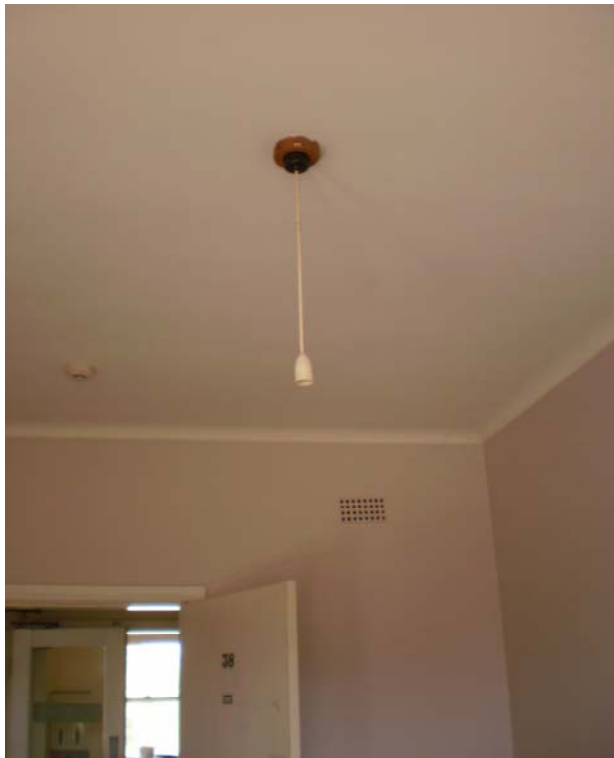
Photo 14/4 - Bakelite light fitting (potentially bonded asbestos + phenol)

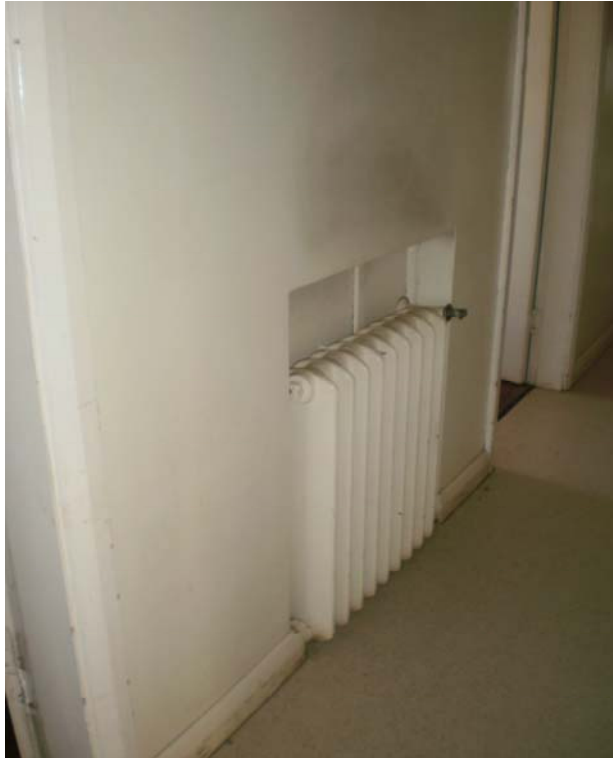
Photo 14/5 - Typical corridor heater (friable asbestos lagging on concealed pipes)

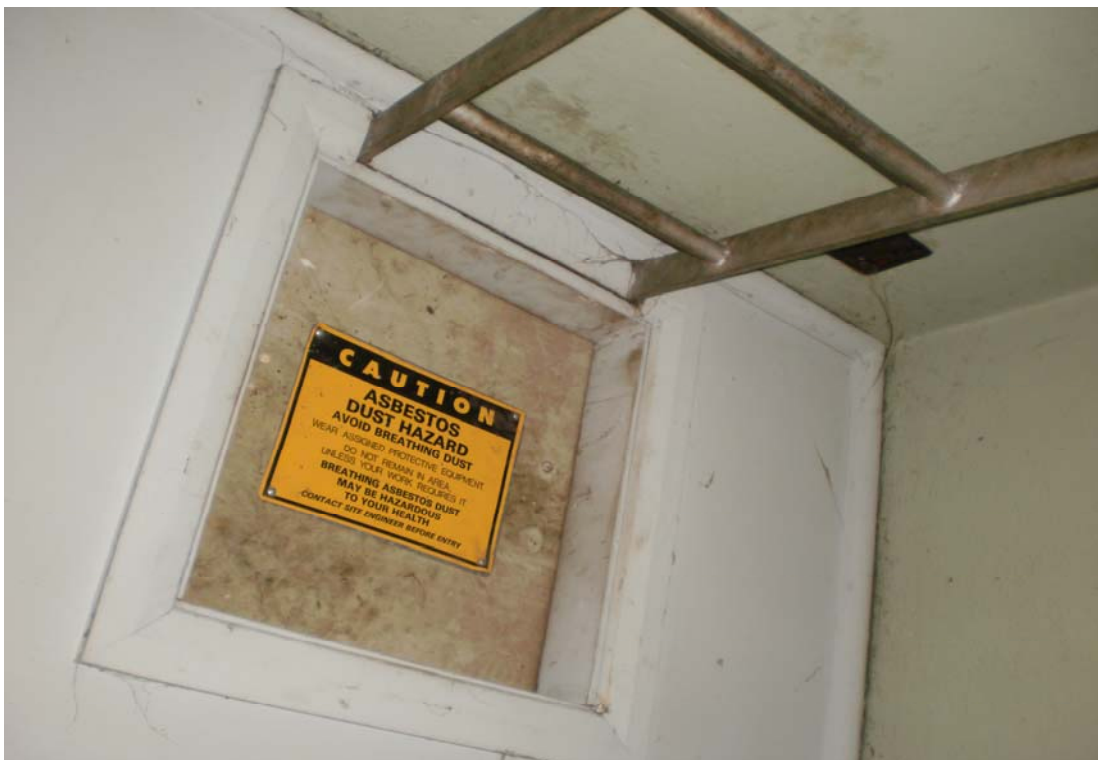
Photo 14/6 - Manhole to ceiling space (friable asbestos lagging on pipes in ceiling)

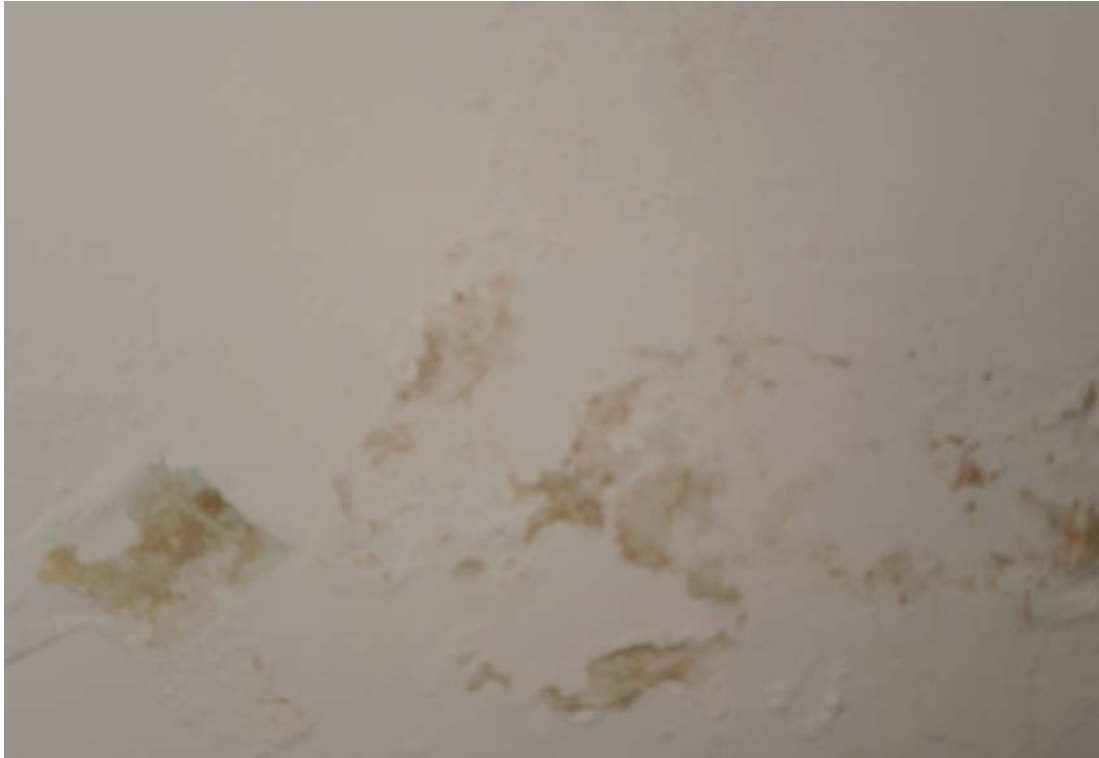
One of the three paint samples (P3) had a significant concentration of lead. The other two samples had low concentrations. It is therefore likely that sample P3 was taken from older paint whereas the other samples were collected from areas in which either lead-based paint had been covered with a more modern variety or the paint application may have occurred following the cessation of lead-based paint use.

Photo 14/7 - Typical example of peeling paint (potentially lead-based)

Due to the age of the hospital buildings it is recommended that all paint be assumed to be lead-based and appropriate safety precautions (e.g. coveralls, face mask, eye protection etc.) be adopted by the demolition contractor during the removal of painted materials. Even if the upper layers of paint are not lead-based it is possible that lead-based paint was used originally and still remains. Disposal of lead-based painted items should be undertaken at a licensed landfill in a manner that minimises dust generation.

Lead-based paint was identified in one location and is likely to be present elsewhere in the buildings. As previously mentioned, all paint should be conservatively assumed to contain lead and appropriate precautions taken during handling to reduce the risk of dust generation and ingestion. Painted building elements should be disposed of at a licensed landfill.

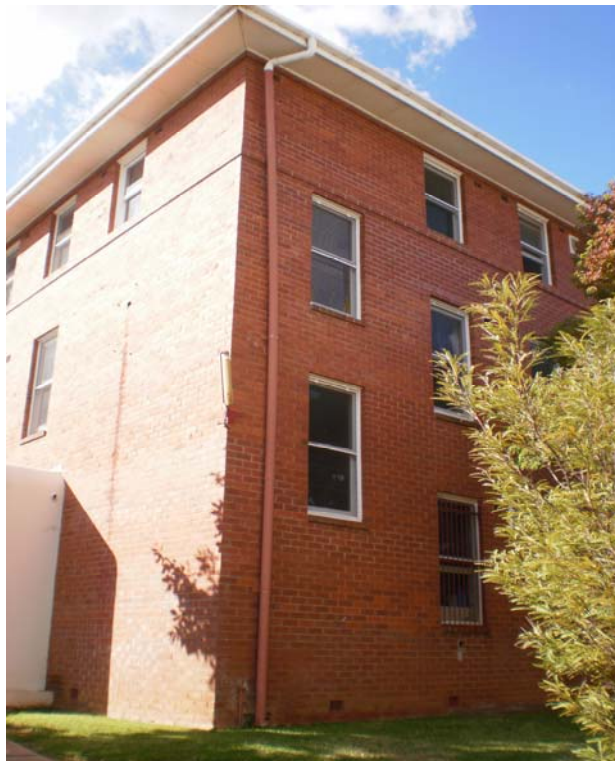
Photo 14/8 - View of bonded asbestos eave lining

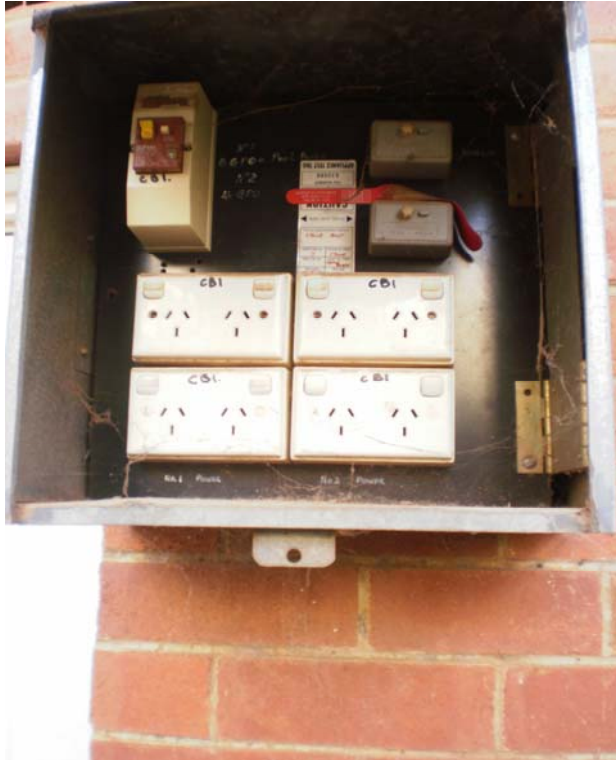
Photo 14/9 - Electrical switchboard (potentially bonded asbestos mounting board)

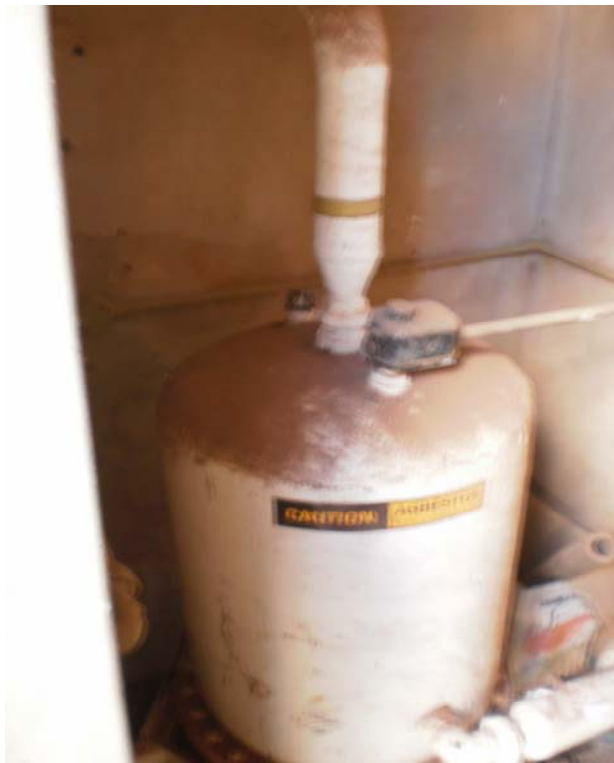
Photo 14/10 - Heat exchange unit (internal and external friable asbestos lagging)

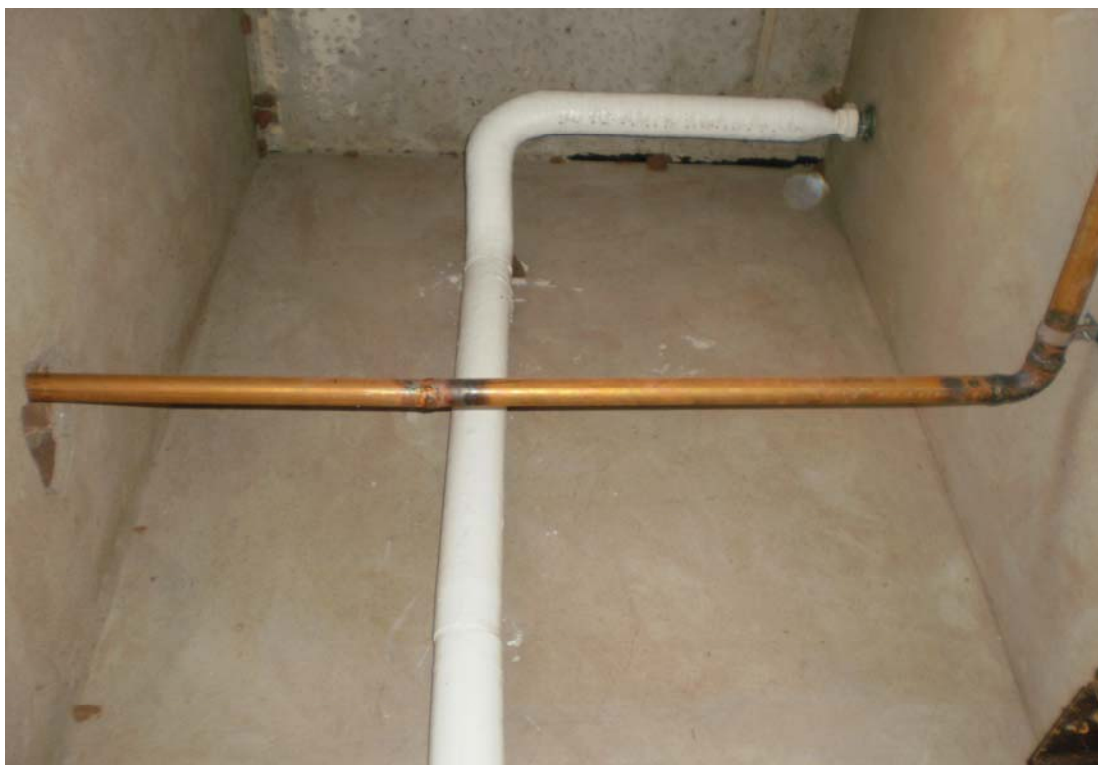
Photo 14/11 - Friable asbestos lagging in underfloor area

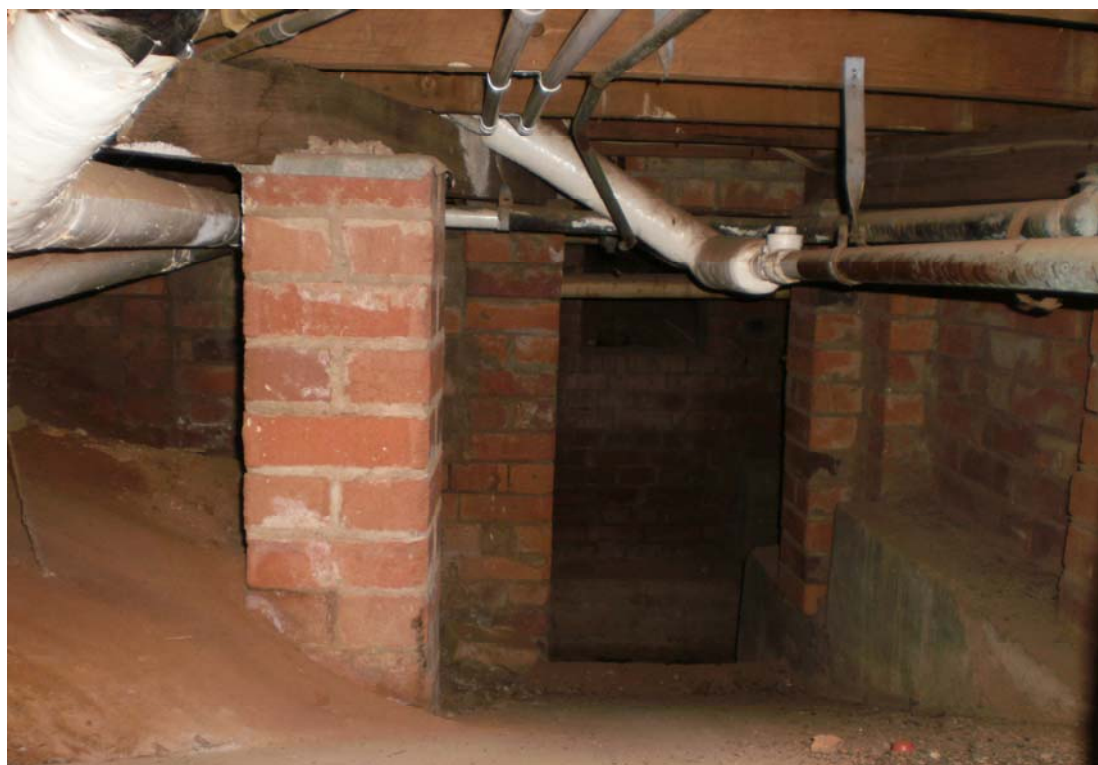
Photo 14/12 - Friable asbestos lagging in underfloor area

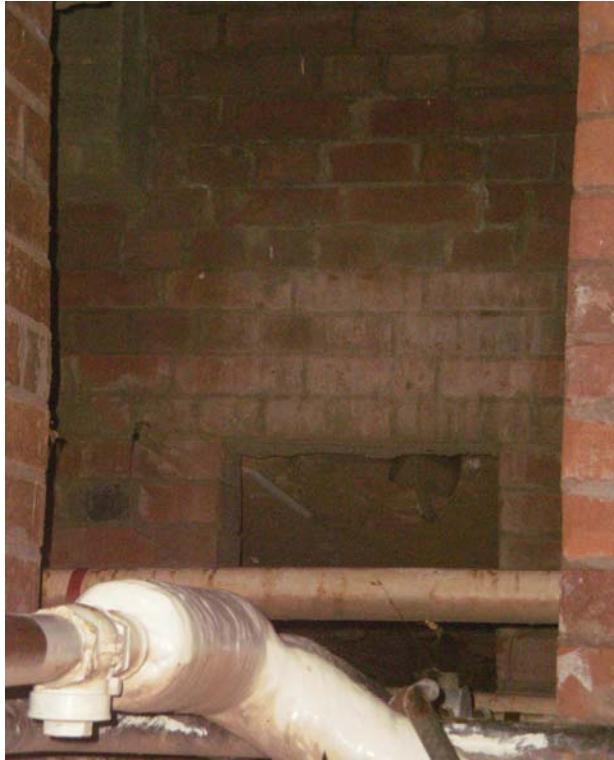
Photo 14/13 - Friable asbestos lagging in underfloor area (note lagging on ground)

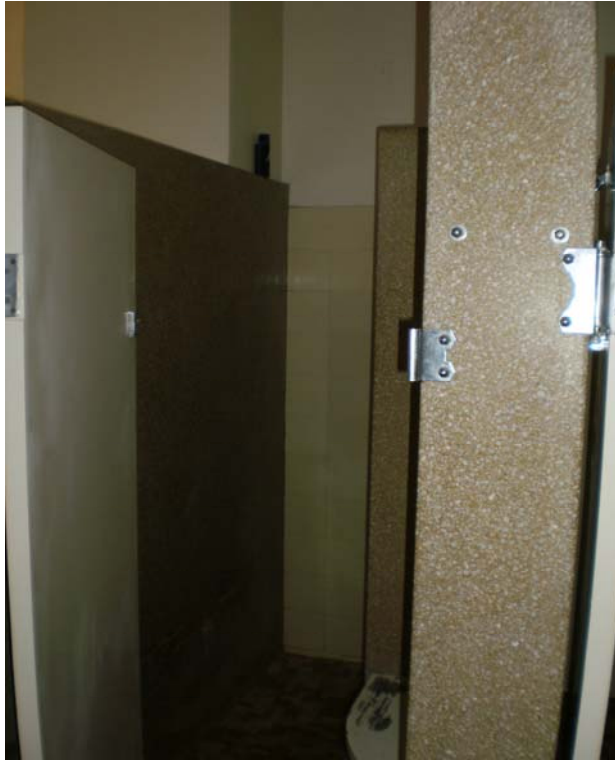
Photo 14/15 - Bonded asbestos partitions in bathroom

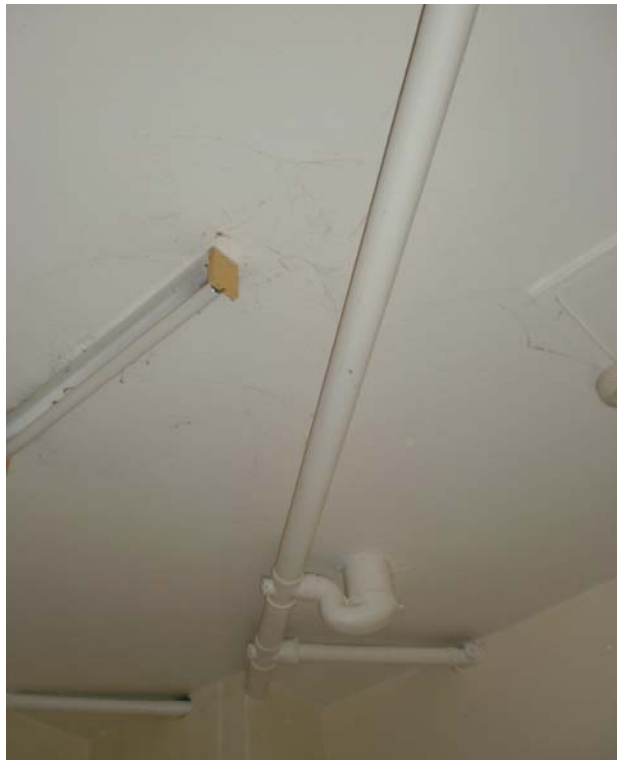
Photo 14/16 - Friable asbestos pipe lagging in bathroom

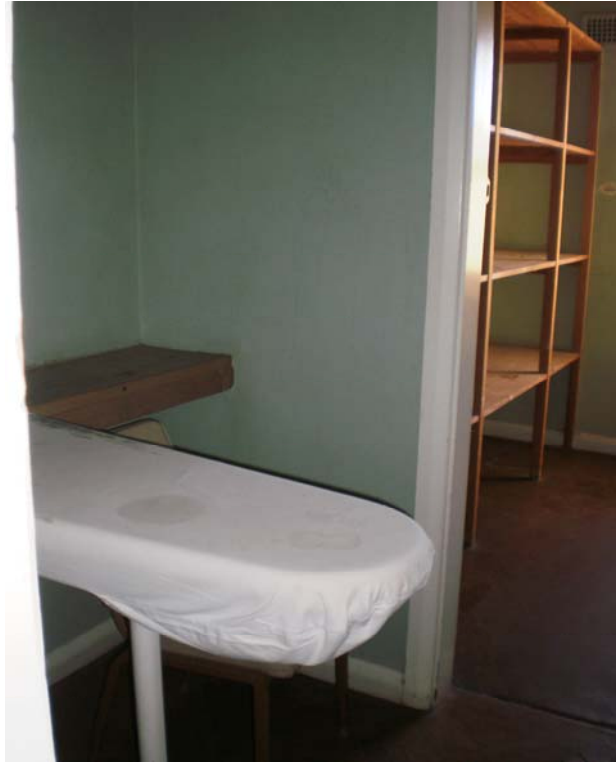
Photo 14/17 - Bonded asbestos partitions in laundry
