Phase 1 Contamination Assessment

IMAX Theatre, 31 Wheat Road
Darling Harbour

Prepared for
Grocon Group

Project 73201.01
February 2012

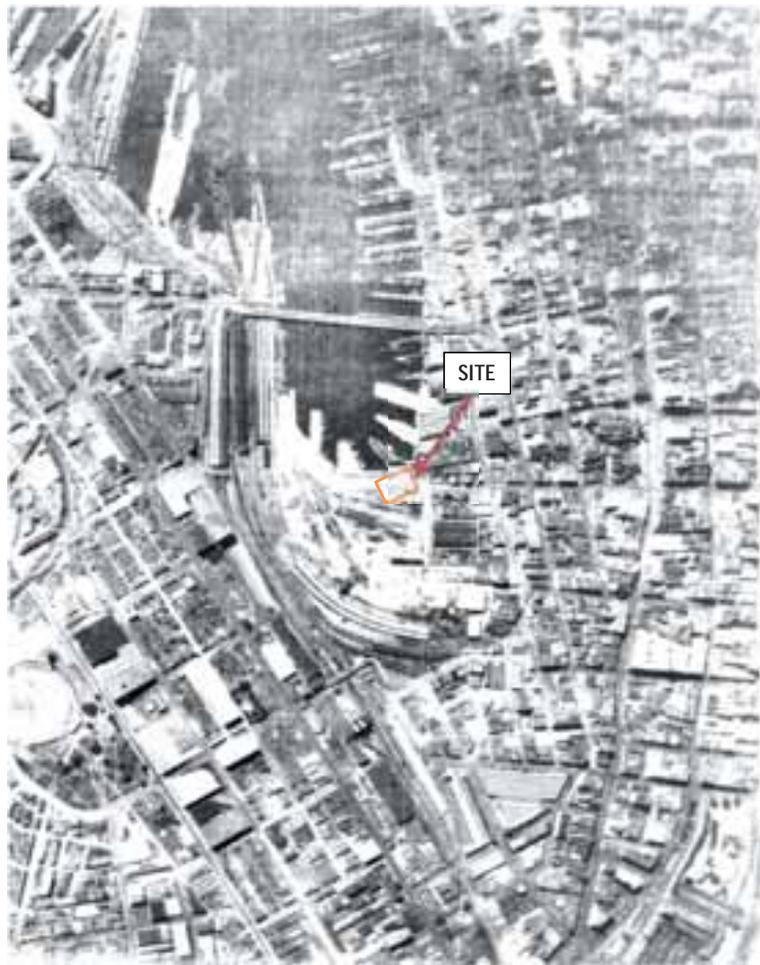
Plate
1
1930

- 1930 The site is located at the south-eastern edge of the Cockle Bay finger wharves. The photograph is poor quality and specific site features cannot be clearly identified. The region surrounding the site, however, appears to be occupied by rail lines and associated buildings. At the time the site was owned by the Minister for Public Works, suggesting possibly a public domain.

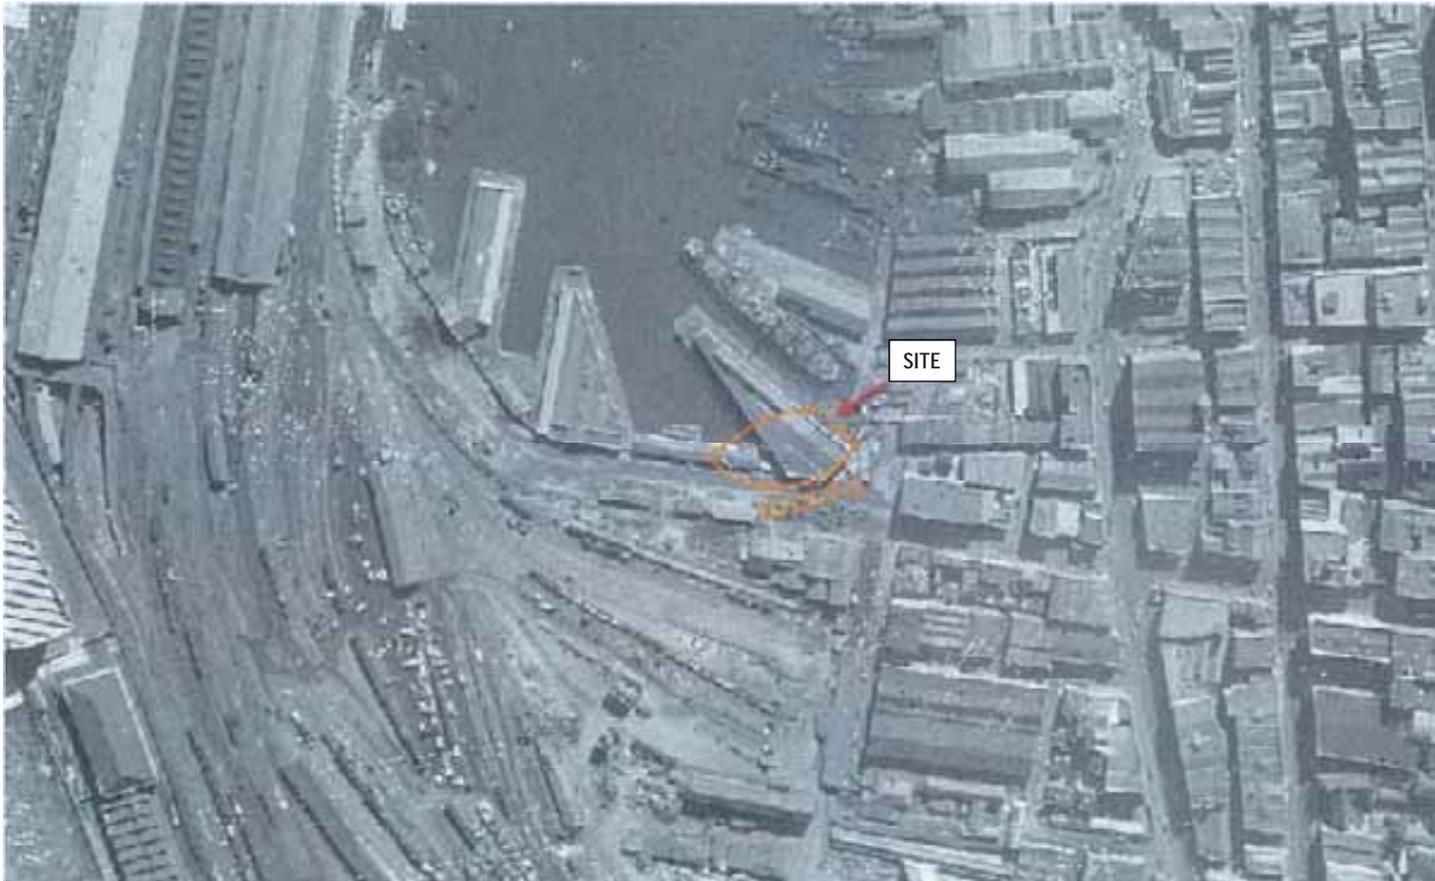
Plate
2
1943

- 1943 The image is clearer and it appears that the site area sits at the south-eastern end of one of the finger wharves as well as some access roads and other buildings. The area to the south and west of the site is heavily utilised as a rail network.

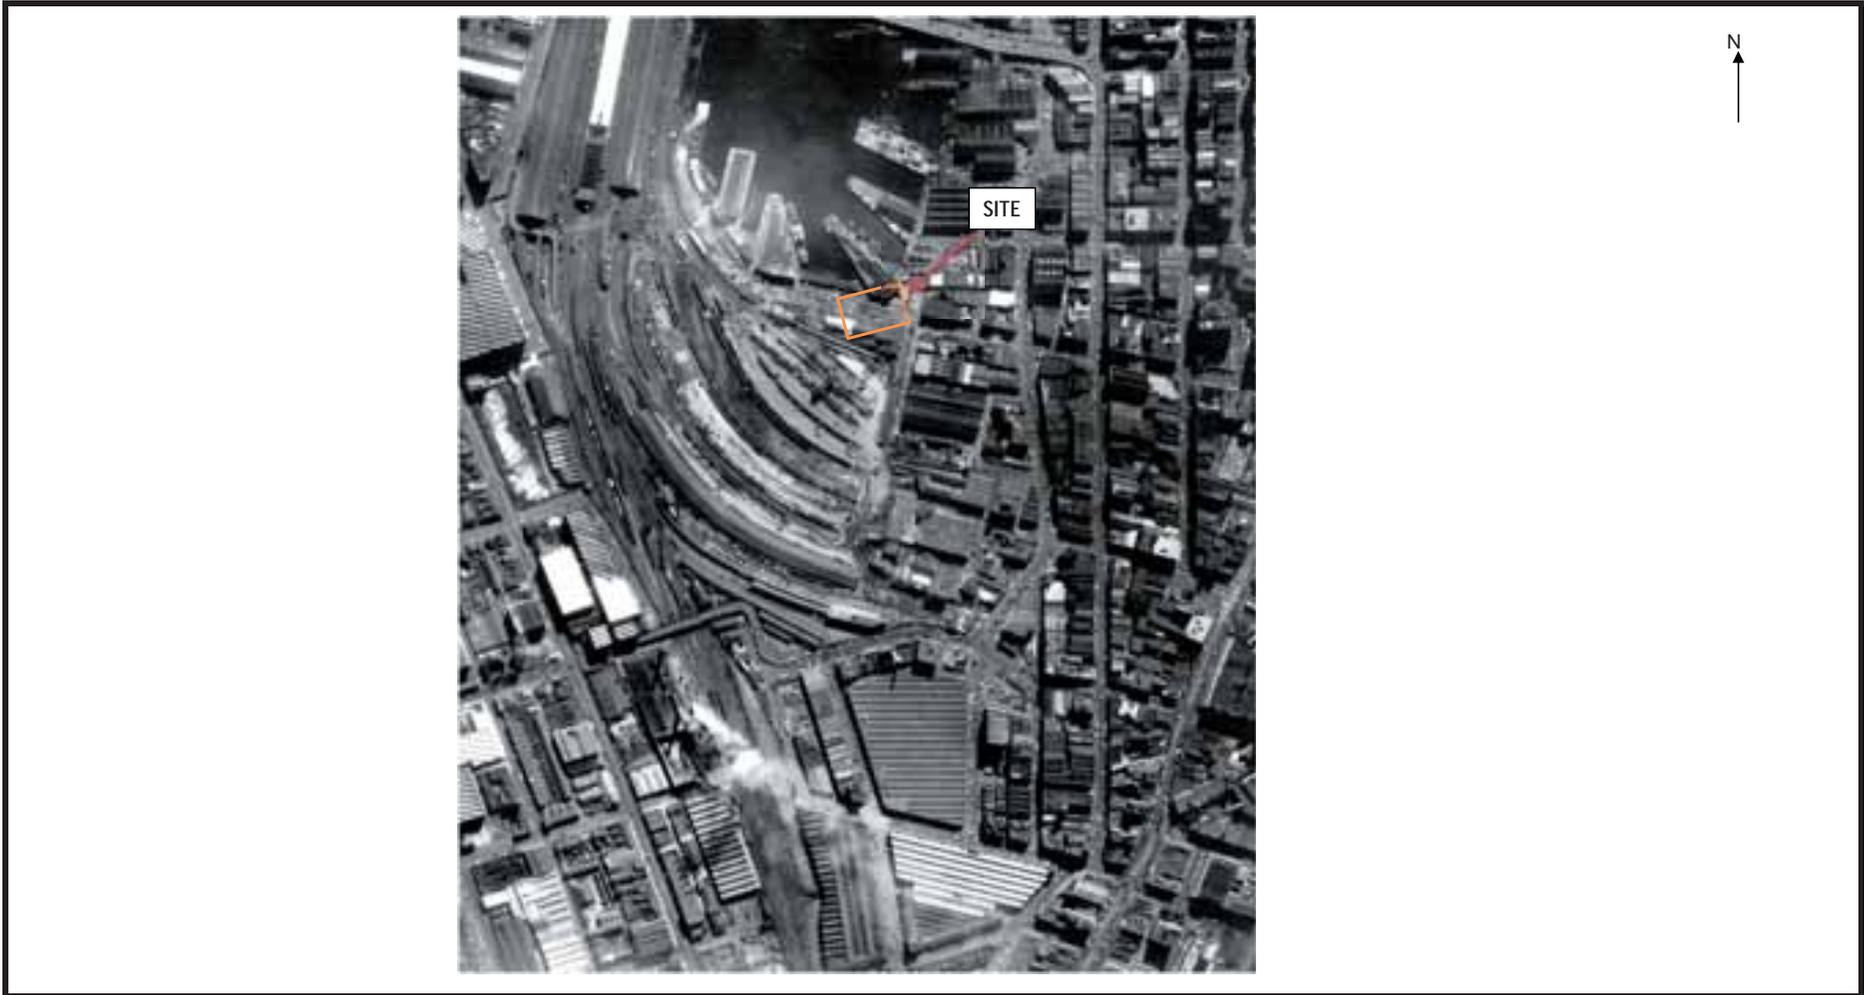
Plate
3
1951

- 1951 A clearer image shows the site occupied by the southern tip of the finger wharf, vehicular and pedestrian traffic areas and part of a number of small buildings to the south. The surrounding land uses have not changed significantly since 1943.

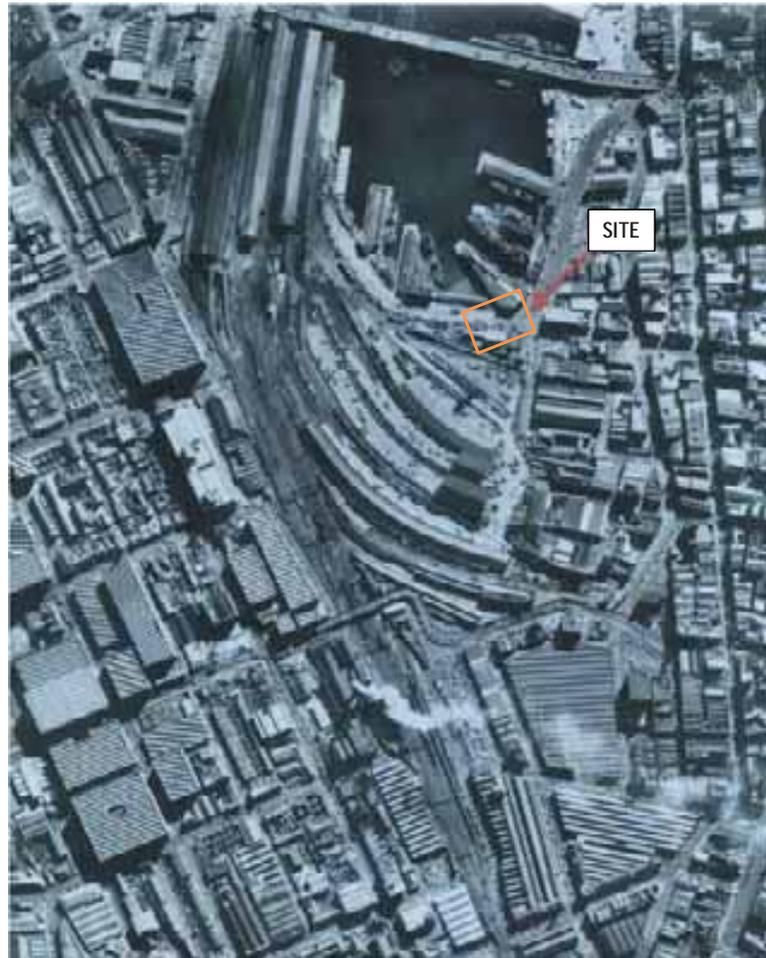
Plate
4
1961

- 1961 There is no significant change to the site and surrounding layout since 1951.
- 1968 There is no significant change to the site and surrounding layout since 1961.

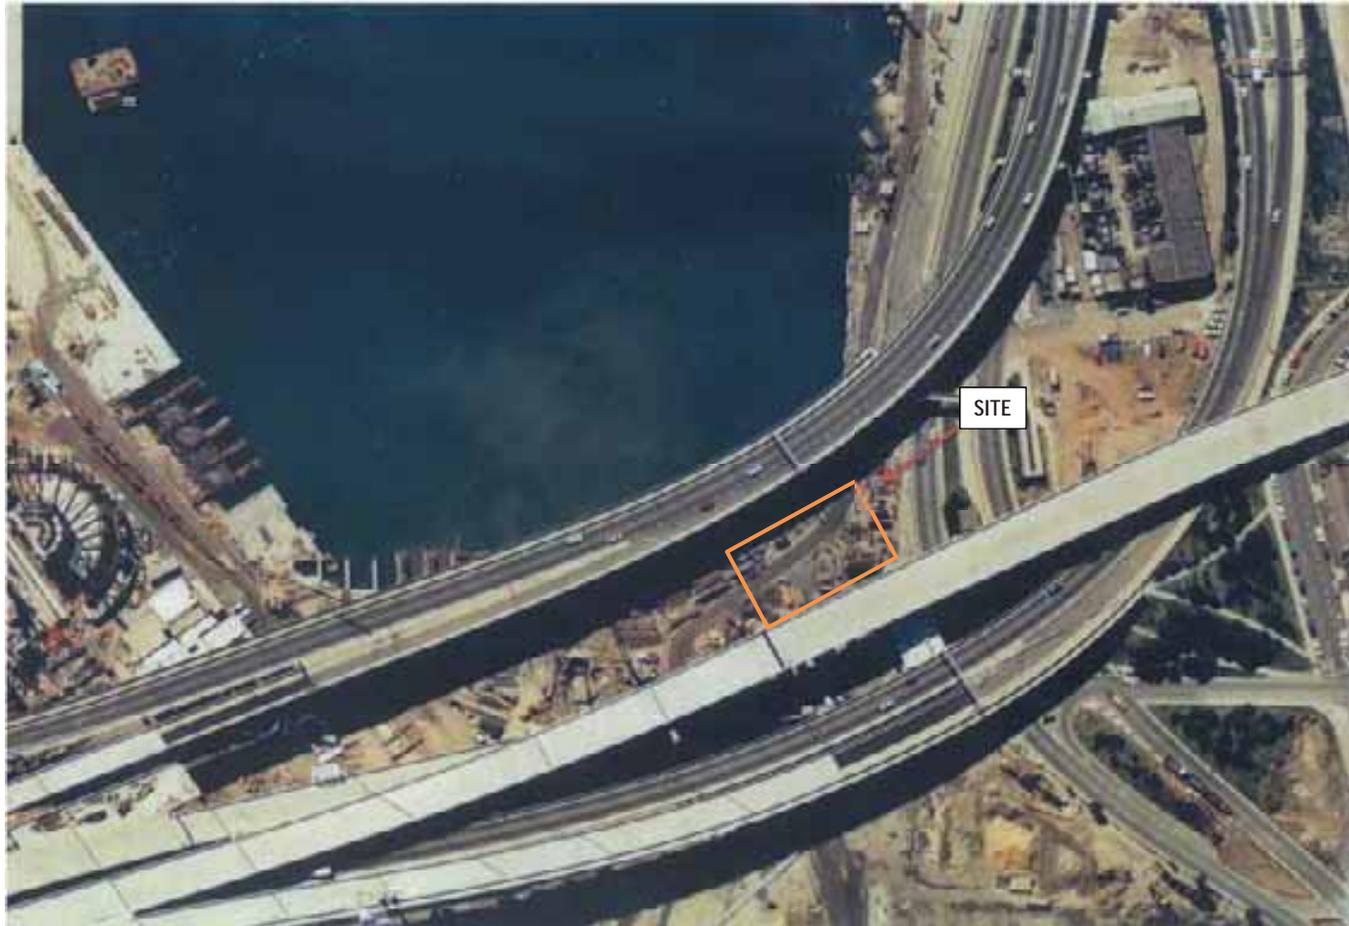
Plate
7
1986

- 1972 There is no significant change to the site and surrounding layout since 1968.
- 1986 The site has changed since 1972. The site area (and surrounds) appears to be used for the storage of materials and equipment associated with the redevelopment works along the Cockle Bay foreshore. An access road (likely for construction purposes) passes through the site. The site is situated between several Western Distributor overpasses, partially under construction. The extensive rail use noted in previous photographs in areas surrounding the site is no longer visible.

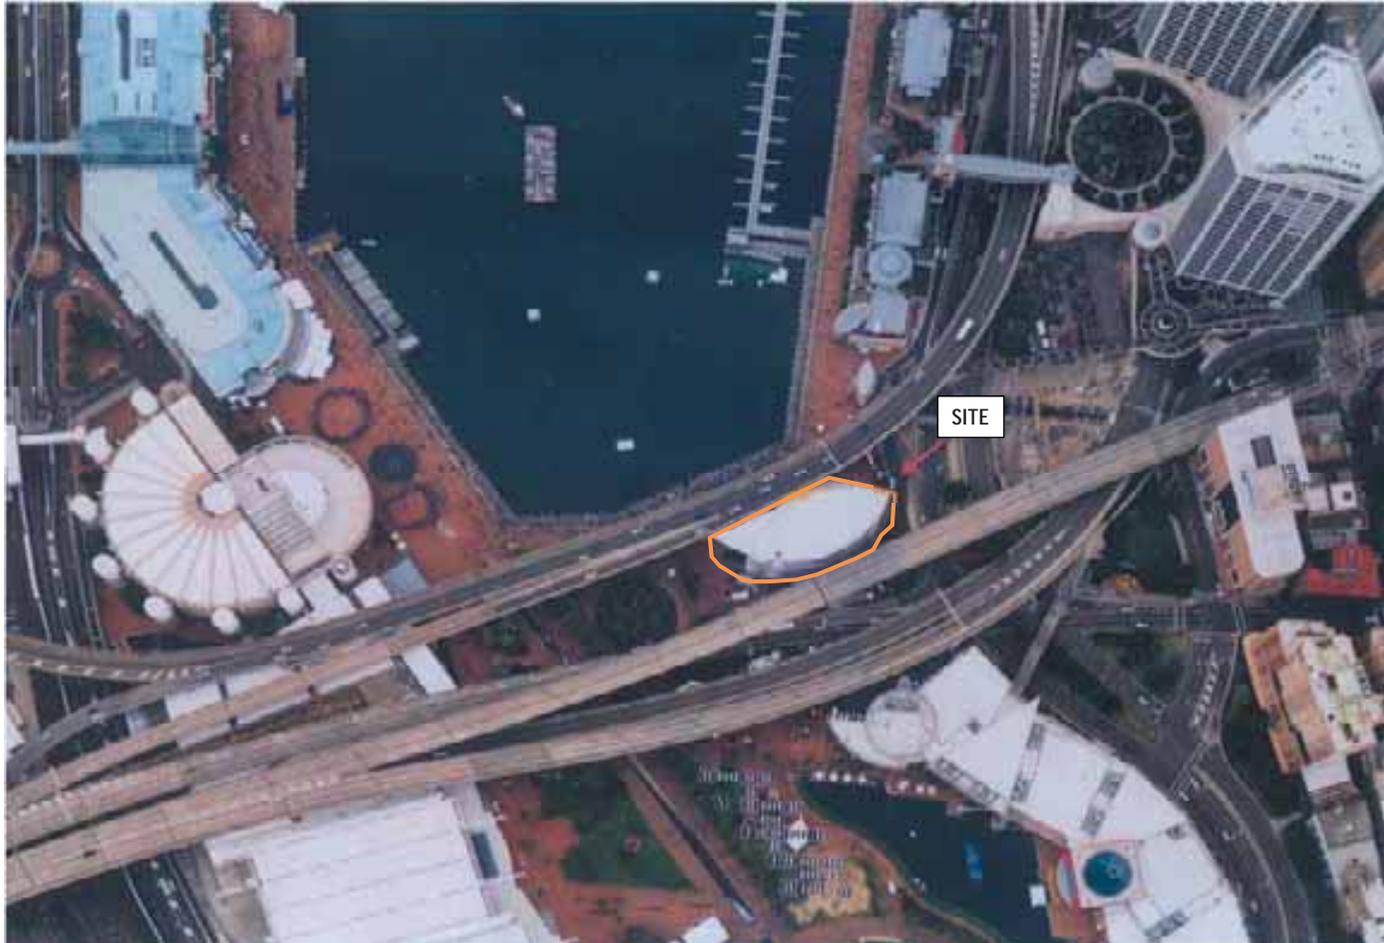
Plate
8
1999

- 1999 The site is occupied by the IMAX building, which remains present today (2012). The Darling Harbour complex and foreshore, seen under construction in the 1986 photograph, has been completed and is in use. There is also a new building to the south of the site.

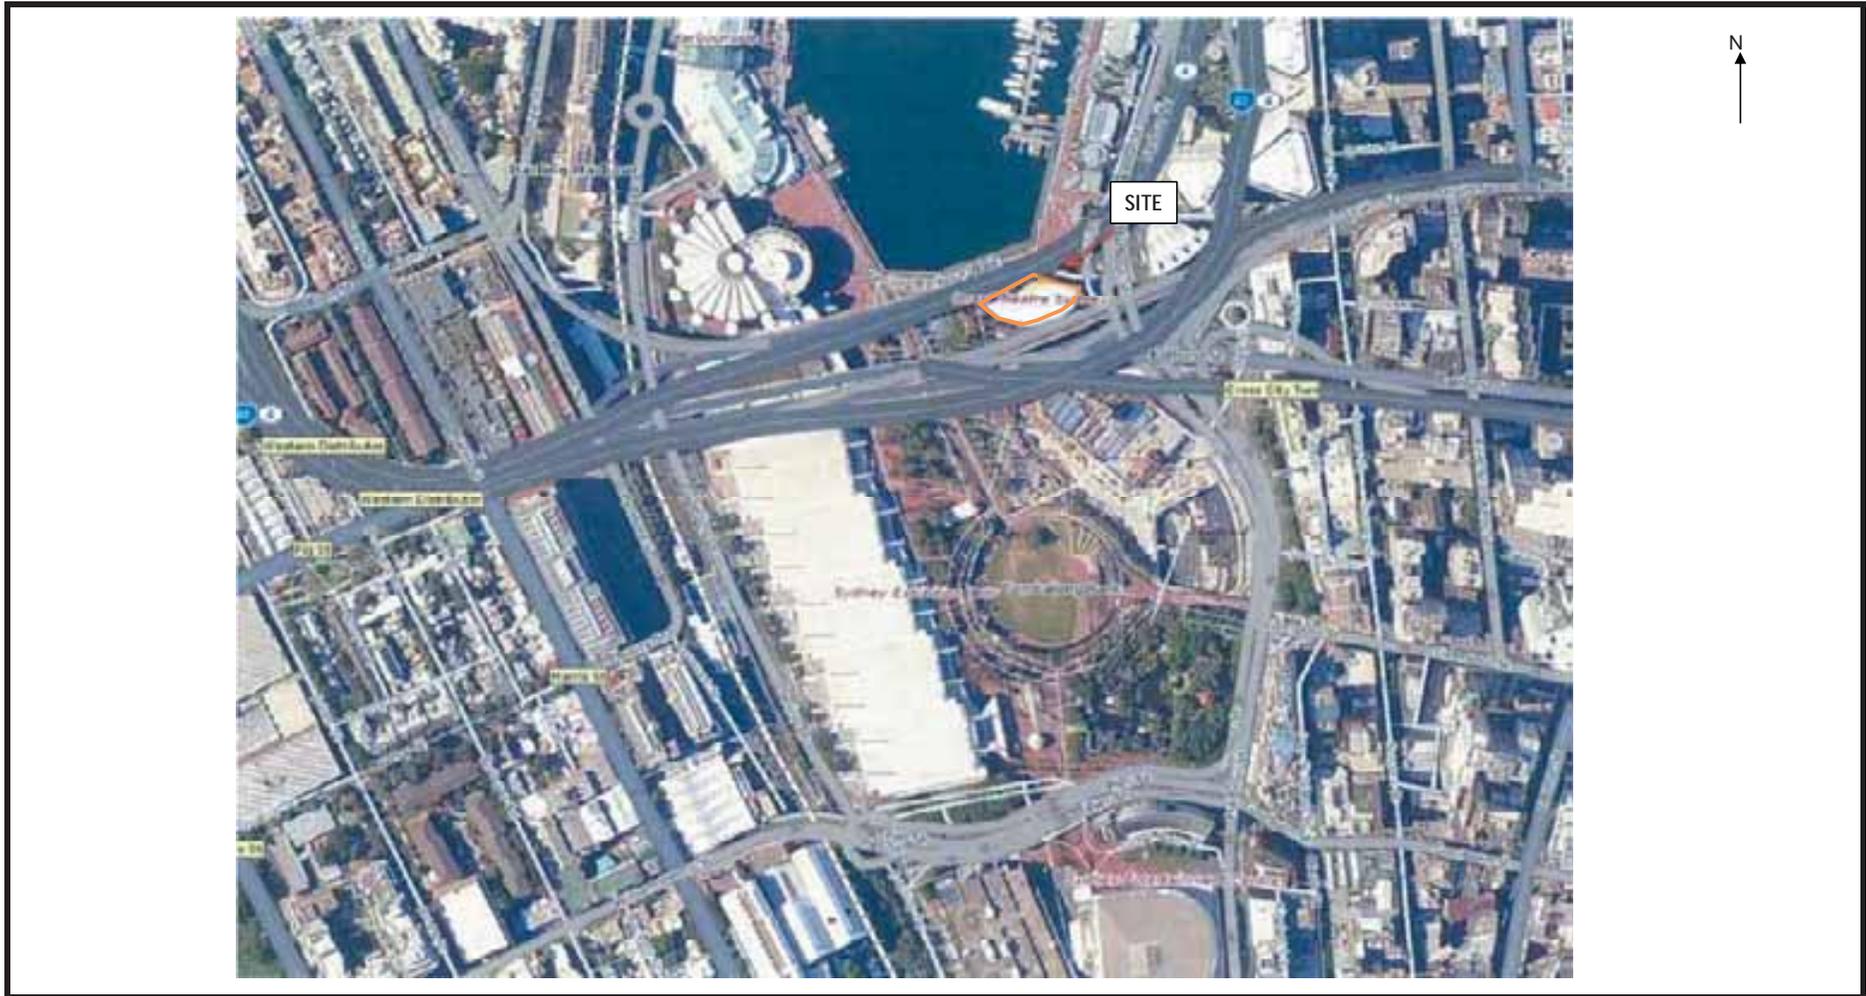
Plate
9
2009

- 2009 The site and surrounds have not noticeably changed since 1999. The area to the south of the site is the process of being redeveloped, and is currently a construction site.
