Report on
Geotechnical Desktop Study

Proposed Wahroonga Adventist School
Fox Valley Road, Wahroonga

Prepared for
Stanton Dahl Architects

Project 73244.00
November 2012

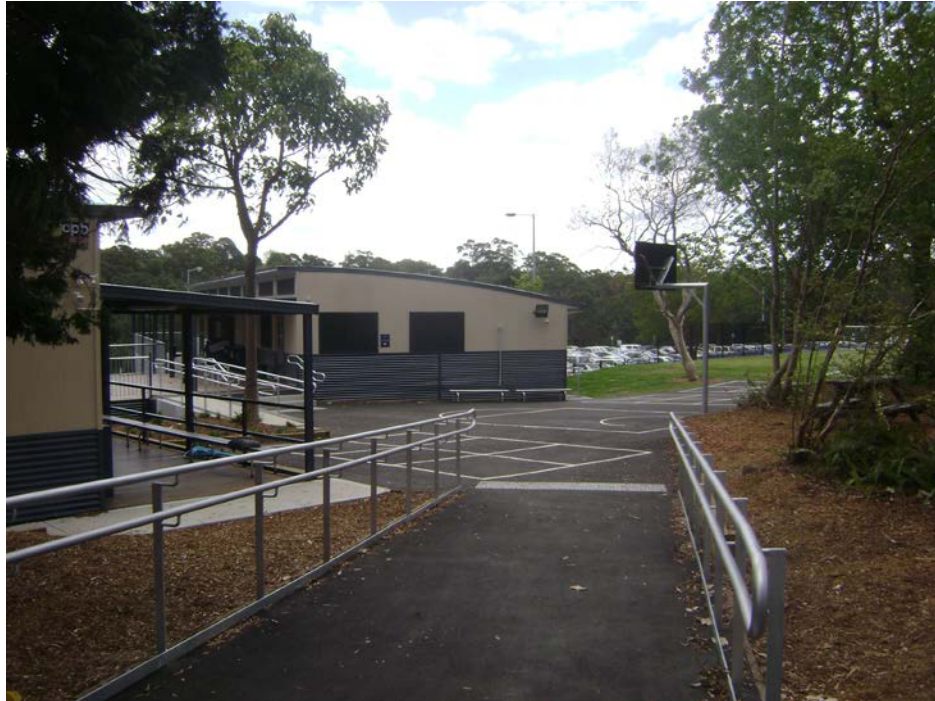
- The grassed playing field, playground area and outdoor areas along the northern side of the existing school have been constructed on raised fill areas (see Photos 1 and 2);

Photo 1 – School Buildings and Grounds

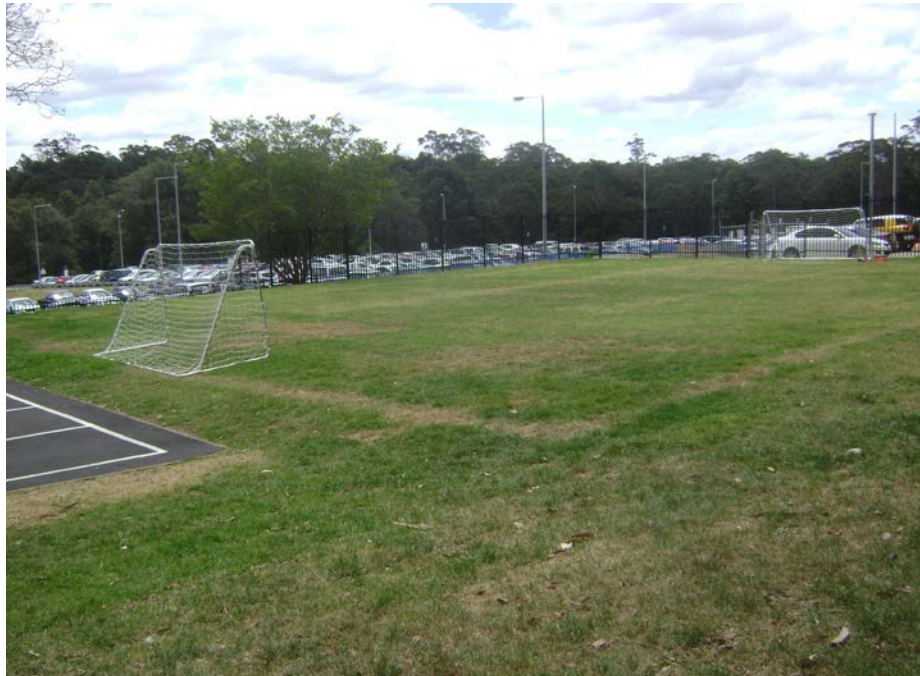
Photo 2 – School Playing Field and Carpark

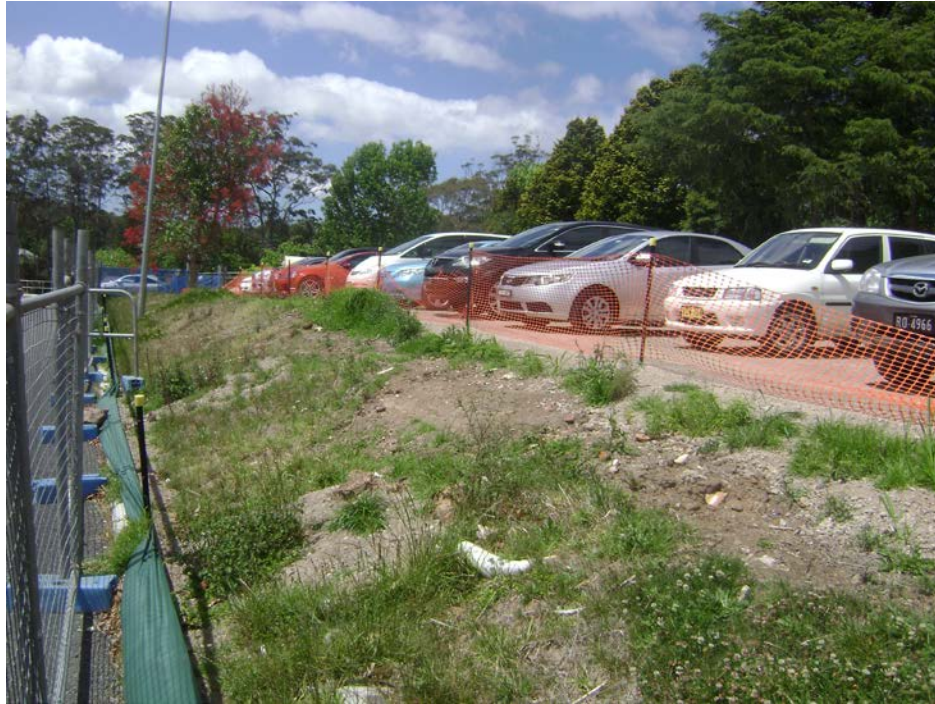
Photo 3 – Sealed and unsealed carparks separated by 0.5m to 2m high soil batter (possible filling) within proposed school building/basement footprint

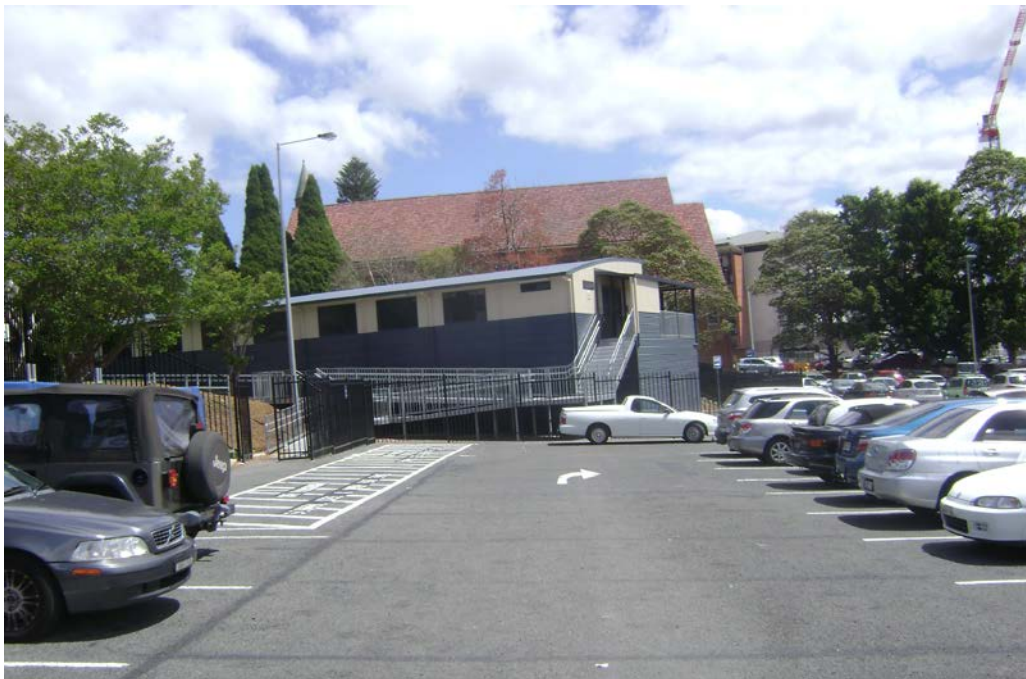
Photo 4 – Sealed carpark and school buildings within proposed school building/basement footprint

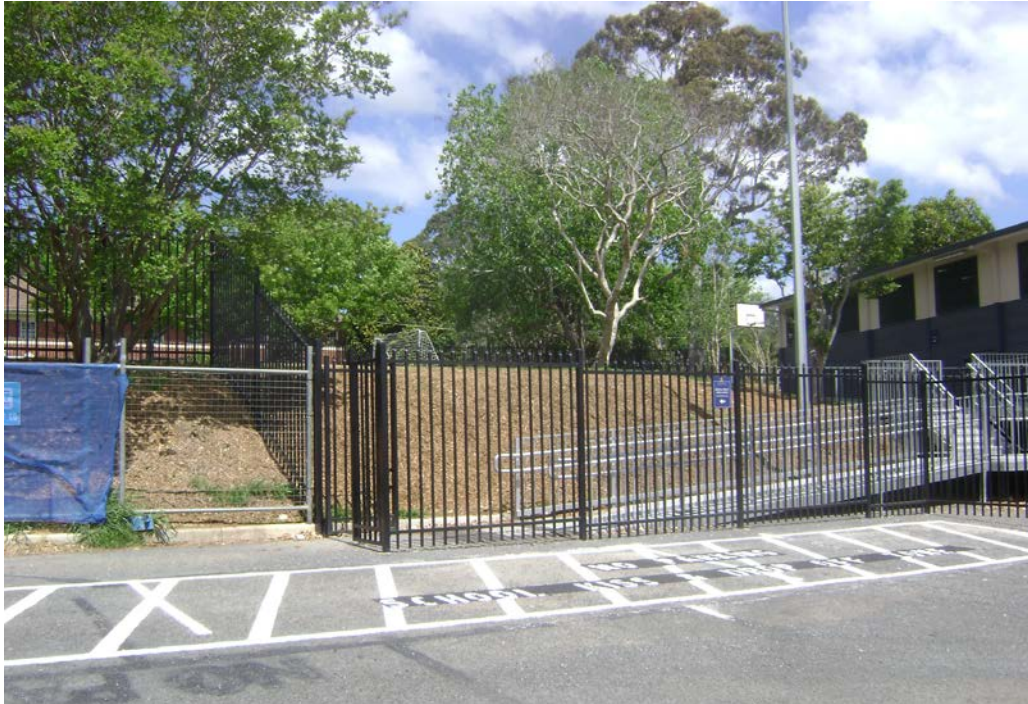
Photo 5 – Continuation of 2m high soil batter (possible filling) along northern side of school grounds and within proposed school building/basement footprint

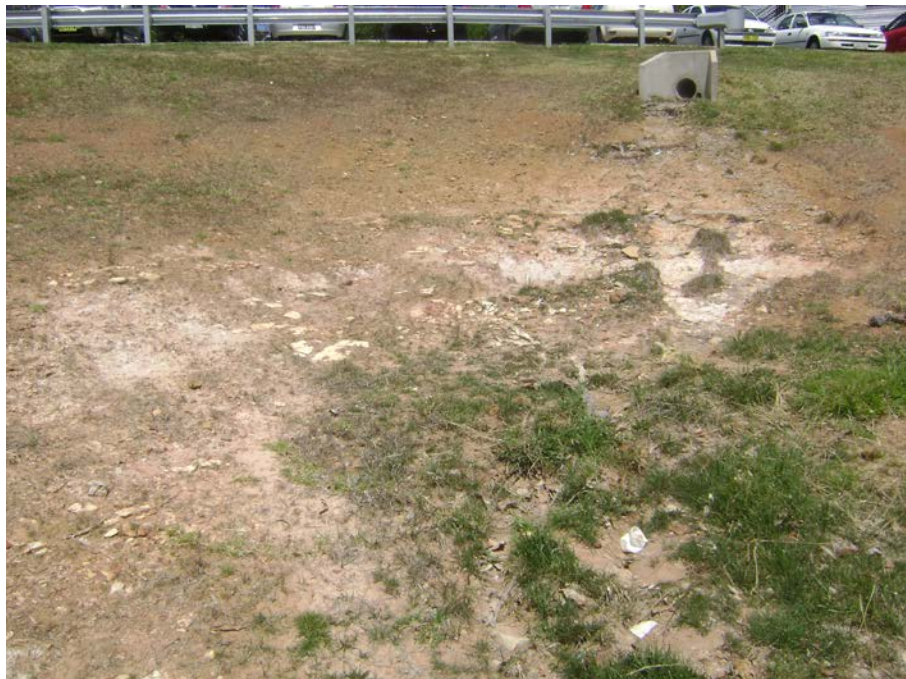
- A 0.5 m to 2.0 m high batter, sloping at approximately 2:1 (Horizontal:Vertical) extends along the northern side of the school grounds and unsealed gravel carpark. This batter face exposed filling, indicating past cut and fill earthworks to form current site levels (see Photos 3 and 5);
- Residual, stiff, red brown clay underlain by stiff, light grey clay with 'high strength' ironstone bands are exposed in the base and sidewalls of the detention basin immediately north of the site (see Photo 6).

Photo 6 – Stiff residual clay and ironstone bands exposed within stormwater detention basin north of proposed school building/basement footprint

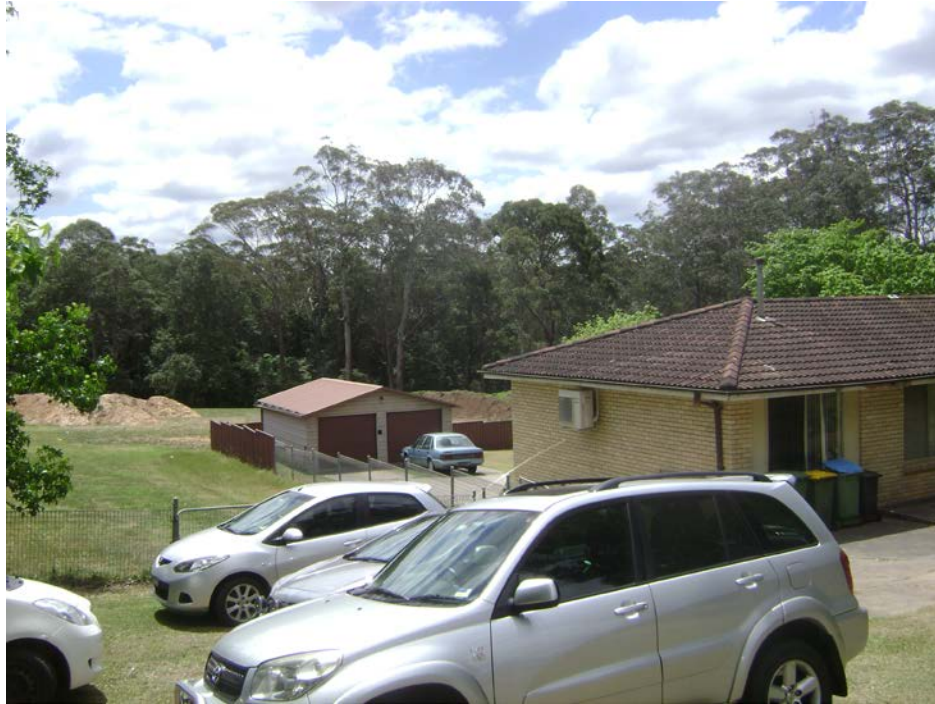
Photo 7 – Residential properties south of proposed playing fields

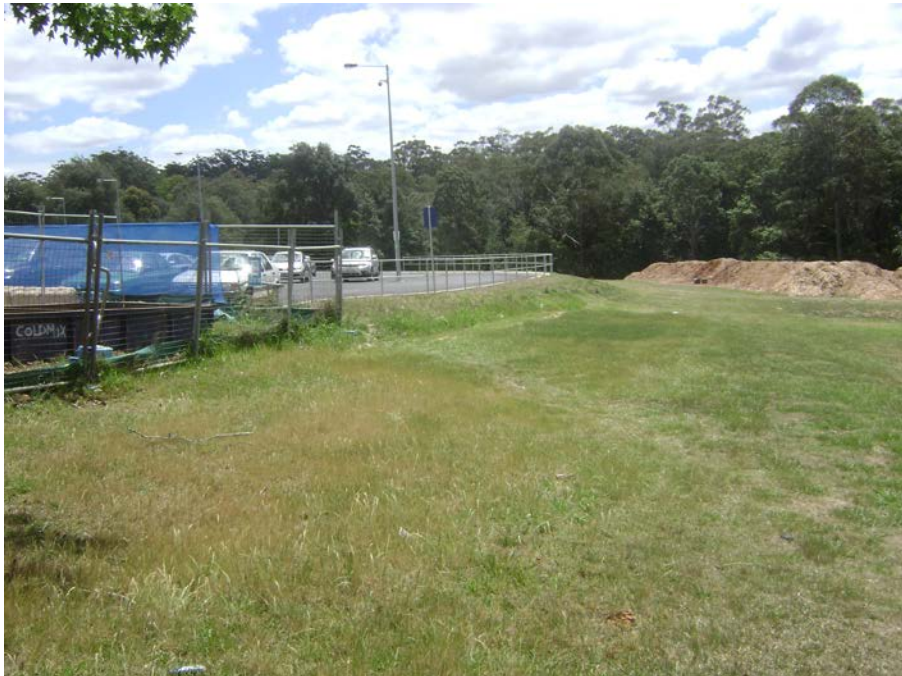
Photo 8 – Southern side of proposed playing fields, stockpile of woodchips, possible filling beneath carpark

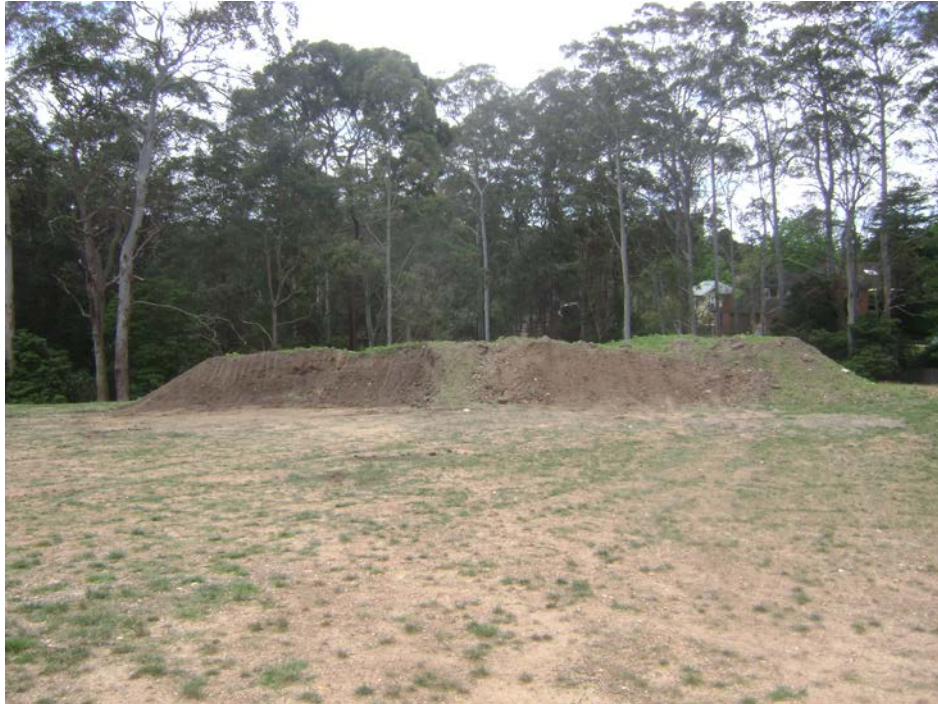
Photo 9 – Stockpile of mixed silty sand topsoil, clay, gravel, shale sandstone, concrete and organics on proposed playing fields

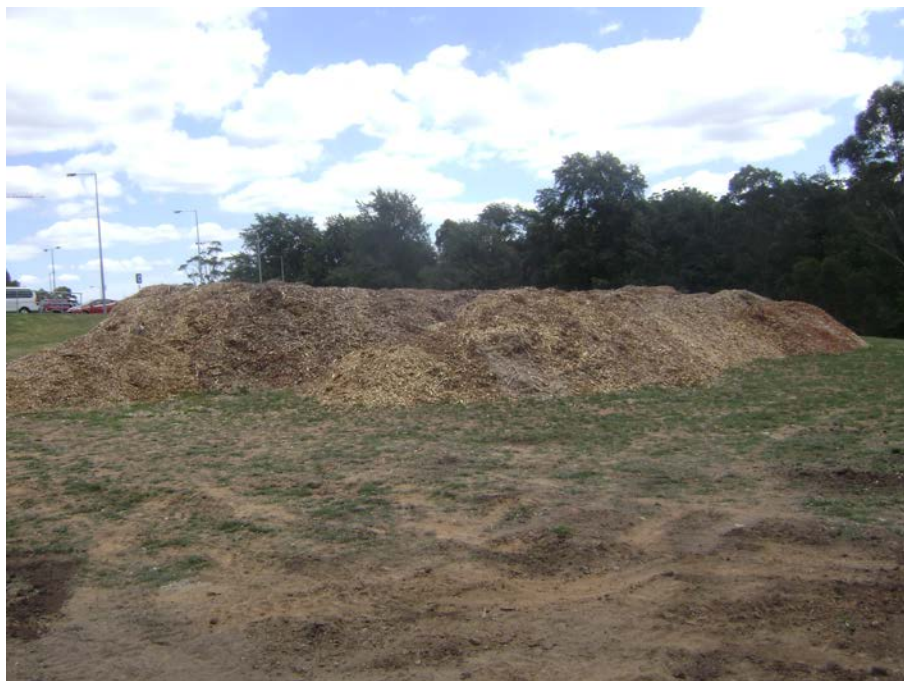
Photo 10 – Stockpile of woodchips on proposed playing fields

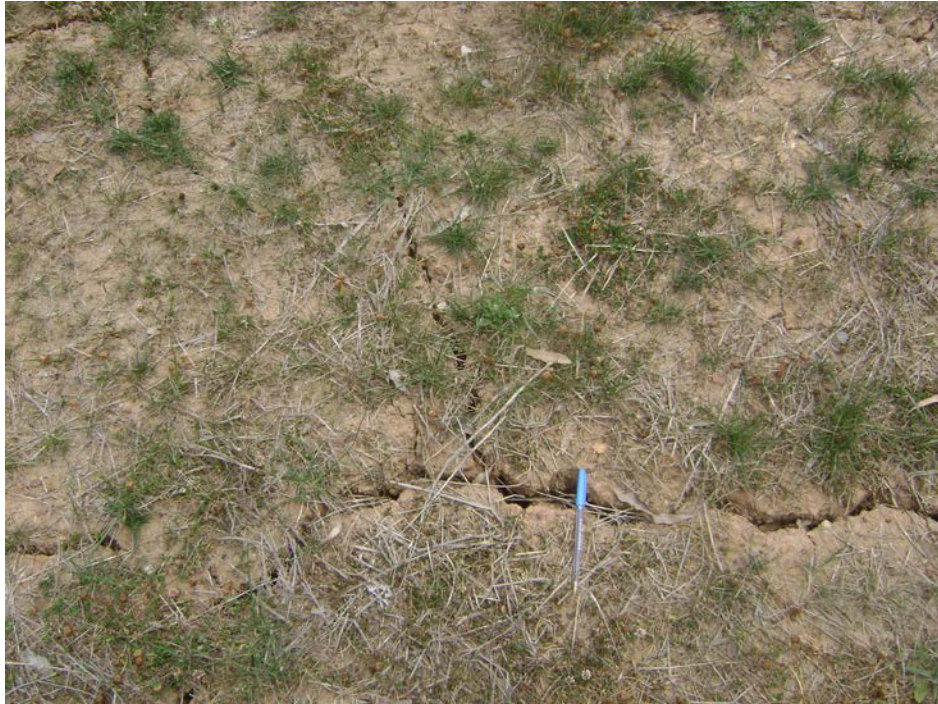
There were no signs of slope instability observed on the site. There was some cracking observed along the crest of a filled batter but this is probably due to shrink-swell movements of reactive clays.

Photo 11 – Tension/shrinkage cracks up to 20mm wide and 150mm deep along crest of northern slope at proposed playing fields

To avoid slope instability being caused by the proposed development it is recommended that all permanent cut and fill batters be sloped at 2H:1V or flatter, with erosion protection provided as required. In addition, where new filling is to be placed over existing slopes, the existing slope should first be benched to form a series of near horizontal benches onto which the filling can be placed and compacted.

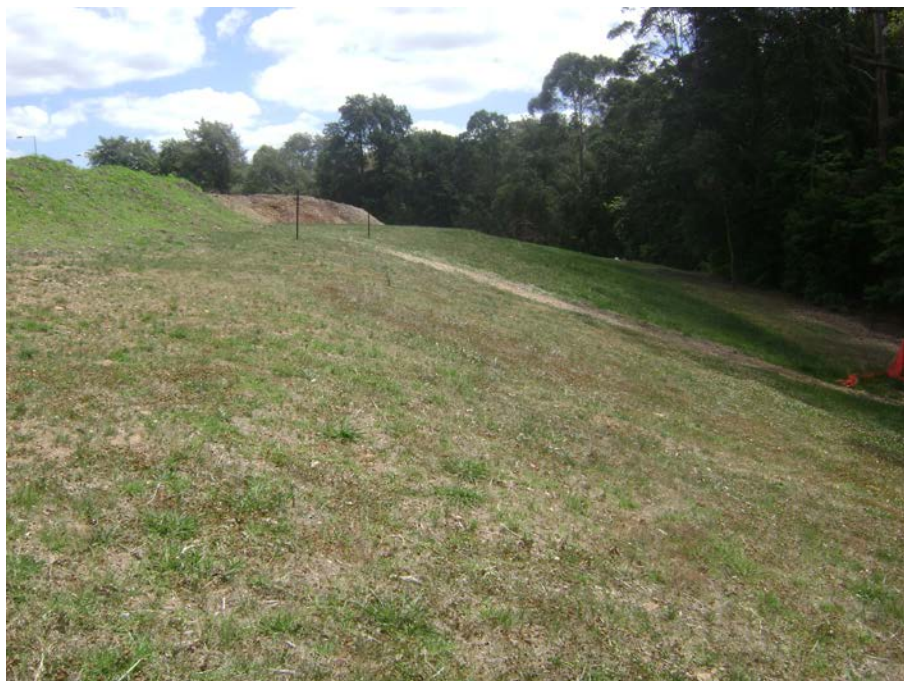
Photo 12 – Ground surface slopes at approximately 3:1 (H:V) along northern side of proposed playing fields, possible filling in this area
