Subject	SPR38 and SPR1302 Trigger Investigation	Project Name	Springvale Groundwater Monitoring
Attention	Natalie Gardiner	Project No.	IA132000
From	Quan Bui		
Date	13 January 2021		
Copies to

1. Introduction

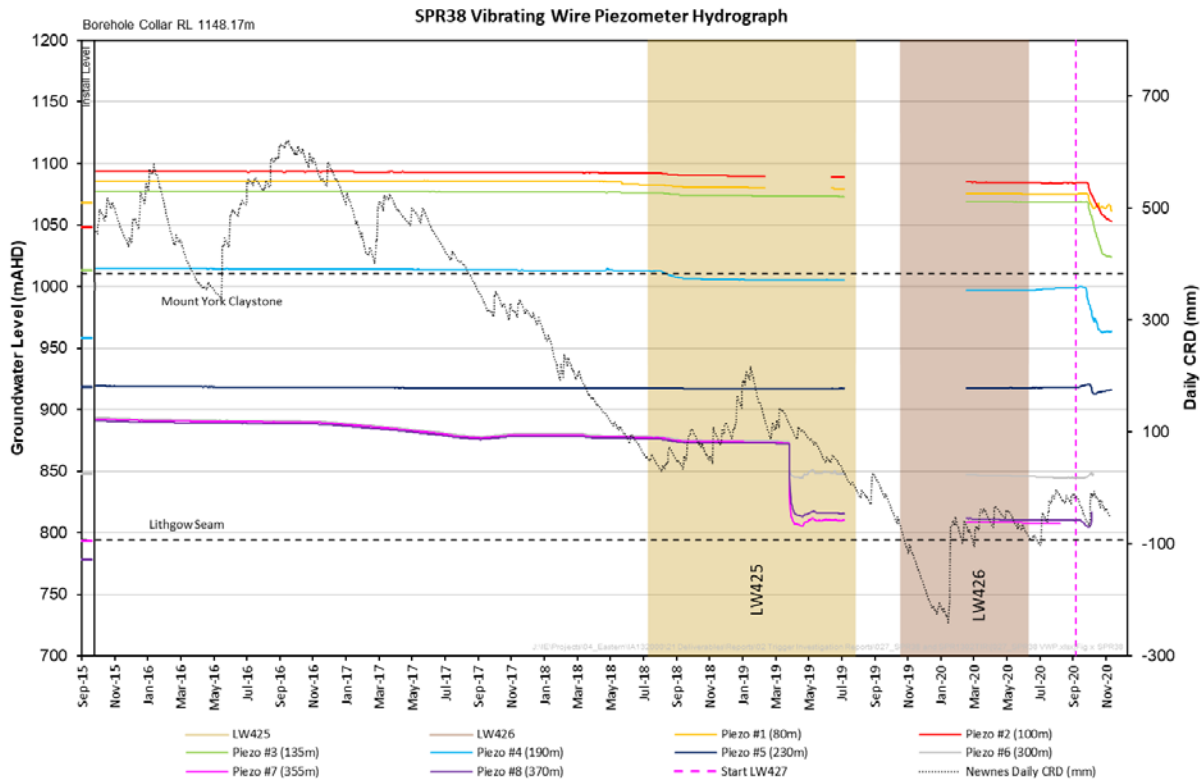
Figure 4.1: SPR38 Hydrograph

Figure 4.1 present the hydrograph of SPR38 with the vertical dotted line representing the start of LW427. Based on VWP data at SPR38, the upper aquifer above the Mount York Claystone at this location was first observed to depressurise from 20th October 2020. The response occurred when LW427 was within 50m of SPR38. Based on data up to 1 December 2020, compared to the pressures before the decline, Sensor #1 has recorded a 14m decrease and has become unsaturated, so the full magnitude of the pressure decline at Sensor #1 cannot be assessed; Sensor #2 has recorded a 31m decrease in pore pressure; Sensor #3 has recorded a 45m decrease, Sensor #4 has recorded a 35m decrease, Sensor #5 has been unsaturated since installation, Sensor #6 was unsaturated since 2019 under LW425; and communication was lost with Sensors #7 and #8. It is noted that pressures at Sensor #4 have stabilised and pressure declines at Sensors #2 and #3 have slowed.

Previously, a depressurisation response was observed at SPR38 in the lower three sensors close the Lithgow seam during the heading development for LW427 in April 2019. This was a direct response to the headings passing very close to the sensors and not a widespread mining response. No other sensors were affected in this period.

At SPR38, the piezometric pressure declines are still continuing at Sensor #2 and #3. It is noted that the stabilisation of pressures at Sensor #4 would indicate that the decline was due to fracture dilation and bed separation as opposed to connective fracturing. Mining is still in close vicinity to SPR38 and it will take some time before groundwater pressures stabilise and a conclusion is drawn.

SPR38 shows significant depressurisation, most likely due to fracture dilation and bed separation caused by subsidence. Piezometric pressures at several sensors at SPR38 are still in decline.

- Continued monitoring as per Chart 3 of the SMP for LW424-7
- Monitor groundwater extraction rates from the Springvale mine.

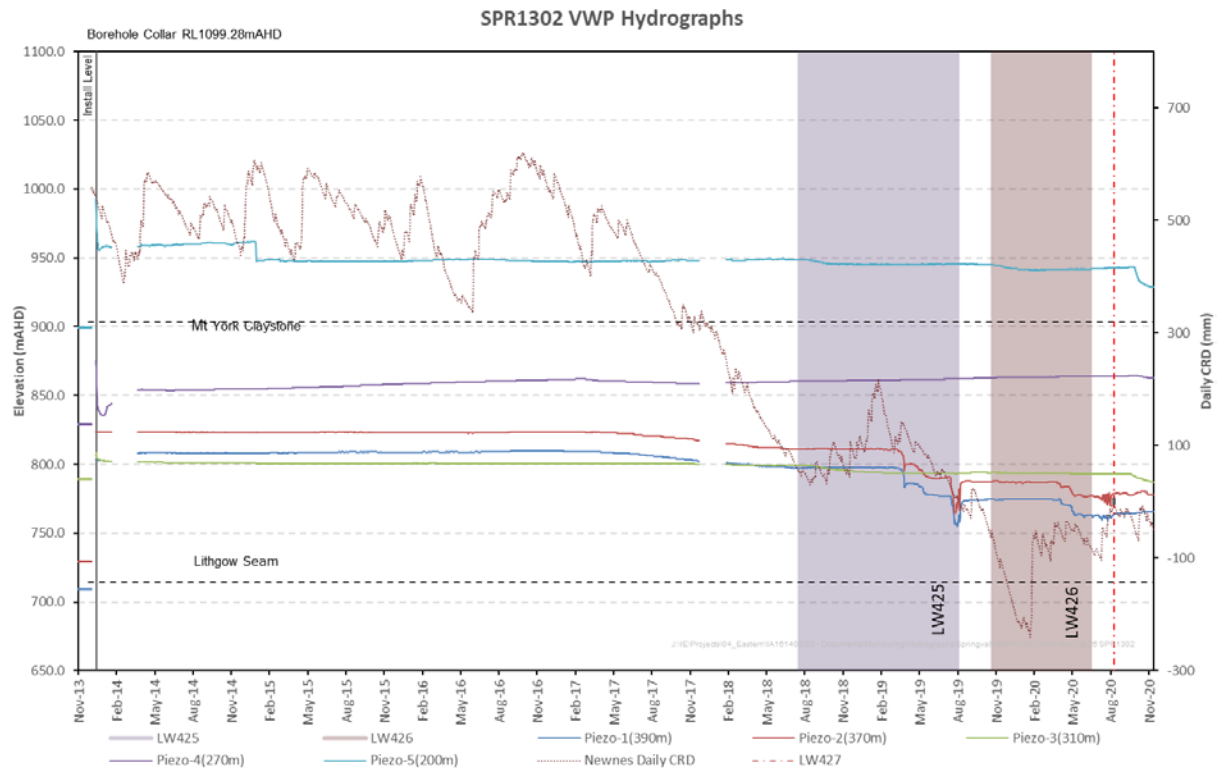
Figure 4.2: SPR1302 Hydrograph

Figure 4.2 present the hydrograph of SPR1302 with the vertical line representing the start of LW427. Depressurisation of the upper sensor located just below the Mount York Claystone was observed on 16 October 2020. The response occurred after LW427 was at its closest point to SPR1302 and as it was moving away. The upper (Sensor #5) has recorded a decline of 14.4m since the observation was made. The decline has appeared to stabilise and is currently recording stable pore pressures.

Previously, SPR1302 has recorded depressurisation responses during the extraction LW425 between April and September 2019 and during LW426 in April 2020 in the lowest two sensors located close to the Lithgow seam. Both these longwalls were over 600m away from SPR1302 when these observations were made.

At SPR1302, the response is consistent with groundwater re-equilibration resulting from bed separation and increased storage above LW427. At this point in time, vertical fracturing from the goaf and deep drainage to the deeper aquifer is not evident

At SPR1302, the hydrograph shows groundwater pressures have re-equilibrated with subsided formations located above LW427. There is no evidence of continued decline associated with vertical fracturing or deep drainage at this point in time.

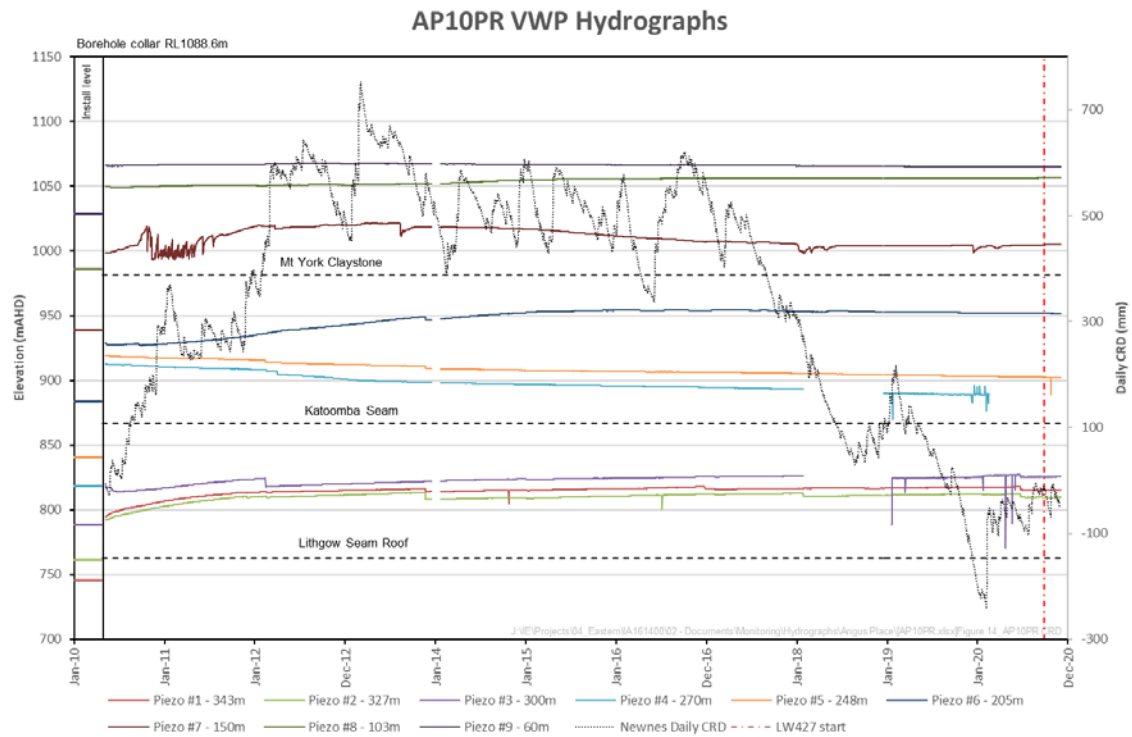
Figure 5.1: AP10PR hydrograph

At AP10PR, the two upper sensors monitor the Bankswall Sandstone Formation. Sensor #9 located 44mbgl in the Bankswall sandstone recorded stable pore pressures, fluctuating less than 0.14m between the start and end of the period. Sensor #8 located 72mbgl in the Bankswall sandstone also recorded stable pore pressures fluctuating less than 0.13m in the period.

In summary, both reference sites displayed stable pore pressures over the period from 20 October 2020 to 1 December 2020.

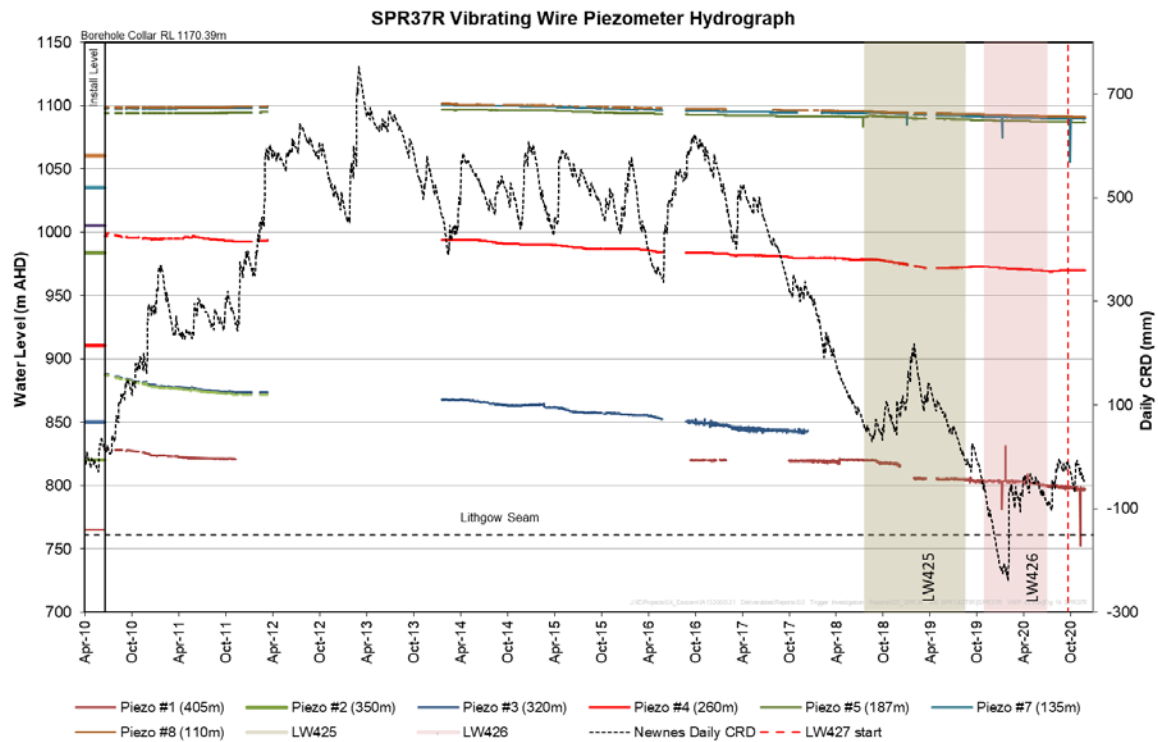
Figure 5.2: SPR37 hydrograph

At SPR37, the upper 3 sensors monitor the Bankswall Sandstone formation. Sensors #8, #7 and #6 are installed at depths of 100m, 135m and 165m respectively. Sensors #8 and #7 recorded less than a 0.4m fluctuation in this period. Sensor #6 is recording erroneous data.
