Blast Impact Assessment Main Creek

**REVIEW OF THE IMPACT OF BLASTING ON ROCK
STRATA FRACTURING ON MAIN CREEK**

Report No: UM-1705-240518

**Thomas Lewandowski
24th May 2018**

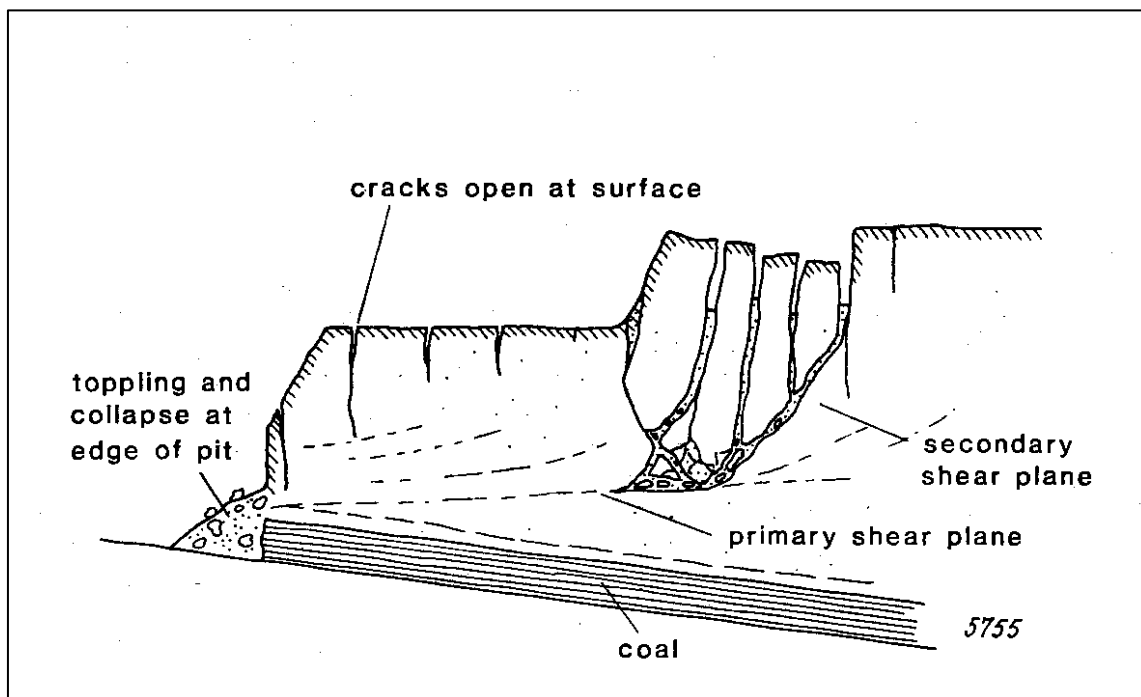
- The extent of damage, including back-break cracking, which developed on the surface (vertical cracks or semi vertical), was limited to 23 m from the highwall (based on extensometer results). Based on a seismic survey the extent of the damage is limited to approximately 30 m showing a reduction in the seismic velocity.
- The extent of the horizontal cracks (along the weak strata layer) was estimated to be 50 m horizontally from the blasting area (based on extensometer results). The mechanism of rock damage was described in detail and was driven by gas penetration of the blasting product through the rock strata.

Figure 5A – Highwall Damage Due to Adjacent Blasting (after CSIRO 1983 Report)

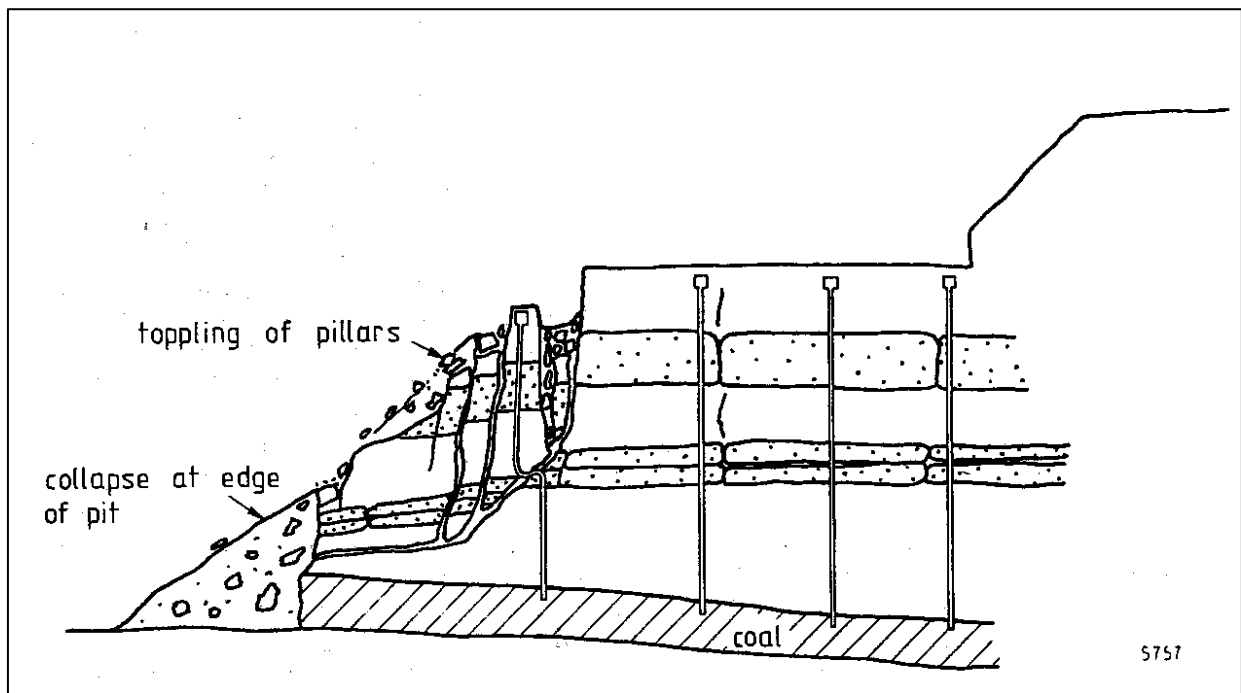
Figure 5B – Damage Showing Vertical and Horizontal Cracks (after CSIRO 1983 Report)

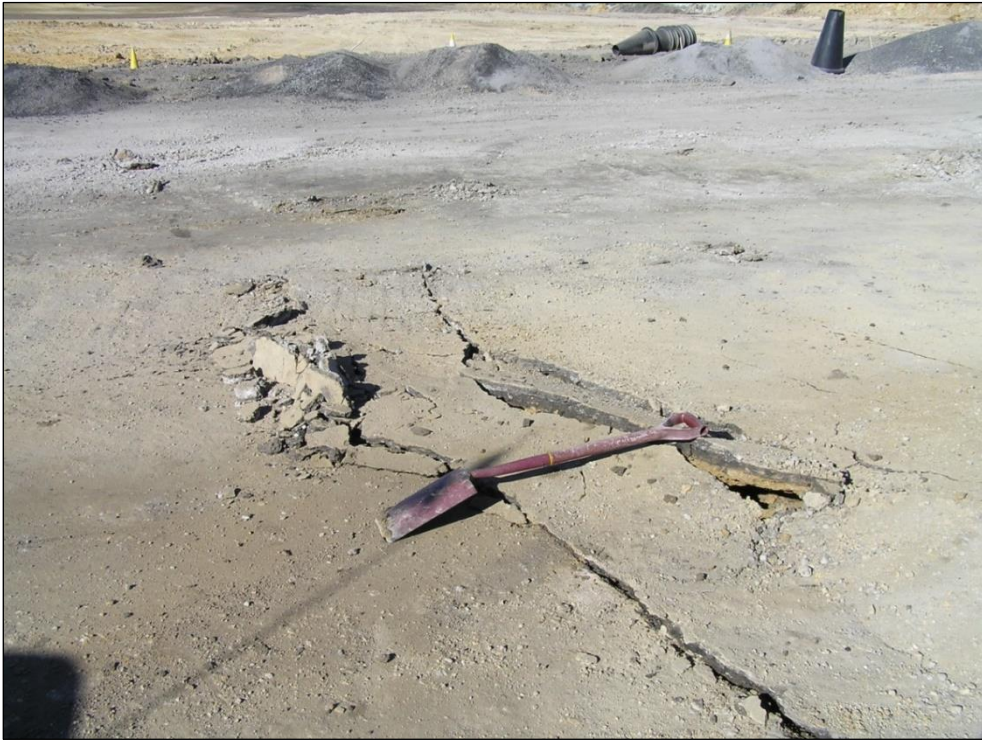
The blasts of interest included pre-split blasts with an MIC of 530 kg. For these particular geological conditions the extent of damage was relatively limited and was in line with other open cut mine experiences in the Hunter Valley, i.e. up to approximately 20 m behind the blast. The detected damage (manifested as a number of surface cracks and some surface layer displacement) was estimated to be in the order of up to 17 m from the edge of the blast, see **Figures 6B** and **6C**.

Figure 6B – Impact of Blasting – Showing Surface Rock Strata Damage to Blasted Pre-Split Line; Extending up to 17 m from the Edge of the Blast (after Lewandowski and Cope 2009) ,

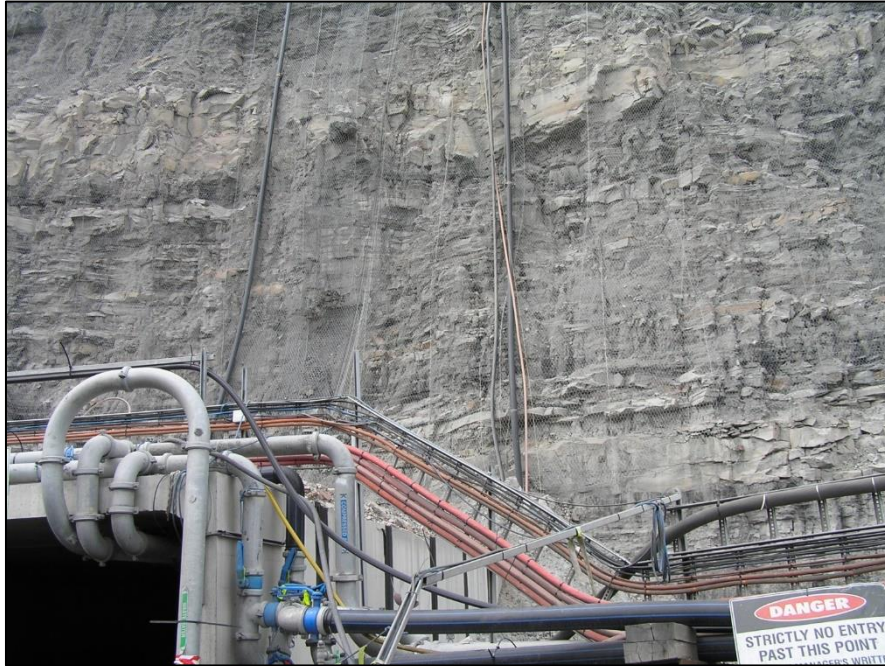
Figure 8A – Underground Mine Entry and Highwall Conditions after Blasting (ESC Study 2008)

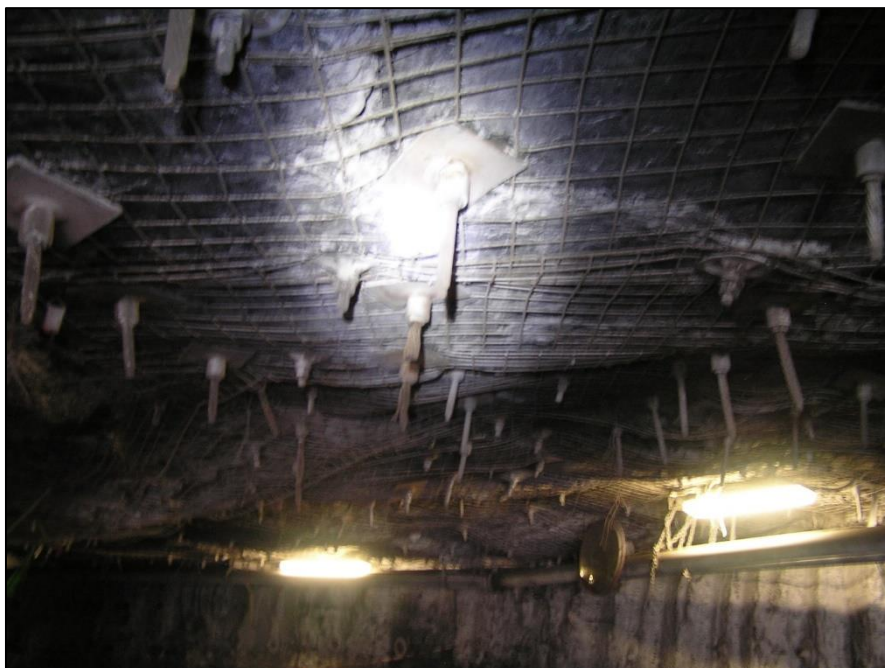
The study included an assessment of ground fracturing and rock wall damage within the underground tunnel, see **Figure 8B**. The assessment included a detailed inspection of the rock strata conditions for the underground tunnel, with the main aim to assess the level and extent of damage to the rock strata. A sample of the strata immediately above the roof of the underground roadways is shown in **Figure 8C**. The study was also supported by analysis of roof dilation data using roof extensometer measurements. This would provide evidence of horizontal crack formation caused by the adjacent strata blasting, see **Figure 8D**.

Figure 8B – Underground Strata Conditions and Induced Damage due to Previous Surface Blasting (ESC Study 2008)

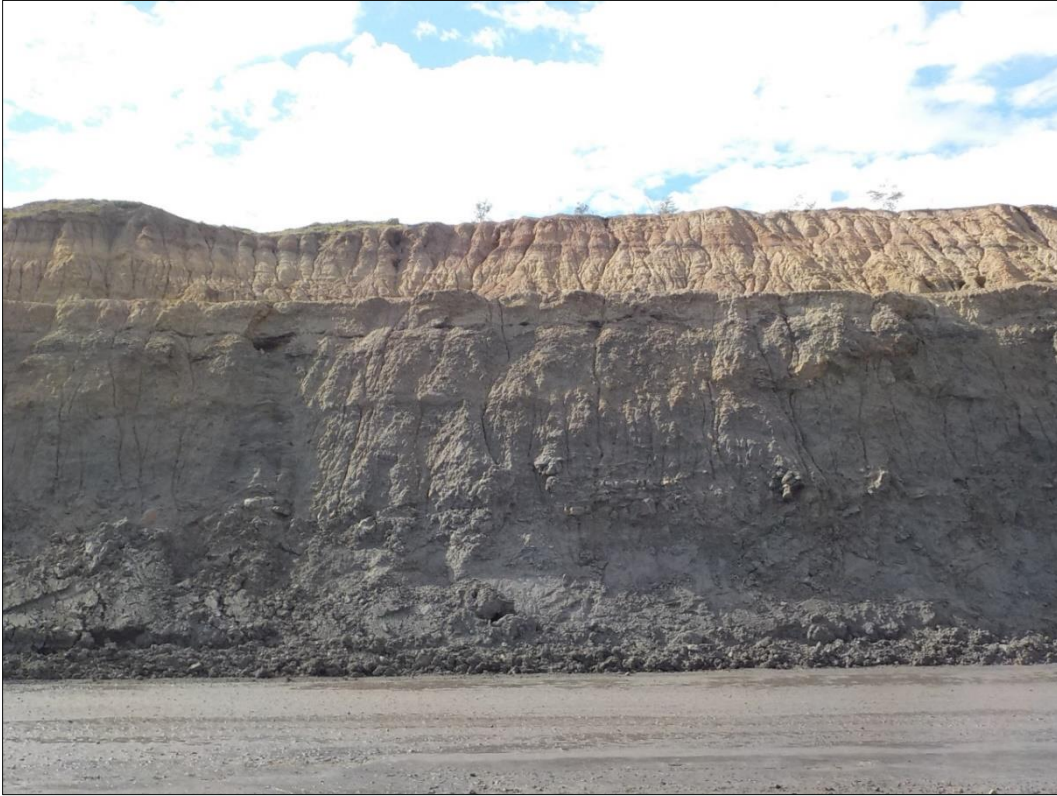
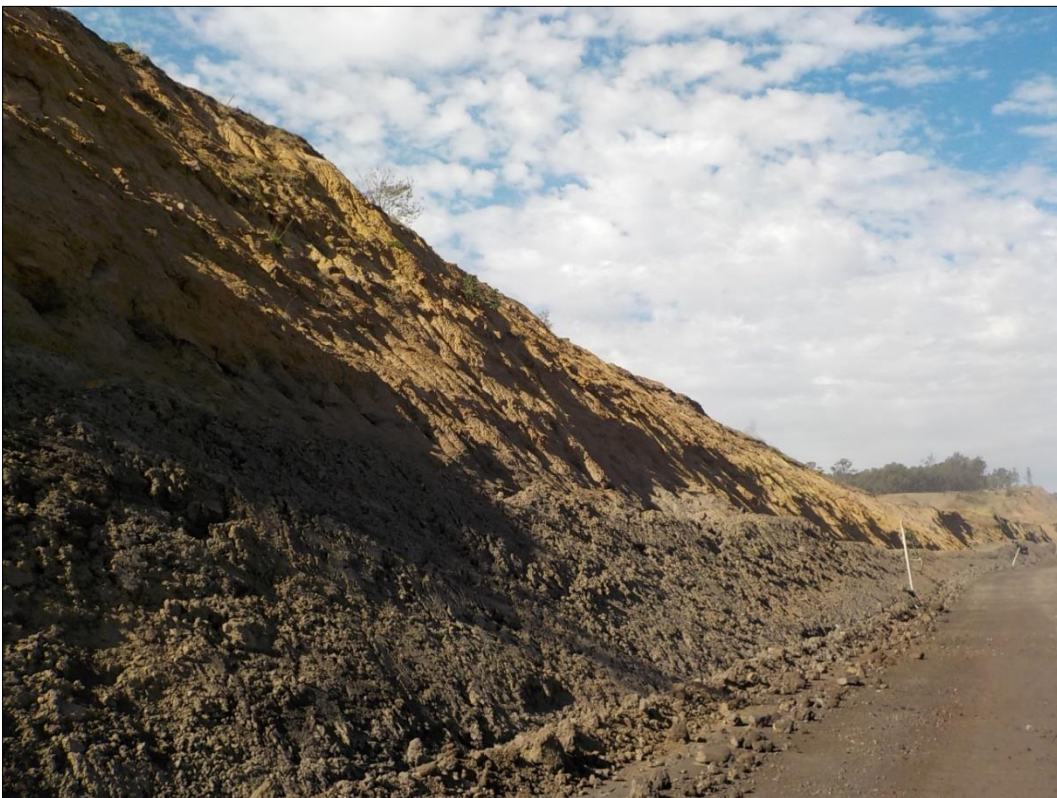
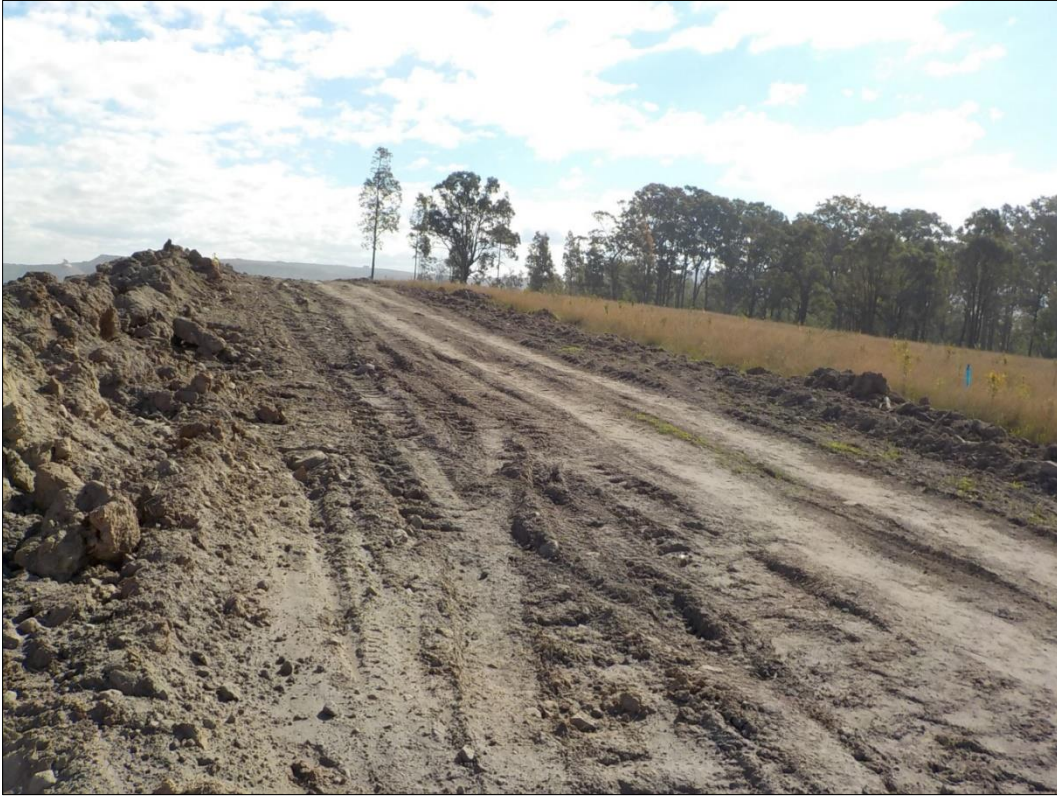
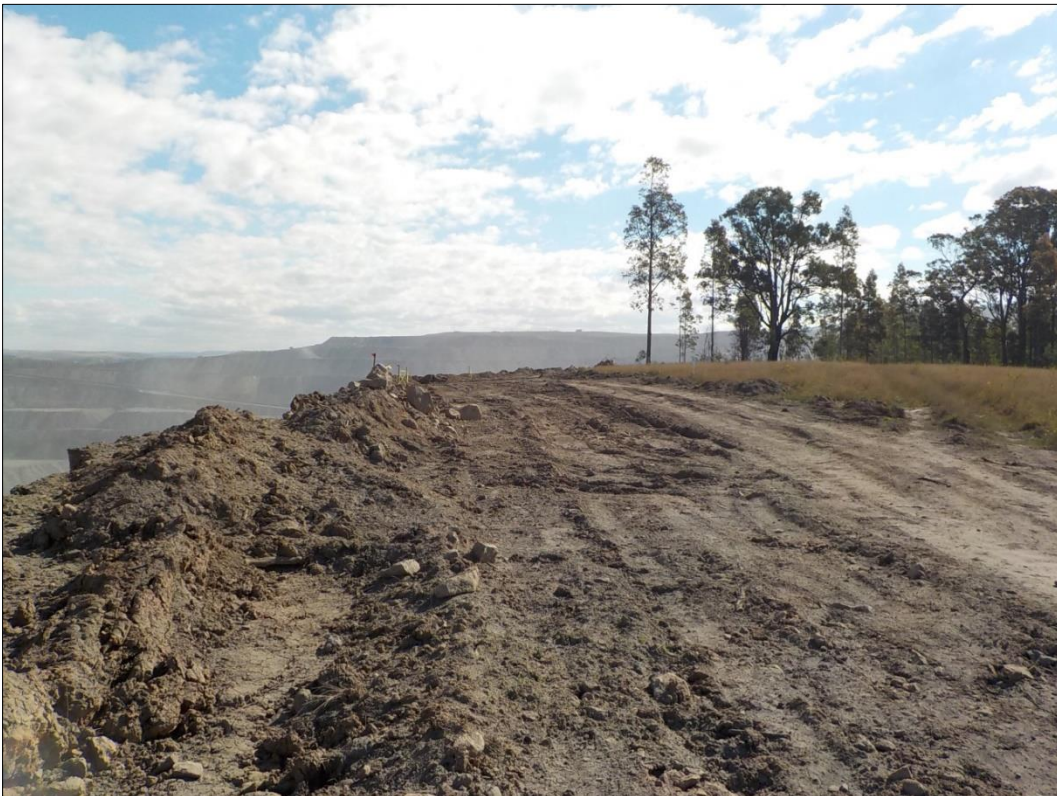
The inspection included an overview of the eastern rock wall conditions of North Pit as well as surface soil conditions near the eastern wall area. This was to provide an indication of the potential rock strata behaviour when blasted and excavated near the Main Creek Study Area. The inspection of the eastern wall and adjacent surface area revealed the absence of any slope stability issue or the presence of any surface cracks, see **Appendices 2A to 2D**. There is some ongoing minor water erosion at the top of the

slope (limited to the soft strata layers), which is typical and non-consequential for development of adjacent surface strata cracking.

Appendix 2A – View of Eastern Wall Conditions

Appendix 2B – View of Eastern Wall Conditions

Appendix 2C – View of Top Surface Strata Adjacent to Eastern Wall

Appendix 2D – View of Top Surface Strata Adjacent to the Eastern Wall

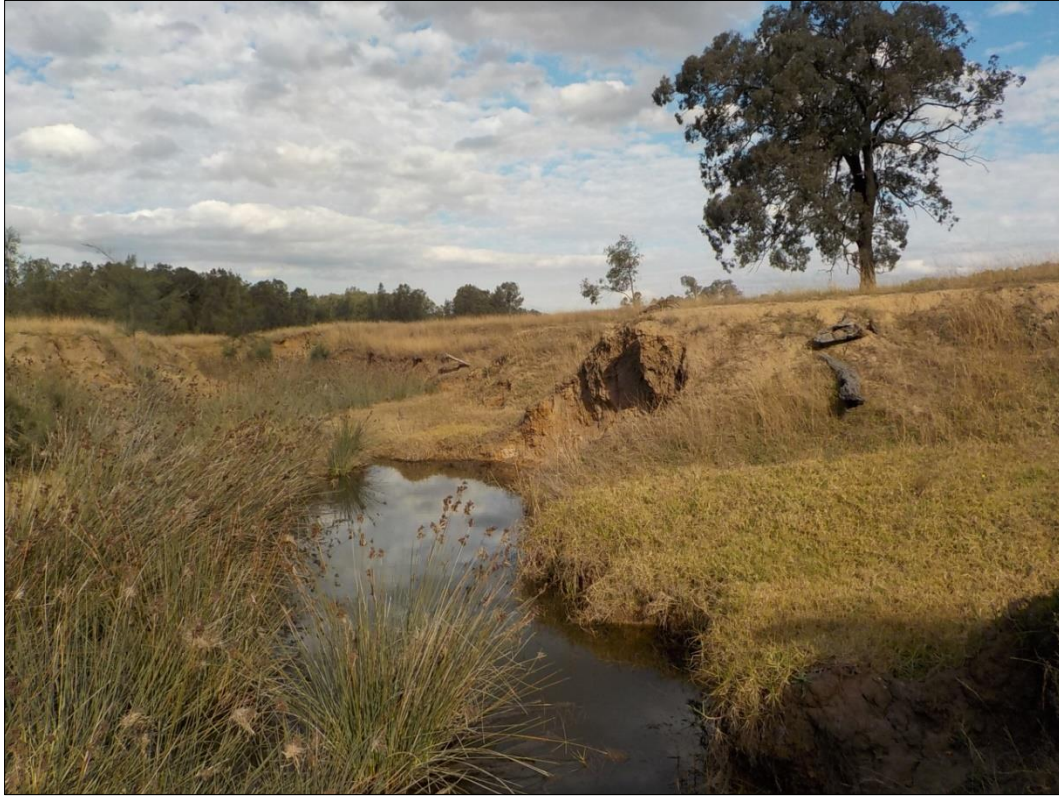
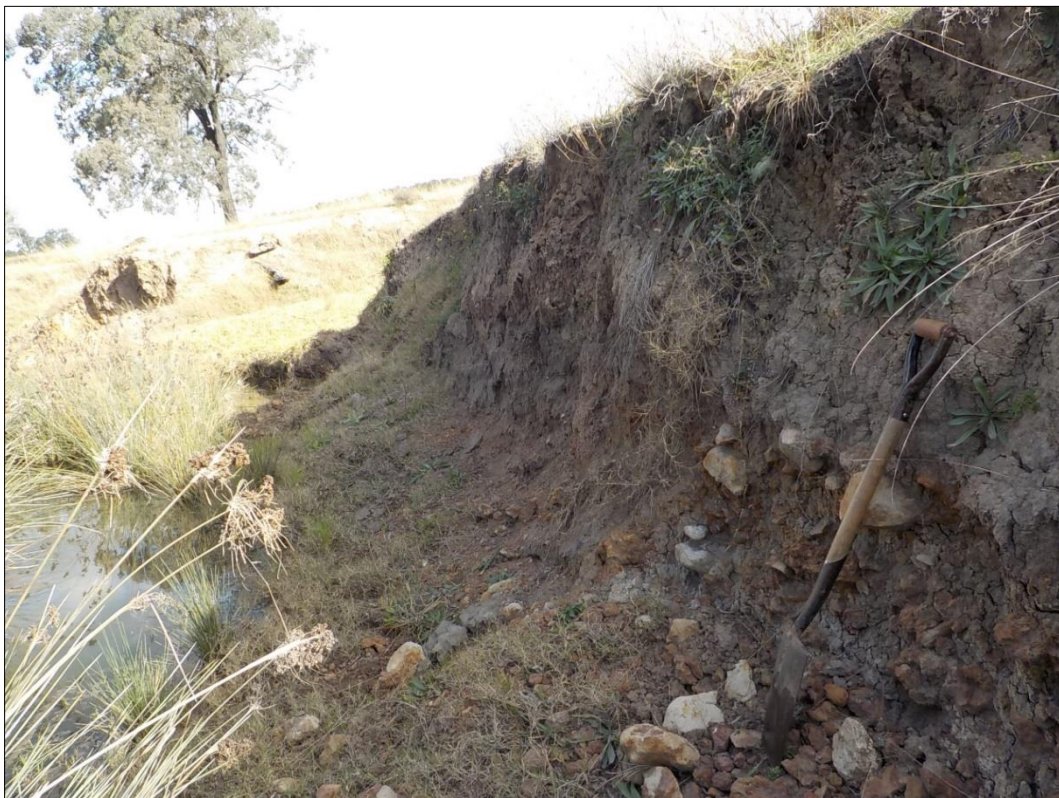
Overall, the creek embankments present are stable and resistant to ground vibration. It should also be recognised that creek embankments will still be prone to water erosion (physical force of water action and moisture intake into the clay / soil material) and ongoing degradation. However, the water erosion will not have any effect on the underlying strata and its propensity to be impacted by adjacent blasting practices.

Appendix 3A – View of Main Creek Study Area and Embankment Conditions

Appendix 3B – View of Creek Embankment Area

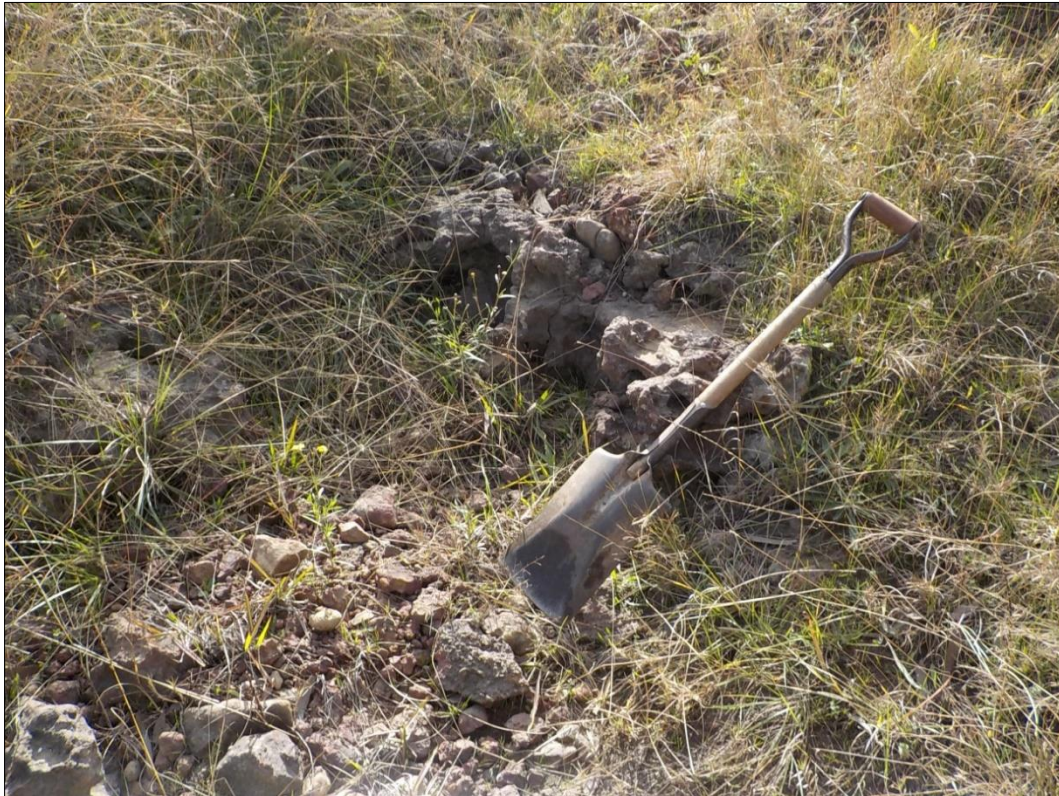
The site inspection revealed that the majority of the strata around the Main Creek Study Area is of heavy compacted soil / clay material (in the top section) with approximate strength in the range of 5 to 10 MPa. Due to the operational ranges of the instruments it was not possible to determine the rock strength more accurately. The other observed material included alluvium and weathered conglomerate layers. There were also some weathered sandstone layers detected.

Appendix 3C – View of Weathered Sandstone Strata Layer

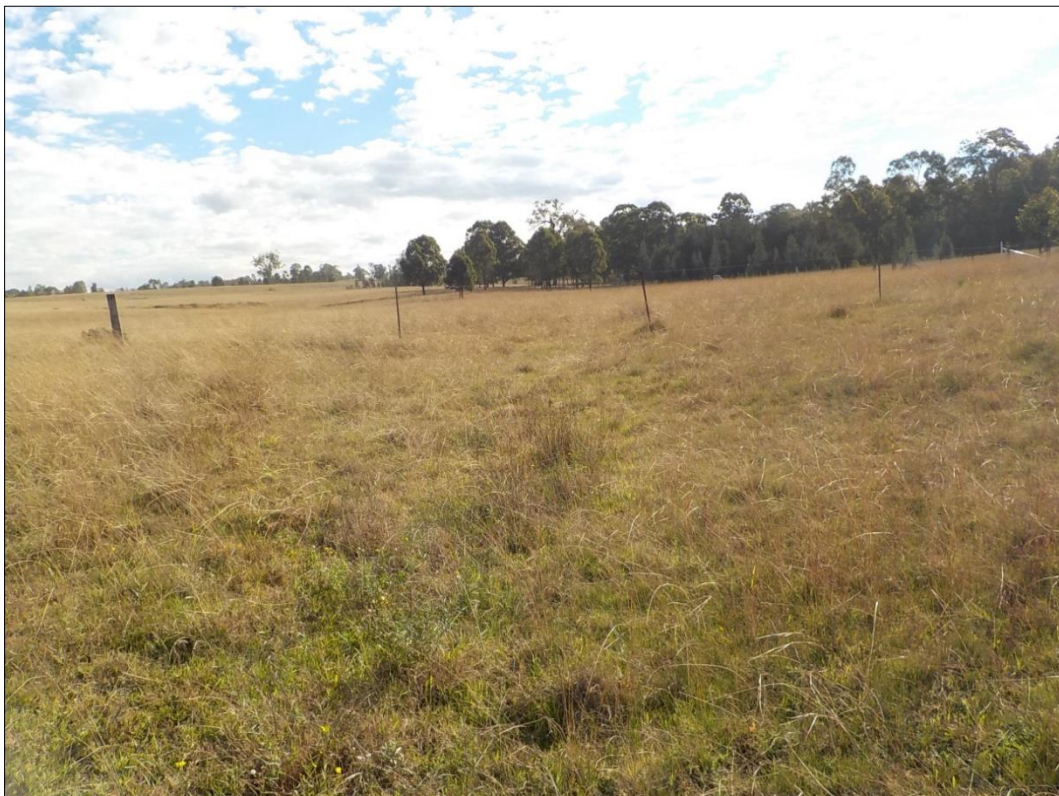
Appendix 3D – View of Surface Strata between Main Creek Study Area and Proposed Modification Pit Shell

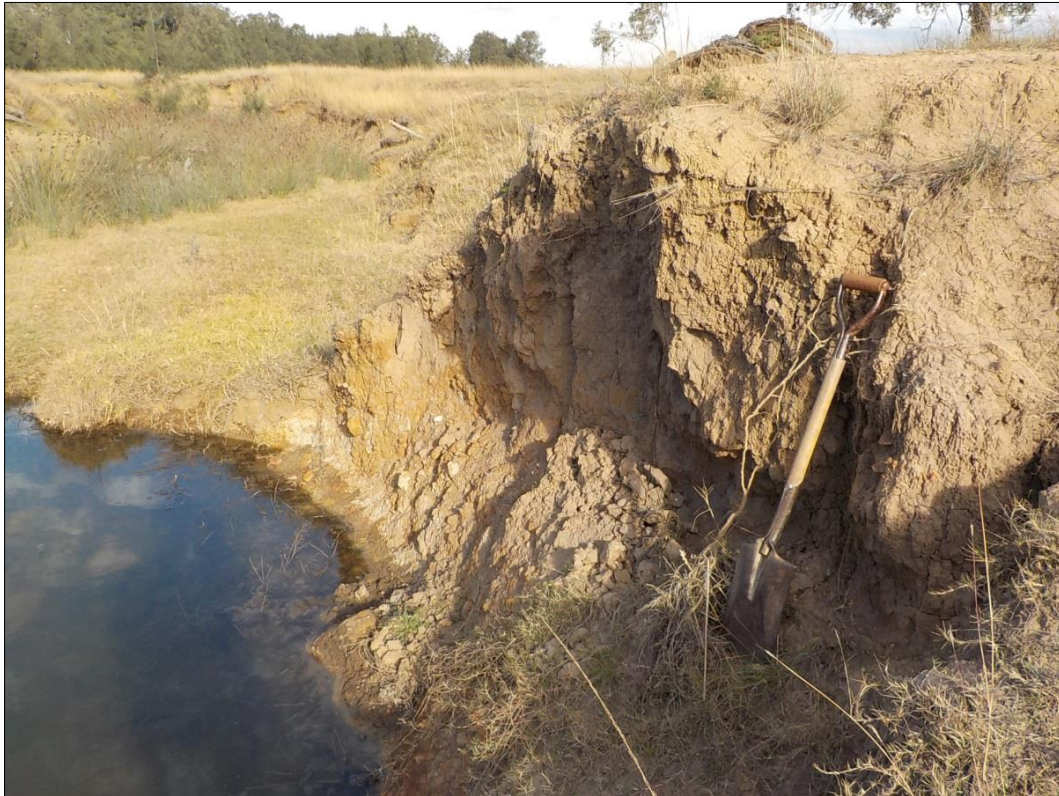
Appendix 3E – View of Embankment – Clay Conditions

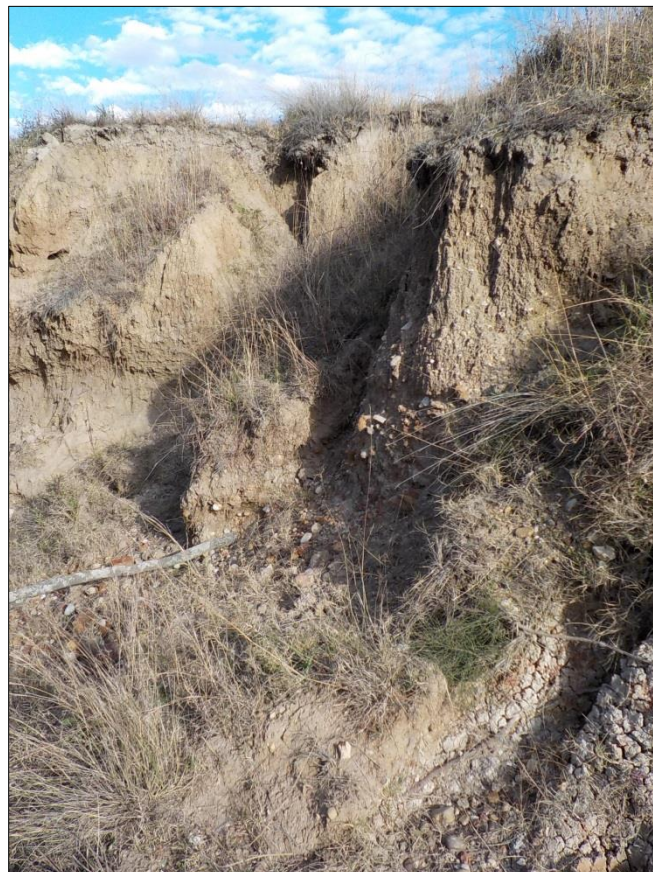
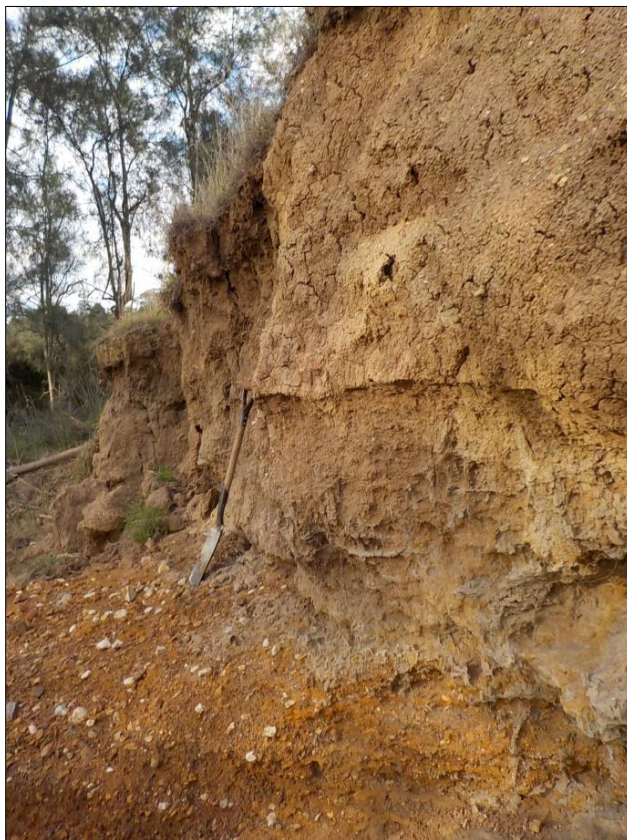
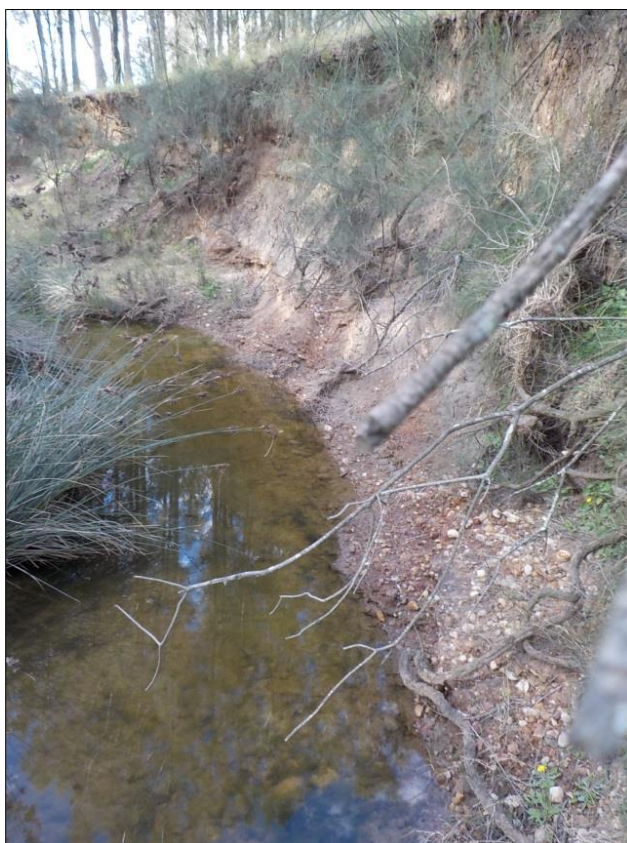
Appendix 3F – View of Surface Strata – Conglomerate Conditions

Appendix 3G – View of Surface Strata – Conglomerate Conditions

Appendix 3H – View of Surface Strata – Conglomerate Conditions
