ARBORIST'S REPORT

PROPERTY:	4 Murray Rose Avenue, Homebush Bay
NUMBER OF SUBJECT TREES:	2
DATE OF REPORT:	30/10/2013
REQUESTED BY:	Lend Lease Project Management and Construction
CONTACT:	Johanna Nolan

ARBORIST'S SUPPLEMENTARY REPORT

PROPERTY:	7 Parkview Parade, Homebush Bay
NUMBER OF SUBJECT TREES:	8
DATE OF REPORT:	18/11/2009
DEVELOPMENT APPLICATION:	
REQUESTED BY:	Bovis Lend Lease
CONTACT:	Grant Eckett

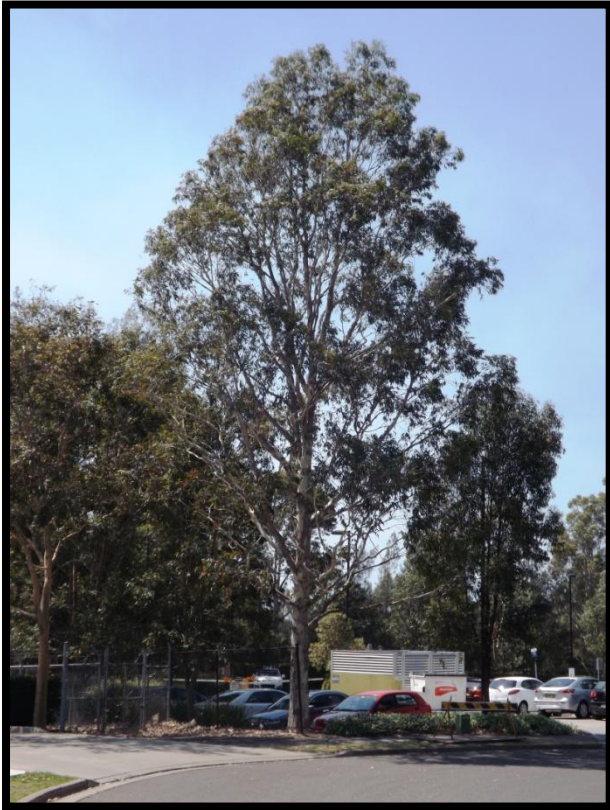
Tree Identification	Description		Health	Structure	U.L.E. (Useful Life Expectancy)
Tree 1s Botanical Name <i>Corymbia maculata</i>	<u>Age:</u>	Mature	The tree is in good health having the following defects: Leaf density of 60% coverage.	The tree has a good structure.	The tree has been given a ULE of 2B due to its good condition.
	<u>CBH</u>	1490mm			
	<u>DBH</u>	474mm			
Common Name Spotted Gum	<u>Height:</u>	16 metres	Slight deadwood to 50mm diameter. Some twig galls.		
	<u>Canopy Spread:</u>	9 x 10 metres			
Tree 2s Botanical Name <i>Corymbia maculata</i>	<u>Age:</u>	Early Mature	The tree is in good health having the following defects: Leaf density of 60% coverage. Slight deadwood to 50mm diameter. Some tip dieback. Some twig galls. Slight deadwood stubs around trunk.	The tree has a fair structure having the following defects: Co - dominant stems from 6 metres high. Slight stem bow at 5 metres high.	The tree has been given a ULE of 3B due to its fair condition.

Tree 1:	H1=1 H2=2 H3=3 1+2+3=6	Hazard rating is 6. The deadwood branches are the parts most likely to fail.
Tree 2:	H1=1 H2=2 H3=3 1+2+3=6	Hazard rating is 6. The deadwood branches are the parts most likely to fail.

Tree 1 (centre) viewed from the west.

Tree 1 is a good specimen whose relocation may be a viable option since protection cannot be implemented.

Due to the various aspects of tree condition and position, it is recommended that the trees be removed for the construction to proceed, and compensatory planting be carried out as part of the landscape plan.

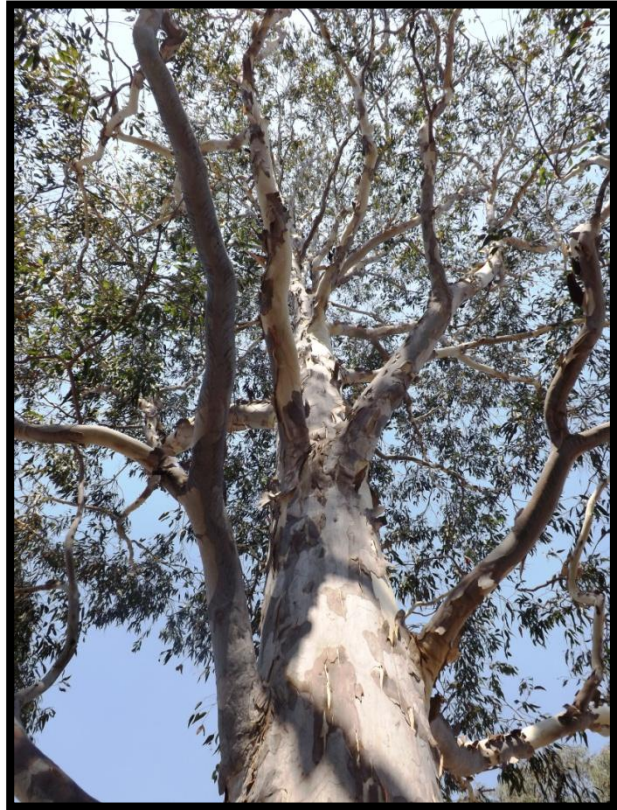
The straight trunk of Tree 1.

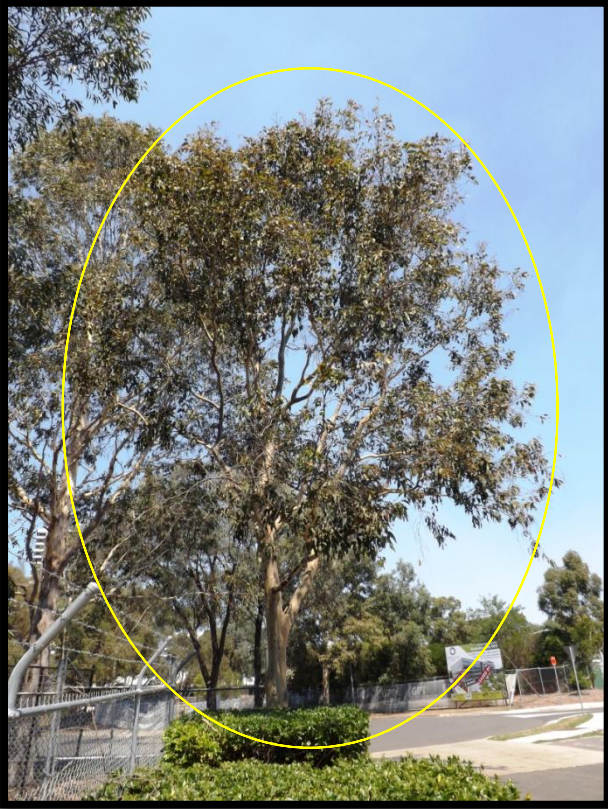
Tree 2 (outlined) viewed from the east.

Tree 2 is a fair specimen whose removal and replacement with a good specimen may be a more viable option.

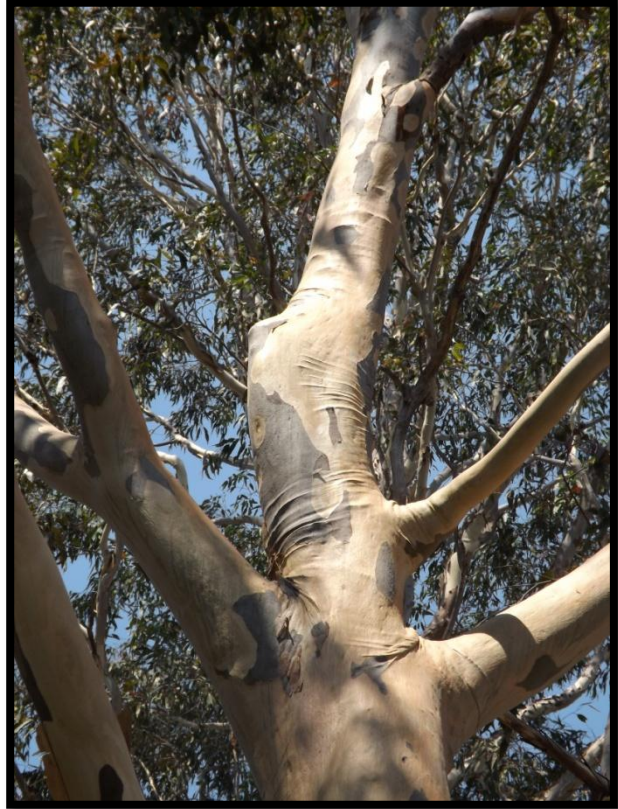
Stem bow in Tree 2.

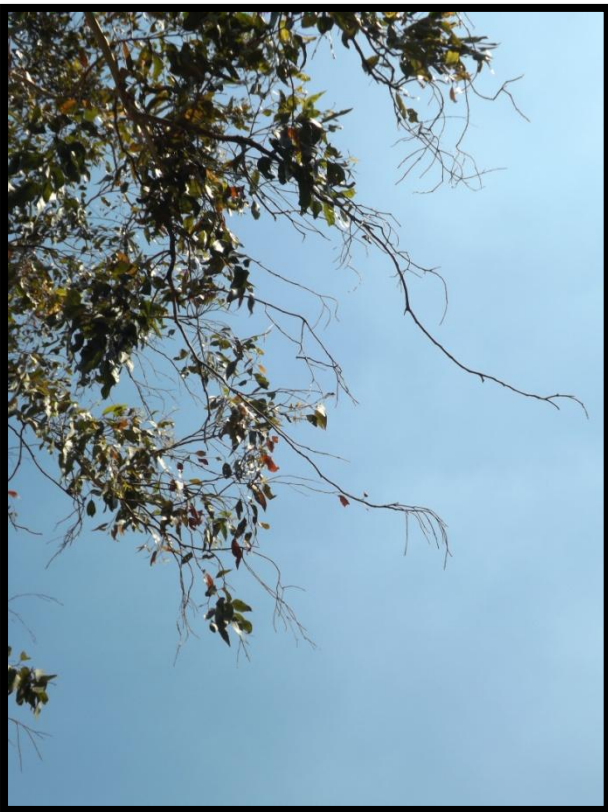
Tip dieback in Tree 2.

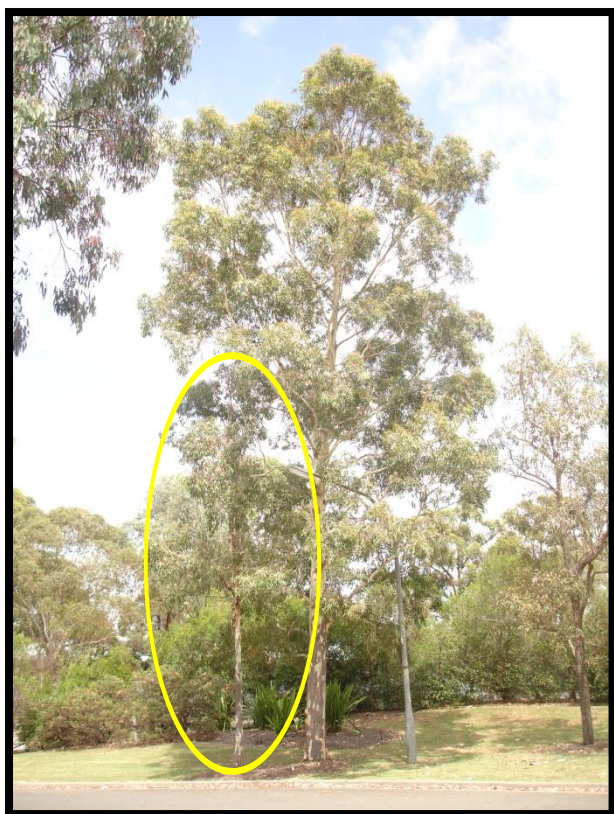
Tree 1S (circled) and Tree 2S (centre).

Tree Identification	Description		Health	Structure	U.L.E. (Useful Life Expectancy)
Tree 1s Botanical Name <i>Corymbia maculata</i> Common Name Spotted Gum	<u>Age:</u>	Semi mature	The tree is in poor health. The main stem has died back, and some small scaffold branches the new leaders.	The tree has a poor structure, due to the dead main stem.	The tree has been given a ULE of 4A due to the dieback.
	<u>DBH</u>	152mm			
	<u>Height:</u>	9 metres			
	<u>Canopy Spread:</u>	2.5 metres			
Tree 2s Botanical Name <i>Corymbia maculata</i> Common Name Spotted Gum	<u>Age:</u>	Mature	The tree is in good health.	The tree has a good structure.	The tree has been given a ULE of 3B due to its age and species, which is too large for its position.
	<u>DBH</u>	423 mm			
	<u>Height:</u>	15 metres			
	<u>Canopy Spread:</u>	8 metres			
Tree 3s Botanical Name <i>Eucalyptus crebra</i> Common Name Small Leaved Ironbark	<u>Age:</u>	Early Mature	The tree is in fair health, having moderate tip dieback. The leaf density is tending toward thin, and a branch has been lost at 5.5 metres high.	The tree has a fair structure, having co – dominant stems from 3.5 metres high. Moderate [sized] epicormic growth is present, and the canopy is approximately 80% epicormic.	The tree has been given a ULE of 3B due to health and structure.

Trees 1s – 7s may be removed due to either health/structure or the fact that the species is too large for the development.

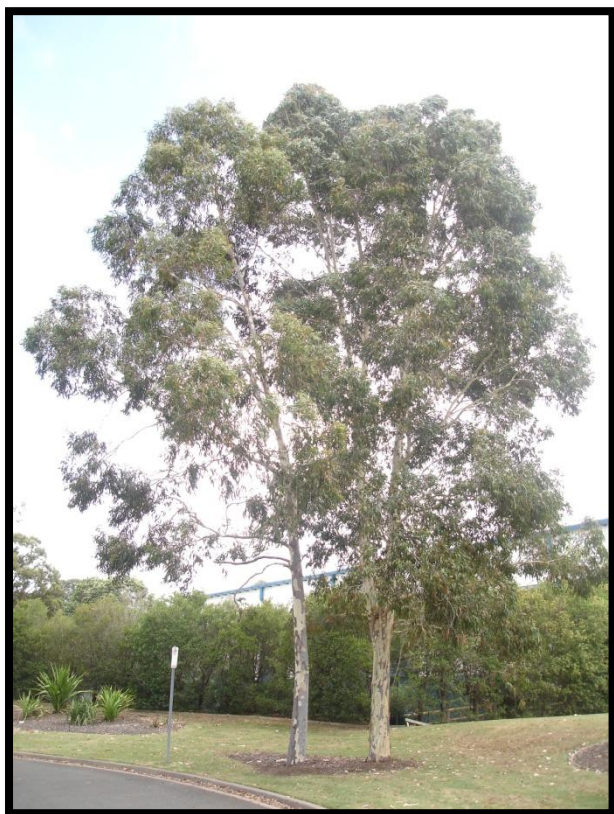
Tree 4s (left) and Tree 5s (right).

Tree Identification	Description		Health	Structure	U.L.E. (Useful Life Expectancy)
Tree 4s Botanical Name <i>Corymbia maculata</i>	<u>Age:</u>	Mature	The tree is in fair health, having slight deadwood to 50mm diameter, and the leaf density is tending toward thin.	The tree has a fair structure, having co – dominant stems from 6 metres high, and slight trunk bow.	The tree has been given a ULE of 3B due to the health and structure.
	<u>DBH</u>	302mm			
Common Name Spotted Gum	<u>Height:</u>	13.5 metres			
	<u>Canopy Spread:</u>	6 metres			
Tree 5s Botanical Name <i>Corymbia maculata</i>	<u>Age:</u>	Early Mature	The tree is in good health.	The tree has a fair structure, having co – dominant stems from 2.5 metres high.	The tree has been given a ULE of 3B due to its age and species, which is too large for its position.
	<u>DBH</u>	375mm			
Common Name Spotted Gum	<u>Height:</u>	9 metres			
	<u>Canopy Spread:</u>	5 metres

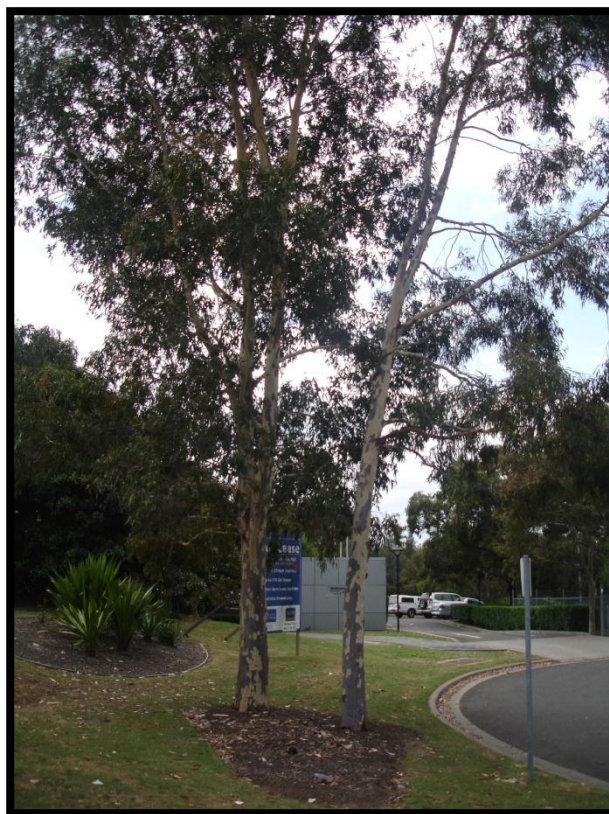
Tree 4s (right), note the trunk bow.

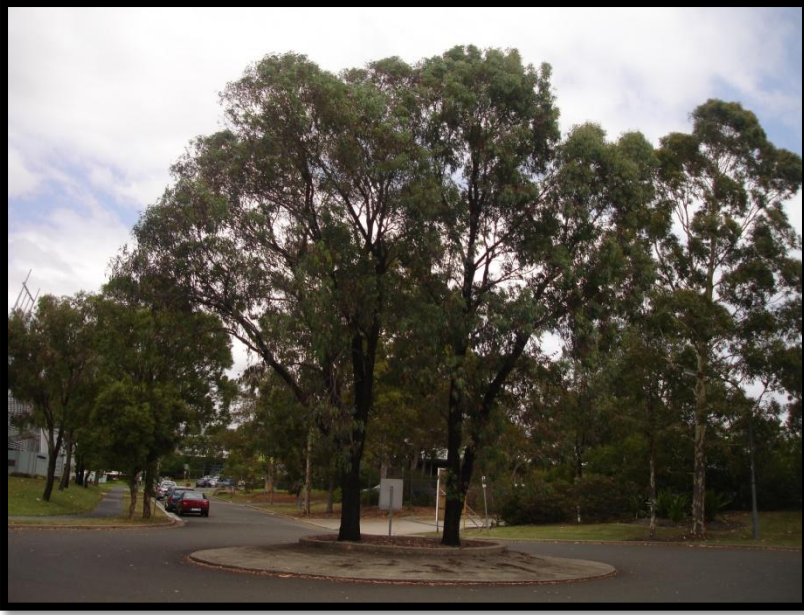
Tree 6s (left) and Tree 7s (right).

Tree 6s Botanical Name <i>Eucalyptus sideroxylon</i>	<u>Age:</u>	Early Mature	The tree is in fair health, having slight tip dieback on some branches, the leaf density is tending toward thin.	The tree has a poor structure, having co - dominant stems from 1.5 metres high. Some epicormic growth is also present.	The tree has been given a ULE of 3B due to its age, structure and species, which is too large for its position.
	<u>DBH</u>	398mm at 800mm high			
Common Name Mugga Ironbark	<u>Height:</u>	10 metres			
	<u>Canopy Spread:</u>	6 metres

Tree Identification	Description		Health	Structure	U.L.E. (Useful Life Expectancy)
Tree 7s Botanical Name <i>Eucalyptus sideroxylon</i>	<u>Age:</u>	Early	The tree is in fair health, having slight deadwood to 25mm diameter, and the leaf density is tending toward thin.	The tree has a fair structure, having 3 dominant stems from 2 metres high, and some epicormic growth.	The tree has been given a ULE of 3B due to its age, structure and species, which is too large for its position.
	<u>DBH</u>	414mm			
	<u>Height:</u>	10 metres			
Common Name Mugga Ironbark	<u>Canopy Spread:</u>	8 metres			
Tree 8s Botanical Name <i>Ficus rubiginosa</i>	<u>Age:</u>	Mature	The tree is in fair health, having a severe infestation of Black Scale and some accompanying Sooty Mould.	The tree has a poor structure, having 3 dominant stems from 1 metre high, and the trunk has a 30° lean to the SSW.	The tree has been given a ULE of 3B due to the structure. As the tree is intended for retention, various remedial actions will be required to increase the ULE.

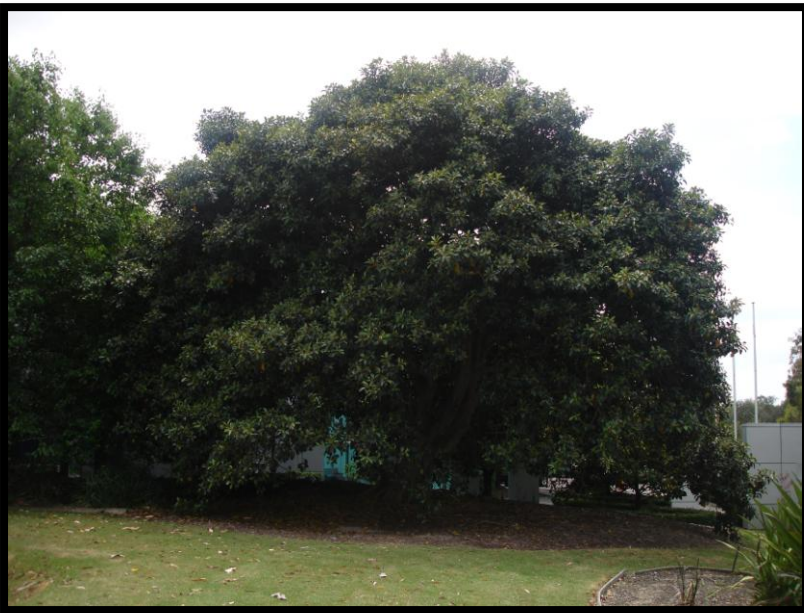
Tree 8s viewed from the west.

<u>DBH</u>	764mm at 600mm high			
	<u>Height:</u>	7 metres	There is slight deadwood to 60mm diameter.	The tree has moved in the ground as is indicated by soil heaving on the NNE side.	
Common Name Port Jackson Fig	<u>Canopy Spread:</u>	11 metres			
				The tree is also growing around an old fence post.

Tree 8s will require remedial action to increase its ULE. The most effective options for this are being considered, given the species and large size of the tree.

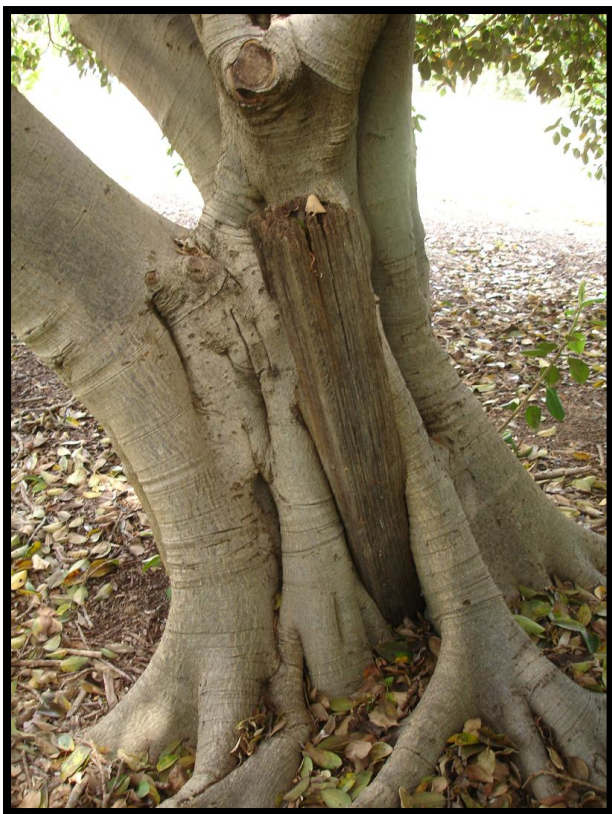
The post in Tree 8s, note the angle of the trunk.

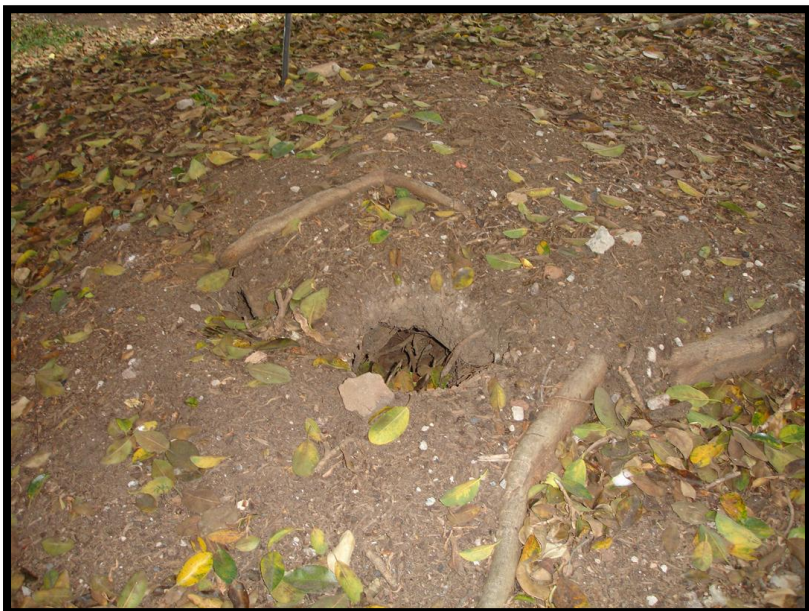
Soil heaving in the root zone of Tree 8s.
