# Addenda Report to Phase I ESA, Old Wallgrove Road, Acquisition Lands

Client: Goodman Property Services (Aust) Pty Ltd

18-Dec-2014

Job No.: 60220882\_3.0

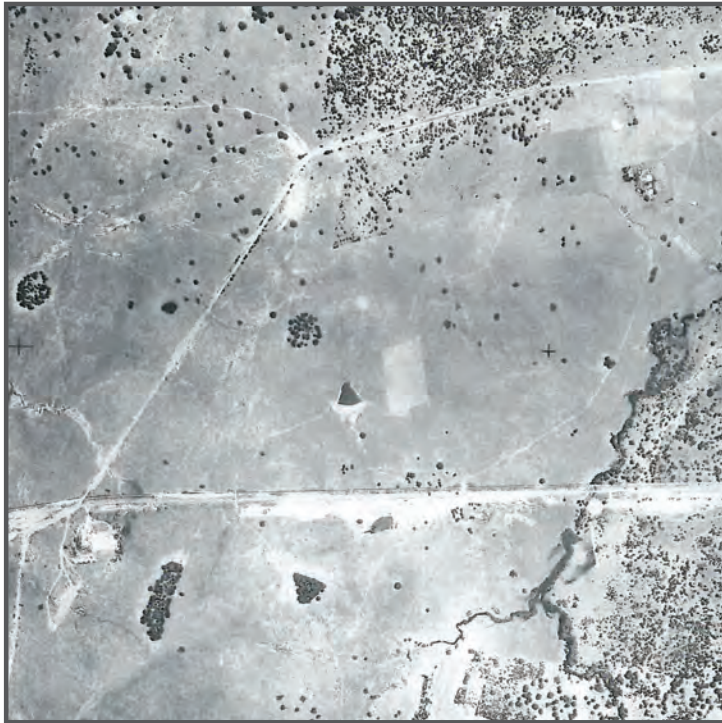
Historical Aerial Photograph - 1947

Year	Comments
Jan' 1947	Old Wallgrove Road is present, possibly dirt (i.e. not asphalt). Water pipeline easement is visible to the north of the Site and may be under construction. A small 'work-site like' feature is present on the southern side of the easement in what is currently the Austral Bricks Plant. No obviously visible areas of disturbed soil (i.e. excavations, stockpiles etc) adjacent to Old Wallgrove Road (i.e. the Site).
1961	Area surrounding Old Wallgrove Road appears to be rural (paddocks). No obviously visible areas of disturbed soil (i.e. excavations, stockpiles etc) at the Site.
Apr' 1978	Austral Bricks Plant is present, including the AST. Car park area in the northern portion and undeveloped land along eastern boundary of Austral Bricks are present. No development opposite the substation or opposite Austral Bricks. No obviously visible areas of disturbed soil (i.e. excavations, stockpiles etc) at the Site.

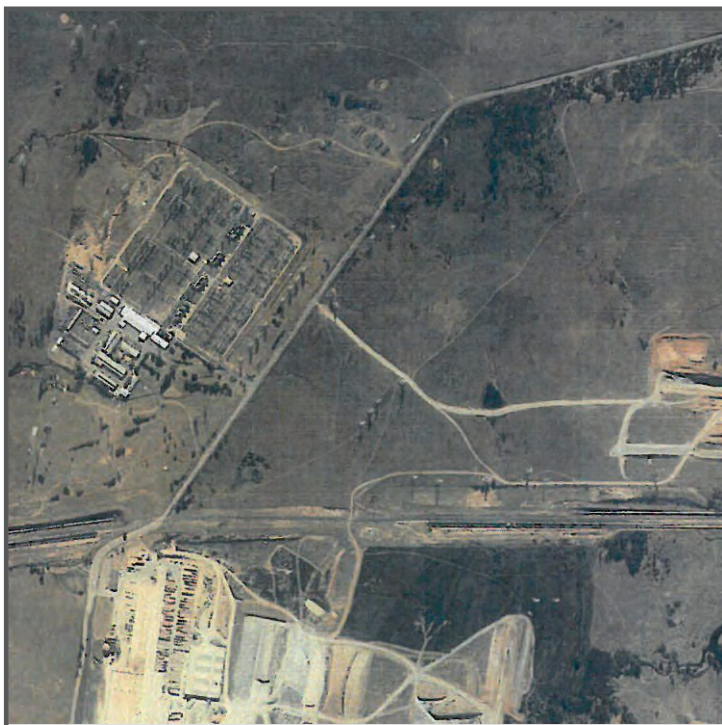
Historical Aerial Photograph - 1986

Aug' 1986	Austral Bricks Plant is present. No obvious changes to the layout of this property since the 1978 photograph. Site remains undeveloped. No development present opposite Austral Bricks.
Oct' 1994	No obvious changes from the 1986 photograph.
Dec' 2005	No obvious changes from the 1986 photograph.
