Hazardous Materials Re-Inspection Report

South Eastern Sydney Illawarra Area Health Service

Edmund Blackett West (6)

May 2011

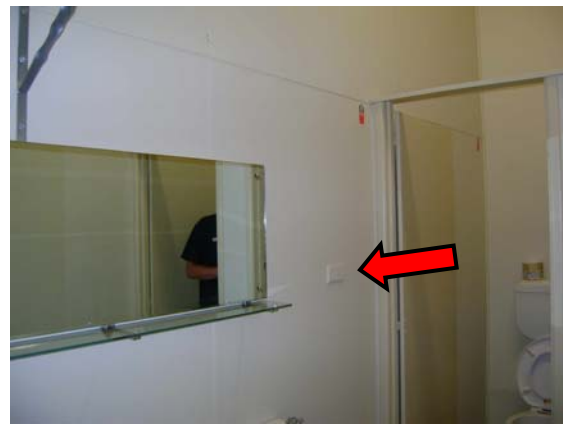
Photo 1. Level 0, Room 01, Lower walls – Asbestos containing fibre cement sheeting

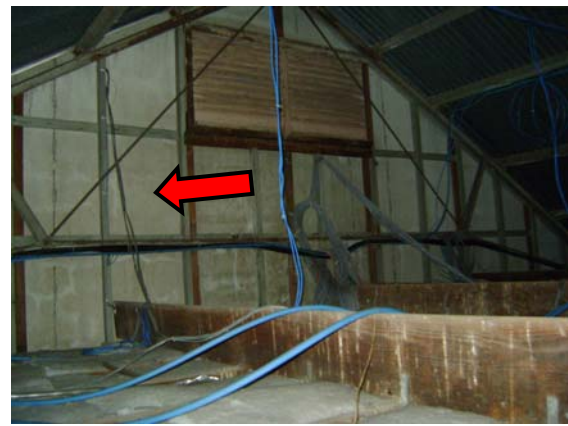
Photo 2. Exterior, Gable ends (North & South) – Asbestos containing fibre cement sheeting

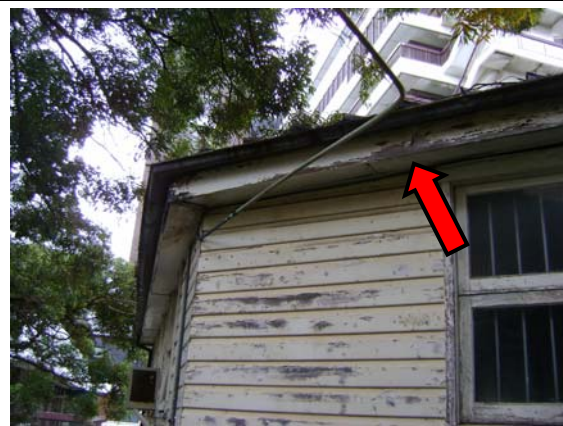
Photo 3. Exterior, Level 0, Eaves – Asbestos containing fibre cement sheeting

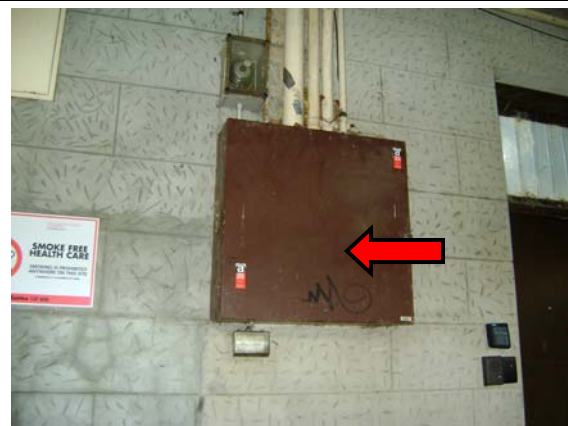
Exterior Switchboard Electrical backing board *Not sampled; electrical hazard	-	Suspected Positive	4	1 unit	Good	Non-Friable	Low	Low	May 2012	4	Confirm status and maintain in a good condition. Remove under controlled conditions by an appropriately licensed asbestos contractor prior to refurbishment/demolition works.	-

Photo 4. Exterior, Level 0, Switchboard – Suspected asbestos containing electrical backing board

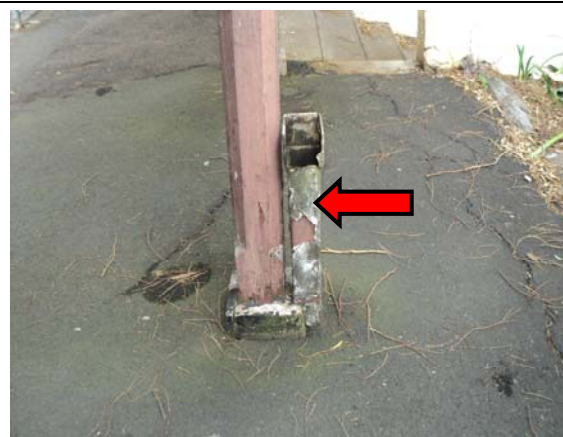
Photo 5. Exterior, South-east Corner, Adjacent Walkway, Downpipe – Asbestos containing moulded fibre cement

- ☐ Encapsulate the moulded fibre cement downpipe in fair condition located at Level 0, Exterior, South-east Corner, Adjacent Walkway.
- ☐ Maintain asbestos materials in good condition. Remove all asbestos materials under controlled conditions by an appropriately licensed contractor prior to refurbishment/demolition works.
- ☐ Conduct asbestos fibre air monitoring and clearance inspections during the removal of all asbestos containing materials.
- ☐ Schedule periodic reassessment of the asbestos containing materials remaining on-site to monitor their aging/deterioration - as per the *Management and Control of Asbestos in Workplaces* [NOHSC: 2018 (2005)].
- ☐ Prior to demolition/refurbishment works, undertake a Destructive Hazardous Material Survey as per Australian Standard AS 2601:2001 *'The Demolition of Structures'*.

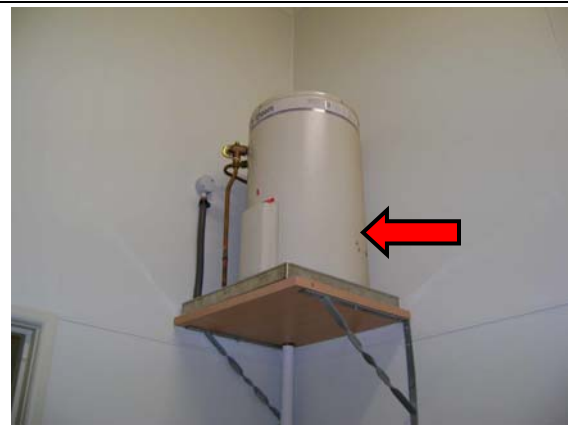
Location Item Description	Photo No.	Form	Extent	Risk Status	Control Recommendation
Level 0					
Room 01 Hot Water Unit Suspected internal insulation	6	Bonded	1 unit	Low	Maintain in current condition. Remove under controlled conditions prior to demolition.
Room 07, Throughout Old Ceiling Space Insulation batts	7	Bonded	~250m ²	Low	Maintain in current condition. Remove under controlled conditions prior to demolition.
Room 07, Ceiling Space Hot Water Unit Suspected internal insulation	8	Bonded	1 unit	Low	Maintain in current condition. Remove under controlled conditions prior to demolition.

Photo 6. Level 0, Room 01, Hot Water Unit – Suspected internal SMF insulation

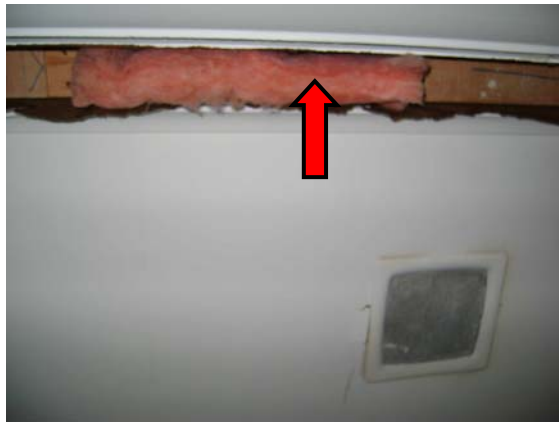
Photo 7. Level 0, Room 07, Throughout old Ceiling Space – SMF insulation batts

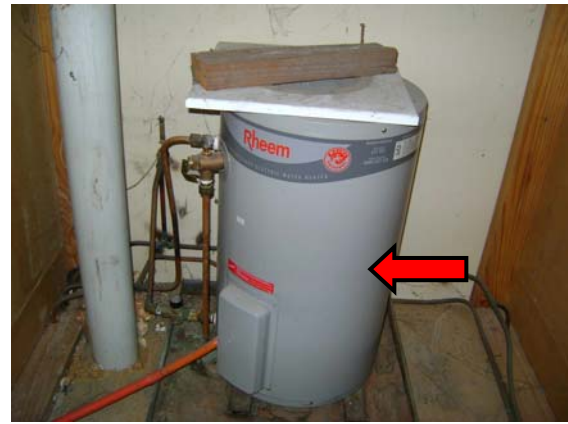
Photo 8. Level 0, Room 07, Ceiling Space, Hot Water Unit – Suspected internal SMF insulation

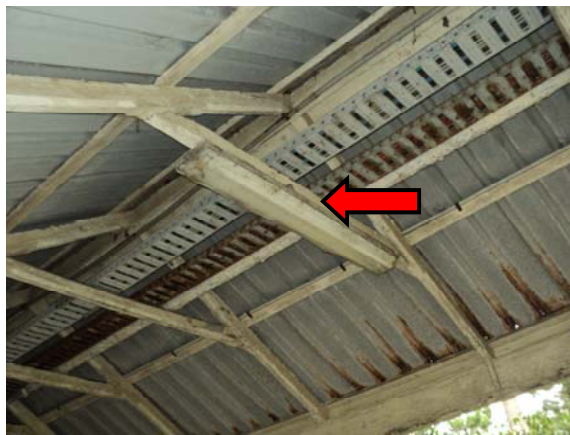
Location Item Description	Photo No.	Specifications	No. Fittings	Comments/Control Recommendation
Level 0				
Exterior East Walkway 1200mm double tubed fluorescent light fittings	9	-	7	Suspected PCB present. Approach with caution during maintenance works. Remove and dispose of appropriately prior to refurbishment or demolition works. Personnel undertaking such works should wear appropriate PPE, including nitrile gloves and disposable overalls.

Photo 9. Level 0, Exterior, East Walkway, Within 1200mm Double Tubed Fluorescent Light Fitting – Suspected PCB containing capacitor

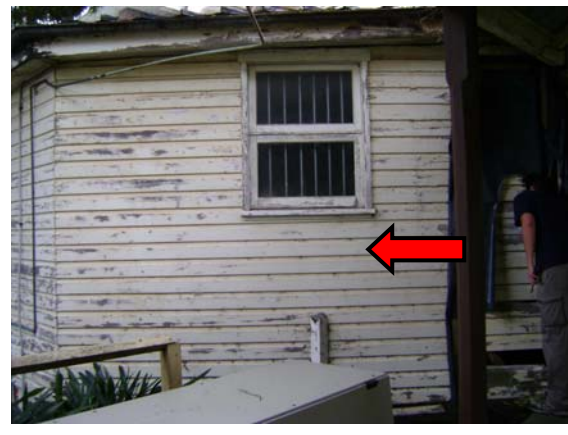
Location Colour Description, Comments	Photo No.	Results	Extent	Condition	Control Recommendation
Level 0					
Exterior Southern Room, Walls Cream coloured paint system	10	Positive	~50m ²	Fair	Remove flaking paint under controlled conditions. Paint over with a lead-free paint as part of ongoing maintenance. If refurbishment works are likely to involve the disturbance of confirmed lead containing paint, dust suppression techniques should be utilized.
Exterior South Wall Window Frames White coloured paint systems	11	Positive	7 Units	Poor	Remove flaking paint under controlled conditions. Paint over with a lead-free paint as part of ongoing maintenance. If refurbishment works are likely to involve the disturbance of confirmed lead containing paint, dust suppression techniques should be utilized.
Exterior East Walkway Wooden Posts Brown coloured paint systems	12	Positive	16 Units	Fair	Remove flaking paint under controlled conditions. Paint over with a lead-free paint as part of ongoing maintenance. If refurbishment works are likely to involve the disturbance of confirmed lead containing paint, dust suppression techniques should be utilized.

Photo 10. Level 0, Southern Room exterior – Cream coloured lead paint system

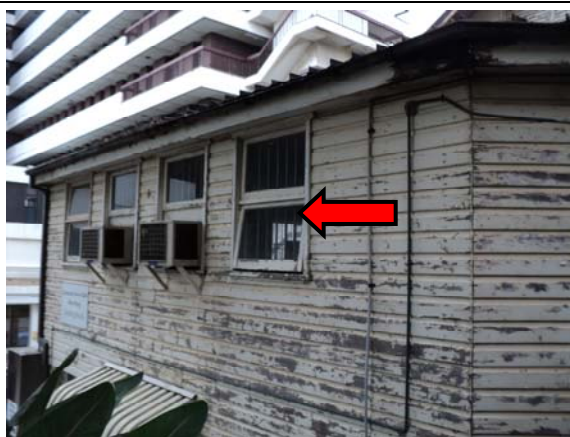
Photo 11. Level 0, Exterior, South Wall, Window Frames – White coloured lead paint systems

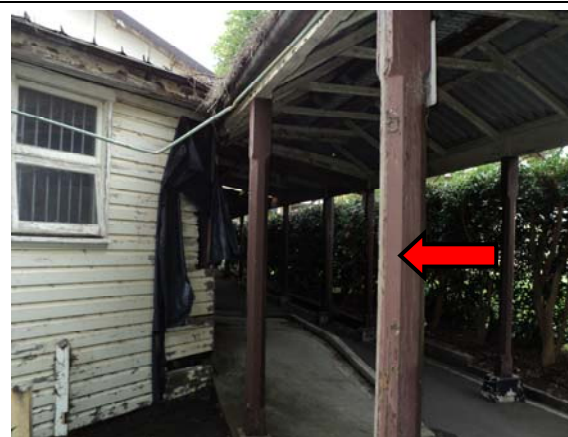
Photo 12. Level 0, Exterior, East Walkway, Wooden Posts – Brown coloured lead paint systems

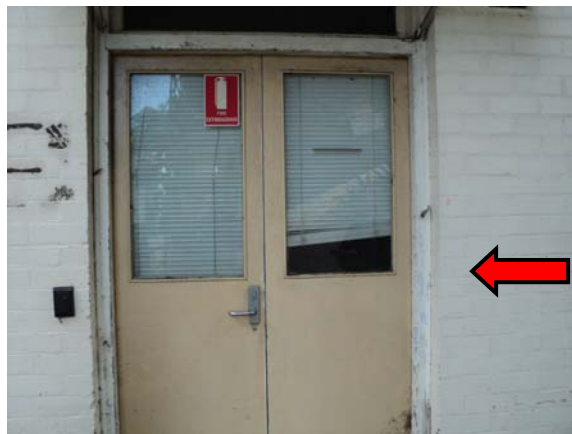
Level B1					
Exterior South Wall White coloured paint system	13	Positive	~10m ²	Poor	Remove flaking paint under controlled conditions. Paint over with a lead-free paint as part of ongoing maintenance. If refurbishment works are likely to involve the disturbance of confirmed lead containing paint, dust suppression techniques should be utilized.
Exterior South Wall Door Upper layer cream coloured paint system	-	Negative	-	-	-

Photo 13. Level B1, Exterior, South Wall – White coloured lead paint system

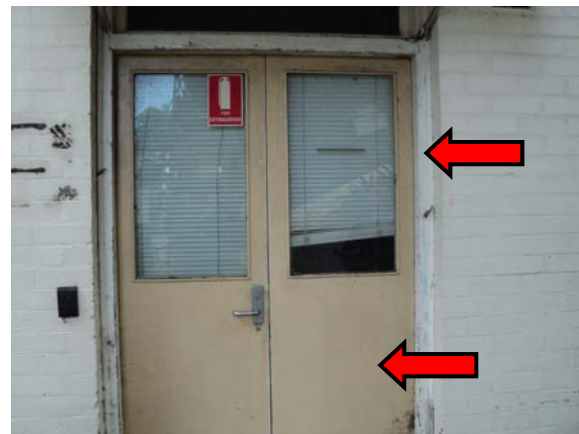
Location Colour Description, Comments	Photo No.	Results	Extent	Condition	Control Recommendation
Exterior South Wall Door Lower layer multi coloured paint systems	14	Positive	1 Unit	Fair	Remove flaking paint under controlled conditions. Paint over with a lead-free paint as part of ongoing maintenance. If refurbishment works are likely to involve the disturbance of confirmed lead containing paint, dust suppression techniques should be utilized.
Exterior South Wall Door Frame White coloured paint system	14	Positive	1 Unit	Poor	Remove flaking paint under controlled conditions. Paint over with a lead-free paint as part of ongoing maintenance. If refurbishment works are likely to involve the disturbance of confirmed lead containing paint, dust suppression techniques should be utilized.

Photo 14. Level B1, Exterior, South Wall, Door – Lower layer multi coloured lead paint system; & Door Frame – White coloured lead paint system
