arboricultural impact assessment, proposed development fifteenth avenue commercial precinct, west hoxton

29th May 2015

prepared by Melanie Howden - Ass. Dip. Hort. (Haw. Ag. C.), SoA. Arb. MAIH, MIACA

drawing title
**existing site - tree locations &
reference numbers**

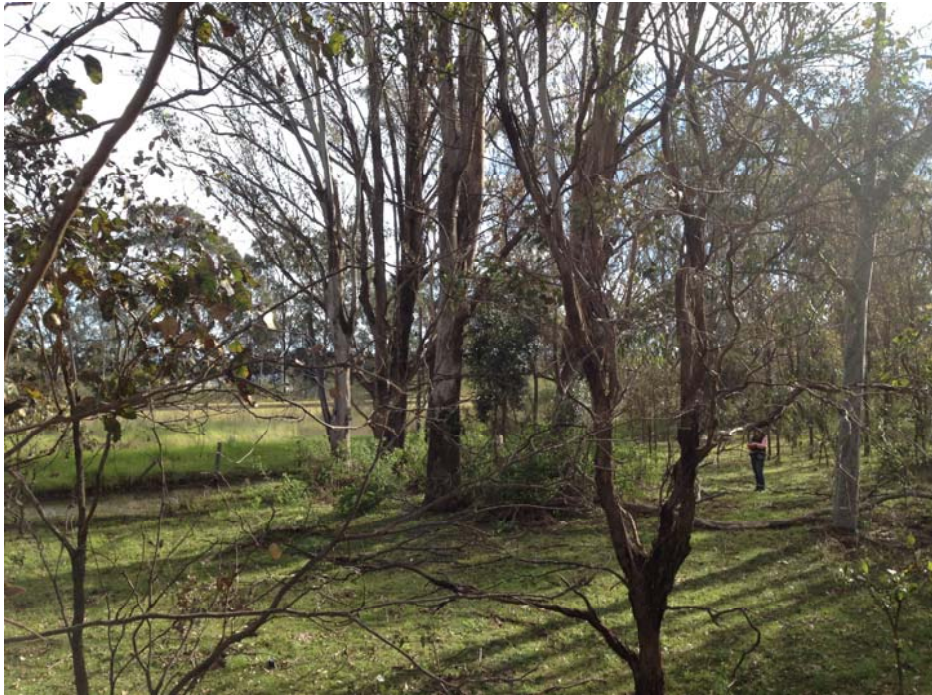
Figure 7.1 Trees in the north western portion of the site with Tree No. 76 the large Eucalypt in the centre (rear) of photo.

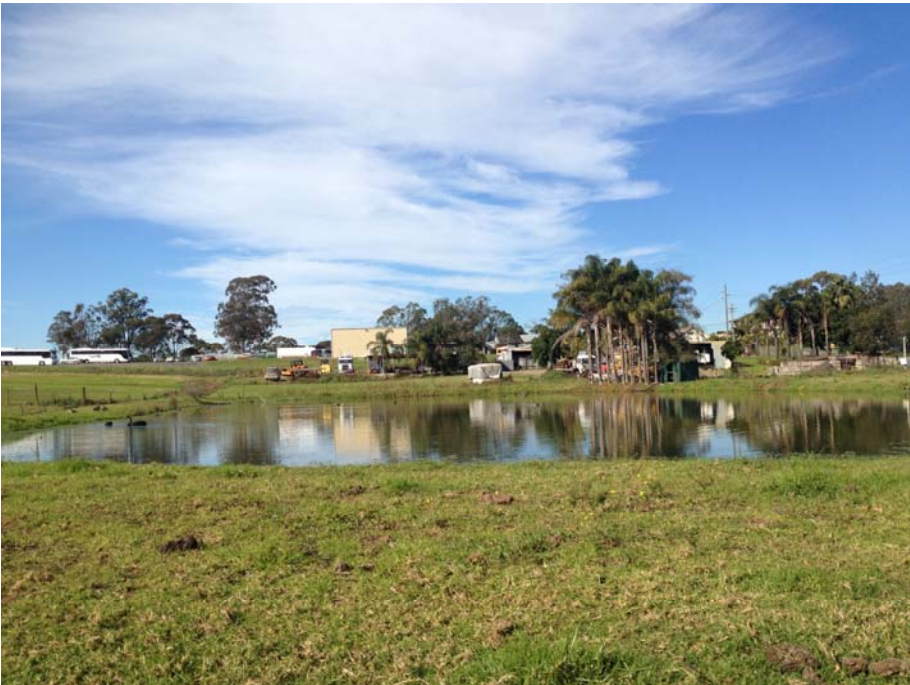
Figure 7.2 Looking east across the site with the group pf Cocos Palms, Tree No's 49-64 behind the dam (centre right).

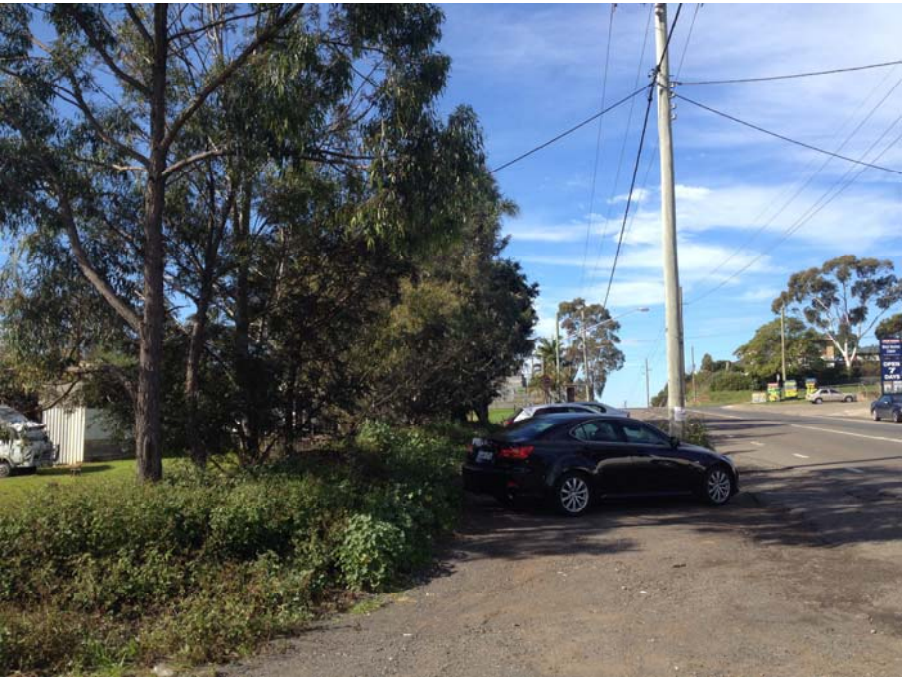
Figure 7.3 Trees along the road frontage looking east with Tree No. 47 in the foreground (left) with Tree No's 11, 10, 9, & 8 in the background centre right)

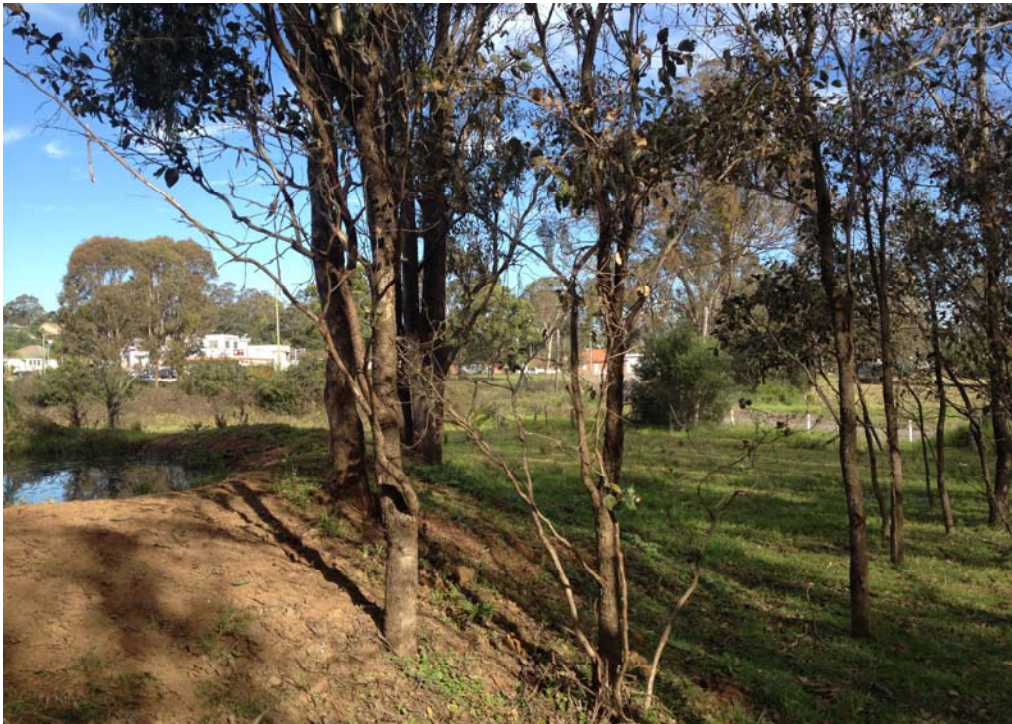
Figure 11.1 View of the site looking south with Tree No's 74 & 73 adjacent the small dam in the north western corner of the site.

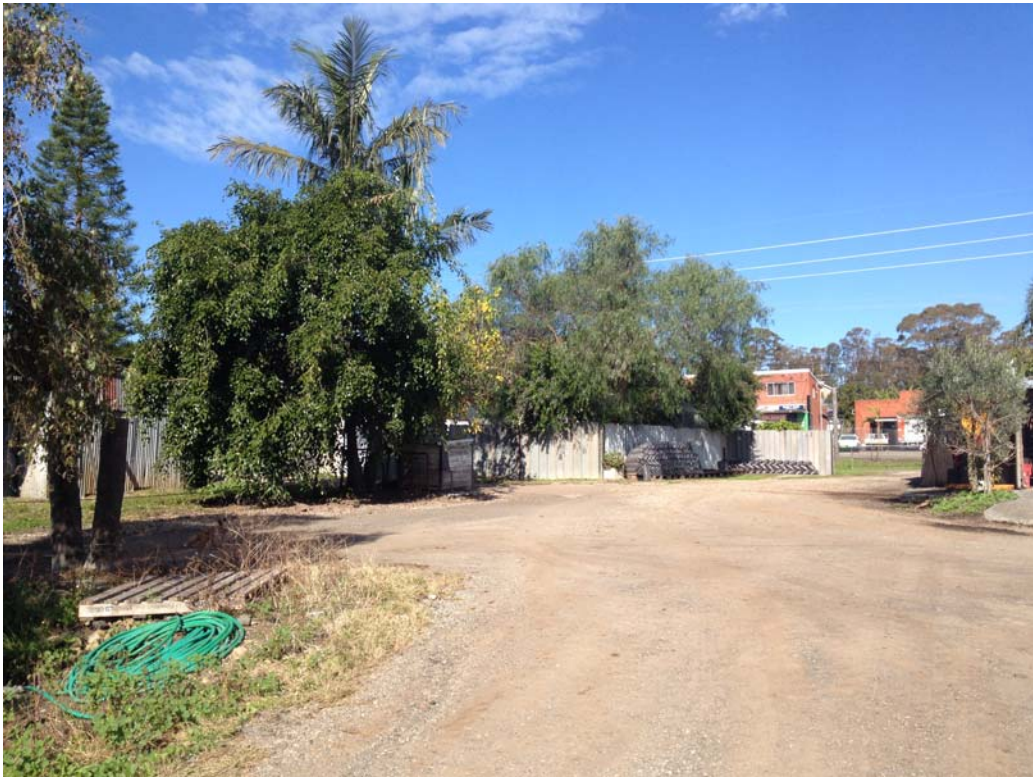
Figure 11.2 The existing dwelling at 195-215 Fifteenth Avenue looking south with Tree No's 16, 17 & 18 (centre left) and Tree No. 19 (centre right)
