27 October 2015

**RE: Martins Creek Quarry Extension Project – Quarry Face Stability Assessment
Preliminary Geotechnical Assessment**

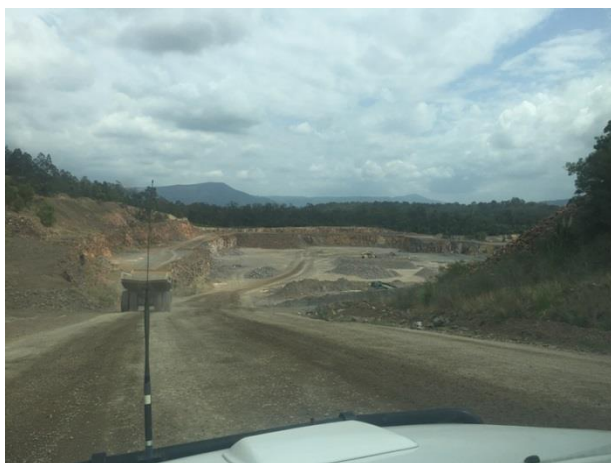
Photo 1: Entering quarry from main haul road, looking west.

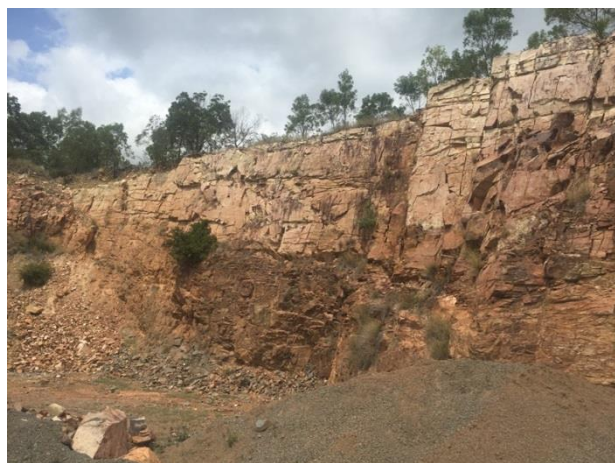
Photo 2: Old southern quarry face. No extraction works in recent times.

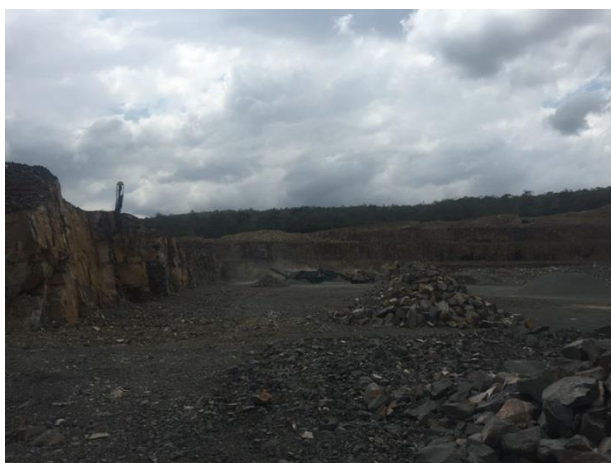
Photo 3: Quarry floor (Bench 5). Western face on left hand side, looking towards the north.

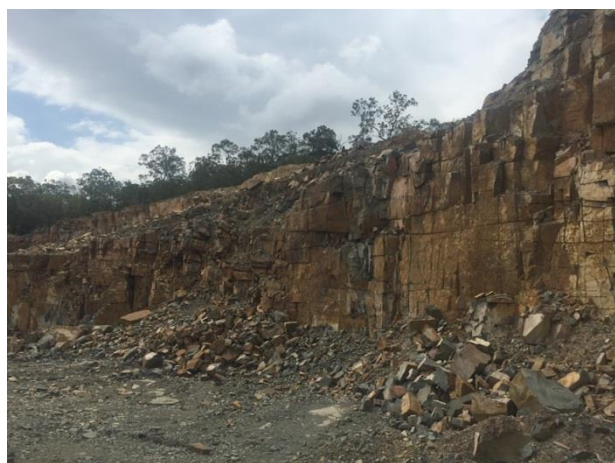
Photo 4: Quarry floor (Bench 5), eastern face.

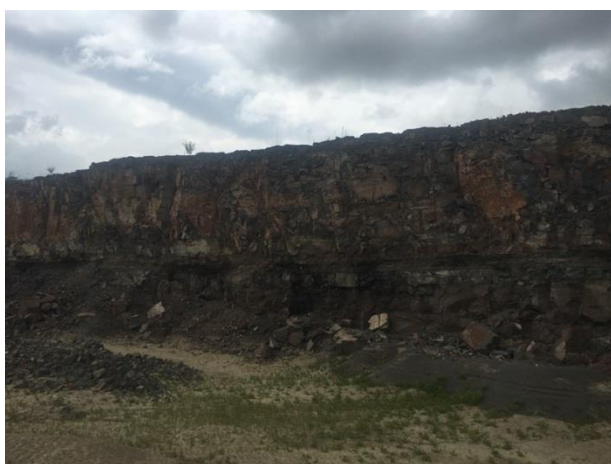
Photo 5: Eastern face of main pit. Contact between Andesite and underlying Meta-sediments visible.

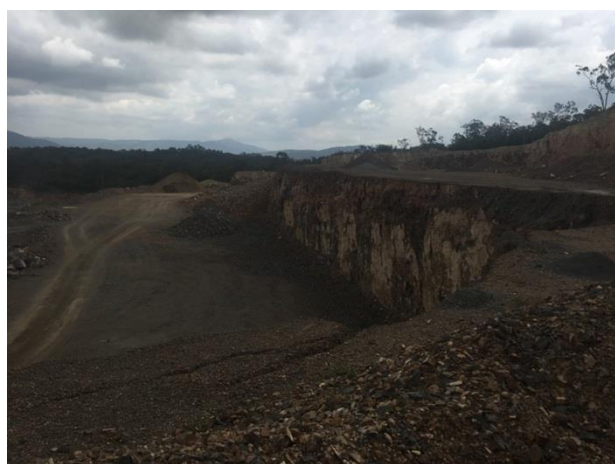
Photo 6: Northern face (Bench 2). Tension cracks in overburden (soil) material visible.

- Drainage measures should be implemented above and behind the quarry face to avoid concentrated water flows on the quarry face or infiltration into the soil/rock profile behind the quarry face;

- Surface water flows from upslope areas should be diverted away from the quarry face;
- Little to no seepage was observed and it is assessed that the proposed future quarry expansion will exhibit similar 'dry' quarrying conditions. It is recommended that benches and the pit floor be graded to promote positive drainage conditions;
