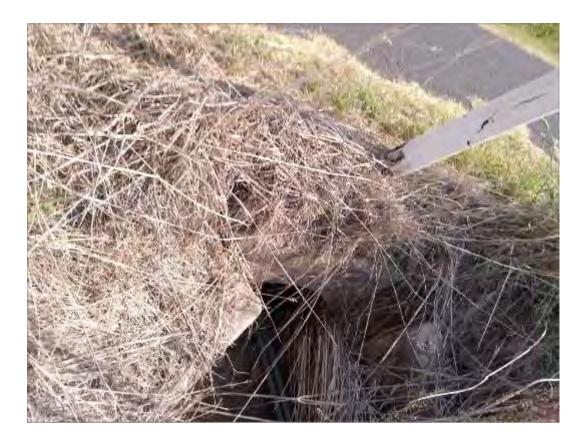
S076 - Coolah Creek Rd - 2500m West of Oakdale Rd Intersection 450mm Pipe Culvert with broken headwall

Moderate Condition and Serviceable

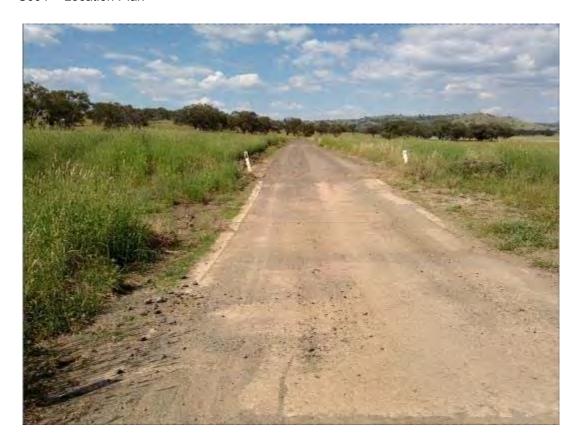
Causeway, Prone to Flooding, Fair Condition and Serviceable Upgrade may be required

S091 – Causeway, Signs of water damage on either side of road

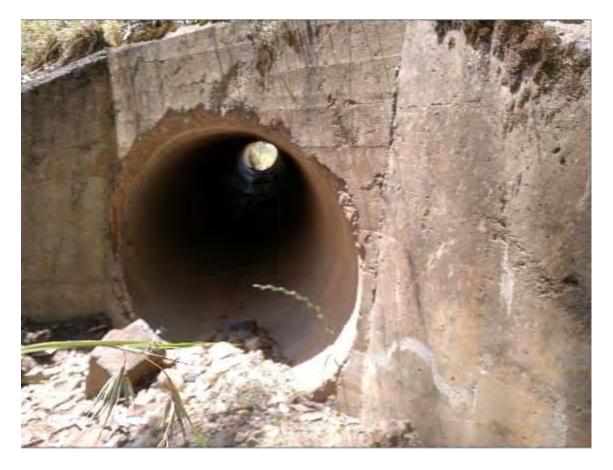
Fair Condition and Serviceable, Internal condition is also Fair

S108 – Skewed 1050mm Pipe Culvert showing Interior Condition

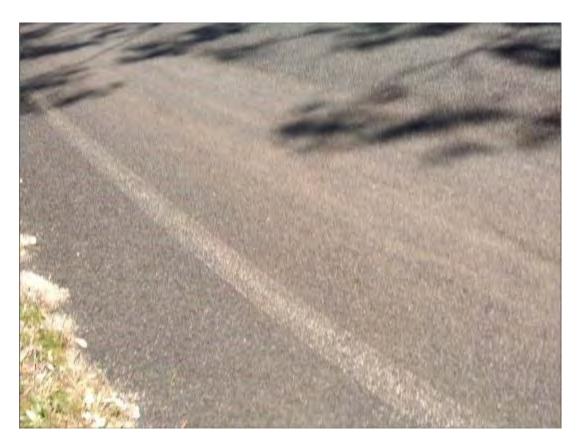
Unknown Condition, upgrade may be required

S112 - View of Causeway showing signs of rutting

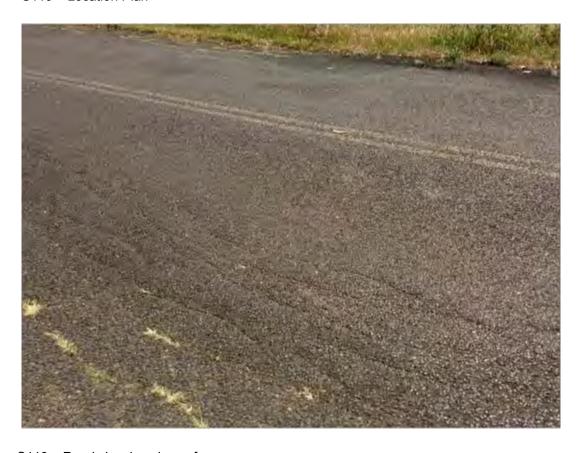
S119 – Road showing signs of wear

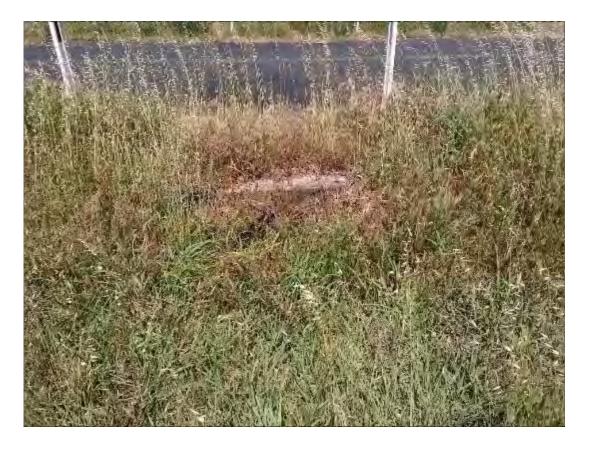
Moderate Condition and Serviceable, upgrade may be required.

Further inspection of internal condition is required

S119 - 600mm Pipe Culvert

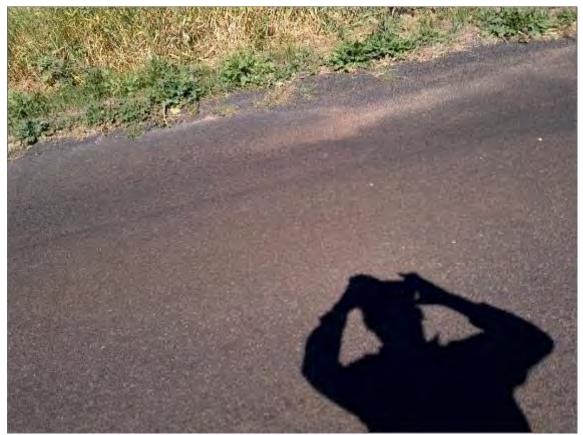
S127 – Pothole on Road Caused by Rutting

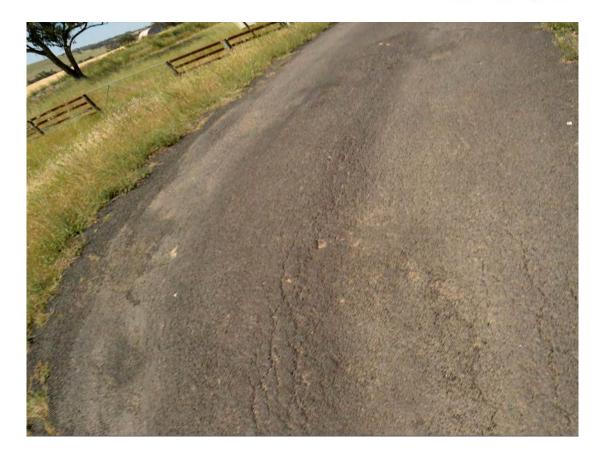
S146 - Road showing Cracking/Ravelling

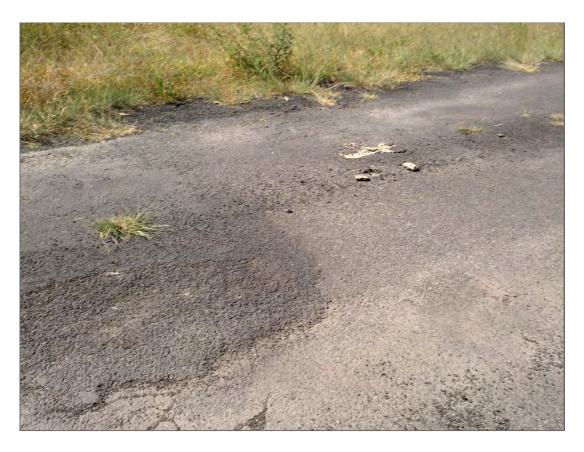
S147 - Road in sub-par condition

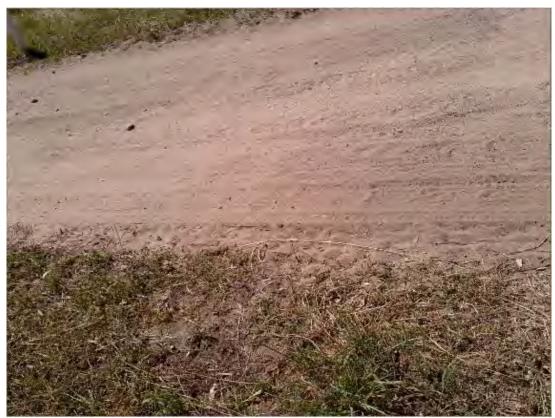
Poor Condition and Serviceable,

S154 – View of Causeway, Water damage shown on close side

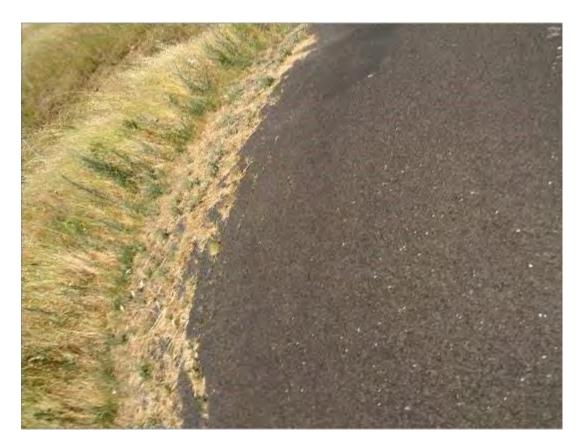
S181 – Water damage on Road

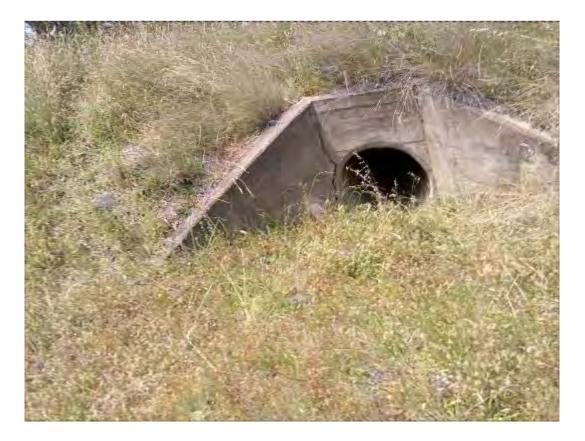
750mm Pipe Culvert with cracked headwall Moderate Condition and Serviceable

S186 - 750mm Pipe Culvert with cracked headwall

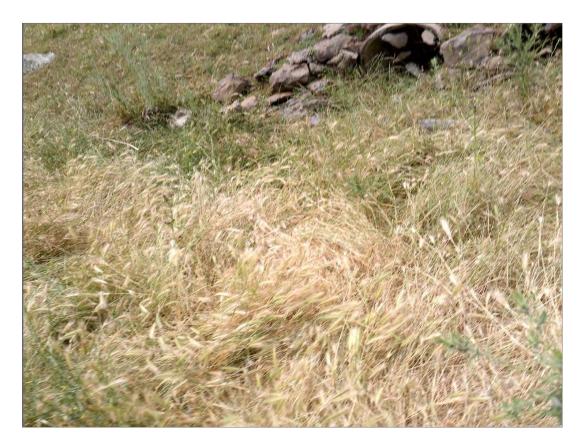
Dual – 600mm Pipe Culvert - Broken Poor Condition and Serviceable, Upgrade likely required.

S199 - 600mm Pipe Culvert broken

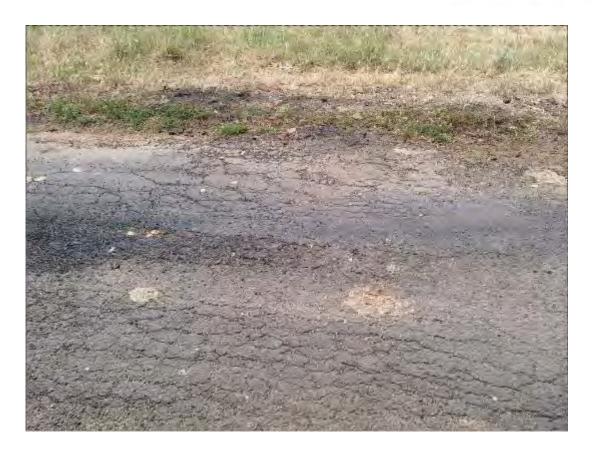
Poor Condition and Serviceable, may require upgrade

S201 – Road badly damaged at Location, Rutting and Extreme Cracking shown above, also signs of Stripping

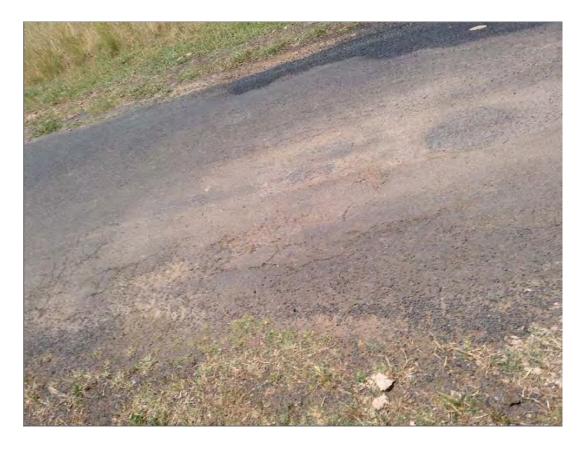
S203 – Rotherwood Rd - 1150m West of Yarrawonga RdBitumen floodway Road in Poor Condition,

S203 – Damage on Road due to Floodway

Upgrade required

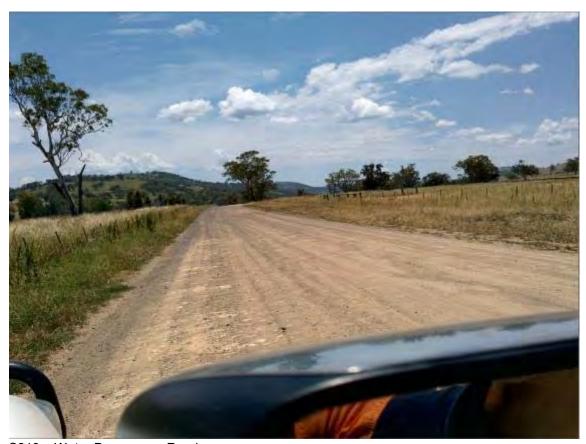
S213 - Water Damage on Road

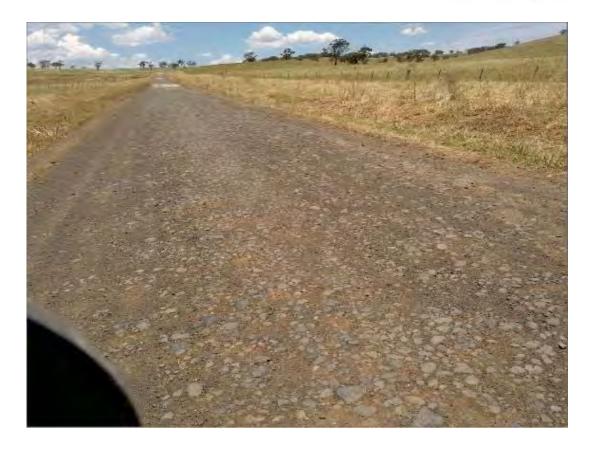
S216 - View to South, Causeway down to Sub-Base Material

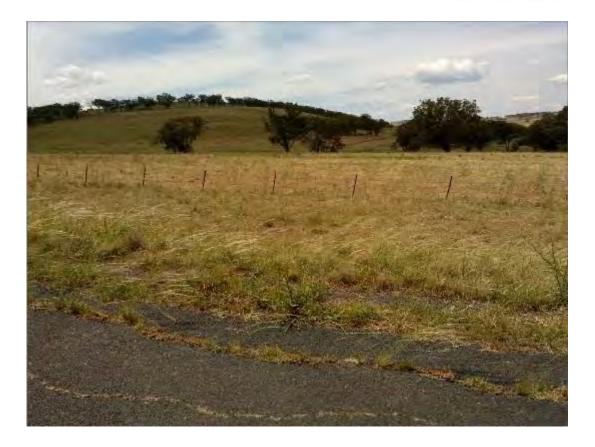
S223 – Road has signs of cracking and it being overgrown

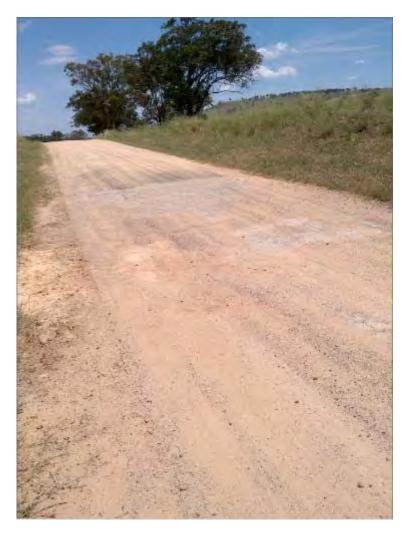
Poor Condition and Serviceable, may need to be upgraded

S231 – Causeway with damages

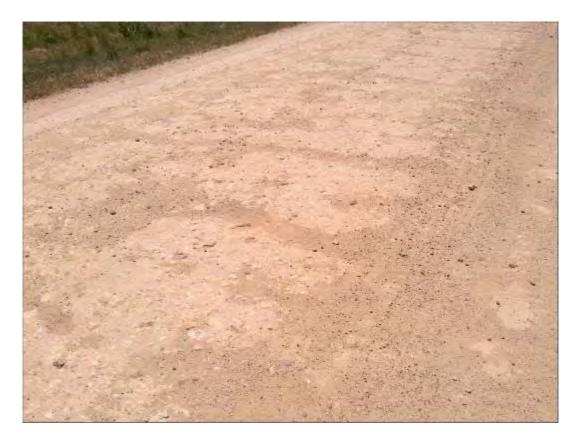
S232 - Road in poor condition

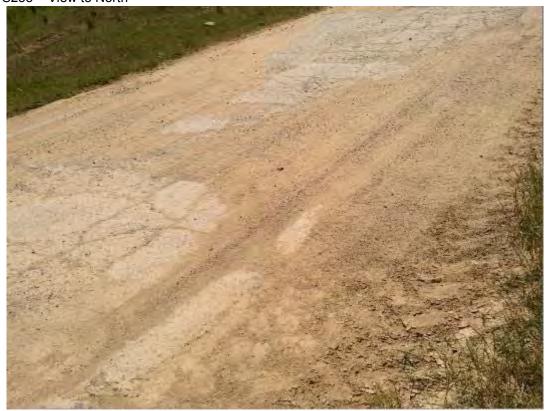
Causeway, may require upgrade Poor Condition and Serviceable,

S233 - Causeway in Poor Condition
