Arboricultural Development Assessment Report

St Vincent's Private Hospital 406 Victoria Street Darlinghust NSW 2010 February 2015 Final

Prepared for: St Vincent's Private Hospital

Prepared by: Paul Vezgoff

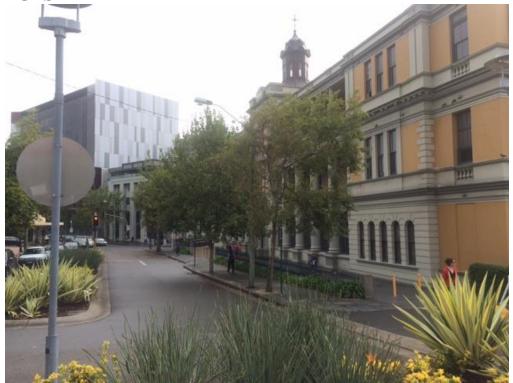
- 3.5 The street trees are numbered as Trees 1-19. These trees are a mixture of Oriental plane (*Platanus orientalis*) and London plane (*Platanus x hybrida*). In general, the street trees are in excellent health and condition. The main trunk, first and second order branches are free of any cracks, splits or fruiting bodies. New extension growth was noted. The basal areas and woody root zone were free of any ground heaving, or lifting with only minor disturbance to the surrounding paving occurring. Trees 7 and 8 are somewhat suppressed due to be located under much larger specimens (Plate 2). Trees 7 and 8 will be affected by the installation of the new Sub-station.

Plate 1: Image showing Trees 1-3. P. Vezgoff.

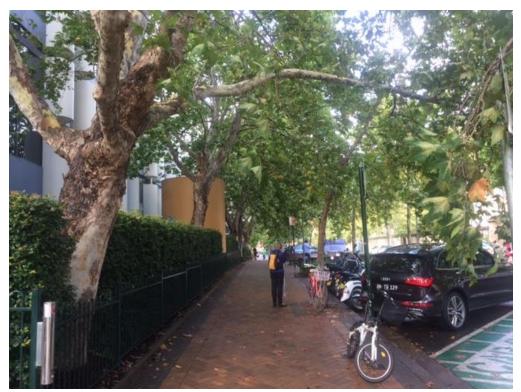
Plate 2: Image showing the general street view. Tree 22 left of image. P. Vezgoff.

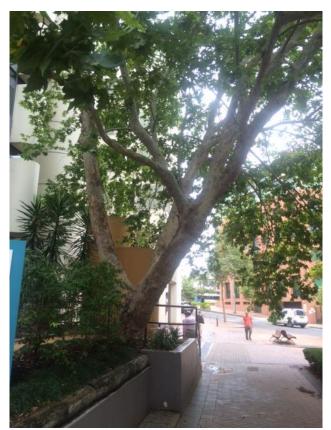
- 3.6 Trees 20-32 are located within the Hospital grounds. Trees 20-25 are large mature London plane (*Platanus x hybrida*) all in good health and condition (Plate 3). No major structural defects were noted on these trees. The outer edge of these canopies are generally against the exiting building. These trees form part of the memorial garden. The new substation will be located near trees 24 and 25.

Plate 3: Tree 20 growing in a restricted root space. P. Vezgoff.

- **4.3** Any pruning required for Trees 20-23 will be pruned back to the nearest branch collar with pruning cuts not greater than one hundred (100) millimetres in diameter. Cuts shall be undercut so that branches do not tear from the tree. Pruning shall retain the natural shape of the tree as best as possible.

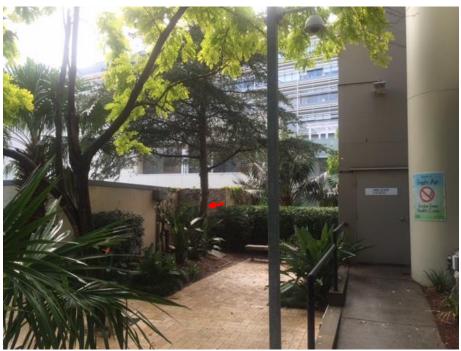
- 3.10 Memorial Tree: Tree 28 is a semi mature The Deodar cedar (*Cedrus deodara*). This tree is in fair health and condition (Plate 4). The main trunk, first and second order branches are free of any cracks, splits or fruiting bodies. New extension growth was noted. The basal area and woody root zone were free of any ground heaving, or lifting. This tree was noted as being a memorial tree planted in 1992 as a gift to the Hospital (Plate 6). The Deodar cedar (*Cedrus deodara*) is an evergreen conifer tree that originates from the western Himalayas in eastern Afghanistan, northern Pakistan, north Republic of India, south westernmost Tibetan (China) and western Nepal. The species can grow to some 50 metres tall and 5-10 metres wide at maturity. The canopy is pyramidal in shape, with a straight trunk. It develops horizontal and pendulous branches at maturity.

Plate 4: Tree 28 (The memorial tree, red arrow) that has been requested to be relocated. P. Vezgoff.

- 3.11 I have been informed that Tree 28 is to be relocated for the duration of the construction works, stored at Centennial Park and replanted. Dicots, trees with woody root systems can be a little more difficult to transplant than monocots. If this specimen were growing in open space, the transplant would have a higher success rate as access to root ball excavation would be easier; however Tree 28 has grown in a restricted root space competing with footings and also the possibility of services running below it. As shown in the diagram in Appendix 7, tree roots would normally extend far beyond the drip line. The crowded growing area will also make it difficult to successfully excavate around the root ball in order to lift the tree. Relocating this tree is not impossible however the chances of success will only be limited. A detailed Transplant Method Statement is attached in Appendix 8. Cuttings should be taken from the tree and propagated should the transplant fail. An experienced nurseryman should be used to propagate these cuttings.

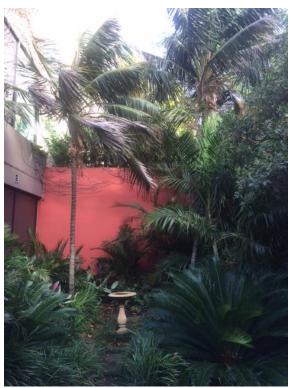
- 3.9 Species possible to relocate: Trees 26, 29 31 and 32 are all monocot species being Palm trees that have fibrous root systems. Trees 26 and 29 are semi mature Cabbage tree palms (*Livistona australis*) that are native to Australia. Trees 31 and 32 are mature Kentia palm (*Howea fosteriana*) that originate from Lord Howe Island. These palms have developed tall slender stems in a protected location (Plate 5). These two (2) specimens could readily be transplanted.

Plate 5: Palms 31 and 32 that are also possible to relocate.

- 4.4 Palm trees numbered as 26, 29, 31 and 32 could readily be relocated. The Transplant Method Statement in Appendix 8 should be followed to ensure these palms have the best possible chance of survival.

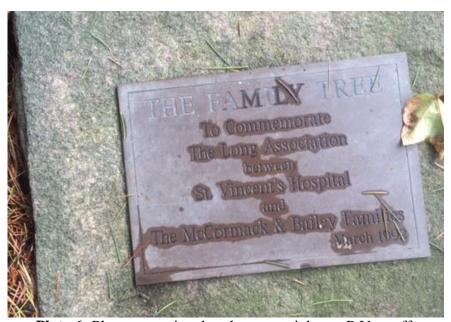
Plate 6: Plaque associated to the memorial tree. P. Vezgoff.

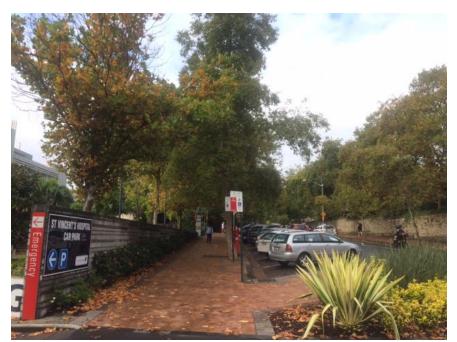
- 3.8 Trees 36-38 are mature specimens of London plane (*Platanus x hybrida*). These trees are located along a small wall (Plate 7). Only in fair condition these trees have possibly suffered root damage as evidenced by the twiggy dieback within the canopies. Extensive epicormic growth was also noted, a sign that these trees are under stress. These trees are not expected to be affected by the proposed works.

Plate 7: Trees 36-38 (Left) behind a small wall, showing canopy dieback. P. Vezgoff.

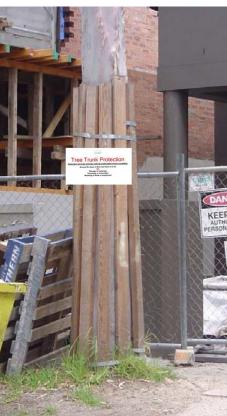
Plate 8: Example of trunk protection with sign attached, recommended for the street trees. P. Vezgoff.

- **4.6** Trees 9-15 and 20-23 will require trunk protection as specified in Section 5.1 of this report. This trunk protection will be required due to the proximity of heavy equipment operating near these trees (Plate 8). Some of the smaller trees may only require two sections of timber to protect them. It is important to protect the bark on trees. Bark is a very effective barrier that helps to protect trees from pest, disease and decay pathogens.

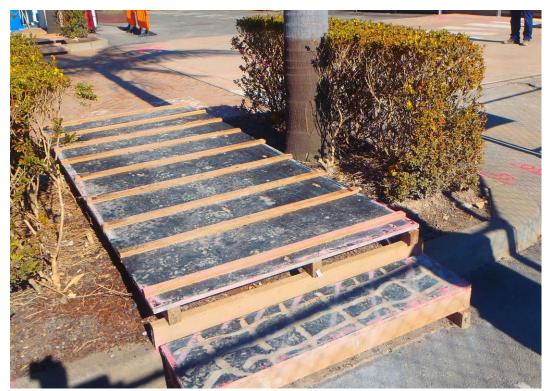
Plate 9: An example of board protection to reduce compaction over the root zone. This technique should be used over the root zone of Trees 20-23. P. Vezgoff.

- 4.8 The root zones of Trees 20-23 may also require protection from compaction depending on the full extent of works. Compaction of the root zone reduces oxygen and moisture exchange of the roots. This will lead to premature death of the tree. Ply sheeting is to be placed over the root zone to the extent of the drip line. Sheeting to be 19mm thick 1200mm x 2400mm. The sheeting is to remain until all construction works are completed. See Plate 9 for an example. The indicative areas for ply sheeting can be seen in the Tree Protection Plan.
