## **ASBESTOS INSPECTION REPORT**

### **PROPOSED SUMATRAN TIGER ADVENTURE**

#### **MOSMAN TARONGA ZOO SITE**

Date: 2 March 2015

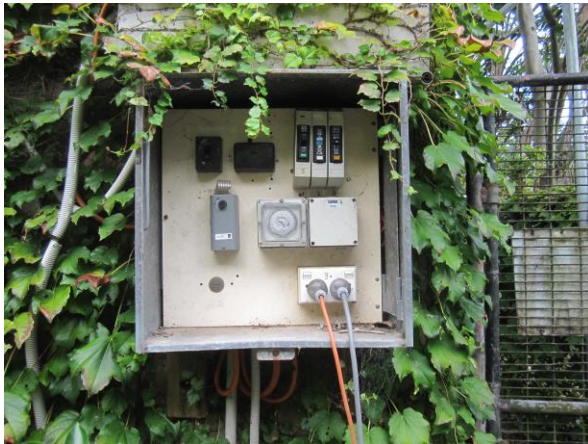
Photo 1: Fennec fox, electrical distribution board

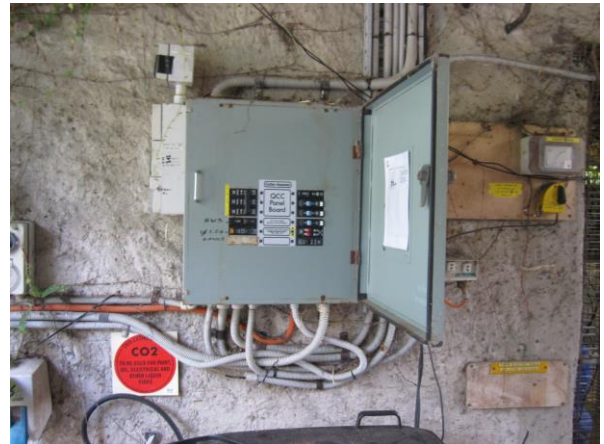
Photo 2: Tapir, electrical distribution board

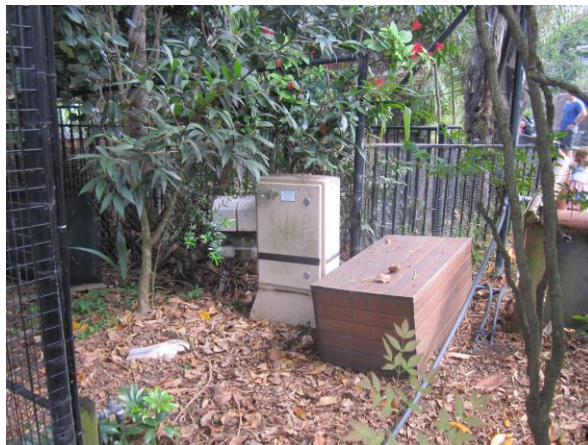
Photo 3: Tapir, front of house electrical box

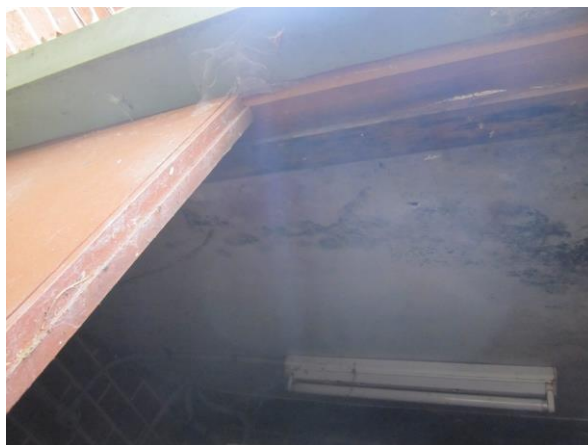
Meerkat	back of house area, including breeding areas													no photo	area inspected no ACM found.
Snow leopard	electrical alcove, south side of exhibit	ceiling lining	fibre cement				NAD						82473	5	
Snow leopard	entrance to back of house area	ceiling lining	fibre cement				NAD						82474	6	note: 2 types of ceiling material, both were NAD
Snow leopard	electrical distribution boards	mounting board	mounting board				NAD						visual inspection	7	
Snow leopard	corridor between gate & dens	ceiling lining	fibre cement				NAD						visual inspection	no photo	based on results of 82474

Photo 5: Snow Leopard, electrical alcove, south side of exhibit, ceiling

Sample No	Lab No	Sample Information	Analysis Result	Description
1	82473	Snow Leopard Exhibit, electrical alcove, south side of exhibit, ceiling	No asbestos detected	The sample was a grey fibre-cement, of approximate weight <1 g, in which organic fibres were detected. No asbestos fibres were detected in the sample.
2	82474	Snow Leopard Exhibit, entrance to back of house area, ceiling, (A) small ceiling section on right hand side, (B) main section of ceiling	No asbestos detected	The sample was (A) a damp, dark grey, crumbly material and (B) a grey, crumbly material, of total approximate weight 3 g. No asbestos fibres were detected in parts (A) or (B) of the sample.

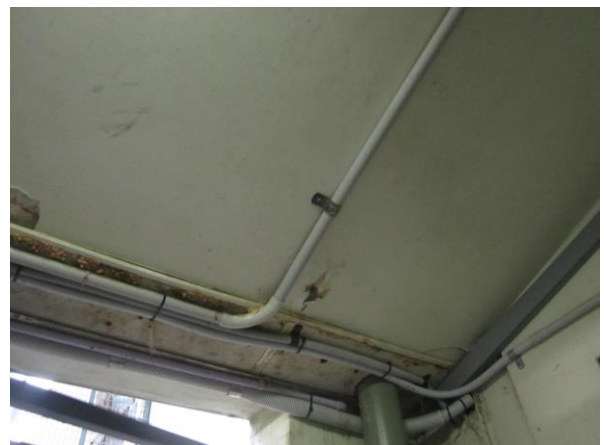
Photo 6: Snow Leopard, entrance to back of house area, ceiling

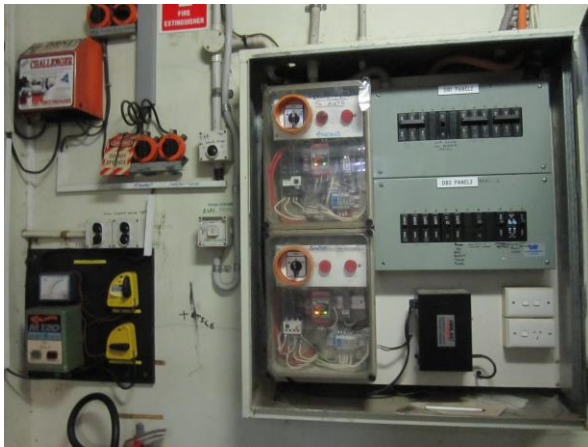
Photo 7: Snow Leopard, electrical distribution boards

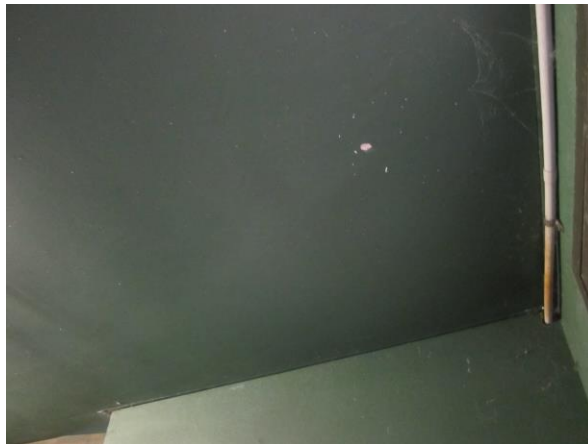
Photo 9: Ecx 005 den foyer, ceiling

<i>Sample No</i>	<i>Lab No</i>	<i>Sample Information</i>	<i>Analysis Result</i>	<i>Description</i>
3	82475	ECX 005 den foyer ceiling (green)	No asbestos detected	The sample was a grey fibre-cement with a green coating on one surface, of approximate weight <1 g, in which organic fibres were detected. No asbestos fibres were detected in the sample.
4	82476	Amenities Lobby, base under hot water heater	No asbestos detected	The sample was a grey fibre-cement, of approximate weight <1 g, in which organic fibres were detected. No asbestos fibres were detected in the sample.
5	82477	Shower Room, wall sheeting	No asbestos detected	The sample was a grey fibre-cement, with a white coating on one surface, of approximate weight <1 g, in which organic fibres were detected. No asbestos fibres were detected in the sample.

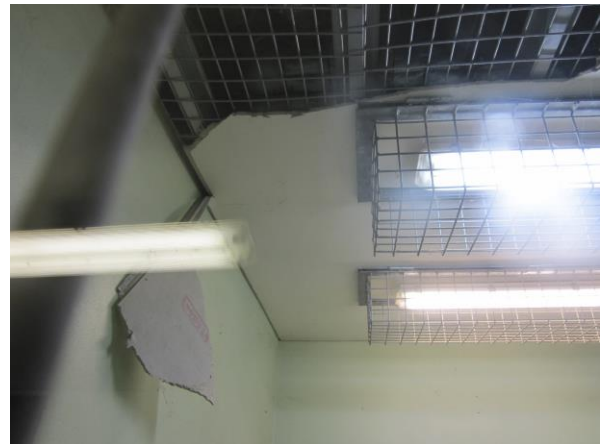
Photo 10: Sun bear dens D&E, ceiling

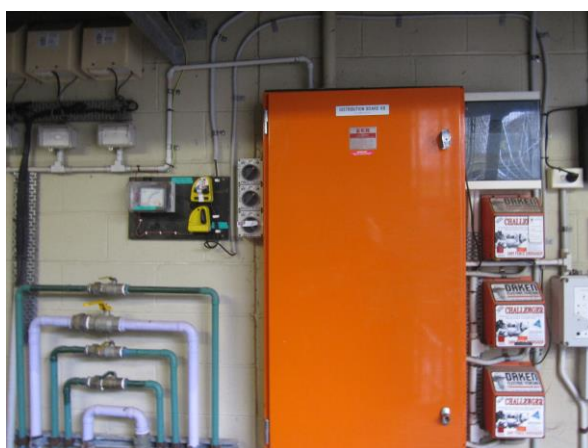
Photo 11: Sun bear, electrical distribution board

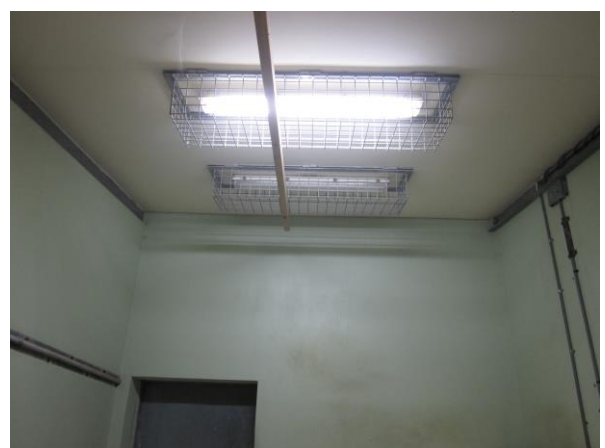
Photo 12: Ecx 006 (B), ceiling

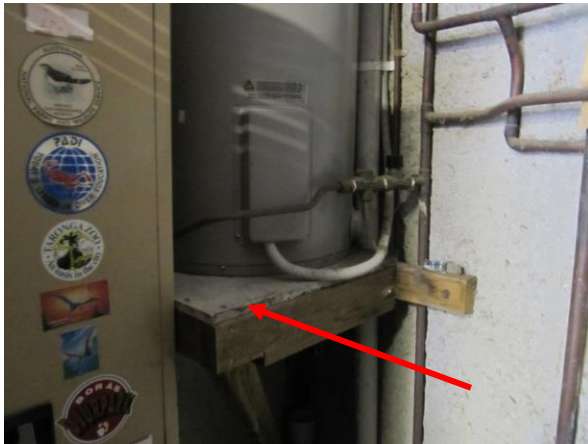
Photo 13: Staff amenities, hot water heater base

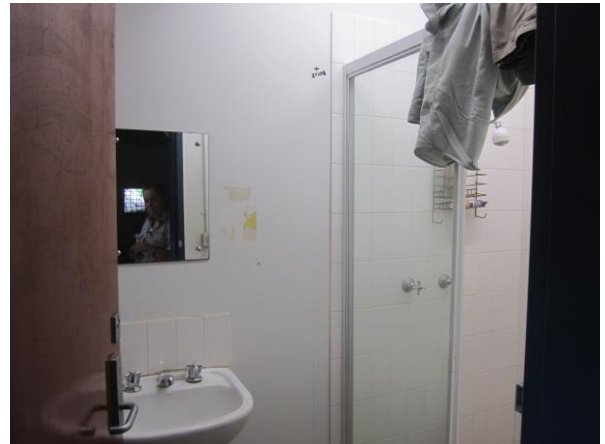
Primary Location	Secondary Location	Application	Material	ACM Type	Quantity (sqm)	Condition	ACM Status	Risk Rating	Occupancy	Accessibility	Control	Labelling	Sample ID	Photo ID	Comment
Lions & Tigers	lions den service area and dens	ceiling lining	plasterboard				NAD						visual inspection	8	photo location: ecx 003 ceiling
Lions & Tigers	ecx 005, den foyer, green ceiling	ceiling lining	fibre cement				NAD						82475	9	
Sun bear	bear dens D&E & adjacent corridor	ceiling lining	plasterboard				NAD						visual inspection	10	
Sun bear	electrical distribution board KB	mounting board	mounting board				NAD						visual inspection	11	
Sun bear	ecx 007/8, dens A, B, C: ecx 006, den B	ceiling lining	plasterboard				NAD						visual inspection	12	photo location: ecx 006 (B)
Cat & bear exhibits building	staff amenities lobby, hot water heater base	fibre cement	fibre cement				NAD						82476	13	
Cat & bear exhibits building	staff amenities shower room	wall linings	fibre cement				NAD						82747	14

Photo 14: Staff amenities, shower walls

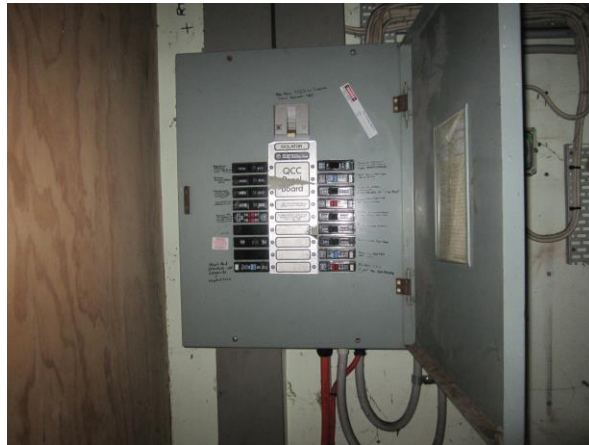
Cat & bear exhibits building	staff amenities, toilet	wall linings	fibre cement				NAD						visual inspection	no photo	based on results of 82477
Cat & bear exhibits building	staff offices & balcony						NAD						visual inspection	no photo	area inspected no ACM found.
Cat & bear exhibits building	sub floor areas						NAD						visual inspection	no photo	sub floor areas inspected underneath the building, no ACM found
Cat exhibits public area	electrical distribution board, rear ecx 004	mounting board	mounting board				NAD						visual inspection	15

Photo 15: Rear ecx 004, electrical distribution board
