Taronga Conservation Society Australia

# Arboricultural Assessment

Sumatran Tiger Adventure

Prepared by: Tom Hare – Consulting Arborist (AQF Level 5)  
April 20, 2015.

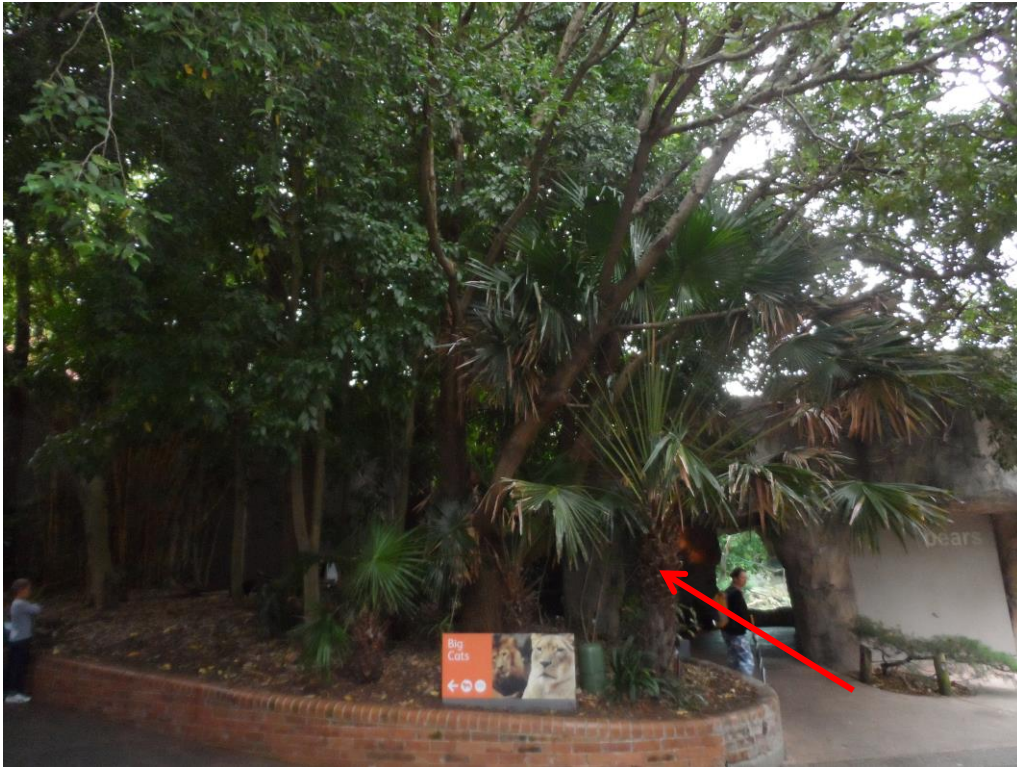
Figure 6: *Livistona chinensis*, this tree will be relocated to another area within the zoo.

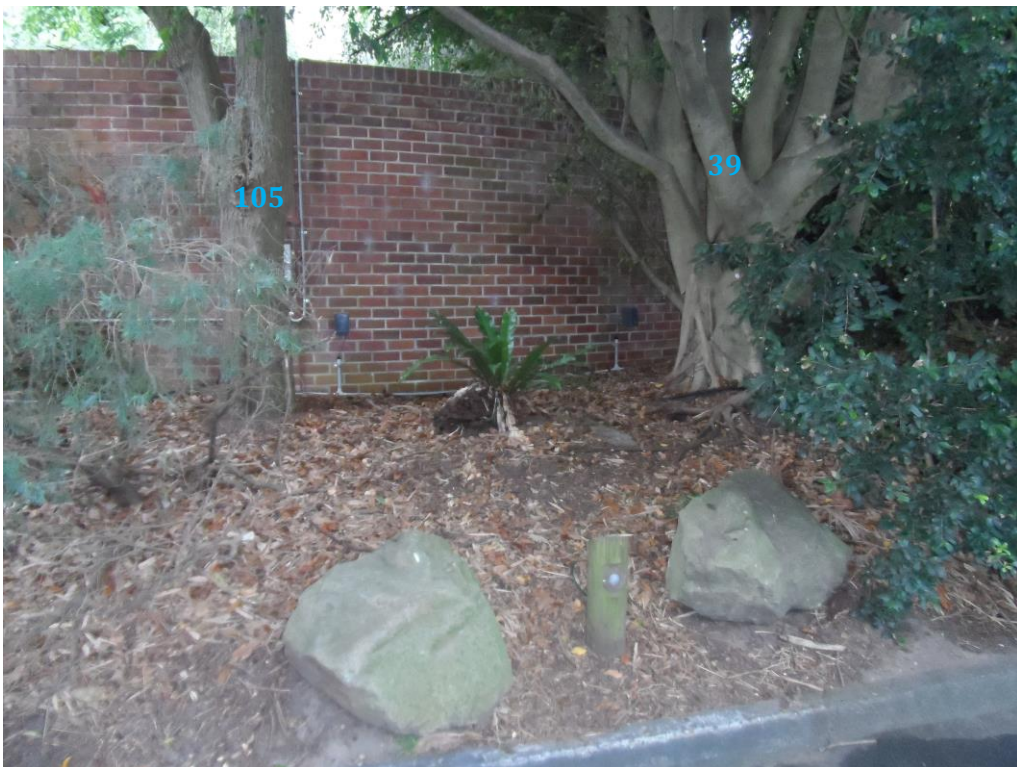
Figure 7: Trees 39 + 105, these trees are nominated for retention, they will be impacted upon by the removal of the brick wall and installation of a new low wall in front of the trees. Tree protection measures will need to be implemented.

105	Resurfacing and removal of existing retaining wall and installation of new wall.	Non-destructive excavation will be required and the new retaining wall will need to be designed to allow for the roots which are discovered, this may require pier and beam construction or other less invasive construction methods. The proposed paving will be Forest trail decorative concrete, it is assumed that this will not be permeable, however as the tree is currently in a raised garden bed the root impacts may be minimised. Removal of existing retaining walls must be done by hand and not torn out with machinery. This should be done under supervision of a suitably qualified Arborist.
97	New exhibit	May receive impacts from redesign of internal features of the exhibit however the amount of disturbance is unclear. Maintain Tree protection zones 12x trunk diameter as per AS4970-2009.
98	New exhibit	May receive impacts from redesign of internal features of the exhibit however the amount of disturbance is unclear. Maintain Tree protection zones 12x trunk diameter as per AS4970-2009.

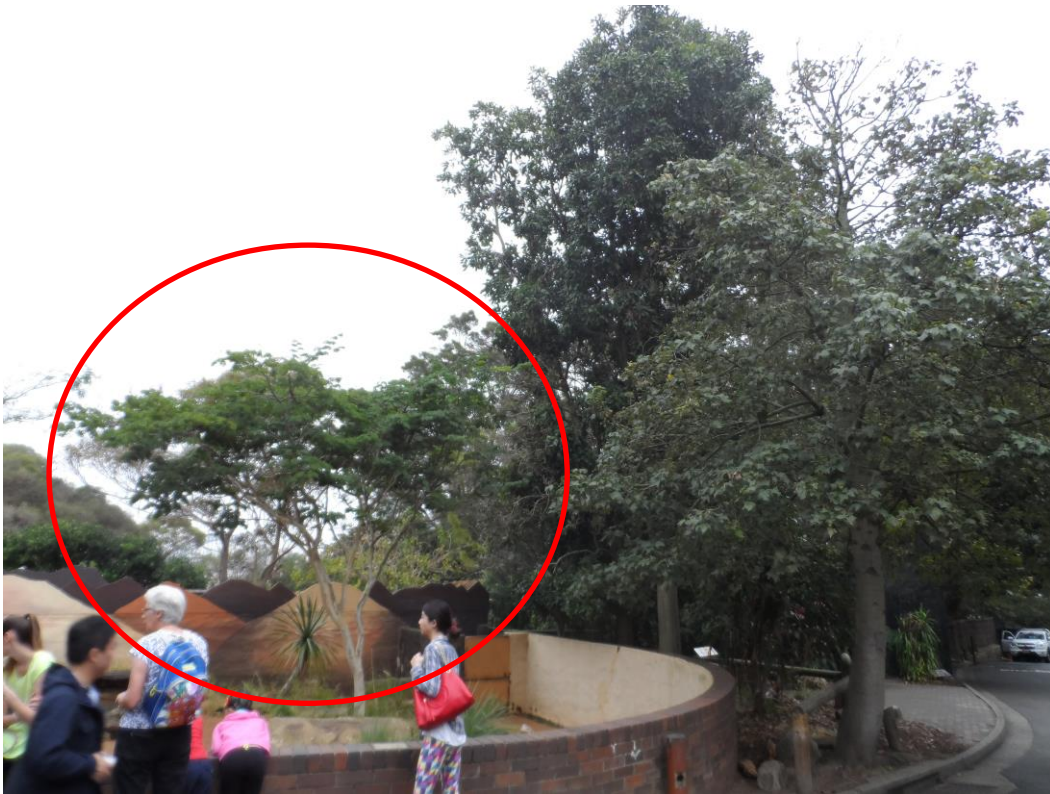
Figure 8: *Caesalpineia ferrea* (tree 126), this tree will be relocated to another area within the zoo.

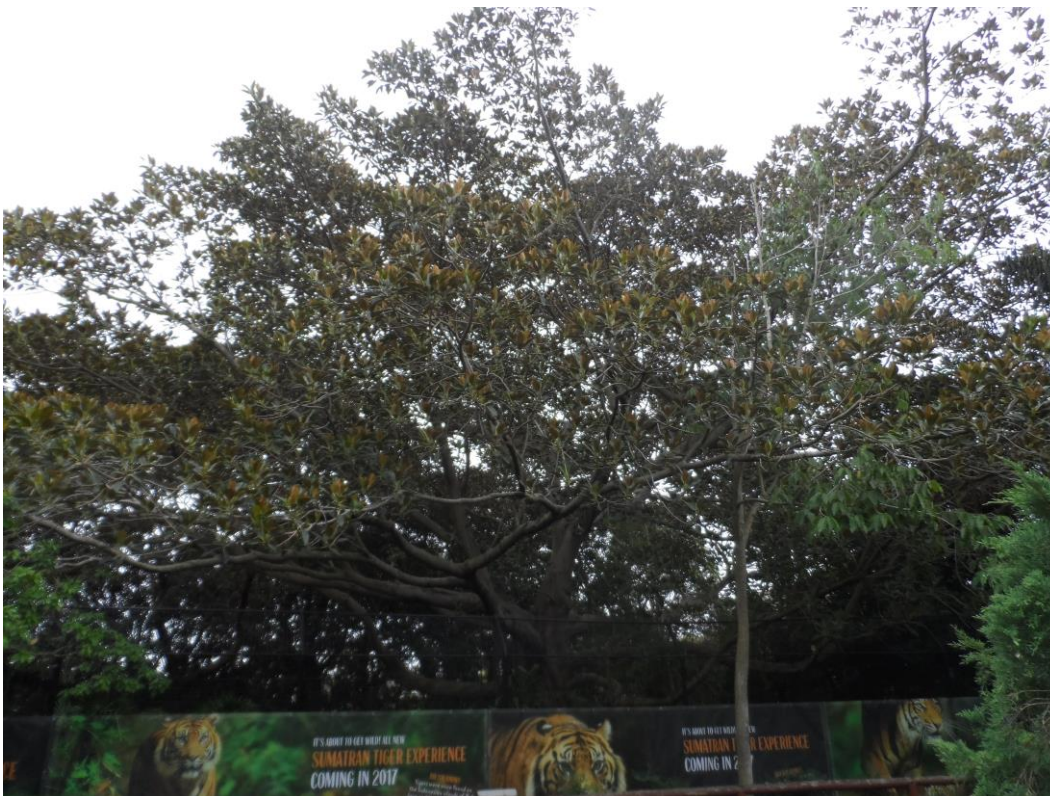
Figure 9: Tree 49 is a mature *Ficus macrophylla* which will form the centrepiece of the new exhibit. This tree will require pruning to allow netting to be installed in the first order branch structure.

49	New exhibit, removal of existing structures and installation of new structures. Exposure to wind and increased light levels. Proposed pruning, installation of netting.	Non-destructive excavation will be required to pothole for new fence post locations, the design must allow for the roots which are discovered. Removal of the existing water feature must be done by hand and not torn out with machinery. This should be done under supervision of a suitably qualified Arborist. The demolition of the rear walls of the exhibit must be conducted from outside the exhibit and machinery must be excluded from within the current enclosure. The entire enclosure will become the tree protection zone. The tree will require significant pruning to reduce the long lateral branches and there will be an alteration of light patterns and wind exposure, this tree will need to be regularly monitored following development.

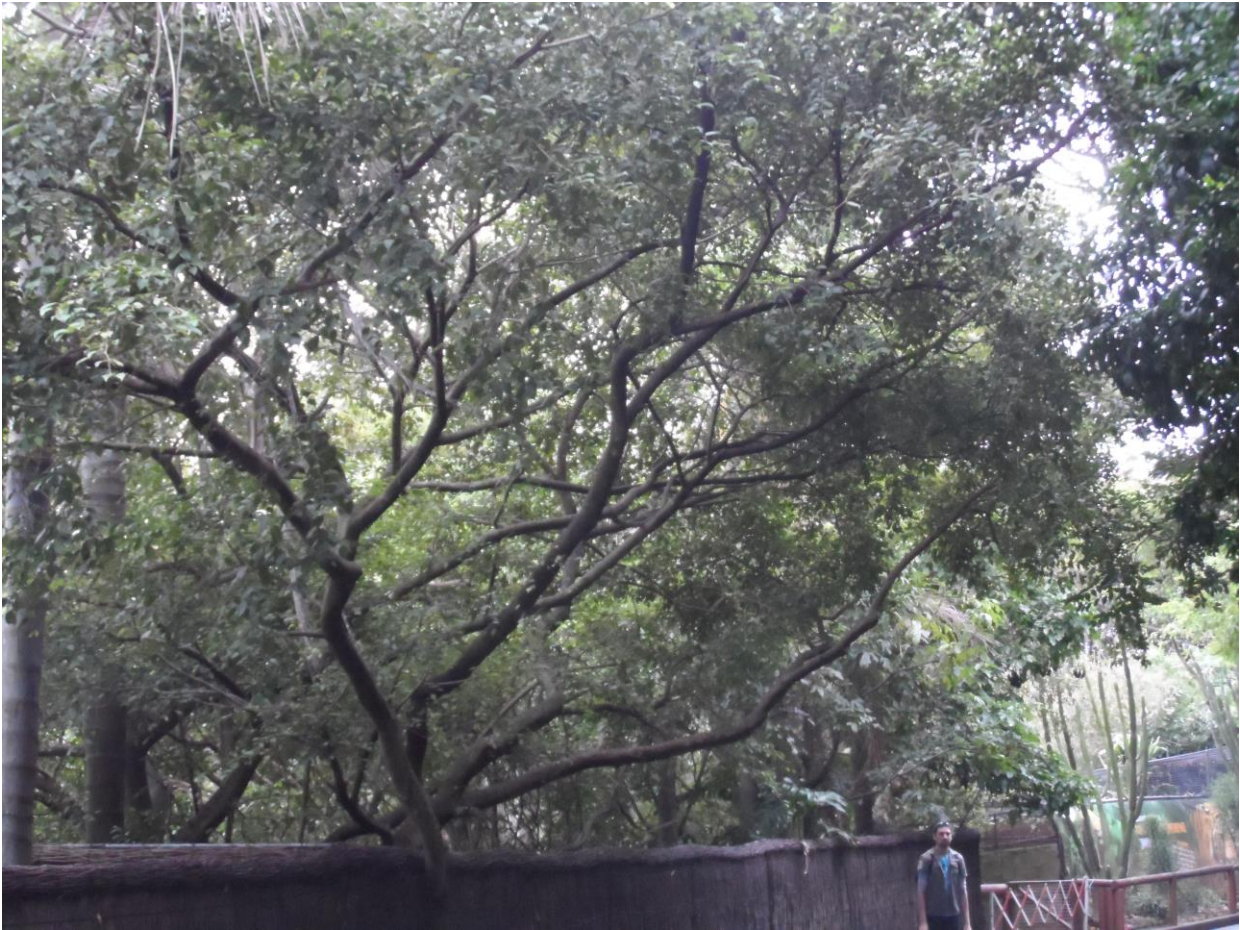
**Figure 10: Tree 51, this tree will require significant pruning of the lower canopy to allow for the construction of a new building under the canopy.**

51	New building under canopy	Significant pruning will be required to enable construction of the building. There may be roots under the current footpath which may become impacted by the new building; this will need to be assessed once the Bitumen has been removed.
15	Resurfacing	There may be roots under the current footpath which may become impacted by the resurfacing; this will need to be assessed once the Bitumen has been removed.
50	Resurfacing	There may be roots under the current footpath which may become impacted by the resurfacing; this will need to be assessed once the Bitumen has been removed but it is expected that there will be minimal impact.
39	Resurfacing and removal of existing retaining wall and installation of new wall.	Non-destructive excavation will be required and the new retaining wall will need to be designed to allow for the roots which are discovered, this may require pier and beam construction or other less invasive construction methods. The proposed paving will be Forest trail decorative concrete, it is assumed that this will not be permeable, however as the tree is currently in a raised garden bed the root impacts may be minimised. Removal of existing retaining walls must be done by hand and not torn out with machinery. This should be done under supervision of a suitably qualified Arborist.
