ARBORICULTURAL IMPACT REPORT

WENONA SCHOOL
NORTH SYDNEY NSW

9 JUNE 2015

PREPARED FOR WENONA SCHOOL

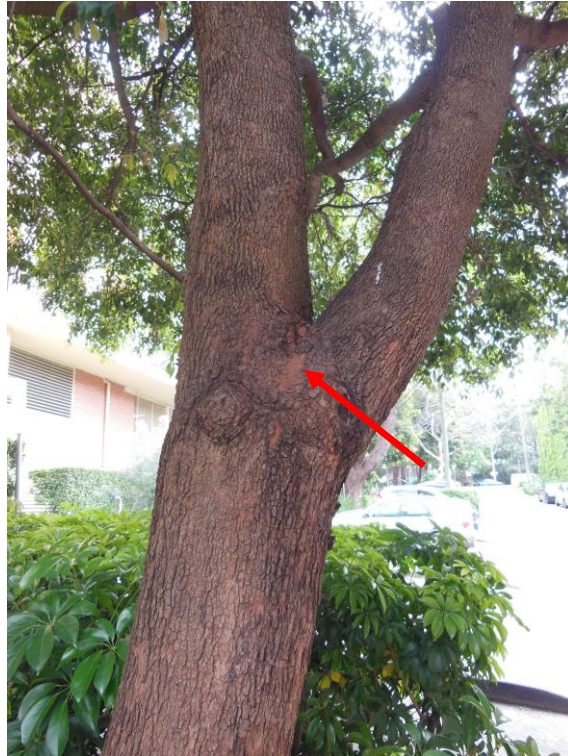
TREE NO.	SCIENTIFIC AND COMMON NAME	TPZ	SRZ	COMMENTS
1	<i>Syzigium paniculatum</i> (Brush Cherry, Magenta Lilly Pilly)	4.2 metres	2.3 metres	A mature, single trunked specimen approximately 11 metres in height with a canopy spread of 9 metres and a DBH of 350mm. In good health and of moderate to high landscape significance. Located on the nature strip frontage of the site. The tree displays fair branch attachment with codominant leaders from 1.7 metres with some evidence of poor attachment at the junction - the junction is a weak point in the tree's structure with increased risk of failure but is not considered at risk of failure in the short term. Exposed woody roots.
4	<i>Acmena smithii</i> (Lilly Pilly)	9.6 metres	3 metres	A mature, multi trunked specimen approximately 12 metres in height with a canopy spread of 16 metres and DBH of up to ca. 340mm (ca. 800mm above the root flare). In good health and of moderate to high landscape significance. The tree displays fair to poor branch attachment with multiple leaders form near ground level evidence of poor attachment at the junction - the junction is a weak point in the tree with increased risk of failure (junction not inspected at close range as access to preschool was not available at time of inspection). Crossing branch at 5 metres (with T5).

Photograph 1: Tree # 1 – Illustrating the codominant leaders from 1.7 metres with some evidence of poor attachment at the junction.

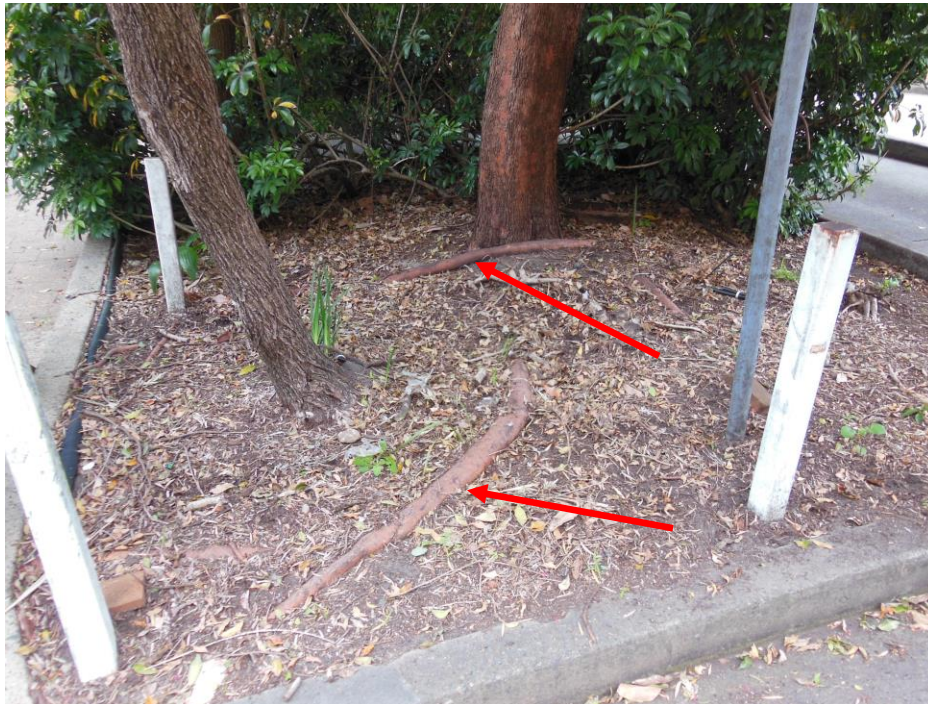
Photograph 2: Tree # 1 – Illustrating the exposed woody roots adjacent infrastructure.

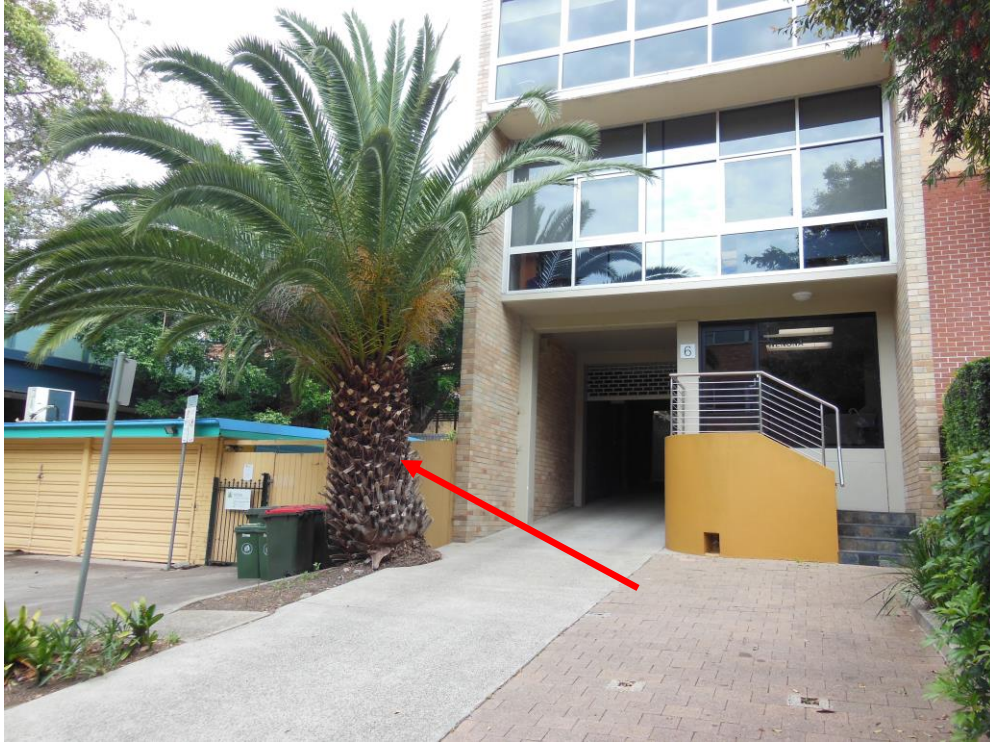
TREE NUMBER(S)	SCIENTIFIC AND COMMON NAME	COMMENTS*
2	<i>Phoenix canariensis</i> (Canary Island Date Palm)	Located within the footprint of the proposed works and identified to be removed as part of the works. NB: If feasible Wenona School may lift this palm, store during construction works and replant this palm at the site in accordance with the attached transplant method statement (Appendix E)
4	<i>Acmena smithii</i> (Lilly Pilly)	Located within the footprint of the proposed works and identified to be removed as part of the works.

Photograph 3: Tree # 2 – Illustrating the location and context.

NB: If feasible Wenona School proposes to lift tree number 2 (Date Palm), store during construction works and replant this palm at the site in accordance with the attached transplant method statement (Appendix E)

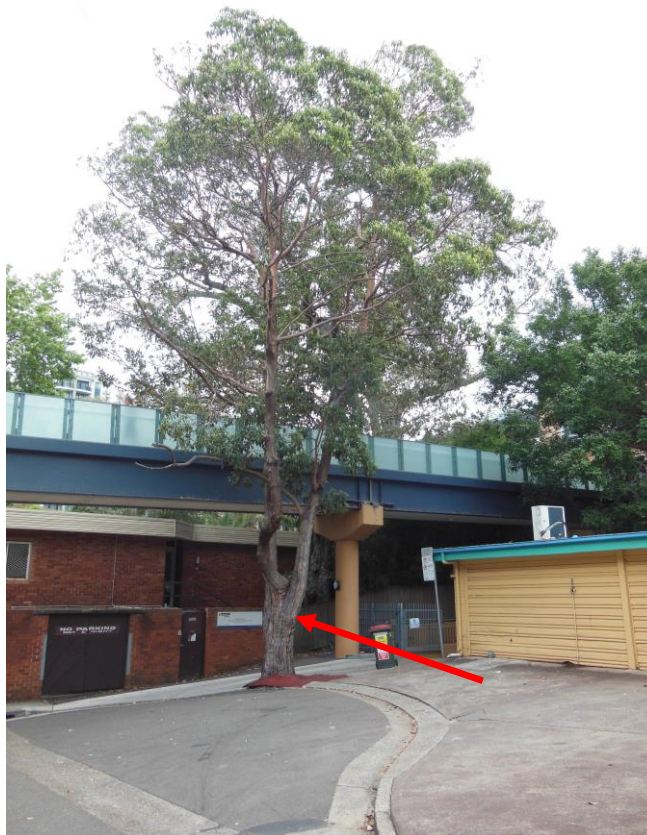
TREE NO.	SCIENTIFIC AND COMMON NAME	TPZ	SRZ	COMMENTS
3	<i>Lophostemon confertus</i> (Brushbox)	9.3 metres	3 metres	A mature, twin trunked specimen approximately 18 metres in height with a canopy spread of 14 metres and trunk diameters at breast height (DBH) of 420 and 610mm. In moderate health and of high landscape significance. Located on the nature strip frontage of the site. The tree displays fair branch attachment with codominant leaders from 1.3 metres and multiple leaders from 2.2 metres with some evidence of poor attachment at the junctions - not considered at risk of failure in the short term. There is evidence of past tissue loss on the NE side of the lower trunk from 0.7 to 1.4 metres - possible canker. There is also evidence of past mechanical injury on the south side at 0.6 to 1.4 metres. At the time of inspection the tree was of moderate health and fair vigour and exhibited reduced foliage size, reduced foliage density and low levels of dieback.

Photograph 4: Tree # 3 – Illustrating the location and context.

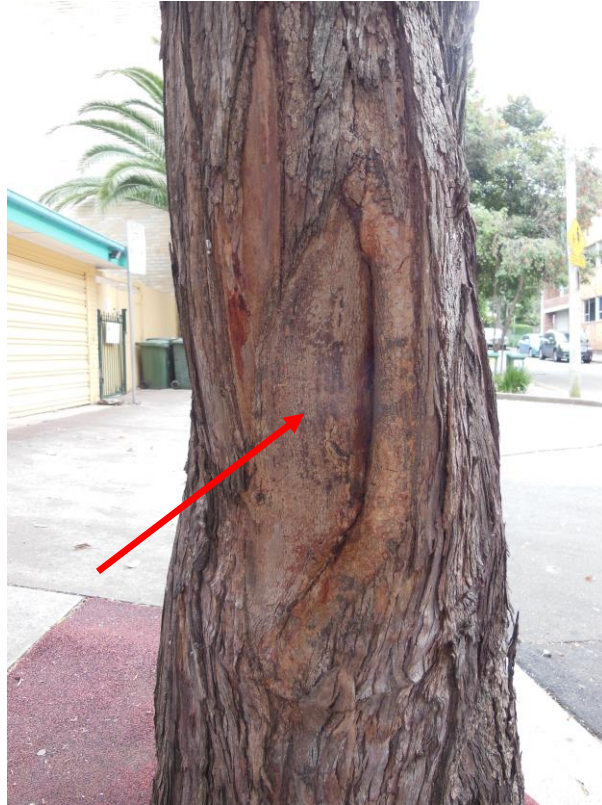
Photograph 5: Tree # 3 – Illustrating the evidence of past mechanical injury on the south side at 0.6 to 1.4 metres.

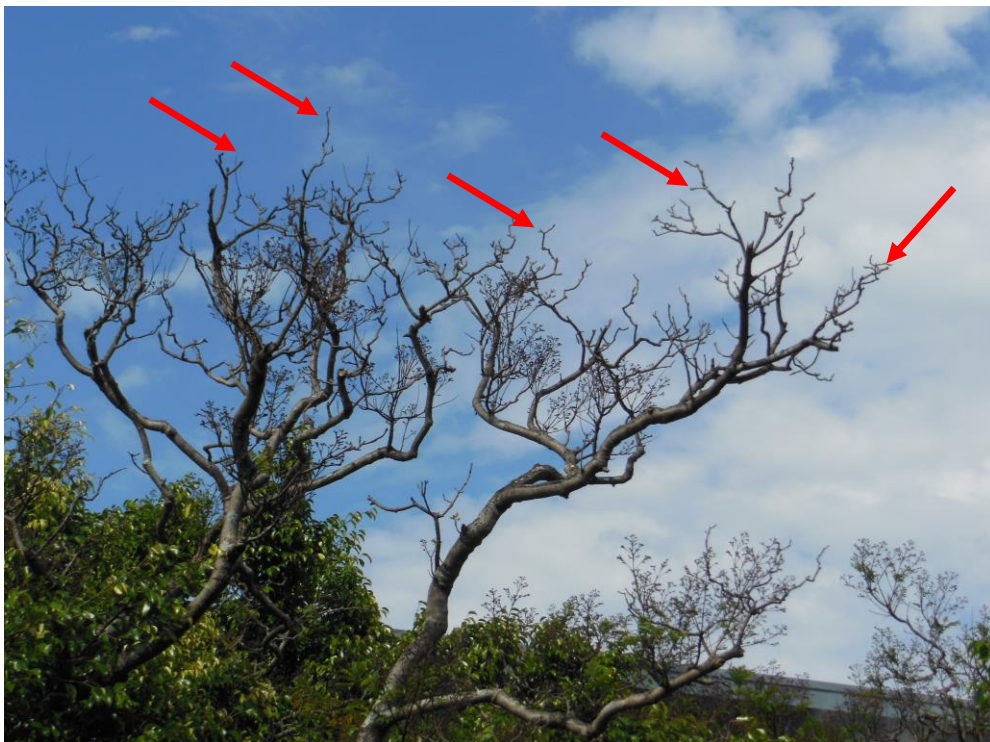
At the time of inspection the tree was of fair vigour and exhibited moderate levels of dieback in the upper canopy. Crossing branch at 7 metres (with T6).
10	<i>Ficus rubiginosa</i> (Port Jackson Fig)	7.9 metres	2.8 metres	A mature, multi trunked specimen approximately 12 metres in height with a canopy spread of 14 metres and DBH of up to 410mm (660mm above the root flare). In good health and of moderate to high landscape significance. The tree displays fair branch attachment with multiple, codominant leaders from 1.3 metres with some evidence of poor attachment at the junction - the junction is a weak point in the tree's structure with increased risk of failure but is not considered at risk of failure in the short term.
11	<i>Ulmus parvifolia</i> (Chinese Elm)	5.3 metres	2.6 metres	A mature, single trunked specimen approximately 15 metres in height with a canopy spread of 12 metres and a DBH of 440mm. In good health and of moderate to high landscape significance. The tree displays fair branch attachment with evidence of past branch failures in the upper canopy. At the time of inspection the tree was of fair vigour and exhibited low to moderate level of dieback in the upper canopy.

Photograph 6: Tree # 7 – Illustrating the moderate levels of dieback in the upper canopy.

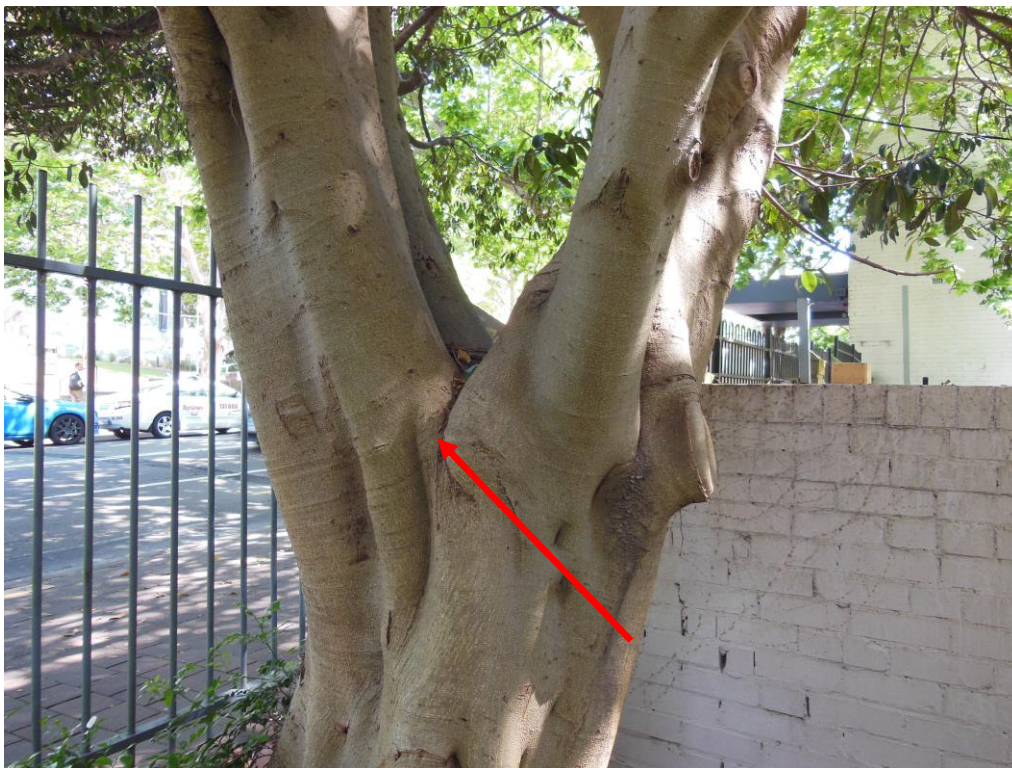
Photograph 7: Tree # 10 – Illustrating the multiple, codominant leaders from 1.3 metres with some evidence of poor attachment at the junction.

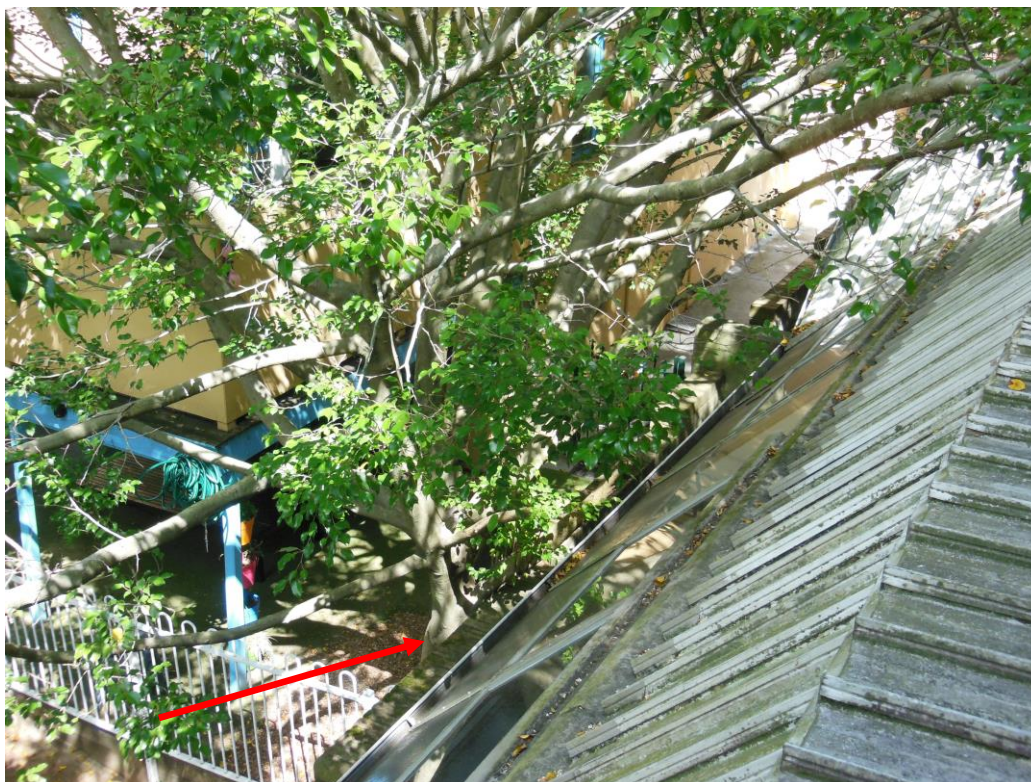
Photograph 8: Tree # 8 – Illustrating the close proximity to buildings, retaining walls etc.

8	<i>Acmena smithii</i> (Lilly Pilly)	13	12 x 16	Up to ca. 400 (ca. 600 above root flare)	600	600	Good foliage condition	Mature	Multi trunked	Upright trunk	Balanced canopy area	Lower limbs pruned in past to 4 metres, upper branches pruned on NE and SW for buildings	Appears stable	Fair to poor branch attachment	Good health	Fair vigour	5%	No visual evidence of significant pest or disease	3 Short (5 to 15 years)	Moderate to high landscape significance	3	The tree displays fair to poor branch attachment with multiple leaders from approx. 1.4 metres - the junction is a weak point in the tree with increased risk of failure (junction not inspected or seen as access to pre school was not available at time of inspection). At the time of inspection the tree was of fair vigour and exhibited low levels of dieback. Short ULE due to very close proximity to buildings, retaining walls etc.
