Stage 1 Contamination Assessment:

Lot 3 DP 568613
& Lot 384 DP 755952
Mundamia
NSW.

P0802193JR01_v1
March 2009

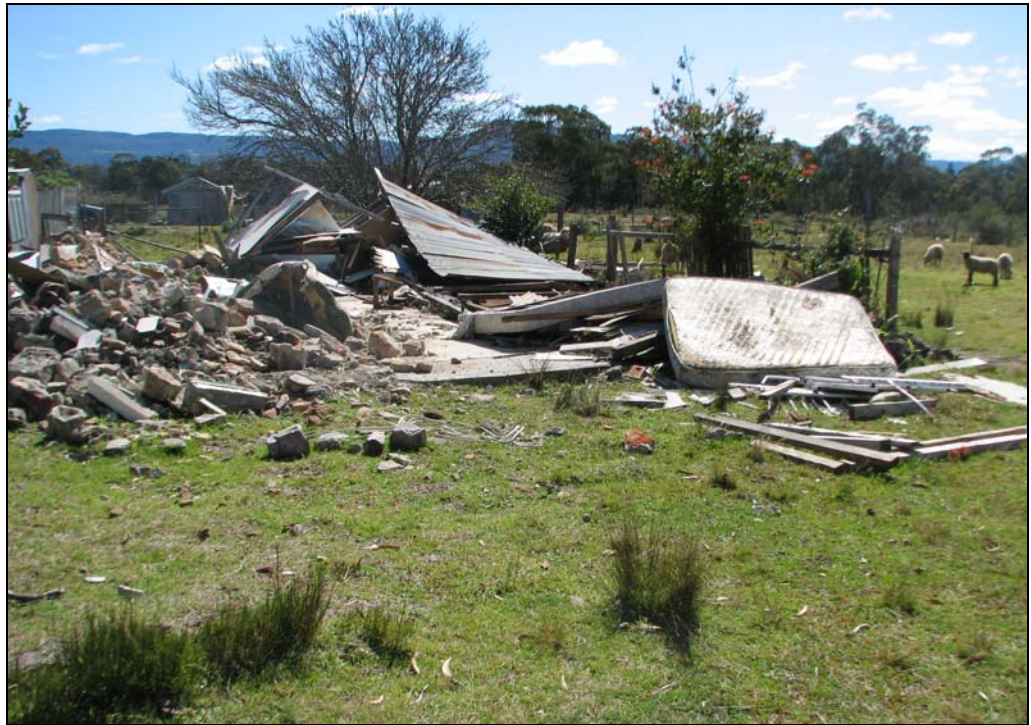
- Single storey brick dwelling in the southern portion of the lot.
- 2 disused dwellings, 1 dilapidated and 1 completely demolished (Figure 1), to the east of the brick dwelling.
- Corrugated iron or weatherboard sheds ranging in size (approximately 8 – 10) in the southern portion of the site.
- 3 dams; one located along the southern boundary of the lot, one in the middle and one located along the northern boundary of the lot.
- Sheep grazing.
- Rubbish piles consisting of general waste (Figure 2), machinery and asbestos (Figure 3) and randomly scattered items (such as fencing wire, corrugated iron water tanks, farm machinery, general refuse) across the lot.

Figure 1: Collapsed dwelling, Lot 384.

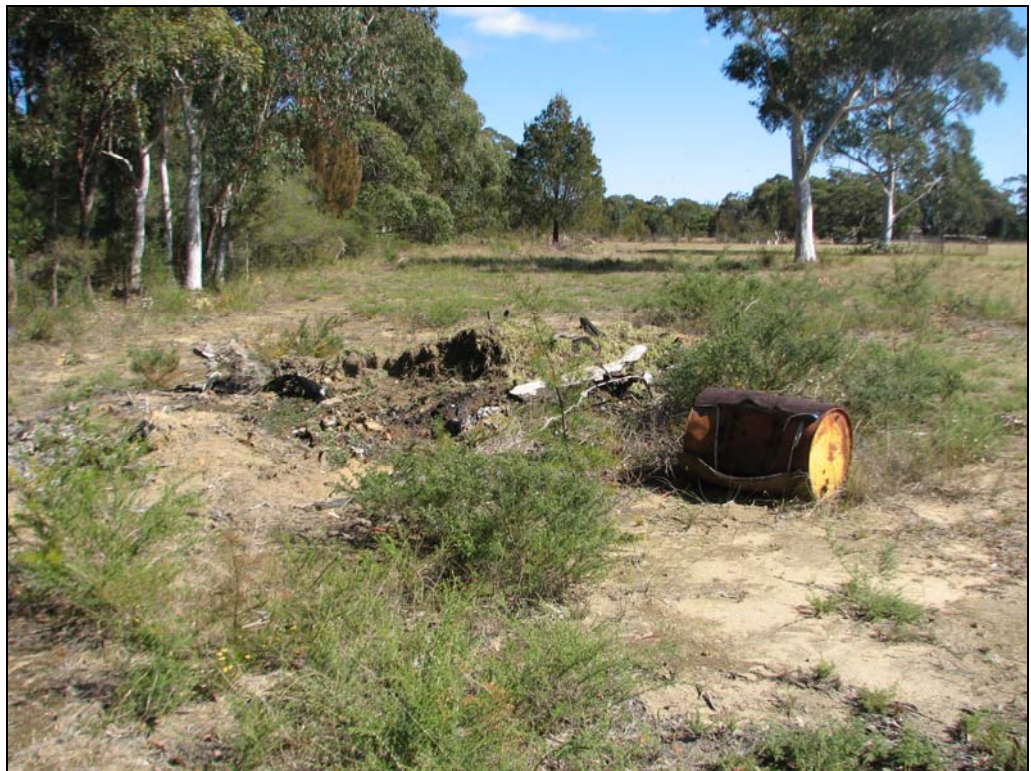
Figure 2: Pile of fill containing farm machinery, storage drums etc, south eastern corner of Lot 384.

Rubbish dumps were observed on Lot 384 contained a mixture of: rusted chemical drums; fibrous cement sheeting (likely to contain asbestos), corrugated iron sheeting, rusted farm machinery parts, rolls of chain link fencing wire and assorted rubbish. Additionally, Lot 384 had a number of dilapidated buildings containing fibro sheeting.

| Location | Activity | Potential Contaminants |
|--|--|---|
| Scattered disused machinery and areas of rubbish fill and soil stockpiling, across the site (see Figures 1 & 2). | Dumping of old car parts, various pieces of machinery, fibro sheeting and other building products. | HM, TRH, BTEX, PAH's, OCP/OPP and asbestos. |

| Location | Number of sampling points |
|---|---|
| Assorted rubbish areas | 2 / pile |

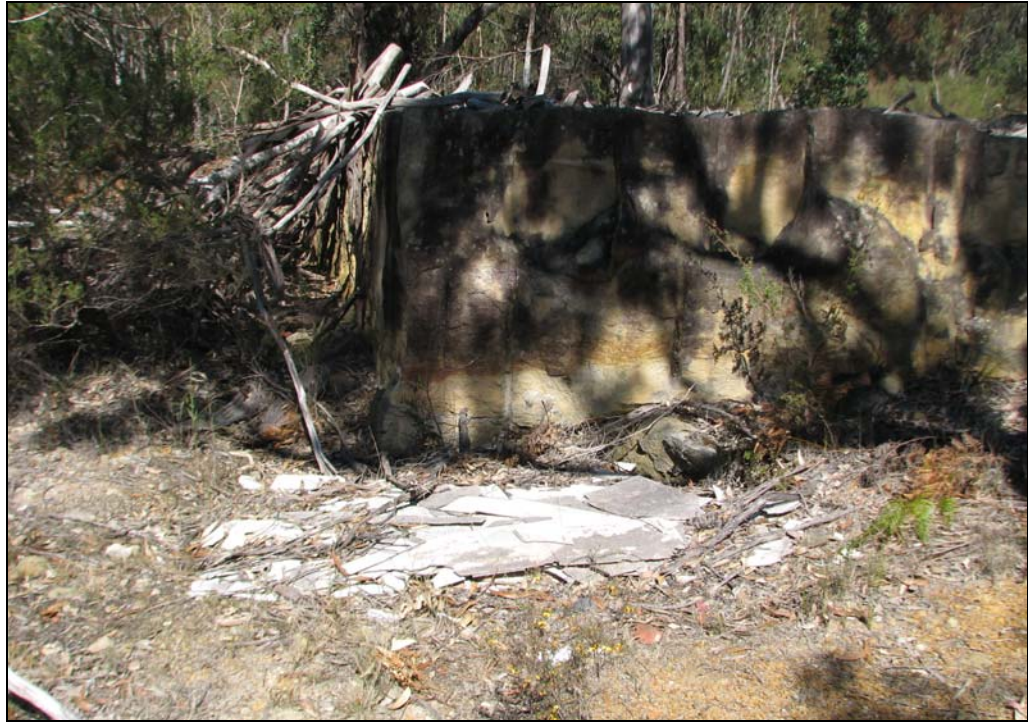
Figure 3: Pile of fibro, south eastern corner of Lot 384.

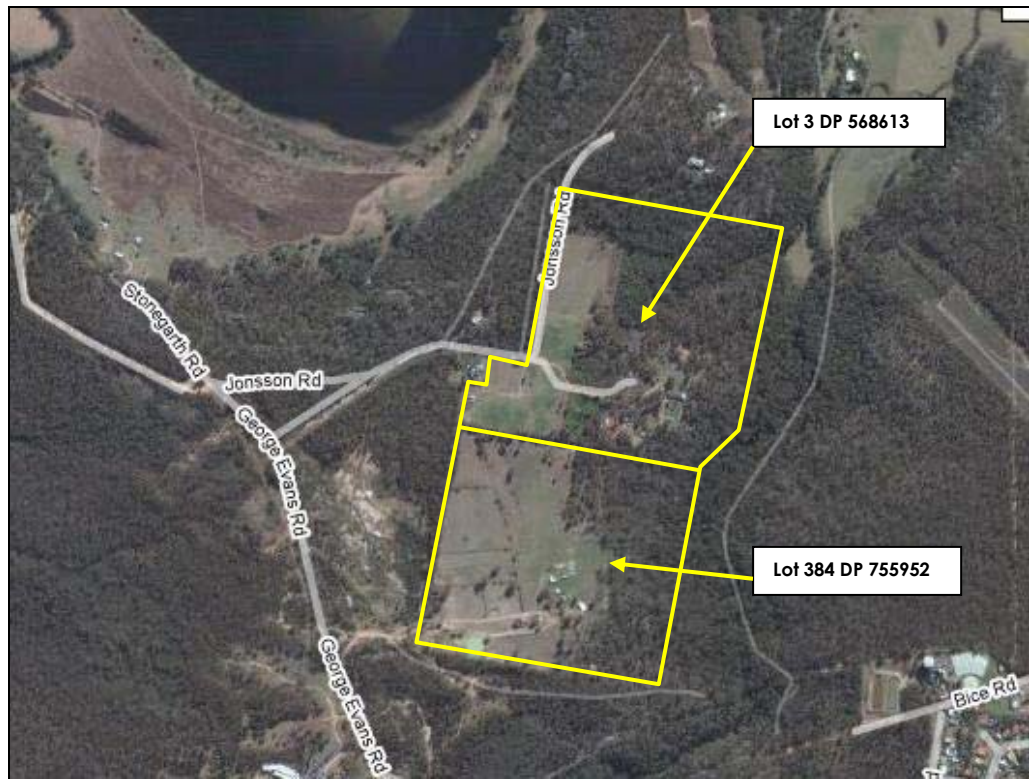
| Year | Description of / Changes to Land-use | |
|---|--|---|
| 2008 | Building as described in 1961 has been demolished. | No significant changes from above. |

Figure 4: Aerial photograph (2008) showing the site in its environmental context.

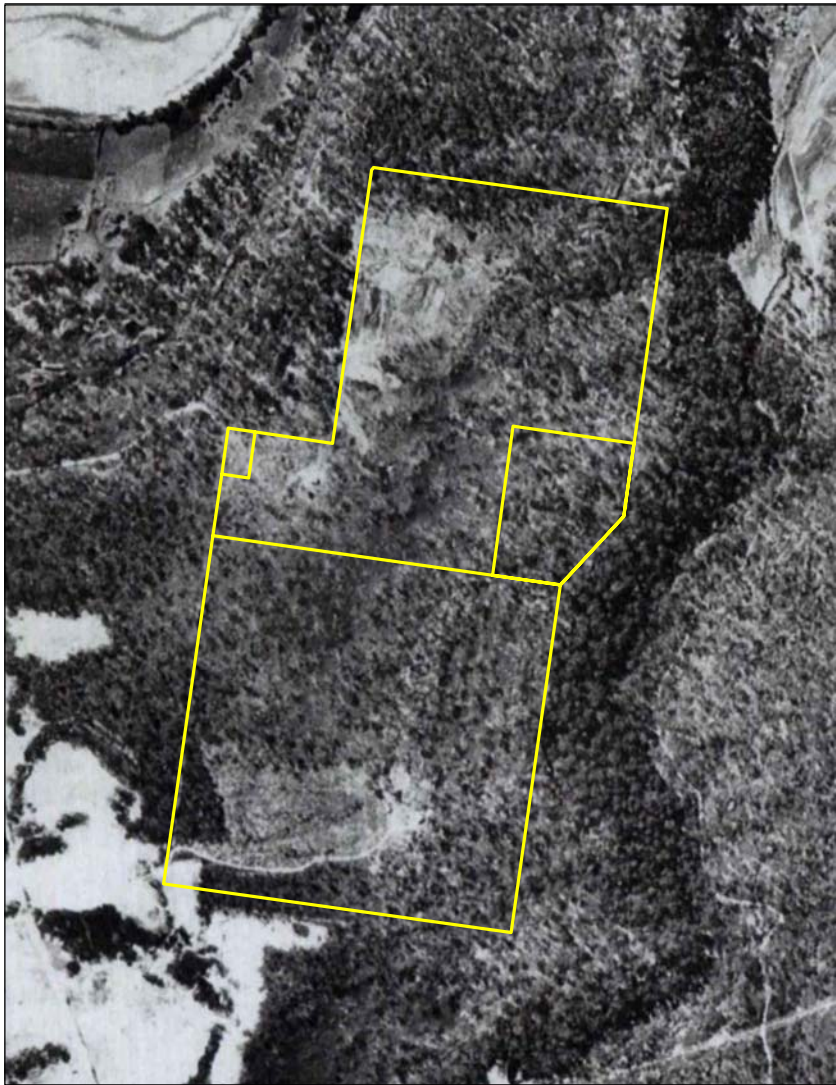
| Year | Description of / Changes to Land-use | |
|---|--|---|
| 1961 | Dwelling observed in the western portion of the lot. North western portion appears partly cleared, however no indication of separate paddocks for agricultural usage. | Access track and at least 3 buildings observed in the southern portion of the site. Approximately 15-20% of site cleared, the rest is well vegetated. |

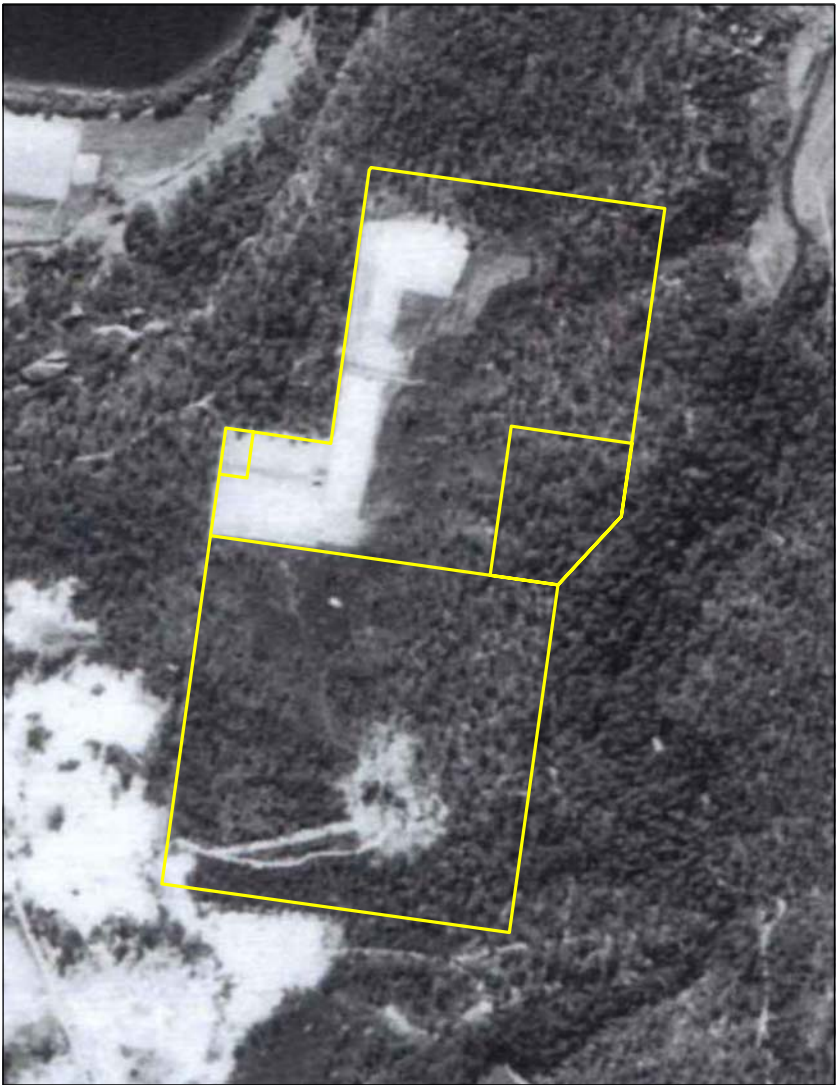
| Year | Description of / Changes to Land-use | |
|---|--|---|
| 1970 | Eastern portion of the site cleared, with areas split into paddocks. Western portion remains well vegetated. | As above, however with one more building. Cleared area appears to be mostly re-vegetated. |
