PRE-CONSTRUCTION DILAPIDATION REPORT AND PHOTOGRAPHIC SURVEY

Project Address: Lot 2 Forrester Road St Marys NSW 2760

Property Inspected: Entry Gate, Road & Council assets at 2 Forrester Road St Marys NSW

Date of Inspection: 04th June 2020

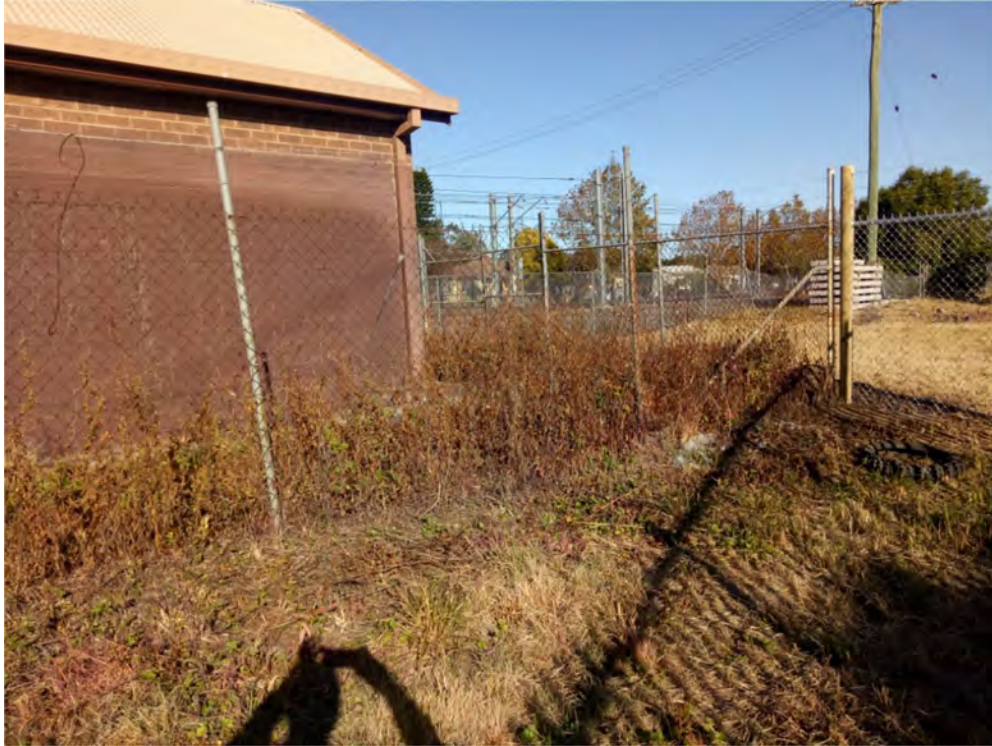
Photo (4): General View wire fence adjacent to the site fence

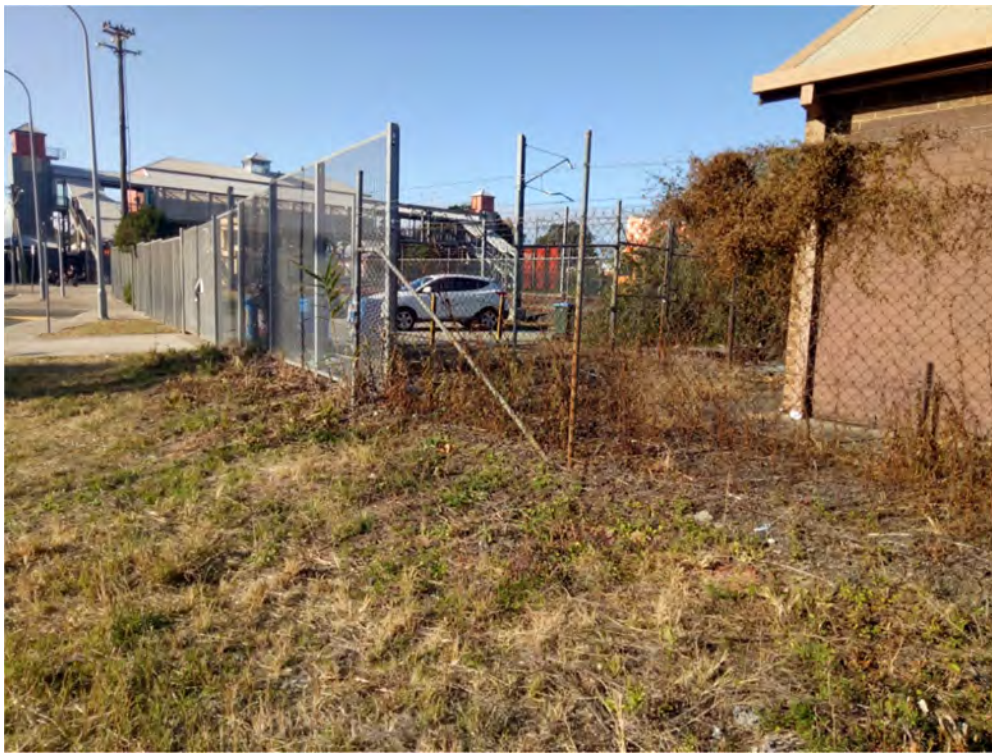
Photo (5): General View wire fence condition along train station

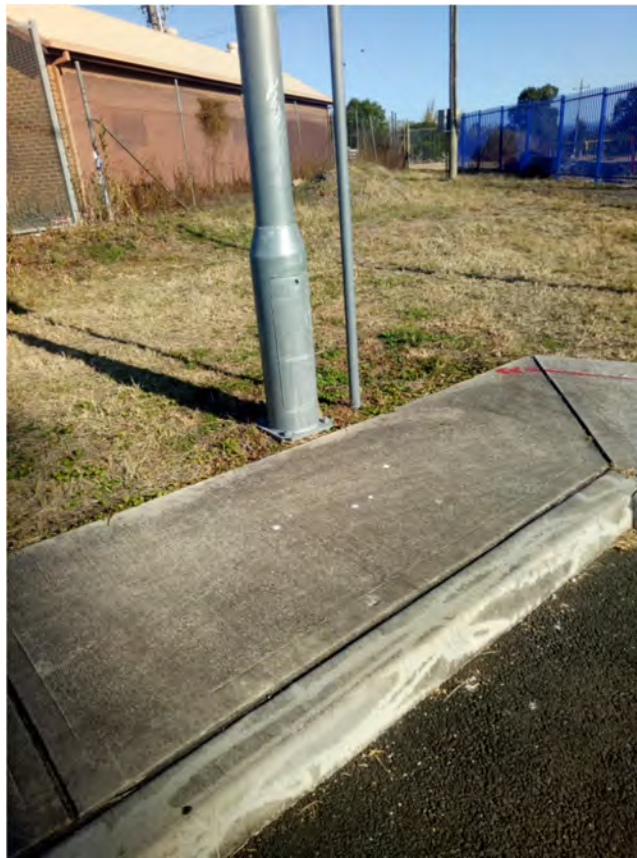
Photo (7): General View site fence

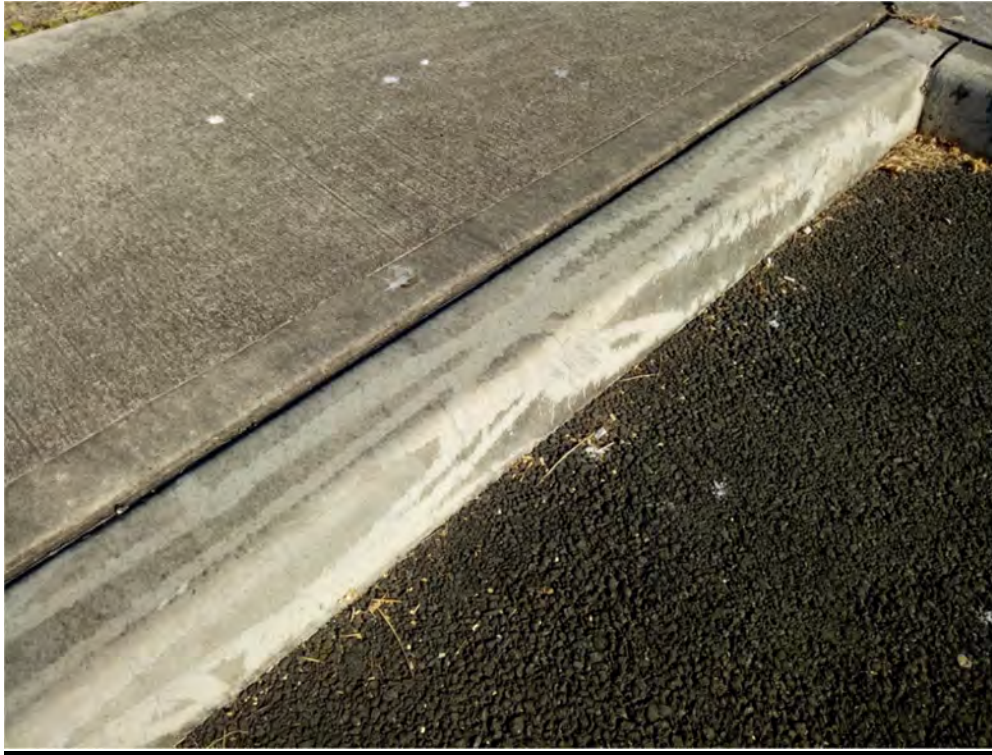
Photo (8): Existing cracks along the kerb adjacent to the site

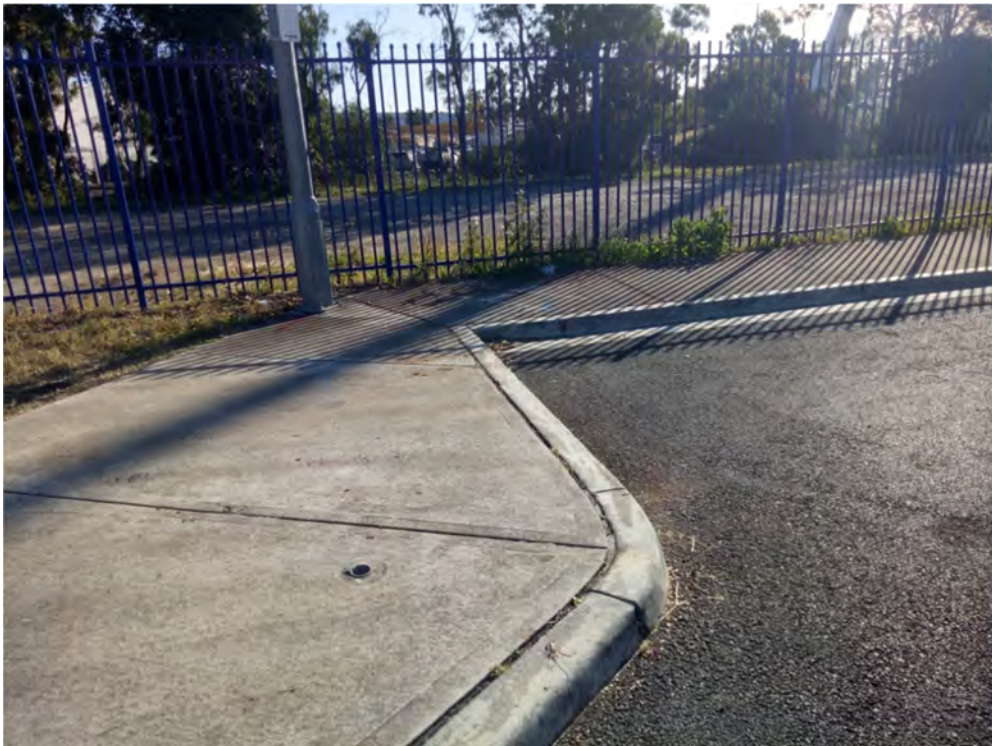
Photo (9): Existing cracks along the kerb adjacent to the site

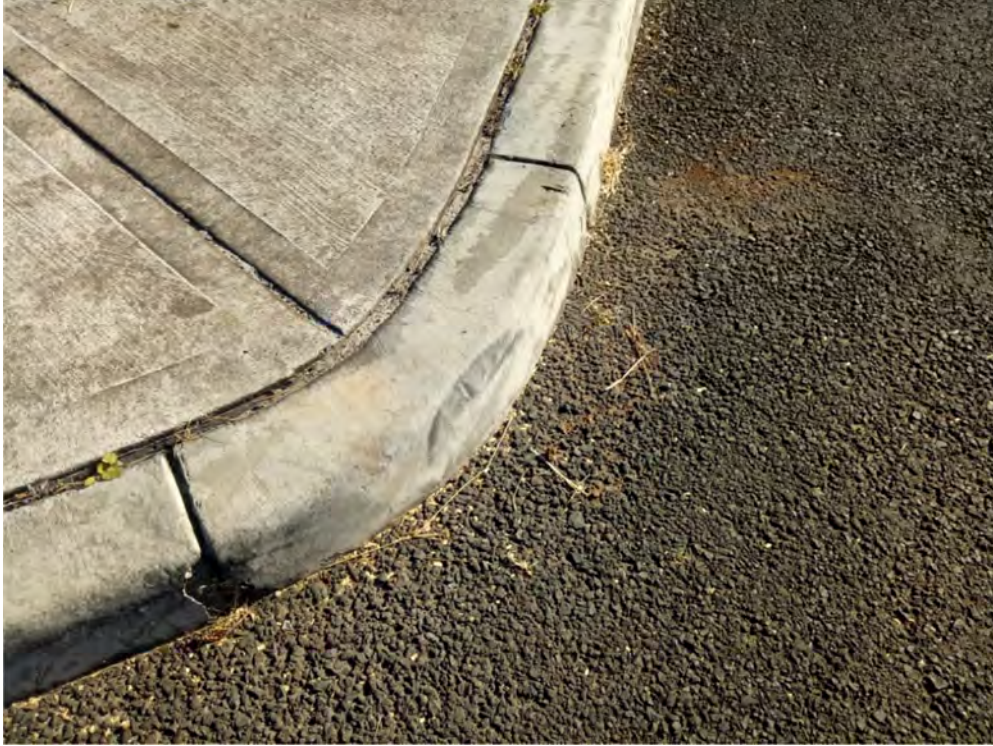
Photo (10): Existing damage in the kerb adjacent to the site

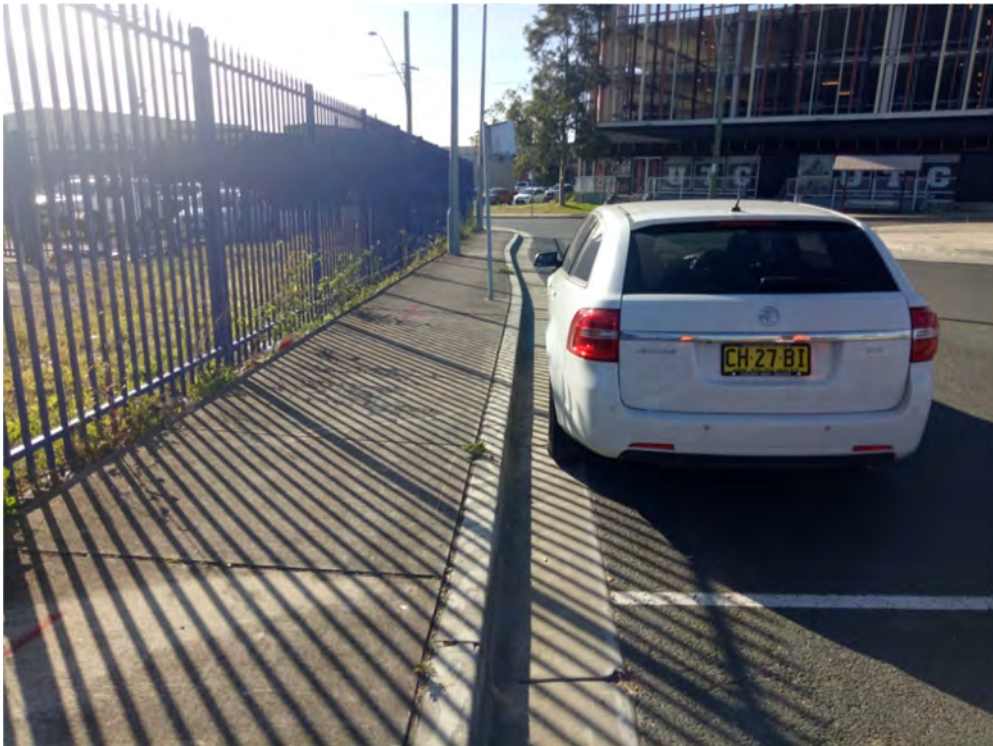
Photo (11): Existing damage in the kerb adjacent to the site

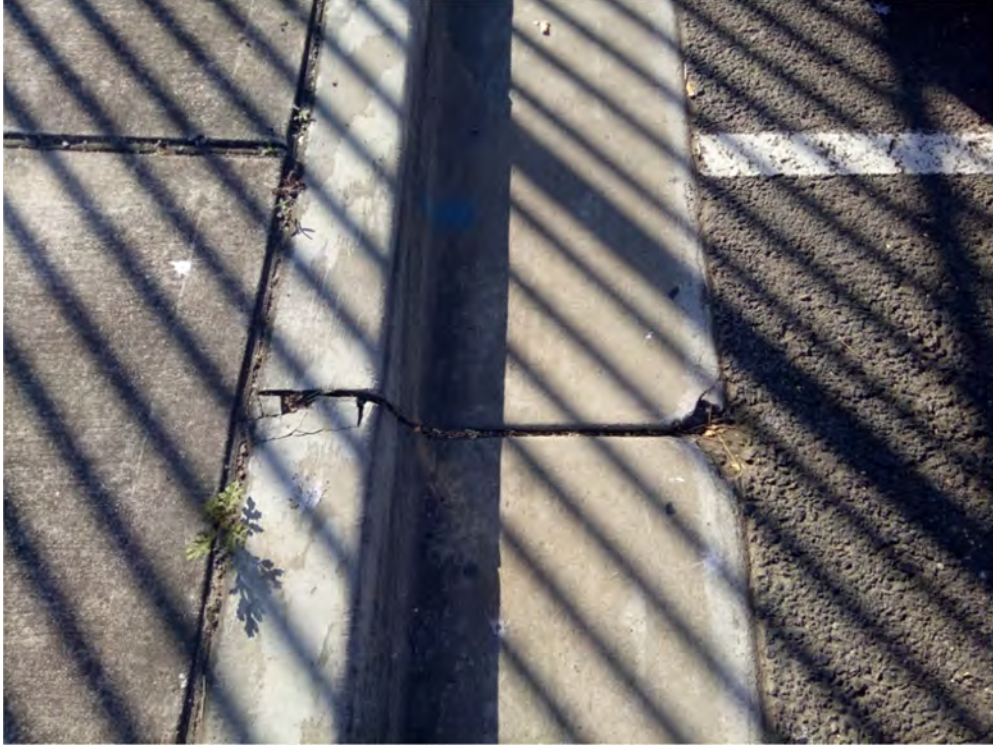
Photo (12): Existing damage in the kerb adjacent to the site

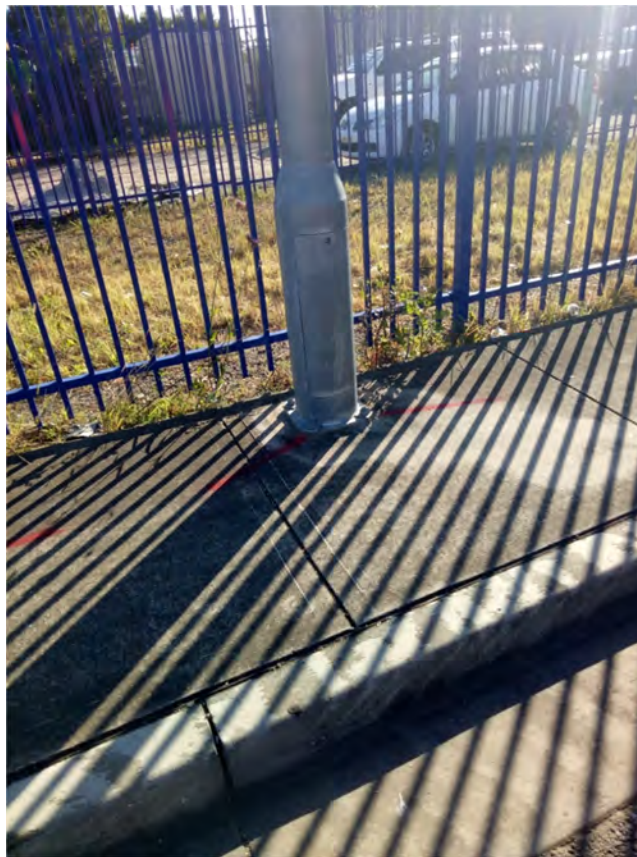
Photo (13): Existing damage in the kerb adjacent to the site

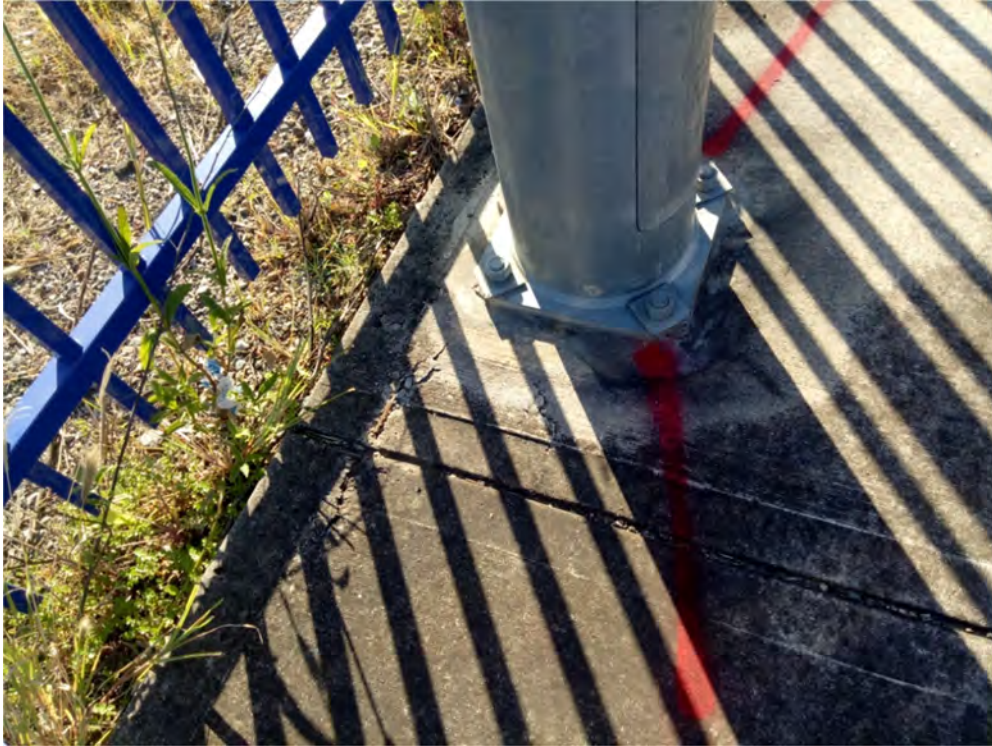
Photo (14): Existing damage in the footpath adjacent to the site

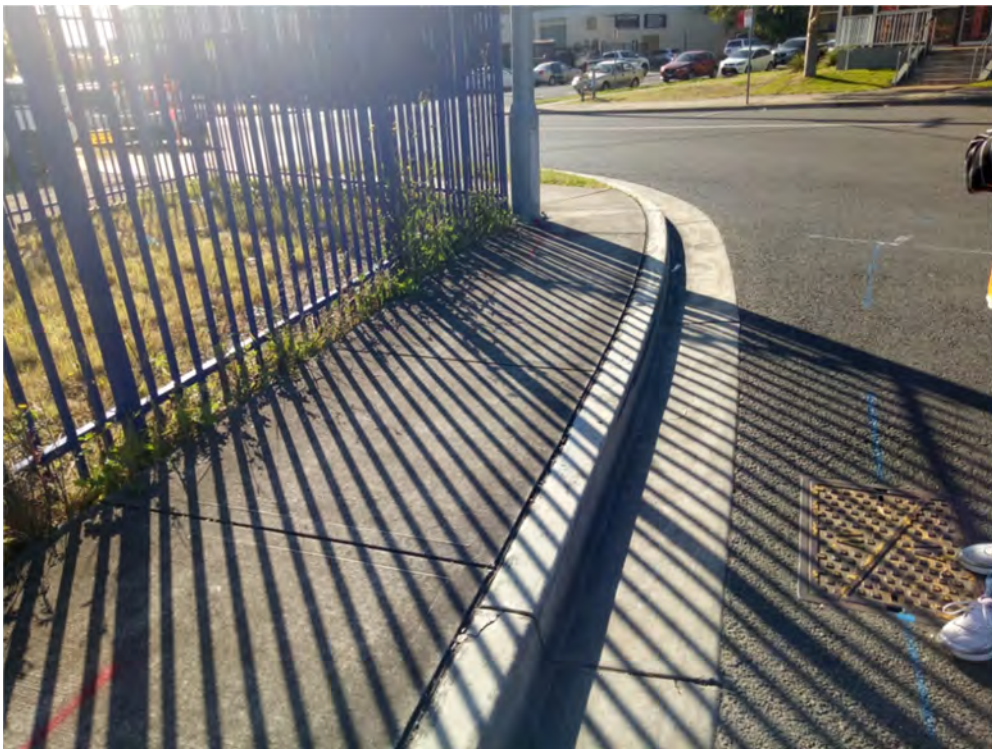
Photo (15): Existing damage in the footpath adjacent to the site

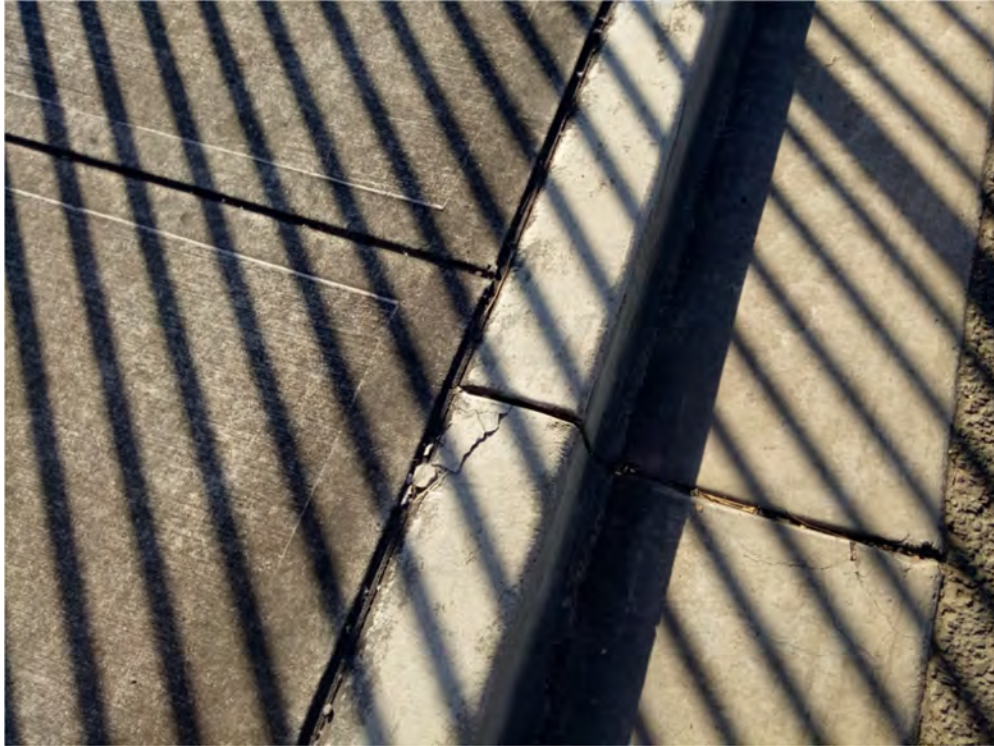
Photo (16): Existing damage in the kerb adjacent to the site

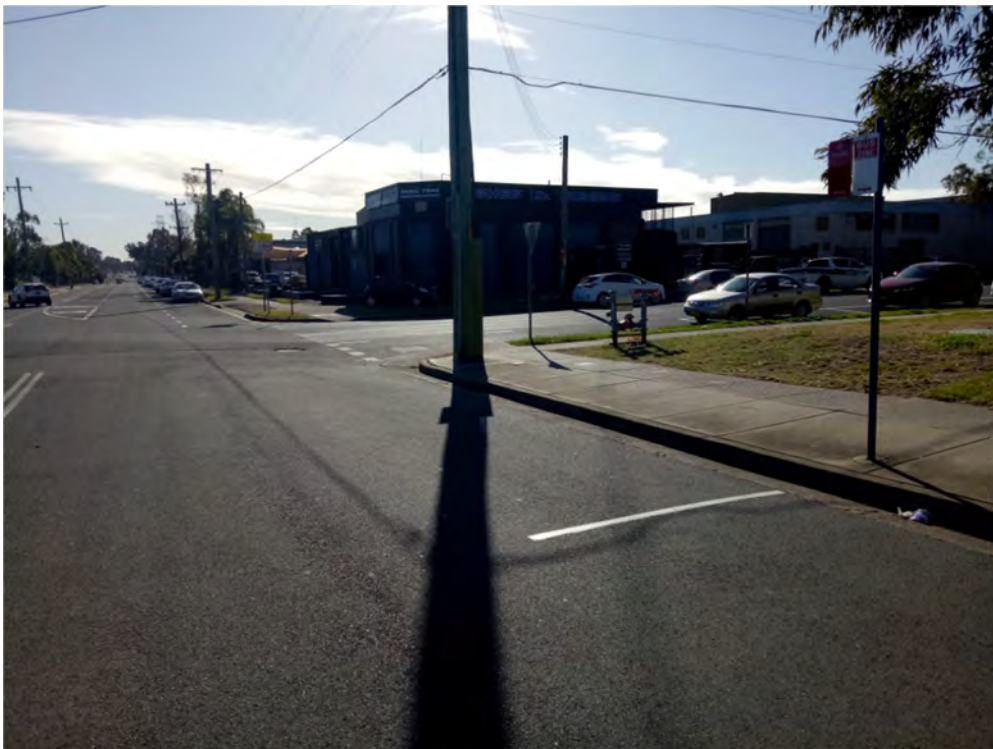
Photo (17): Existing damage in the kerb adjacent to the site

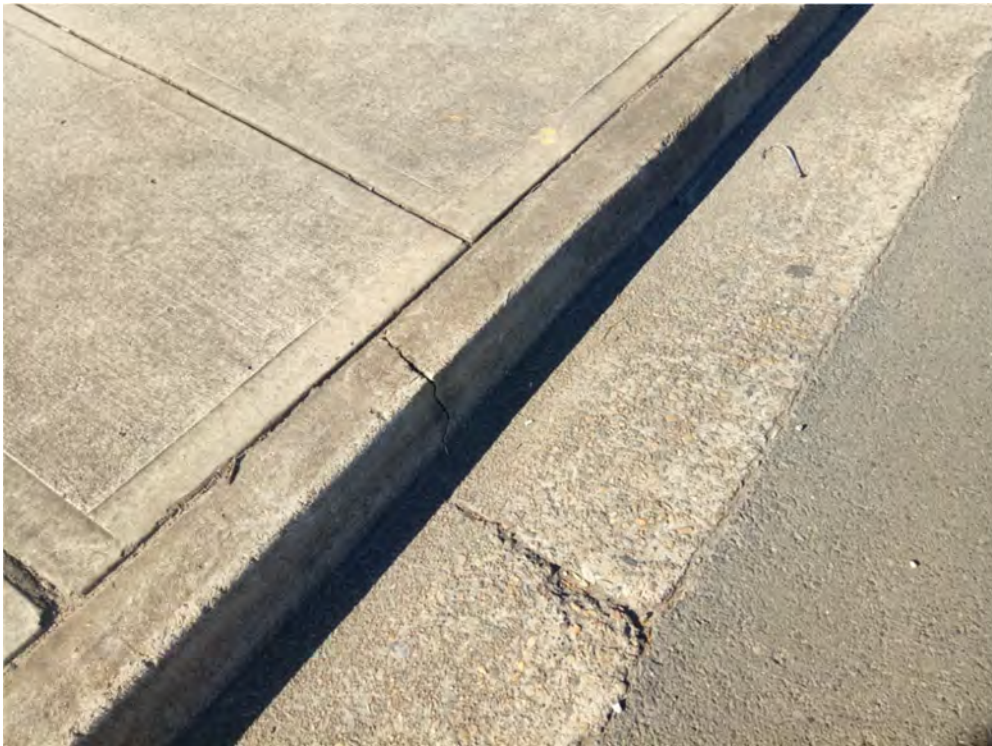
Photo (21): Existing cracks in the kerb & footpath in front of the site entry

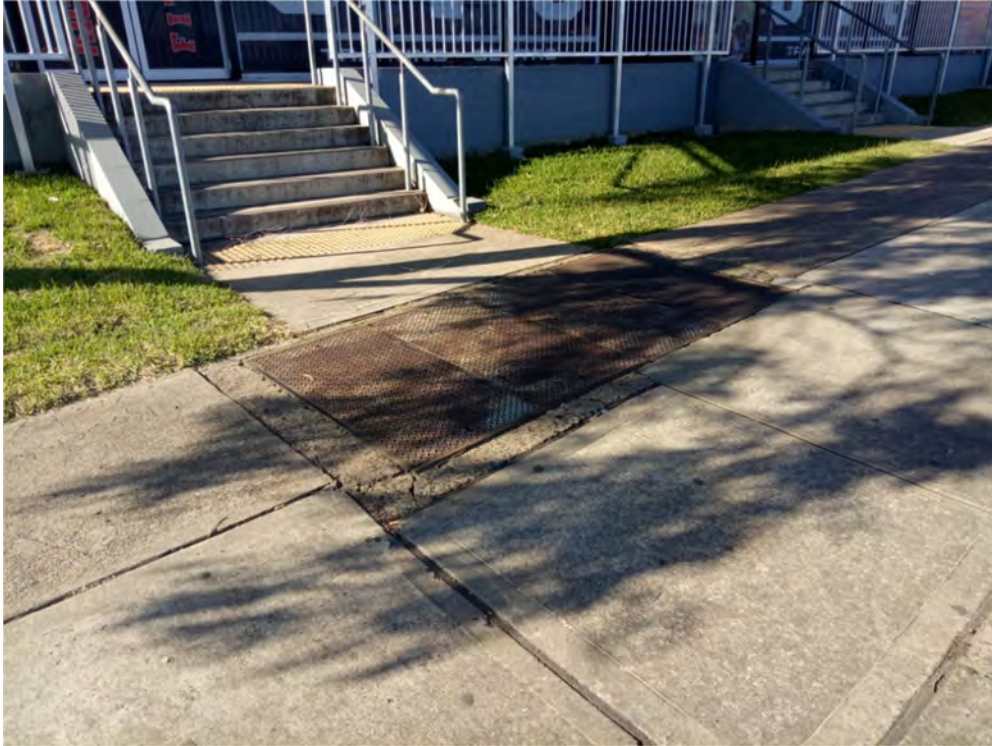
Photo (22): Existing cracks in the kerb & gutter in front of the site entry

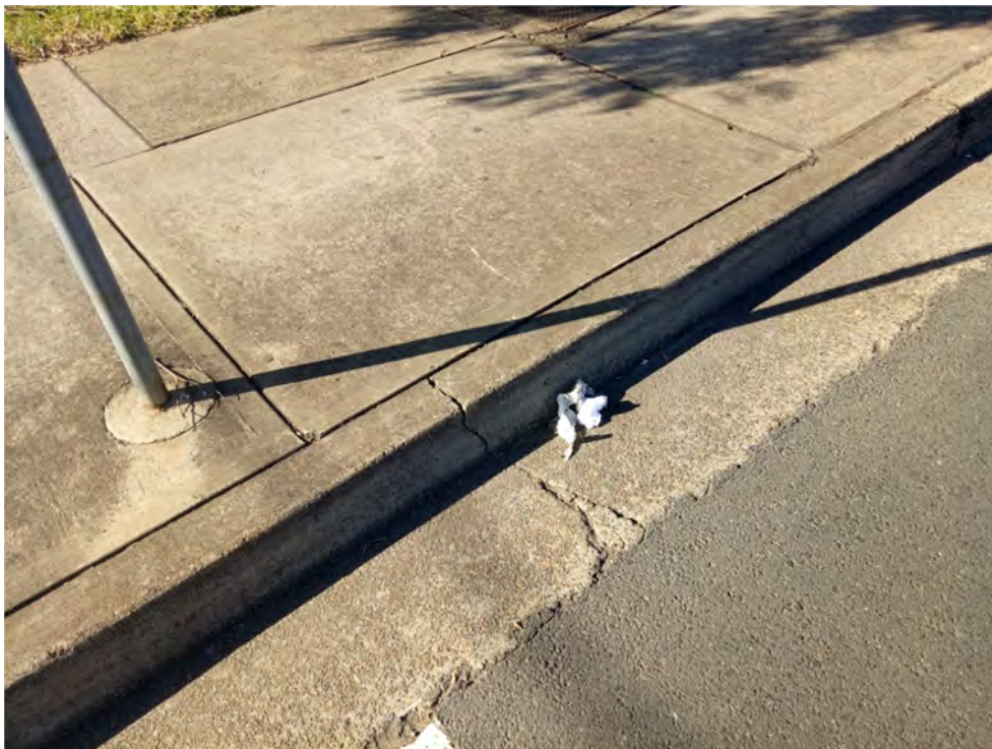
Photo (23): Existing cracks in the kerb & footpath in front of the site entry

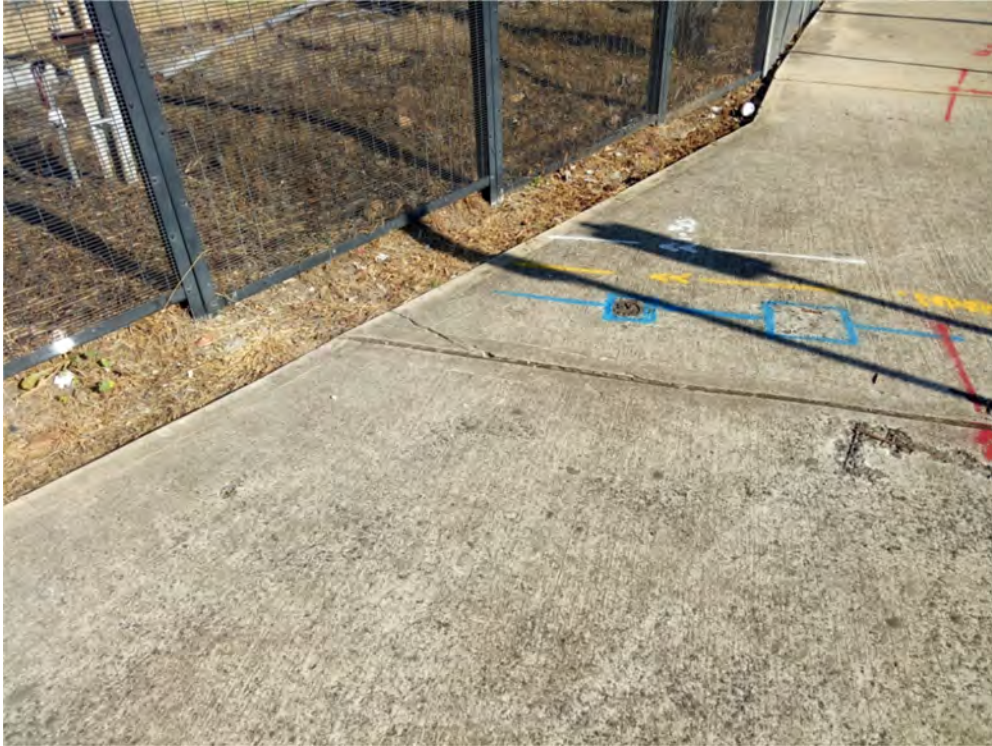
Photo (28): Existing damage in the footpath at the roundabout area

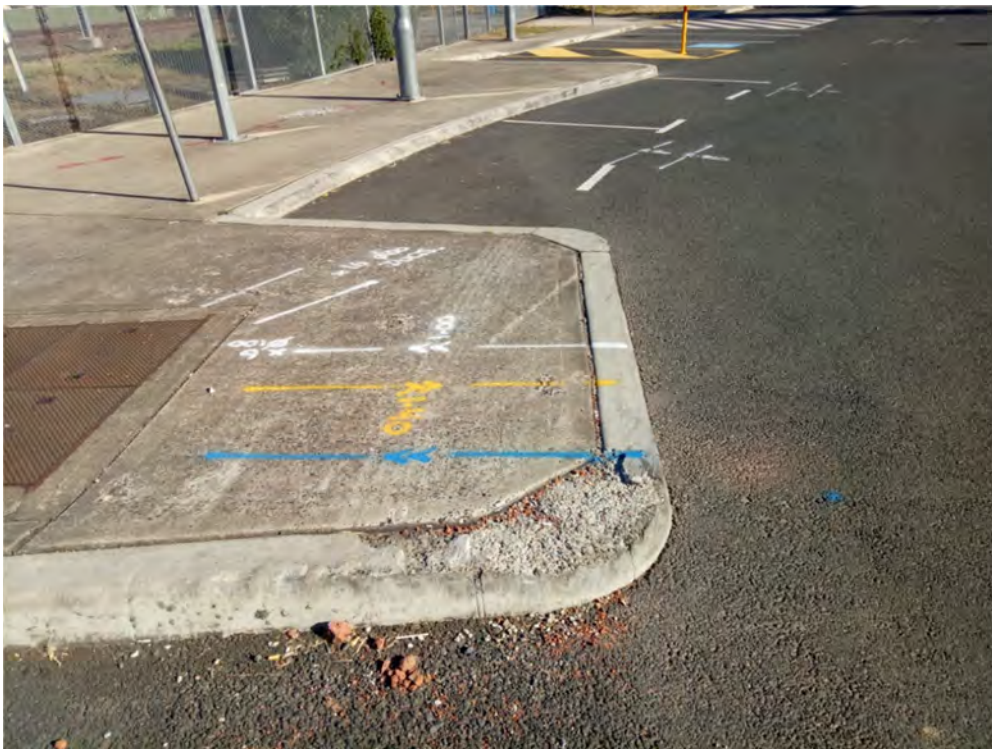
Photo (29): Existing damage in the footpath at the roundabout area

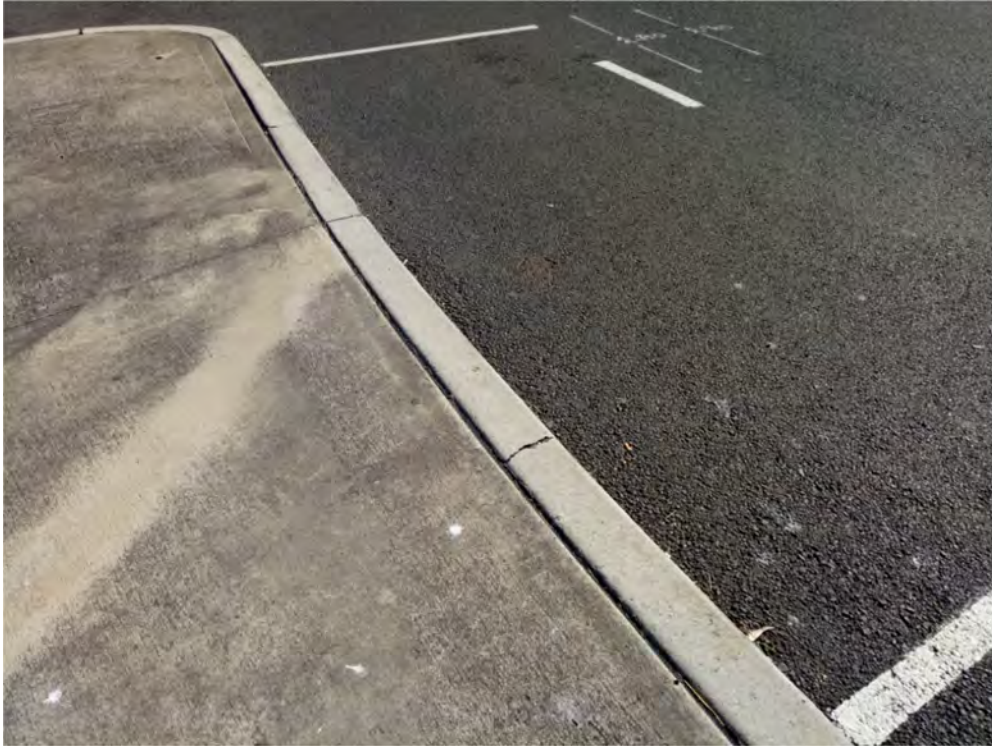
Photo (30): Existing damage in the kerb at the roundabout area

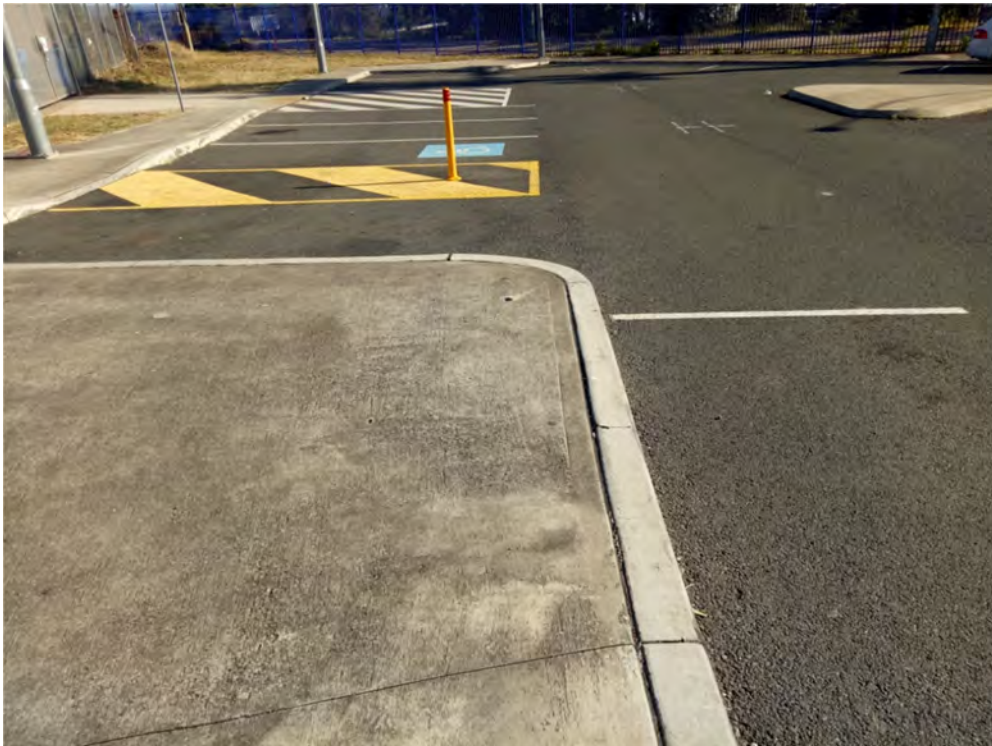
Photo (31): Existing cracks in the kerb at the roundabout area

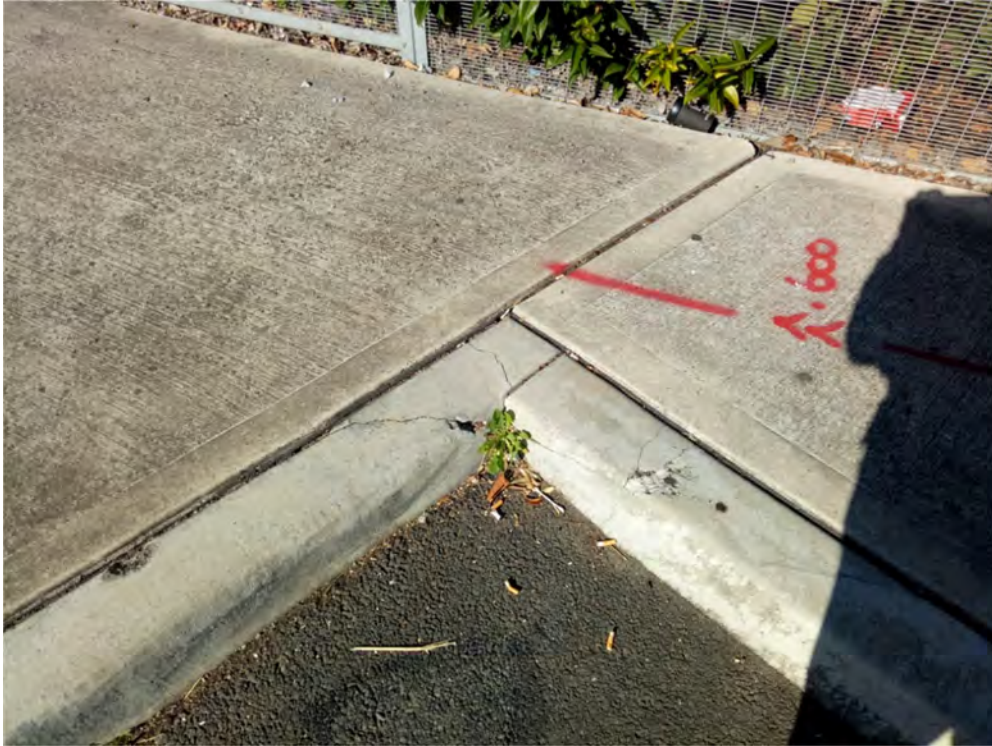
Photo (32): Existing cracks in the kerb at the roundabout area

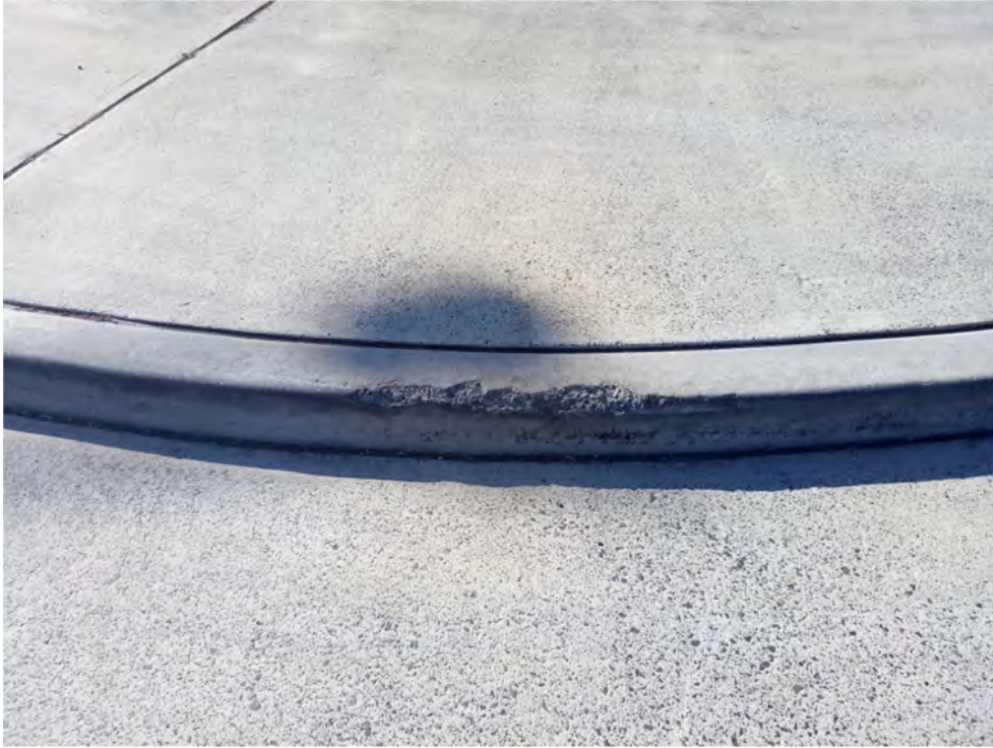
Photo (36): Existing damage in the roundabout

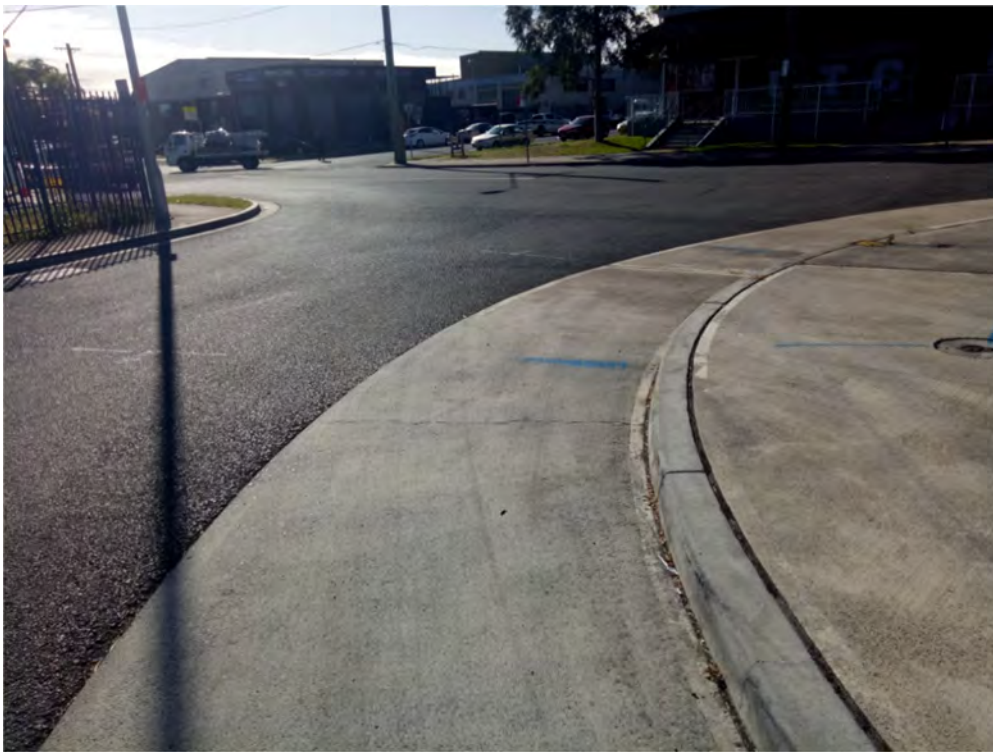
Photo (37): Existing damage in the roundabout

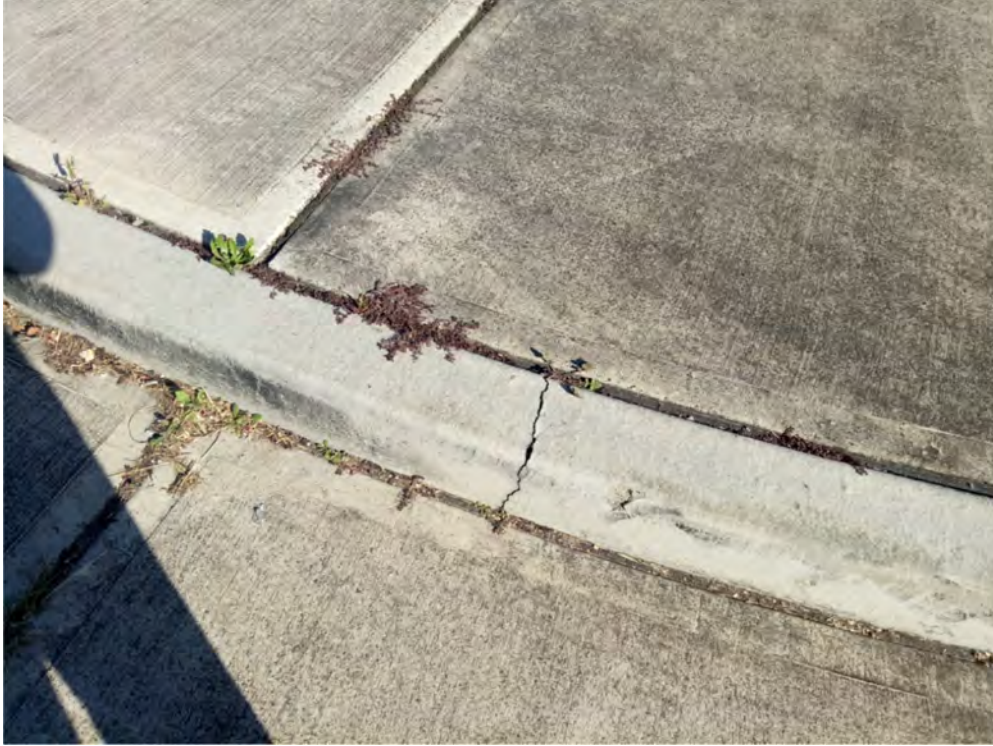
Photo (38): Existing cracks in the roundabout

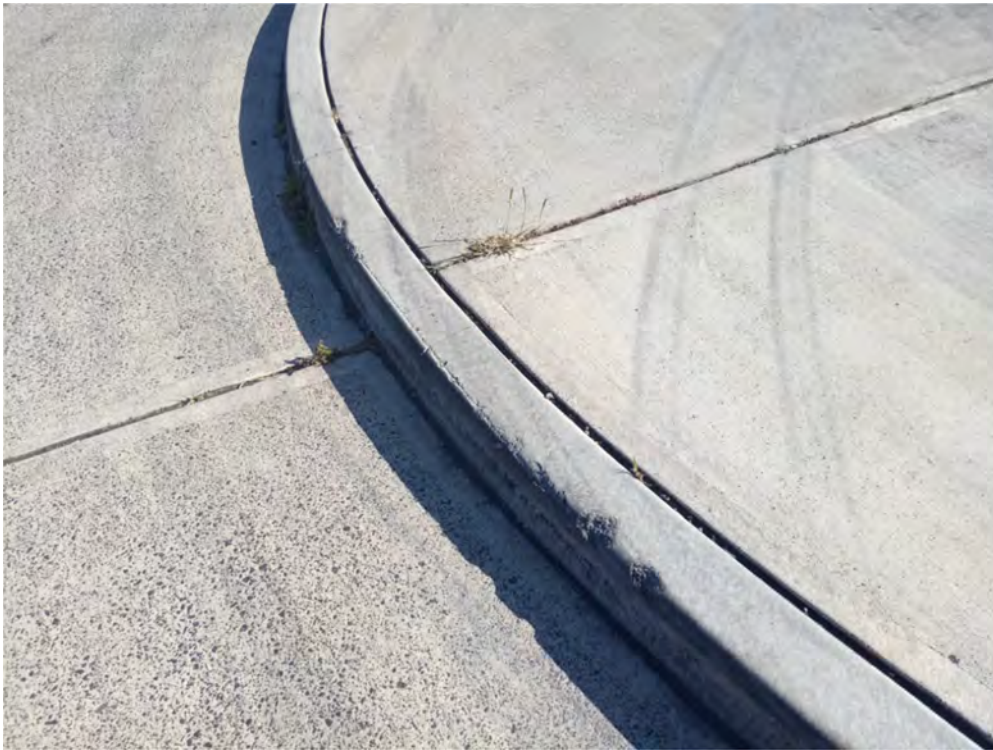
Photo (39): Existing cracks in the roundabout

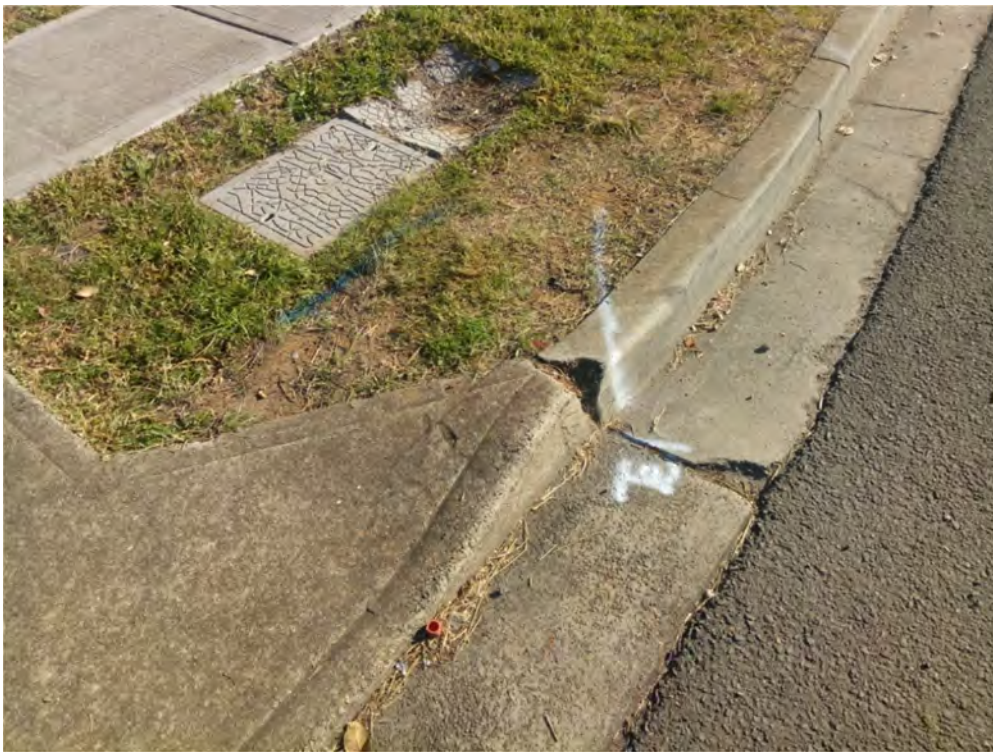
Photo (47): General view for the driveway entry next to the site

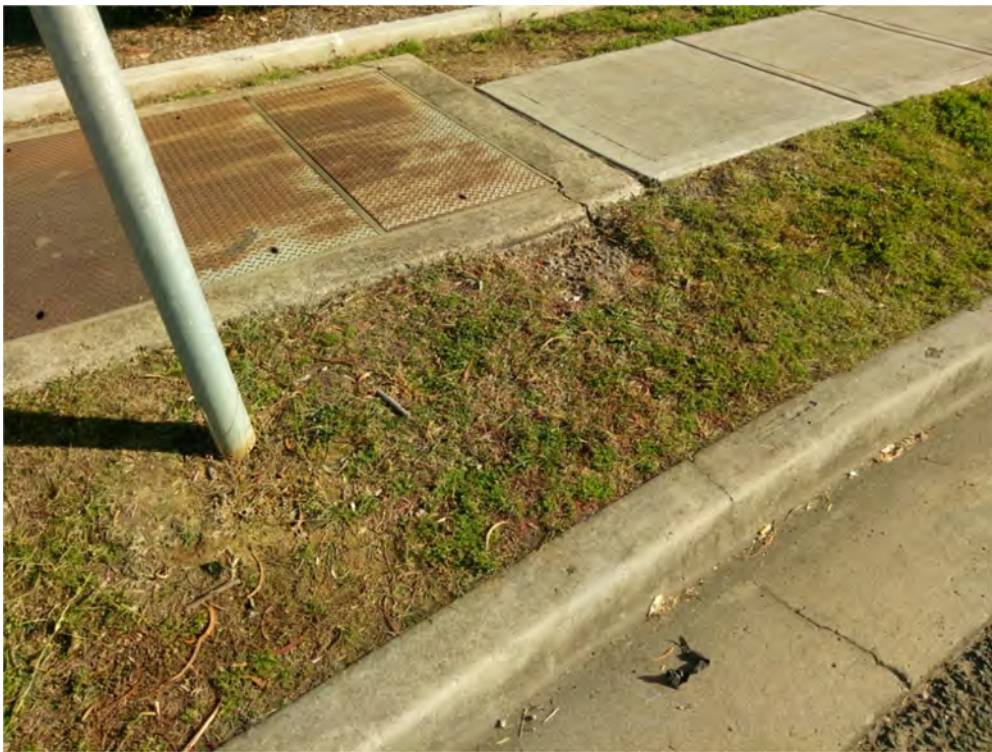
Photo (49): Existing damage/cracks in the kerb & gutter along Forrester road (site same side)

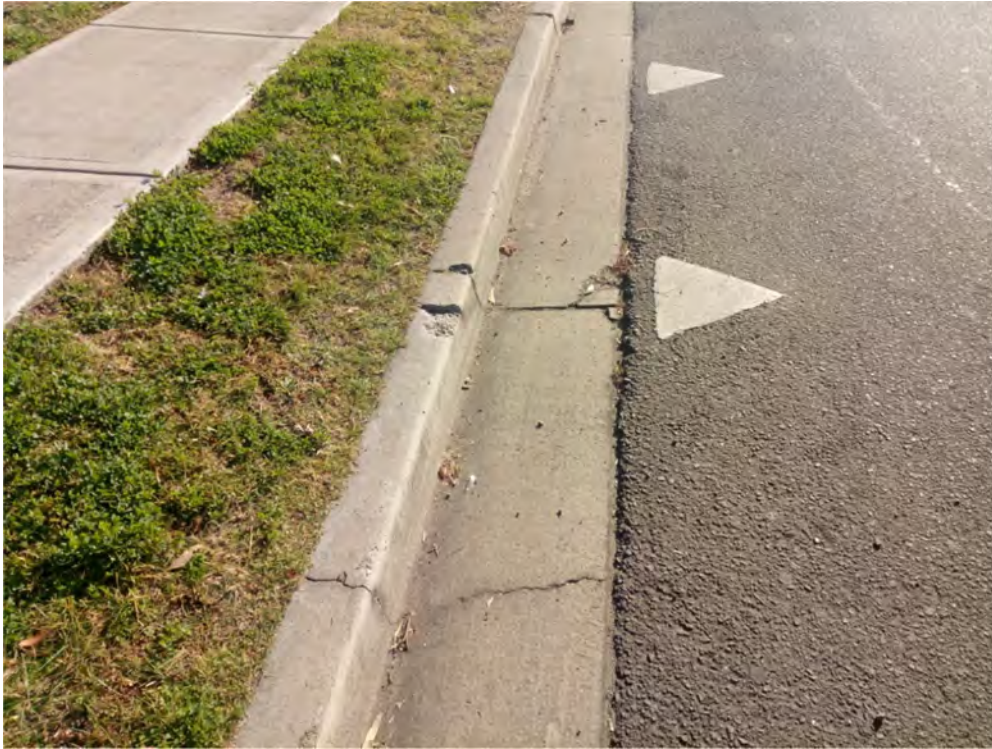
Photo (50): Existing damage/cracks in the kerb & gutter and footpath along Forrester road (site same side)

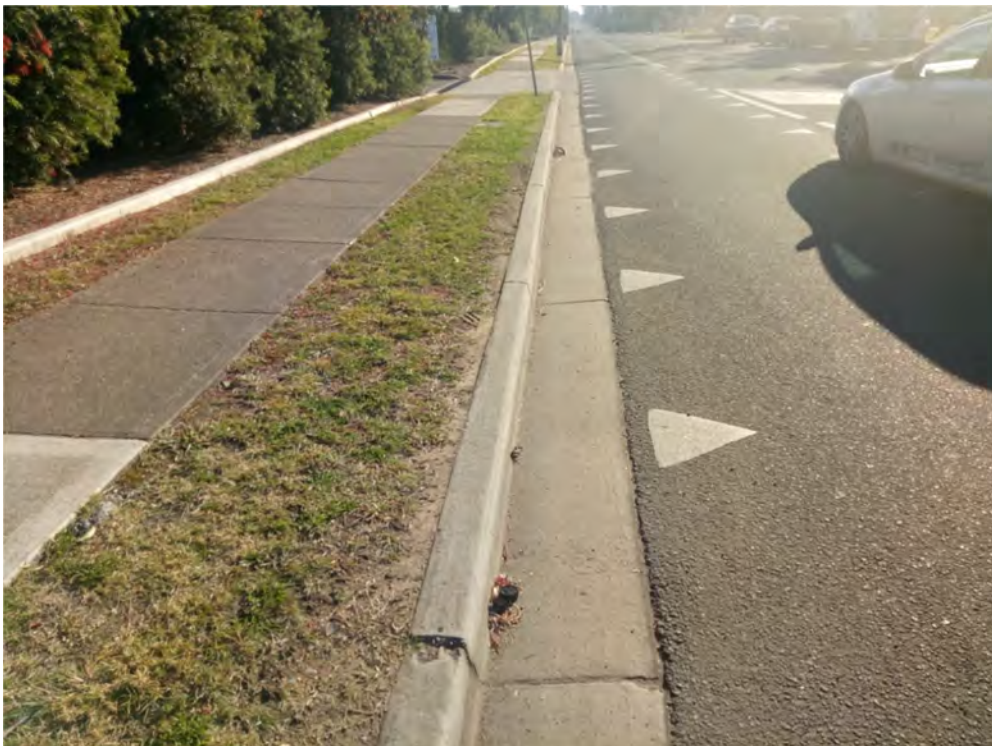
Photo (51): Existing damage/cracks in the kerb & gutter along Forrester road (site same side)

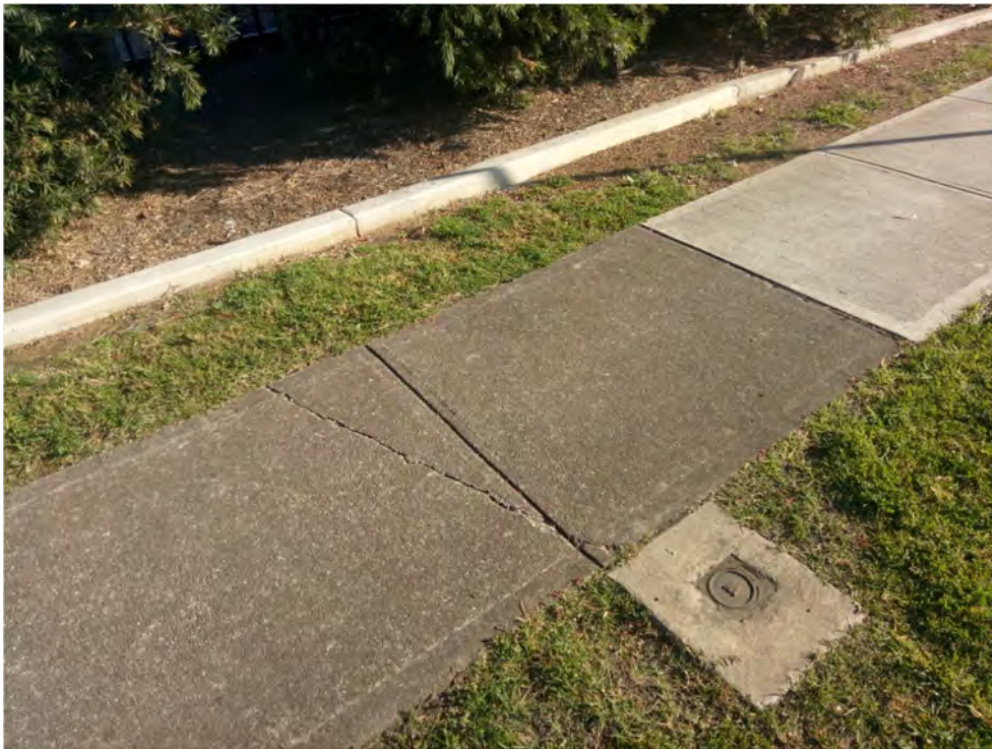
Photo (53): Existing cracks in the footpath along Forrester road (site same side)

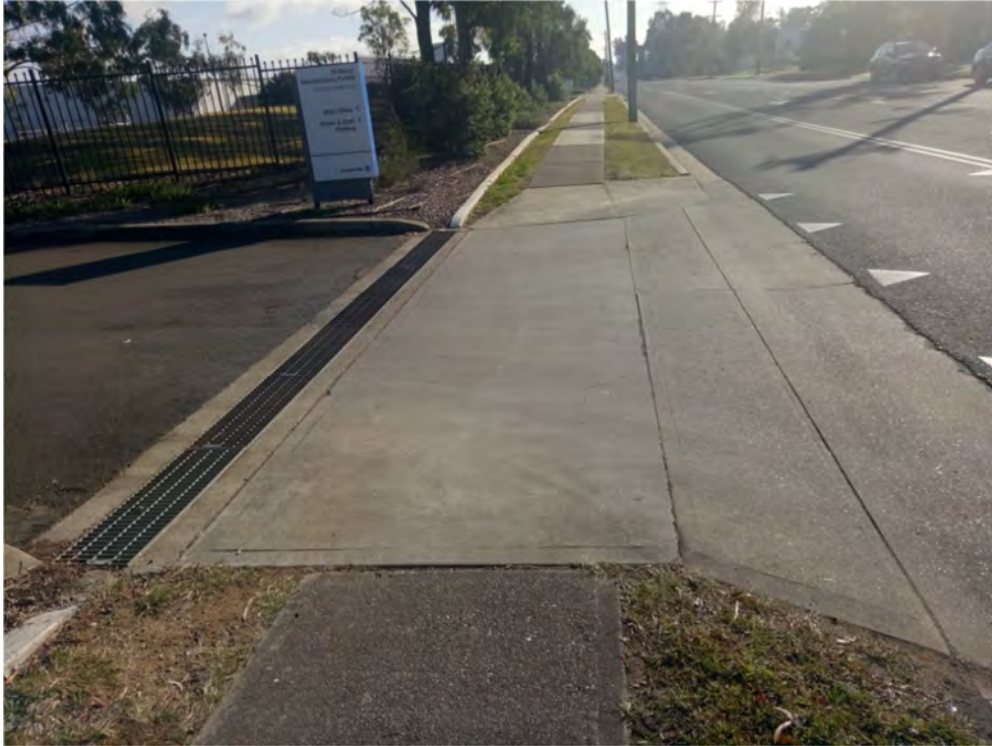
Photo (54): Existing cracks in the footpath along Forrester road (site same side)
