PRE-CONSTRUCTION DILAPIDATION REPORT AND PHOTOGRAPHIC SURVEY

Project Address: Lot 2 Forrester Road St Marys NSW 2760

Property Inspected: Entry Gate, Road & Council assets at 2 Forrester Road St Marys NSW

Date of Inspection: 04th June 2020

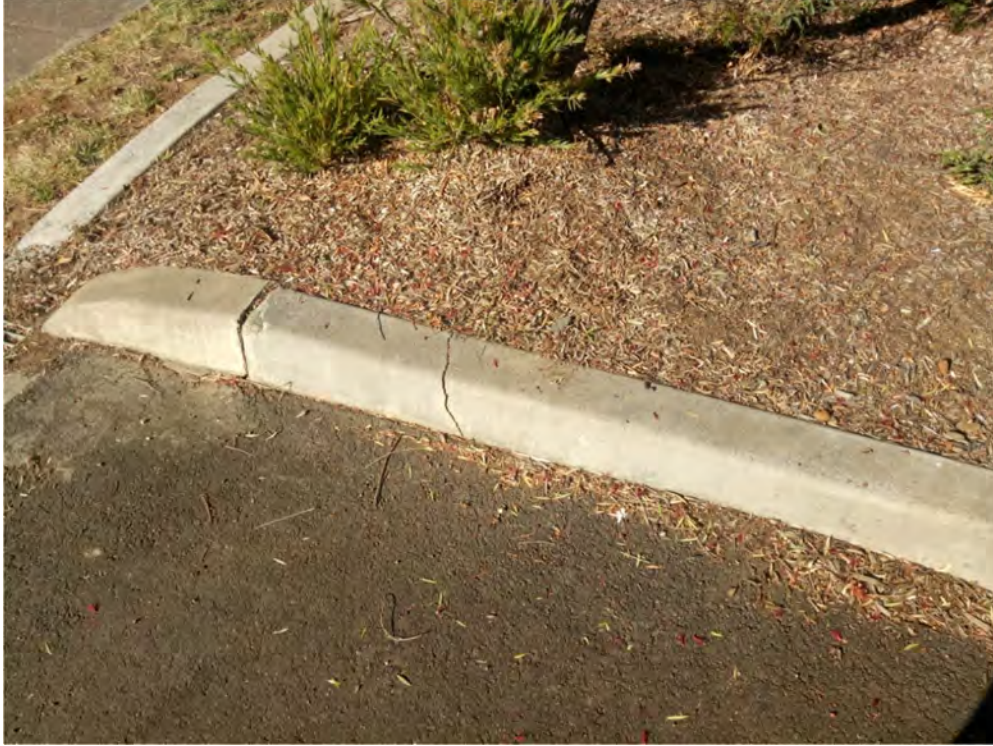
Photo (56): Existing cracks in St Marys manufacturing facilities visitors & staff entry

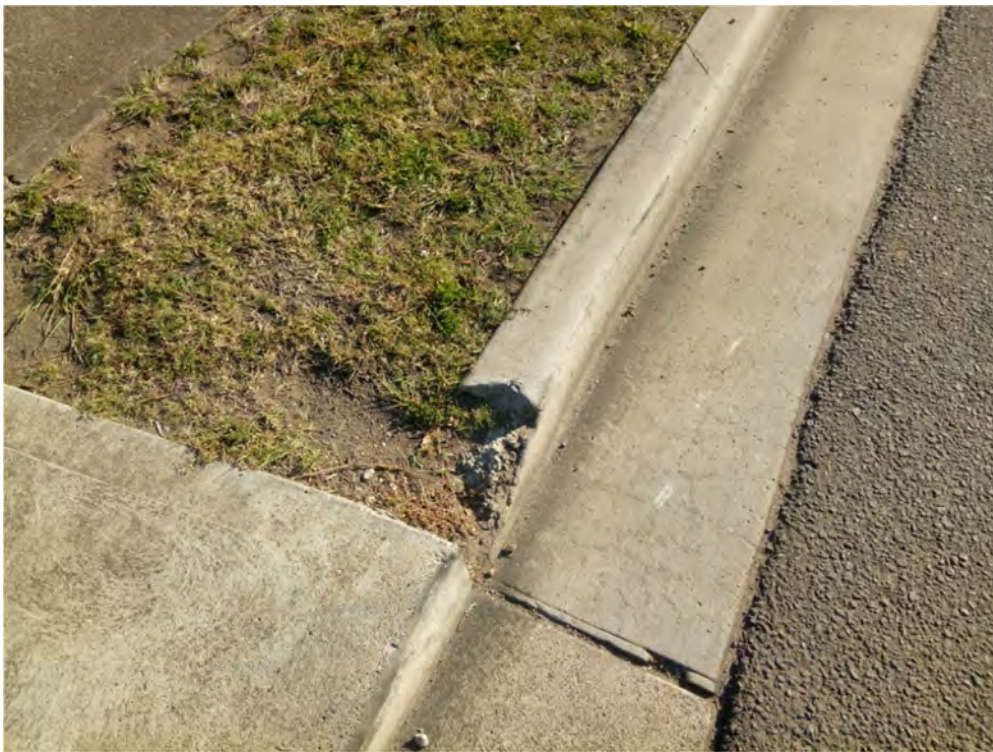
Photo (57): Existing cracks in St Marys manufacturing facilities entry

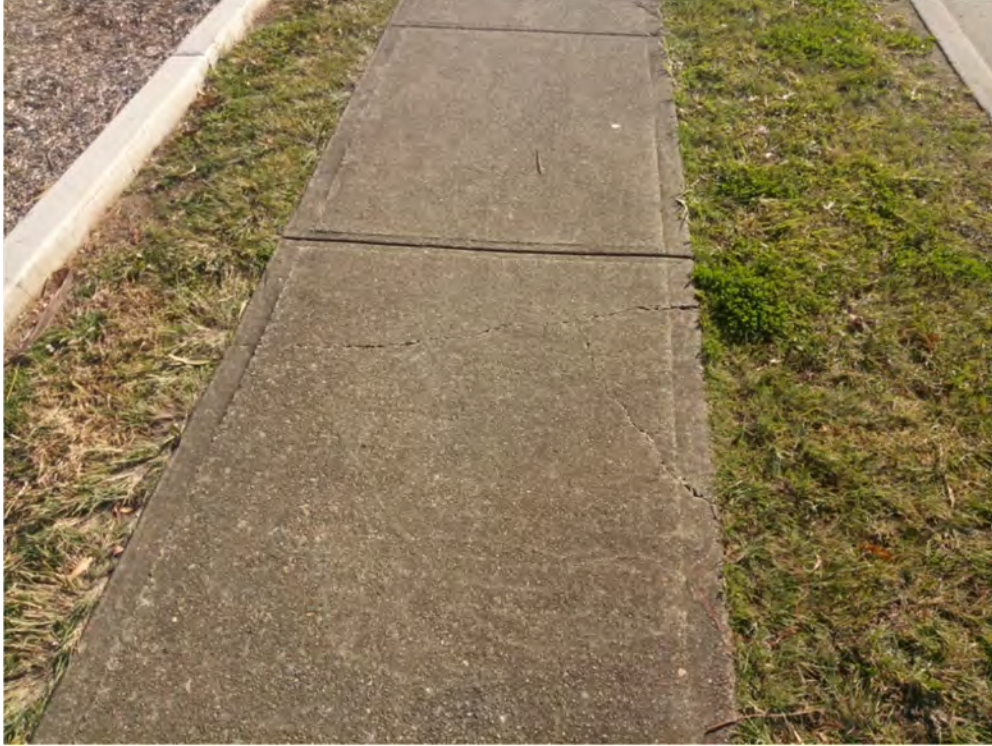
Photo (61): Existing cracks in the pit along Forrester road (site same side)

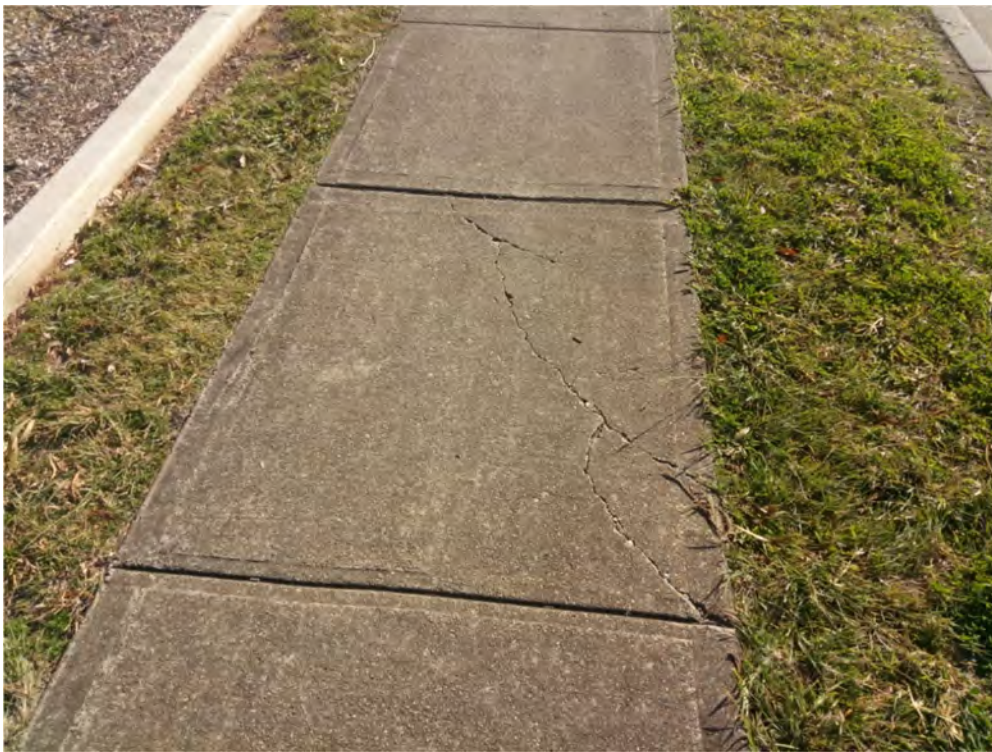
Photo (62): Existing cracks in footpath along Forrester road (site same side)

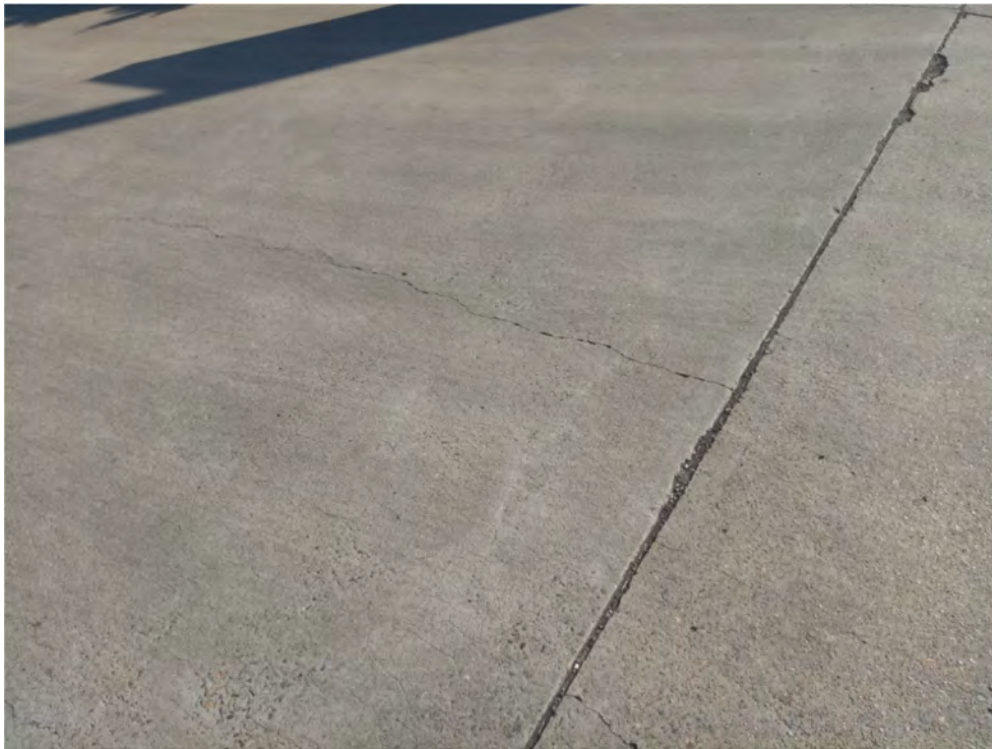
Photo (66): General view for St Marys manufacturing facilities trucks entry

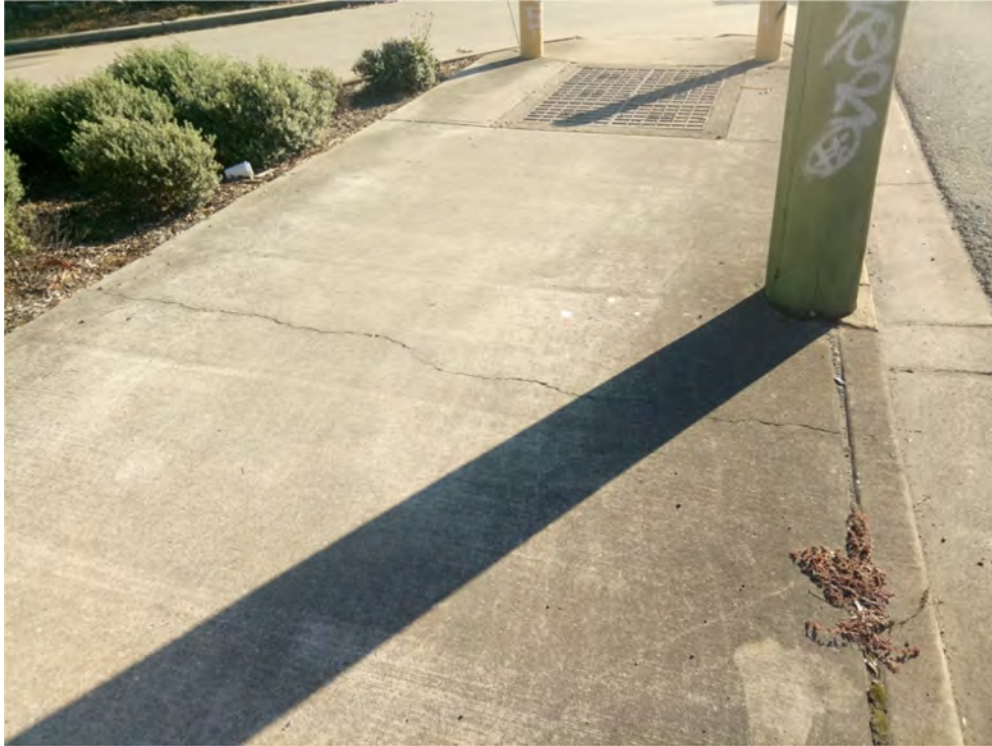
Photo (67): Existing damage/cracks at St Marys manufacturing facilities trucks entry

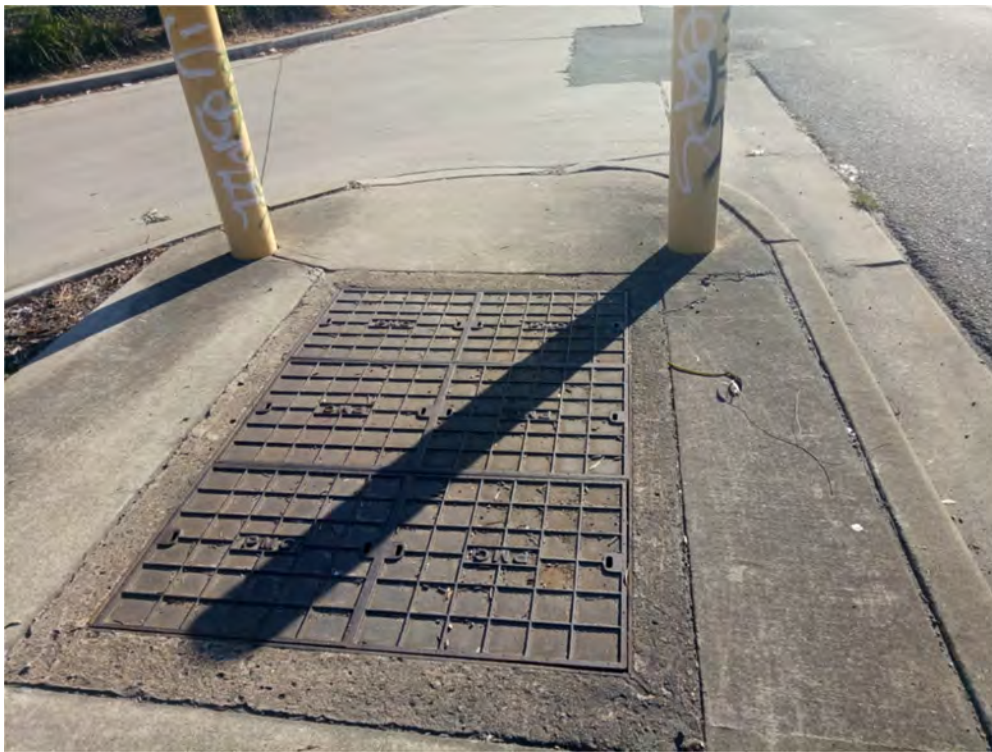
Photo (68): Existing cracks in footpath along Forrester road (site same side)

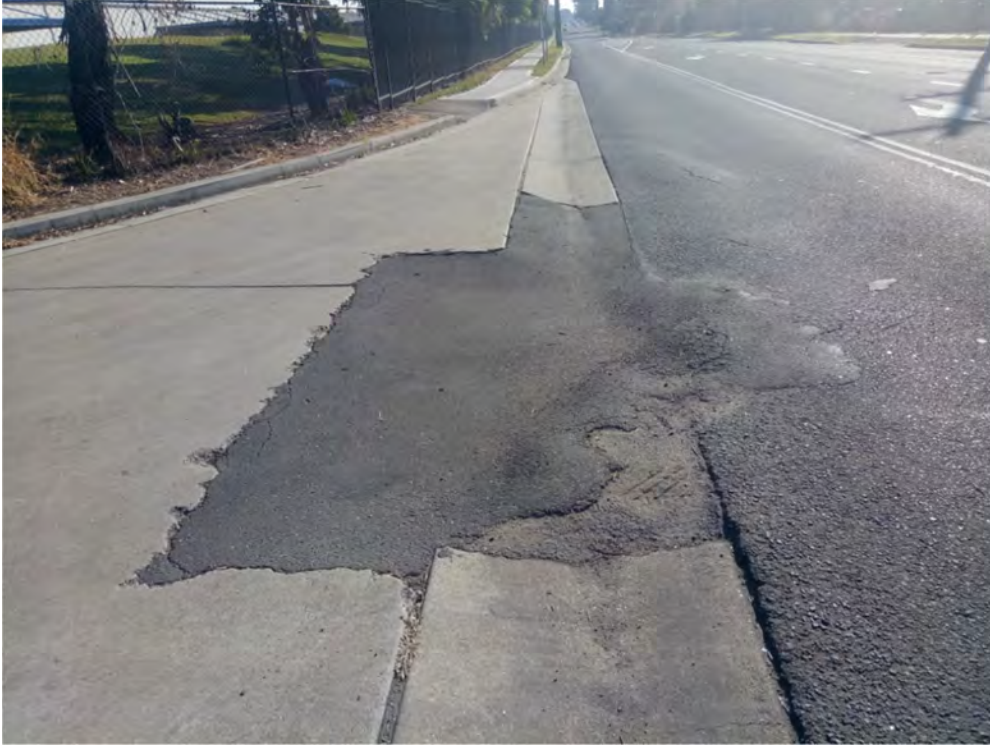
Photo (69): Existing cracks in footpath along Forrester road (site same side)

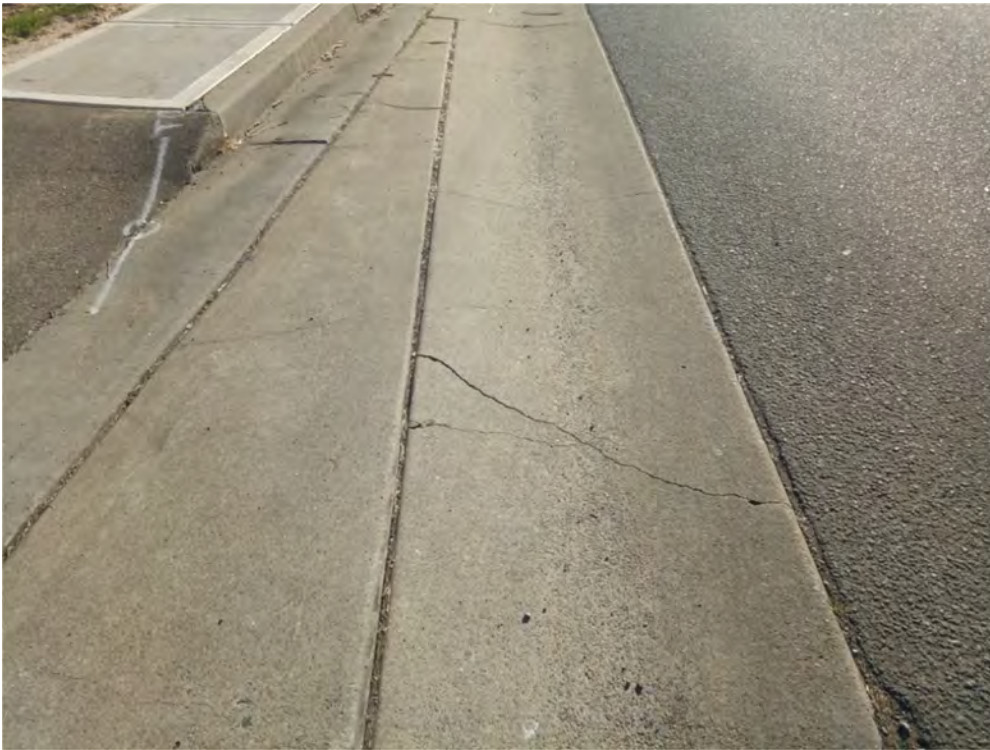
Photo (70): Existing damage in the road and entry along Forrester road (site same side)

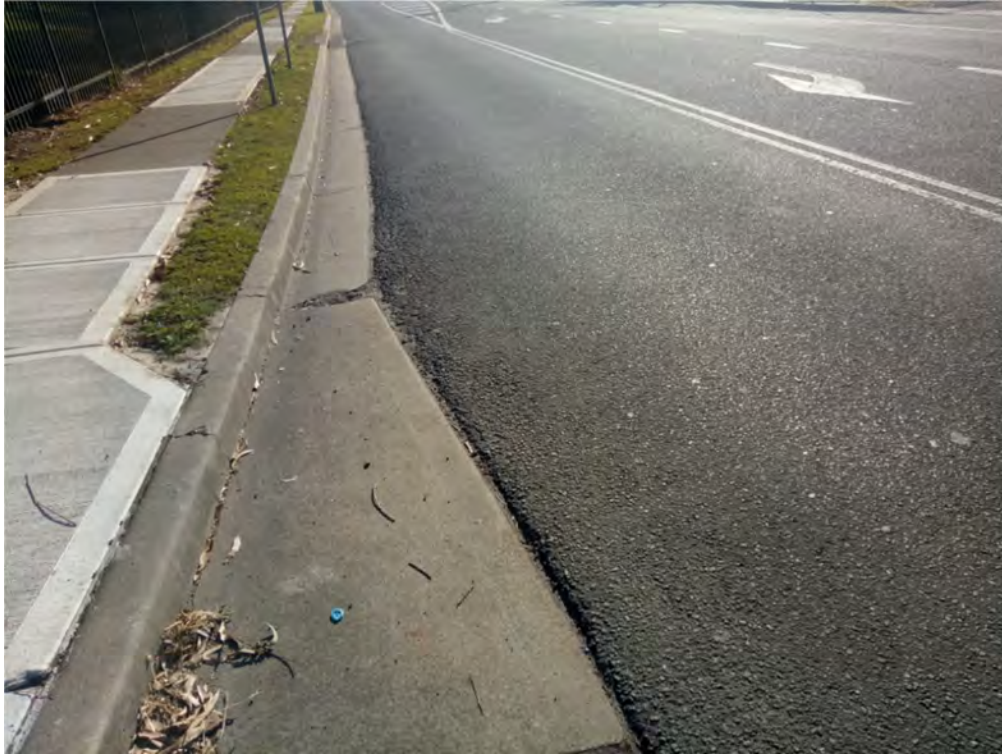
Photo (71): Existing cracks in the gutter along Forrester road (site same side)

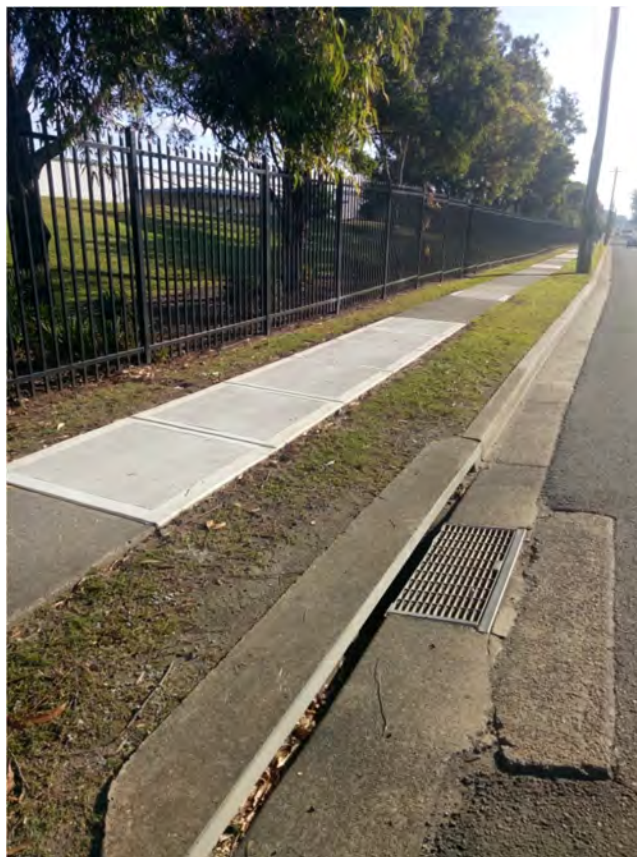
Photo (72): Existing damage/cracks in the kerb & gutter along Forrester road (site same side)

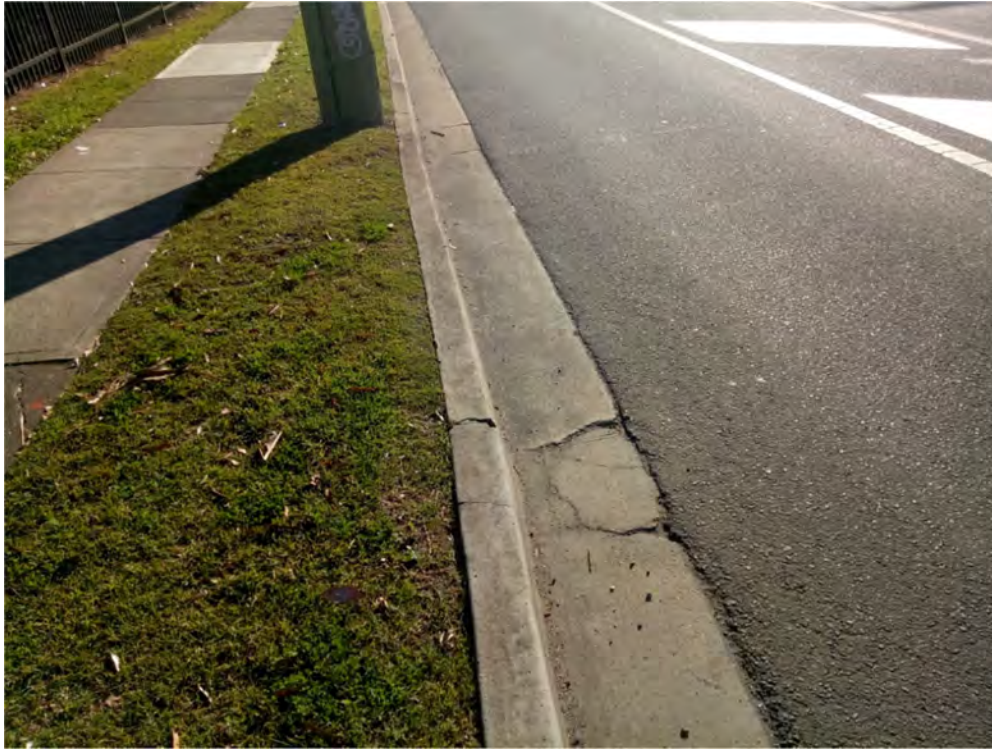
Photo (73): Existing damage/cracks in the kerb & gutter along Forrester road (site same side)

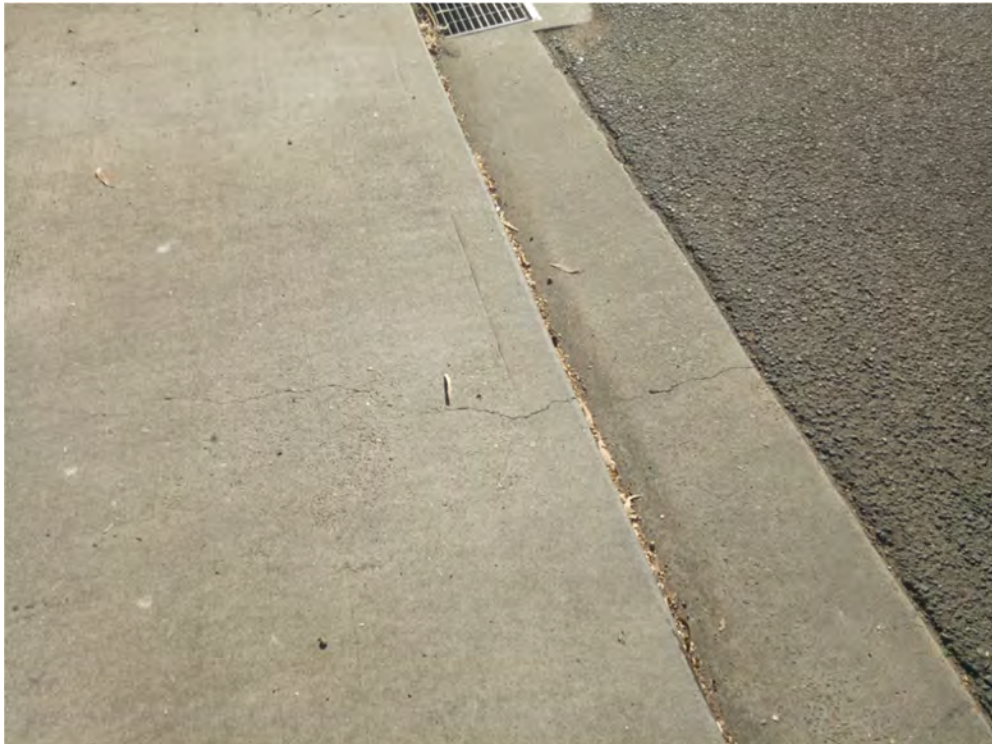
Photo (80): Existing damage in the kerb & gutter at Stockland entry along Forrester road (site same side)

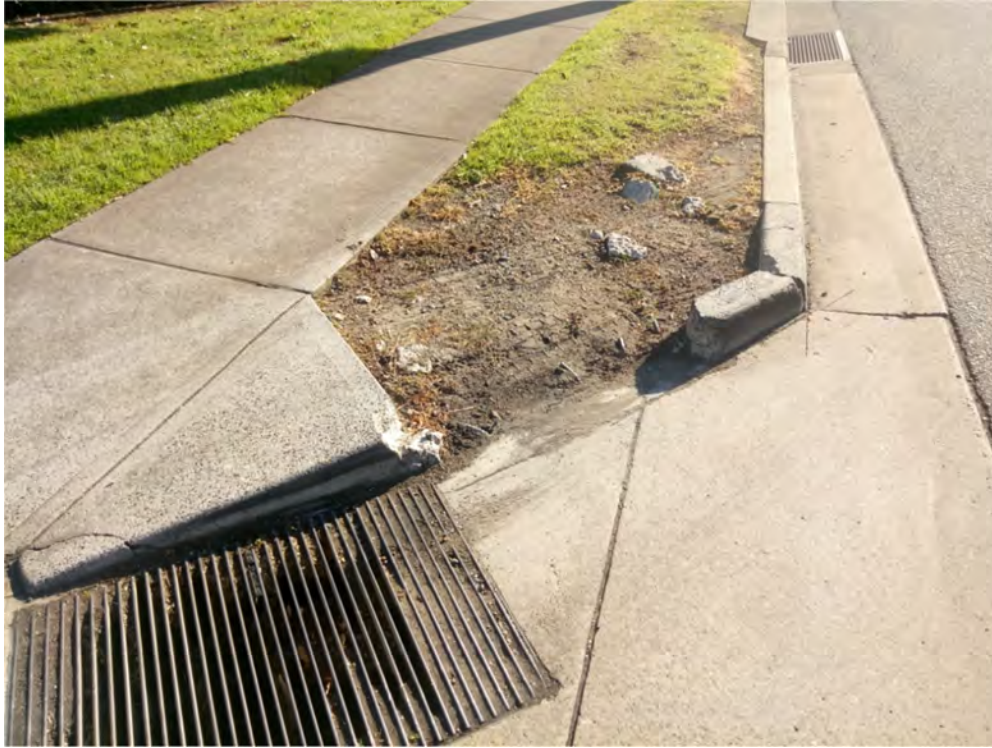
Photo (81): Existing cracks in Stockland entry driveway along Forrester road (site same side)

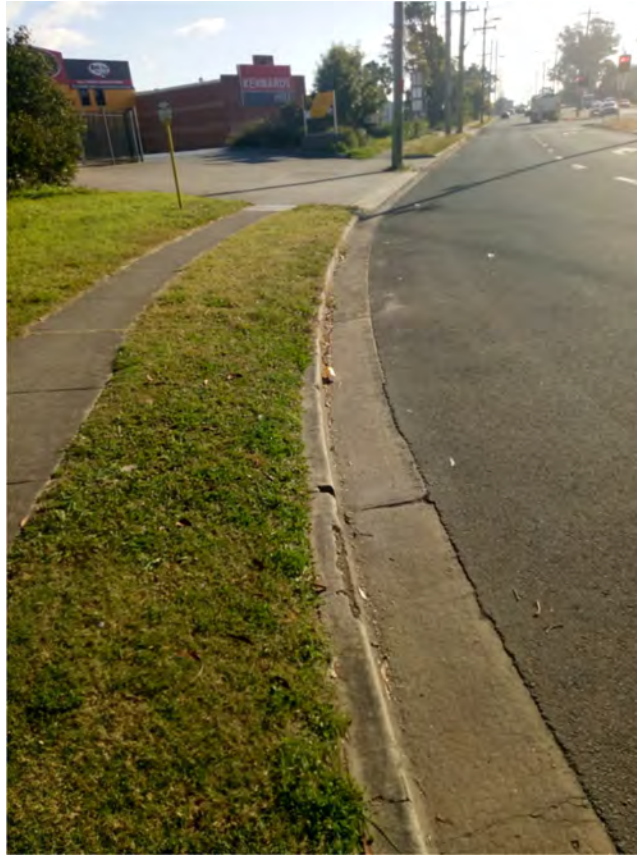
Photo (83): Existing damage in Forrester road

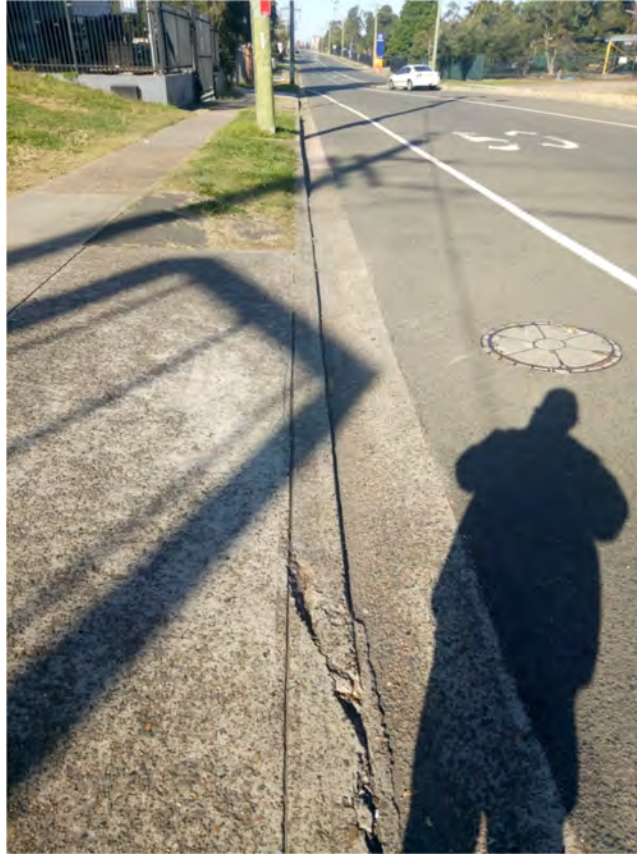
Photo (84): Existing damage in the kerb & gutter along Forrester road (site same side)

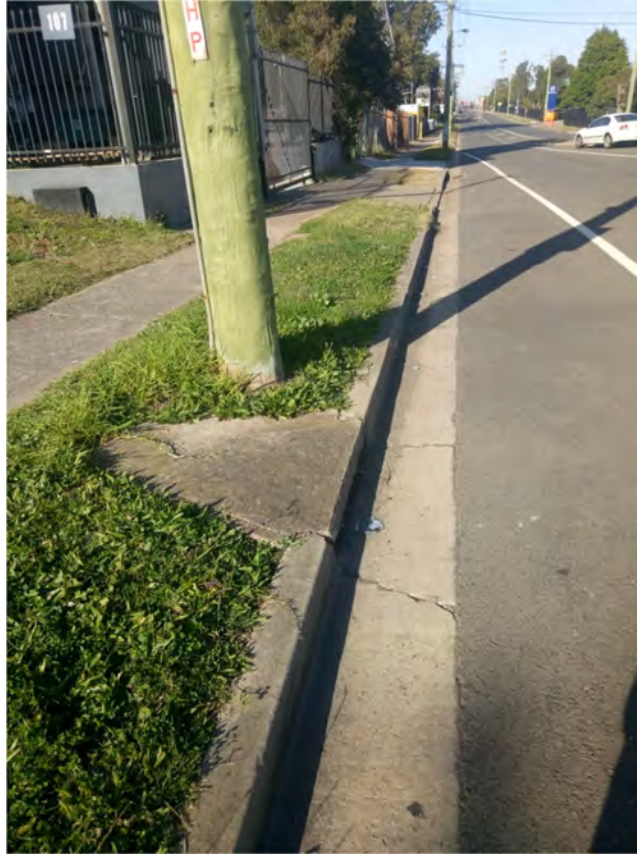
Photo (85): Existing damage in the kerb & gutter along Forrester road (site opposite side)

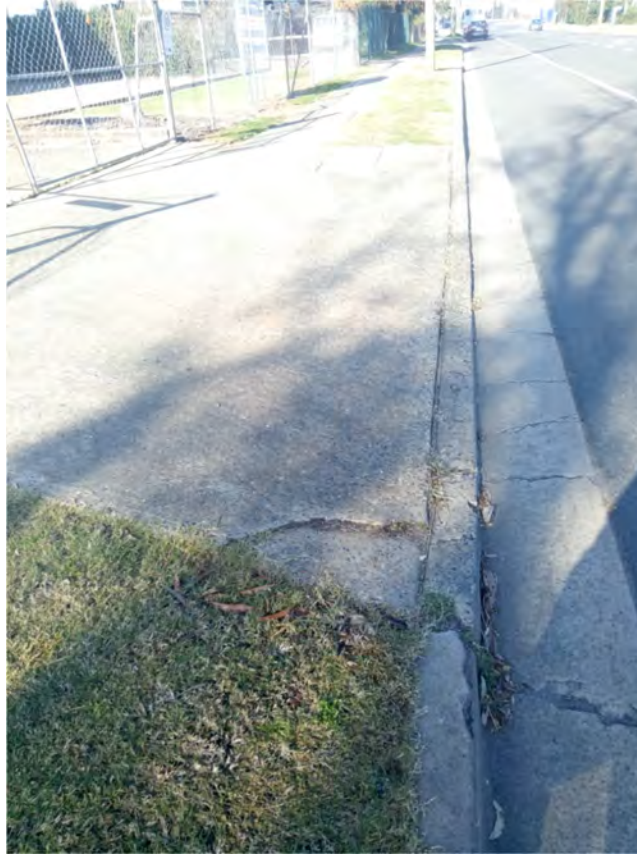
Photo (91): Existing damage in the kerb & gutter along Forrester road (site opposite side)
