# **PRE-CONSTRUCTION DILAPIDATION REPORT AND PHOTOGRAPHIC SURVEY**

**Project Address:** Lot 2 Forrester Road St Marys NSW 2760

**Property Inspected:** Entry Gate for St Marys Site, Road & Council assets  
at Lee Holm Road St Marys NSW

**Document Number:** 20-134\_06

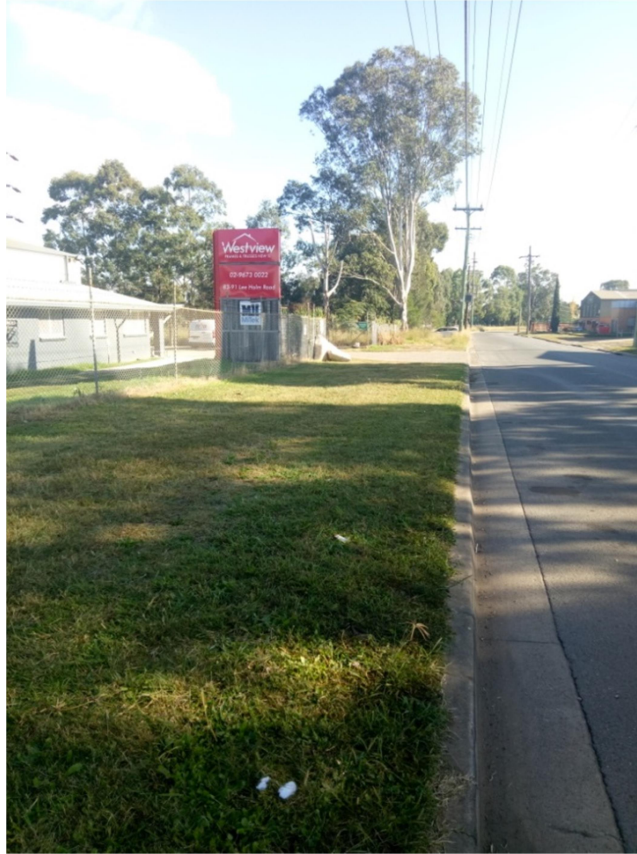
Photo (1): General view for Lee Holm Road

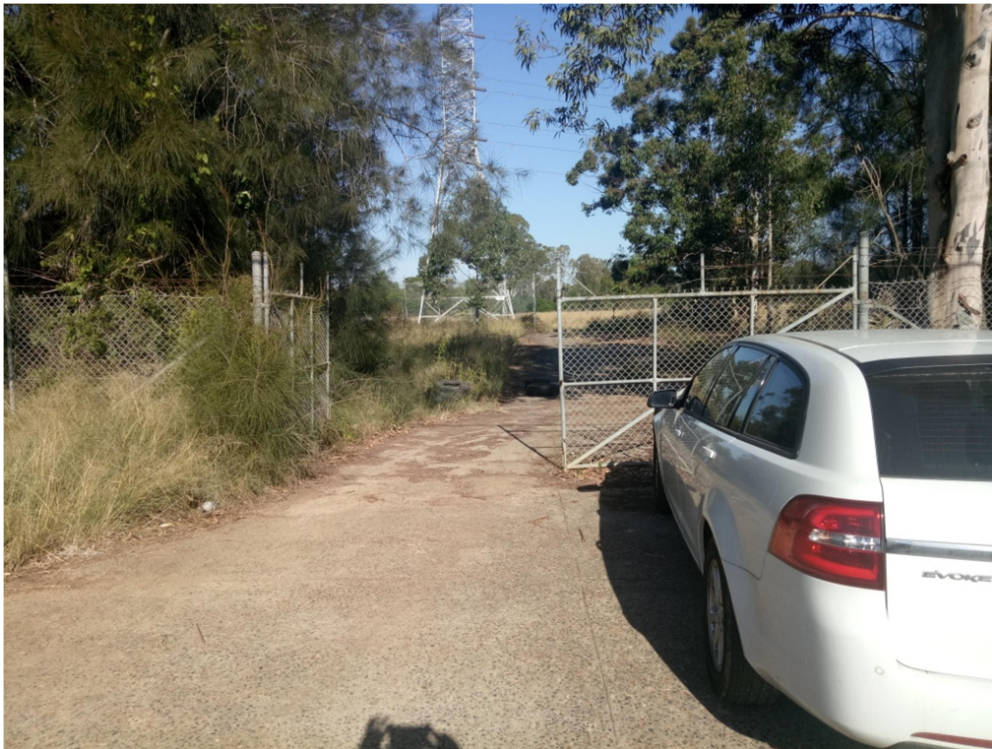
Photo (2): General view for site entry from Lee Holm Road

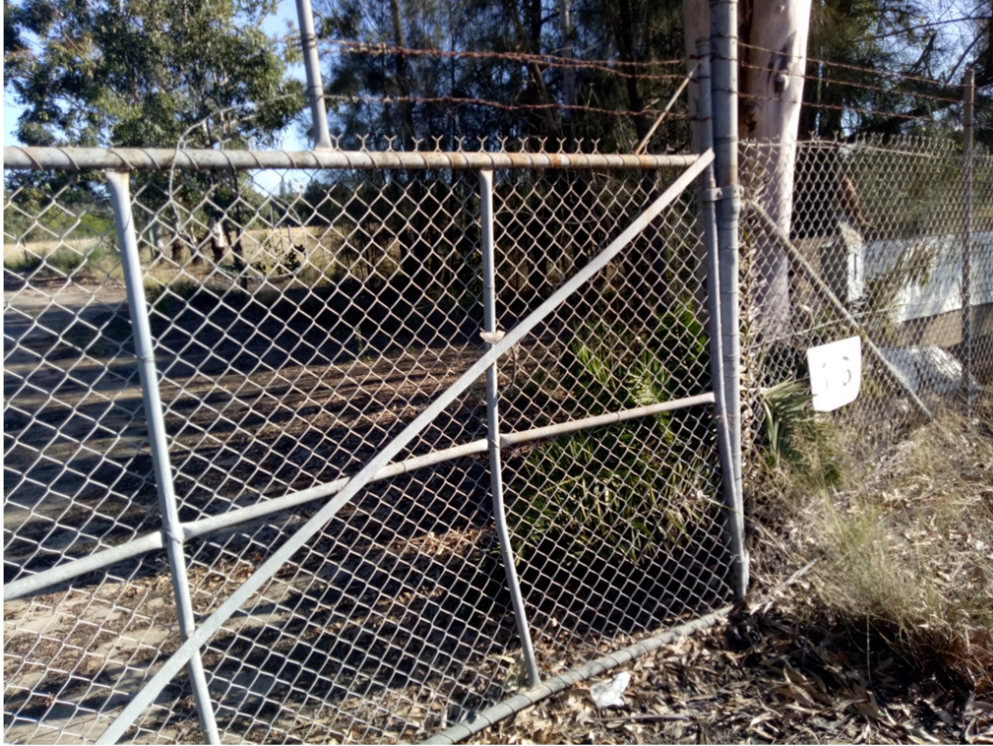
Photo (3): Existing damage in entry gate from Lee Holm Road

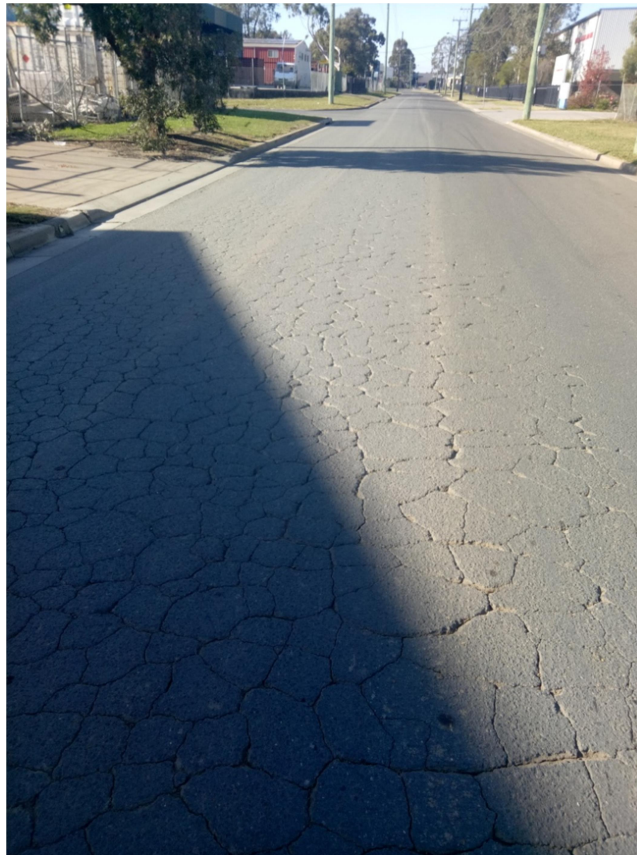
Photo (4): Existing road cracks along Lee Holm Road

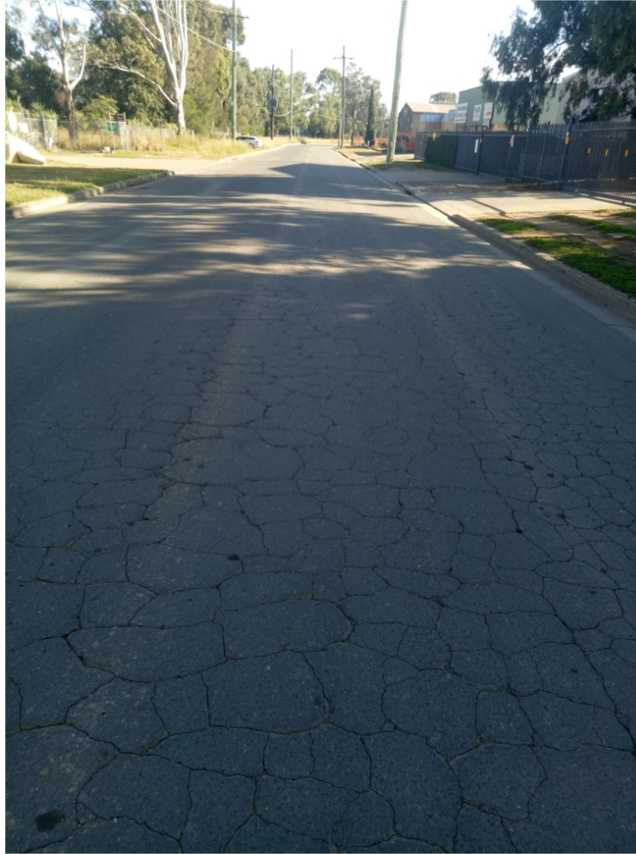
Photo (5): Existing road cracks along Lee Holm Road

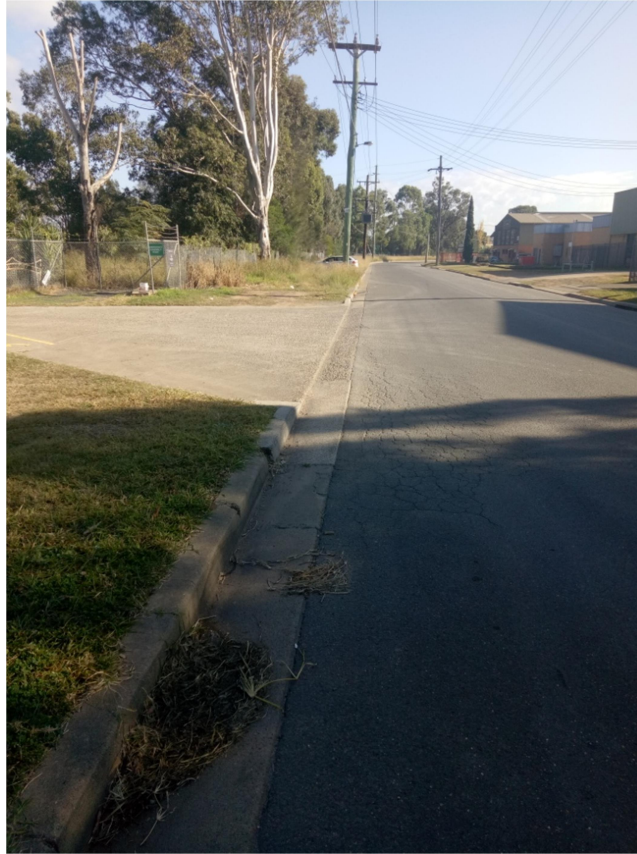
Photo (6): Existing crack/damage in the kerb & gutter along Lee Holm Road (site same side)

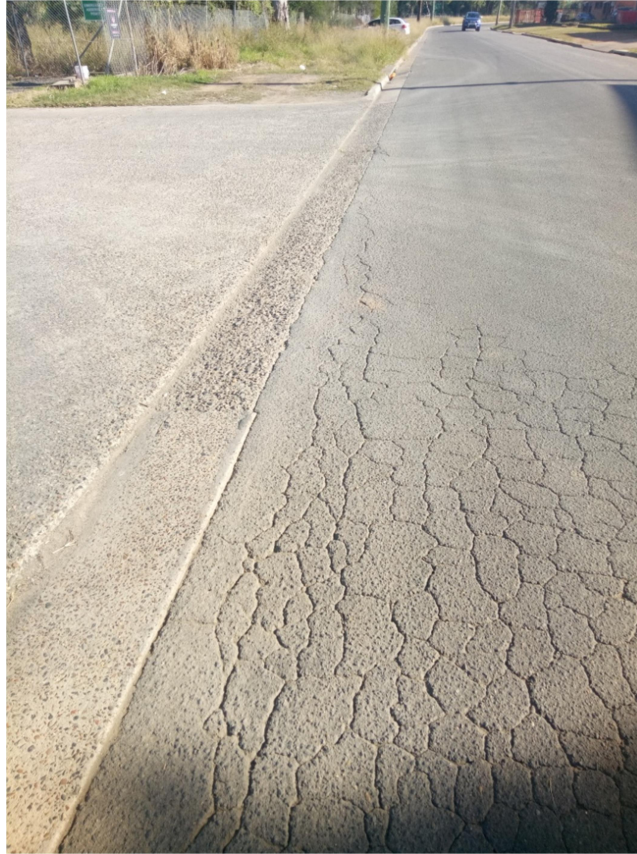
Photo (7): Existing road cracks along Lee Holm Road

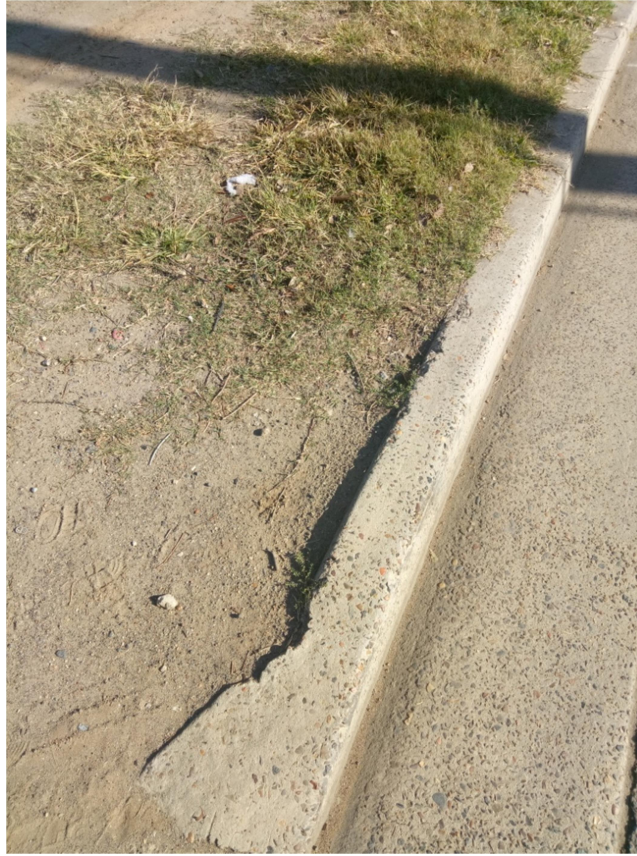
Photo (8): Existing damage in the kerb along Lee Holm Road (site same side)

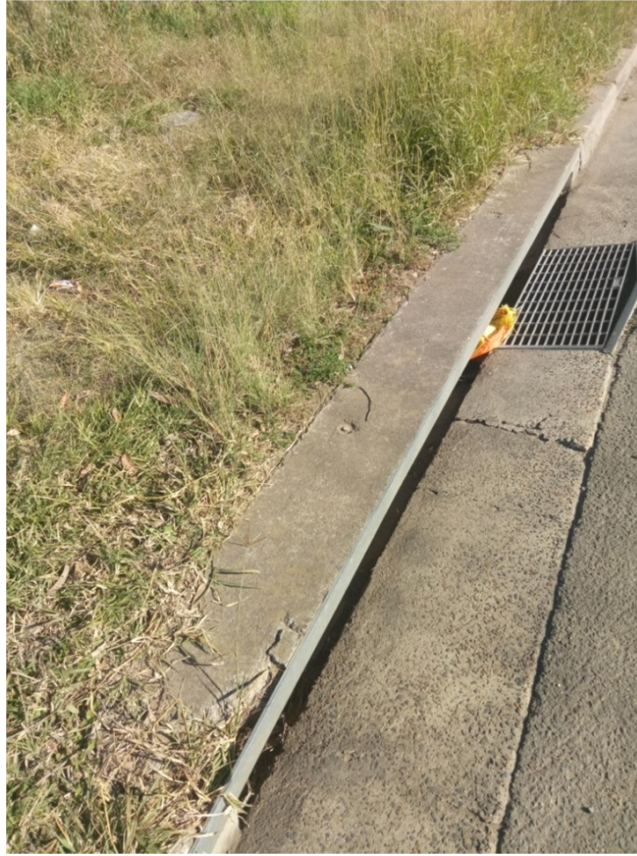
Photo (9): Existing damage in the kerb & gutter along Lee Holm Road (site same side)

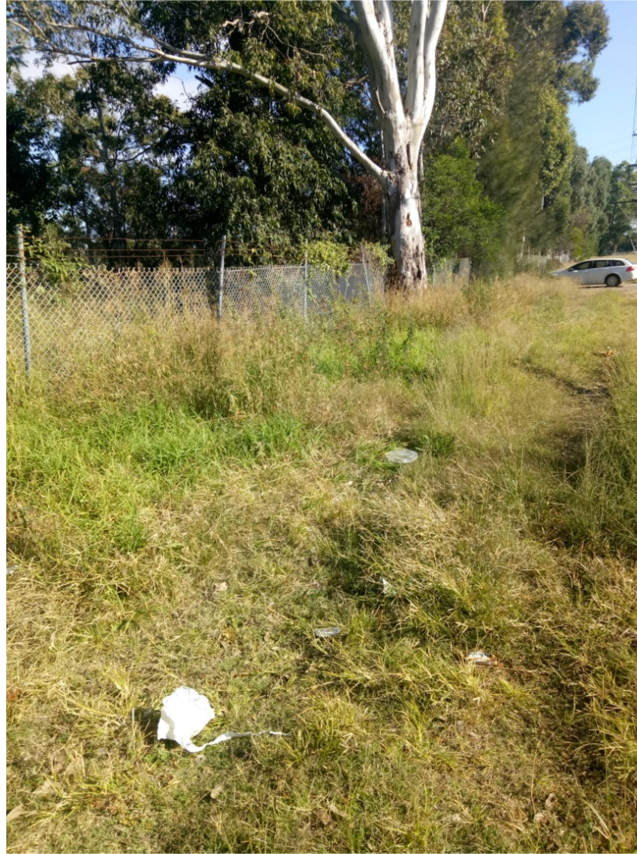
Photo (10): Existing damage in the wire fence along Lee Hom Road (site same side)

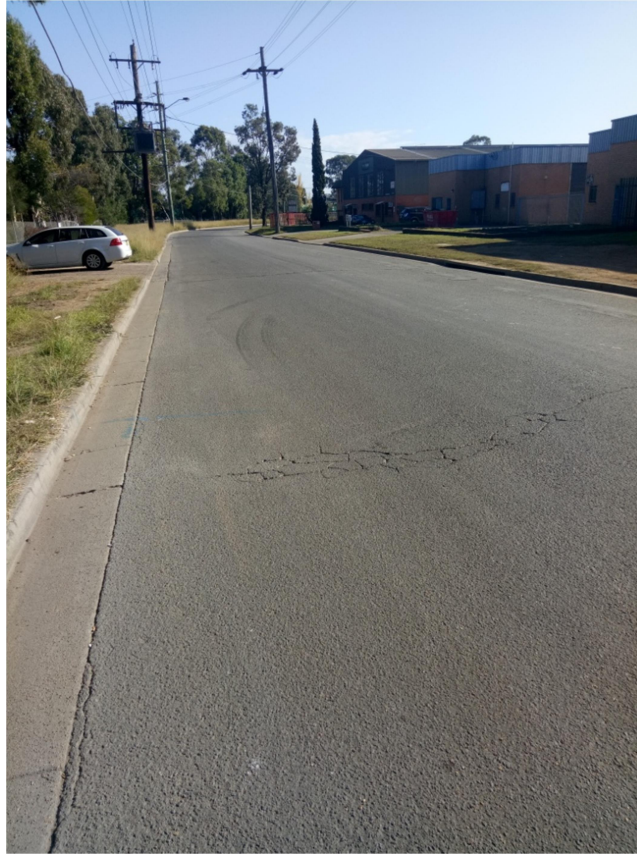
Photo (11): Existing road cracks along Lee Holm Road

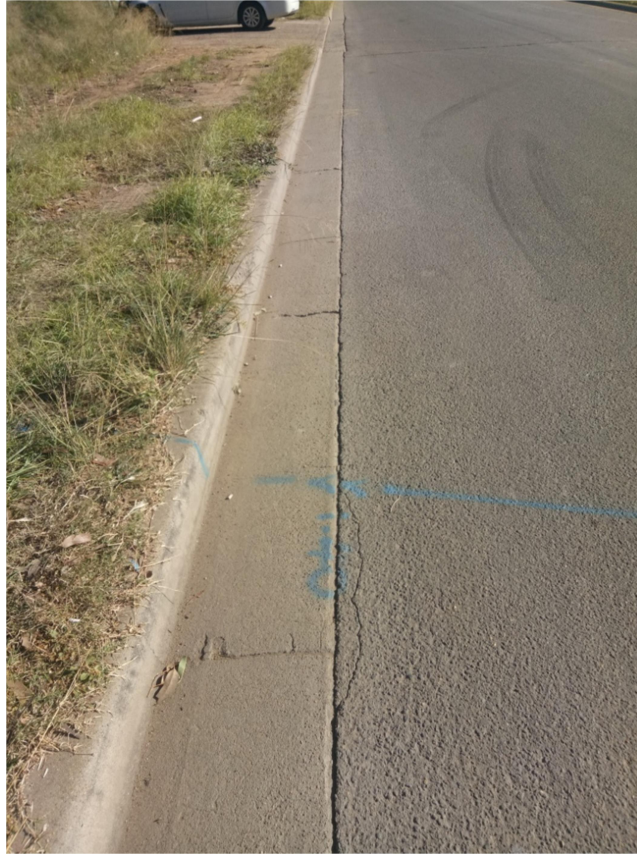
Photo (12): Existing cracks in the kerb & gutter along Lee Holm Road (site same side)

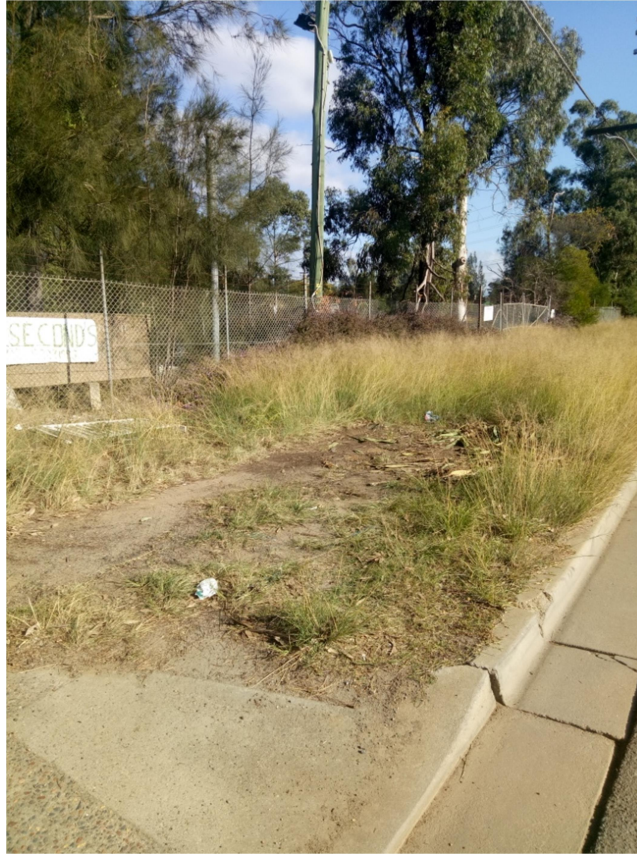
Photo (13): Existing cracks in the kerb & gutter along Lee Holm Road (site same side)

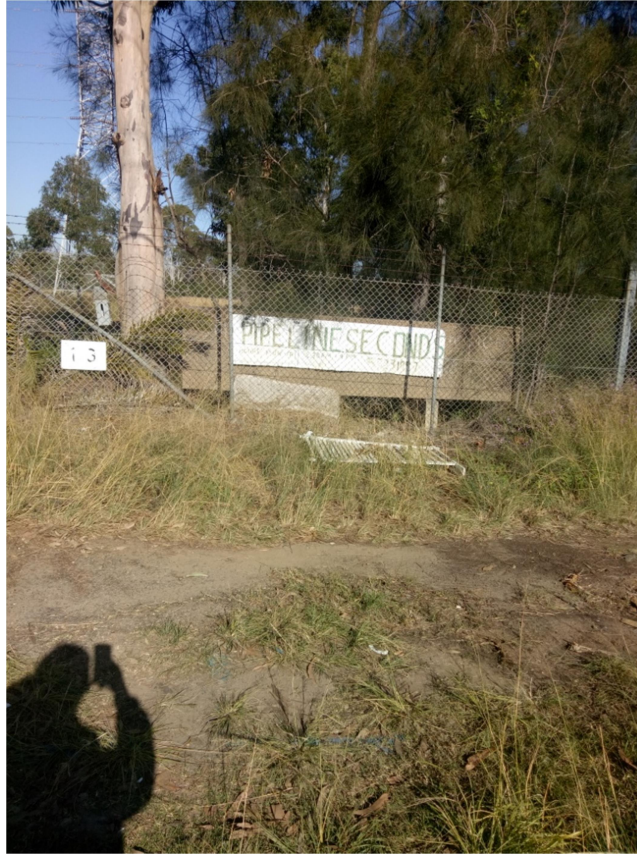
Photo (14): Existing damage in the wire fence along Lee Hom Road (site same side)

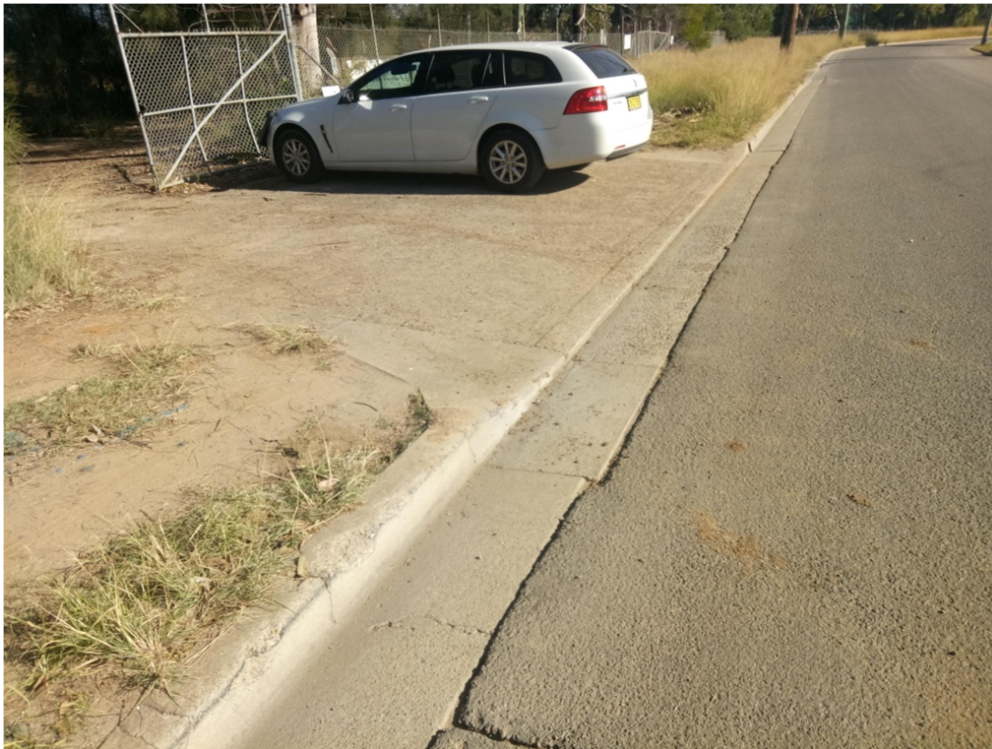
Photo (15): Existing cracks/damage at site entry

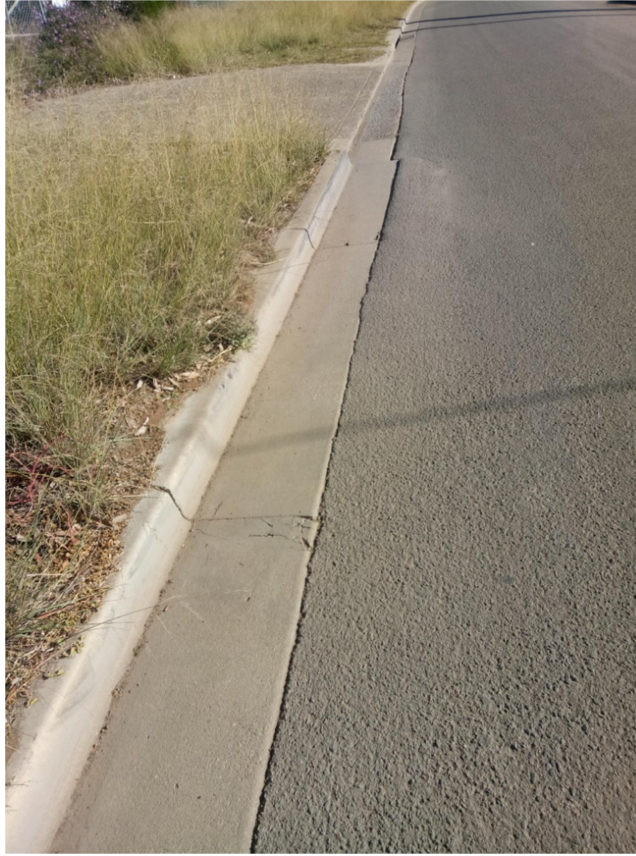
Photo (16): Existing cracks in the kerb & gutter along Lee Holm Road (site same side)

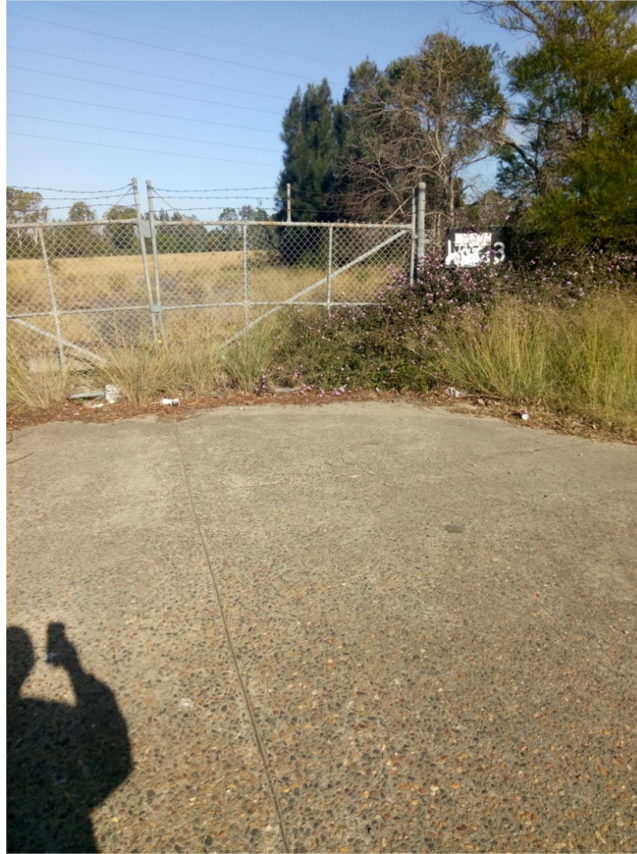
Photo (17): General view for site entry from Lee Holm Road

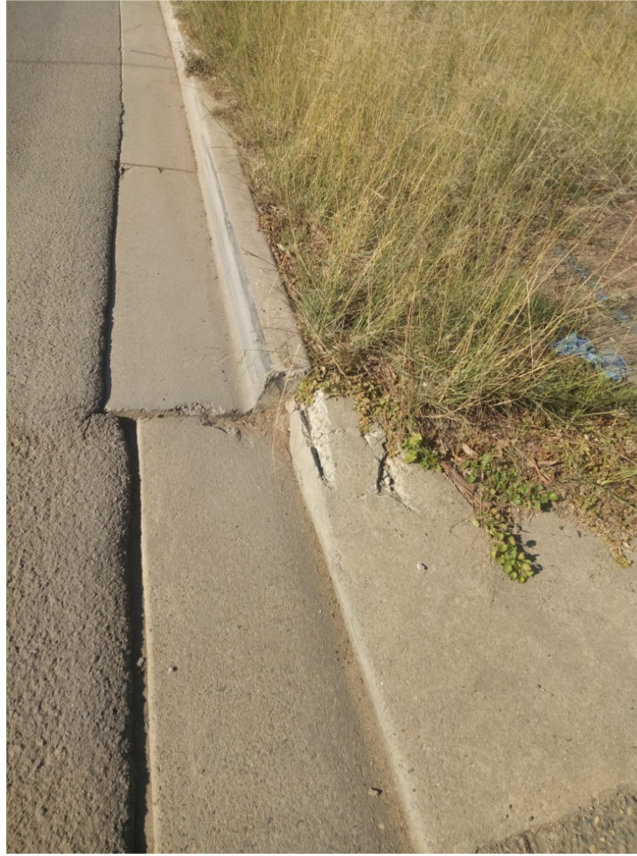
Photo (18): Existing cracks in the kerb & gutter at the site entry

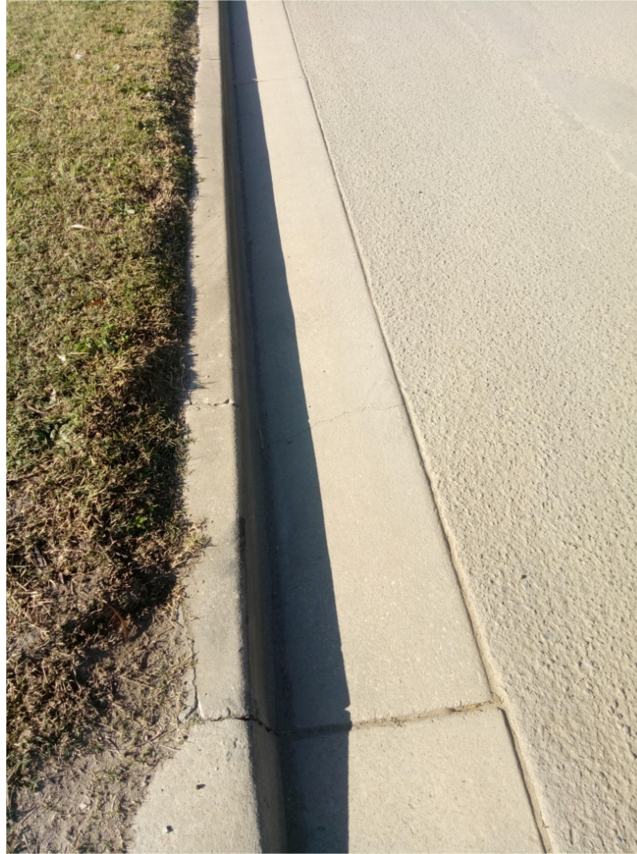
Photo (19): Existing cracks in the kerb & gutter along Lee Holm Road (site opposite side)

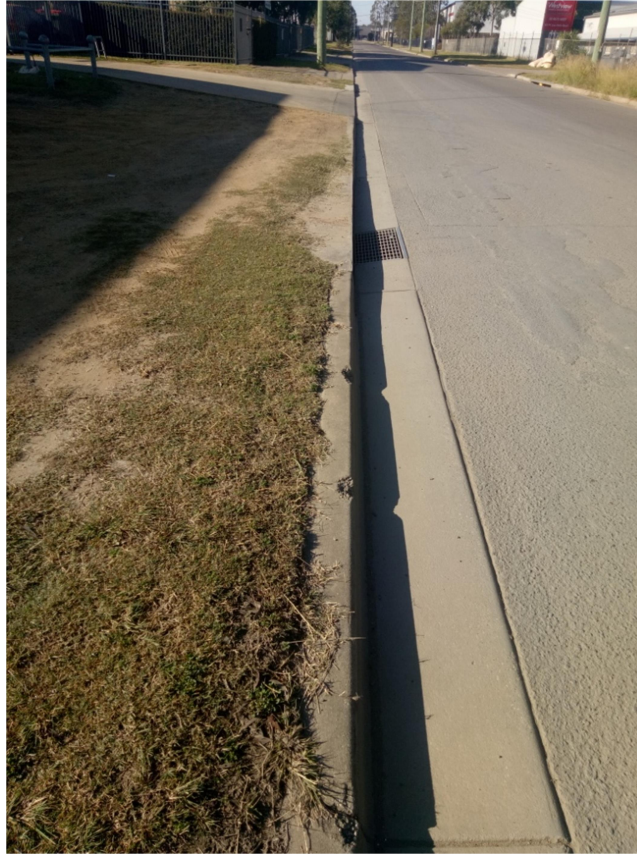
Photo (20): Existing damage in the kerb along Lee Holm Road (site opposite side)

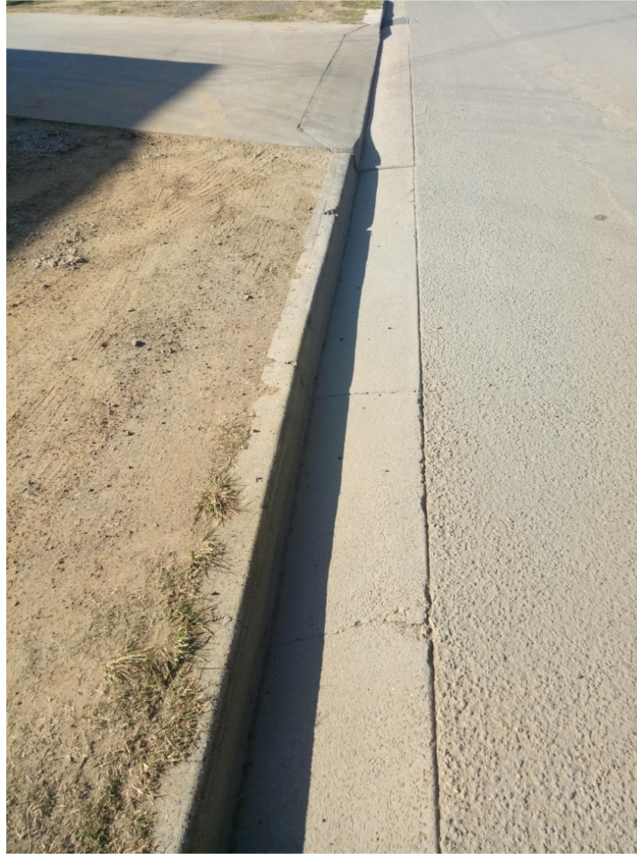
Photo (21): Existing cracks in the kerb & gutter along Lee Holm Road (site opposite side)

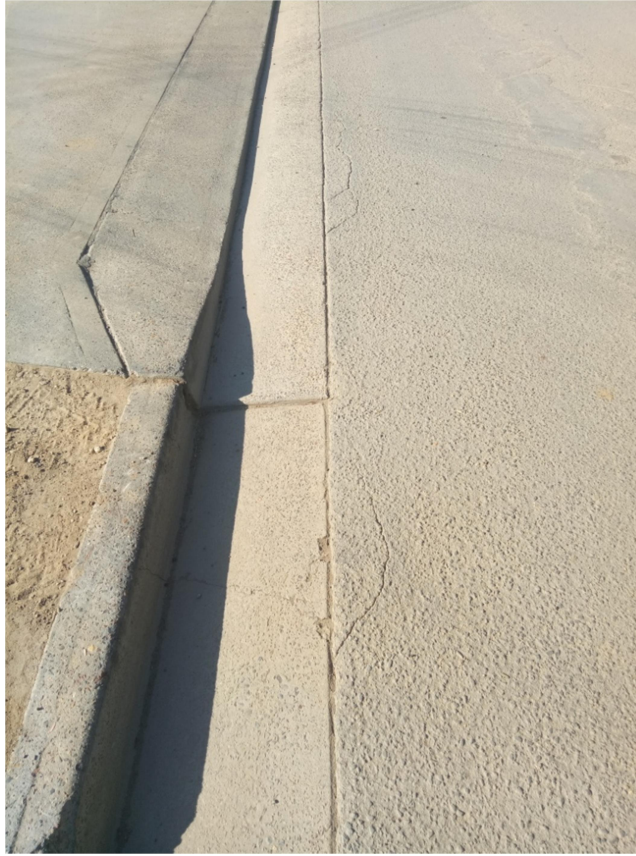
Photo (22): Existing cracks in the road along Lee Holm Road (site opposite side)

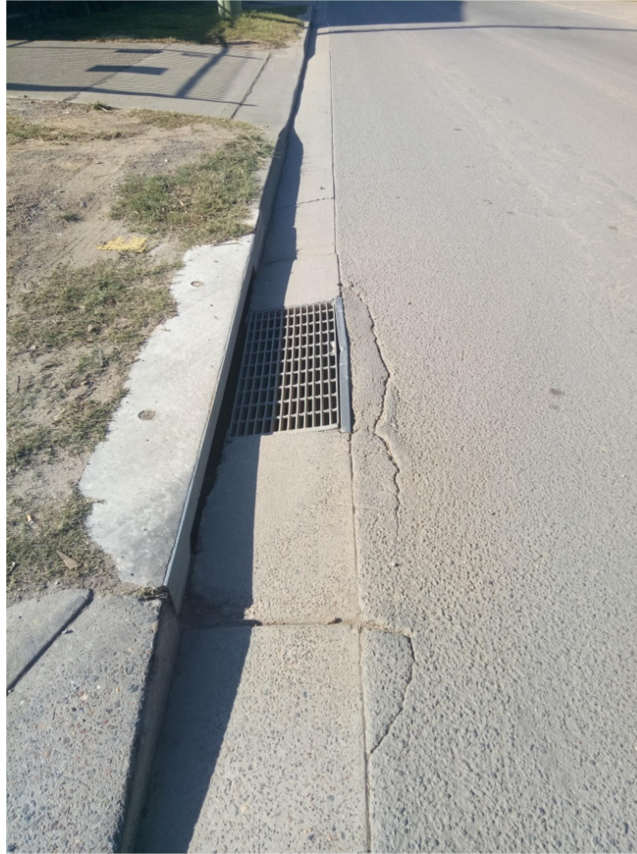
Photo (23): Existing cracks in the road along Lee Holm Road (site opposite side)

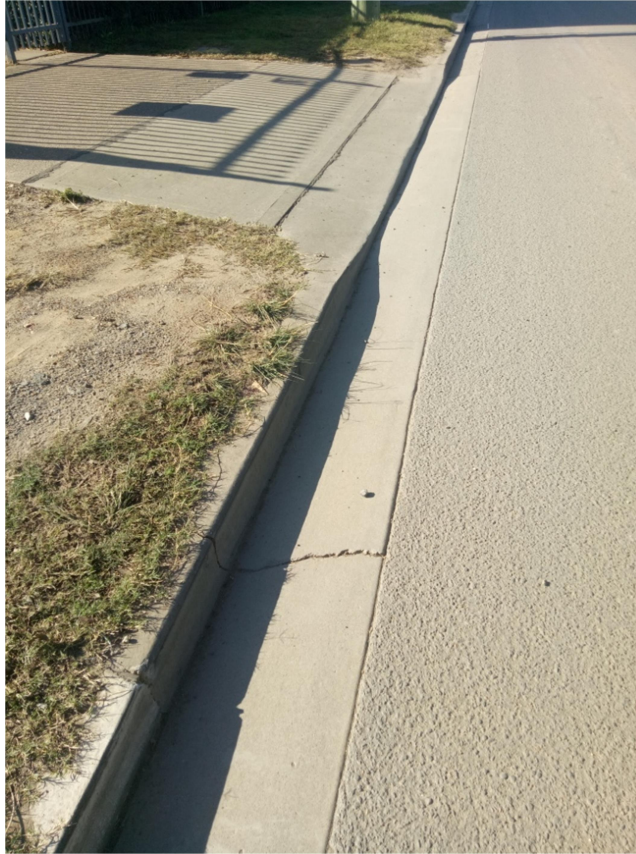
Photo (24): Existing cracks in the kerb & gutter along Lee Holm Road (site opposite side)

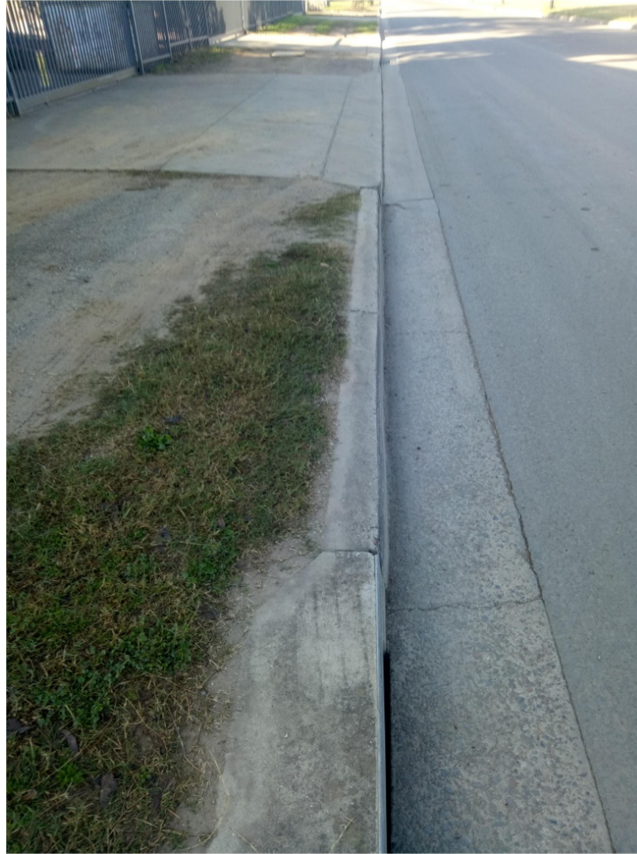
Photo (25): Existing cracks in the kerb & gutter along Lee Holm Road (site opposite side)

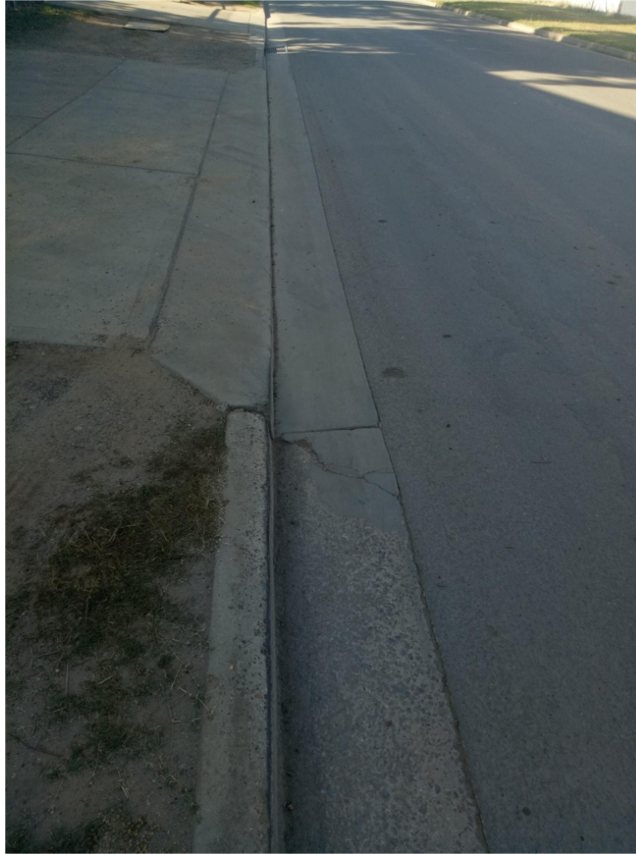
Photo (26): Existing cracks in the kerb & gutter along Lee Holm Road (site opposite side)

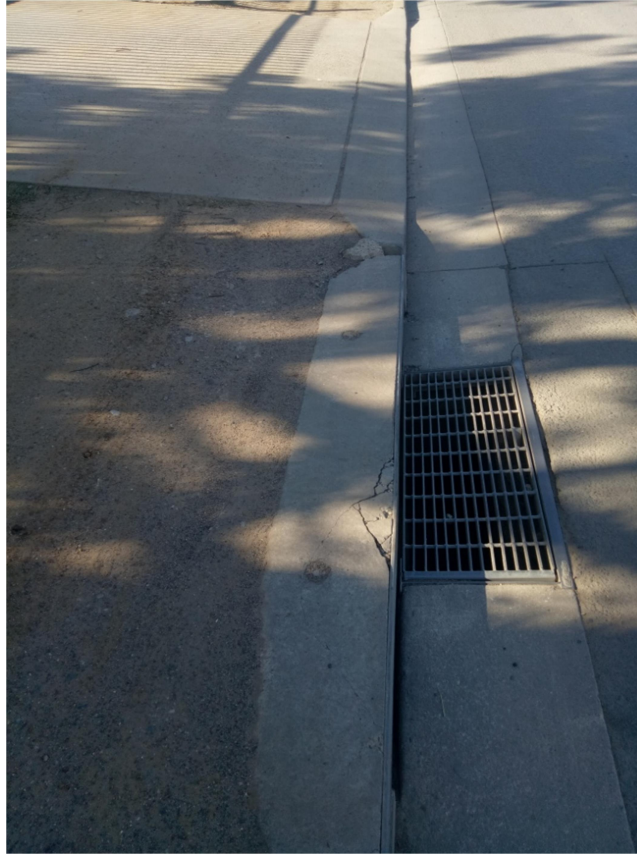
Photo (27): Existing cracks/damage in the kerb & gutter along Lee Holm Road (site opposite side)
