PRE-CONSTRUCTION DILAPIDATION REPORT AND PHOTOGRAPHIC SURVEY

Project Address: Lot 2 Forrester Road St Marys NSW 2760

Property Inspected: St Marys Hub Site Boundaries, Lot 2 Forrester Road, St Marys NSW

Document Number: 20-134_07

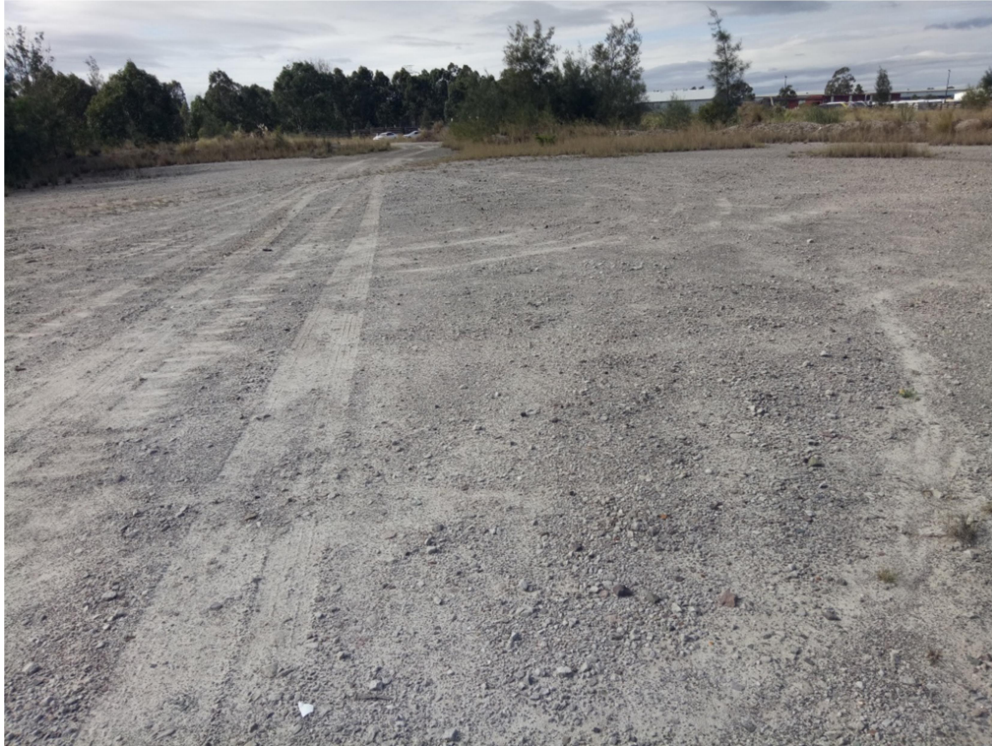
Photo (1): General view of St Marys Hub site

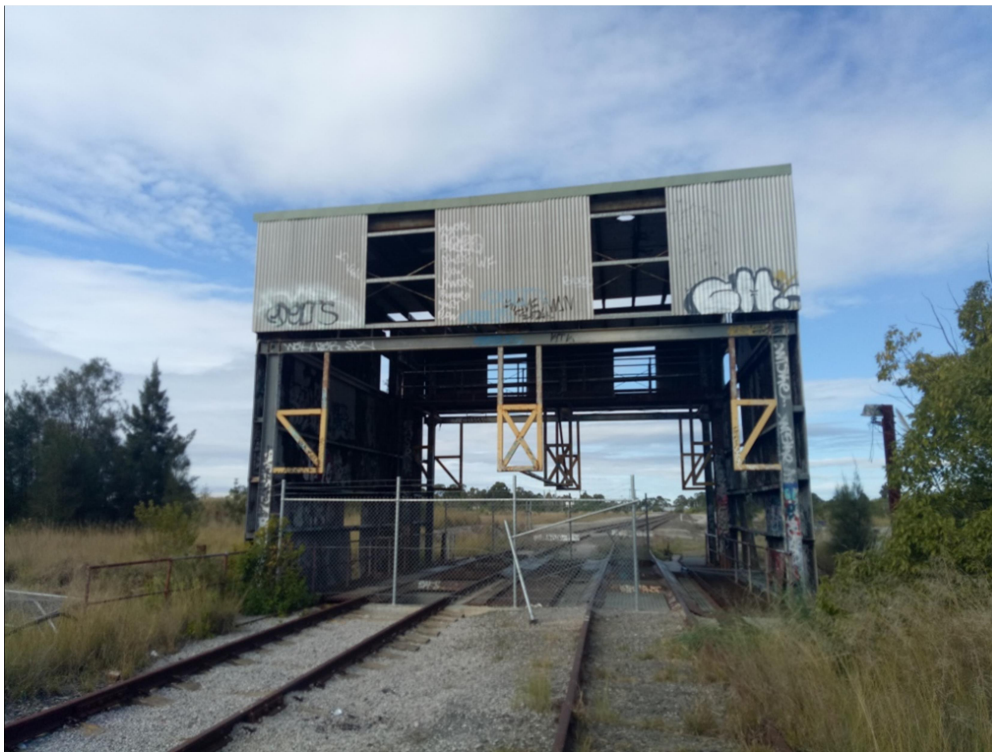
Photo (2): Existing St. Marys train station asset in poor condition

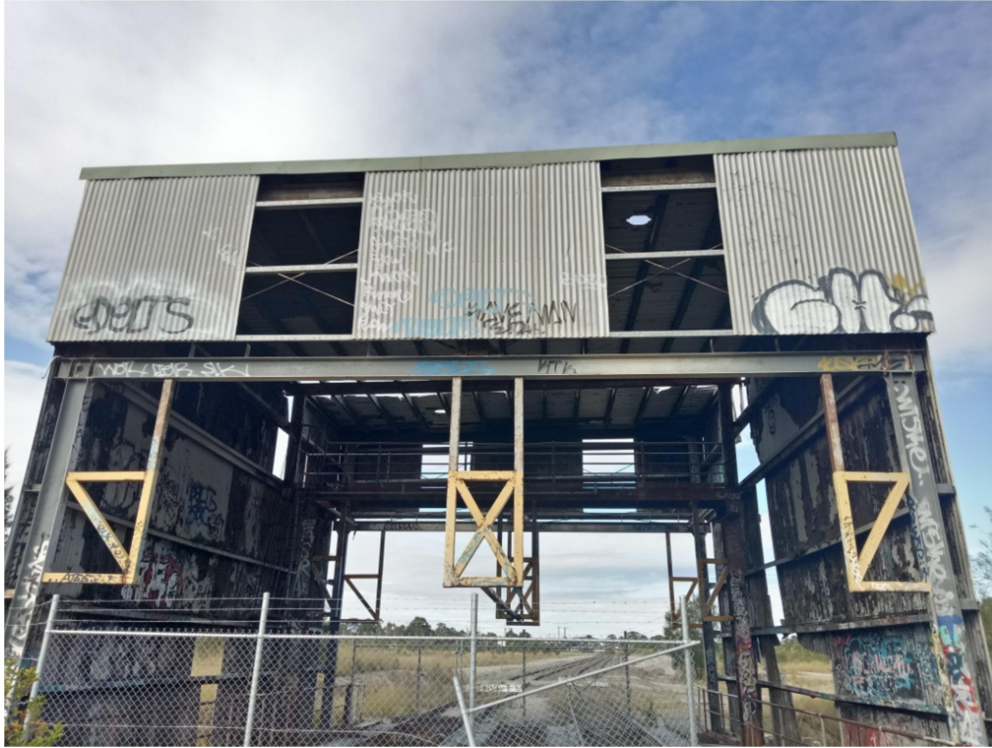
Photo (3): Existing St. Marys train station asset in poor condition

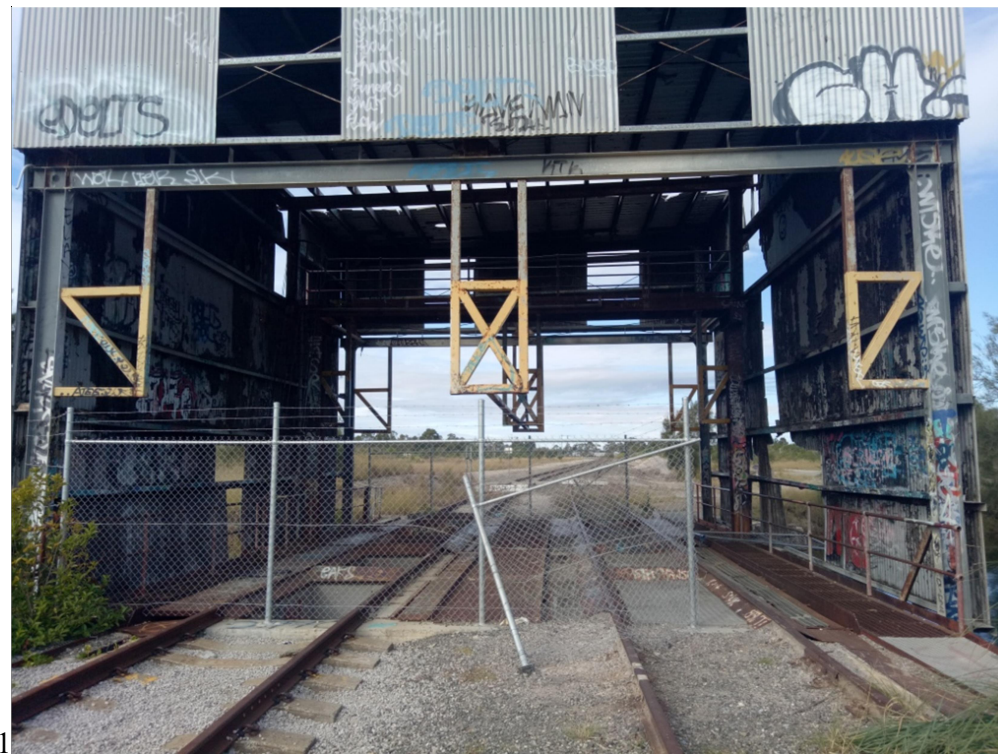
Photo (4): Existing St. Marys train station asset in poor condition

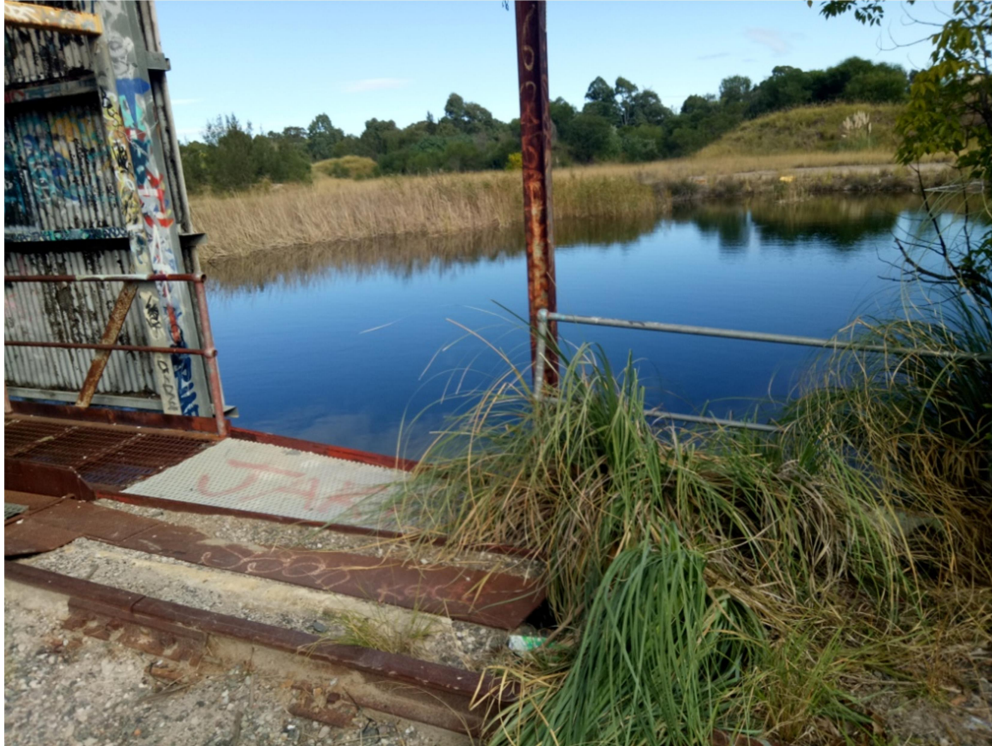
Photo (5): Existing St. Marys train station asset in poor condition

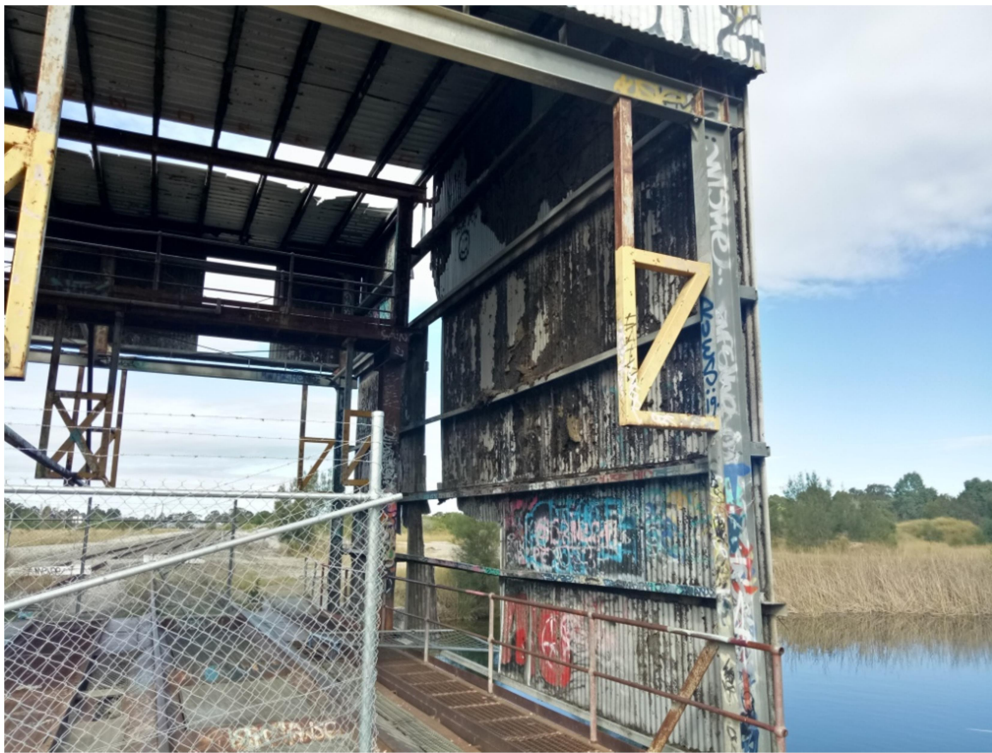
Photo (6): Existing St. Marys train station asset in poor condition

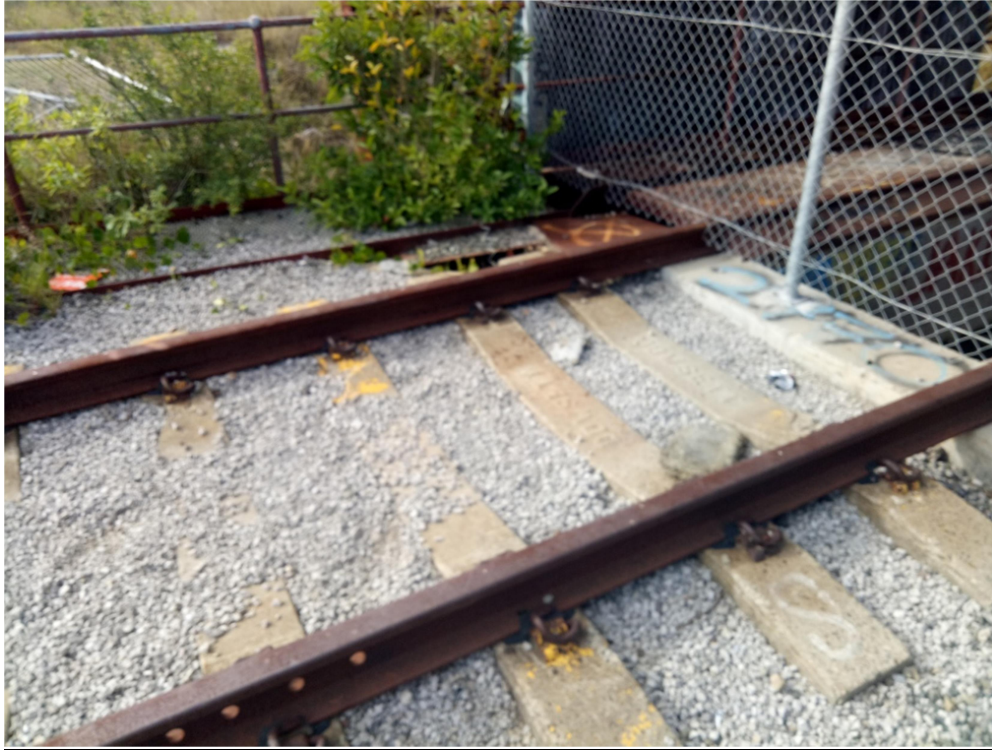
Photo (7): Existing train tracks in poor condition

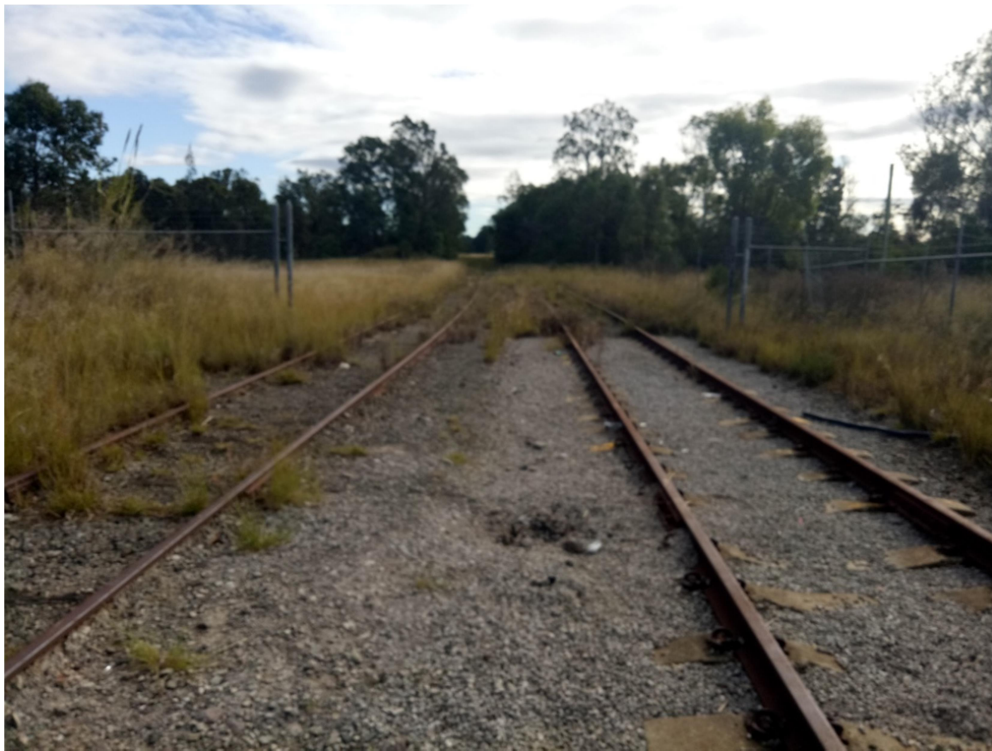
Photo (8): Existing train tracks in poor condition

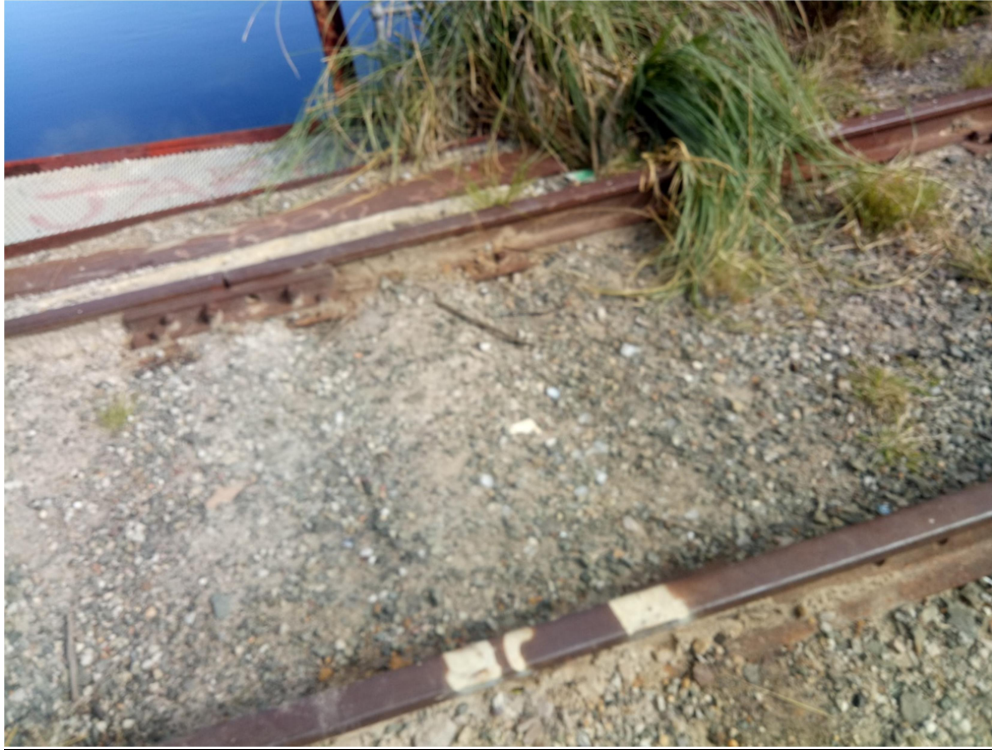
Photo (9): Existing train tracks in poor condition

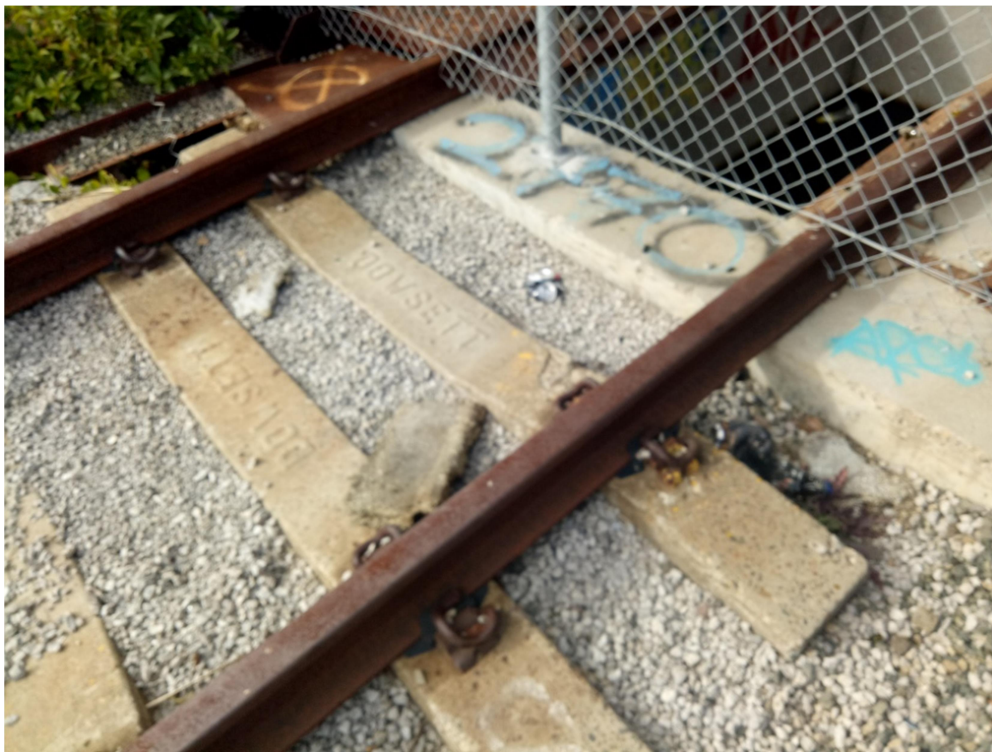
Photo (10): Existing train tracks in poor condition

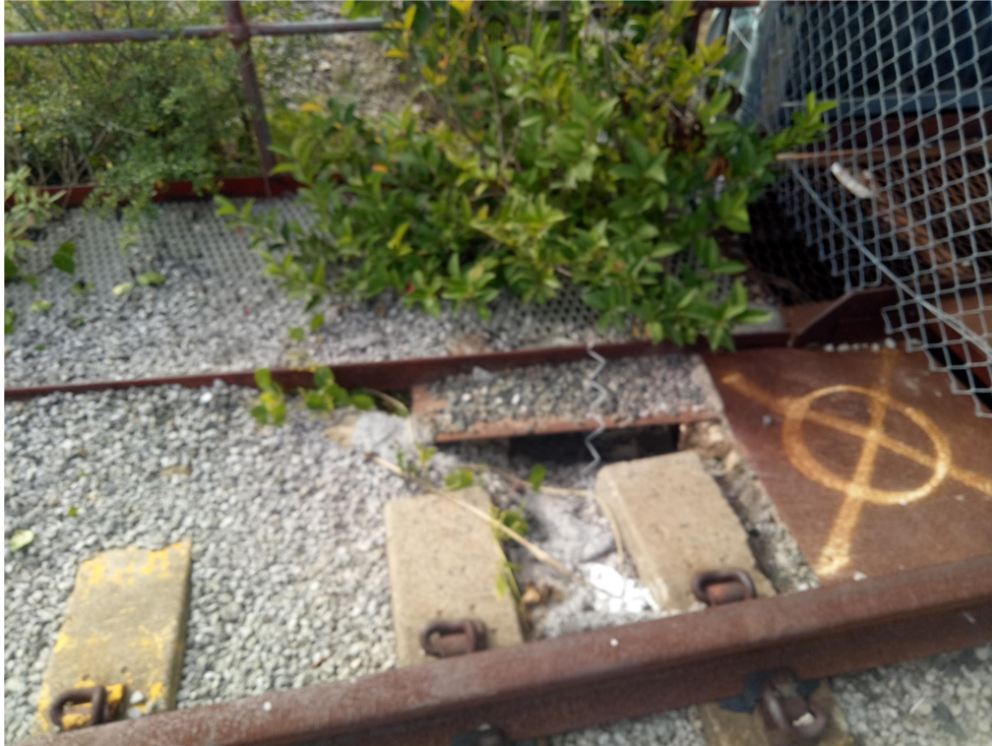
Photo (11): Existing train tracks in poor condition

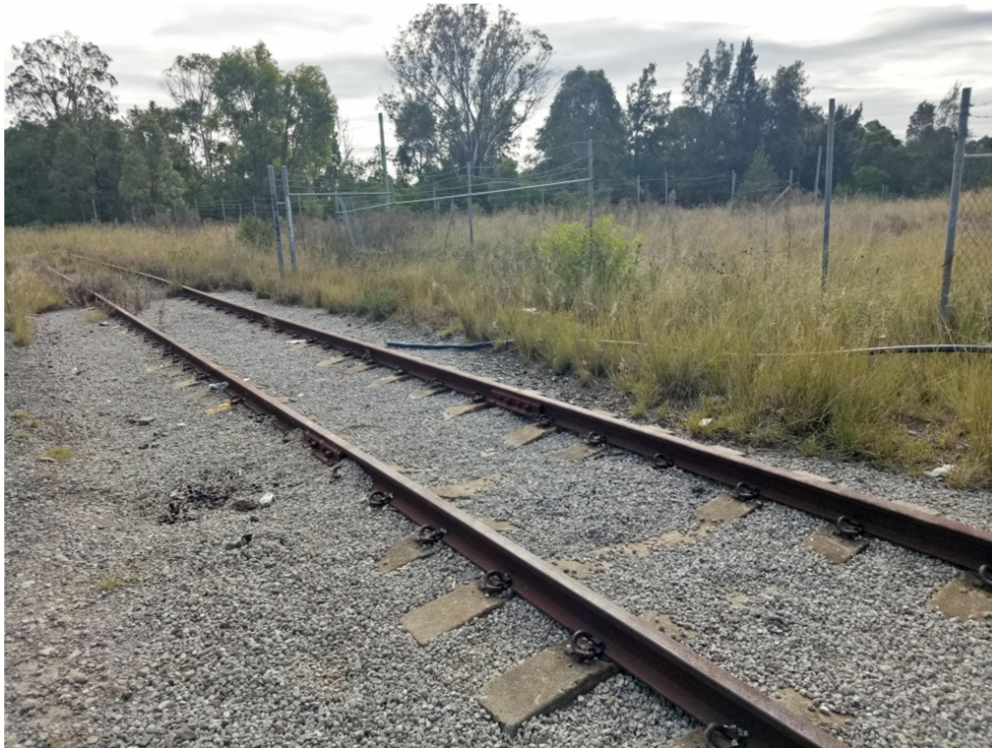
Photo (12): Existing train tracks in poor condition and existing damages in boundary fence

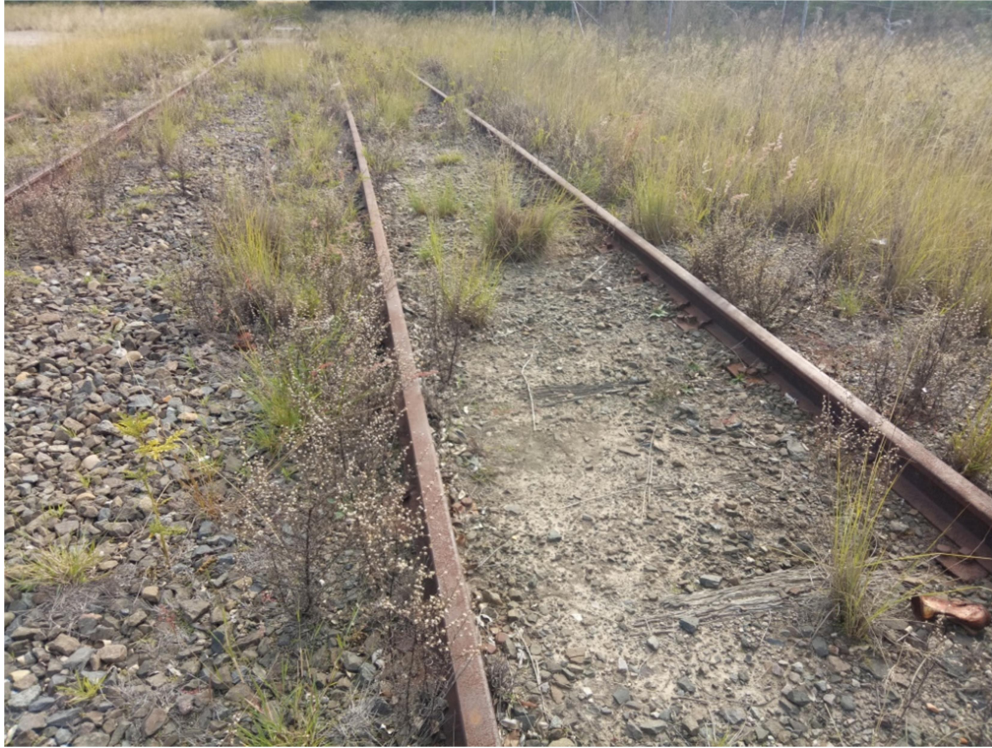
Photo (13): Existing train tracks in poor condition

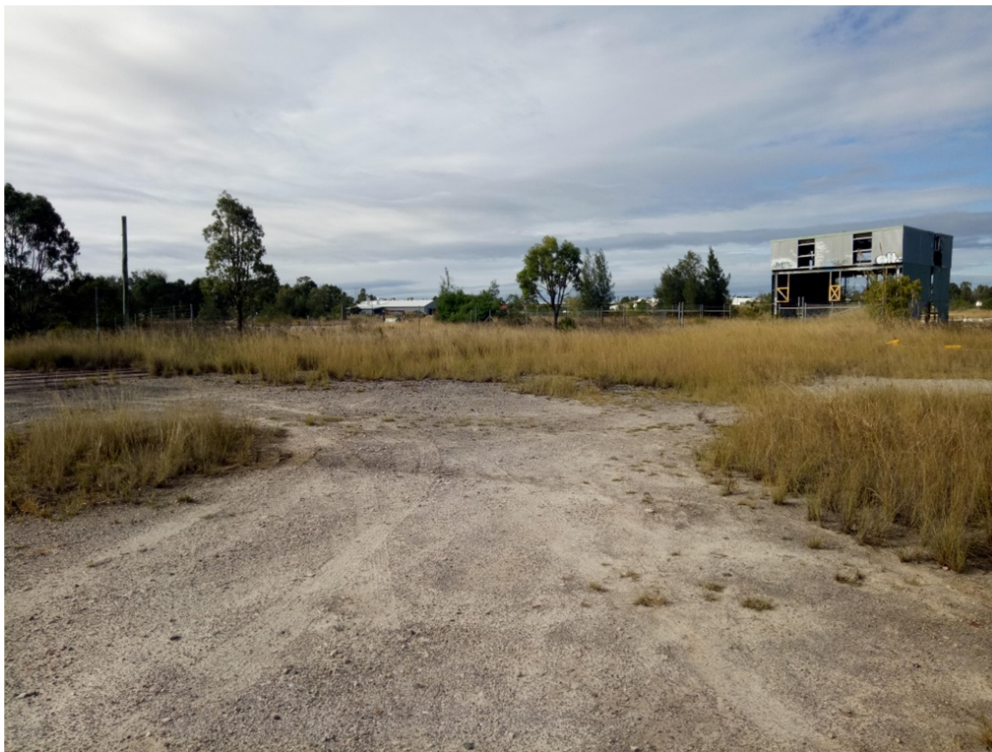
Photo (14): General View for the Site

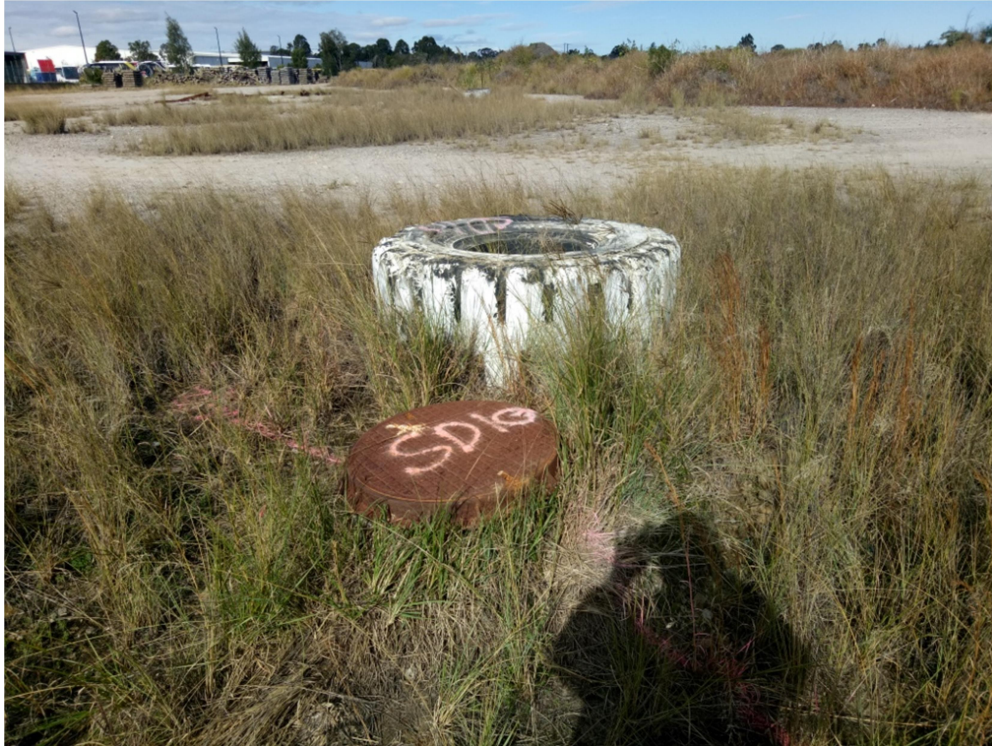
Photo (15): Existing pit

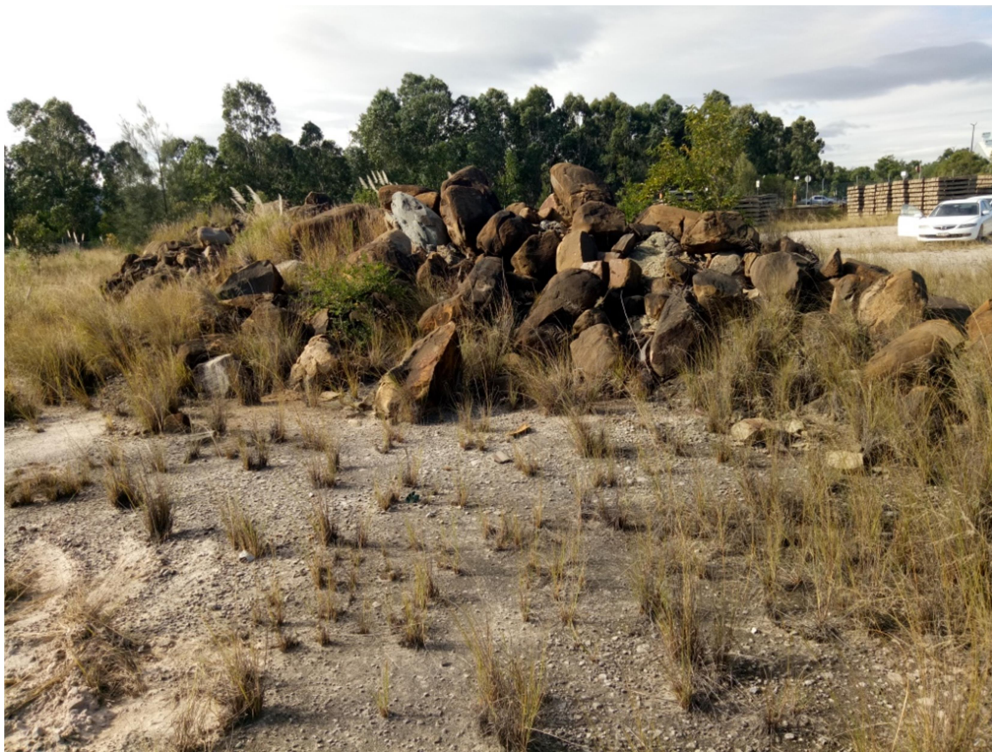
Photo (16): Existing bush rocks

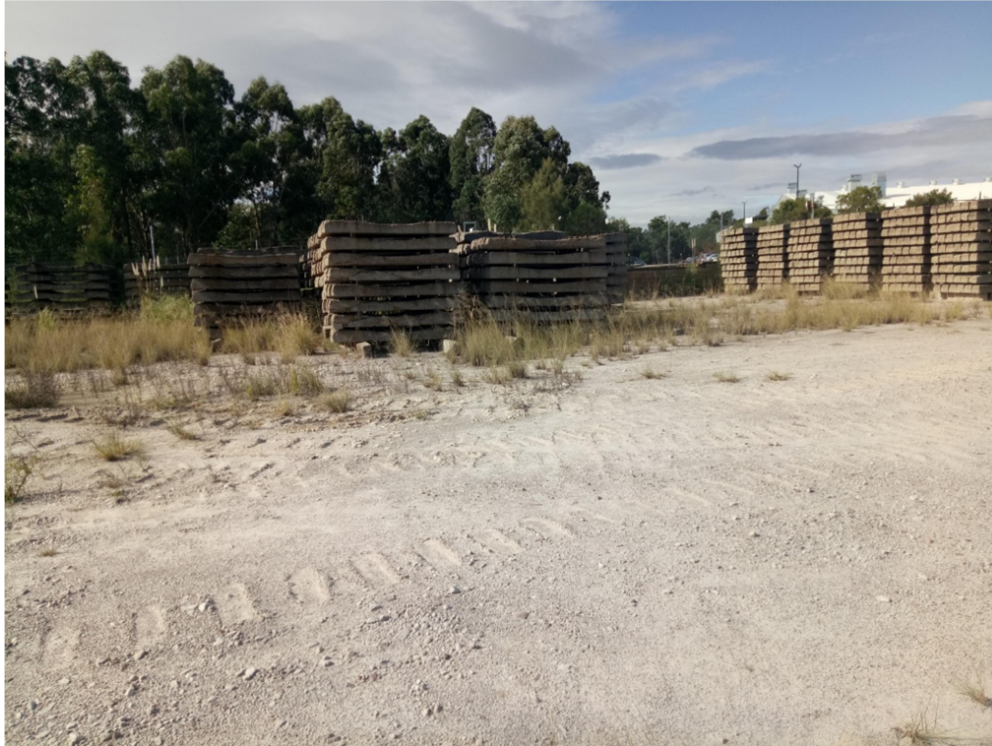
Photo (17): Existing concrete sleepers next to boundary fence

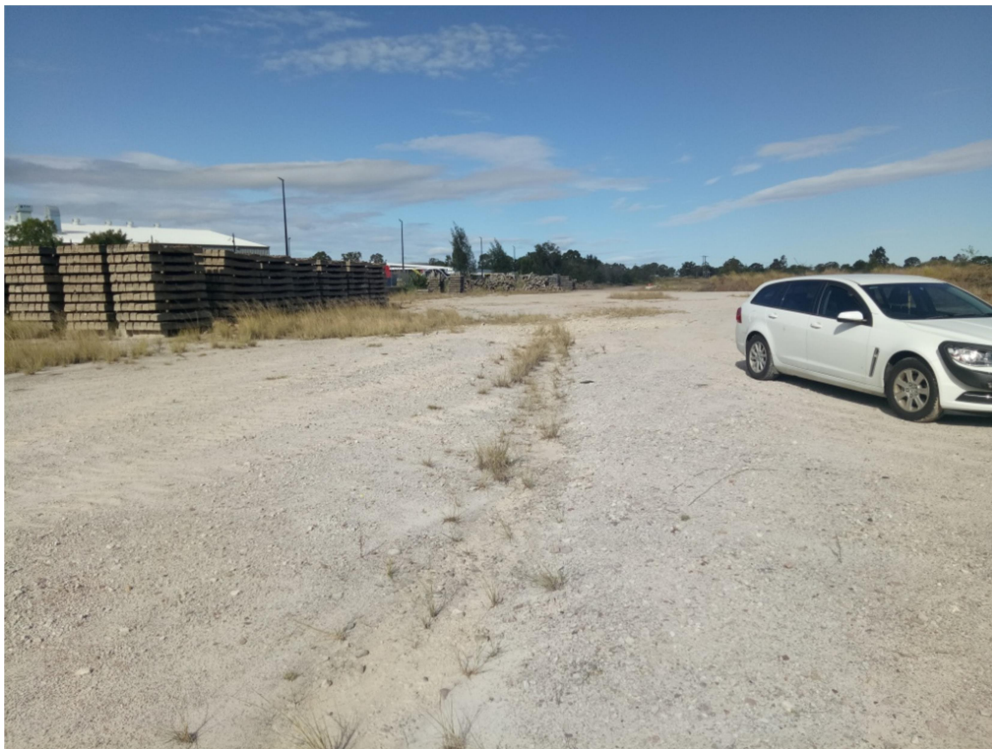
Photo (18): Existing concrete sleepers next to boundary fence

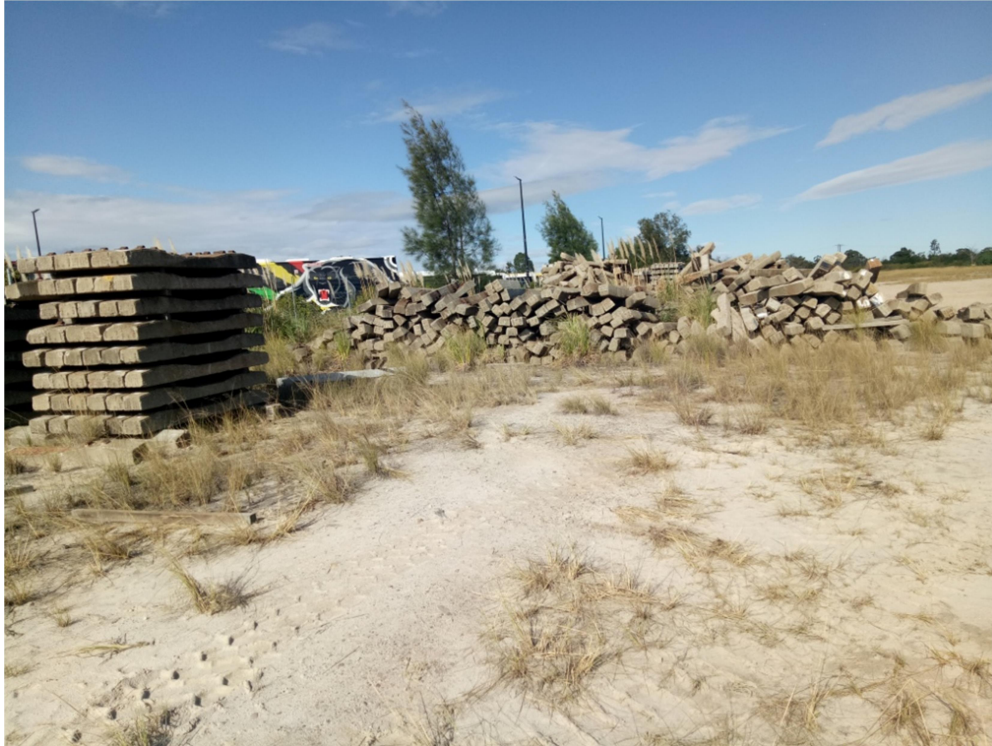
Photo (19): Existing concrete sleepers next to boundary fence

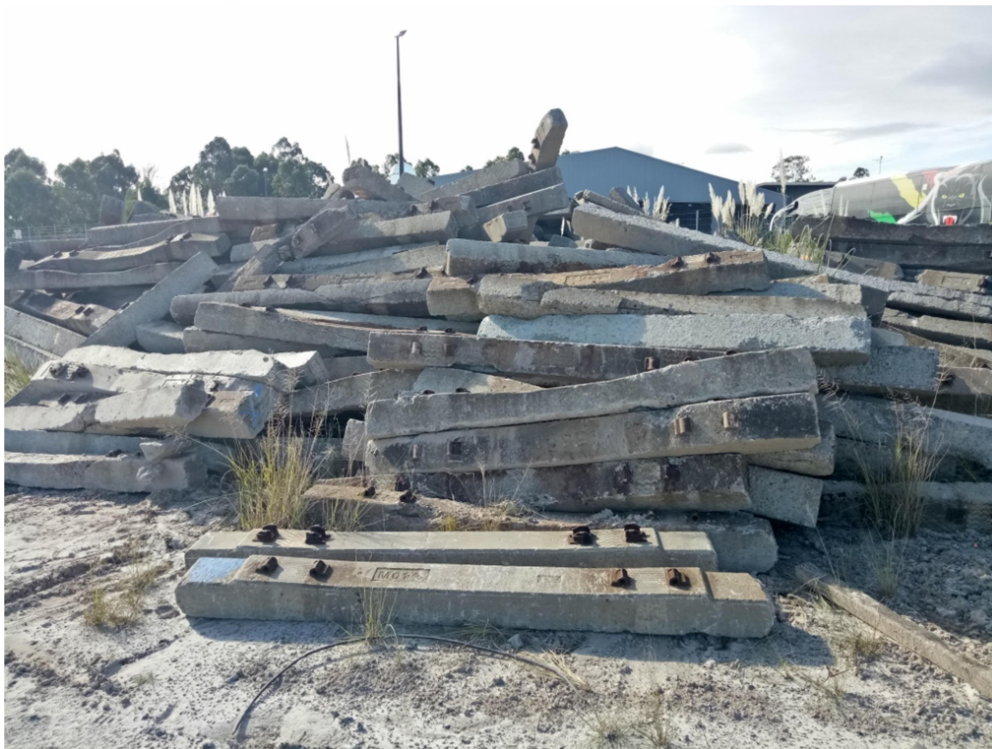
Photo (20): Existing concrete sleepers next to boundary fence

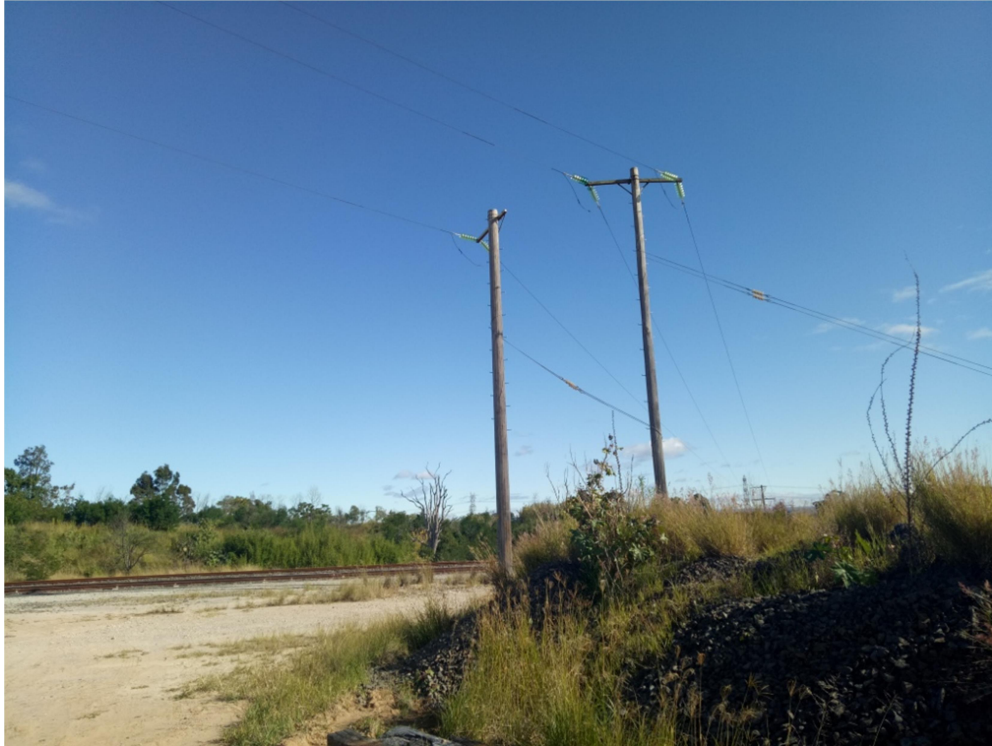
Photo (21): Existing timber power poles

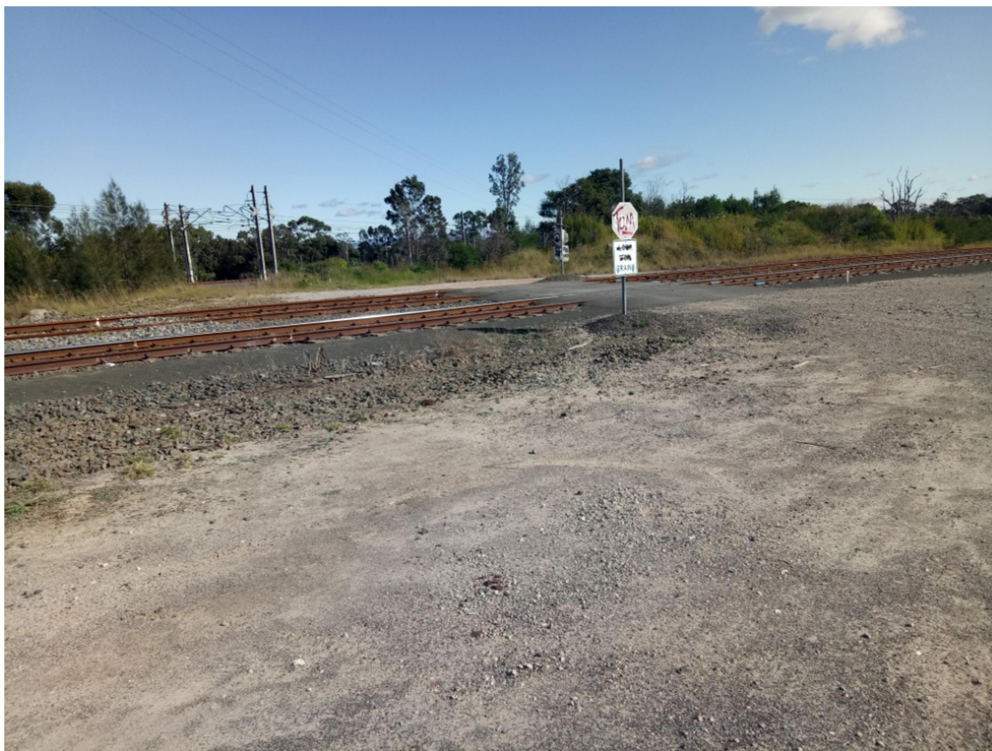
Photo (22): Existing train tracks

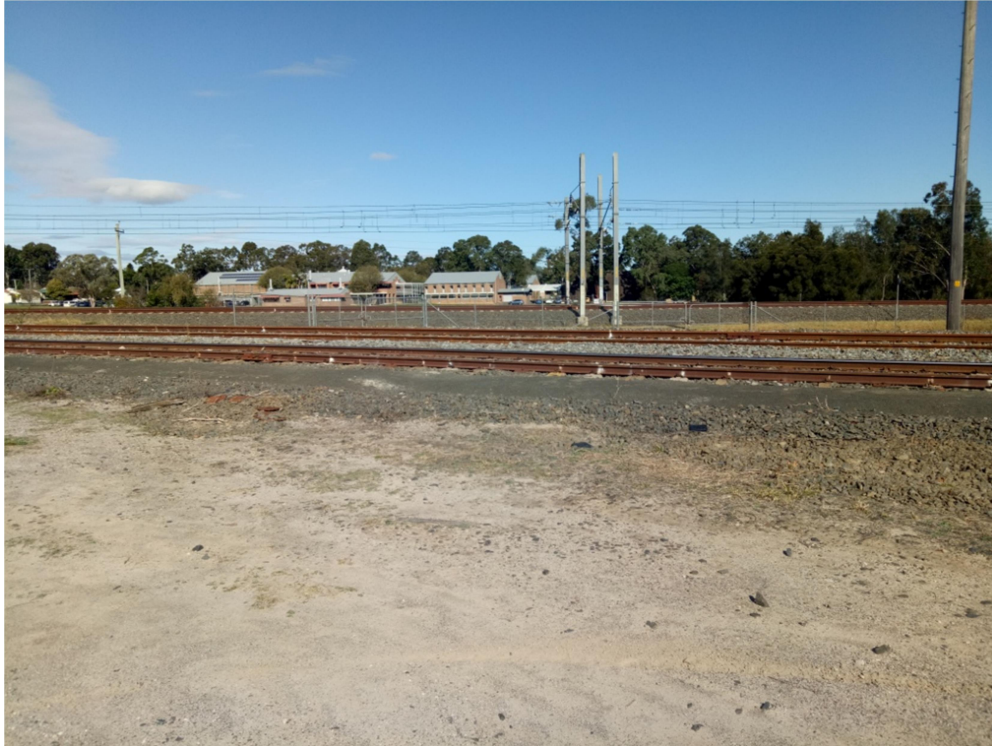
Photo (23): Existing train tracks

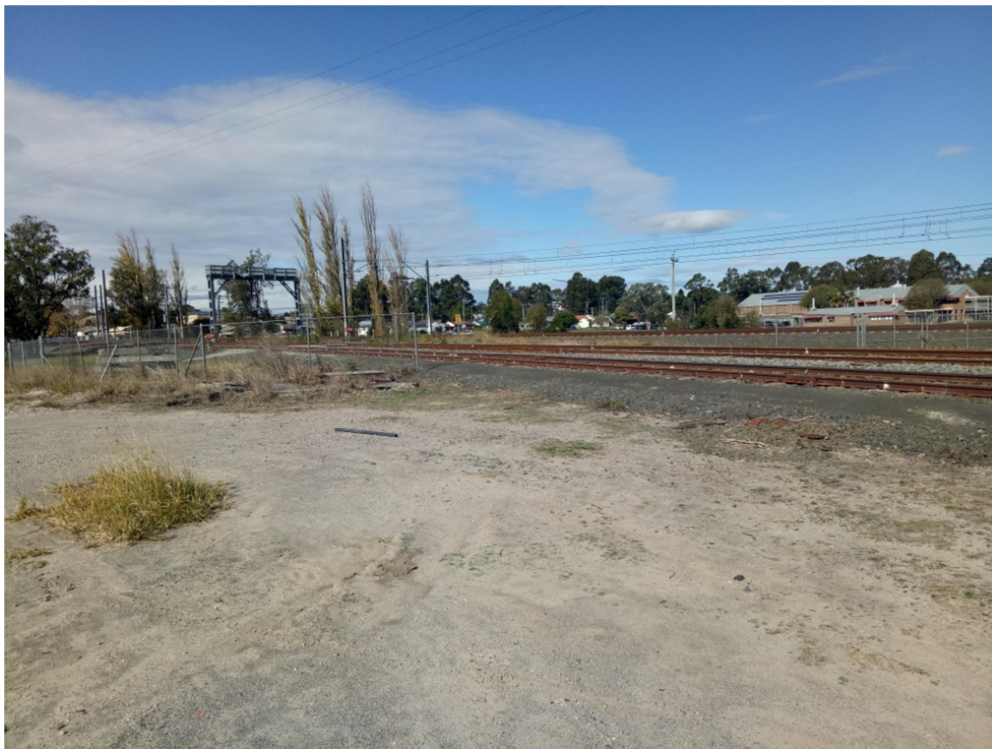
Photo (24): Existing train tracks

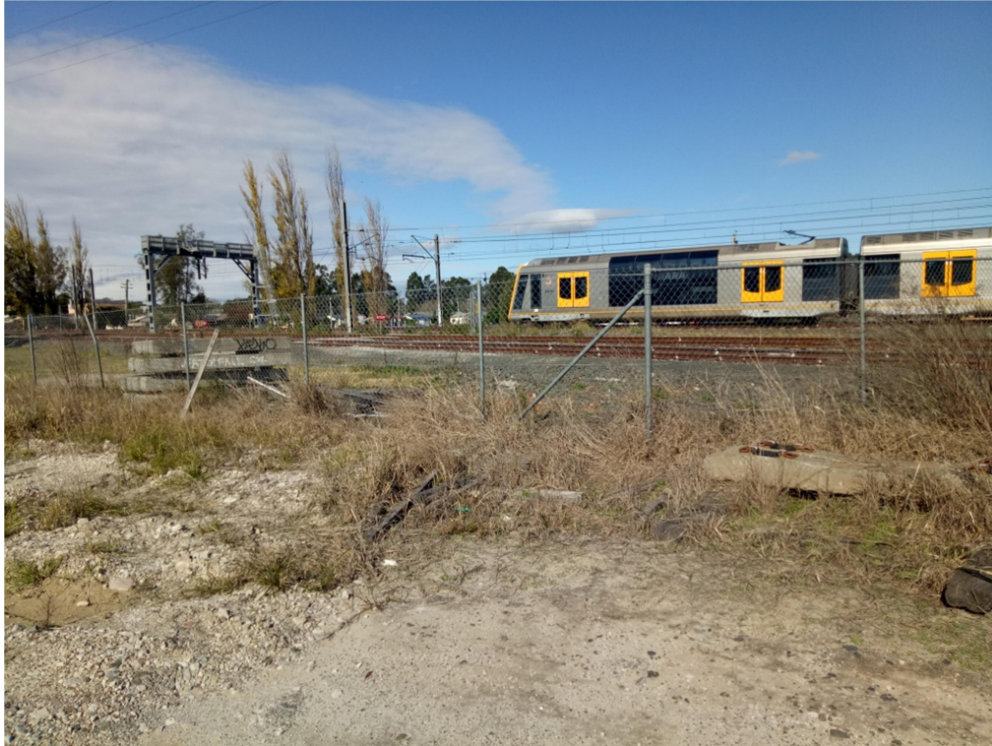
Photo (25): Existing boundary fence

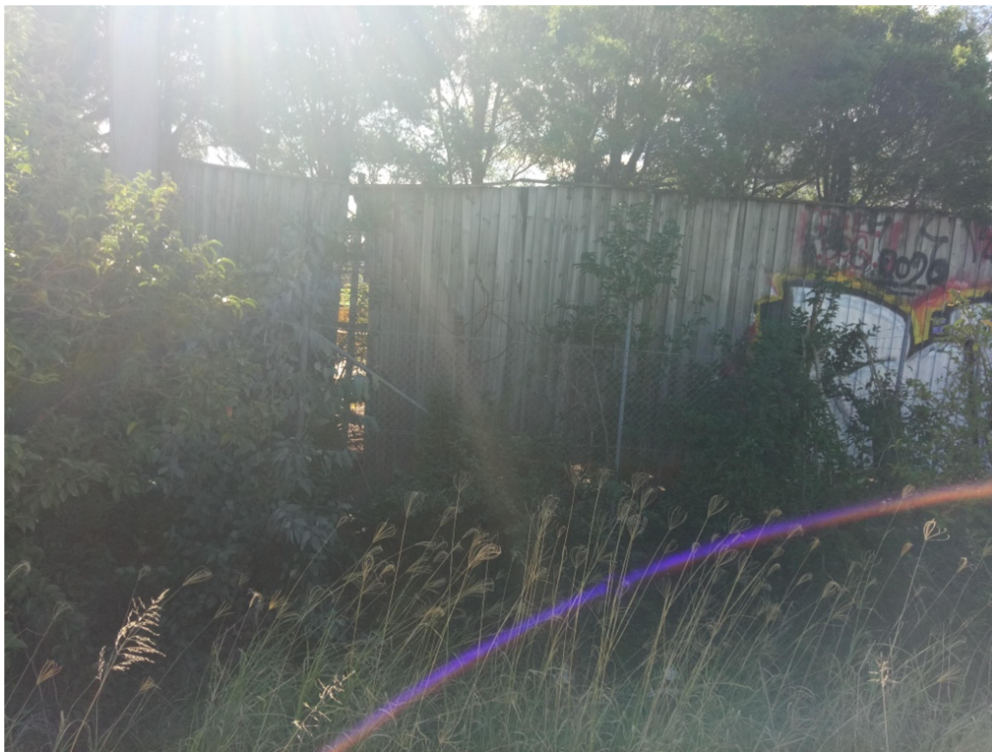
Photo (26): Existing boundary fence in poor condition

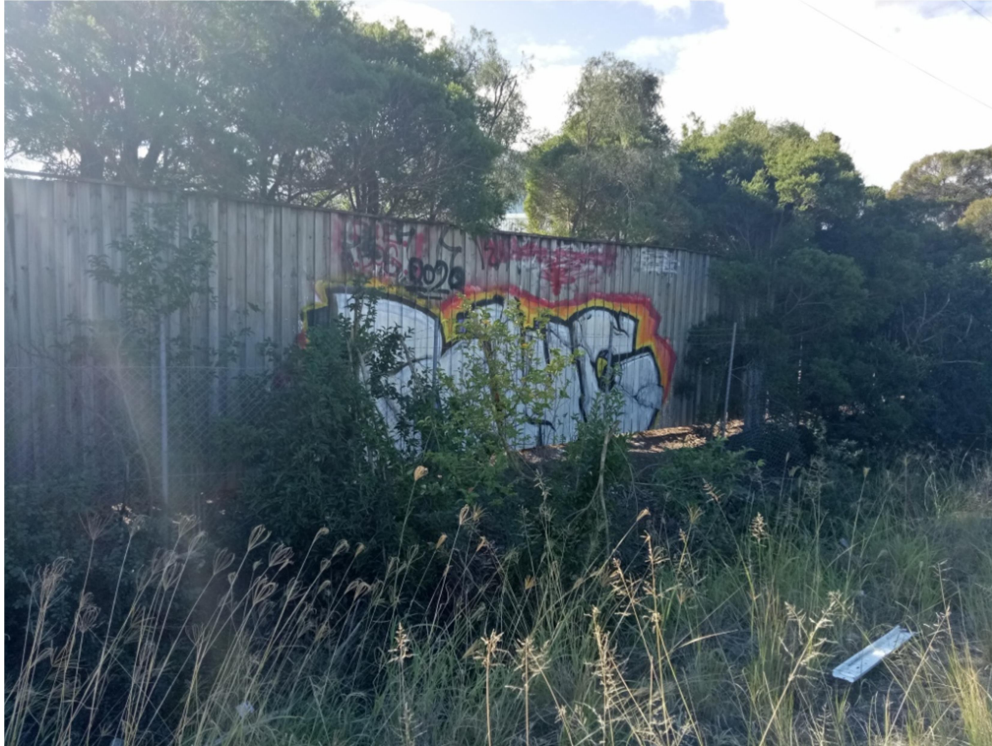
Photo (27): Existing boundary fence in poor condition

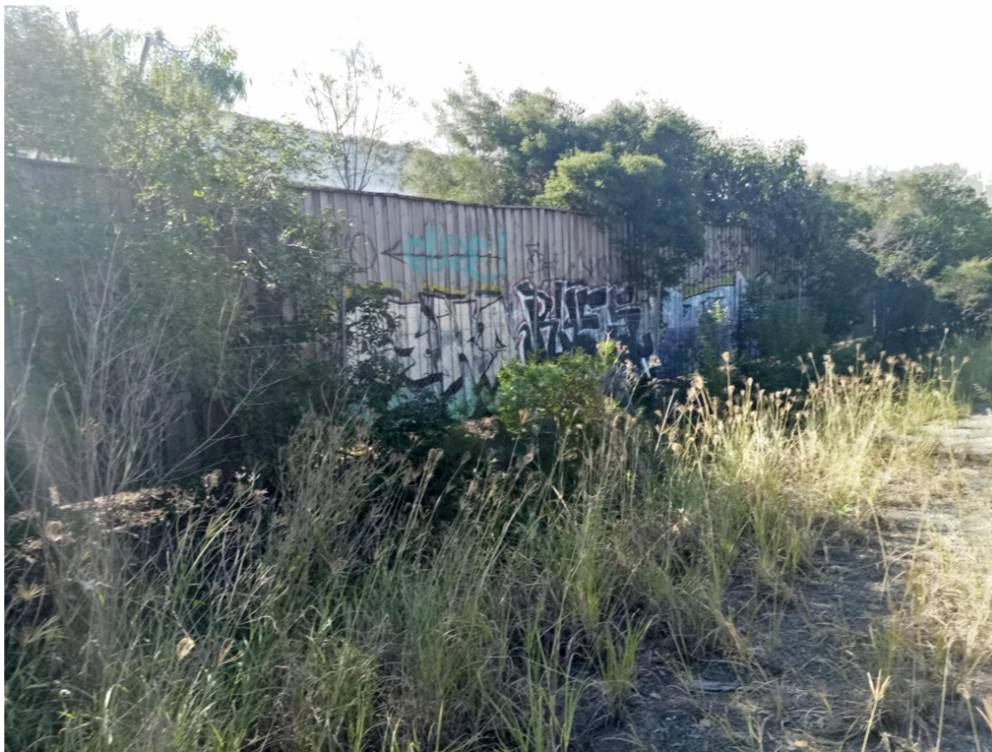
Photo (28): Existing boundary fence in poor condition

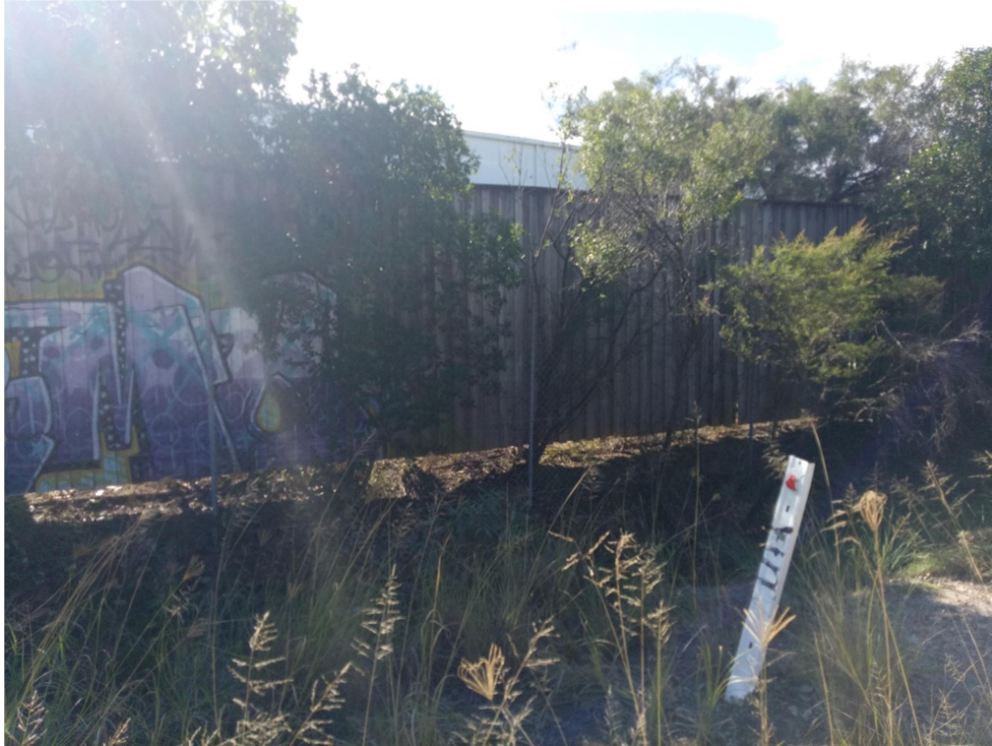
Photo (29): Existing boundary fence in poor condition

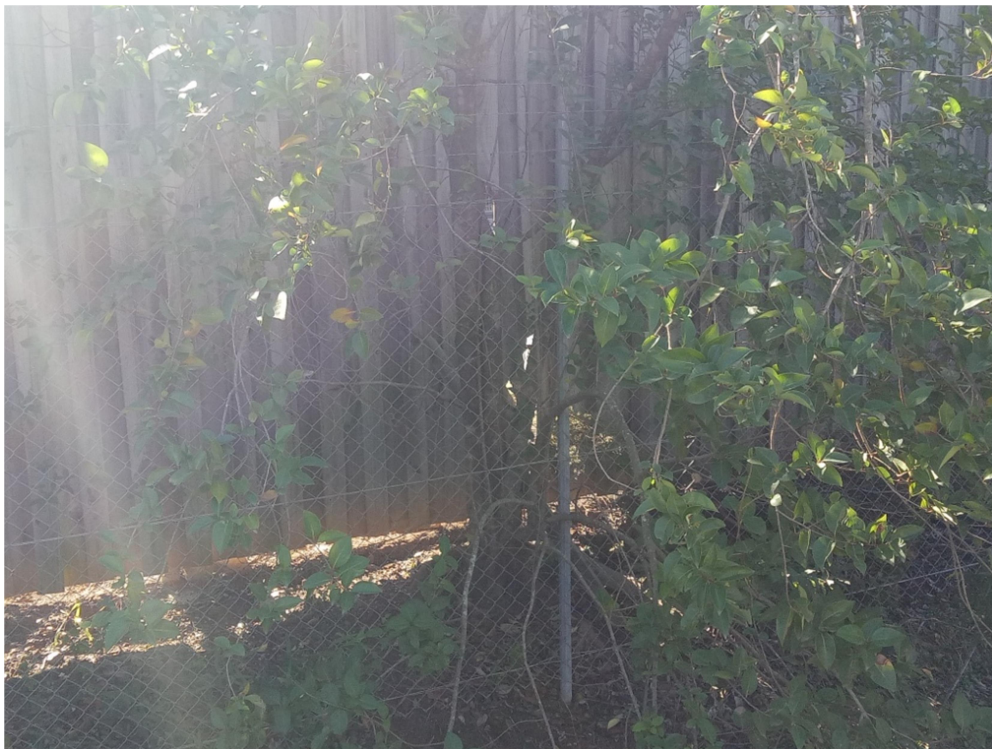
Photo (30): Existing boundary fence in poor condition
