PRE-CONSTRUCTION DILAPIDATION REPORT AND PHOTOGRAPHIC SURVEY

Project Address: Lot 2 Forrester Road St Marys NSW 2760

Property Inspected: St Marys Hub Site Boundaries, Lot 2 Forrester Road, St Marys NSW

Document Number: 20-134_07

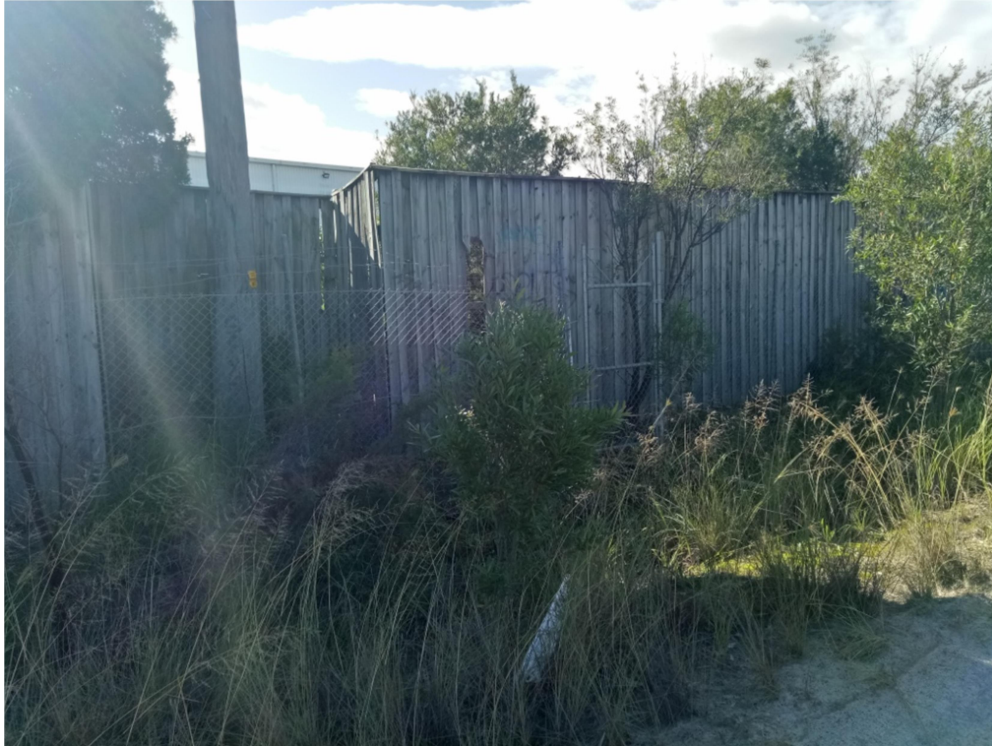
Photo (31): Existing boundary fence in poor condition

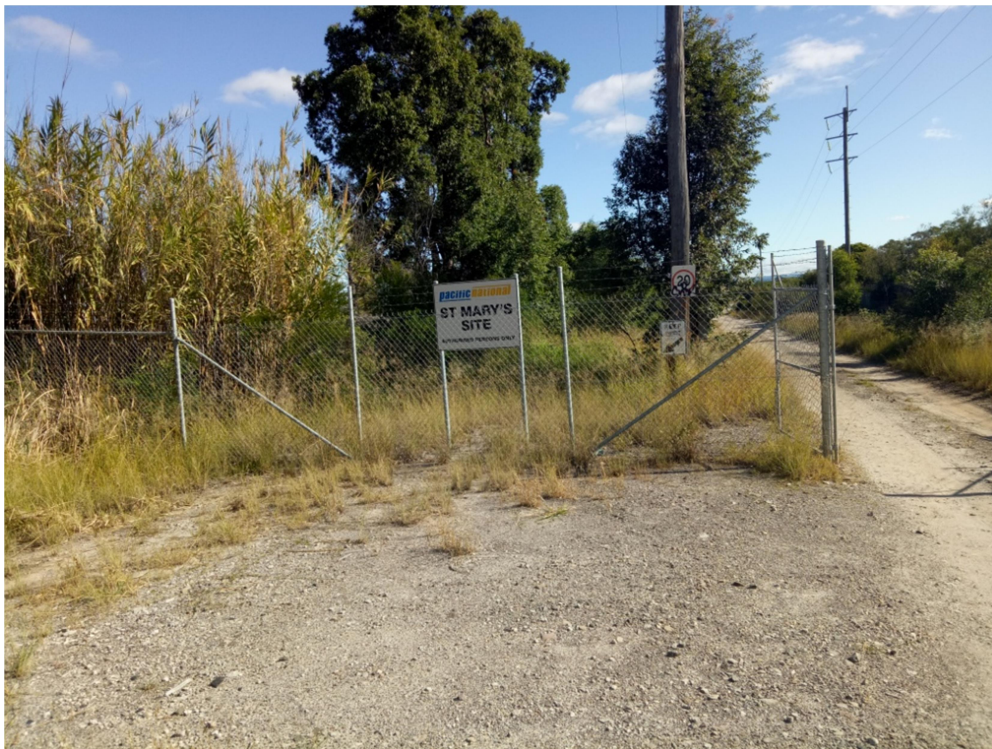
Photo (32): General view for site entry

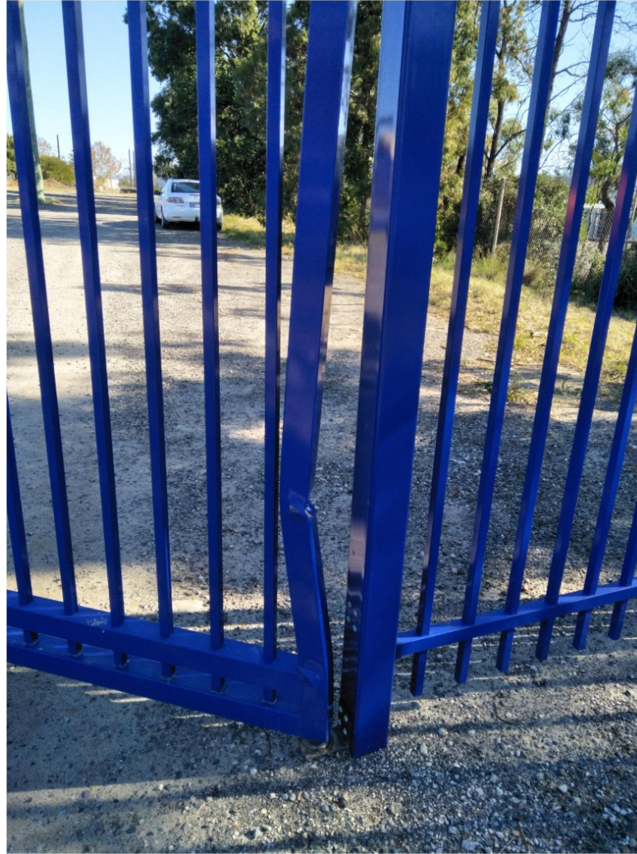
Photo (33): Existing damage in the entry gate from Forrester Road

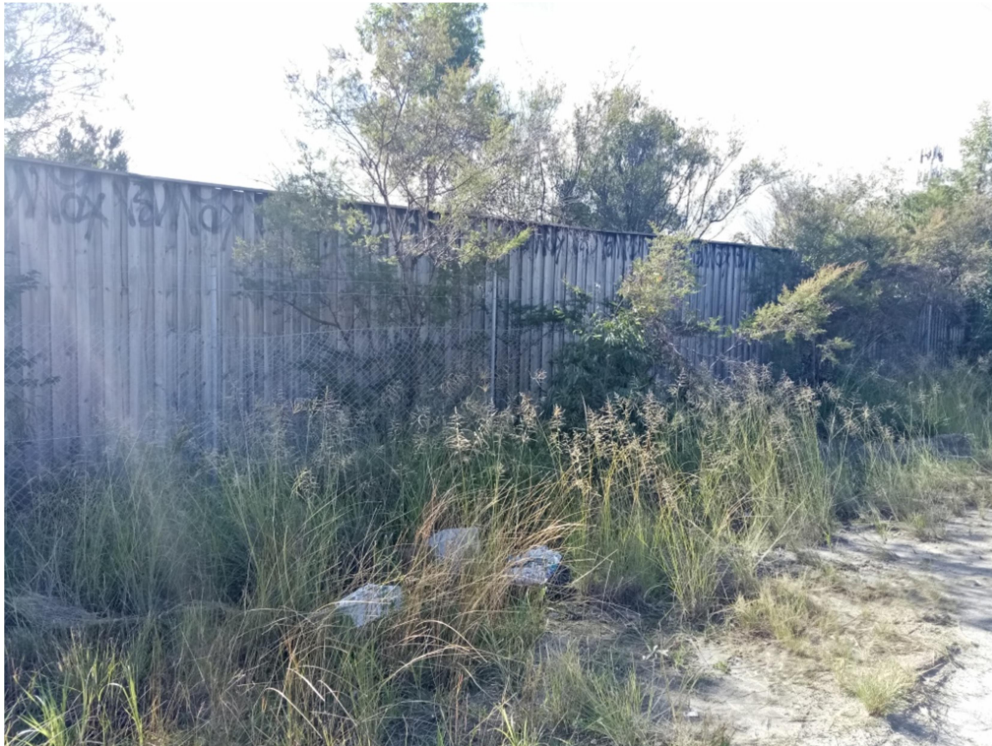
Photo (34): Existing boundary fence in poor condition

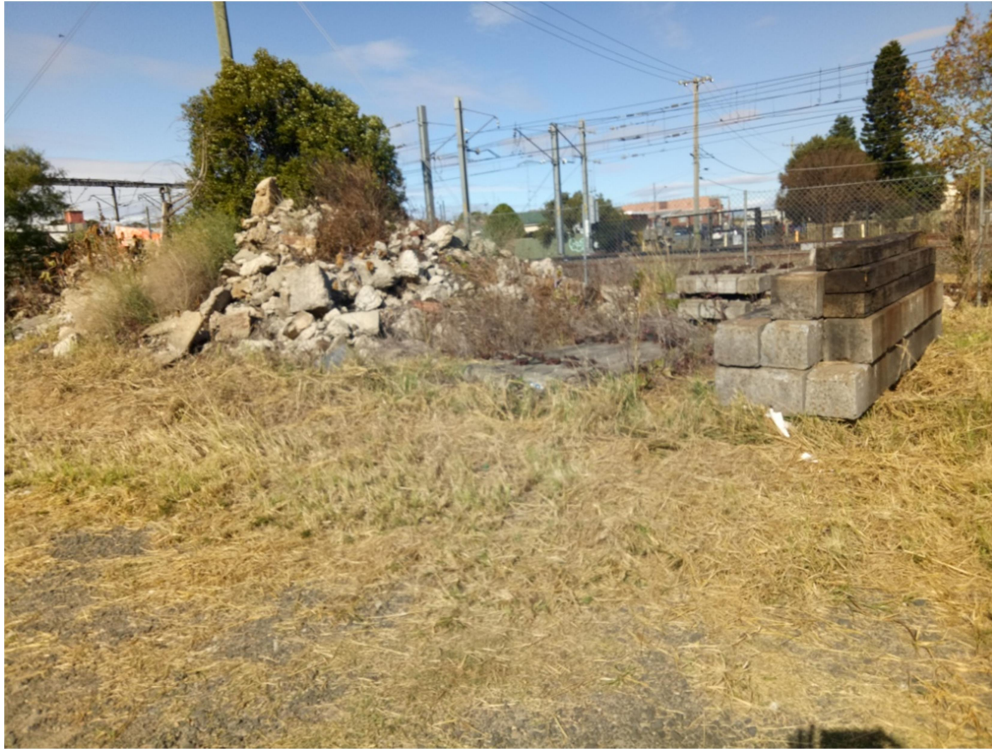
Photo (35): Existing bush rocks/ concrete sleepers next to the boundary fence

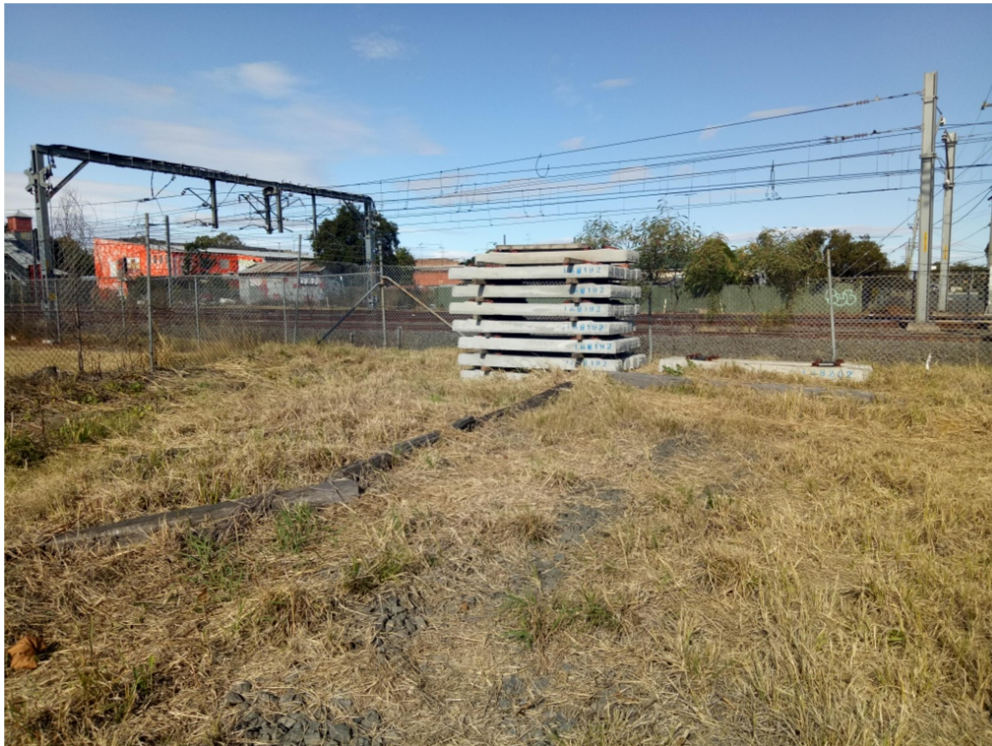
Photo (36): Existing concrete sleepers next to the boundary fence

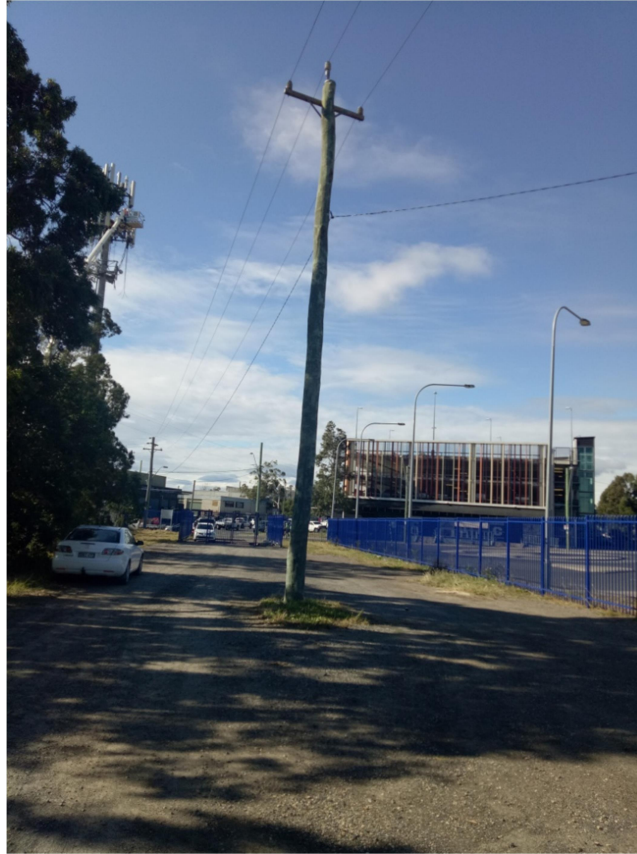
Photo (37): Existing timber power pole in the site entry from Forrester Road

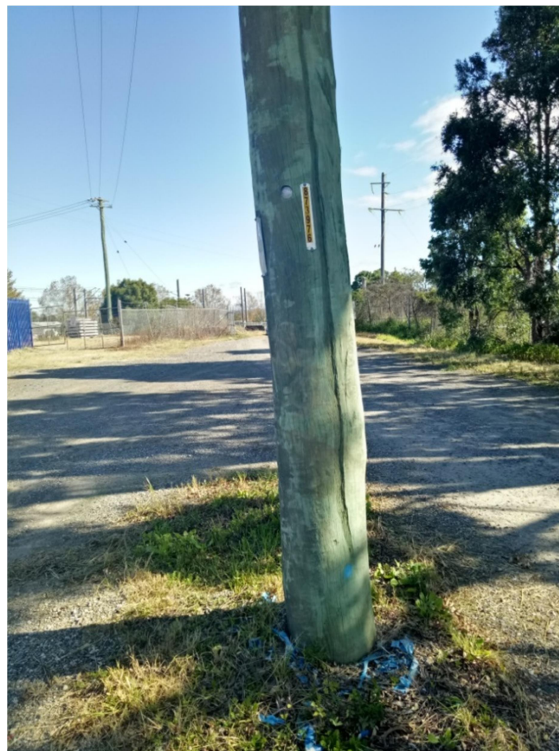
Photo (38): Existing condition of timber power pole in the site entry from Forrester Road

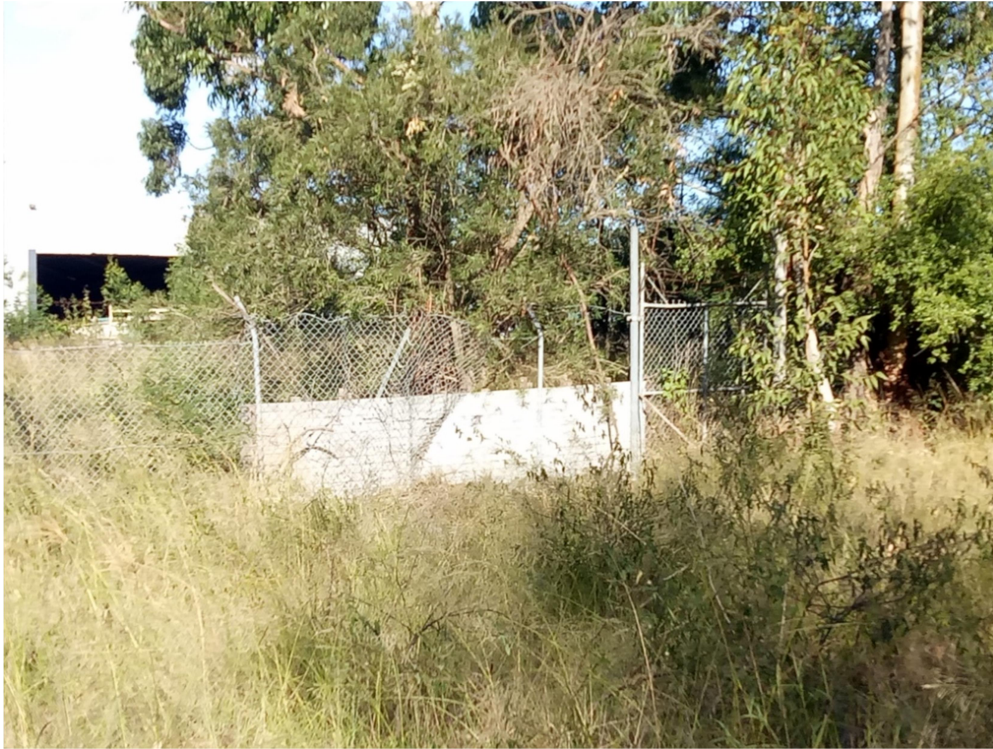
Photo (39): Existing damage in the boundary fence

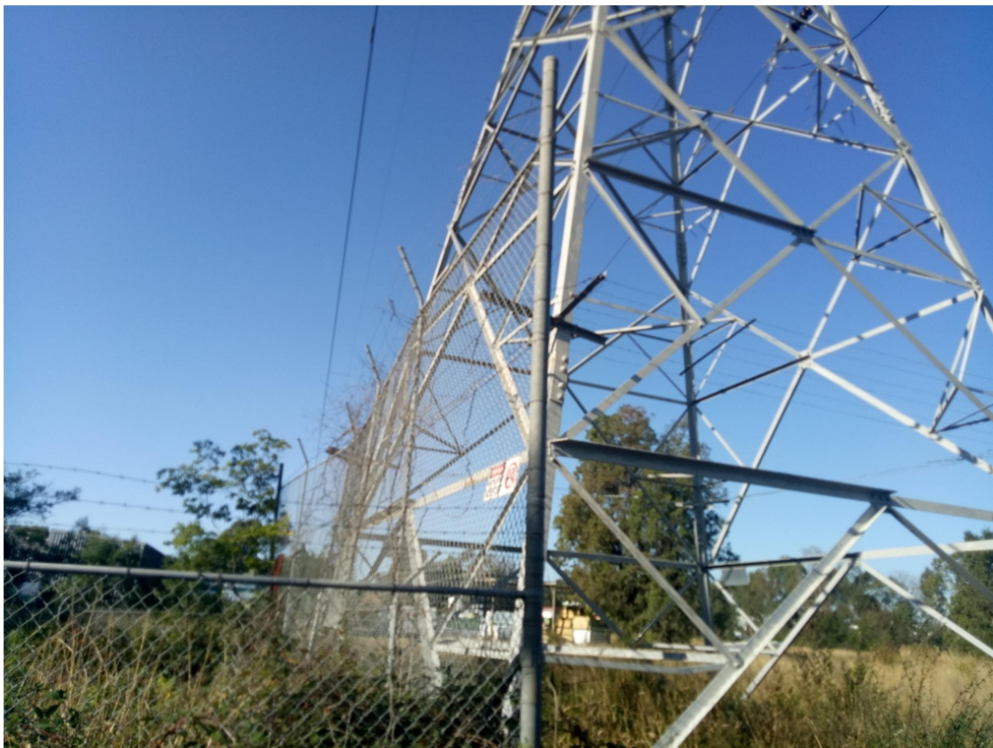
Photo (40): Existing lattice tower with poor condition fence

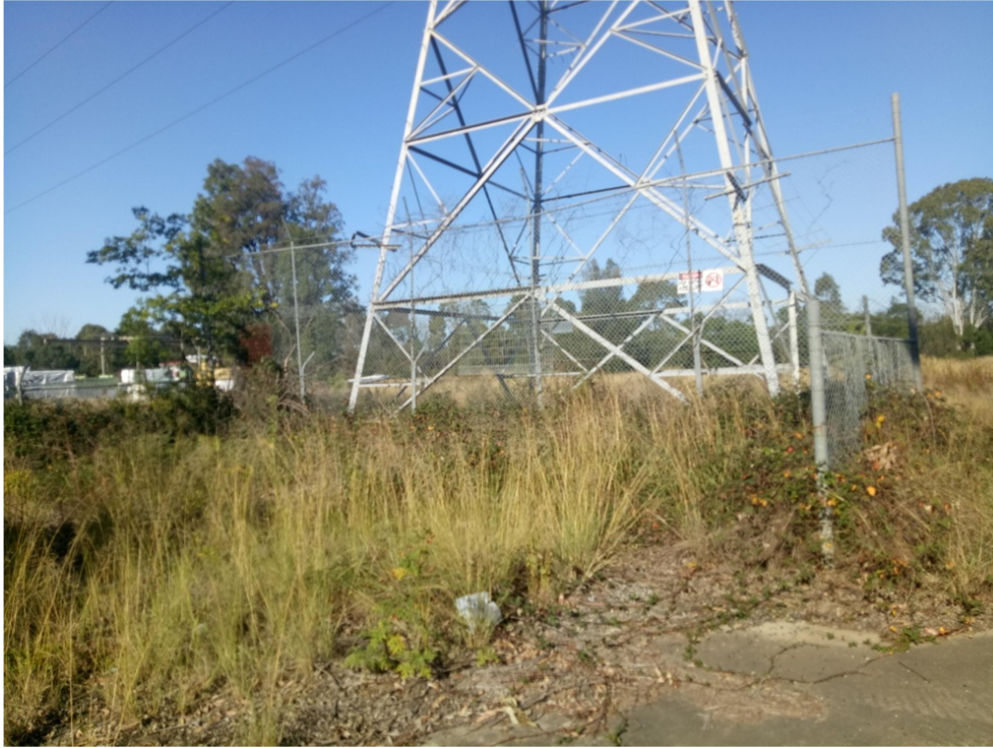
Photo (41): Existing lattice tower with poor condition fence
