ASBESTOS INSPECTION REPORT

PROPOSED TARONGA INSTITUTE

MOSMAN TARONGA ZOO SITE

Date: 12 November 2015

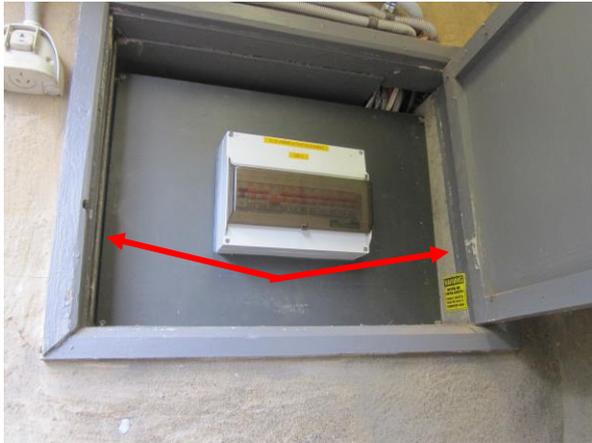
Photo 1: Old Amenities, entrance area to GEO host room, electrical distribution board NAD, cupboard lining ACM

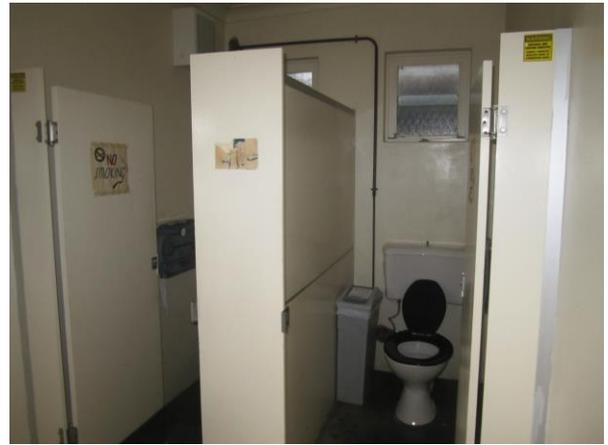
Photo 2: Old Amenities, female toilet, ACM partitions

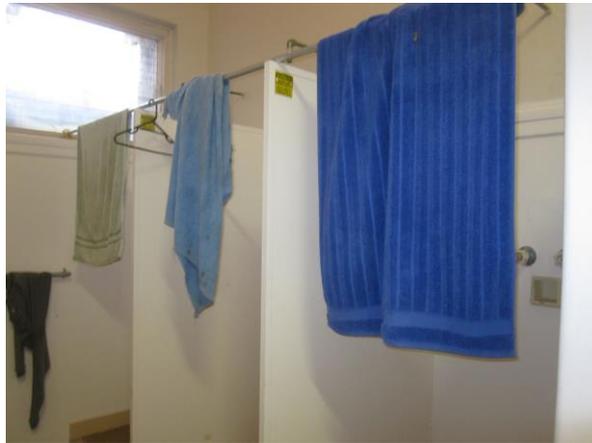
Photo 3: Old Amenities, male showers, ACM partitions

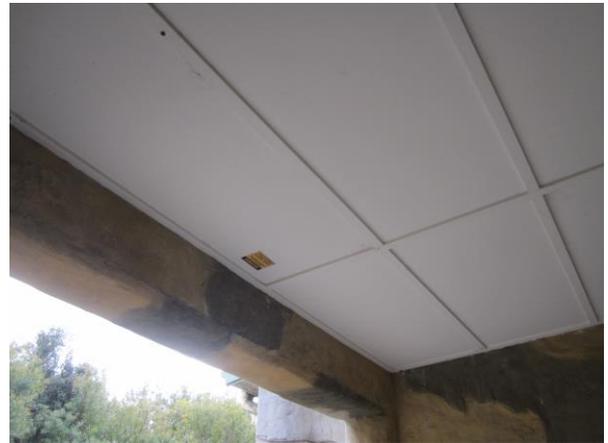
Photo 4: Records Area, entrance foyer ceiling, ACM lining

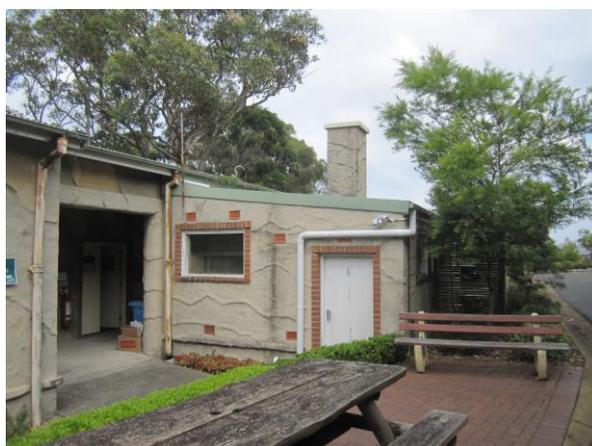
Photo 5: Old Amenities/Records, hot water heater room chimney, ACM suspected

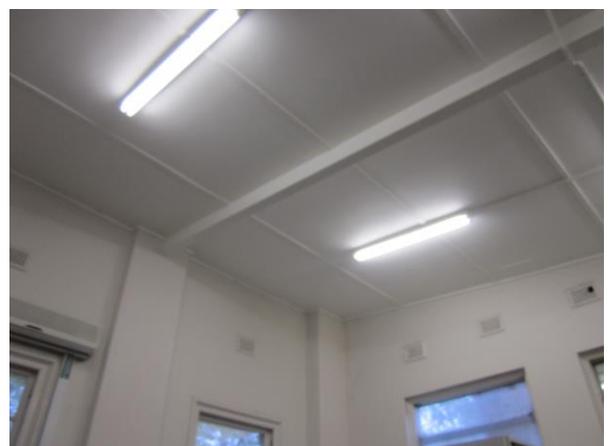
internal	records management (inc. office)	ceiling lining	fibre cement	NF	<100	stable	assumed	low	occupied	INACC	no action	R	visual inspection	6	confirmation required prior to demolition. No ACM suspected under carpet, window putty not suspected to contain asbestos.
internal	kitchen area						NAD						visual inspection		
internal	retail services area						NAD						visual inspection

Photo 6: Records Area, ceiling lining, ACM suspected

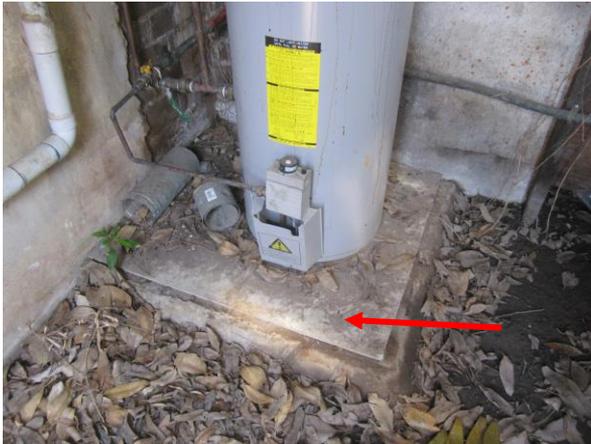
Photo 7: Old Amenities/Records, hot water heater room, ACM base

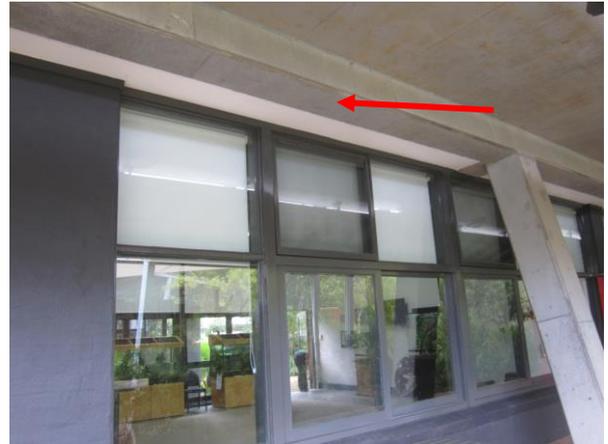
Photo 8: Education Centre, eaves, ACM suspected

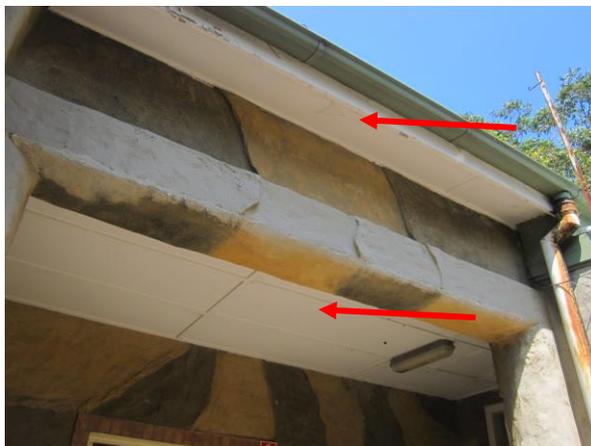
Photo 9: Education Centre, awning lining and eaves, ACM suspected

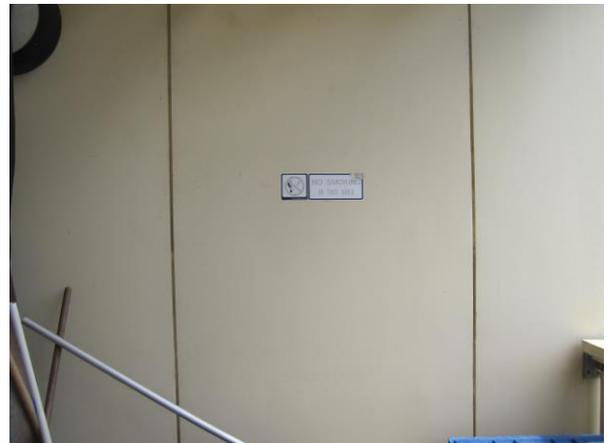
Photo 10: Education Centre, level 1 balcony walls, NAD

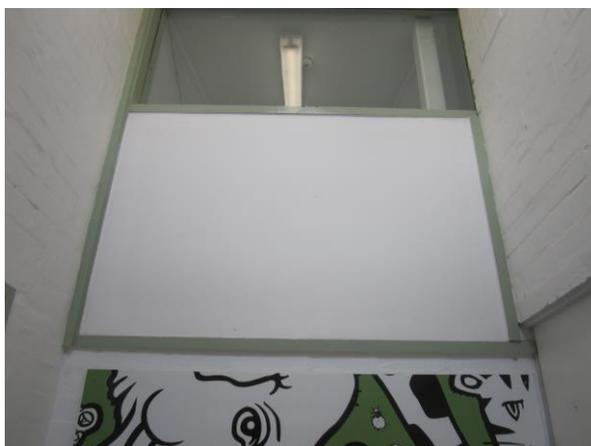
Photo 11: Education Centre, ground floor toilet window infill panel, NAD

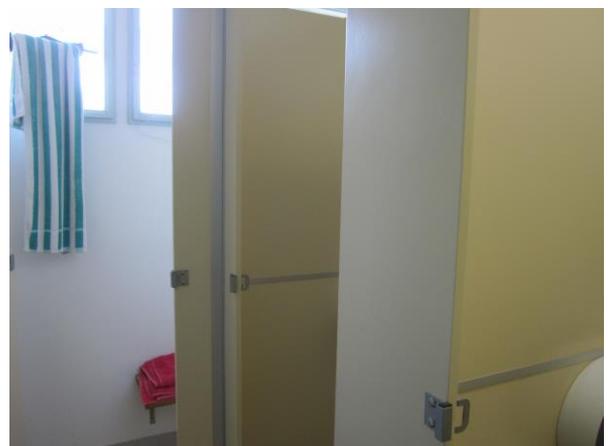
internal	level 1 toilets (male & female)	partitions	fibre cement				NAD						85239	12	photo taken in female toilets

Photo 12: Education Centre, level 1 female toilets, partitions NAD
