The University of Sydney

**000-02 Darlington Road Terraces Rear
Development**

Geotechnical Investigation

27 March 2015

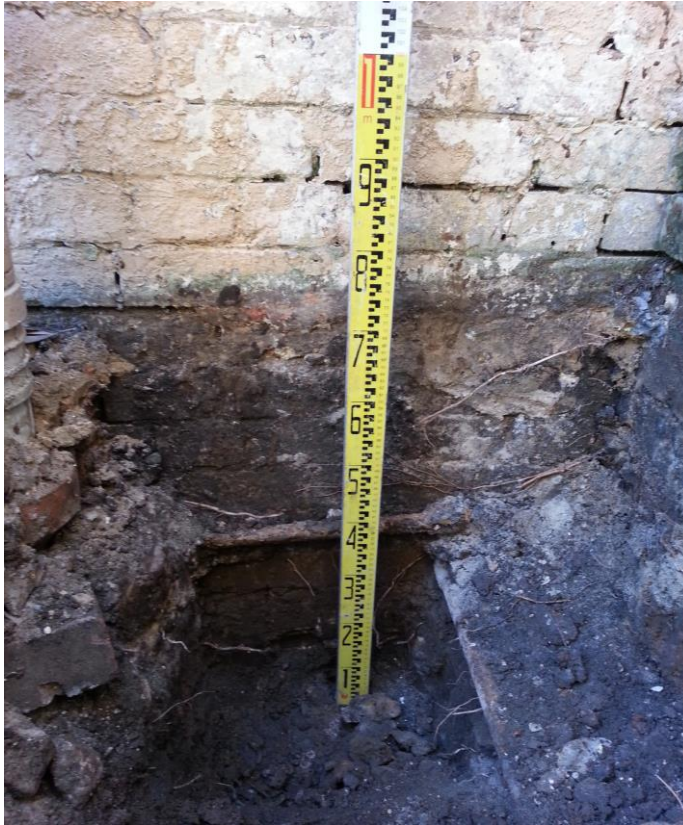
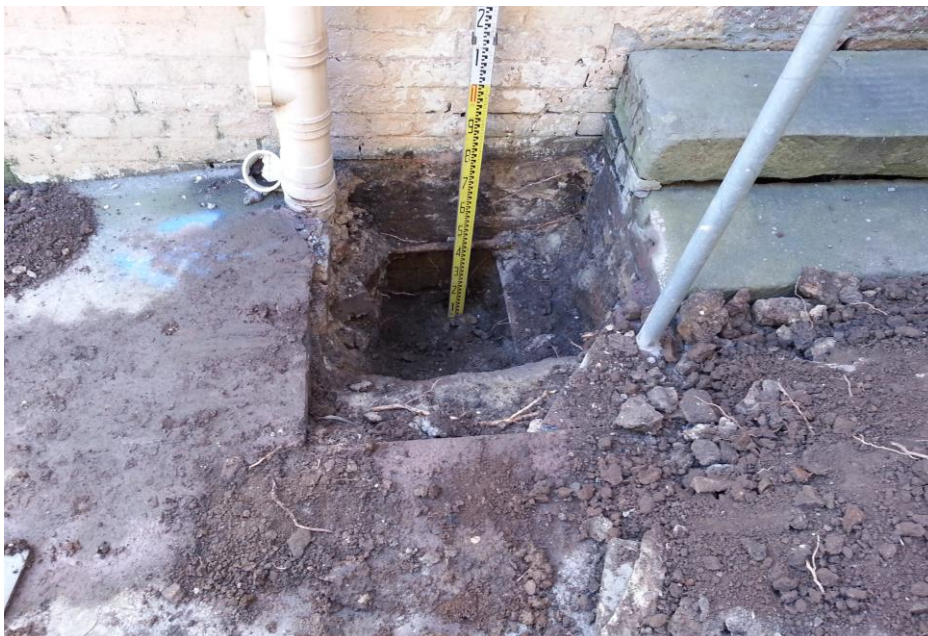
TP1 (1 of 2)

Test Pit	Footing Type	Footing Condition	Footing Depth (m)	Footing Base, RL (m AHD) ^(a)	Footing Width (m)	Material at Base of Footing
TP1	Brick	Apparent good condition	0.75	38.1	0.08	Residual Soil (Silty Clay)
TP2	Brick	Apparent good condition	0.60	37.9	0.08	
TP3 ^(b)	Paver	Poor (separation observed between pavers)	0.10	36.8	0.2 ^(e)	
TP3 ^(c)	Sandstone Block	Apparent good condition	0.90	37.6	0.2 ^(e)	
TP4	Brick	Apparent good condition	0.80	35.7	0.08	
TP5	Brick	Apparent good condition	0.60	34.4	0.08	
TP6	Brick	Apparent good condition	0.5	32.6	0.08

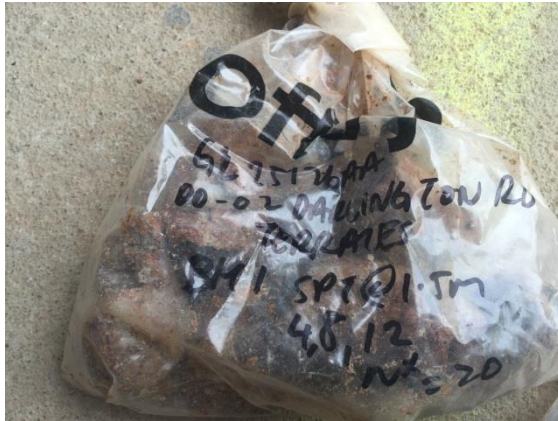
BH1 – 1.5m (IMG_3054.JPG)

- Seepage of water was observed in BH1 and BH3 within the Residual Soil, i.e. near the soil / bedrock interface.
- Groundwater was observed in the Shale slightly below the Residual Soil, at RL 34.8 m AHD (3.2 m below ground surface) and RL 30.8 m AHD (4.2 m below ground surface) in boreholes BH1 and BH4, respectively.
