## Conservation Management Plan for Terrace Houses at Nos. 95-96 and 98-103 Darlington Road, Darlington

Prepared By:  
Janice Hogg  
Stela Rahman  
Mia Langejans  
Daniel O'Keefe  
Fatin Atiqah Abu Othman

June 2008

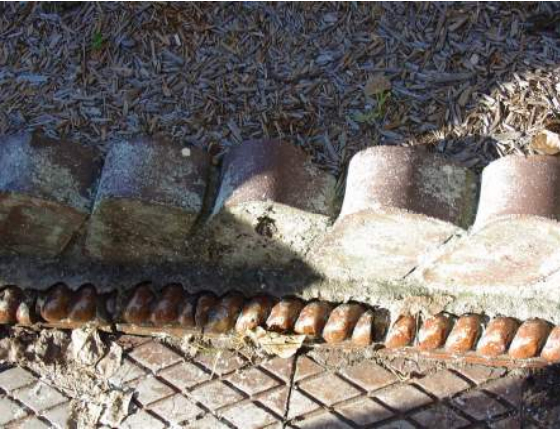
<p><b>Figure 4.5.</b> Original barley twist style edging tiles are visible beside new taller edging tiles in front of terrace No. 98 Darlington Road. (Source: Janice Hogg, April 2008.)</p>

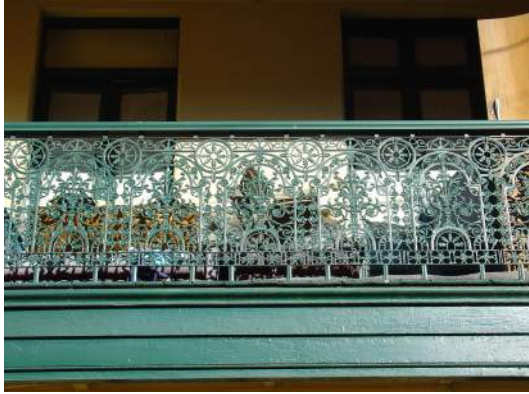
Alteration	Image
<p>Only terrace Nos. 95, 99, 102, and 103 have their original Victorian lace veranda decor. The other terraces have either replacement cast iron lace of a different pattern or replacement aluminium lace.</p>

<p><b>Figure 4.11.</b> Replacement aluminium lace on terrace No. 96 Darlington Road. (Source: Janice Hogg, April 2008.)</p>
<p>Small tin garden sheds have been added to the back yard landscape of the terraces.</p>

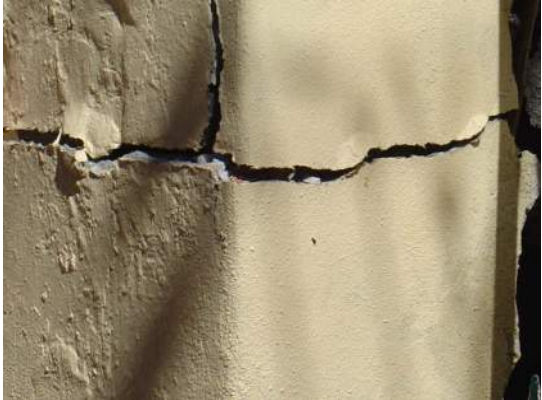
Fabric Condition	Image
<p>Damage is evident in the external render. This could also be possibly caused by subsidence of the foundation.</p>

<p><b>Figure 4.16.</b> Cracks in render of terrace No. 103 Darlington Road. (Source: Janice Hogg, April 2008.)</p>
<p>The tiles are in rough shape on some of the verandahs as there are several missing tiles and some of the tiles are lifting off of the verandah. The original tiles are for the most part still present; however they are not necessarily affixed to the verandahs.</p> <p>The tessellated pattern is still distinguishable and present on many of the verandahs. Many of the original tiles are present and affixed.</p>

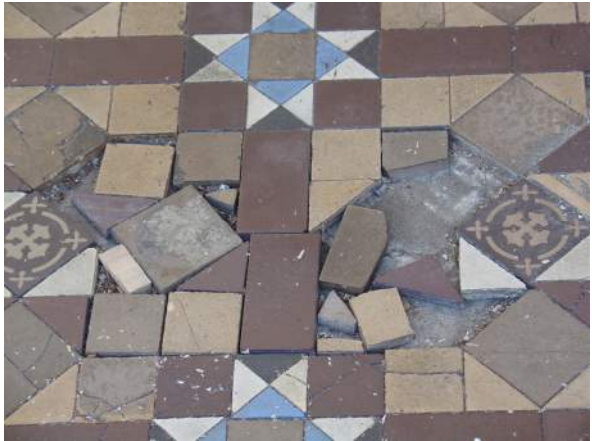
<p><b>Figure 4.17.</b> Lifting and missing encaustic tessellated tiles in front of terrace No. 96 Darlington Road. (Source: Janice Hogg, April 2008.)</p>

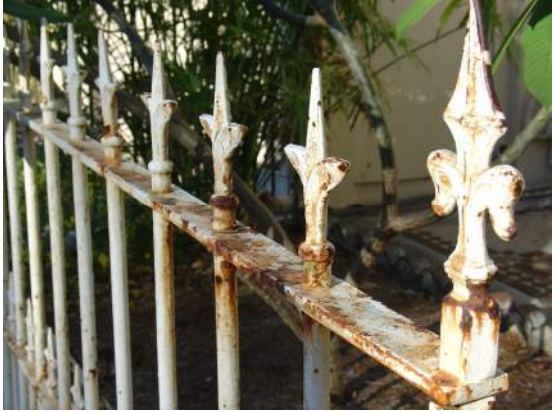
Fabric Condition	Image
<p>The wrought iron fencing generally in good condition with the finials present on all fences except the fence in front of terrace No. 100 Darlington Road. Some of the fencing is rusting and missing paint. The fence is painted dark green in front of all terraces in the row except for terrace No. 98 which is painted white.</p>

<p><b>Figure 4.18.</b> Rusting and missing paint on fencing in front of terrace No. 98 Darlington Road. (Source: Janice Hogg, April 2008.)</p>
<p>Major cracks in the concrete slabs of the backyard are visible. The most likely cause would be laying concrete over an uneven surface, causing the slab to crack and break over time.</p>

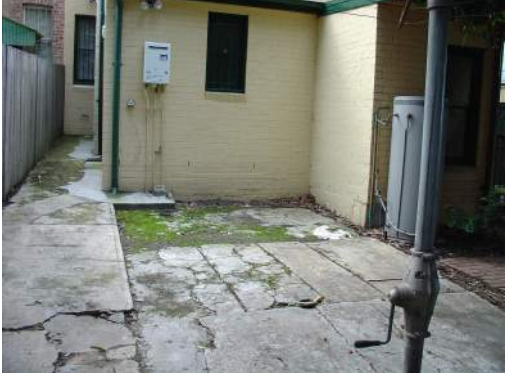
<p><b>Figure 4.19.</b> Cracks in paving behind terrace No. 101 Darlington Road. (Source: Janice Hogg, April 2008.)</p>

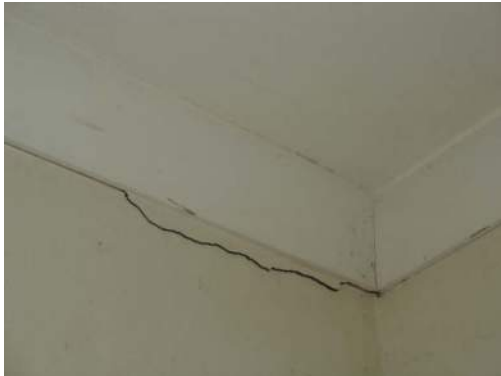
Interior Element	Image
<p>Many of the terraces have retained their original mouldings and joinery. The joinery has been kept in good condition.</p> <p>Some cracking in some of the walls is evident as seen in the photograph</p>

<p><b>Figure APP.4.0.</b> Joinery and cracks in the walls of terrace No. 100 Darlington Road. (Source: Janice Hogg, April 2008).</p>
<p>The fireplaces have been treated very differently in each house. Some of the houses have completely covered the fireplaces while others have preserved an illusion of a functioning fireplace; however none of the viewed houses presently have functioning fireplaces.</p>

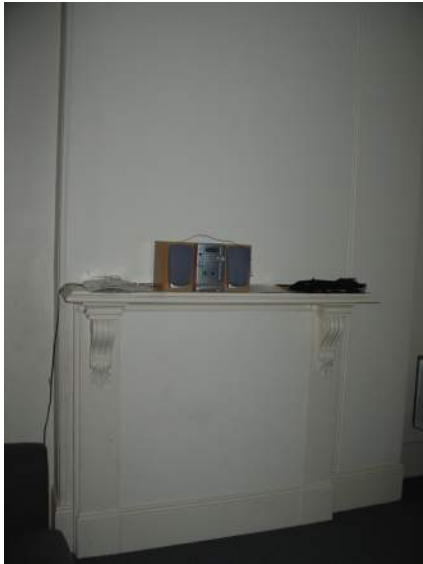
<p><b>Figure APP.4.1.</b> A covered fireplace in terrace No.103 Darlington Road. (Source: Janice Hogg, April 2008).</p>

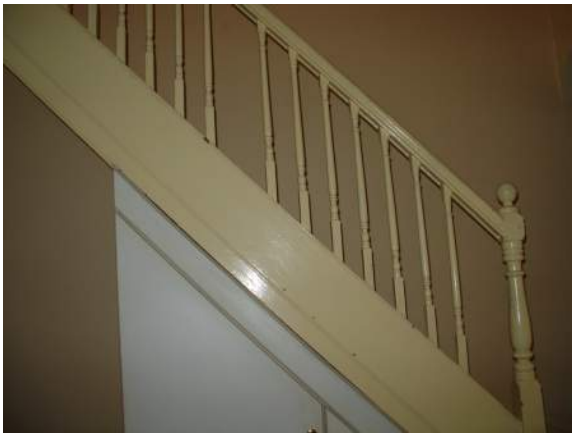
<p><b>Figure APP.4.3.</b> Staircase with missing banister rungs in terrace No. 101 Darlington Road. (Source: Janice Hogg, April 2008).</p>

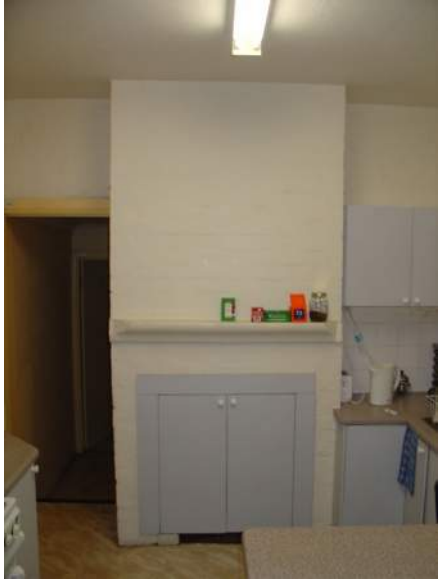
<p><b>Figure APP.4.6.</b> An old fireplace retrofitted as cupboards in terrace No. 101 Darlington Road. (Source: Janice Hogg, April 2008).</p>
<p>In some of the terraces, ceiling rosettes have been retained and add an elegant touch to the interior.</p>
