**THE UNIVERSITY OF SYDNEY
DARLINGTON ROAD TERRACES
(14051)**

**9610
TERRACES EXTERNAL CONDITION
PROPOSED CONSERVATION SCHEDULE**

A visual façade inspection of the Darlington Road Terraces was conducted on 29/07/16 by AJ+C. There are 38 terraces in total, photographs of each terraces north façade and close ups to highlight their existing conditions and areas where repair work will be required.

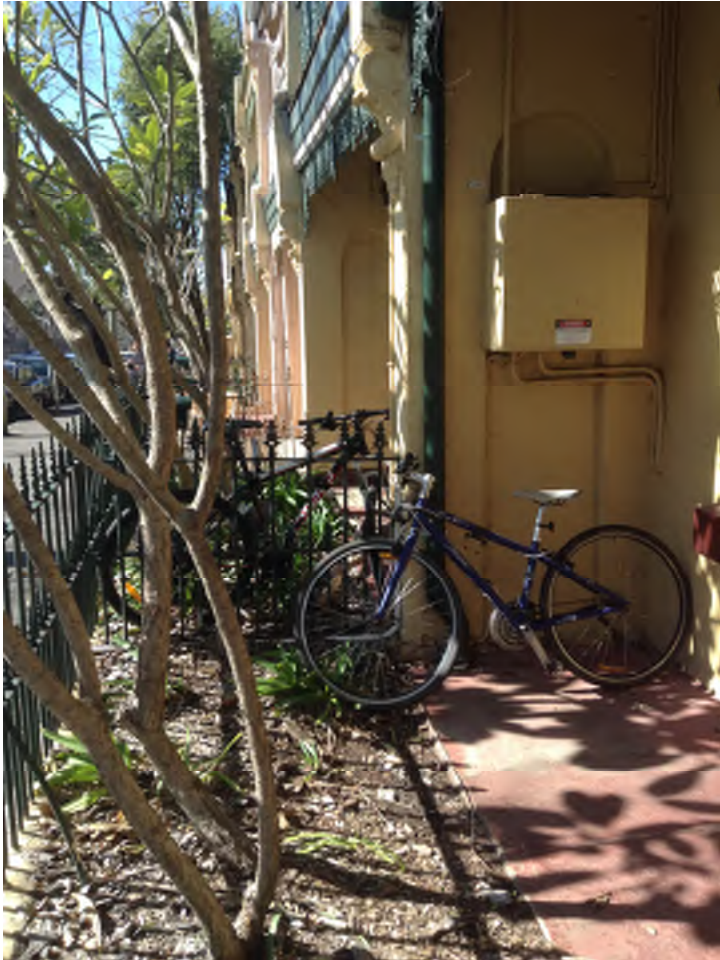
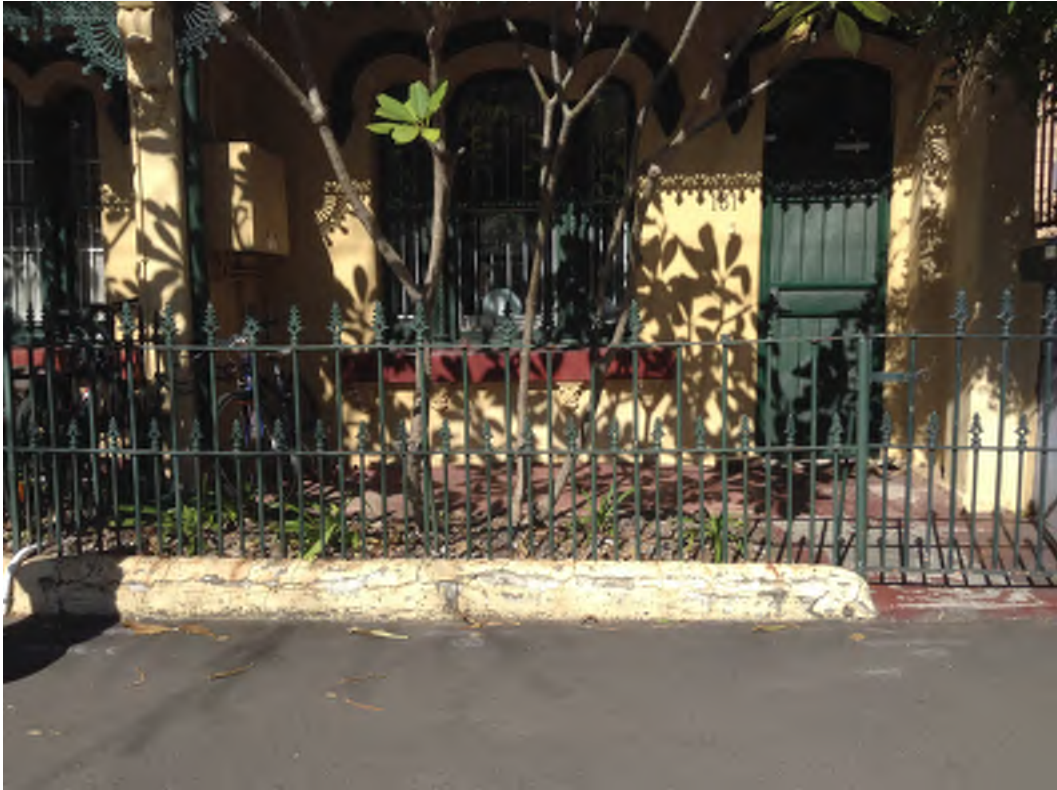
TERRACE NO.	PHOTOS	
131

TERRACE NO.	ELEMENTS	CONDITIONS	COMMENTS	PHOTOS
131	1. Front fence + base and gate	B	Some finials on the fence are missing. Allow for replace to match.

2. Entry path	A		
	3. Garden	A		
	4. Porch	B		
	5. Doors and Windows	A		
	6. External walls	A		
	7. Verandah	A	Allow for removal of verandah gutter.	
	8. Balustrade	A		
	9. Gutters and downpipes	B		
	10. Roof sheeting	A

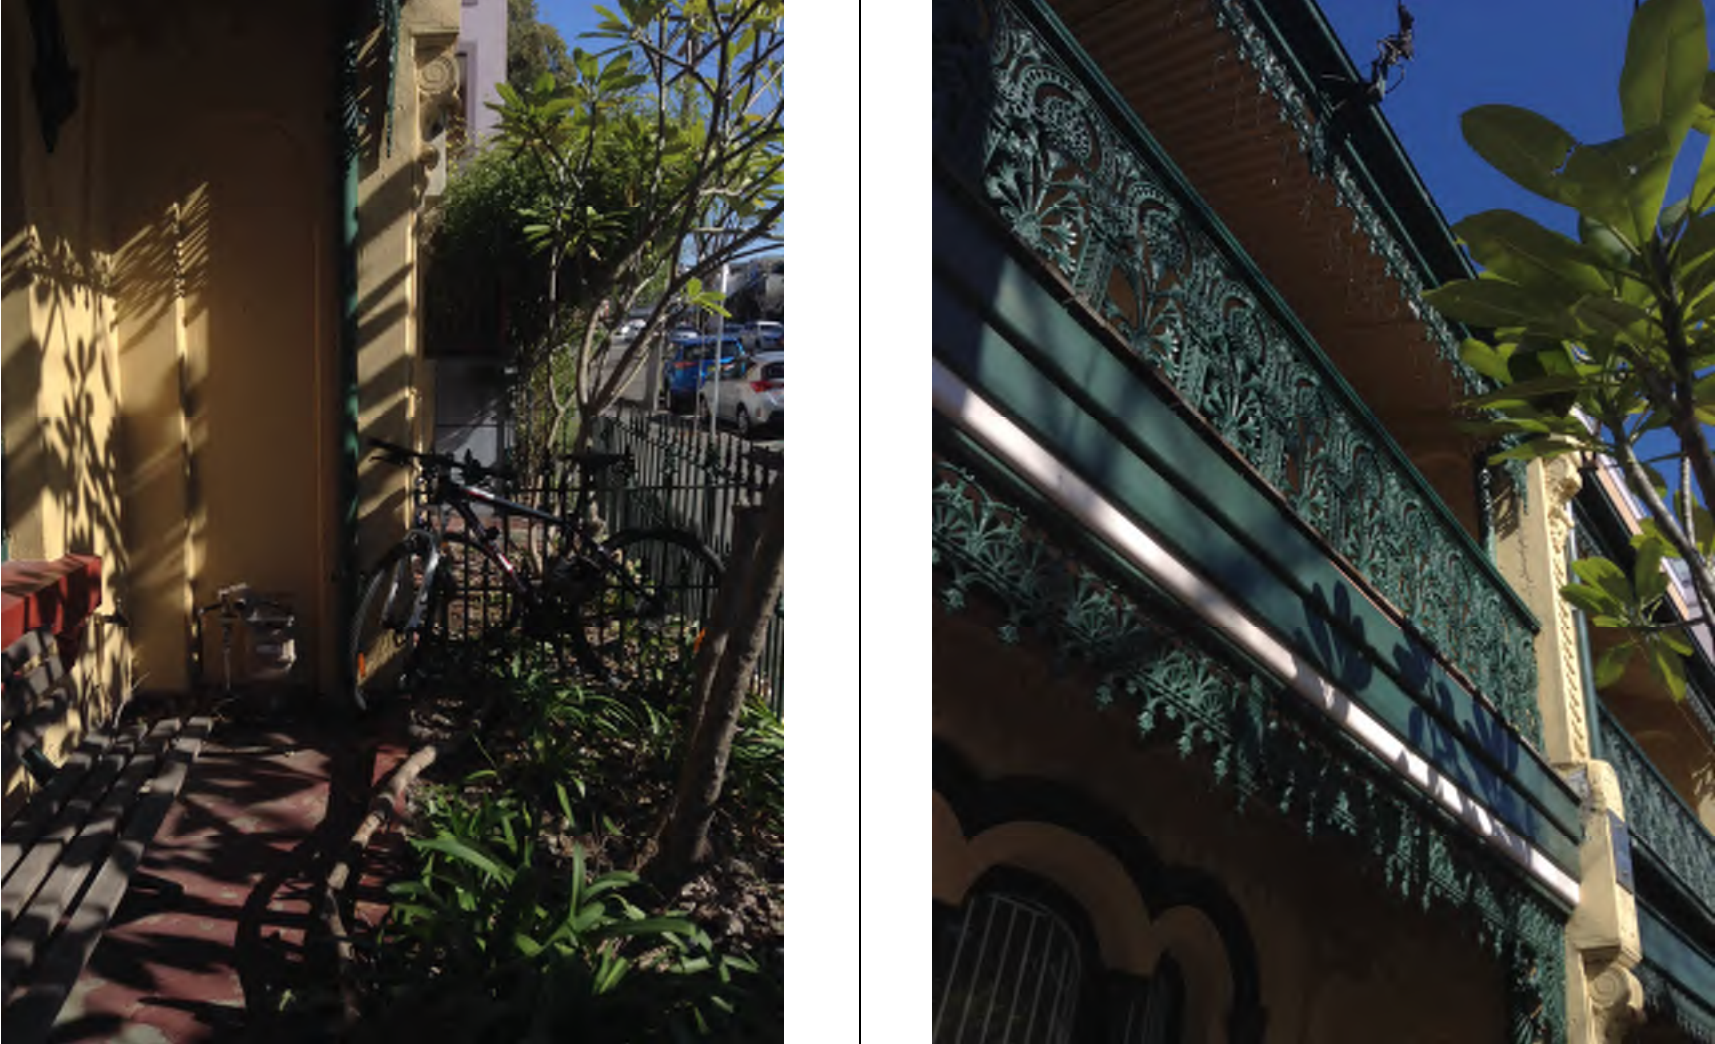
TERRACE NO.	PHOTOS
130

TERRACE NO.	ELEMENT	CONDITIONS	COMMENTS	PHOTOS
130	1. Front fence + base and gate	A	Some finials on the fence are missing. Allow for replace to match.

2. Entry path	A		
	3. Garden	A		
	4. Porch	B		
	5. Doors and Windows	A		
	6. External walls	A		
	7. Verandah	A		
	8. Balustrade	A		
	9. Gutters and downpipes	B		
	10. Roof sheeting	B

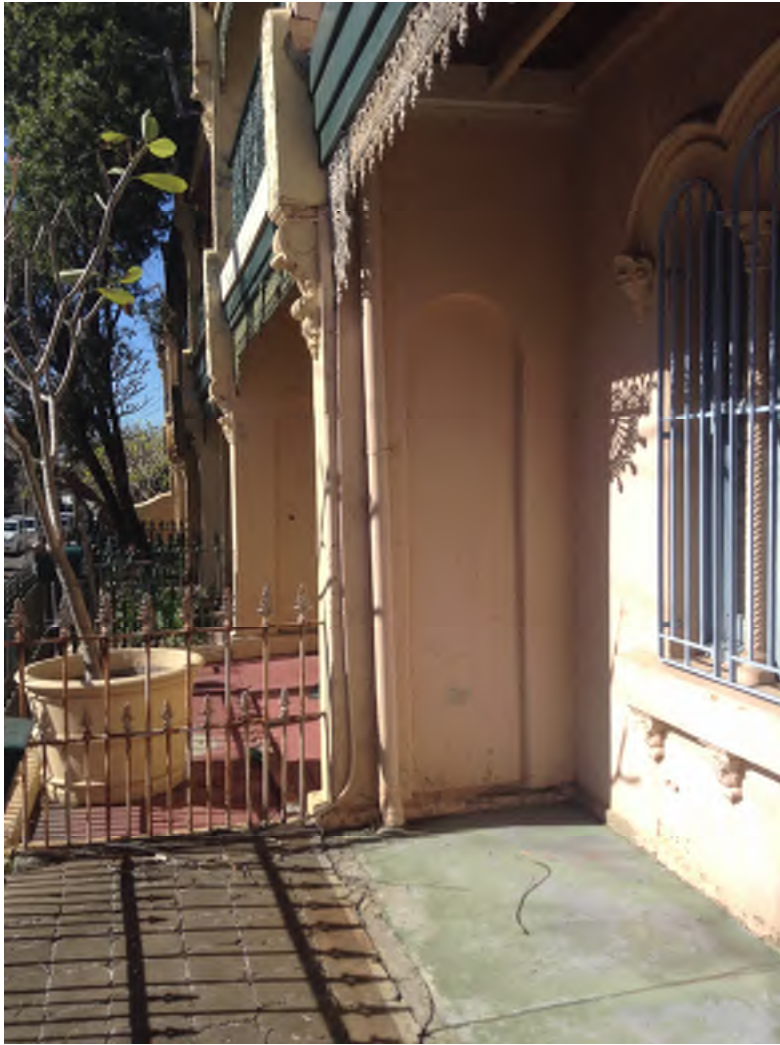
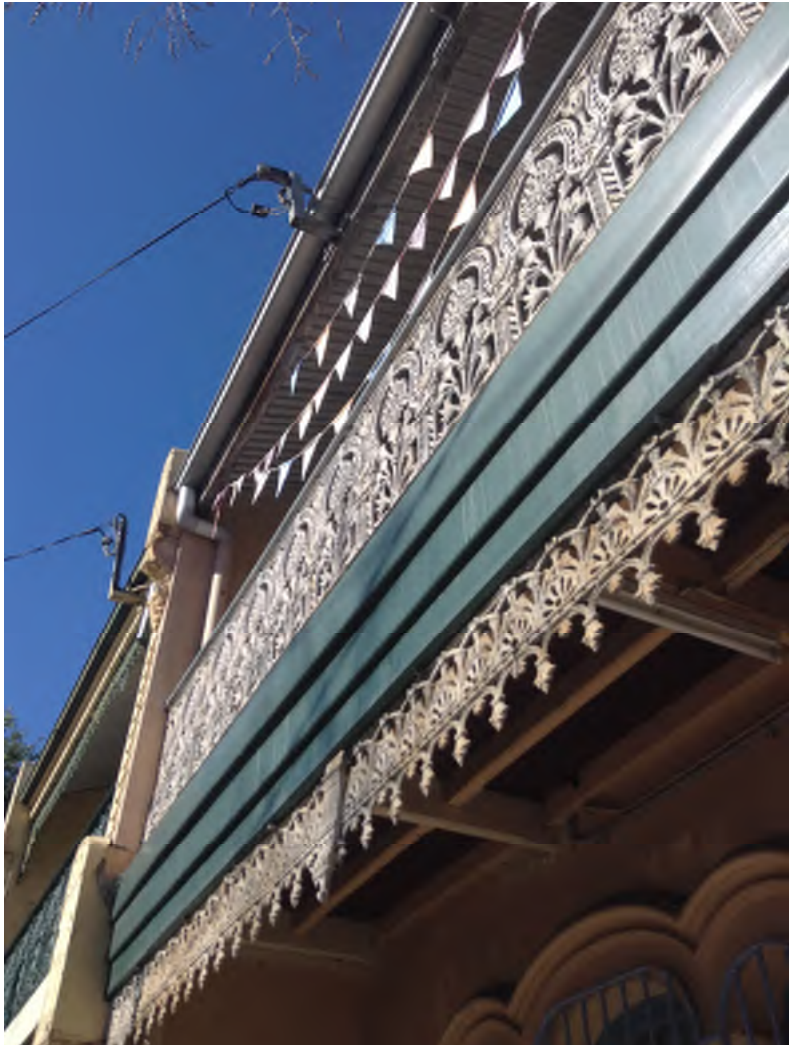
TERRACE NO.	PHOTOS	
129

TERRACE NO.	ELEMENT	CONDITIONS	COMMENTS	PHOTOS
129	1. Front fence + base and gate	B	Some mid vertical post with finials on the fence are missing. Gate missing latch. Allow for replace to match.

2. Entry path	A		
	3. Garden	B		
	4. Porch	A		
	5. Doors and Windows	A		
	6. External walls	A		
	7. Verandah	A		
	8. Balustrade	A		
	9. Gutters and downpipes	B		
	10. Roof sheeting	B

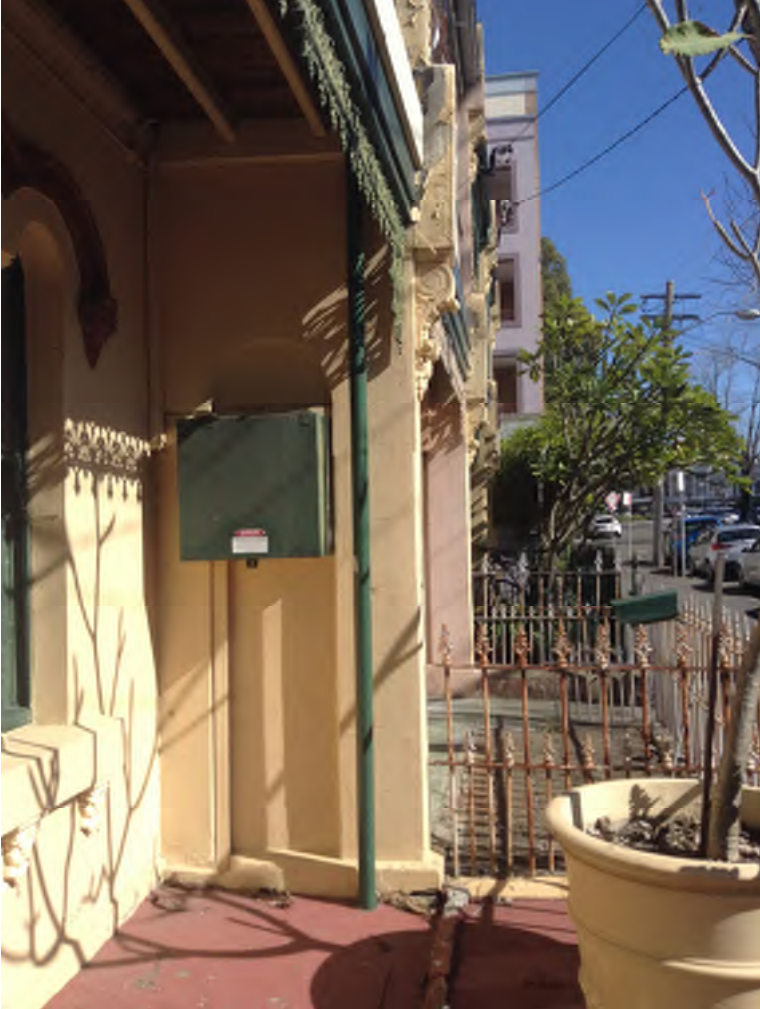
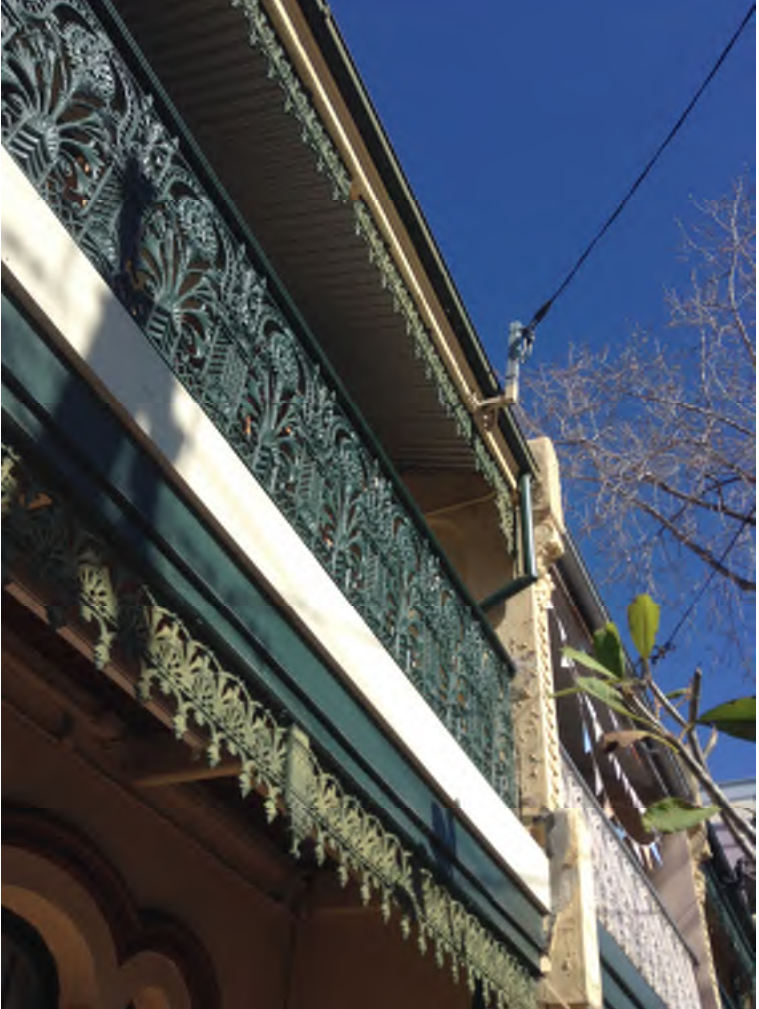
TERRACE NO.	PHOTOS	
128

TERRACE NO.	ELEMENT	CONDITIONS	COMMENTS	PHOTOS
128	1. Front fence + base and gate	B	Some finials on the fence are missing. Allow for replace to match.

2. Entry path	A		
	3. Garden	B	Landscape architect to advise if existing tree in pot to be retained and replanted in new garden bed?	
	4. Porch	A		
	5. Doors and Windows	A		
	6. External walls	A		
	7. Verandah	A		
	8. Balustrade	A	Some lace work missing, allow for replace to match.	
	9. Gutters and downpipes	B		
	10. Roof sheeting	B

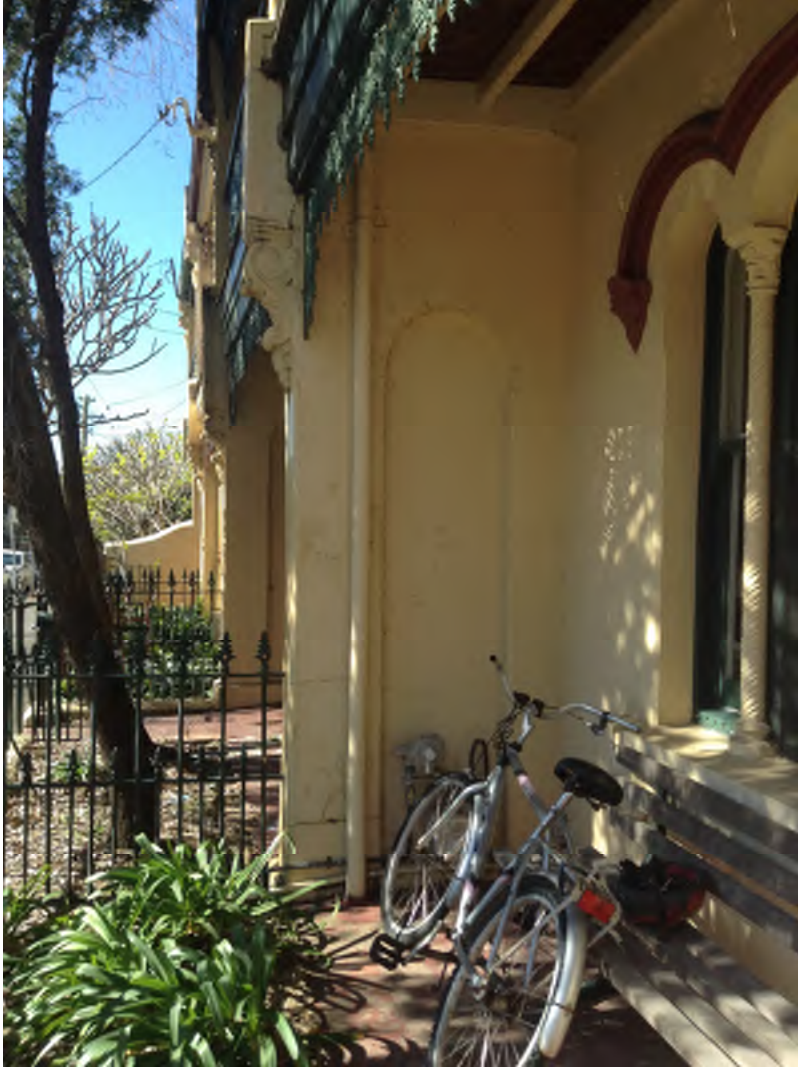
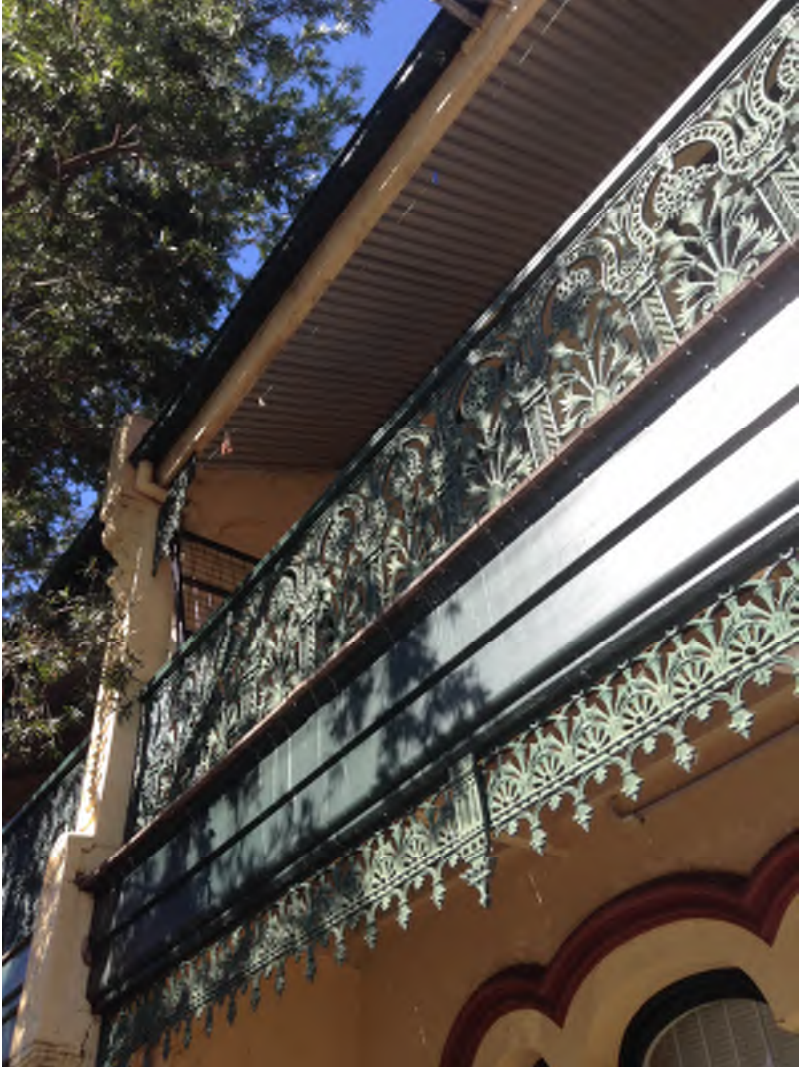
TERRACE NO.	PHOTOS	
127

TERRACE NO.	ELEMENT	CONDITIONS	COMMENTS	PHOTOS
127	1. Front fence + base and gate	A	Some finials on the fence are missing. Allow for replace to match.

2. Entry path	A		
	3. Garden	A		
	4. Porch	A		
	5. Doors and Windows	A		
	6. External walls	B	Allow for repair of crack in party wall between No.126. (see photo below)- refer to engineer's detail.	
	7. Verandah	A		
	8. Balustrade	A	Upper level lace work missing, allow for new to match.	
	9. Gutters and downpipes	B		
	10. Roof sheeting	B

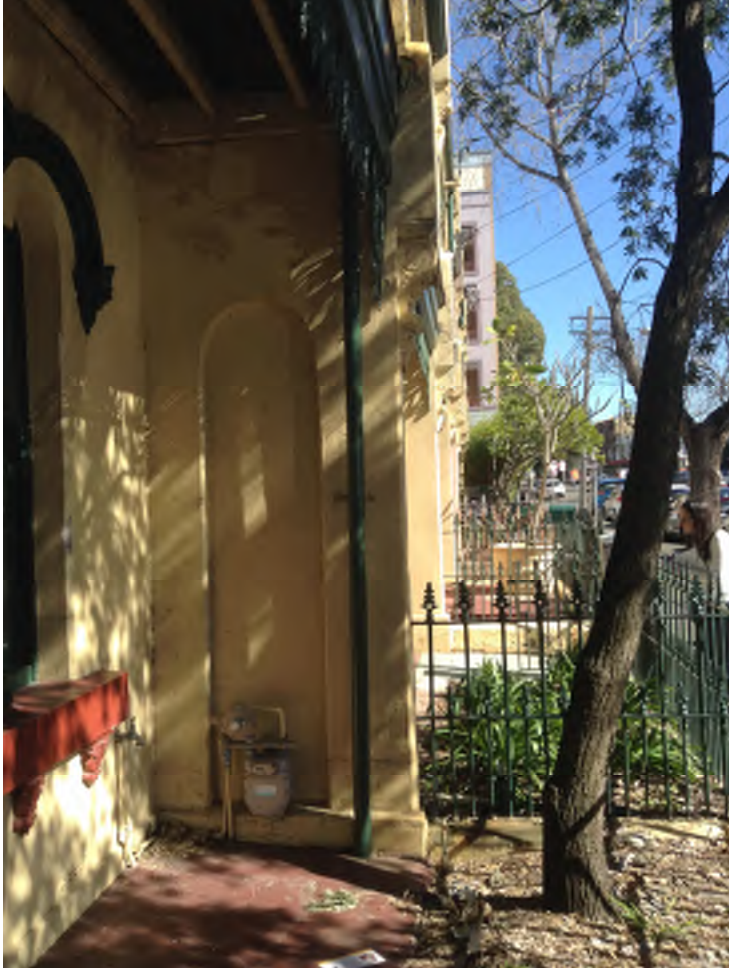
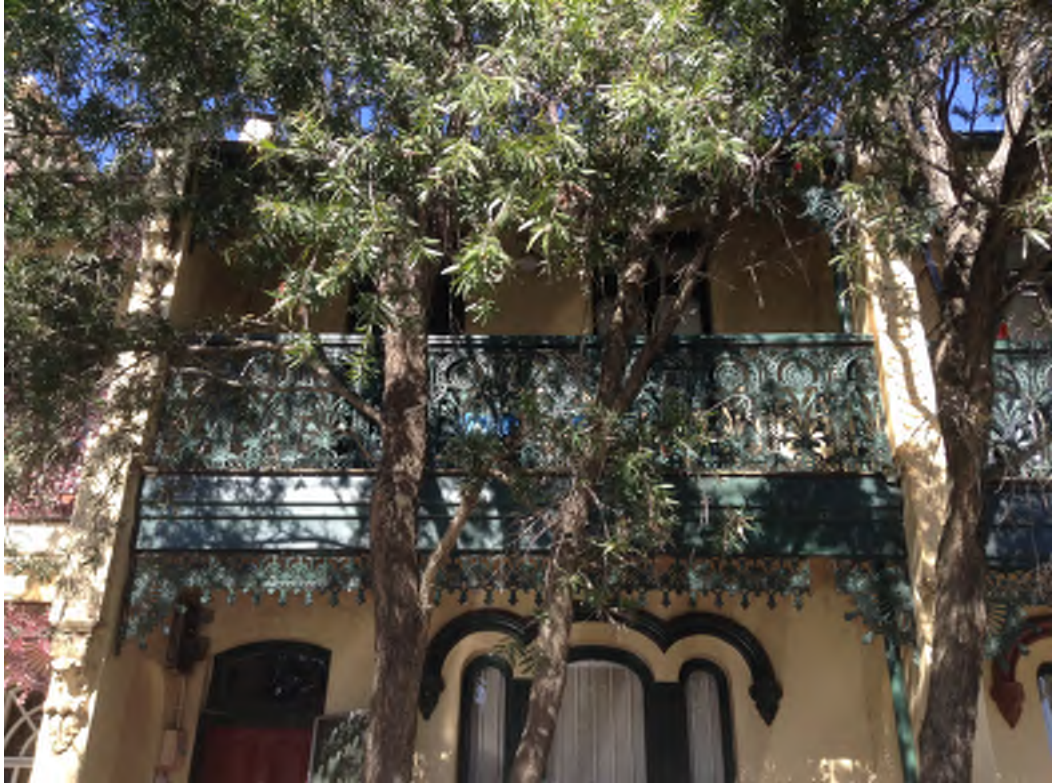
TERRACE NO.	PHOTOS	
126

TERRACE NO.	ELEMENT	CONDITIONS	COMMENTS	PHOTOS
126	1. Front fence + base and gate	B	Some finials on the fence and mid vertical post are missing. Allow for replace to match.

2. Entry path	A		
	3. Garden	A	Allow for removal of 2 trees.	
	4. Porch	A		
	5. Doors and Windows	A		
	6. External walls	B	Allow for repair of crack in party wall between No.127. (see photo below)- refer to engineer's detail.	
	7. Verandah	A		
	8. Balustrade	A	Ground level lace work missing, allow for replace to match.	
	9. Gutters and downpipes	B	All for new fascia board.	
	10. Roof sheeting	B

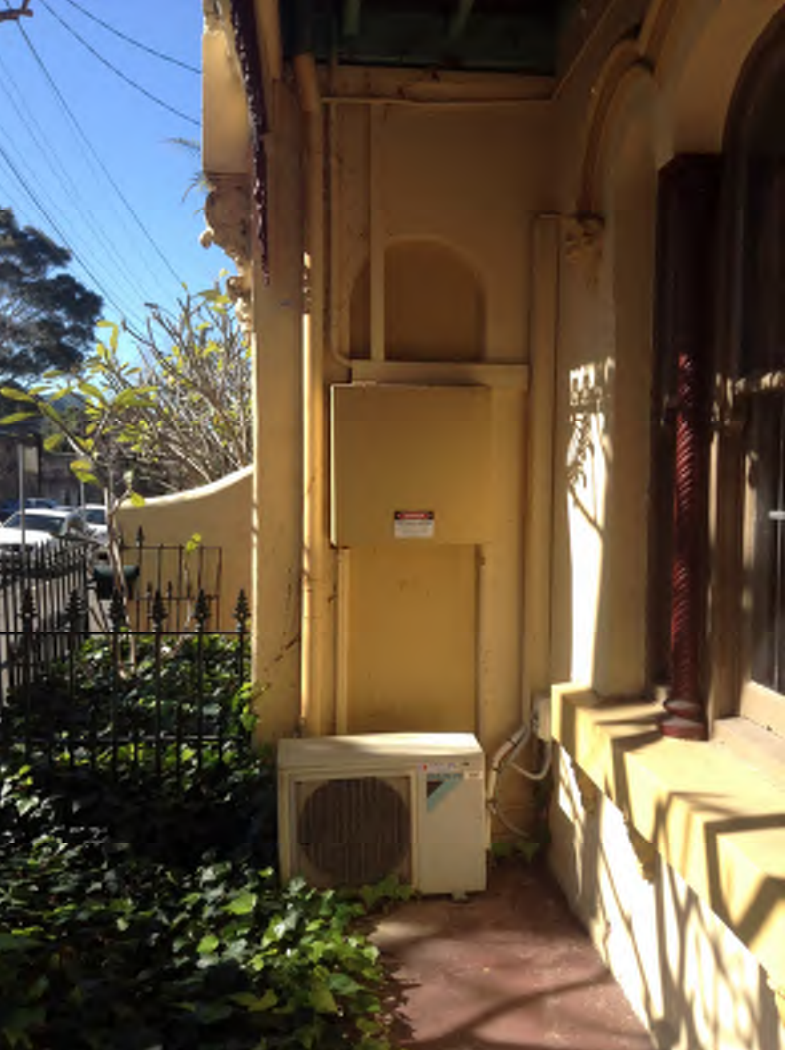
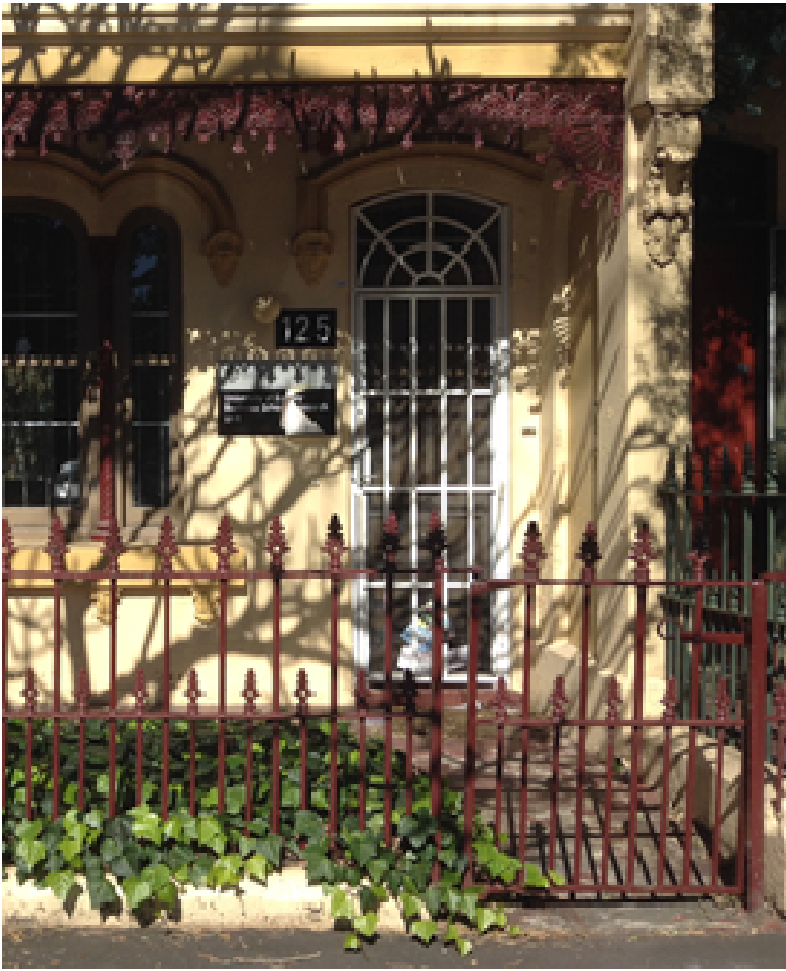
TERRACE NO.	PHOTOS	
125

TERRACE NO.	ELEMENT	CONDITIONS	COMMENTS	PHOTOS
125 *	1. Front fence + base and gate	B	Remove portion of existing fence and all associated components to allow for 850mm clear opening. Remove party fence between No. 124. Refer to drawing for detail.

2. Entry path	B	Remove existing path, to allow for new accessible path. Refer to drawing for detail.	
	3. Garden	B	Remove existing tree to allow for new accessible ramp path. Refer to drawing for detail.

4. Porch	B	Remove portion of porch to allow for wheel chair turning circle at gate. Refer to drawing for detail.	
	5. Doors and Windows	A	Allow for removal of wrought iron security door and replace for new wrought iron security door to match Terrace no. 124.

6. External walls	A	Remove A/C unit and handover to University for storage.	
	7. Verandah	A		
	8. Balustrade	A	Upper level lace work missing, allow for replace to match.

9. Gutters and downpipes	B		
	10. Roof sheeting	B

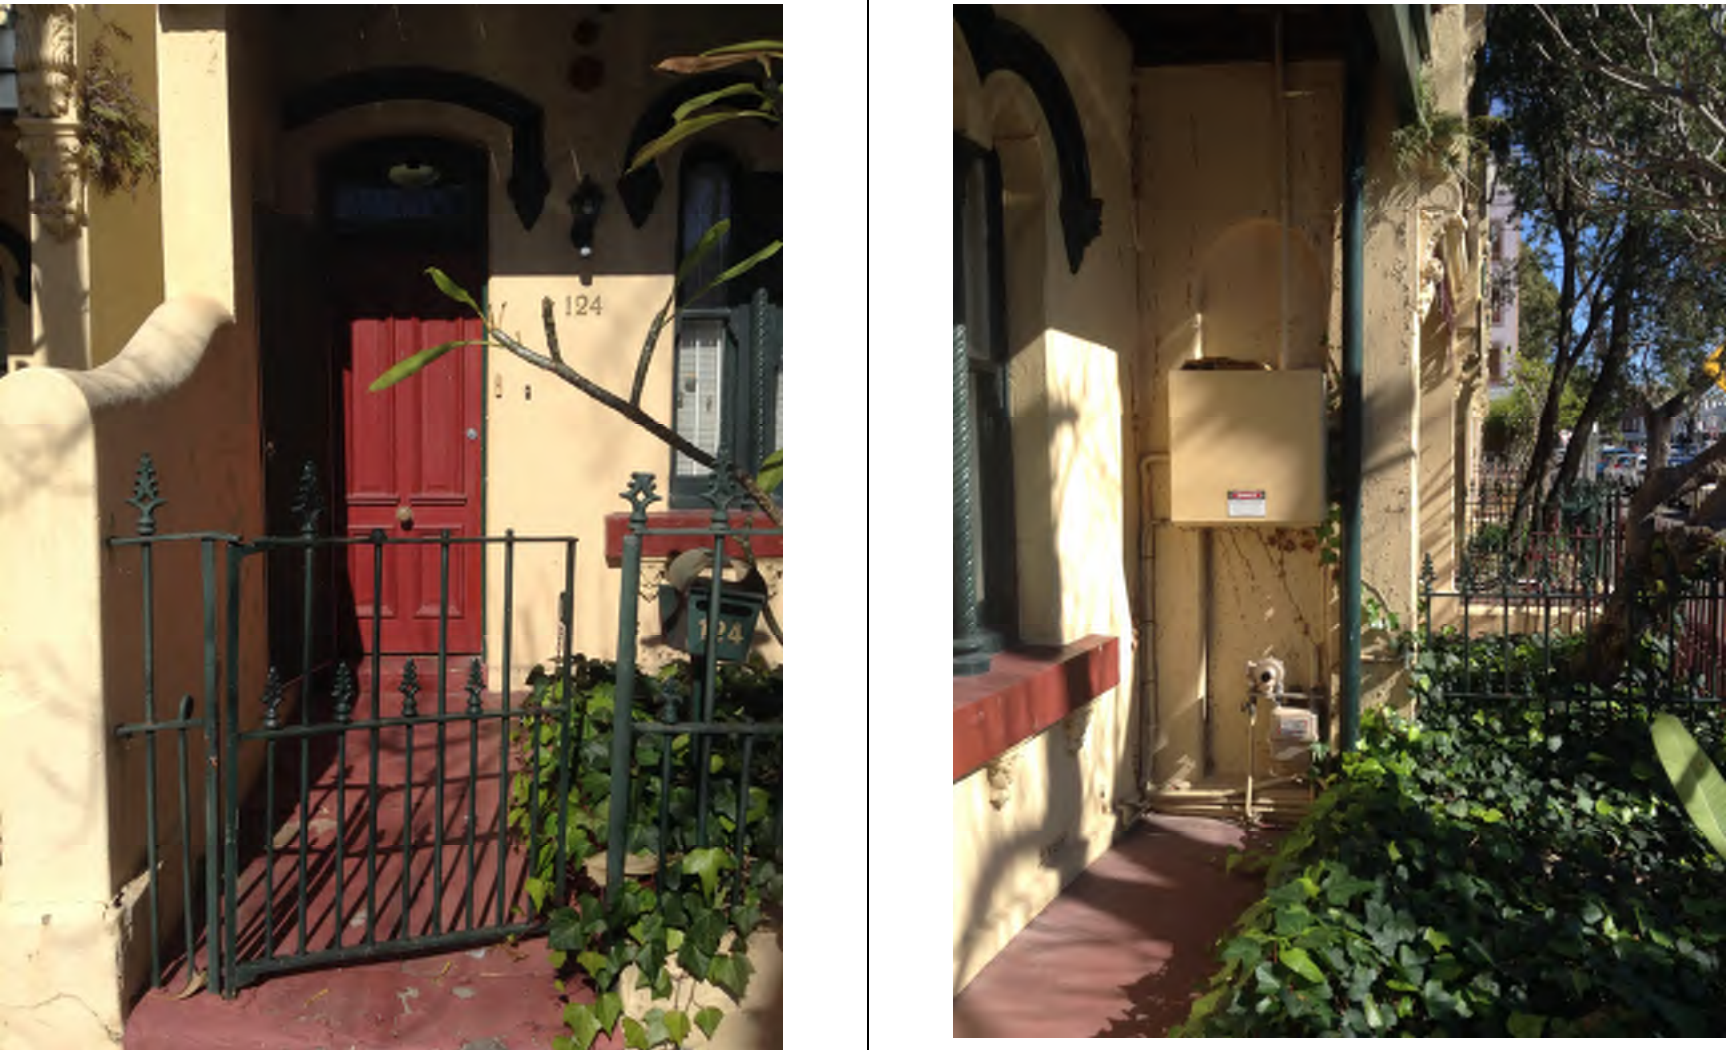
TERRACE NO.	PHOTOS
124

TERRACE NO.	ELEMENT	CONDITIONS	COMMENTS	PHOTOS
124 *	1. Front fence + base and gate	B	Block gate, allow for new accessible ramp path to continue through from Terrace No.125. Refer to drawing for detail.

2. Entry path	B	Remove existing path, allow for new accessible path to entry door. Refer to drawing for detail.	
	3. Garden	B	Allow for new accessible ramp path to continue through from Terrace No.125. Refer to drawing for detail.

4. Porch	B	Remove porch to allow for wheel chair turning circle at ramp landing to entry door. Refer to drawing for detail.	
	5. Doors and Windows	B	Remove front door + screen door and portion of existing wall to install new door and frame for wheel chair access. Refer to drawing for detail.

9. Gutters and downpipes	B		
	10. Roof sheeting	B

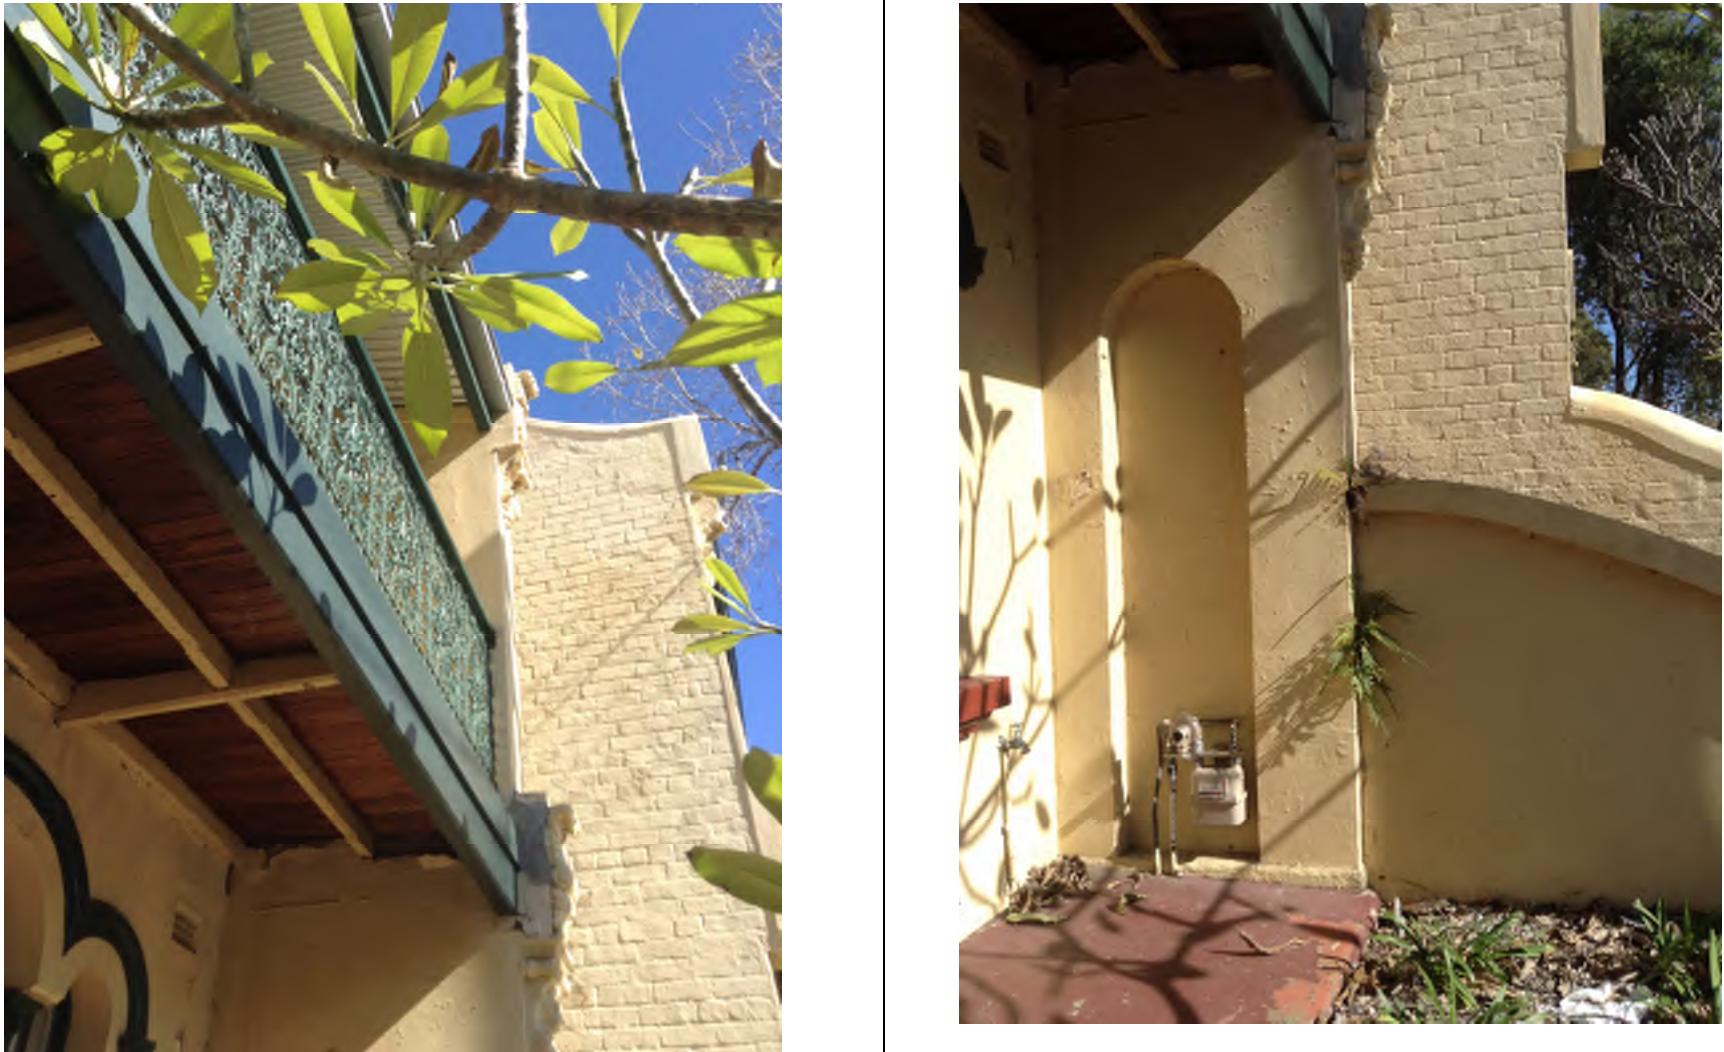
TERRACE NO.	PHOTOS
123

TERRACE NO.	ELEMENT	CONDITIONS	COMMENTS	PHOTOS
123	1. Front fence + base and gate	A	Some finials on the fence are missing. Allow for replace to match.

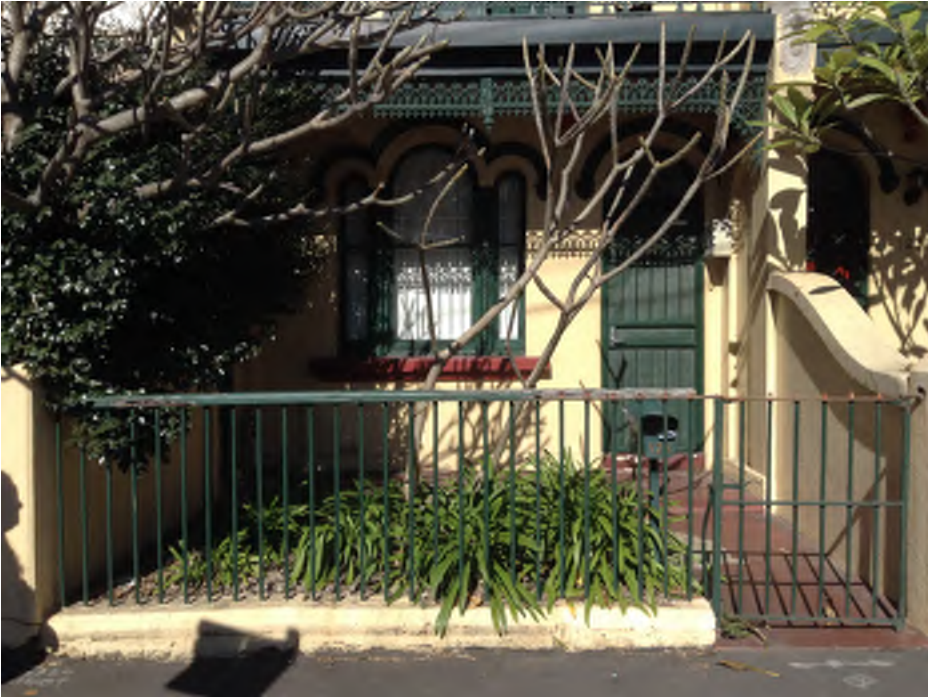
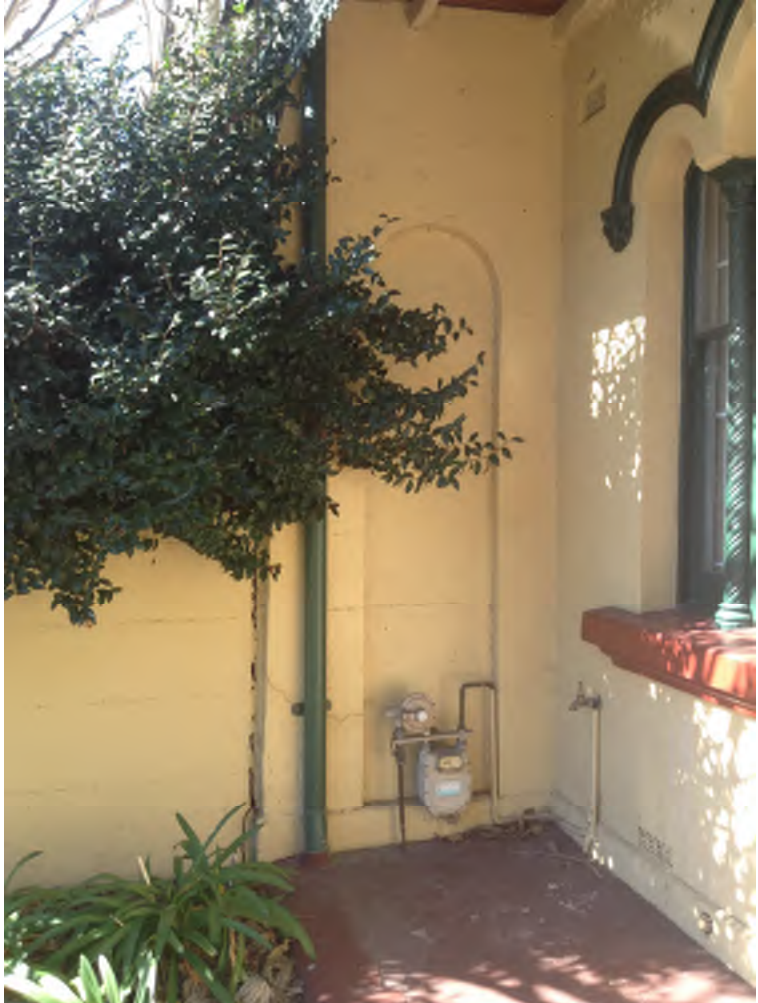
TERRACE NO.	PHOTOS	
122

TERRACE NO.	ELEMENT	CONDITIONS	COMMENTS	PHOTOS
122	1. Front fence + base and gate	B	Remove rotten timber capping over fence. Allow for finials.

2. Entry path	B		
	3. Garden	A		
	4. Porch	B		
	5. Doors and Windows	A		
	6. External walls	B	Allow for repair of crack in party wall between No.121, see photos below - refer to engineers detail.	
	7. Verandah	A		
	8. Balustrade	A		
	9. Gutters and downpipes	A		
	10. Roof sheeting	A

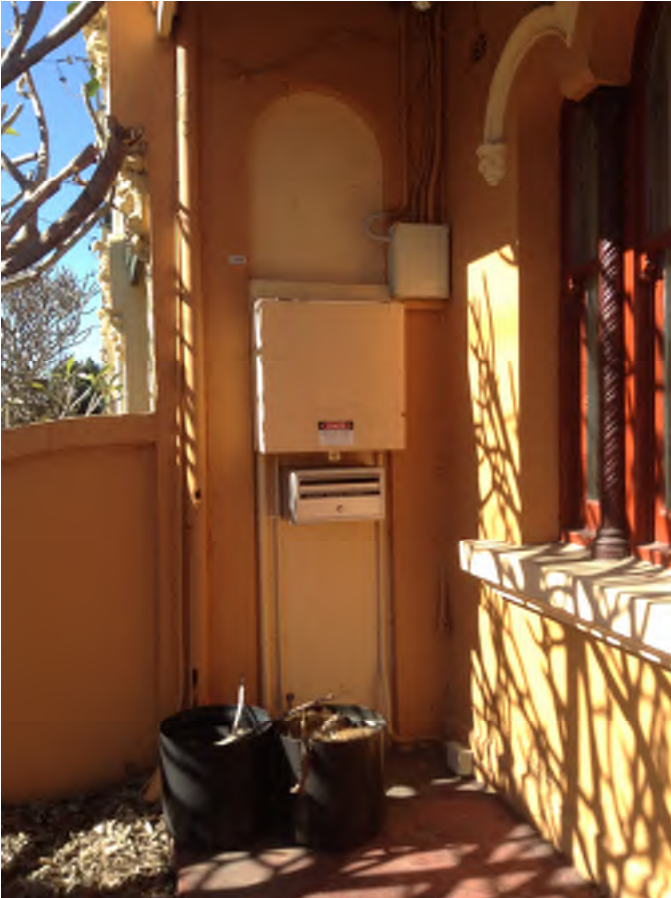
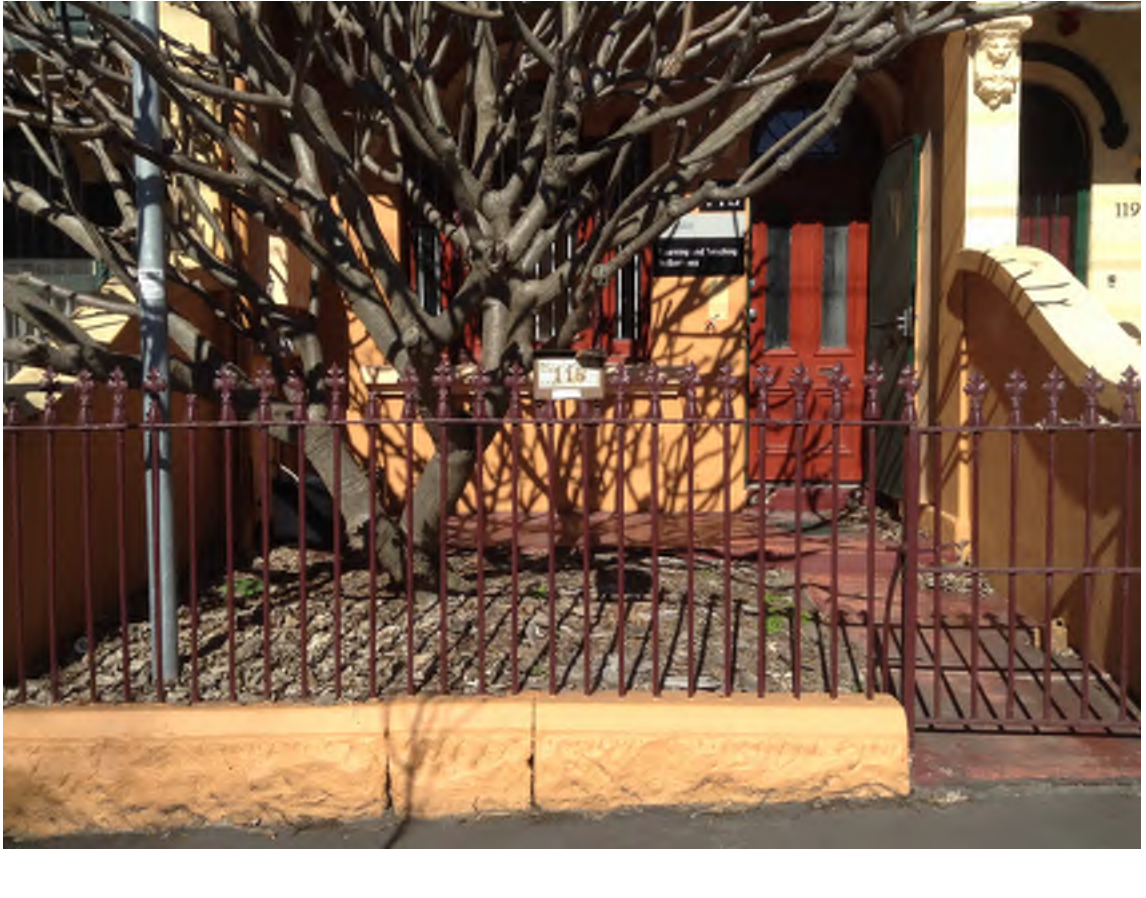
TERRACE NO.	PHOTOS	
118

TERRACE NO.	ELEMENT	CONDITIONS	COMMENTS	PHOTOS
118	1. Front fence + base and gate	A

2. Entry path	A		
	3. Garden	A		
	4. Porch	A		
	5. Doors and Windows	A		
	6. External walls	B	Allow for repair of party wall between No.119. (wall disjointed with the house- refer to engineers detail)	
	7. Verandah	B		
	8. Balustrade	A		
	9. Gutters and downpipes	B		
	10. Roof sheeting	B

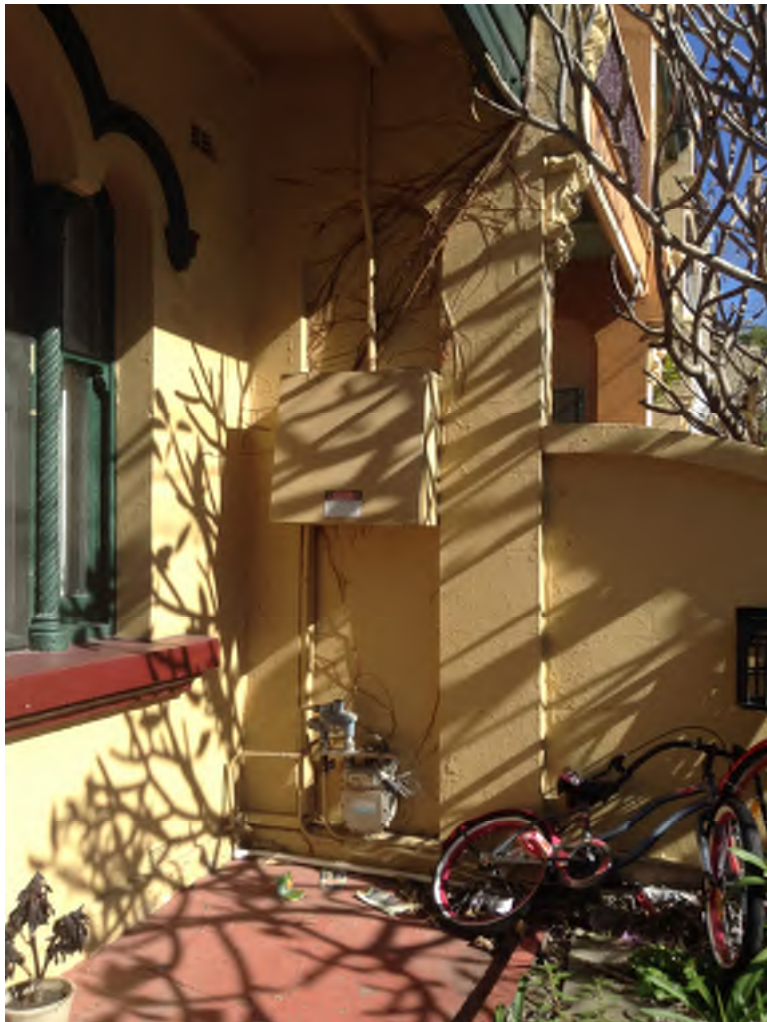
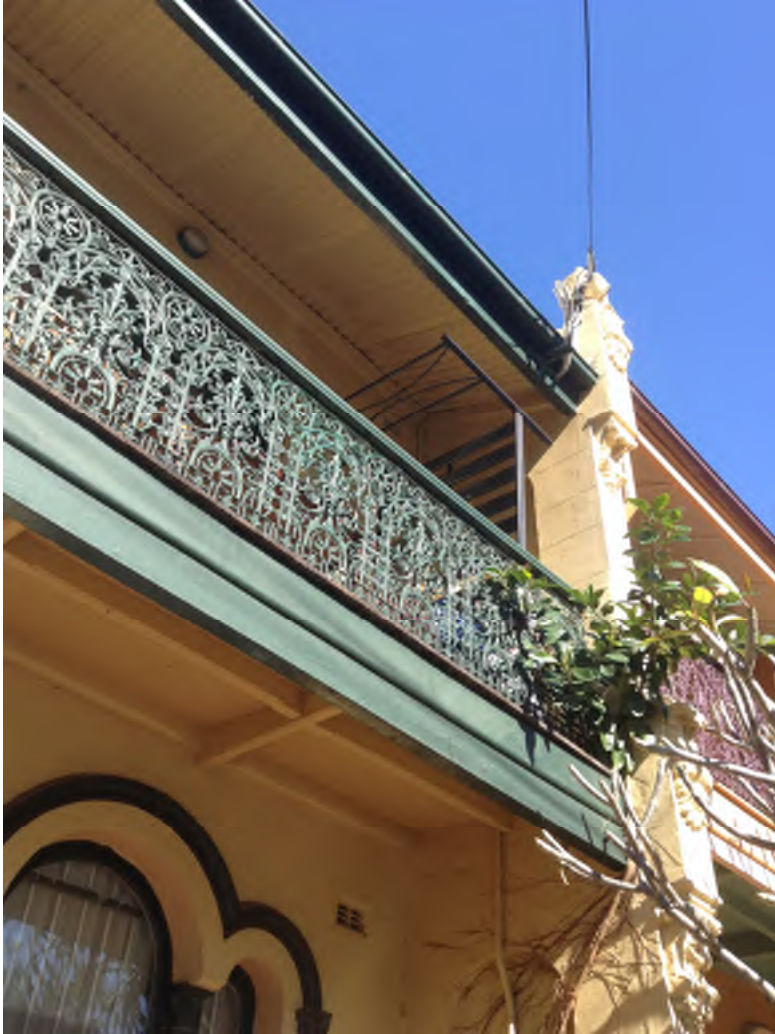
TERRACE NO.	PHOTOS	
117

TERRACE NO.	ELEMENT	CONDITIONS	COMMENTS	PHOTOS
117	1. Front fence + base and gate	B

2. Entry path	B		
	3. Garden	A	Allow for lower garden bed level.	
	4. Porch	A		
	5. Doors and Windows	A		
	6. External walls	A		
	7. Verandah	A		
	8. Balustrade	A		
	9. Gutters and downpipes	B		
	10. Roof sheeting	B

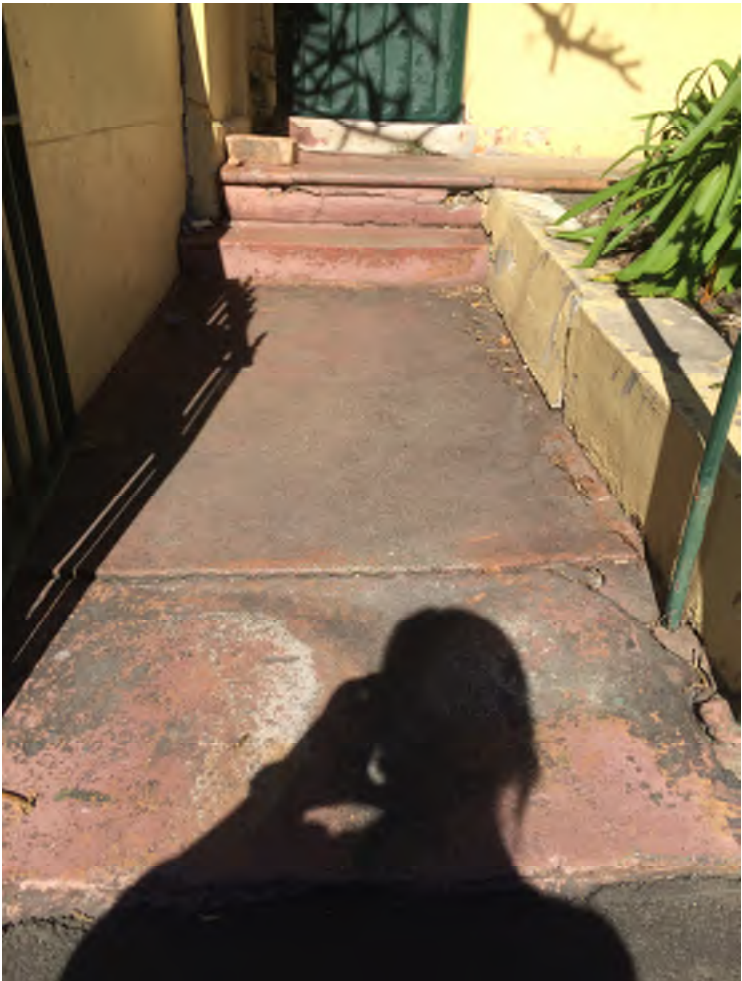
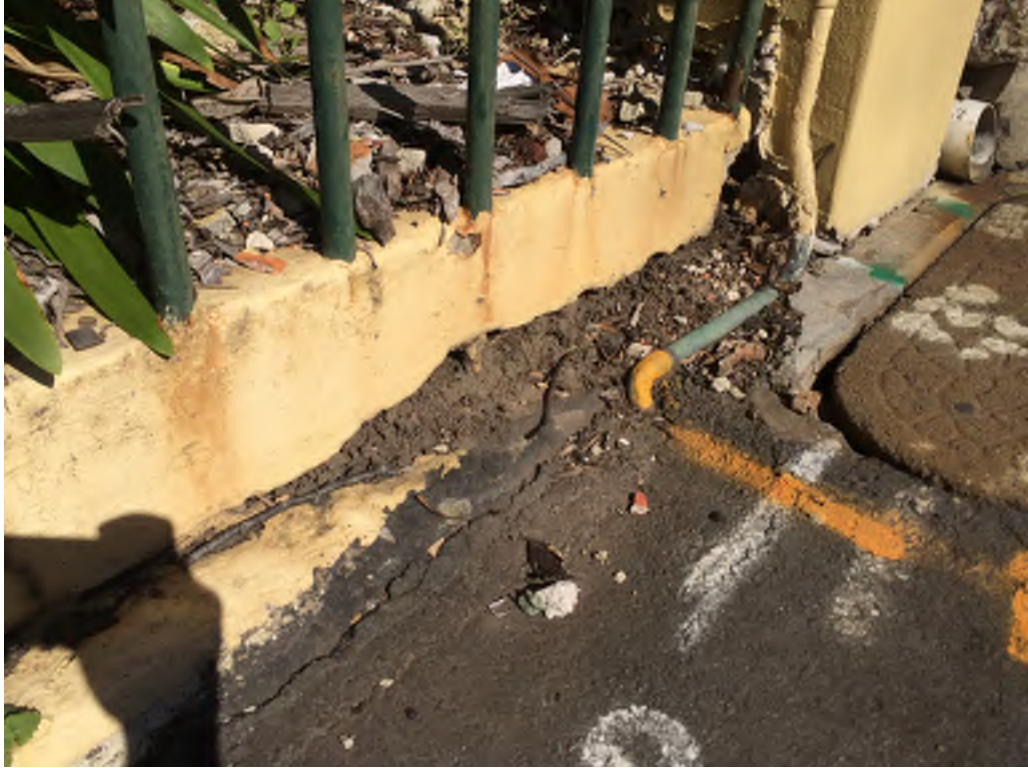
TERRACE NO.	PHOTOS	
115

TERRACE NO.	ELEMENT	CONDITIONS	COMMENTS	PHOTOS
115	1. Front fence + base and gate	B	Some finials are missing, allow for replace to match.

2. Entry path	B	Allow for repair crack in garden bed wall along path way and step to porch.	
	3. Garden	A		
	4. Porch	B		
	5. Doors and Windows	A		
	6. External walls	B	Allow for repair of low party wall between No.114. (crack between low wall and the house- refer to engineers detail)	
	7. Verandah	A		
	8. Balustrade	A		
	9. Gutters and downpipes	B		
	10. Roof sheeting	B
