**THE UNIVERSITY OF SYDNEY
DARLINGTON ROAD TERRACES
(14051)**

**9610
TERRACES EXTERNAL CONDITION
PROPOSED CONSERVATION SCHEDULE**

A visual façade inspection of the Darlington Road Terraces was conducted on 29/07/16 by AJ+C. There are 38 terraces in total, photographs of each terraces north façade and close ups to highlight their existing conditions and areas where repair work will be required.

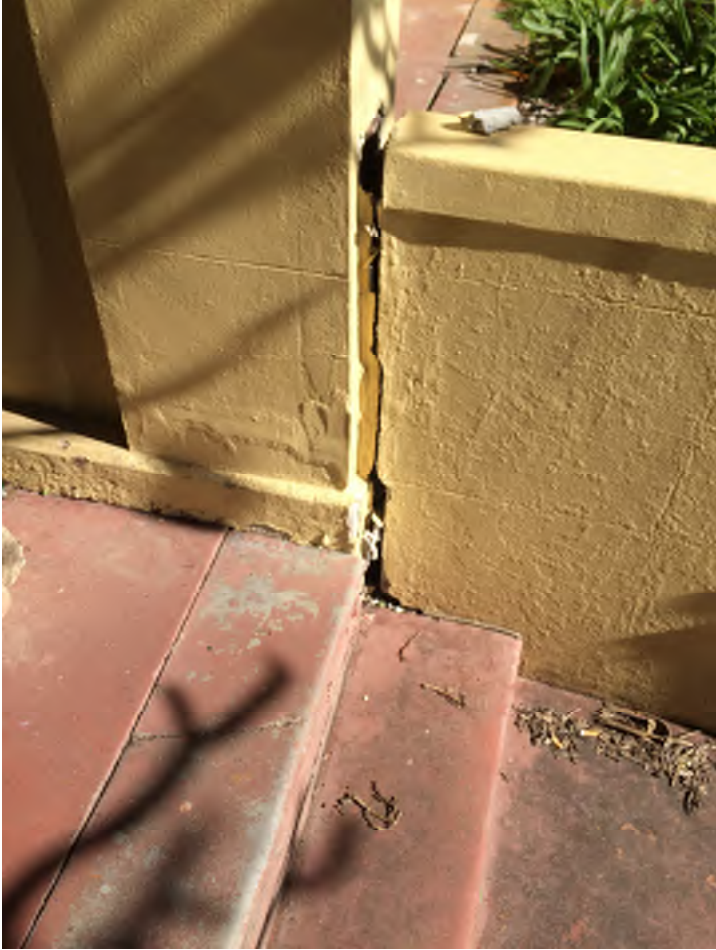
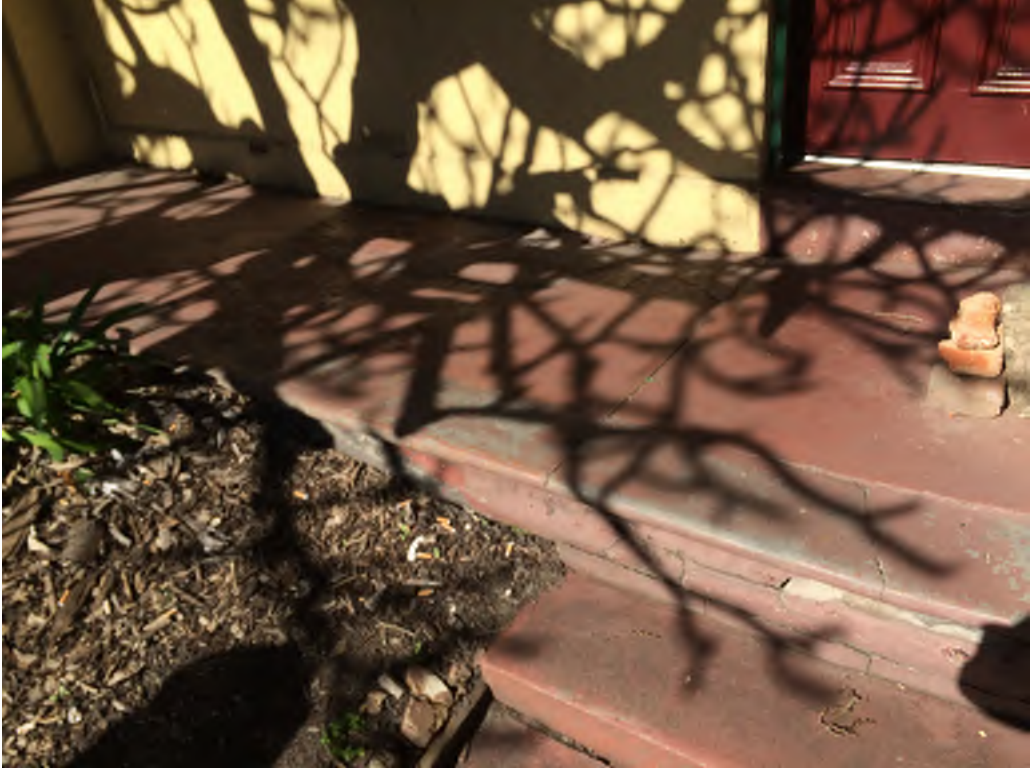
TERRACE NO.	PHOTOS	
114

TERRACE NO.	ELEMENT	CONDITIONS	COMMENTS	PHOTOS
114	1. Front fence + base and gate	B	Some finials are missing, allow for replace to match.

2. Entry path	A		
	3. Garden	B	Allow to lower garden bed level.	
	4. Porch	B		
	5. Doors and Windows	A		
	6. External walls	B	Allow for repair of low party wall between No.115. (crack between low wall and the house- see photo below- refer to engineers detail)	
	7. Verandah	A		
	8. Balustrade	A		
	9. Gutters and downpipes	B		
	10. Roof sheeting	B

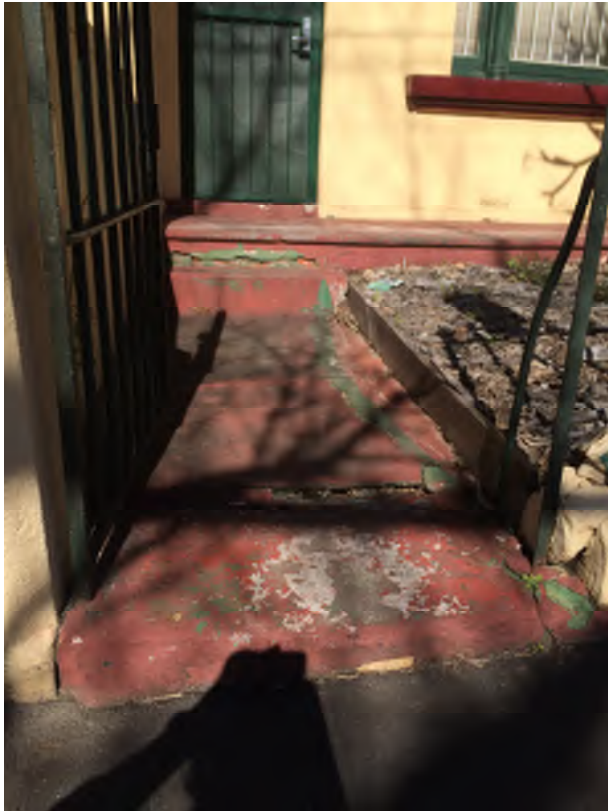
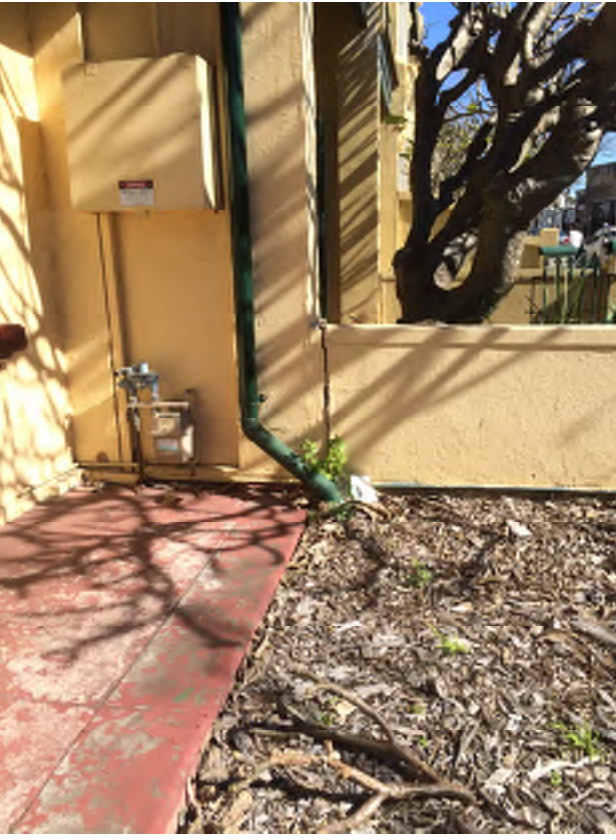
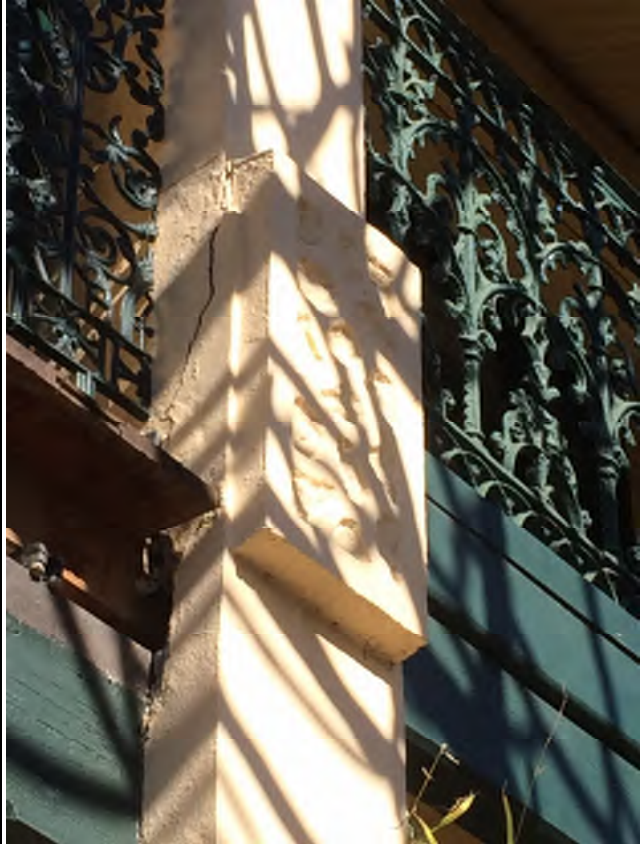
TERRACE NO.	PHOTOS		
113

TERRACE NO.	ELEMENT	CONDITIONS	COMMENTS	PHOTOS
113	1. Front fence + base and gate	B	Some finials are missing, allow for replace to match.

2. Entry path	B		
	3. Garden	B	Allow to lower garden bed level.	
	4. Porch	A		
	5. Doors and Windows	A		
	6. External walls	B	Allow for repair of low party wall between No.114. (crack between low wall and the house and up at the balustrade level - refer to engineers detail). Allow for patch above entry door and repaint all walls.	
	7. Verandah	A	Allow for new cover board below balustrade.	
	8. Balustrade	A		
	9. Gutters and downpipes	A		
	10. Roof sheeting	A

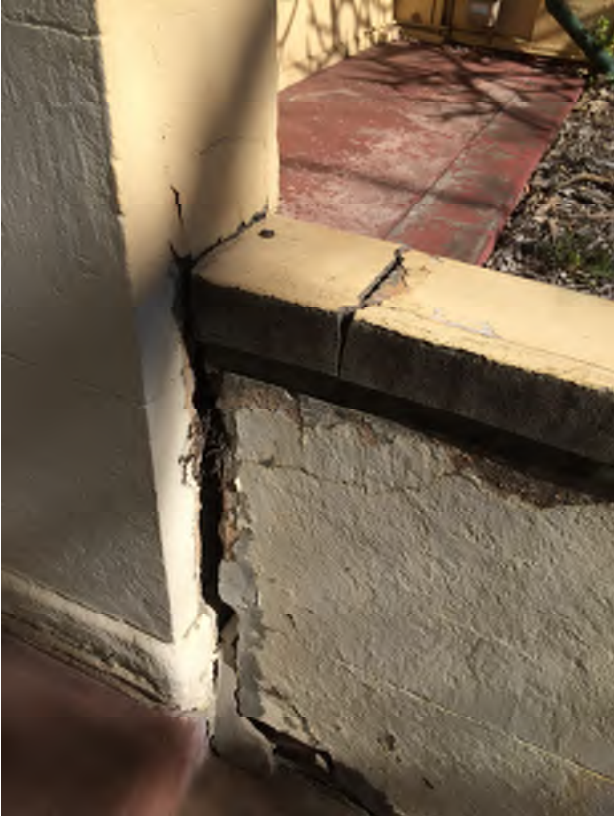
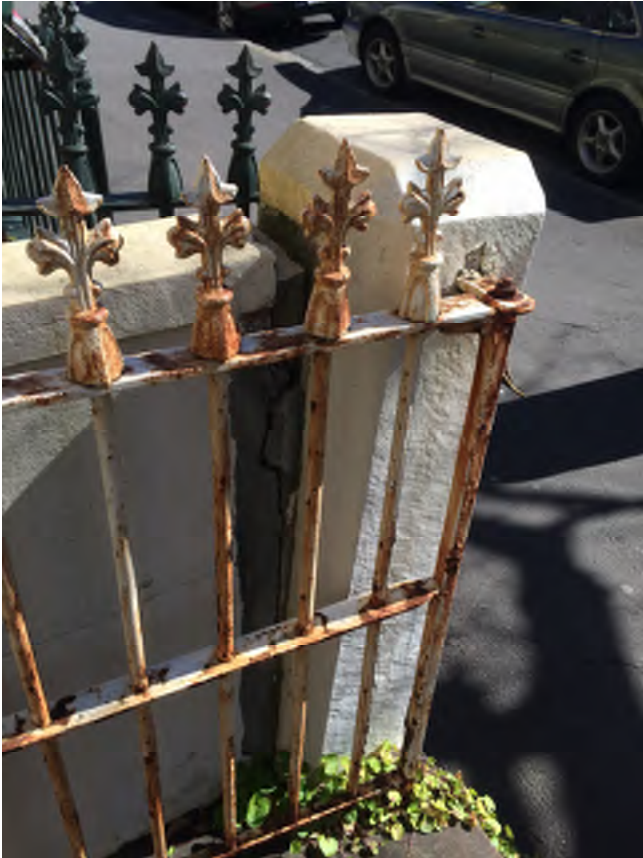
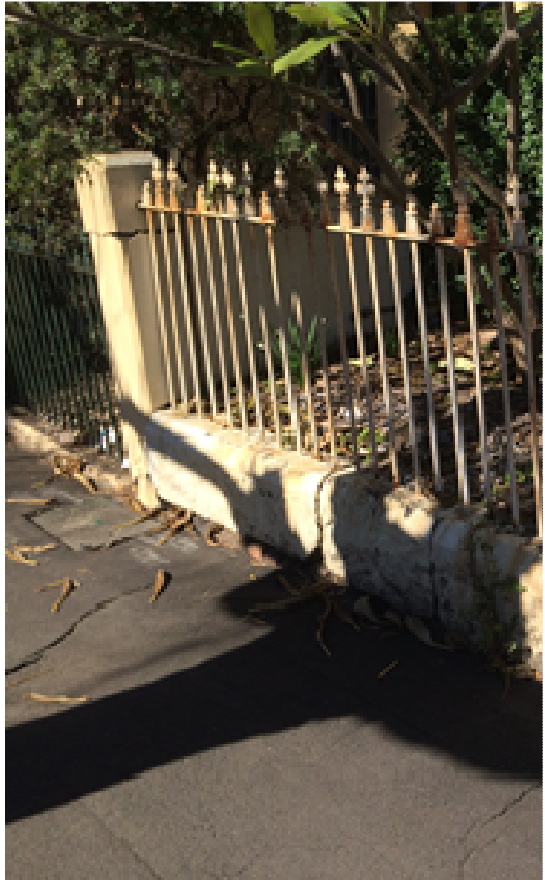
TERRACE NO.	PHOTOS		
112

TERRACE NO.	ELEMENT	CONDITIONS	COMMENTS	PHOTOS
112	1. Front fence + base and gate	B	Some finials are missing, allow for replace to match.

2. Entry path	A		
	3. Garden	A	Allow for removal of hedges.	
	4. Porch	A		
	5. Doors and Windows	A		
	6. External walls	B	Allow for repair crack in low party wall between No.113 & 111 – see photos below -refer to engineers detail).	
	7. Verandah	B	Remove existing verandah and allow to match adjoining neighbor (No 113)	
	8. Balustrade	B	Remove existing timber balustrade panels, install cast iron lace balustrade panels to match adjoining neighbour (No. 113) lace balustrade, raise height to meet compliance.	
	9. Gutters and downpipes	A		
	10. Roof sheeting	A

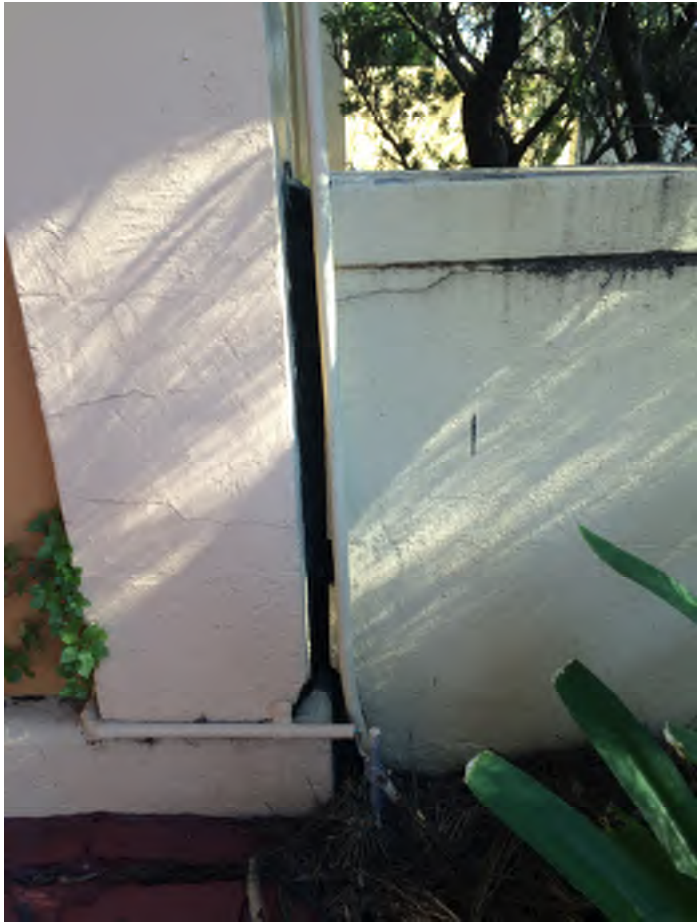
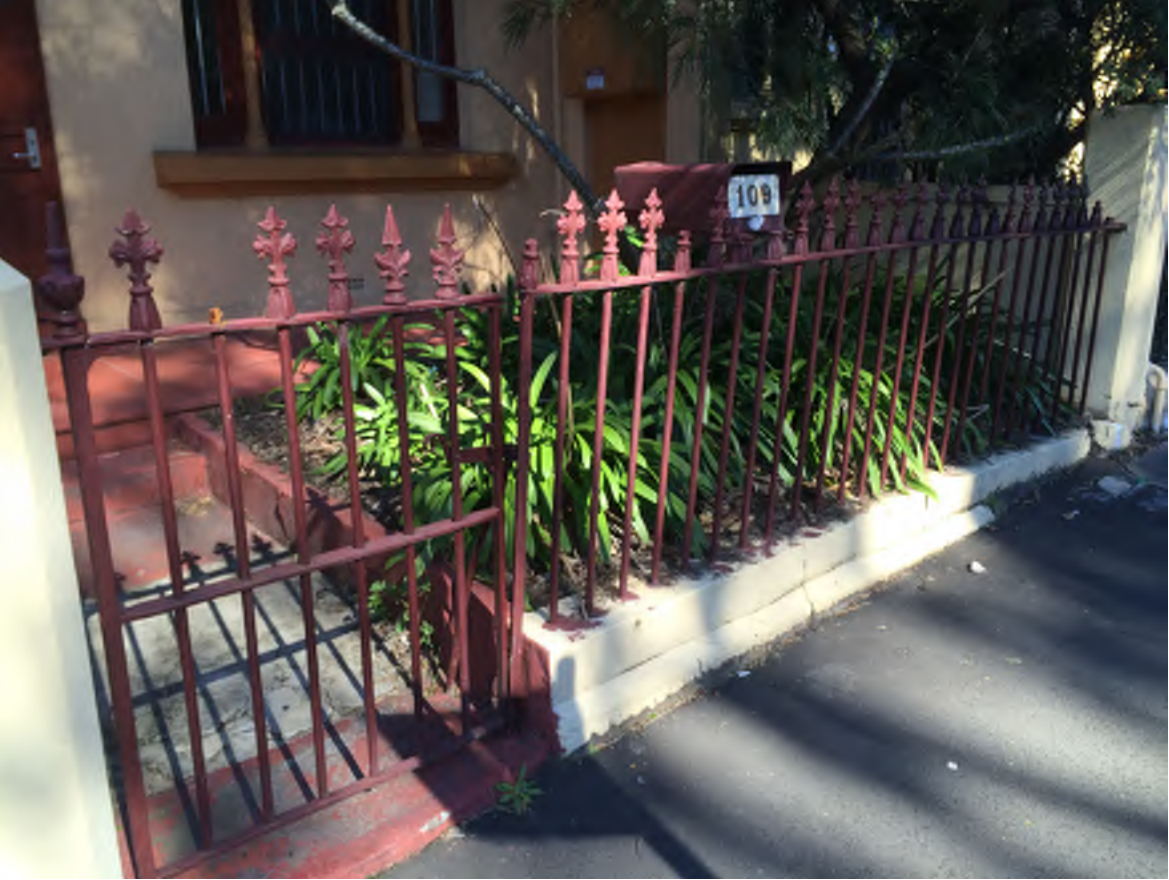
TERRACE NO.	PHOTOS	
109

TERRACE NO.	ITEMS	CONDITIONS	COMMENTS	PHOTOS
109	1. Front fence + base and gate	B	Some finials are missing, allow for replace to match.

2. Entry path	B		
	3. Garden	A	Allow for removal of bottle brush tree, retain frangipani.	
	4. Porch	A		
	5. Doors and Windows	A		
	6. External walls	B	Allow for repair of low party wall between No.110. (crack between low wall and the house – see photos below - refer to engineers detail).	
	7. Verandah	A		
	8. Balustrade	A		
	9. Gutters and downpipes	B		
	10. Roof sheeting	B

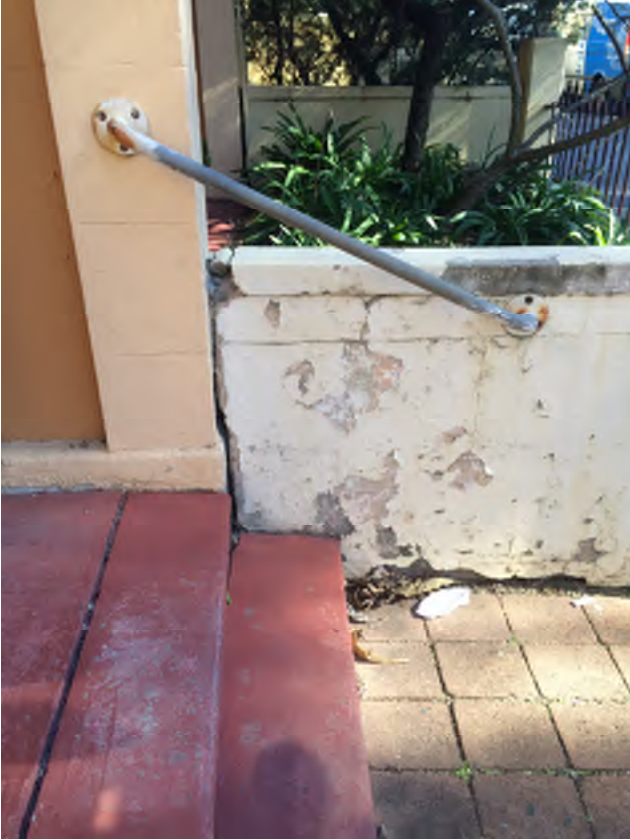
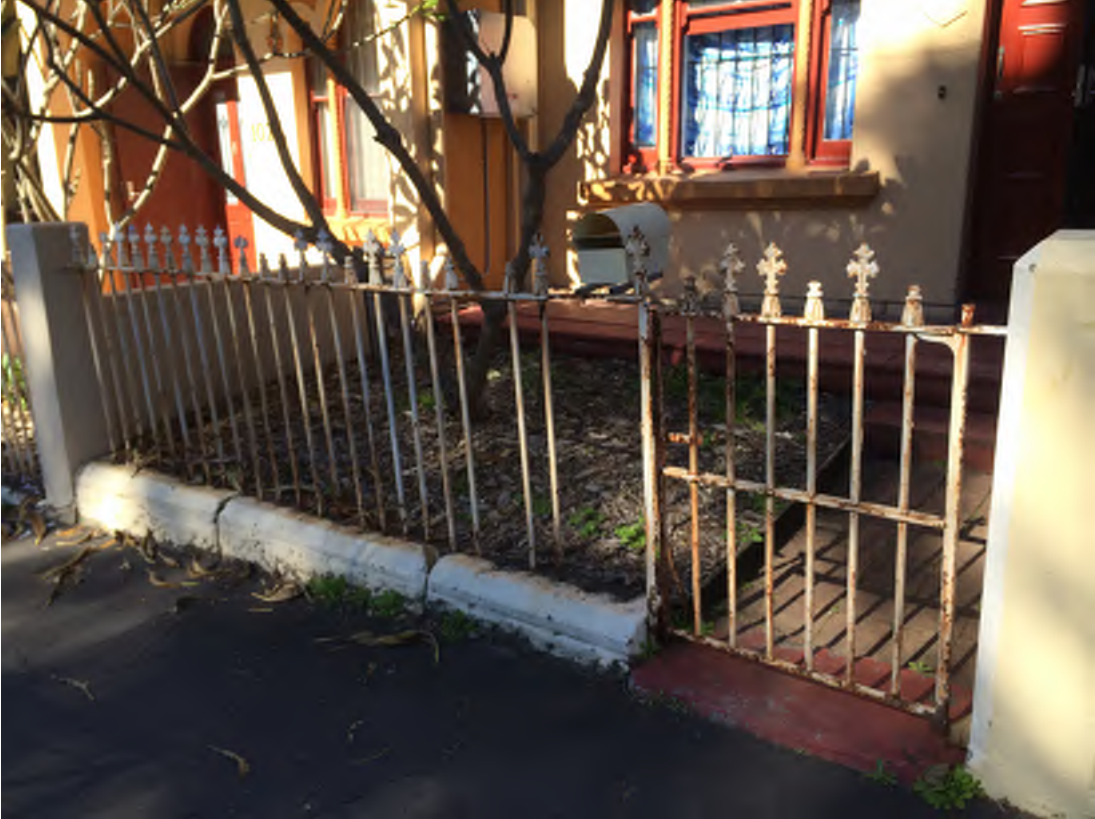
TERRACE NO.	PHOTOS	
108

TERRACE NO.	ELEMENT	CONDITIONS	COMMENTS	PHOTOS
108	1. Front fence + base and gate	B	Some finials and vertical rods are missing. Allow for replace to match.

2. Entry path	B		
	3. Garden	A		
	4. Porch	A		
	5. Doors and Windows	B		
	6. External walls	B	Allow for repair crack in low party wall between No.109 – see photos below - refer to engineers detail). Remove wall railing.	
	7. Verandah	A		
	8. Balustrade	A		
	9. Gutters and downpipes	A		
	10. Roof sheeting	A

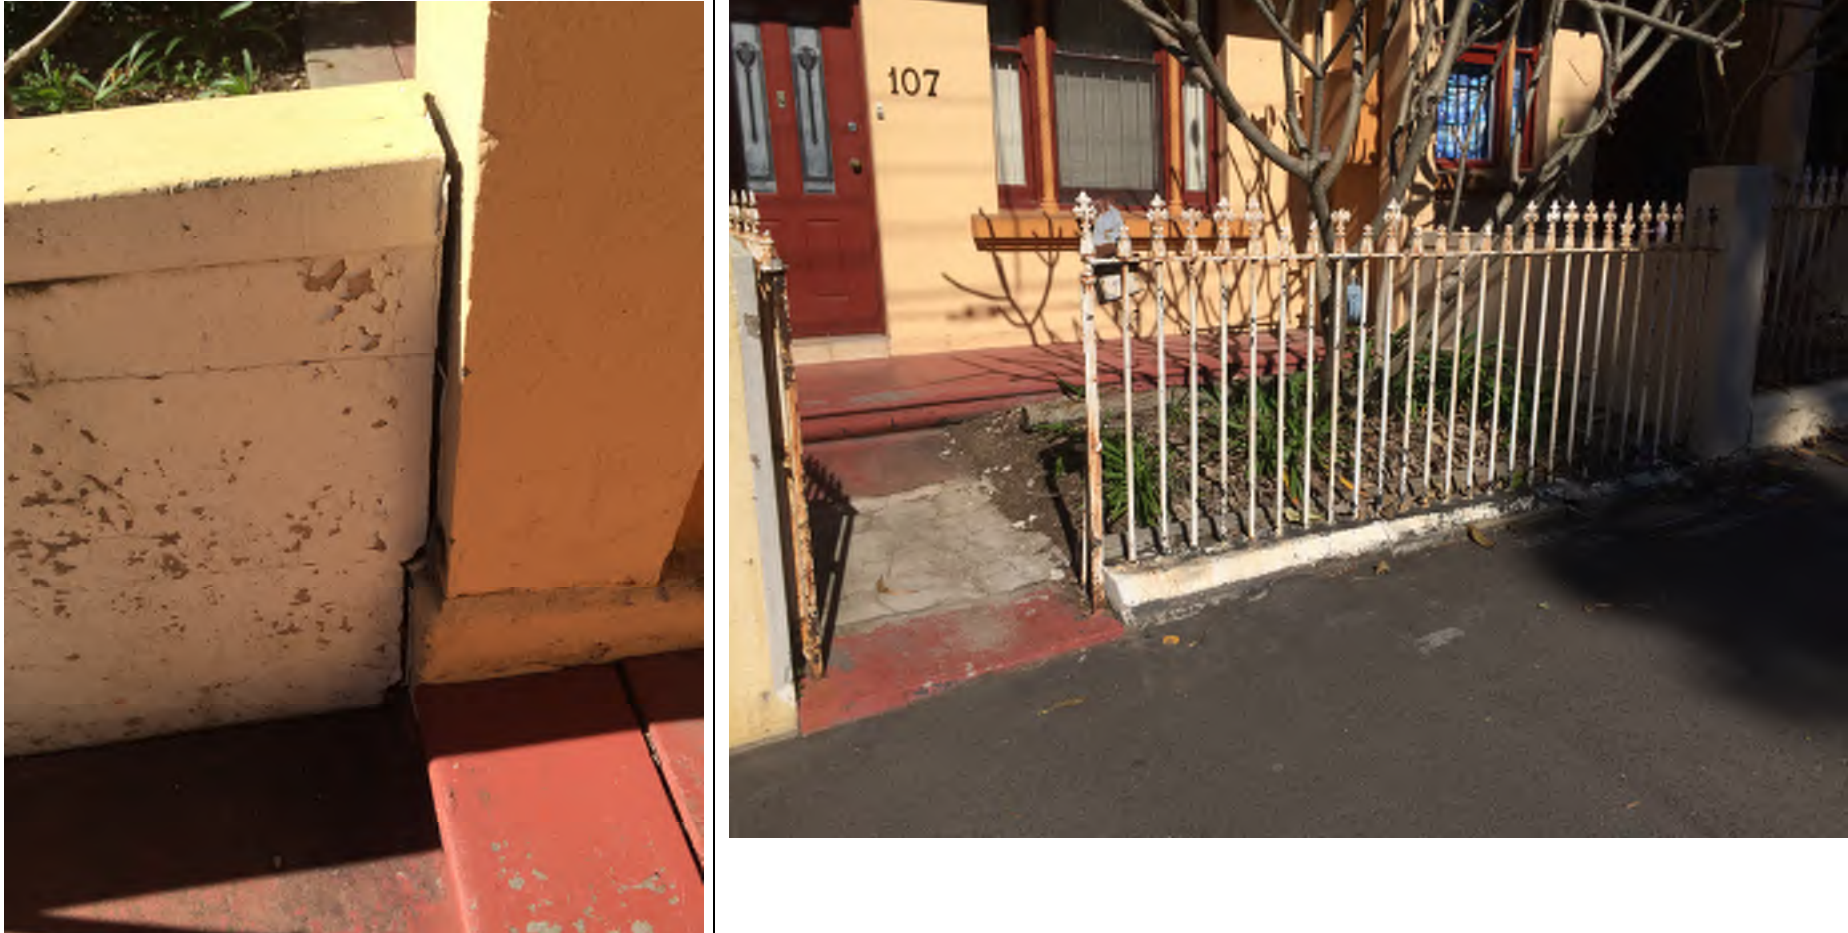
TERRACE NO.	PHOTOS
107

TERRACE NO.	ELEMENT	CONDITIONS	COMMENTS	PHOTOS
107	1. Front fence + base and gate	B	Some finials are missing, allow for replace to match.

2. Entry path	B		
	3. Garden	A	Allow to lower garden bed level.	
	4. Porch	A		
	5. Doors and Windows	A		
	6. External walls	B	Allow for repair crack in low party wall between No.108 + 106- see photo below - refer to engineers detail).	
	7. Verandah	A		
	8. Balustrade	A		
	9. Gutters and downpipes	A		
	10. Roof sheeting	A

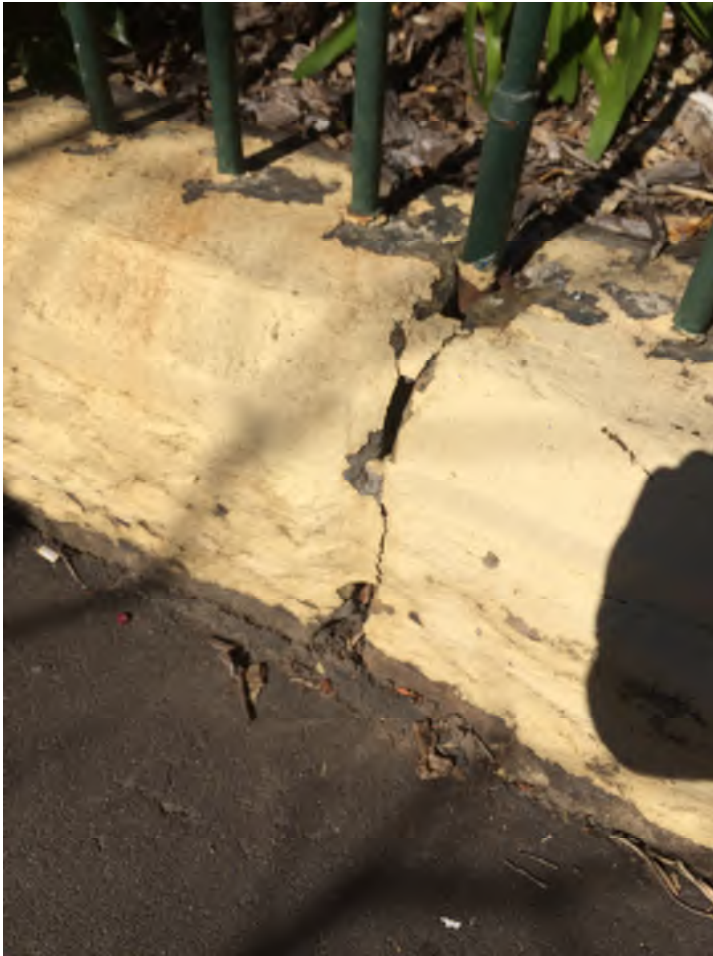
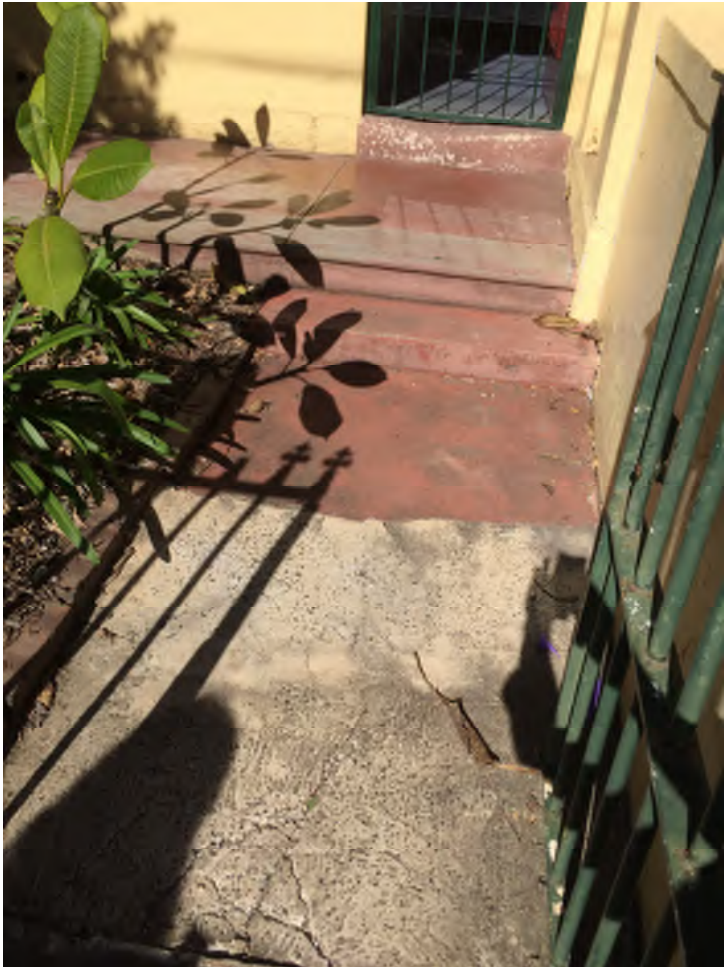
TERRACE NO.	PHOTOS	
106

TERRACE NO.	ELEMENT	CONDITIONS	COMMENTS	PHOTOS
106	1. Front fence + base and gate	B	Some finials are missing, allow for replace to match.

2. Entry path	B		
	3. Garden	A	Remove hedge, retain frangipani	
	4. Porch	A		
	5. Doors and Windows	A		
	6. External walls	A		
	7. Verandah	A		
	8. Balustrade	A		
	9. Gutters and downpipes	B		
	10. Roof sheeting	B

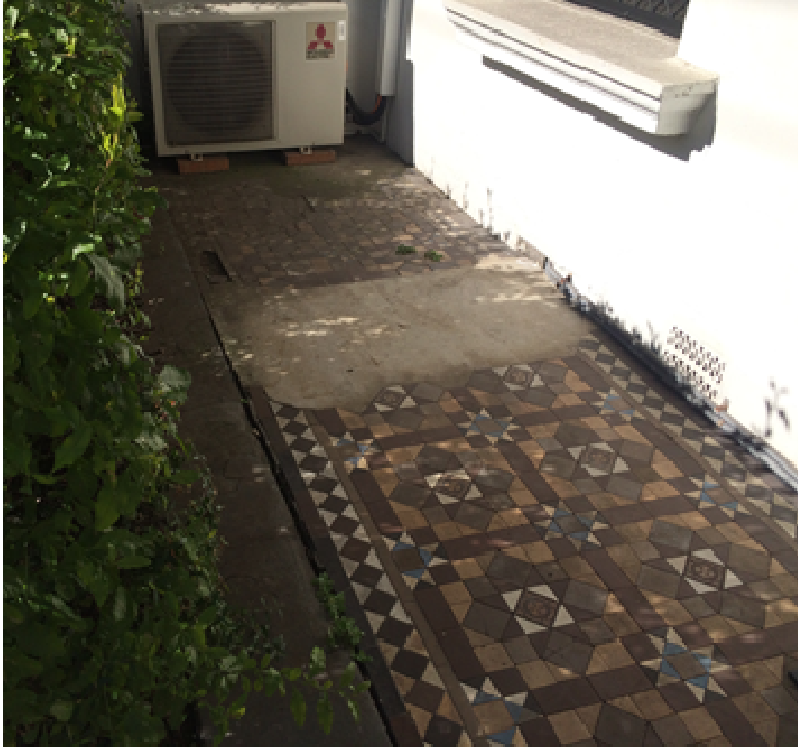
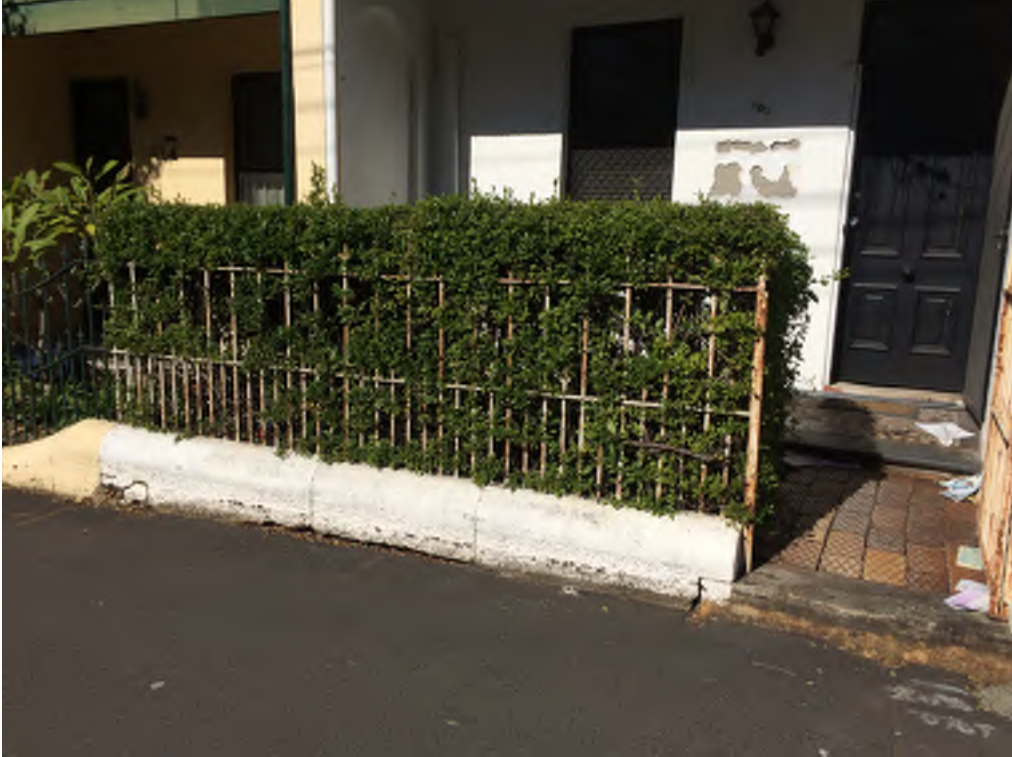
TERRACE NO.	PHOTOS	
102

TERRACE NO.	ELEMENT	CONDITIONS	COMMENTS	PHOTOS
102 *	1. Front fence + base and gate	B	Block gate, allow for new accessible ramp path to continue through from Terrace No.103. Refer to drawing for detail.

2. Entry path	B	Remove existing path, allow for new accessible path to entry door. Refer drawing for new path.	
	3. Garden	B	Allow for new accessible path. Refer to drawing for detail.

4. Porch	B	Allow for new accessible path. Refer to drawing for detail. Allow to replace tessellated tiles.	
	5. Doors and Windows	B	Remove front door + screen door and portion of existing wall to install new door and frame for wheel chair access. Refer drawing for detail.

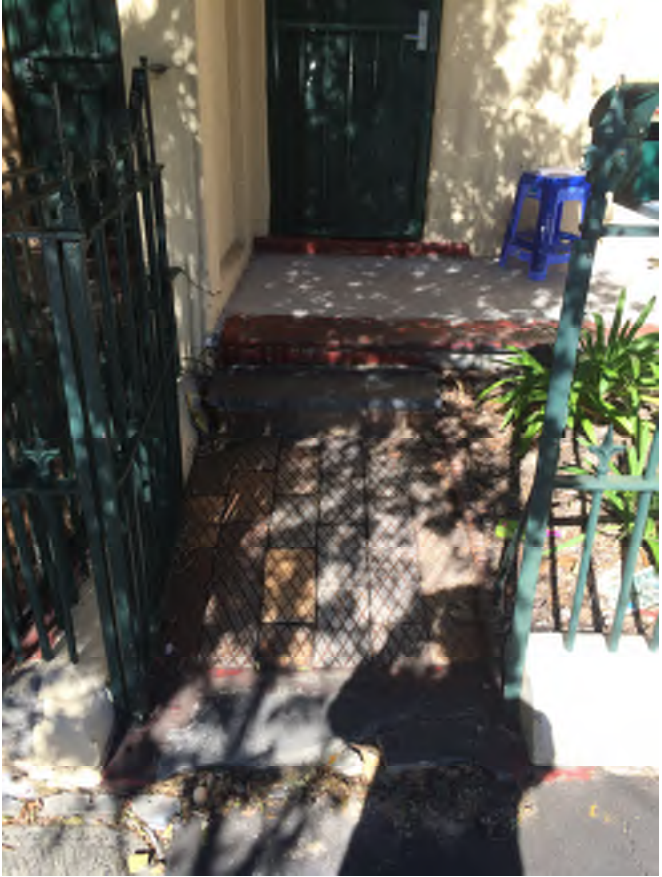
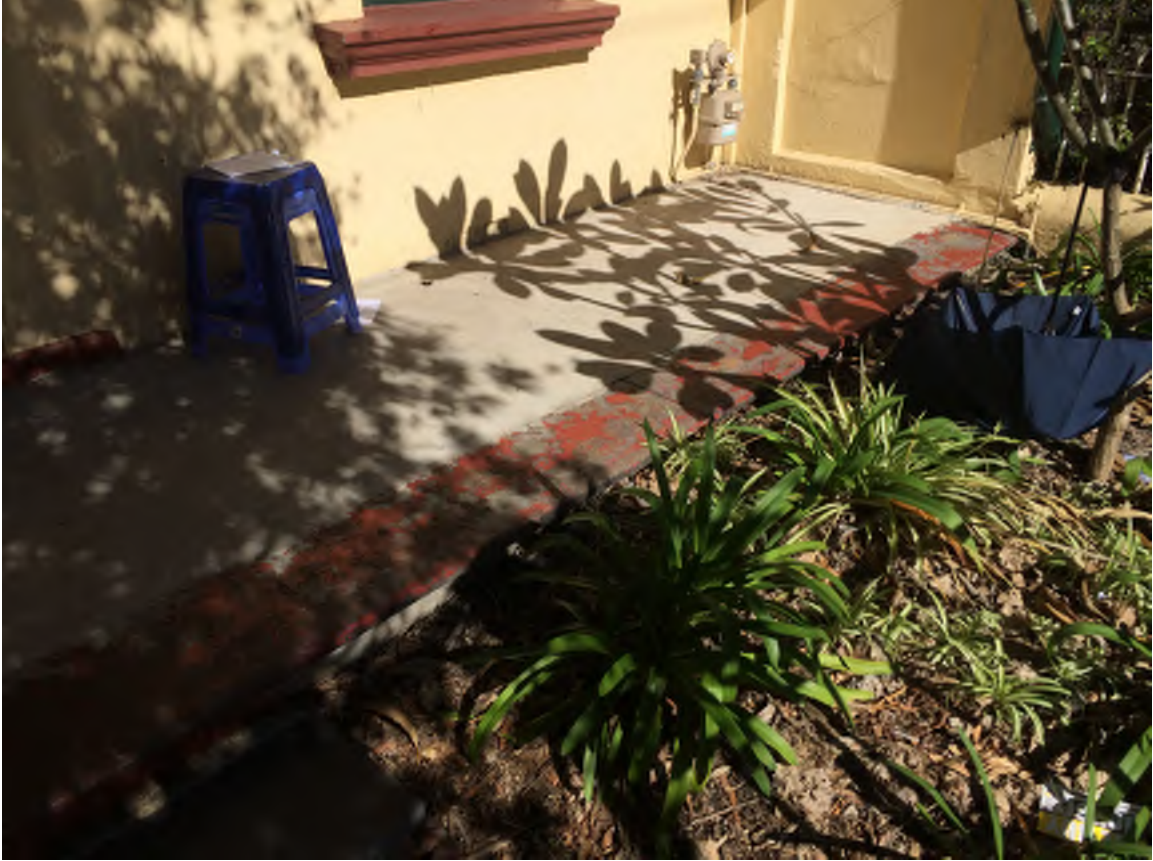
TERRACE NO.	PHOTOS	
101

TERRACE NO.	ELEMENT	CONDITIONS	COMMENTS	PHOTOS
101 *	1. Front fence + base and gate	B	Remove portion of existing fence and all associated components to allow for 850mm clear opening

2. Entry path	B	Remove and store existing pavers and rope edging strip for reuse. refer to drawing for new accessible path.	
	3. Garden	B	Allow for new accessible path, refer to drawing for detail.	
	4. Porch	B	Allow for new accessible path, refer to drawing for detail.	
	5. Doors and Windows	B	Remove front door + screen door and portion of existing wall to install new door and frame for wheel chair access.	
	6. External walls	B	Allow for repair crack in party wall between No.100 - refer to engineers detail). Allow for repaint all walls.	
	7. Verandah	A	Allow for new cover boards to match.	
	8. Balustrade	A		
	9. Gutters and downpipes	B		
	10. Roof sheeting	B

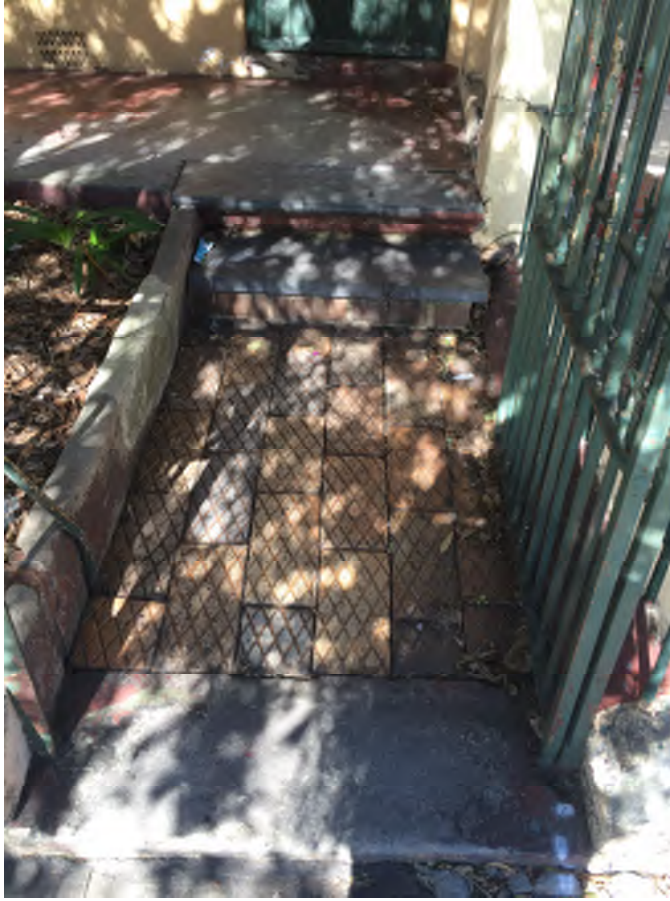
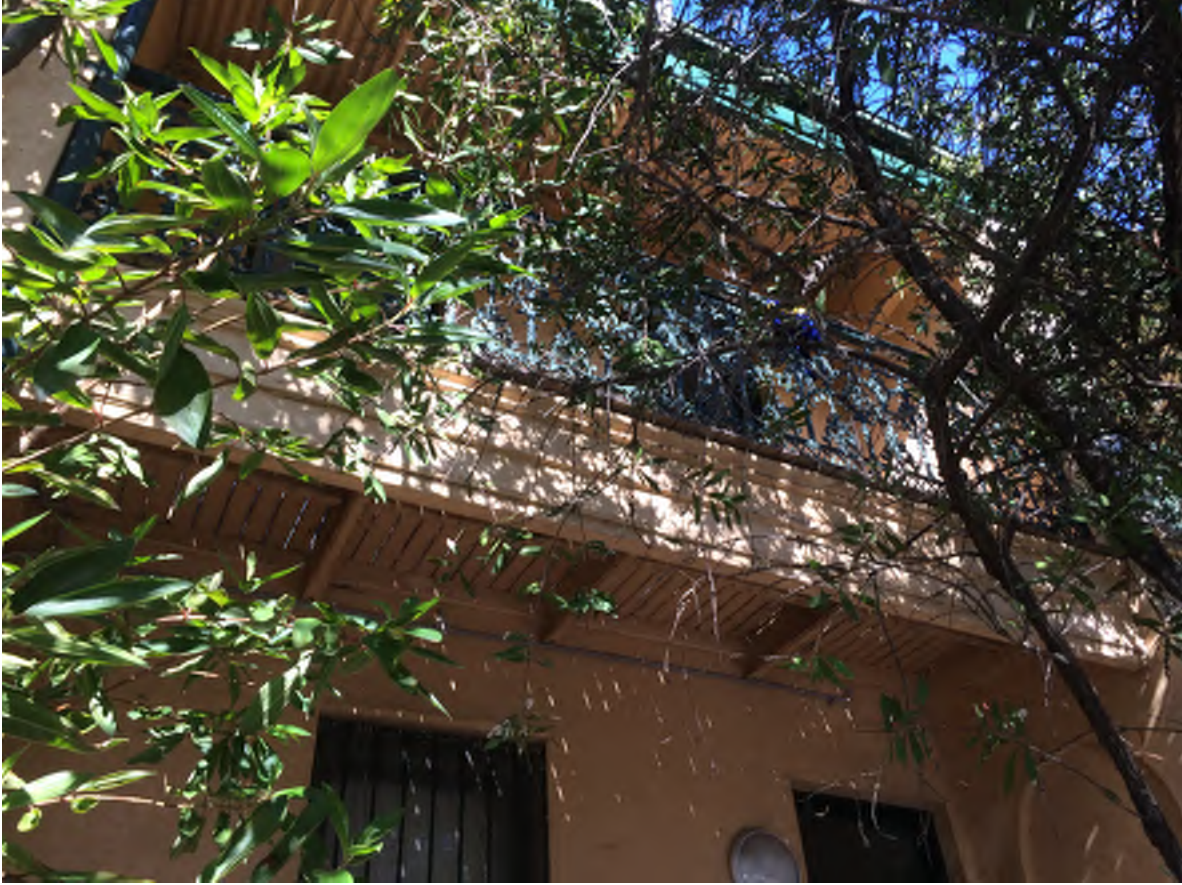
TERRACE NO.	PHOTOS	
100

TERRACE NO.	ELEMENT	CONDITIONS	COMMENTS	PHOTOS
100	1. Front fence + base and gate	B

2. Entry path	B		
	3. Garden	B	Allow for removal of existing tree as advised by landscape architect.	
	4. Porch	A		
	5. Doors and Windows	A		
	6. External walls	A		
	7. Verandah	B	Allow for new cover boards to match.	
	8. Balustrade	A		
	9. Gutters and downpipes	B		
	10. Roof sheeting	B

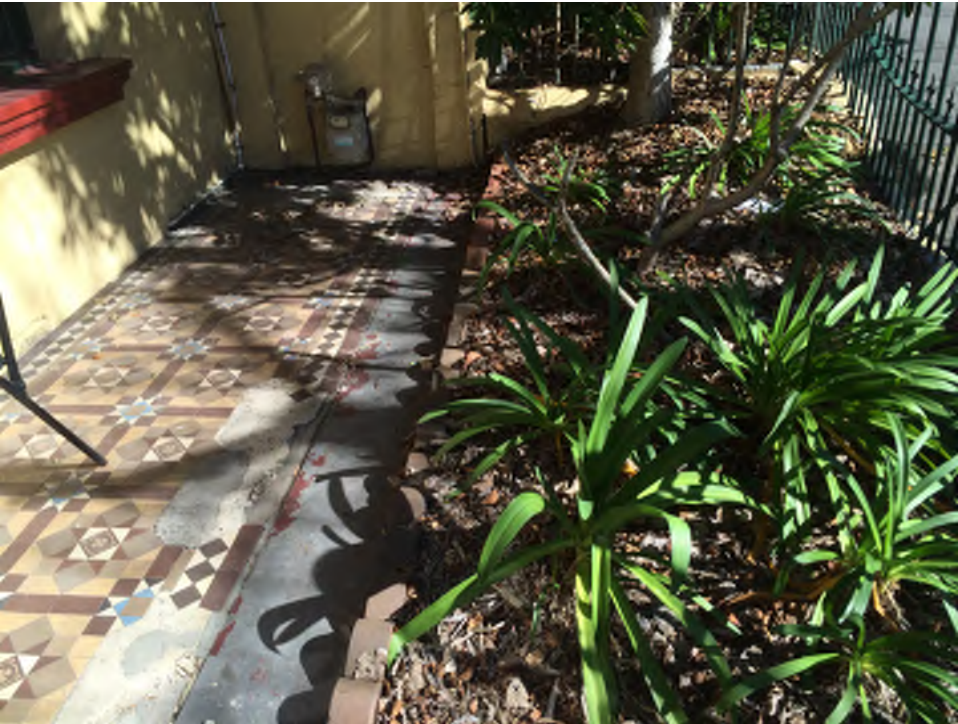
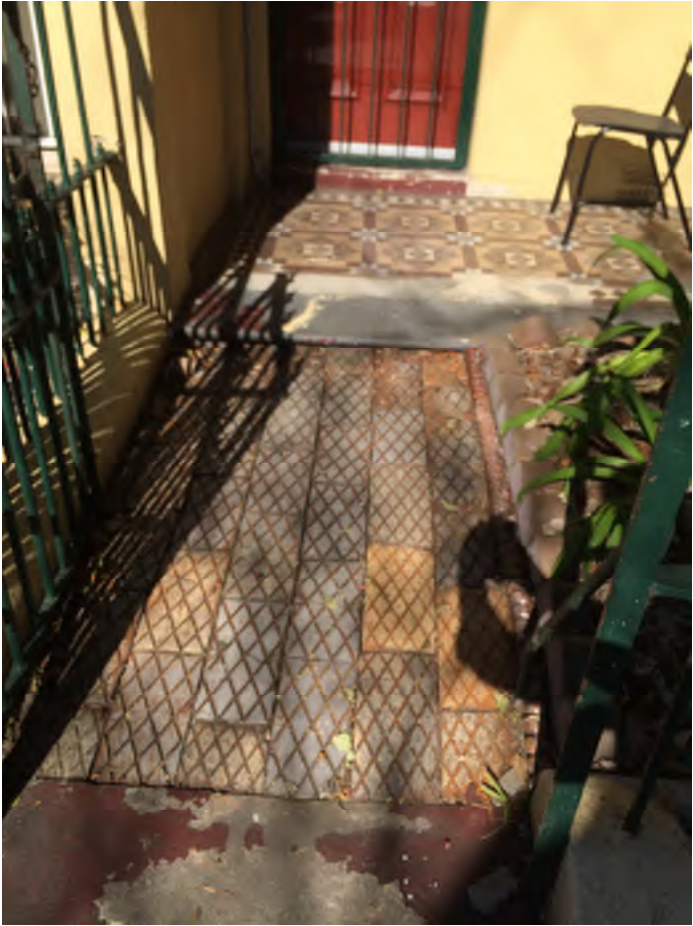
TERRACE NO.	PHOTOS	
99

TERRACE NO.	ELEMENT	CONDITIONS	COMMENTS	PHOTOS
99	1. Front fence + base and gate	A

2. Entry path	A		
	3. Garden	A		
	4. Porch	A	Tessellated tiles to existing porch.	
	5. Doors and Windows	A		
	6. External walls	B	Allow for repair crack in party wall between No.98 - refer to engineers detail).	
	7. Verandah	A		
	8. Balustrade	A		
	9. Gutters and downpipes	A		
	10. Roof sheeting	A

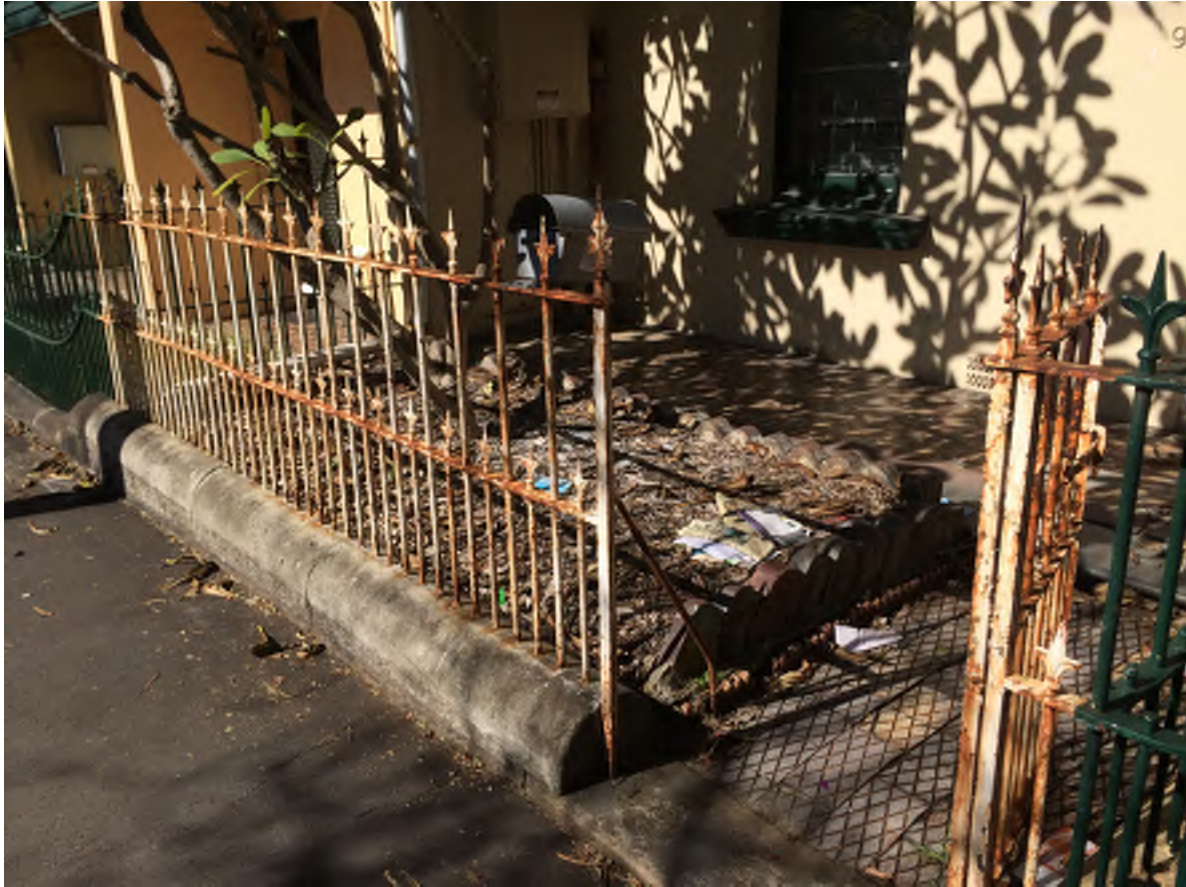
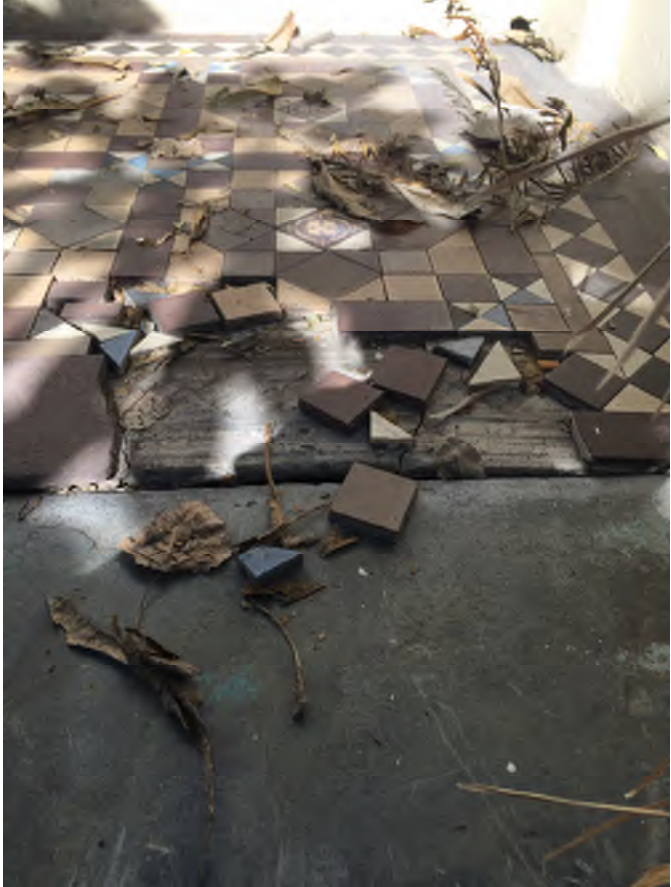
TERRACE NO.	PHOTOS	
98

TERRACE NO.	ELEMENT	CONDITIONS	COMMENTS	PHOTOS
98	1. Front fence + base and gate	A

2. Entry path	A		
	3. Garden	A		
	4. Porch	B	Allow to replace and fix down any loose tessellated tiles.	
	5. Doors and Windows	A		
	6. External walls	A		
	7. Verandah	A		
	8. Balustrade	A		
	9. Gutters and downpipes	A		
	10. Roof sheeting	A

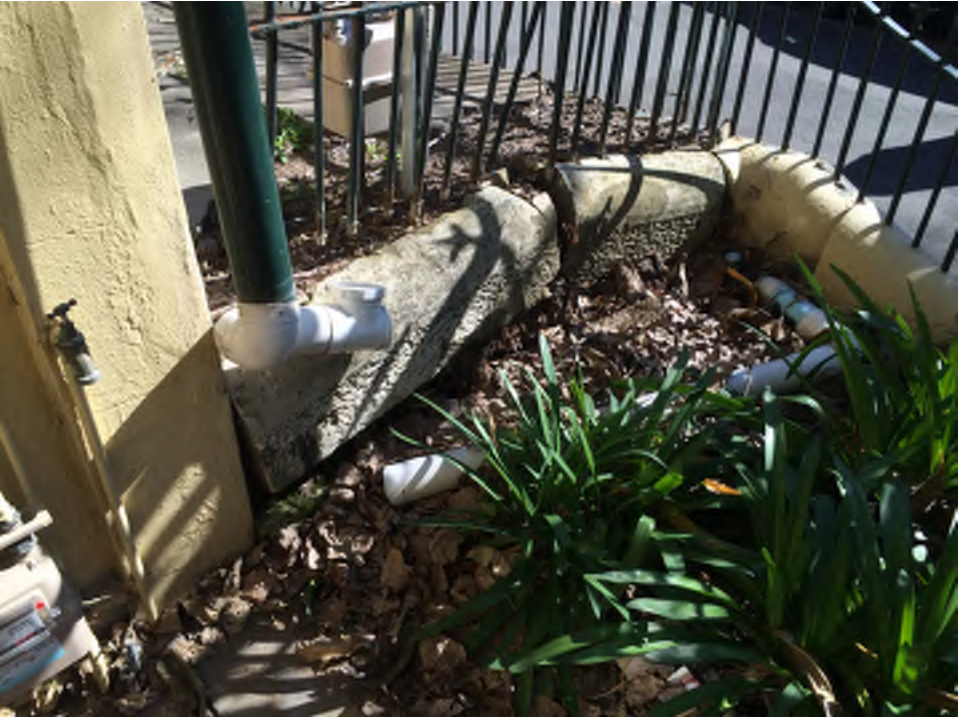
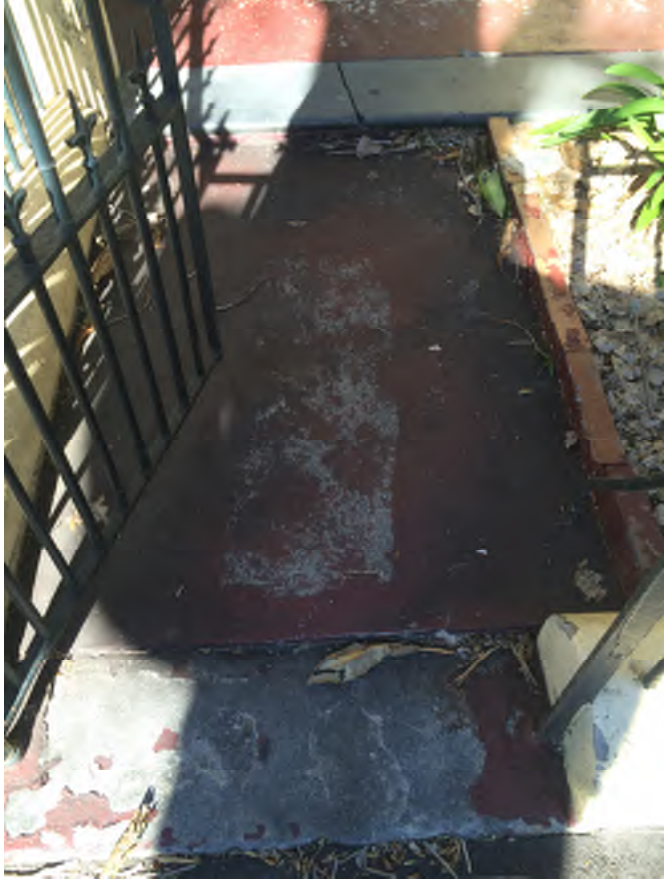
TERRACE NO.	PHOTOS	
95

TERRACE NO.	ELEMENT	CONDITIONS	COMMENTS	PHOTOS
95	1. Front fence + base and gate	B	Allow for repair to damaged fence and base wall between No. 96.

2. Entry path	A		
	3. Garden	A		
	4. Porch	A		
	5. Doors and Windows	A		
	6. External walls	B	Allow for repair damaged party wall and decorative moulding between No. 96. – refer to engineer's detail.	
	7. Verandah	A		
	8. Balustrade	A		
	9. Gutters and downpipes	B		
	10. Roof sheeting	B
