**THE UNIVERSITY OF SYDNEY
DARLINGTON ROAD TERRACES
(14051)**

**9610
TERRACES EXTERNAL CONDITION
PROPOSED CONSERVATION SCHEDULE**

A visual façade inspection of the Darlington Road Terraces was conducted on 29/07/16 by AJ+C. There are 38 terraces in total, photographs of each terraces north façade and close ups to highlight their existing conditions and areas where repair work will be required.

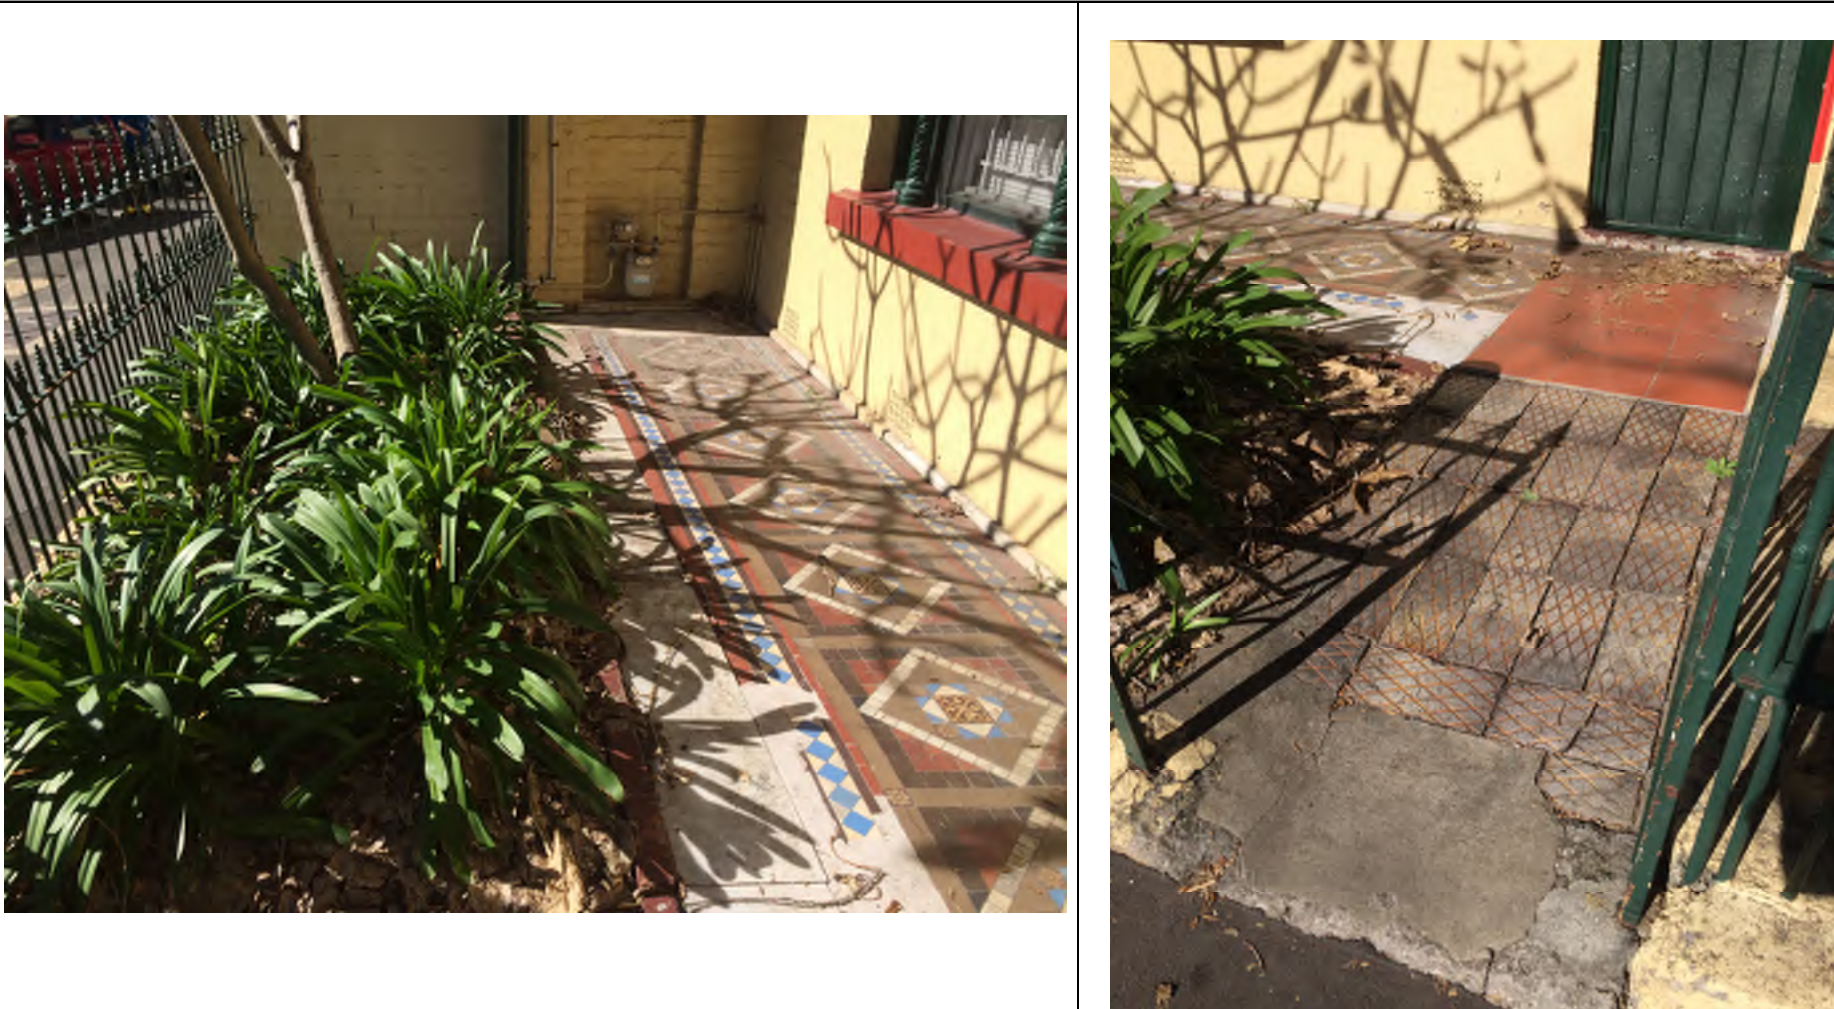
TERRACE NO	PHOTOS
94

TERRACE NO.	ELEMENT	CONDITIONS	COMMENTS	PHOTOS
94 *	1. Front fence + base and gate	B	Remove portion of existing fence and all associated components to allow for 850mm clear opening. Refer to drawing for detail.

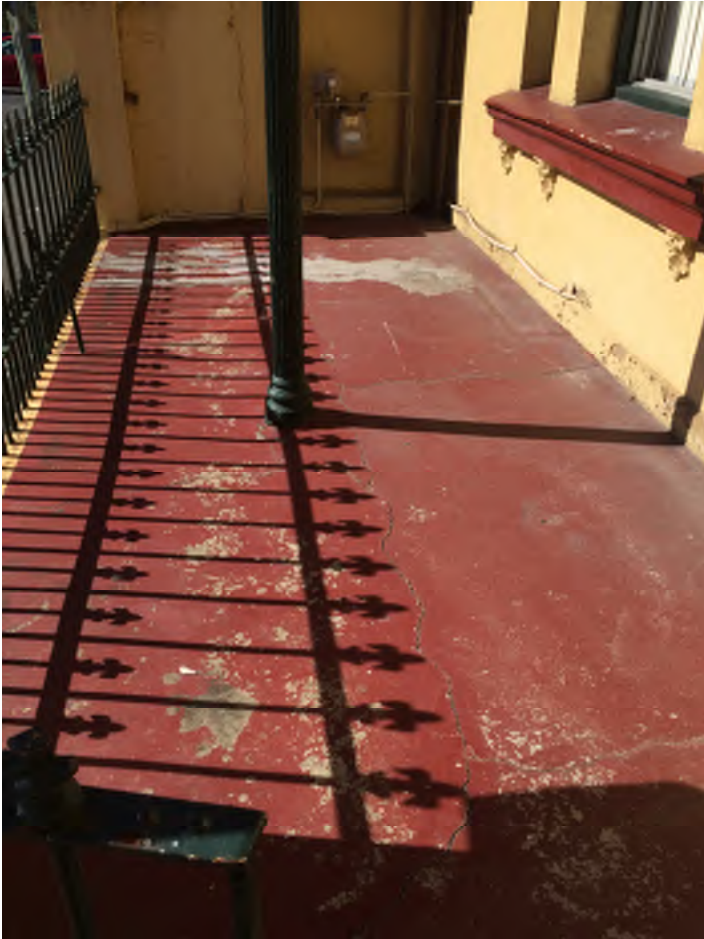
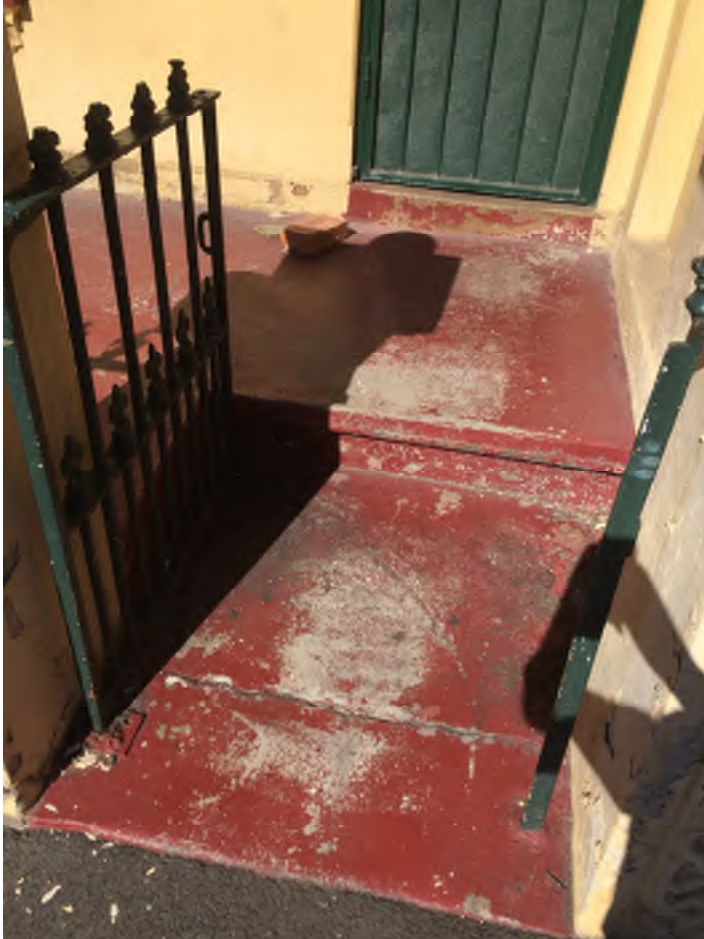
TERRACE NO	PHOTOS	
87

TERRACE NO.	ELEMENT	CONDITIONS	COMMENTS	PHOTOS
87	1. Front fence + base and gate	A

2. Entry path	A		
	3. Garden	-	No new garden to front façade.	
	4. Porch	B		
	5. Doors and Windows	A		
	6. External walls	B	Repair crack in low party wall between 86.	
	7. Verandah	A		
	8. Balustrade	A		
	9. Gutters and downpipes	A		
	10. Roof sheeting	A
