## **Hazardous Materials Survey Report**

**Wharf 4-5, Hickson Road, Walsh Bay NSW**

**Our Ref: SP0145 : 57607-02**

# Hazardous Materials Survey Report

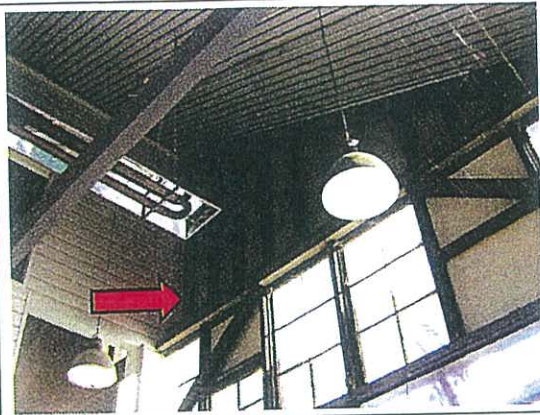
| Location<br>Item Description<br>Comments | Sample No. | Sample Status | Photo No. | Extent | Condition | Friability | Disturb. Potential | Risk Status | Re-inspect Date | Control Priority | Control Recommendation |
|---|---|---|---|---|---|---|---|---|---|---|---|
| Restaurant (Wharf)<br>Apex infill panels<br>Fibre-cement sheeting<br>*Not sampled due to height restrictions | - | Suspected Positive | 1 | 20m <sup>2</sup> | Good | Non - Friable | Low | Low | July 2008 | 3 | Confirm status, label and maintain in current condition. Remove under controlled conditions prior to refurbishment/demolition works. |

**Photo 1.** Upper wall panels, Level 3, Restaurant (Wharf) – Asbestos fibre-cement sheeting

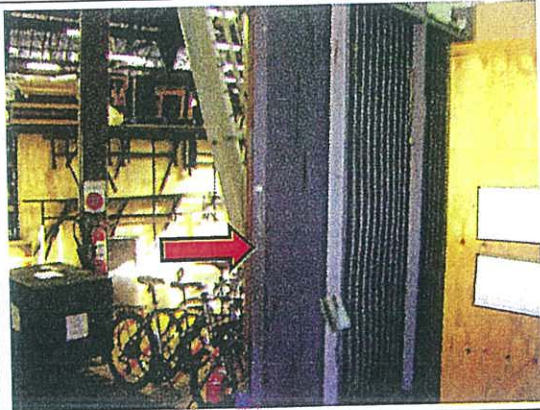
| Location<br>Item Description<br>Comments | Sample No. | Sample<br>Status | Photo<br>No. | Extent | Condition | Friability | Disturb.<br>Potential | Risk<br>Status | Re-<br>inspect<br>Date | Control<br>Priority | Control Recommendation |
|---|---|---|---|---|---|---|---|---|---|---|---|
| Workshop, Entrance<br>Sliding fire door<br>Fire door core<br>Note: Unable to sample to metal<br>cladding | - | Suspected<br>Positive | - | 1 unit x<br>3 m <sup>2</sup> | Good | Friable | Low | Low | July<br>2008 | 3 | Confirm status, label and<br>maintain in current condition.<br>Remove under controlled<br>conditions prior to<br>refurbishment/demolition works. |

**Photo 2.** Sliding fire door, Workshop entrance, Level 3 – Suspected Asbestos fire door core

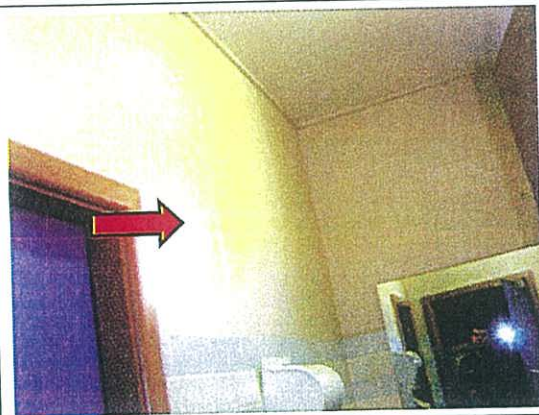
| Location<br>Item Description<br>Comments | Sample No. | Sample<br>Status | Photo<br>No. | Extent | Condition | Friability | Disturb.<br>Potential | Risk<br>Status | Re-<br>inspect<br>Date | Control<br>Priority | Control Recommendation |
|---|---|---|---|---|---|---|---|---|---|---|---|
| Sydney Choir Rehearsal, Male and<br>Female Toilets<br>Walls<br>Fibre-cement sheeting | 57607-02-16 | Positive | 3 | 20m <sup>2</sup> | Good | Non -<br>Friable | Low | Low | July<br>2008 | 3 | Label and maintain in current<br>condition. Remove under<br>controlled conditions prior to<br>refurbishment/demolition works. |

**Photo 3.** Walls, Male and Female Toilets, Level 1, Sydney Choir Rehearsal – Asbestos fibre-cement sheeting

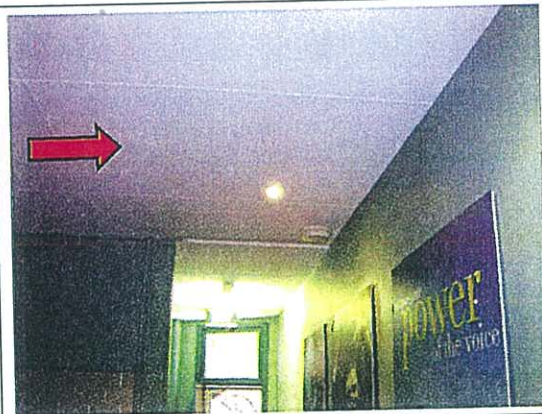
| Location<br>Item Description<br>Comments | Sample No. | Sample<br>Status | Photo<br>No. | Extent | Condition | Friability | Disturb.<br>Potential | Risk<br>Status | Re-<br>inspect<br>Date | Control<br>Priority | Control Recommendation |
|---|---|---|---|---|---|---|---|---|---|---|---|
| Sydney Choir Rehearsal, Reception<br>room<br>Ceiling<br>Fibre-cement sheeting | 57607-02-18 | Positive | 4 | 20m <sup>2</sup> | Good | Non -<br>Friable | Low | Low | July<br>2008 | 3 | Label and maintain in current<br>condition. Remove under<br>controlled conditions prior to<br>refurbishment/demolition works. |

**Photo 4.** Ceiling, Reception room, Level 1, Sydney Choir Rehearsal – Asbestos fibre-cement sheeting

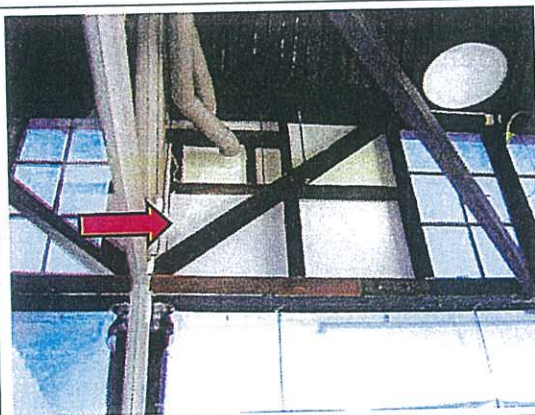
| Location<br>Item Description<br>Comments | Sample No. | Sample<br>Status | Photo<br>No. | Extent | Condition | Friability | Disturb.<br>Potential | Risk<br>Status | Re-<br>inspect<br>Date | Control<br>Priority | Control Recommendation |
|---|---|---|---|---|---|---|---|---|---|---|---|
| Infill panels around windows<br>Fibre-cement sheeting | 57607-02-07 | Positive | 5 | ~200 units x 2m <sup>2</sup> | Good | Non - Friable | Low | Low | July 2008 | 3 | Label and maintain in current condition. Remove under controlled conditions prior to refurbishment/demolition works. |

**Photo 5.** Infill panels around windows, Throughout Building – Asbestos fibre-cement sheeting

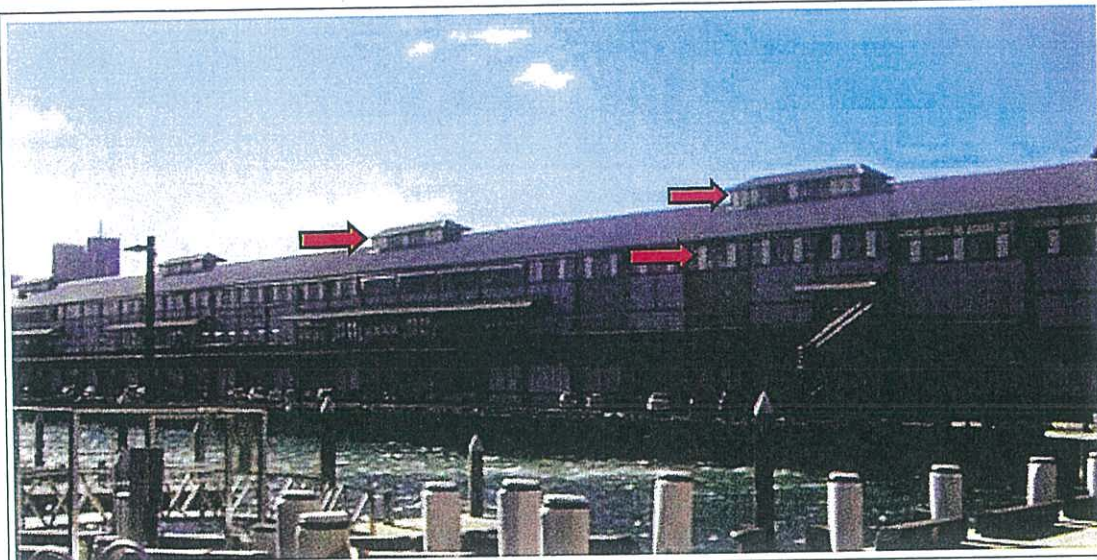
| Location<br>Item Description<br>Comments | Sample No. | Sample<br>Status | Photo<br>No. | Extent | Condition | Friability | Disturb.<br>Potential | Risk<br>Status | Re-<br>inspect<br>Date | Control<br>Priority | Control Recommendation |
|---|---|---|---|---|---|---|---|---|---|---|---|
| Throughout building<br>Infill panels around windows and four hip roof skylights<br>Fibre-cement sheeting | 57607-02-07 | Positive | 6 | ~200 units x 2m <sup>2</sup> | Good | Non - Friable | Low | Low | July 2008 | 3 | Label and maintain in current condition. Remove under controlled conditions prior to refurbishment/demolition works. |

**Photo 6.** Infill panels around windows and four hip roof skylight, Throughout Building – Fibre-cement sheeting

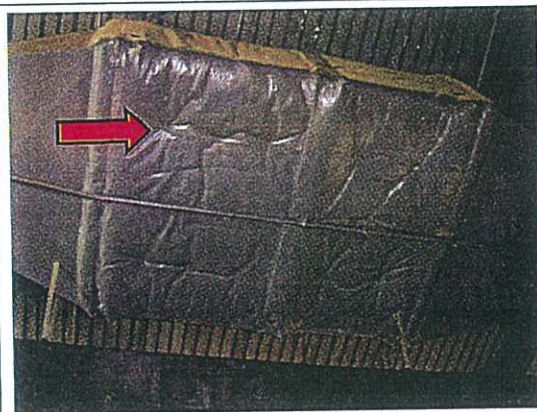
| Location<br>Item Description | Photo<br>No. | Form | Extent | Risk Status | Control Recommendation |
|---|---|---|---|---|---|
| Throughout Building<br>Insulation to air handling ductwork | 7 | Bonded | 100m <sup>2</sup> | Low | Maintain in current condition. Remove under controlled conditions prior to refurbishment |

**Photo 7.** SMF insulation to air conditioning ductwork throughout building.

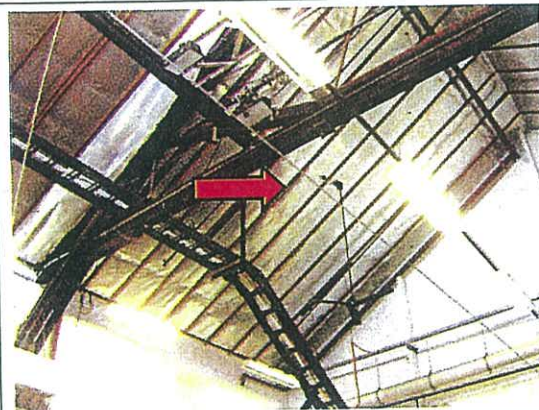
| Location<br>Item Description | Photo<br>No. | Form | Extent | Risk Status | Control Recommendation |
|---|---|---|---|---|---|
| Throughout Building<br>Sarking insulation to ceiling | 8 | Bonded | 500m <sup>2</sup> | Low | Maintain in current condition. Remove under controlled conditions prior to refurbishment |

**Photo 8.** SMF sarking insulation to ceilings throughout building

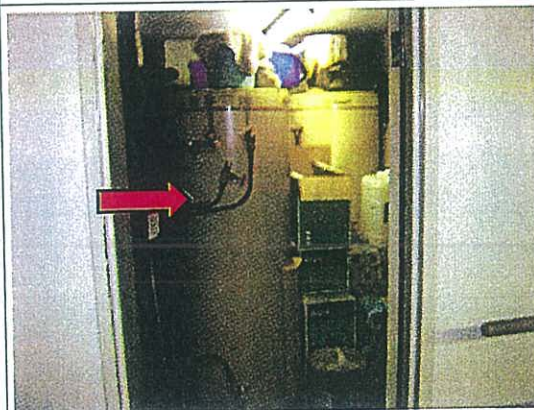
| Location<br>Item Description | Photo<br>No. | Form | Extent | Risk Status | Control Recommendation |
|---|---|---|---|---|---|
| Throughout Building<br>Insulation within hot water heaters | 9 | Bonded | ~15 units x 2m <sup>2</sup> | Low | Maintain in current condition. Remove under controlled conditions prior to refurbishment |

**Photo 9.** Suspected SMF material within Hot water heaters throughout building.

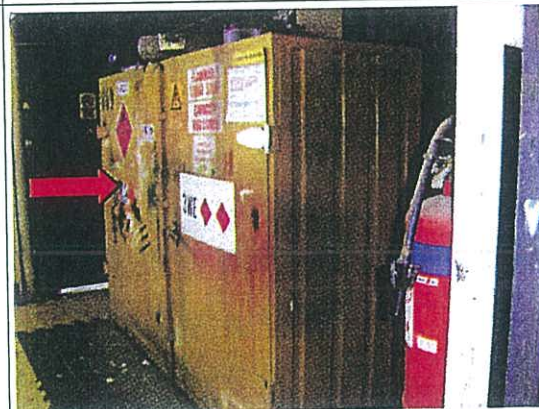
| Location<br>Colour Description, Comments | Photo No. | Results | Extent | Condition | Control Recommendation |
|---|---|---|---|---|---|
| Internal, Level 3, Paint workshop, Metal paint container<br>Yellow paint system | 10 | Positive | 10m <sup>2</sup> | Good | Maintain in current condition, over paint with a lead-free paint as part of ongoing maintenance. |

**Photo 10.** Yellow lead containing paint on paint storage container, Paint workshop, Level 3.
