## 4 PHYSICAL DESCRIPTION OF THE SITE

### 4.1 General External Description

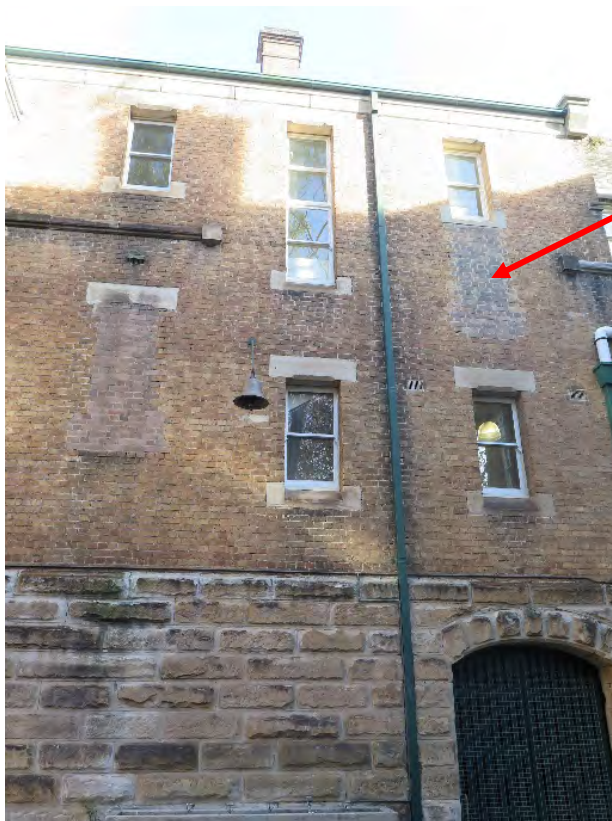
Windows  
have been  
bricked in

FIGURE 4.9 VIEW SHOWING WINDOWS ON THE NORTH FAÇADE OF BUILDING 1A, INCLUDING SEVERAL THAT HAVE BEEN BRICKED IN. NOTE SANDSTONE WALL ON THE LOWER GROUND LEVEL. SOURCE: OCP ARCHITECTS, 2016.

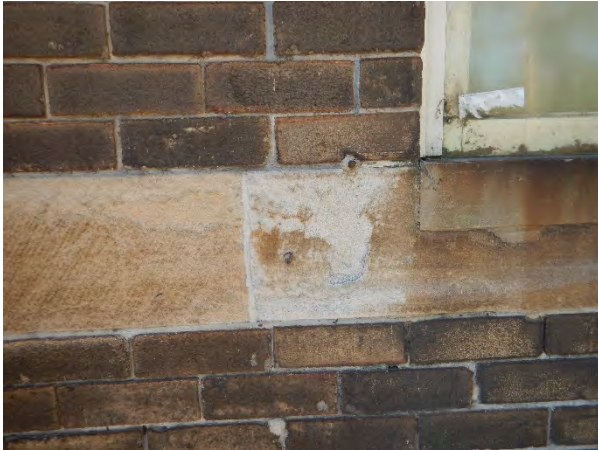
The external facades are in reasonable overall condition, which in part relates to façade conservation works implemented on the Chalmers Street elevation. There are, however, instances of spalling sandstone - for example some sills of the Cleveland Street façade, penetrations into the masonry from previous service installations since removed - most notable on the west façade of the 1909 building and evidence of staining to the masonry – including brick masonry fabric of the north elevation from early metal vents installed above the windows. Stonework will require desalination in the medium term to ensure the ongoing conservation of this significant fabric.

FIGURE 4.12 EXAMPLE OF SPALLING SANDSTONE SILL ON THE CLEVELAND ST ELEVATION OF THE 1909 BUILDING.

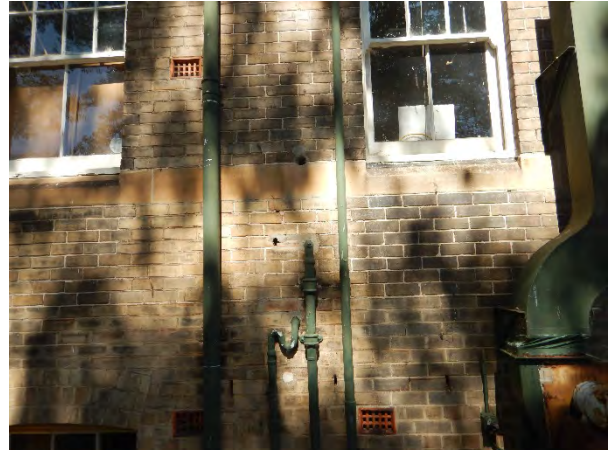
FIGURE 4.13 PENETRATIONS INTO THE MASONRY FABRIC FROM EXTERNALLY MOUNTED SERVICES, INCLUDING THOSE REMAINING WHERE SERVICES HAVE BEEN REMOVED.

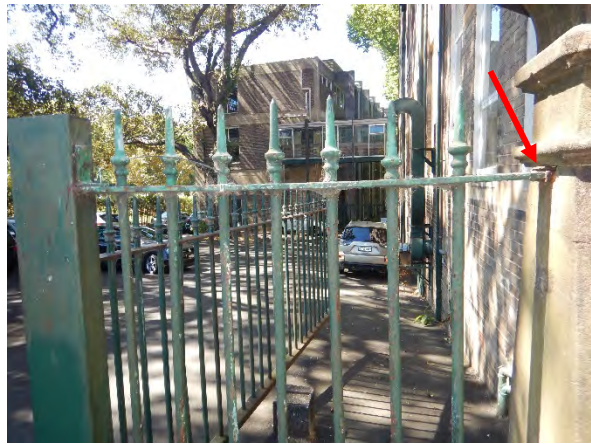
FIGURE 4.15 EARLY PALISADE FENCE ADJACENT TO BUILDING 1B REQUIRES RUST TREATMENT AND PAINTING MAINTENANCE. NOTE RUSTING WHERE SET INTO STONE PIER WILL ALSO AFFECT STONEMASONRY.

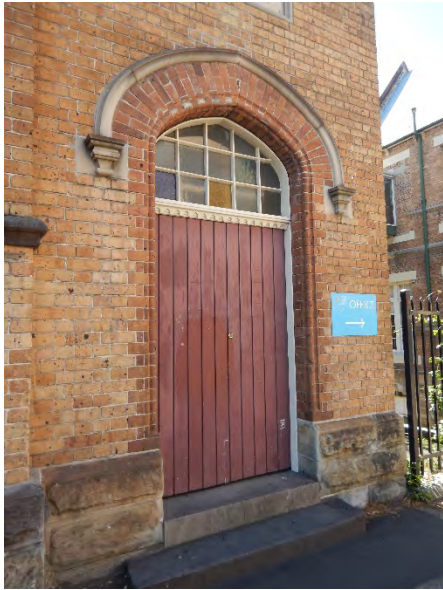
Some self-seeded vegetation and biological growth is also present on the brick masonry at the upper level building, noted on the north façade. External painted finishes on window frames and doors are deteriorating and will require renewal in the medium term to protect the timber fabric.

FIGURE 4.16 EXTERNAL PAINTED TIMBER SURFACES WILL REQUIRE REPAINTING IN THE MEDIUM TERM TO PROTECT TIMBER FABRIC. THIS EXAMPLE IS THE CHALMERS ST ENTRANCE DOOR.

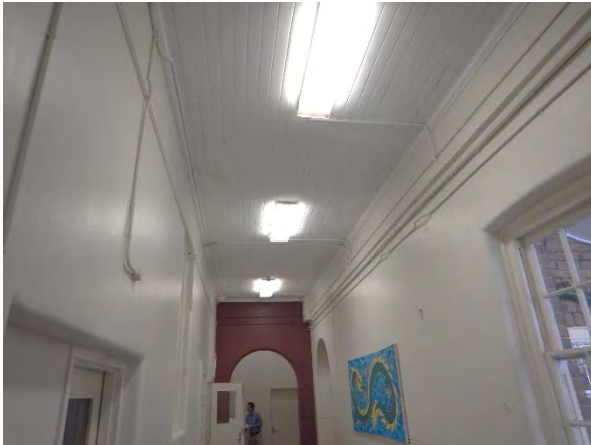
FIGURE 4.18 SURFACE MOUNTED CONDUITS ARE PRESENT ON CEILINGS AND WALLS WITHIN A MAJORITY OF SPACES IN BUILDING 1. THIS EXAMPLE SHOWS THE CORRIDOR ON THE GROUND FLOOR.

The interiors are in good condition overall, however there are a number of areas that require conservation works, including in conjunction with a potential future wholistic services upgrade to address numerous ad hoc penetrations to the building fabric, in particular walls and ceilings.

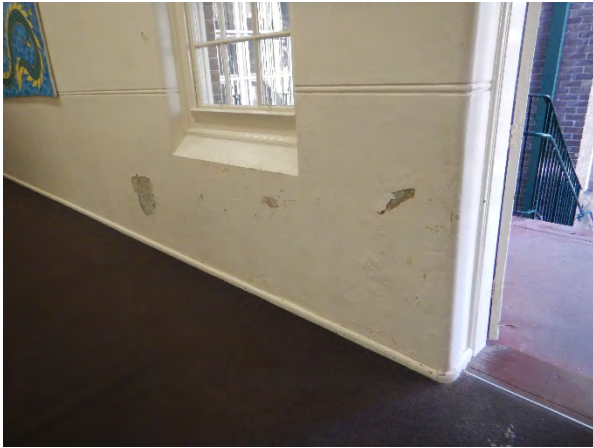
The masonry walls are generally sound, however there are areas of drummy render, including ground floor corridor (space 140) adjacent to external doors and within Room 175 on the first floor. Investigations to determine the source of the problem should be undertaken and remediation works should be implemented prior to repairing walls. It is recommended that the building be thoroughly reviewed for rising damp by a suitable experienced and qualified heritage architect and appropriate remediation measures be implemented as required.

FIGURE 4.22 DRUMMY RENDER AND BLISTERING PAINT IN GROUND FLOOR CORRIDOR (SPACE 140).

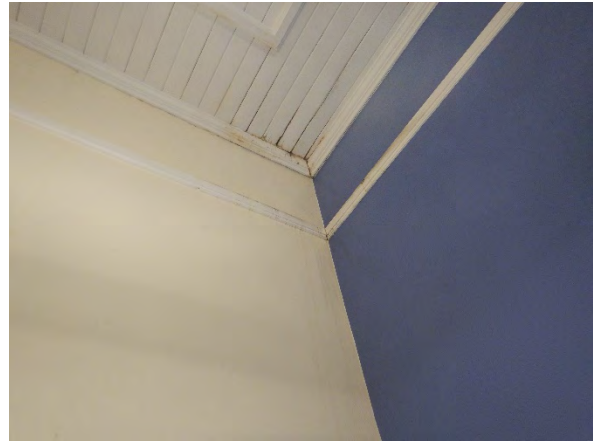
There is also evidence that water ingress has damaged internal fabric on the first floor, including in Room 172 and the stairwell in Building 1B. It is likely that these water ingress problems have been rectified by the new corrugated steel roof recently installed over the whole of the building, however internal remediation work to the extant fabric should also be addressed.

FIGURE 4.23 WATER DAMAGE TO CEILING AND STAINING TO WALL IN FIRST FLOOR ROOM 172.

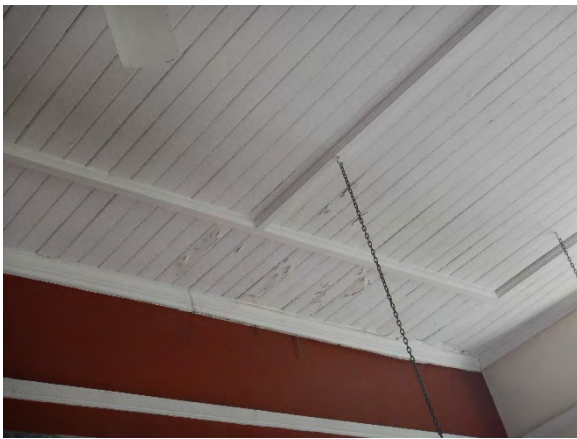
FIGURE 4.24 EXAMPLE OF PEELING AND FLAKING PAINT ON TIMBER BOARDED CEILINGS IN BUILDING 1.

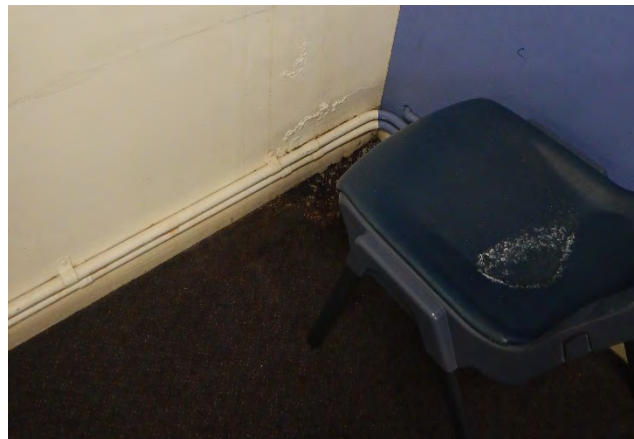
FIGURE 4.25 WATER INGRESS IN ROOM 172 HAS ALSO CAUSED DAMAGE TO WALL AND FLOOR FABRIC.

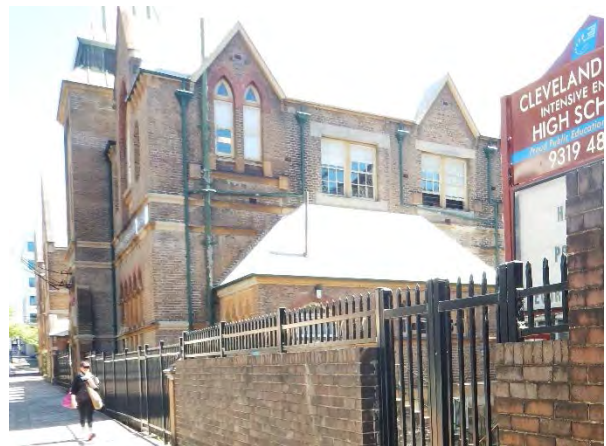
FIGURE 4.34 NORTH ELEVATION OF BUILDING 2A. THE FABRIC REQUIRES CONSERVATION WORKS TO ADDRESS A RANGE OF ISSUES.

- spalling brick and sandstone;
- desalination of stonework;
- repointing of masonry joints to match existing, both brick and stonework, in areas where joints have failed;
- maintenance of external painted timber finishes, which are deteriorating; and
- Removal of self-seeded vegetation and biological growth on the brick masonry, particularly noted on the north façade of Building 2A.

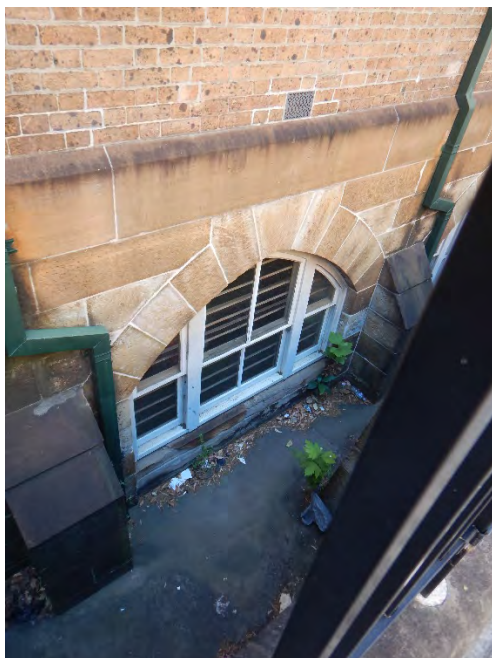
The eastern Chalmers Street facades of Buildings 2A and 2B are in good overall condition owing to façade conservation works implemented by DPWS earlier this century. There is some evidence of staining on the sandstone base wall, including the splayed course owing to build-up of pollutants over time and also in areas around the base of the downpipes. The downpipes do appear sound and it is likely that the staining remains from failure of previous rainwater installations. The stonework of the front façade will require desalination in the medium to long term.

FIGURE 4.35 VIEW OF LOWER GROUND SANDSTONE FABRIC FACING CHALMERS STREET, SHOWING STAINING.

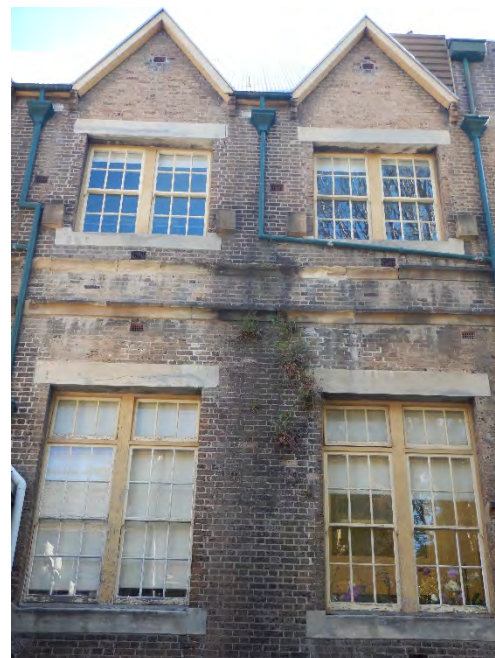
FIGURE 4.36 THE FABRIC OF THE NORTH ELEVATION OF BUILDING 2A TO THE WEST OF THE WALKWAY IS IN POOR CONDITION, WITH SEVERELY SPALLING SANDSTONE (INCLUDING STRING LINES) AND BRICKWORK. A RANGE OF SELF-SEEDING VEGETATION IS ALSO PRESENT.

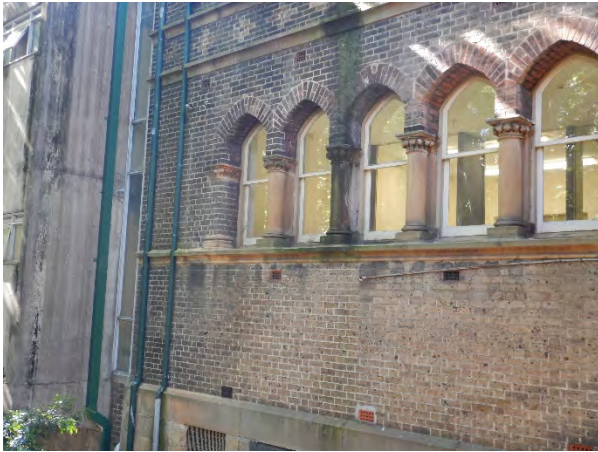
FIGURE 4.37 SOUTH FAÇADE OF BUILDING 2A, WHERE IT CONNECTS TO BUILDING 4 SHOWING SPALLING AND STAINING OF MASONRY FABRIC.

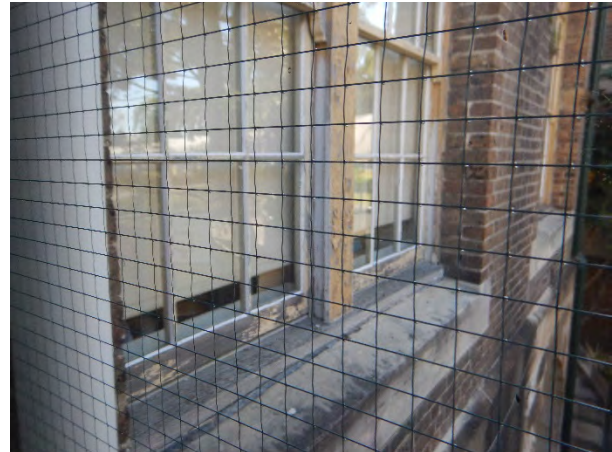
FIGURE 4.38 TIMBER FABRIC, INCLUDING WINDOW FRAMES AND SASHES, REQUIRE PROTECTION VIA PAINTING MAINTENANCE WORKS AS THE CURRENT FINISHES HAVE SEVERELY DETERIORATED. THIS EXAMPLE SHOWS FIRST FLOOR WINDOWS OF THE NORTH ELEVATION.

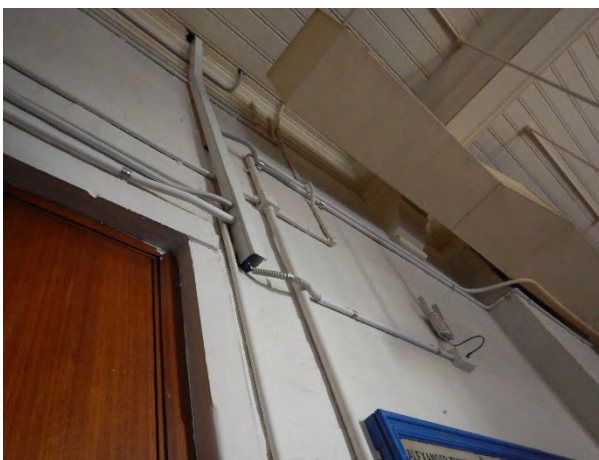
FIGURE 4.43 AN ARRAY OF SURFACE MOUNTED SERVICES HAVE BEEN ATTACHED TO BOTH WALLS AND CEILINGS.

The interiors are in good condition overall, however there are a number of areas that require conservation works, including in conjunction with a potential future wholistic services upgrade to address numerous ad hoc penetrations to the building fabric, in particular walls and ceilings.

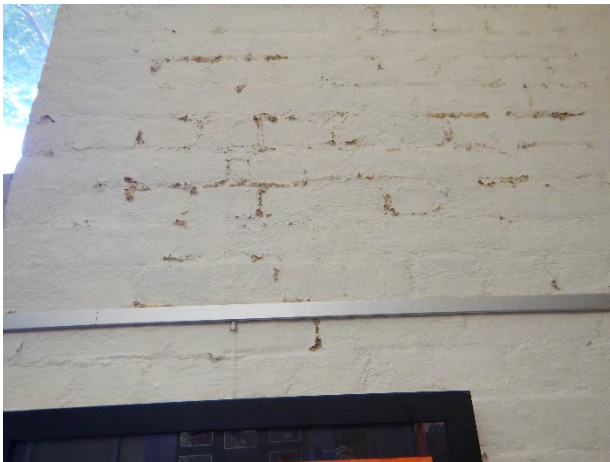
The masonry walls appear to be sound, however some areas of flaking paint, for example in ground floor Room G212 (Building 2B), and efflorescence for example in ground floor Room G205 (south wall reception and north wall office - Building 2A), indicate that further investigation should be undertaken to determine any potential damp issues that may require rectification. It is recommended that the building be thoroughly reviewed for rising damp by a suitable experienced and qualified heritage architect and appropriate remediation measures be implemented as required.

FIGURE 4.45 EFFLORESCENCE ON BRICK MASONRY WALL IN GROUND FLOOR RECEPTION, BUILDING 2A (ROOM G205).

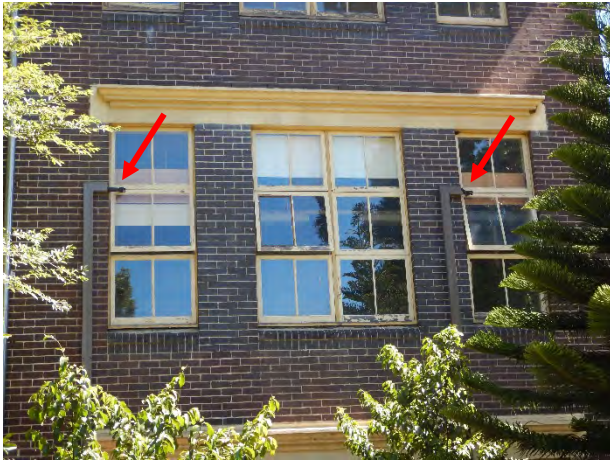
FIGURE 4.51 PARTIAL VIEW OF NORTH ELEVATION SHOWING EXTERNALLY MOUNTED AIR CONDITIONING RISERS, WITH CONDUITS PENETRATING TIMBER WINDOW FRAMES (SHOWN BY RED ARROWS).

- repointing of masonry joints to match existing in areas where joints have failed;
- maintenance of external painted timber finishes, which are deteriorating – in particular timber windows but also eaves and fascias;
- removal of self-seeded vegetation and biological growth, noted on the northern chimney;
- replacement of damaged downpipes, in particular where there is evidence of failure;
- repairs to timber windows where penetrations for air conditioning conduits have been made (to be done in conjunction with rationalisation of services); and
- patching penetrations to brickwork with lime mortar following rationalisation of externally mounted services.

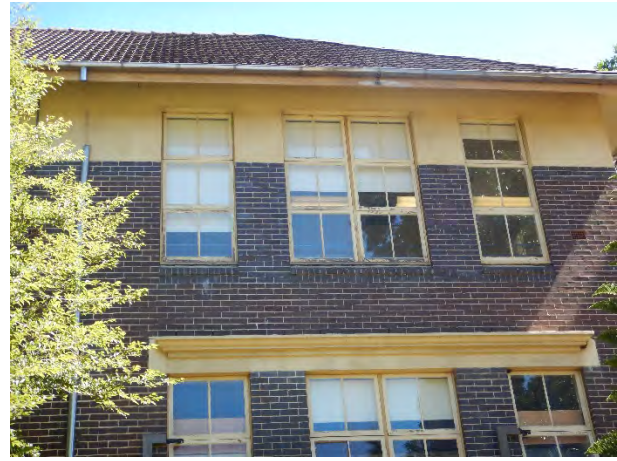
FIGURE 4.52 EXTERNAL PAINTED FINISHES ARE DETERIORATING CONSIDERABLY, INCLUDING WINDOW FRAMES, EAVES AND FASCIAS.

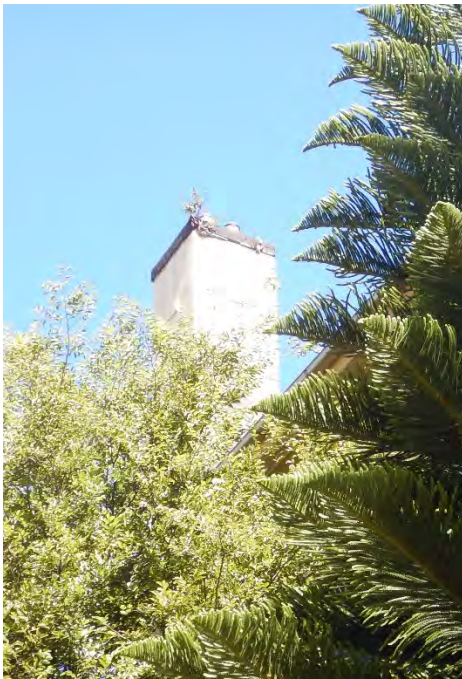
FIGURE 4.53 SELF-SEEDING VEGETATION ON NORTHERN CHIMNEY.

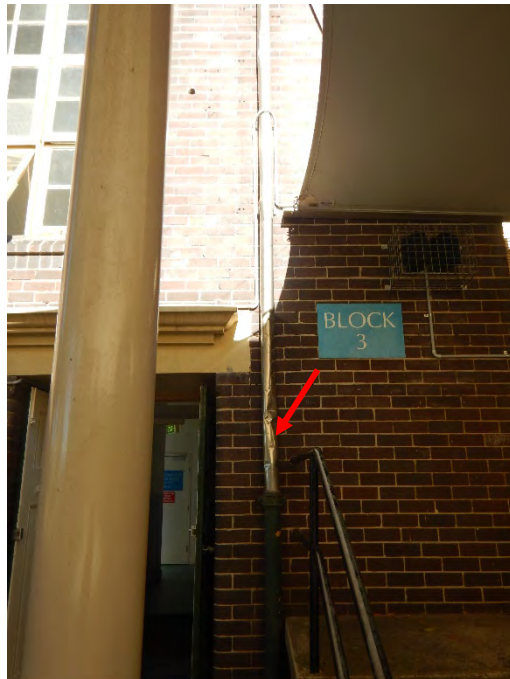
FIGURE 4.54 DAMAGED DOWNPIPE ON THE WESTERN FAÇADE.

Furthermore, it is recommended that the building be thoroughly reviewed for rising damp by a suitable experienced and qualified heritage architect and appropriate remediation measures be implemented as required. A hydraulic analysis of the roofs should also be undertaken to ensure that the provision of downpipes is adequate for the building.

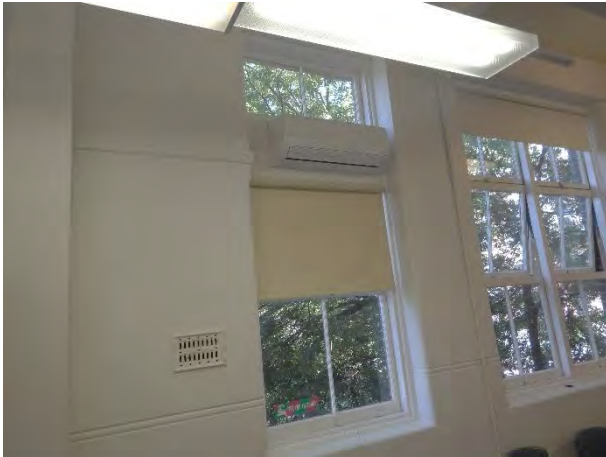
There is only limited air conditioning within the building, which is provided via 'wall mounted' units that are provided to rooms on the ground floor on the north elevation facing the park. The introduced units are intrusive, and have been installed on boards fixed across the windows. In addition, a number of classrooms contain ceiling fans and there are examples of wall mounted heaters, however these are not present in the circulation areas.

FIGURE 4.59 'WALL MOUNTED' AIR CONDITIONING UNIT ON GROUND FLOOR NORTHERN WINDOWS. PENETRATIONS HAVE BEEN MADE TO THE TIMBER FRAME TO CONNECT THE CONDUIT TO THE EXTERNAL RISER.
