Re: DoE ISHS: HazMat

Hazardous Materials Risk Assessment
Department of Education
Cleveland Street Intensive English High School
Corner Chalmers and Cleveland Streets, Surry Hills NSW 2010

Our Reference: C107471 : J141683

Date: January 2016

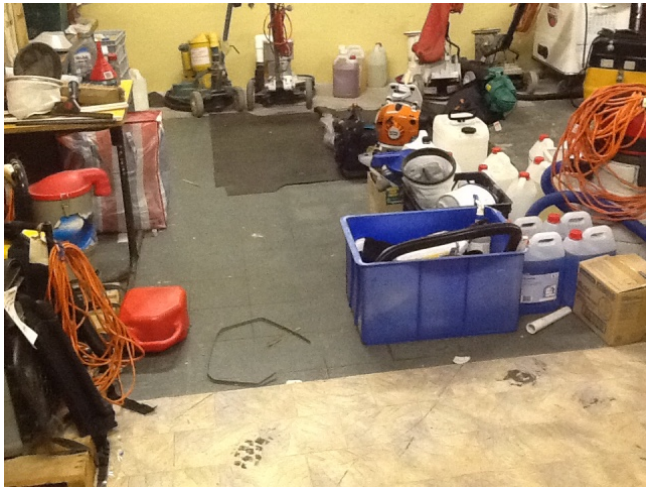
Photo No: J141683-8288-Photo127
Result: Asbestos - Previously Sampled Positive
Building/Level: Building 1-Basement Level
Room/Location: 1R9001-Cleaners Store-
Feature/Material: Floor Covering-Vinyl Tiles & Adhesive

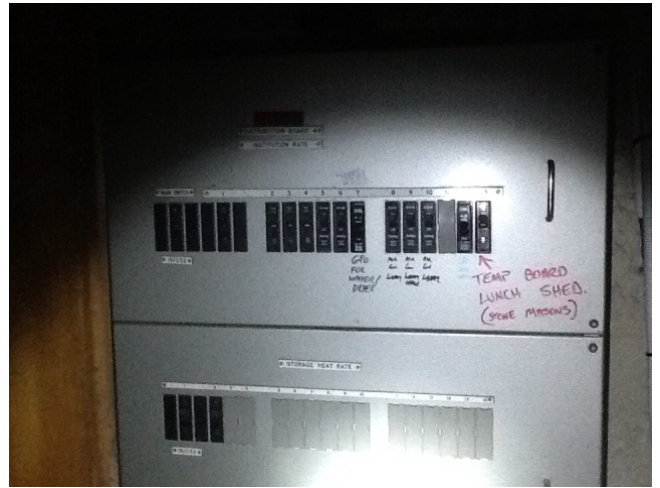
1R9006-Electrical Cupboard - West Electrical - Switch Board - Compressed Bituminous Electrical Panel		Asbestos	Not Sampled Live Electrical Hazard	Presumed Positive	J141683-8288 -Photo128	1 Unit/s	Good	Non Friable	Low	Low	Not Labelled	20-01-2017	P4	Confirm status, label, maintain in current condition and incorporate into a HMMP. Remove by licensed asbestos contractor prior to demolition or refurbishment.	
1R9011-Sports Store - Southeast Heater - Millboard Insulation		Asbestos	Not Sampled Restricted Access	Presumed Positive	J141683-8288 -Photo125	1 m²	Good	Friable	Low	Low	Not Labelled	20-01-2017	P3	Confirm status, label, maintain in current condition and incorporate into a HMMP. Remove by licensed asbestos contractor prior to demolition or refurbishment.	
1R9011-Sports Store - Throughout Floor Covering - Vinyl Tiles & Adhesive		Asbestos	J141683-8288-007	Positive	J141683-8288 -Photo126	12 m²	Good	Non Friable	Low	Low	Not Labelled	20-01-2017	P4	Maintain in current condition, label and incorporate into a HMMP. Remove by licensed asbestos contractor prior to demolition or refurbishment.

Photo No: J141683-8288-Photo128
Result: Asbestos - Presumed Positive
Building/Level: Building 1-Basement Level
Room/Location: 1R9006-Electrical Cupboard-West
Feature/Material: Electrical - Switch Board-Compressed Bituminous Electrical Panel

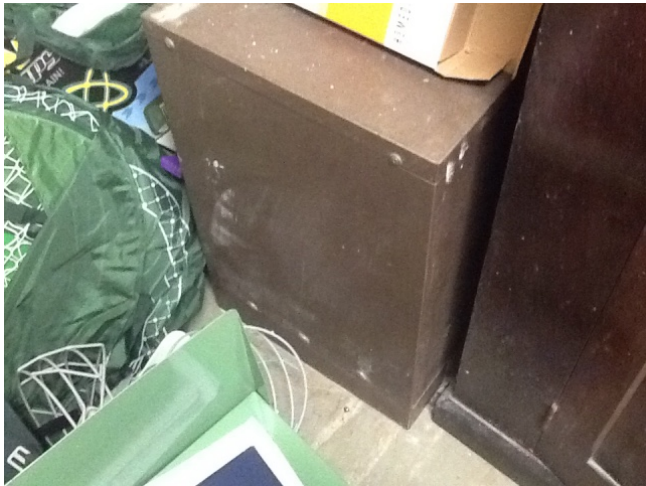
Photo No: J141683-8288-Photo125
Result: Asbestos - Presumed Positive
Building/Level: Building 1-Basement Level
Room/Location: 1R9011-Sports Store-Southeast
Feature/Material: Heater-Millboard Insulation

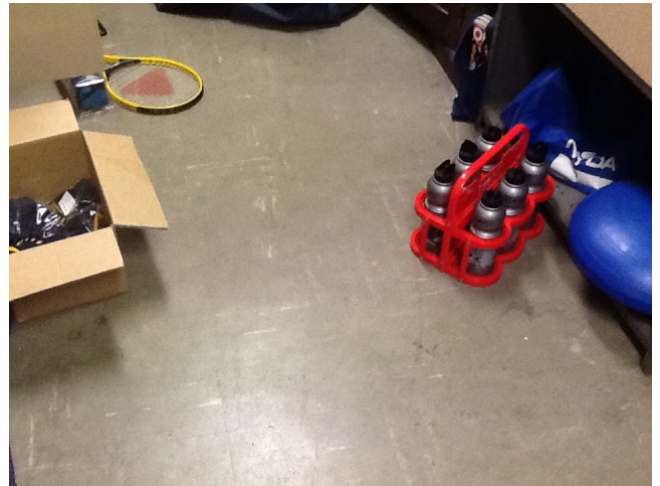
Photo No: J141683-8288-Photo126
Result: Asbestos - Positive
Building/Level: Building 1-Basement Level
Room/Location: 1R9011-Sports Store-Throughout
Feature/Material: Floor Covering-Vinyl Tiles & Adhesive

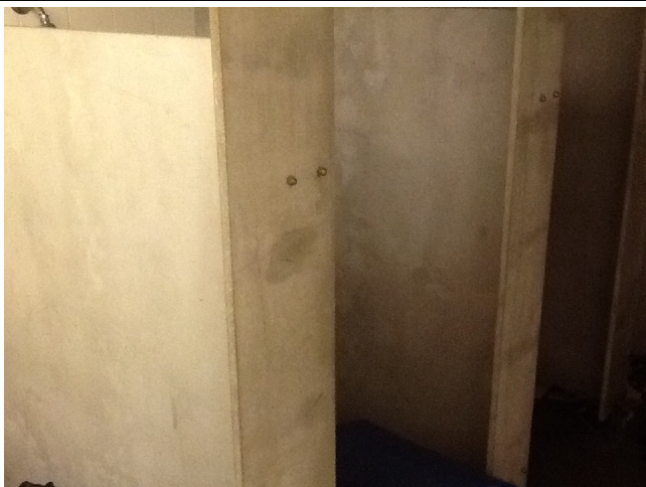
1R9013-Showers - Central Shower Cubicle - Compressed Cement Sheet		Asbestos	Previously Sampled Noel Arnold & Associates Similar to S10	Previously Sampled Positive	J141683-8288 -Photo124	10 m²	Good	Non Friable	Low	Low	Not Labelled	20-01-2017	P4	Maintain in current condition, label and incorporate into a HMMP. Remove by licensed asbestos contractor prior to demolition or refurbishment.	
1R9016-Toilet - North Cubicle Partitions - Compressed Cement Sheet		Asbestos	Previously Sampled Noel Arnold & Associates Similar to S10	Previously Sampled Positive	J141683-8288 -Photo123	6 m²	Good	Non Friable	Low	Low	Not Labelled	20-01-2017	P4	Maintain in current condition, label and incorporate into a HMMP. Remove by licensed asbestos contractor prior to demolition or refurbishment.	
1R9019-Toilet - Central Cubicle Partitions - Compressed Cement Sheet		Asbestos	Previously Sampled Noel Arnold & Associates S10	Previously Sampled Positive	J141683-8288 -Photo122	4 m²	Good	Non Friable	Low	Low	Not Labelled	20-01-2017	P4	Maintain in current condition, label and incorporate into a HMMP. Remove by licensed asbestos contractor prior to demolition or refurbishment.

Photo No: J141683-8288-Photo124
Result: Asbestos - Previously Sampled Positive
Building/Level: Building 1-Basement Level
Room/Location: 1R9013-Showers-Central
Feature/Material: Shower Cubicle-Compressed Cement Sheet

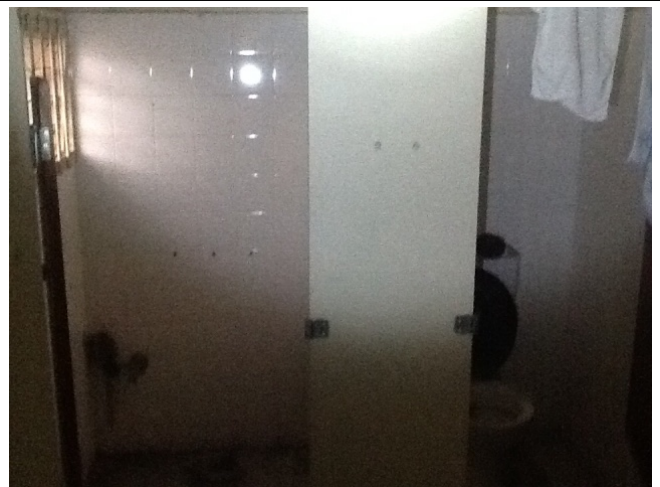
Photo No: J141683-8288-Photo123
Result: Asbestos - Previously Sampled Positive
Building/Level: Building 1-Basement Level
Room/Location: 1R9016-Toilet-North
Feature/Material: Cubicle Partitions-Compressed Cement Sheet

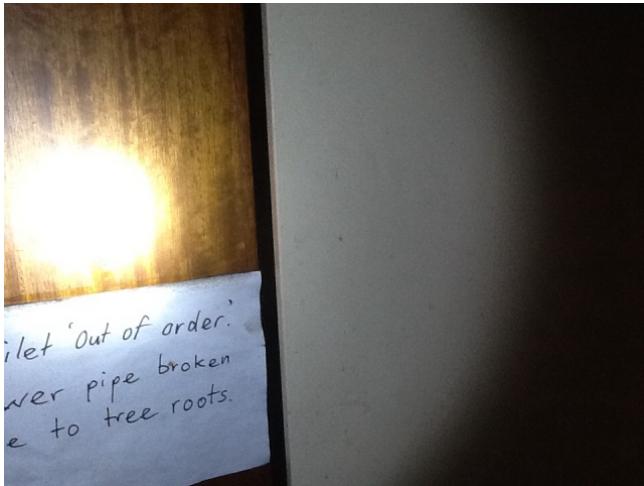
Photo No: J141683-8288-Photo122
Result: Asbestos - Previously Sampled Positive
Building/Level: Building 1-Basement Level
Room/Location: 1R9019-Toilet-Central
Feature/Material: Cubicle Partitions-Compressed Cement Sheet

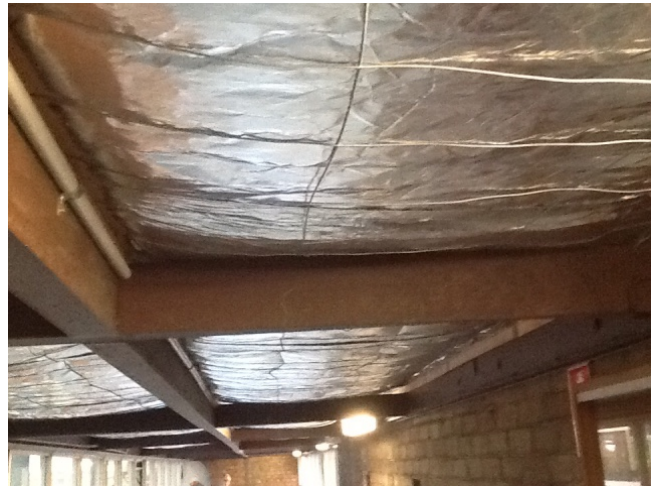
1R0016-Hallway - Throughout Floor Covering - Vinyl Tiles & Adhesive	Asbestos	Similar To: J141683-8288-006	Presumed Negative											
1R0021-Covered Walkway - Throughout Roof Lining - Sarking Insulation	SMF		Positive	J141683-8288-Photo121	35 m ²	Good	Bonded (SMF)						Maintain in good condition and incorporate into a HMMP. Remove under controlled conditions prior to demolition or refurbishment.	
1R0024-Hallway - Throughout Floor Covering - Vinyl Tiles & Adhesive	Asbestos	Similar To: J141683-8288-006	Presumed Negative

Photo No: J141683-8288-Photo121
Result: SMF - Positive
Building/Level: Building 1-Ground Level
Room/Location: 1R0021-Covered Walkway-Throughout
Feature/Material: Roof Lining-Sarking Insulation

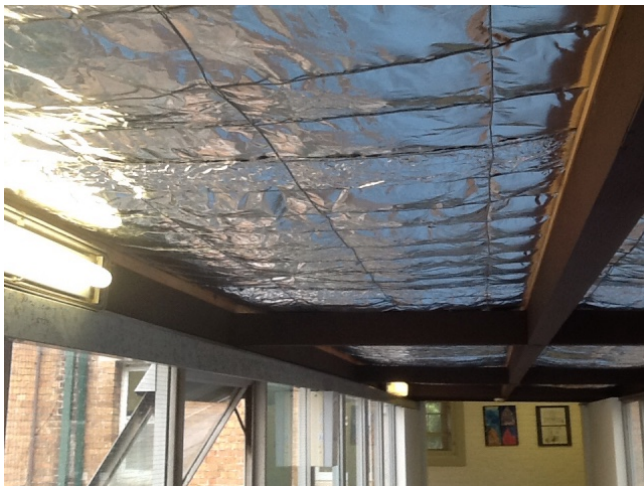
Walkway between building 1 & 2 - Throughout Roof Lining - Sarking Insulation	SMF		Positive	J141683-8288-Photo111	26 m ²	Good	Bonded (SMF)						Maintain in good condition and incorporate into a HMMP. Remove under controlled conditions prior to demolition or refurbishment.	
--	-----	--	----------	-----------------------	-------------------	------	--------------	--	--	--	--	--	--	--

Photo No: J141683-8288-Photo111
Result: SMF - Positive
Building/Level: Building 1-Level One
Room/Location: Walkway between building 1 & 2-Throughout
Feature/Material: Roof Lining-Sarking Insulation

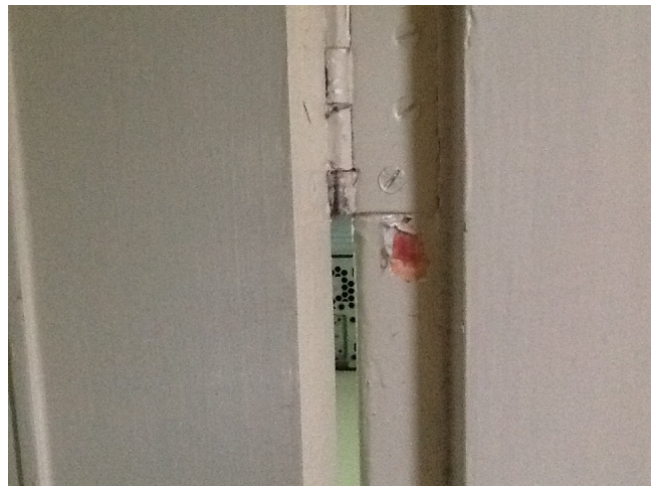
All Rooms - Various Throughout Timber Work - Upper & Lower Paint System/s	Lead (Paint)	J141683-8288-LC-002	Positive	J141683-8288-Photo110	130 m ²	Good							Maintain in good condition and incorporate into a HMMP. Remove under controlled conditions prior to demolition or refurbishment.	
---	--------------	---------------------	----------	-----------------------	--------------------	------	--	--	--	--	--	--	--	--

Photo No: J141683-8288-Photo110
Result: Lead (Paint) - Positive
Building/Level: Building 1-All Levels
Room/Location: All Rooms-Various Throughout
Feature/Material: Timber Work-Upper & Lower Paint System/s

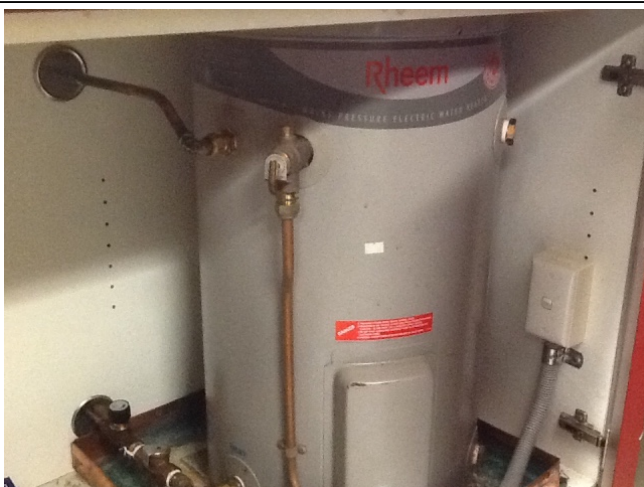
Photo No: J141683-8288-Photo133
Result: SMF - Presumed Positive
Building/Level: Building 2-Ground Level
Room/Location: 2R0006-Canteen-East
Feature/Material: Hot Water Heater-Insulation Material

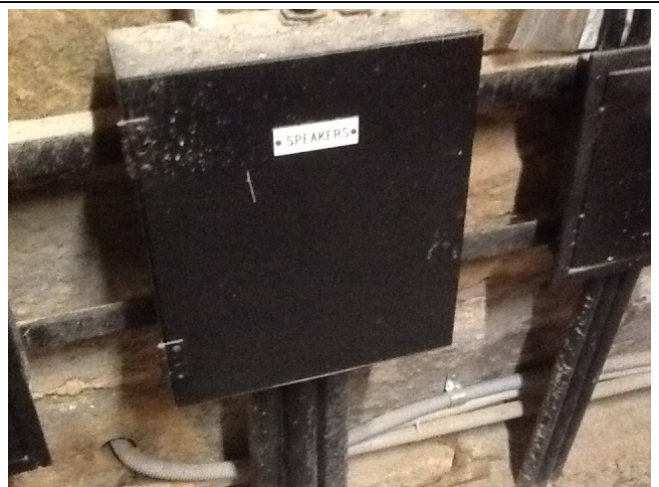
2R0007-Main Switchroom - East Electrical - Switch Board - Compressed Bituminous Electrical Panel	Asbestos	Not Sampled Live Electrical Hazard	Presumed Positive	J141683-8288 -Photo131	1 Unit/s	Good	Non Friable	Low	Low	Not Labelled	20-01-2017	P4	Confirm status, label, maintain in current condition and incorporate into a HMMP. Remove by licensed asbestos contractor prior to demolition or refurbishment.	
2R0007-Main Switchroom - Throughout Wall - Pointing	Asbestos	J141683-8288-008	Negative											
2R0016-toilet/shower - North Hot Water Heater - Insulation Material	SMF		Presumed Positive	J141683-8288 -Photo130	1 Unit/s	Good	Bonded (SMF)						Maintain in good condition and incorporate into a HMMP. Remove under controlled conditions prior to demolition or refurbishment.	
Building 2 - Interior - Level One														
Covered Walkway - North Roof Lining - Sarking Insulation	SMF		Presumed Positive	J141683-8288 -Photo134	16 m ²	Good	Bonded (SMF)						Maintain in good condition and incorporate into a HMMP. Remove under controlled conditions prior to demolition or refurbishment.

Photo No: J141683-8288-Photo131
Result: Asbestos - Presumed Positive
Building/Level: Building 2-Ground Level
Room/Location: 2R0007-Main Switchroom-East
Feature/Material: Electrical - Switch Board-Compressed Bituminous Electrical Panel

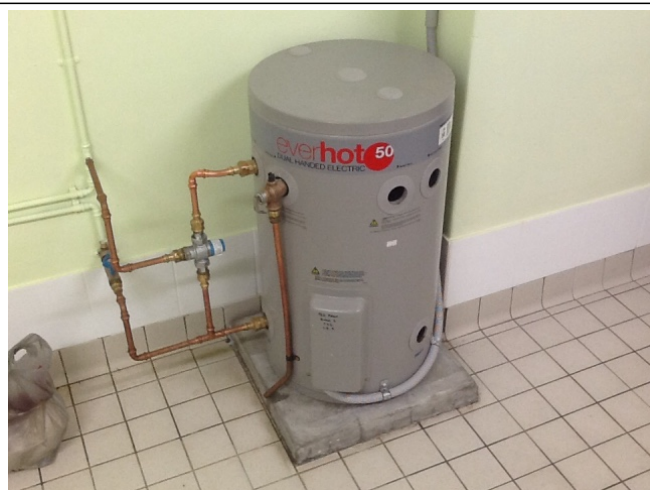
Photo No: J141683-8288-Photo130
Result: SMF - Presumed Positive
Building/Level: Building 2-Ground Level
Room/Location: 2R0016-toilet/shower-North
Feature/Material: Hot Water Heater-Insulation Material

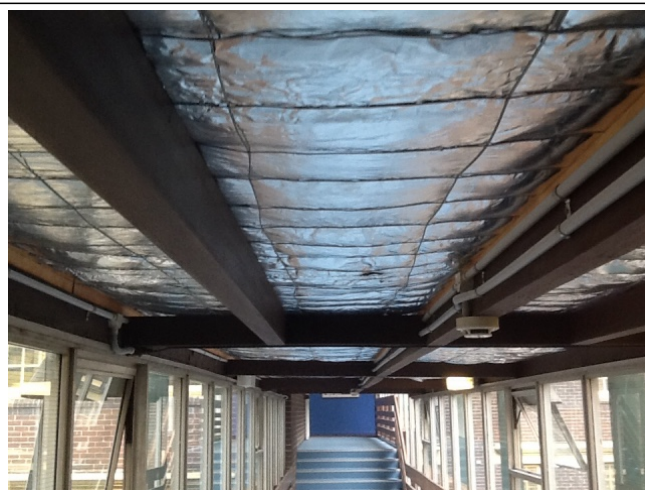
Photo No: J141683-8288-Photo134
Result: SMF - Presumed Positive
Building/Level: Building 2-Level One
Room/Location: Covered Walkway-North
Feature/Material: Roof Lining-Sarking Insulation

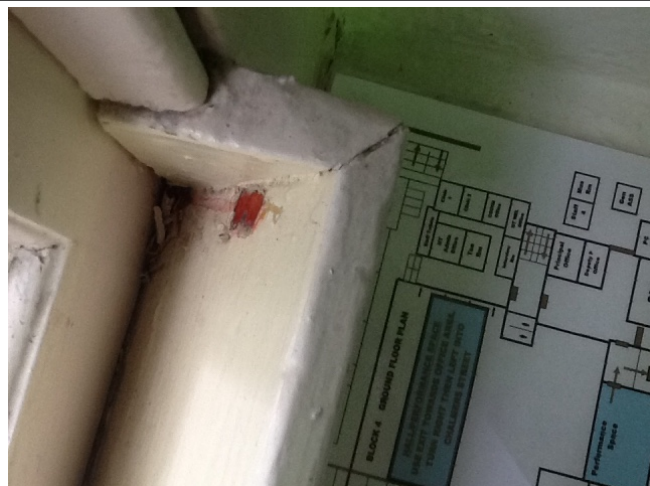
Building 2 - Interior - All Levels														
All Rooms - Various Throughout Timber Work - Upper & Lower Paint System/s	Lead (Paint)	J141683-8288-LC-003	Positive	J141683-8288 -Photo129	60 m ²	Good							Maintain in good condition and incorporate into a HMMP. Remove under controlled conditions prior to demolition or refurbishment.

Photo No: J141683-8288-Photo129
Result: Lead (Paint) - Positive
Building/Level: Building 2-All Levels
Room/Location: All Rooms-VariouS Throughout
Feature/Material: Timber Work-Upper & Lower Paint System/s

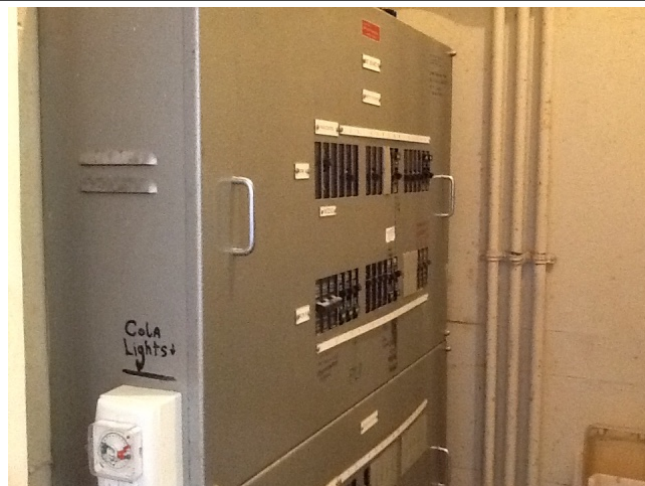
Photo No: J141683-8288-Photo152
Result: Asbestos - Presumed Positive
Building/Level: Building 3-Ground Level
Room/Location: 3R0003-Electrical Switchroom-South
Feature/Material: Electrical - Switch Board-Compressed Bituminous Electrical Panel

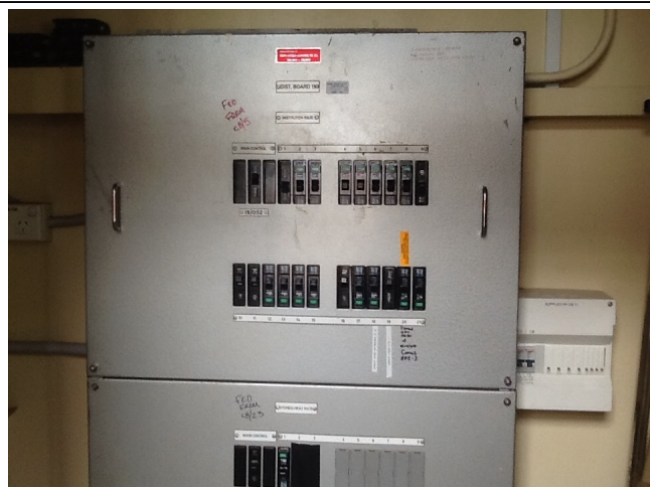
Photo No: J141683-8288-Photo161
Result: Asbestos - Presumed Positive
Building/Level: Building 3-Level One
Room/Location: 3R1003-Electrical Switchboard-North
Feature/Material: Electrical - Switch Board-Compressed Bituminous Electrical Panel

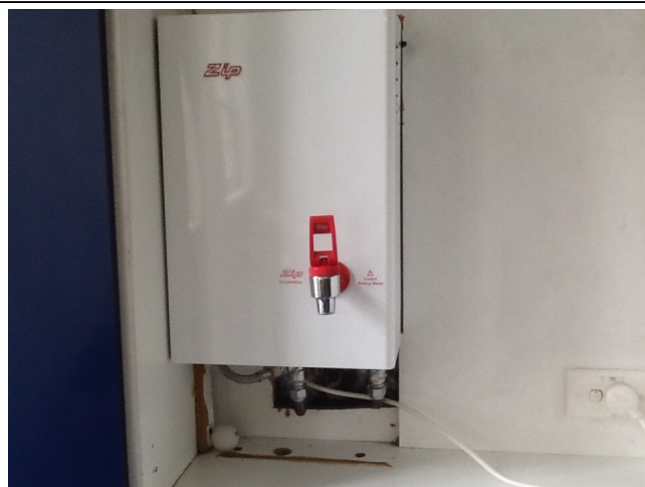
3R1007-Staff Room - Southwest Hot Water Heater - Insulation Material	SMF		Presumed Positive	J141683-8288-Photo156	1 Unit/s	Good	Bonded (SMF)						Maintain in good condition and incorporate into a HMMP. Remove under controlled conditions prior to demolition or refurbishment.	
3R1007-Staff Room - Throughout Floor Covering - Vinyl Tiles & Adhesive	Asbestos	Similar To: J141683-8288-009	Presumed Negative											
3R1009-Movement - Throughout Floor Covering - Vinyl Tiles & Adhesive	Asbestos	Similar To: J141683-8288-009	Presumed Negative											
3R1012-Movement - Throughout Roof Lining - Sarking Insulation	SMF		Presumed Positive	J141683-8288-Photo158	16 m ²	Good	Bonded (SMF)						Maintain in good condition and incorporate into a HMMP. Remove under controlled conditions prior to demolition or refurbishment.	
Building 3 - Interior - Level Two														
3R2003-Storeroom - Throughout Floor Covering - Hessian Backed Sheet Vinyl	Asbestos	J141683-8288-010	Negative

Photo No: J141683-8288-Photo156
Result: SMF - Presumed Positive
Building/Level: Building 3-Level One
Room/Location: 3R1007-Staff Room-Southwest
Feature/Material: Hot Water Heater-Insulation Material

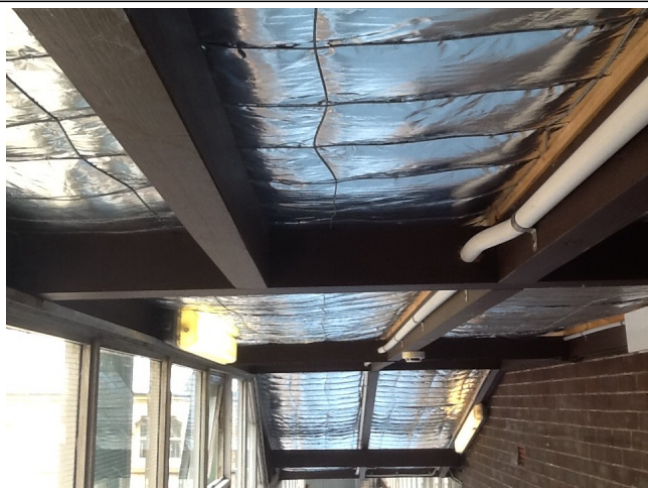
Photo No: J141683-8288-Photo158
Result: SMF - Presumed Positive
Building/Level: Building 3-Level One
Room/Location: 3R1012-Movement-Throughout
Feature/Material: Roof Lining-Sarking Insulation

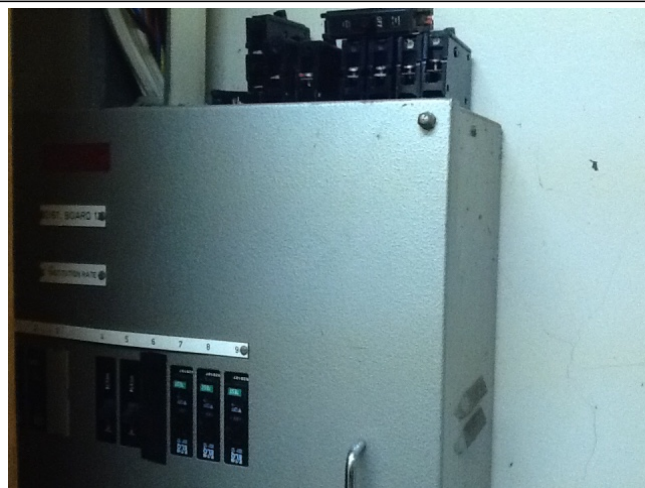
Photo No: J141683-8288-Photo164
Result: Asbestos - Presumed Positive
Building/Level: Building 3-Level Two
Room/Location: 3R2004-Electrical Board-West
Feature/Material: Electrical - Switch Board-Compressed Bituminous Electrical Panel

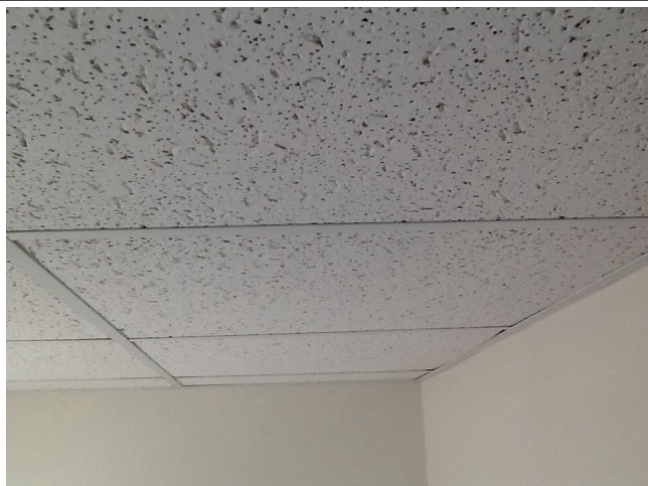
Photo No: J141683-8288-Photo162
Result: SMF - Presumed Positive
Building/Level: Building 3-Level Two
Room/Location: 3R2008-Stairs-South
Feature/Material: Ceiling-Compressed Ceiling Tiles

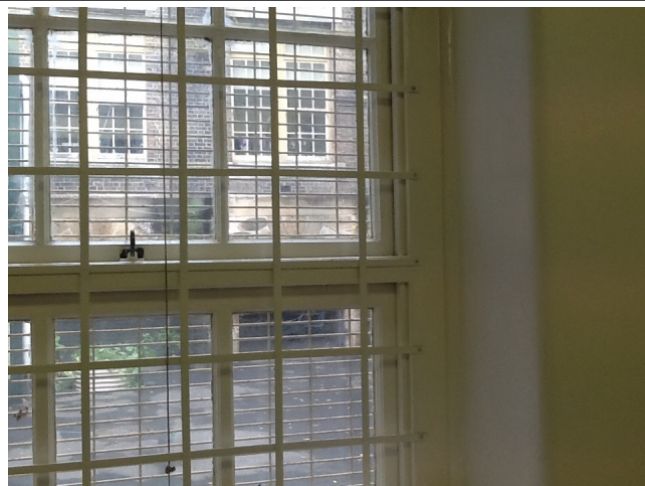
Photo No: J141683-8288-Photo151
Result: Lead (Paint) - Positive
Building/Level: Building 3-All Levels
Room/Location: All Rooms-Various Throughout
Feature/Material: Timber Work-Upper & Lower Paint System/s

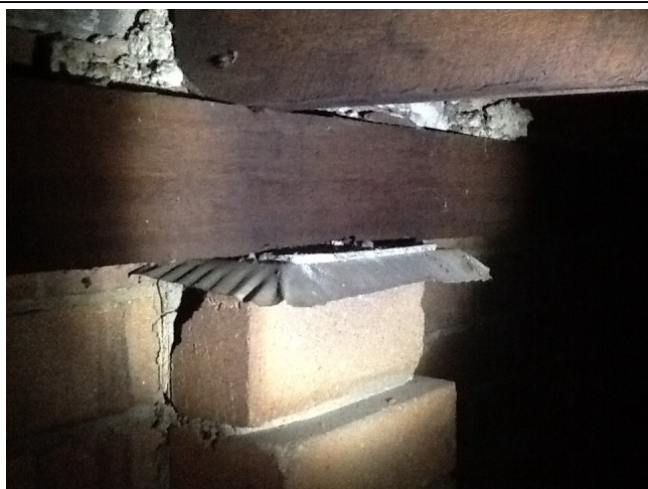
Photo No: J141683-8288-Photo010
Result: Asbestos - Positive
Building/Level: Building 4-Ground Level
Room/Location: Subfloor-Various Throughout
Feature/Material: Packer-Fibre Cement Sheeting

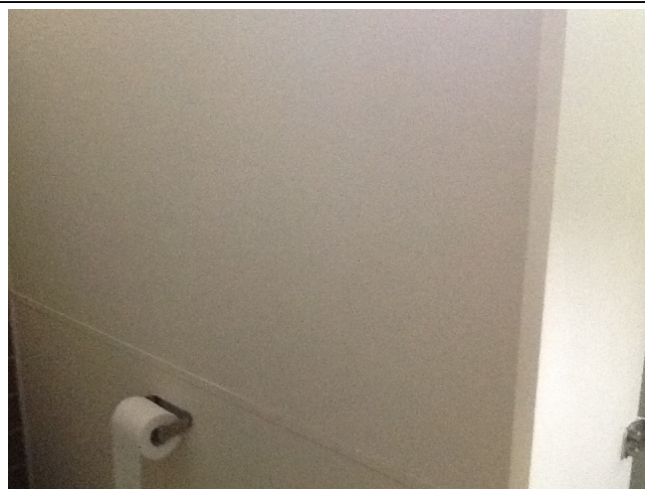
Photo No: J141683-8288-Photo053
Result: Asbestos - Previously Sampled Positive
Building/Level: Building 4-Level One
Room/Location: 4R1001 (Toilet)-Throughout
Feature/Material: Cubicle Partitions-Compressed Cement Sheet

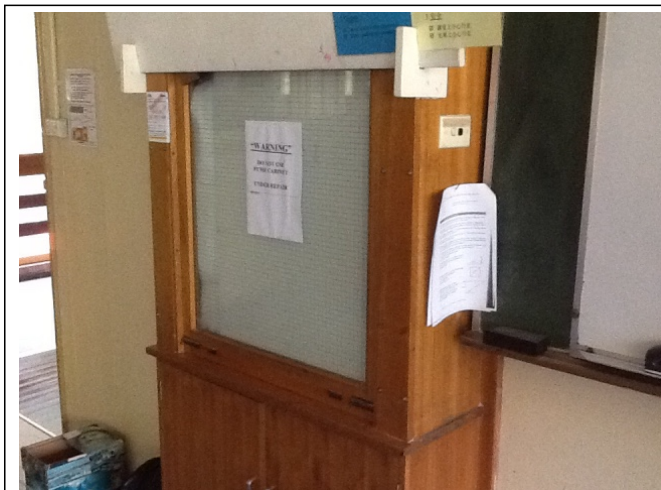
Photo No: J141683-8288-Photo024
Result: Asbestos - Presumed Positive
Building/Level: Building 4-Level One
Room/Location: 4R1011 (Room 12)-
Feature/Material: Fume Cupboard Lining-Fibre Cement Sheeting

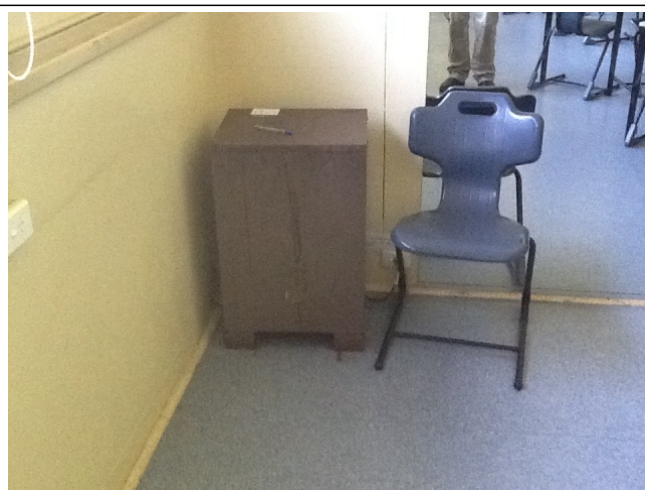
Photo No: J141683-8288-Photo026
Result: Asbestos - Presumed Positive
Building/Level: Building 4-Level One
Room/Location: 4R1011 (Room 12)-Northwest
Feature/Material: Heater-Insulation

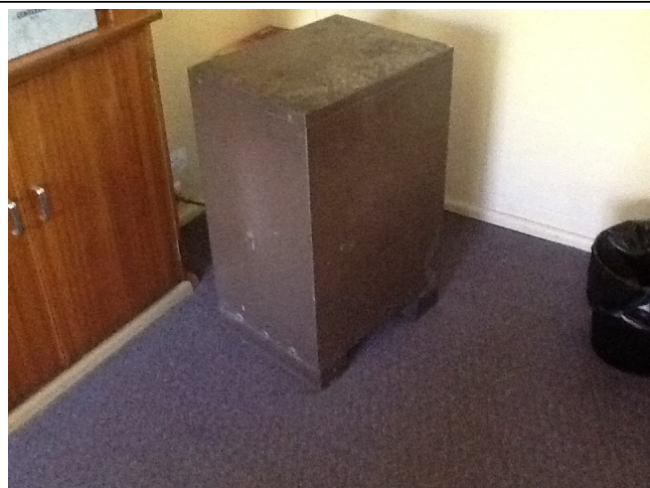
Photo No: J141683-8288-Photo028
Result: Asbestos - Presumed Positive
Building/Level: Building 4-Level One
Room/Location: 4R1013 (Room 11)-Northeast
Feature/Material: Heater-Insulation

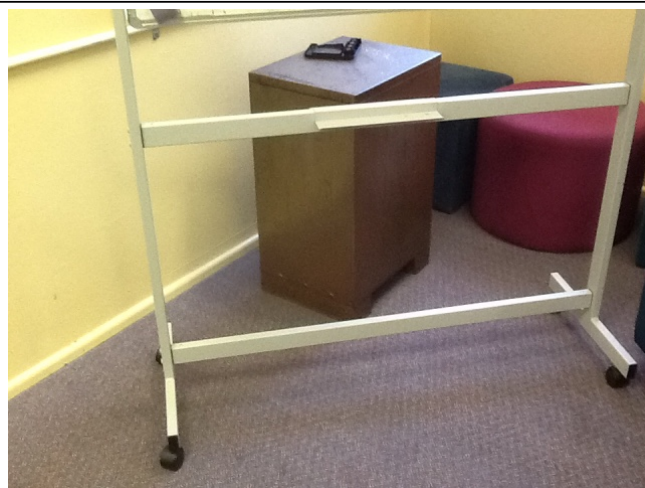
Photo No: J141683-8288-Photo029
Result: Asbestos - Presumed Positive
Building/Level: Building 4-Level One
Room/Location: 4R1014 (Room 10)-Southwest
Feature/Material: Heater-Insulation

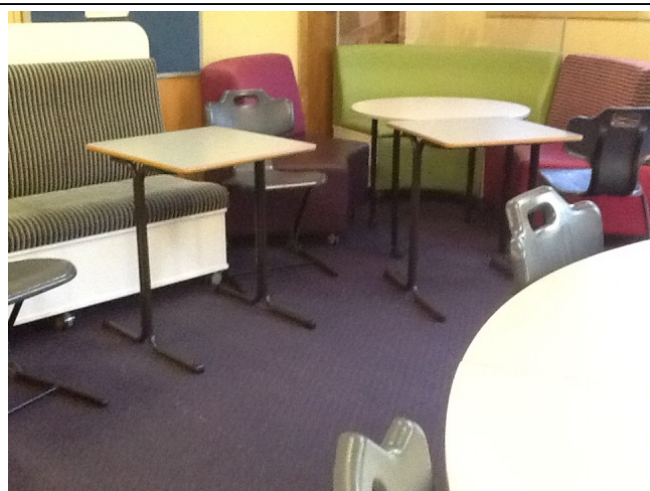
Photo No: J141683-8288-Photo033
Result: Asbestos - Previously Sampled Positive
Building/Level: Building 4-Level One
Room/Location: 4R1016 (Room 9)-Throughout
Feature/Material: Floor Covering-Vinyl Tiles & Adhesive

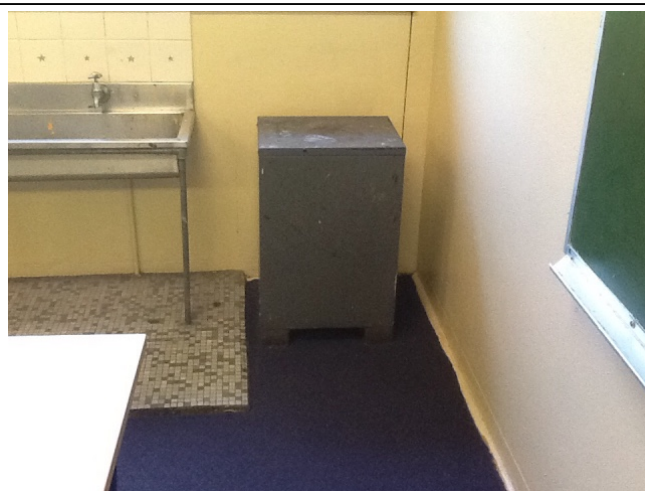
Photo No: J141683-8288-Photo031
Result: Asbestos - Presumed Positive
Building/Level: Building 4-Level One
Room/Location: 4R1016 (Room 9)-Various Throughout
Feature/Material: Heater-Insulation

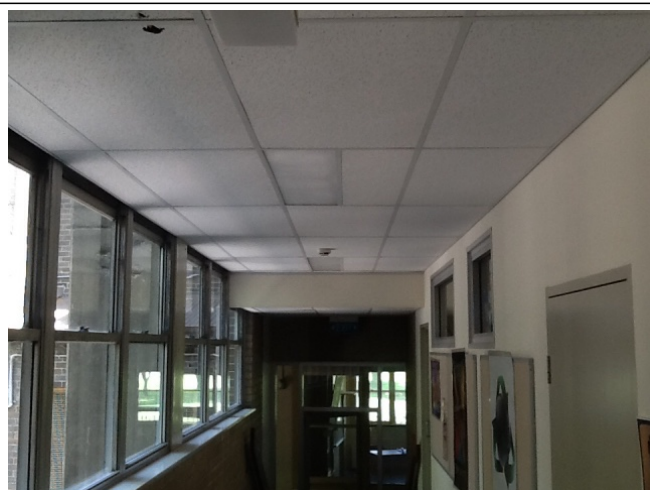
Photo No: J141683-8288-Photo040
Result: SMF - Positive
Building/Level: Building 4-Level One
Room/Location: 4R1024 (Movement)-Throughout
Feature/Material: Ceiling-Compressed Ceiling Tiles

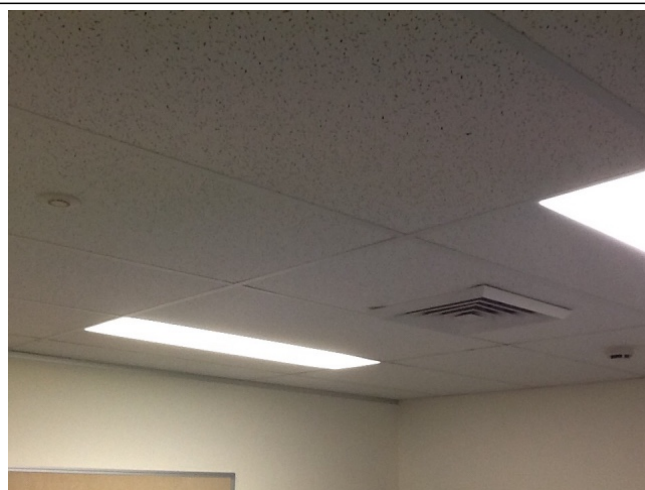
Photo No: J141683-8288-Photo051
Result: SMF - Positive
Building/Level: Building 4-Level One
Room/Location: 4R1025 (Meeting Room)-Throughout
Feature/Material: Ceiling-Compressed Ceiling Tiles

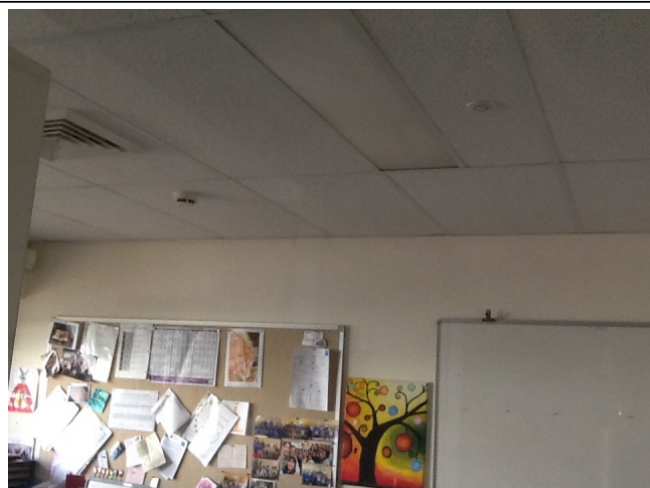
Photo No: J141683-8288-Photo049
Result: SMF - Positive
Building/Level: Building 4-Level One
Room/Location: 4R1026 (Head Teacher)-Throughout
Feature/Material: Ceiling-Compressed Ceiling Tiles

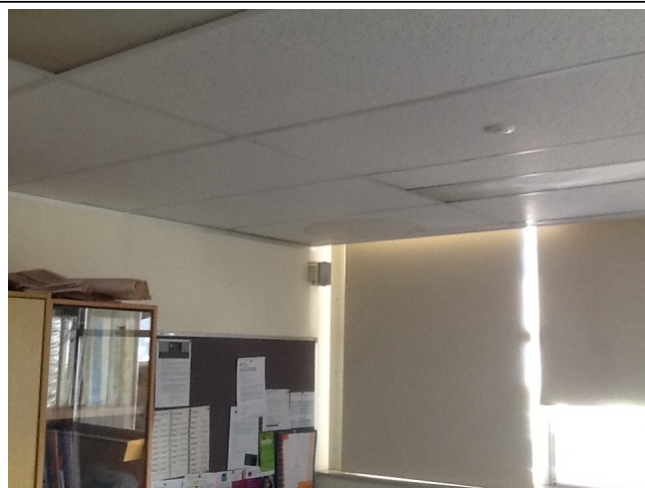
Photo No: J141683-8288-Photo045
Result: SMF - Positive
Building/Level: Building 4-Level One
Room/Location: 4R1027 (Counsellor)-Throughout
Feature/Material: Ceiling-Compressed Ceiling Tiles

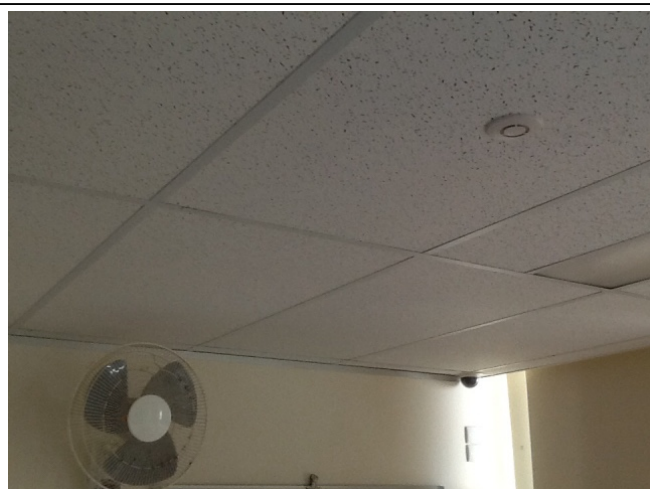
Photo No: J141683-8288-Photo044
Result: SMF - Positive
Building/Level: Building 4-Level One
Room/Location: 4R1028 (Clinic)-Throughout
Feature/Material: Ceiling-Compressed Ceiling Tiles

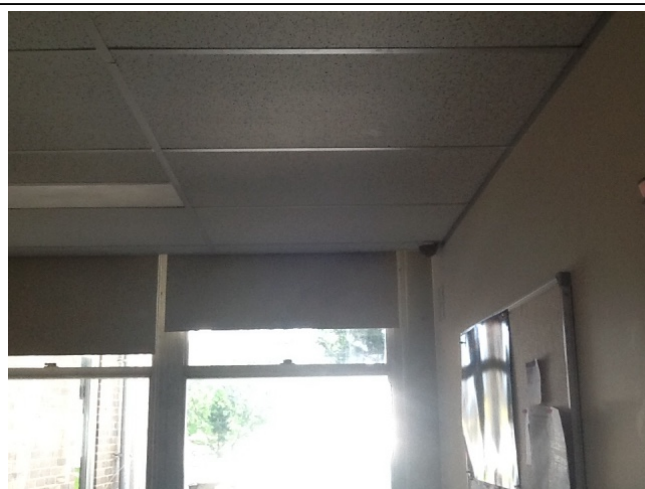
Photo No: J141683-8288-Photo043
Result: SMF - Positive
Building/Level: Building 4-Level One
Room/Location: 4R1029 (Head Teacher)-Throughout
Feature/Material: Ceiling-Compressed Ceiling Tiles

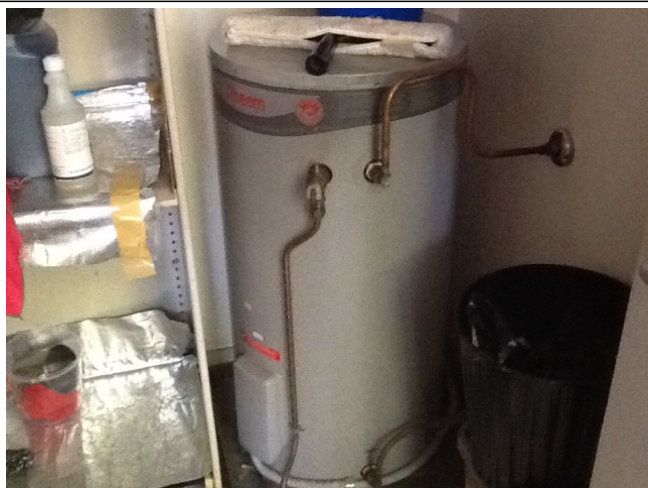
Photo No: J141683-8288-Photo050
Result: SMF - Presumed Positive
Building/Level: Building 4-Level One
Room/Location: 4R1031 (Cleaners Room)-Northeast
Feature/Material: Hot Water Heater-Insulation Material

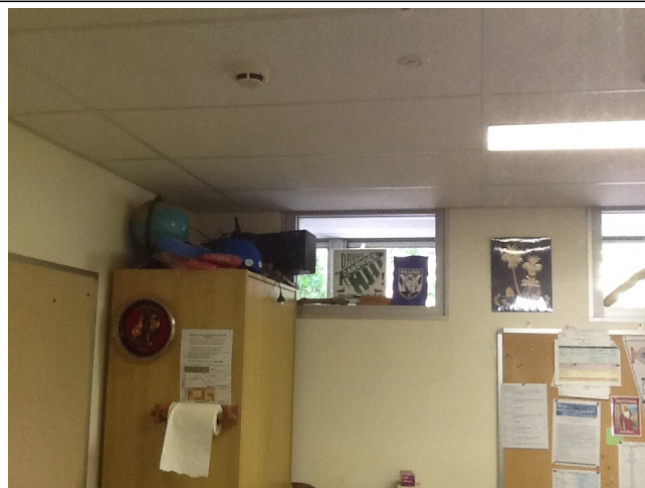
Photo No: J141683-8288-Photo042
Result: SMF - Positive
Building/Level: Building 4-Level One
Room/Location: 4R1032 (Head Teacher)-Throughout
Feature/Material: Ceiling-Compressed Ceiling Tiles

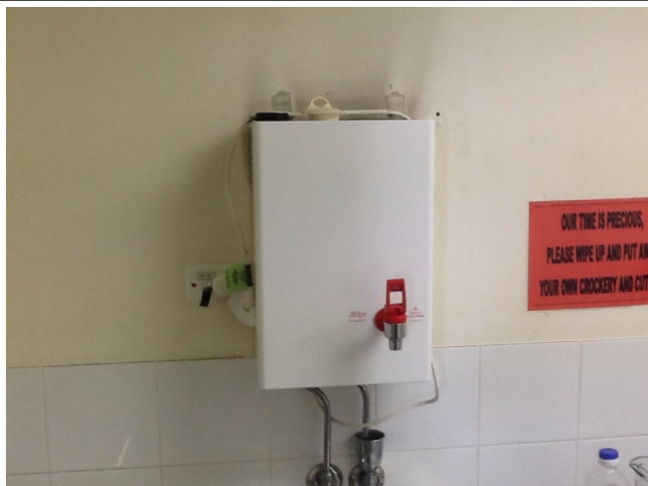
Photo No: J141683-8288-Photo047
Result: SMF - Presumed Positive
Building/Level: Building 4-Level One
Room/Location: 4R1033 (Tea Room)-Above sink
Feature/Material: Hot Water Heater-Insulation Material

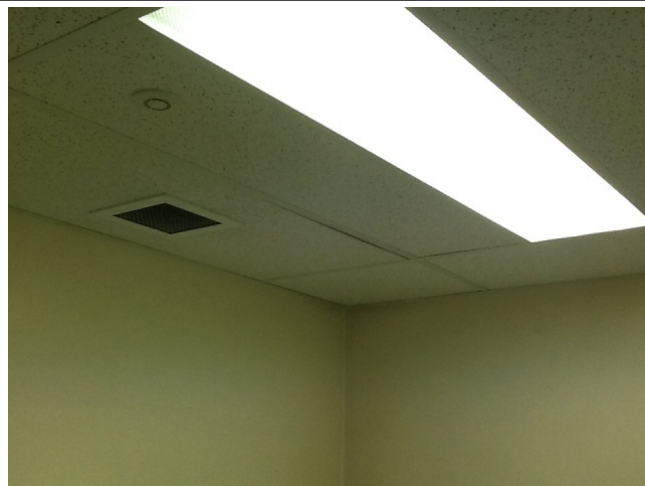
Photo No: J141683-8288-Photo046
Result: SMF - Positive
Building/Level: Building 4-Level One
Room/Location: 4R1033 (Tea Room)-Throughout
Feature/Material: Ceiling-Compressed Ceiling Tiles

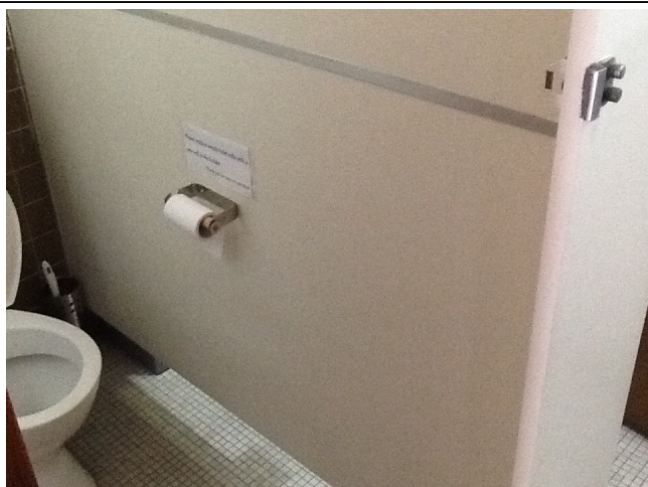
Photo No: J141683-8288-Photo056
Result: Asbestos - Previously Sampled Positive
Building/Level: Building 4-Level Two
Room/Location: 4R2001 (Toilet)-Throughout
Feature/Material: Cubicle Partitions-Compressed Cement Sheet

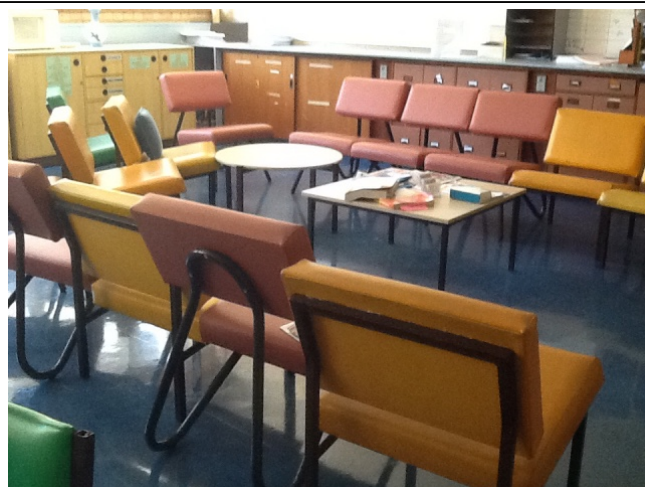
Photo No: J141683-8288-Photo061
Result: Asbestos - Presumed Positive
Building/Level: Building 4-Level Two
Room/Location: 4R2002 (Staff Lounge)-Throughout
Feature/Material: Floor Covering-Vinyl Tiles & Adhesive

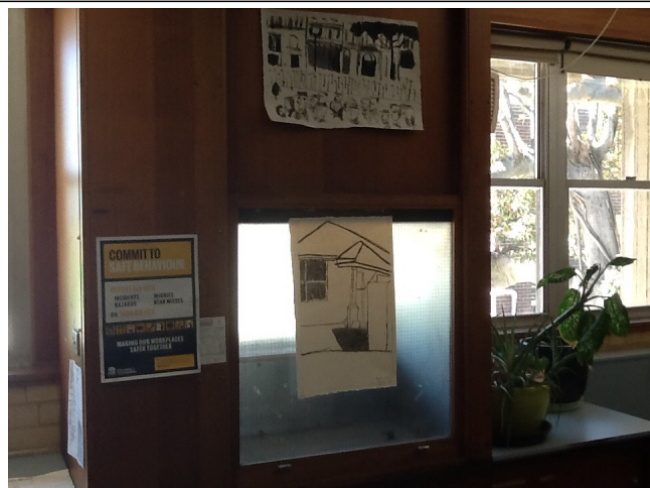
Photo No: J141683-8288-Photo063
Result: Asbestos - Presumed Positive
Building/Level: Building 4-Level Two
Room/Location: 4R2002 (Staff Lounge)-Throughout
Feature/Material: Fume Cupboard Lining-Fibre Cement Sheetting

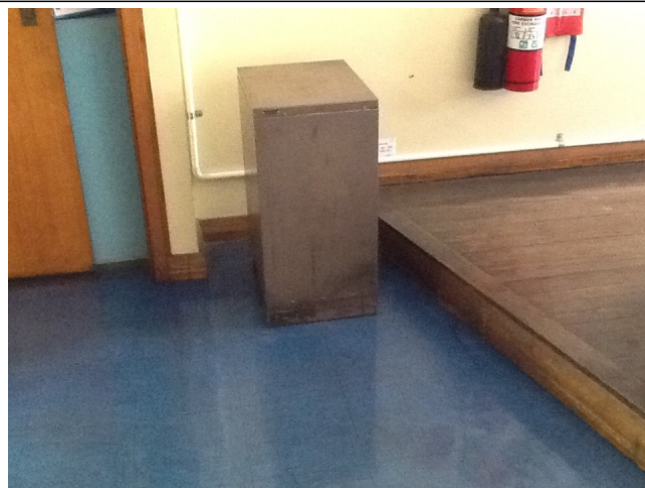
Photo No: J141683-8288-Photo062
Result: Asbestos - Presumed Positive
Building/Level: Building 4-Level Two
Room/Location: 4R2002 (Staff Lounge)-Throughout
Feature/Material: Heater-Insulation

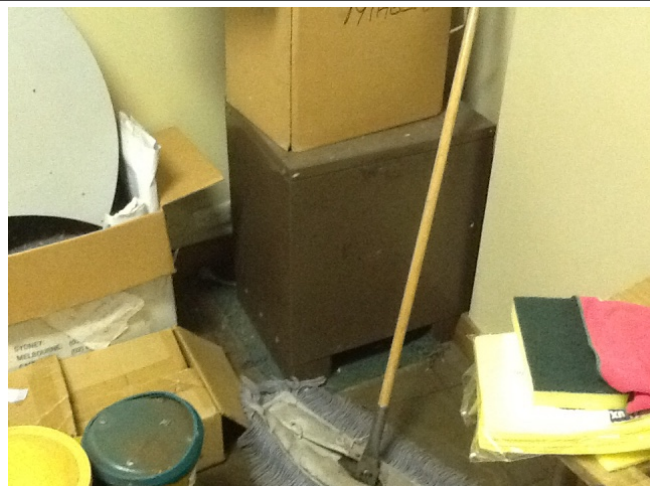
Photo No: J141683-8288-Photo071
Result: Asbestos - Presumed Positive
Building/Level: Building 4-Level Two
Room/Location: 4R2006 (Storeroom)-Throughout
Feature/Material: Heater-Insulation

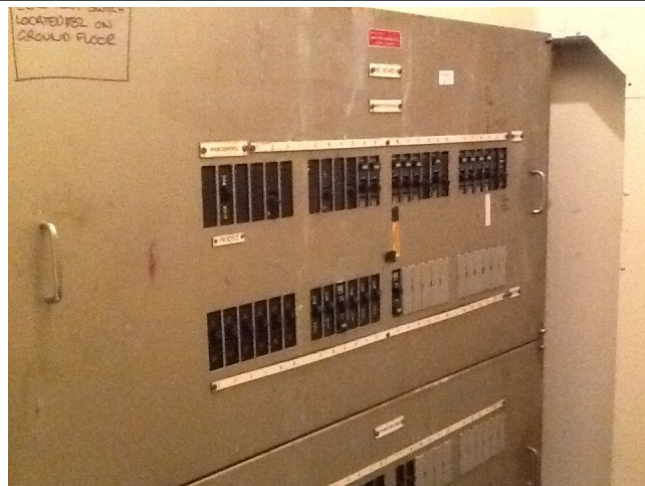
Photo No: J141683-8288-Photo073
Result: Asbestos - Presumed Positive
Building/Level: Building 4-Level Two
Room/Location: 4R2007 (EDB)-North
Feature/Material: Electrical - Switch Board-Compressed Bituminous Electrical Panel

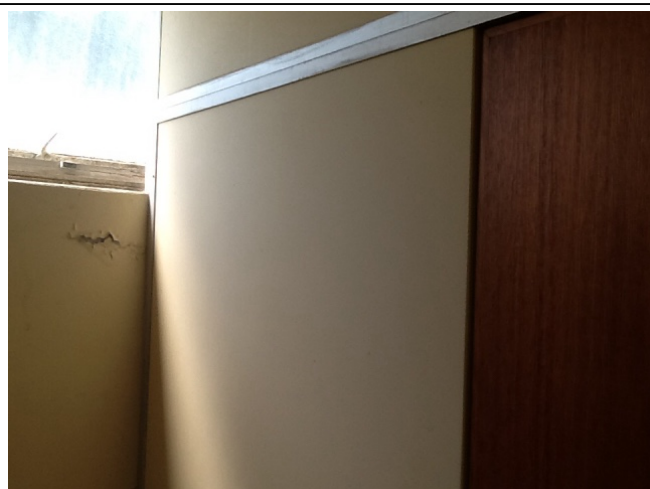
Photo No: J141683-8288-Photo074
Result: Asbestos - Previously Sampled Positive
Building/Level: Building 4-Level Two
Room/Location: 4R2009 (Staff Toilet)-Various Throughout
Feature/Material: Cubicle Partitions-Compressed Cement Sheet

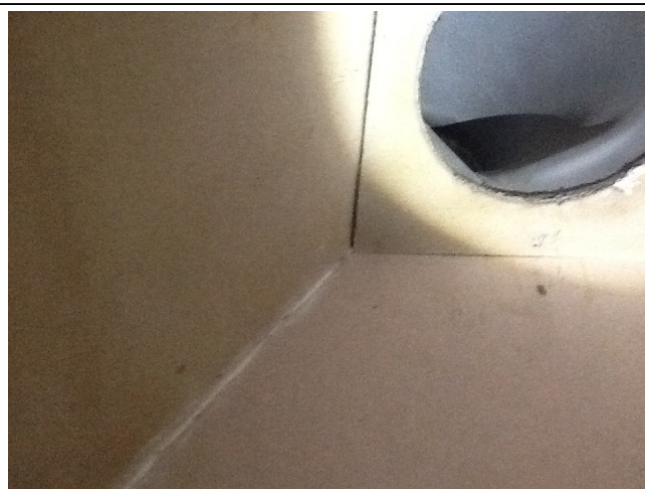
Photo No: J141683-8288-Photo016
Result: Asbestos - Positive
Building/Level: Building 4-Level Two
Room/Location: 4R2010 (Science Lab)-South
Feature/Material: Fume Cupboard Lining-Fibre Cement Sheetting

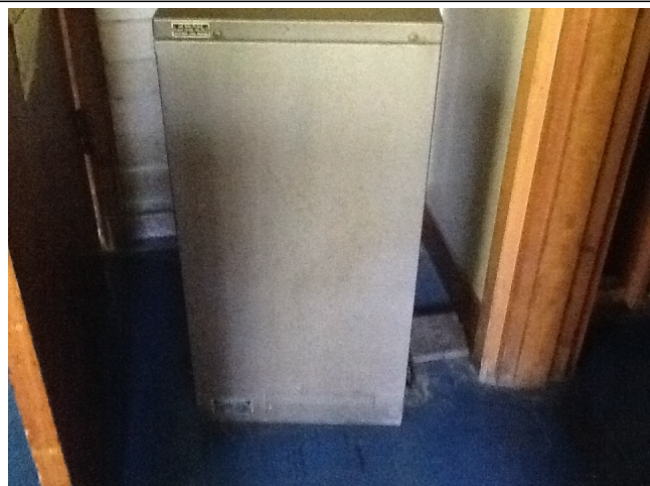
Photo No: J141683-8288-Photo019
Result: Asbestos - Presumed Positive
Building/Level: Building 4-Level Two
Room/Location: 4R2010 (Science Lab)-Various Throughout
Feature/Material: Heater-Insulation

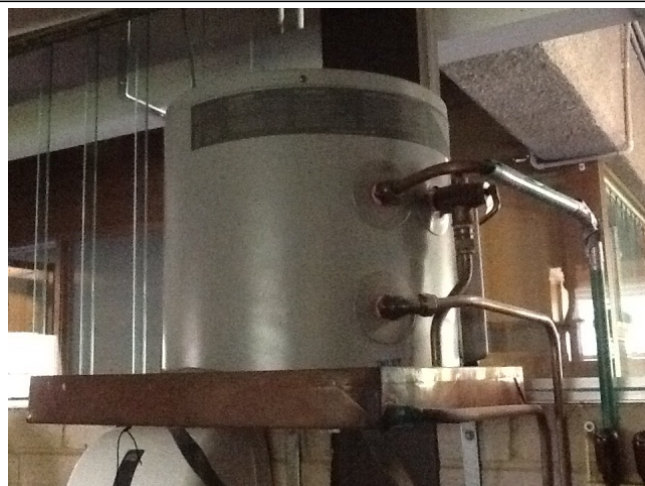
Photo No: J141683-8288-Photo081
Result: SMF - Presumed Positive
Building/Level: Building 4-Level Two
Room/Location: 4R2012 (Old Prep Room)-East
Feature/Material: Hot Water Heater-Insulation Material

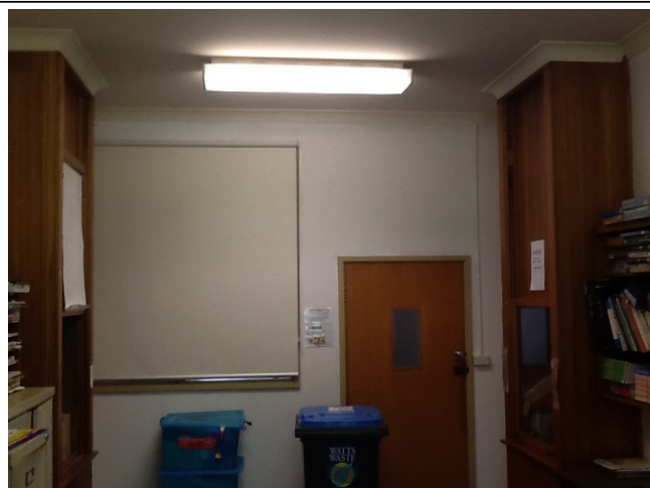
Photo No: J141683-8288-Photo027
Result: Asbestos - Presumed Positive
Building/Level: Building 4-Level Two
Room/Location: 4R2012 (Old Prep Room)-Throughout
Feature/Material: Fume Cupboard Lining-Fibre Cement Sheeting

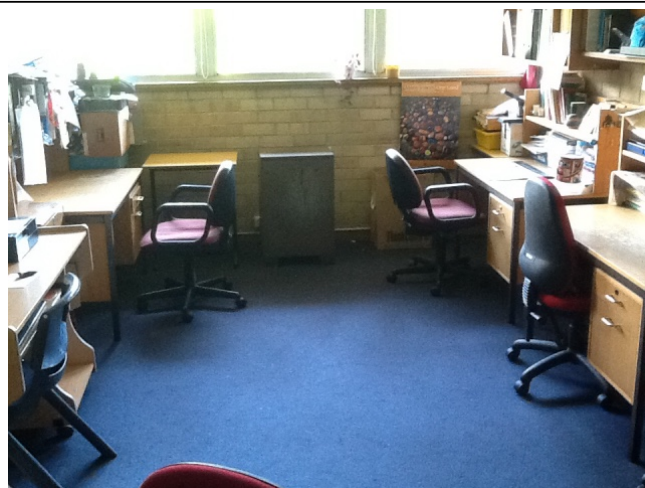
Photo No: J141683-8288-Photo085
Result: Asbestos - Presumed Positive
Building/Level: Building 4-Level Two
Room/Location: 4R2014 (Staffroom 2)-West
Feature/Material: Heater-Insulation

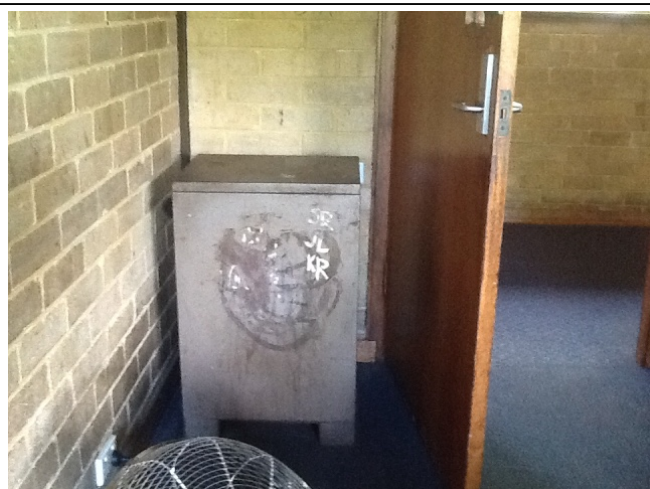
Photo No: J141683-8288-Photo087
Result: Asbestos - Presumed Positive
Building/Level: Building 4-Level Two
Room/Location: 4R2015 (Seminar Room)-Various Throughout
Feature/Material: Heater-Insulation

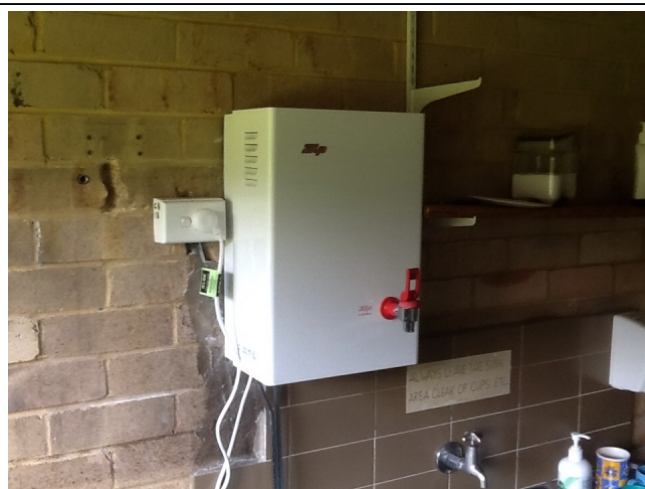
Photo No: J141683-8288-Photo091
Result: SMF - Presumed Positive
Building/Level: Building 4-Level Two
Room/Location: 4R2017 (Kitchenette)-Above sink
Feature/Material: Hot Water Heater-Insulation Material

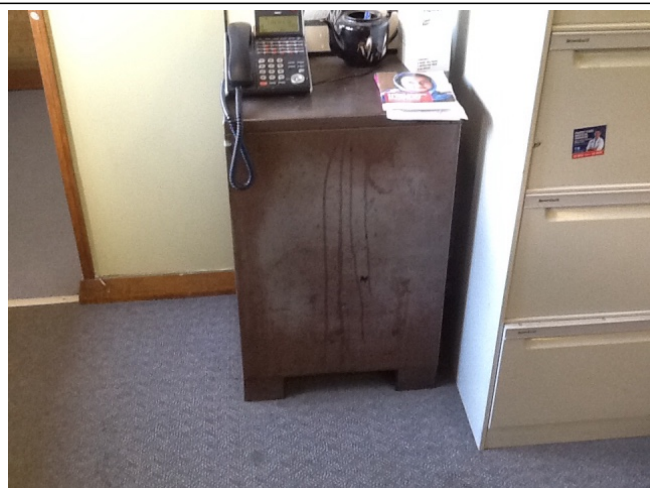
Photo No: J141683-8288-Photo094
Result: Asbestos - Presumed Positive
Building/Level: Building 4-Level Two
Room/Location: 4R2018 (Staff room)-North
Feature/Material: Heater-Insulation
