Hazardous Materials Assessment Wharf 2/3 13A Hickson Road The Rocks NSW 2000

Preston Rowe Paterson New South Wales
October 2011 - Rev01

Job No: 50290-07: Client No: P0009

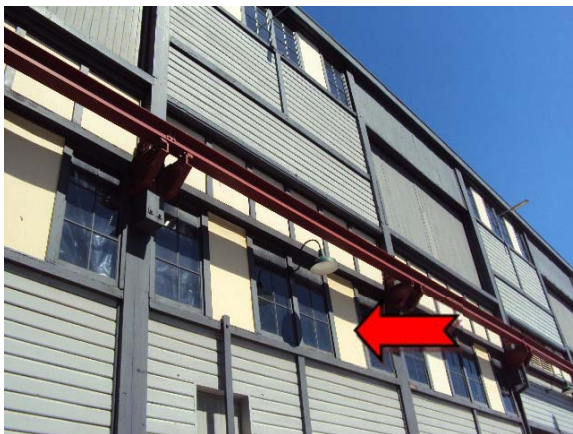
Photo 3. Exterior/interior, throughout, infill panels – suspected asbestos-containing fibre cement sheeting

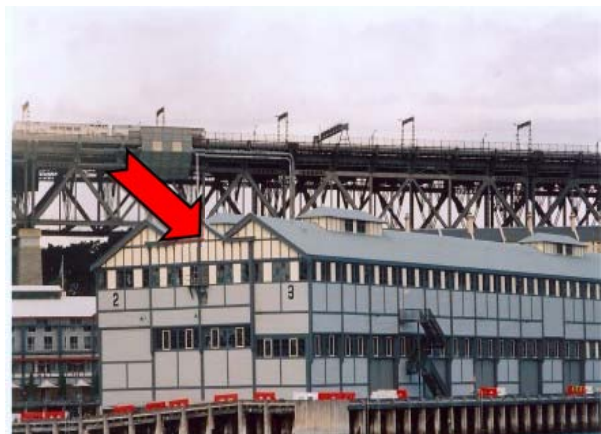
Photo 4. Exterior/interior, level 1, north wall, gable infill panel – suspected asbestos-containing fibre cement sheeting

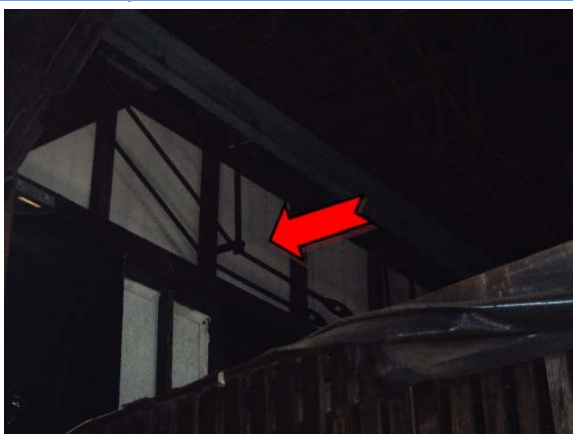
Exterior/Interior, ground level	Throughout	Infill panels to windows	Fibre cement sheeting	Asbestos	Not sampled due to height	Suspected Positive	5	~240m ²	Good	Non-Friable	Low	Low	Oct-12	P4	Confirm Status, label as containing asbestos and maintain in good condition if to remain in-situ, remove under controlled bonded asbestos removal conditions prior to refurbishment or demolition works by an AS-2 (bonded) licensed asbestos removal contractor.
Interior, level 1	North, toilet	Infill panels to window	Fibre cement sheeting	Asbestos	50290-07-03	Positive	6	~2m ²	Good	Non-Friable	Low	Low	Oct-12	P4	Encapsulate exposed sections, label as containing asbestos and maintain in good condition if to remain in-situ, remove under controlled bonded asbestos removal conditions prior to refurbishment or demolition works by an AS-2 (bonded) licensed asbestos removal contractor.
Interior, level 1	North, toilet	Infill panels to urinal	Fibre cement sheeting	Asbestos	50290-07-04	Positive	6	~3m ²	Good	Non-Friable	Low	Low	Oct-12	P4	Encapsulate exposed sections, label as containing asbestos and maintain in good condition if to remain in-situ, remove under controlled friable asbestos removal conditions prior to refurbishment or demolition works by an AS-1 (friable) licensed asbestos removal contractor.

Photo 5. Interior, ground level, throughout, infill panels to windows – suspected asbestos-containing fibre cement sheeting

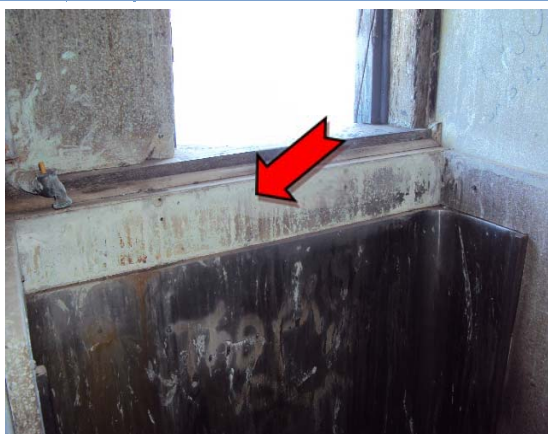
Photo 6. Interior, level 1, north toilet, infill panels to urinal and windows – asbestos-containing fibre cement sheeting

- Encapsulate the asbestos-containing fibre cement infill panels to the urinal and windows, located on Level 1 within the northern toilet block as soon as practicable. The asbestos removal works should be conducted by an appropriately licensed asbestos removal contractor (i.e. AS-1 friable or AS-2 bonded) under controlled asbestos removal working conditions.

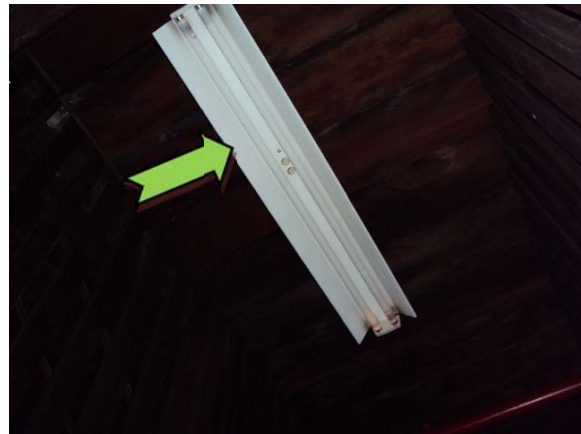
Photo 10. Interior, ground level, central, northern stairwell, ceiling throughout, double tube fluorescent light fittings – suspected negative for the presence of PCB-containing capacitors

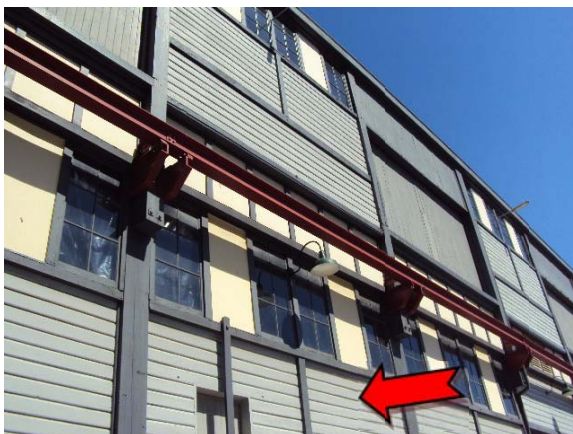
Photo 11. Exterior, throughout, timber features – lead-containing white lower colour paint system

- Works that are likely to cause disturbance of LCP systems should be conducted under controlled conditions by a suitably qualified contractor. Dust suppression techniques should be utilized and works should be conducted in accordance with the requirements of AS 4361.2 1998 *Guide to lead paint management, Part 2: Residential and commercial buildings*.
