PRELIMINARY ENVIRONMENTAL SITE ASSESSMENT

**PROPOSED LINDFIELD LEARNING VILLAGE
DEVELOPMENT**

ETON ROAD, LINDFIELD

15 MARCH 2017

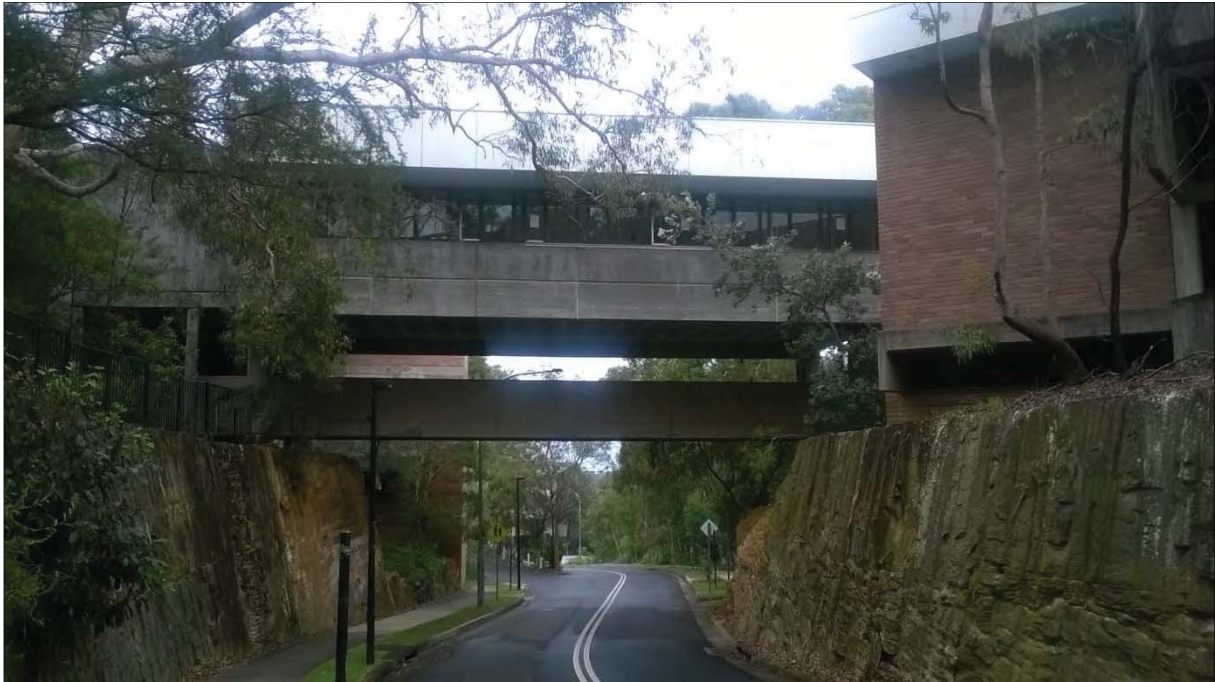
Plate 1: buildings and roadways in the northern section of the site, showing sandstone outcrops.

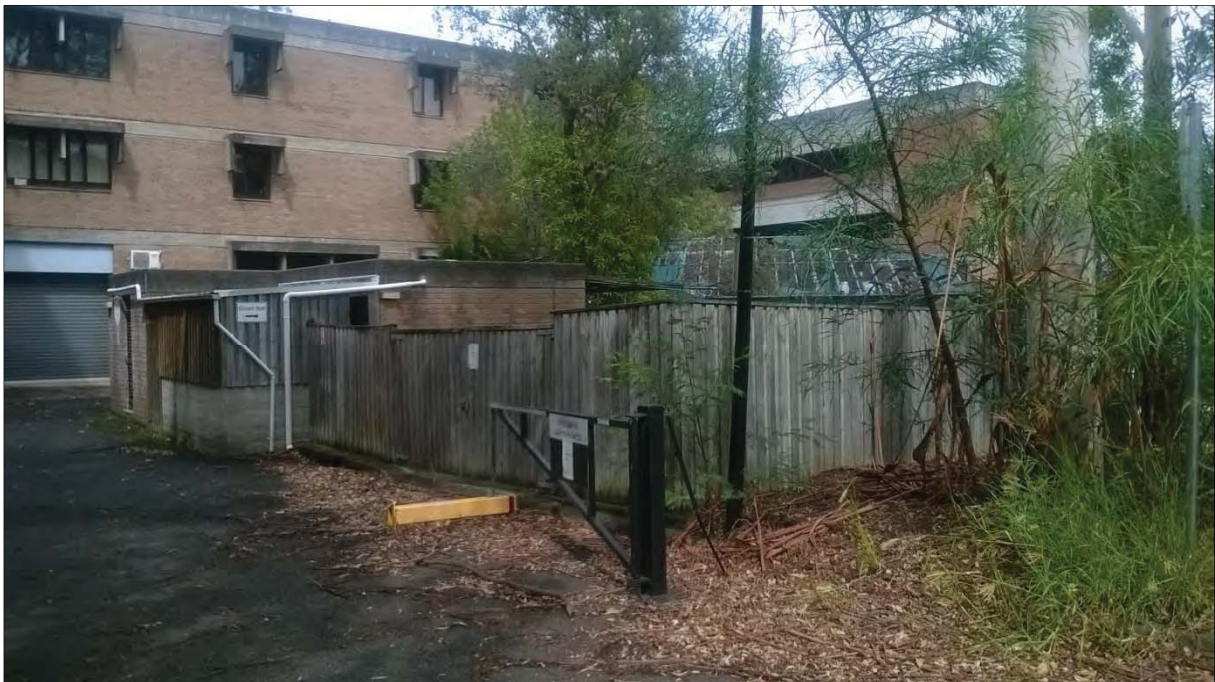
Plate 2: ground staff area in the south-western section of the site.

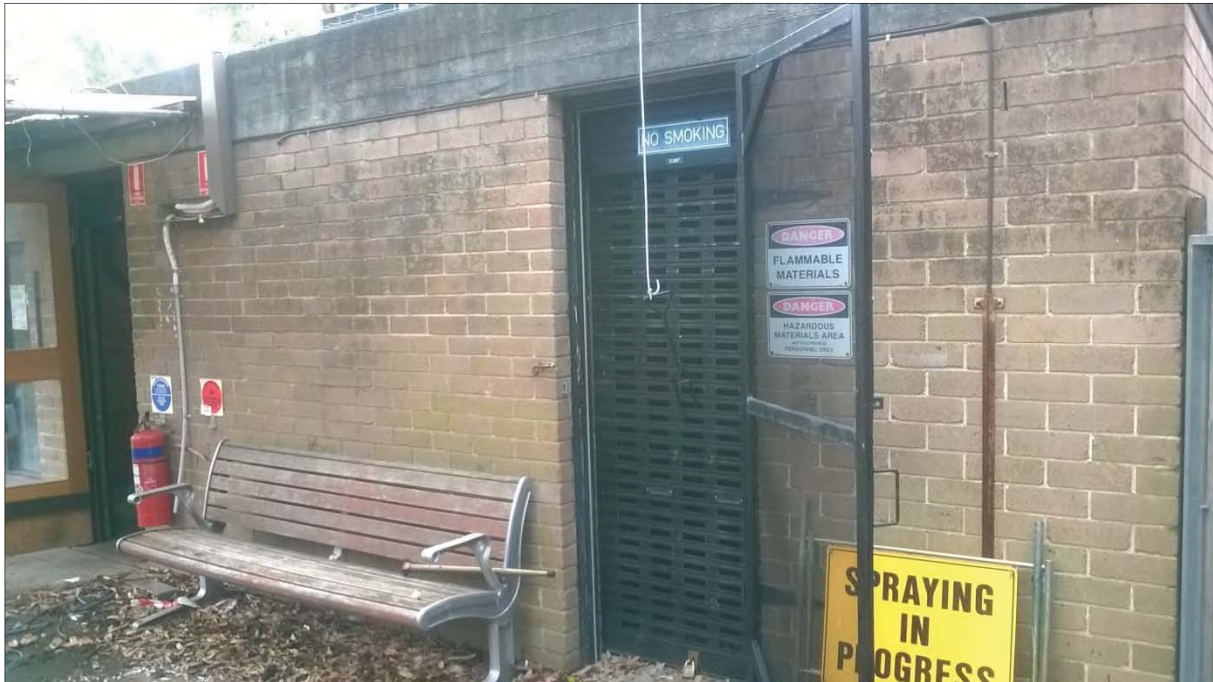
No obvious signs of potentially contaminating activities were observed. A hazardous materials storage area was observed within a ground staff works area. The storage area was located within a brick building with a concrete floor which was observed to be in good condition.

Plate 3: hazardous materials store within the ground staff area.

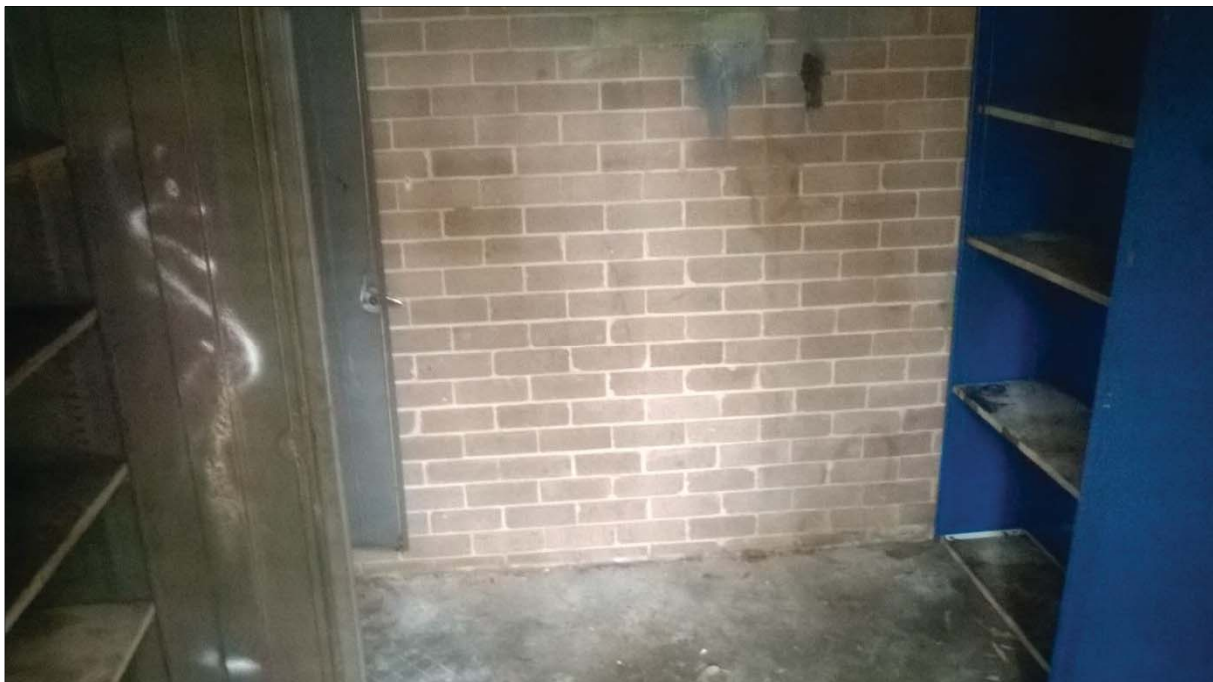
Plate 4: interior of the hazardous materials store.

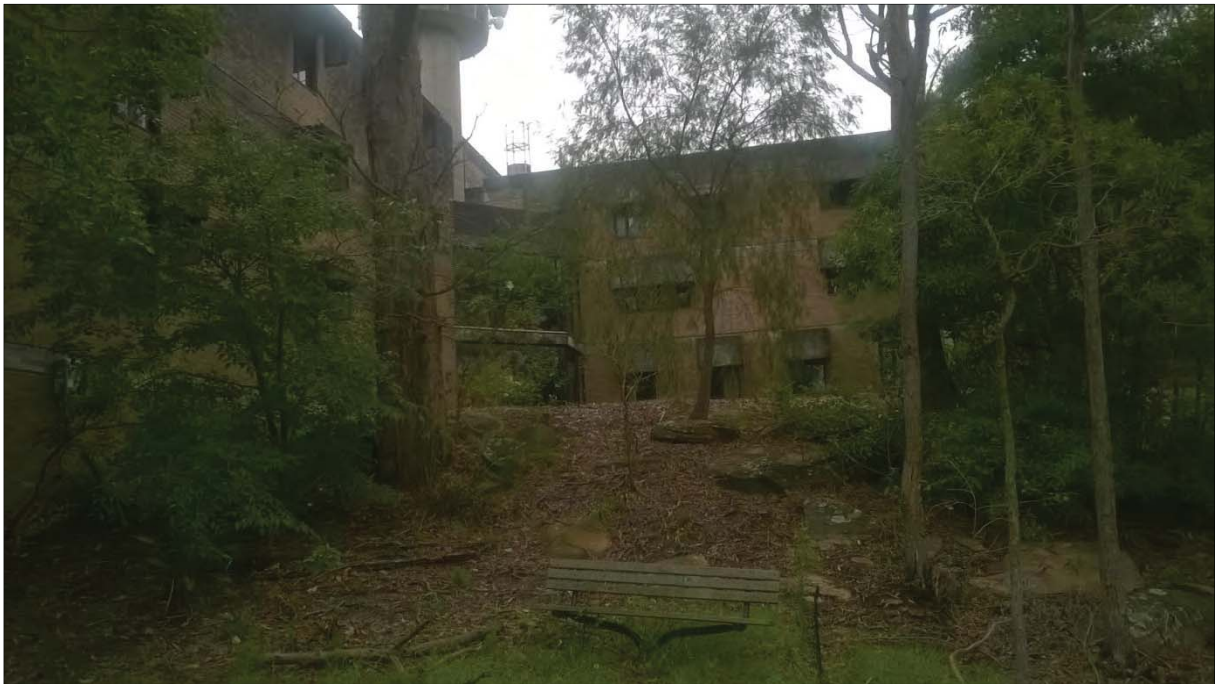
Plate 5: buildings in the southern section of the site.

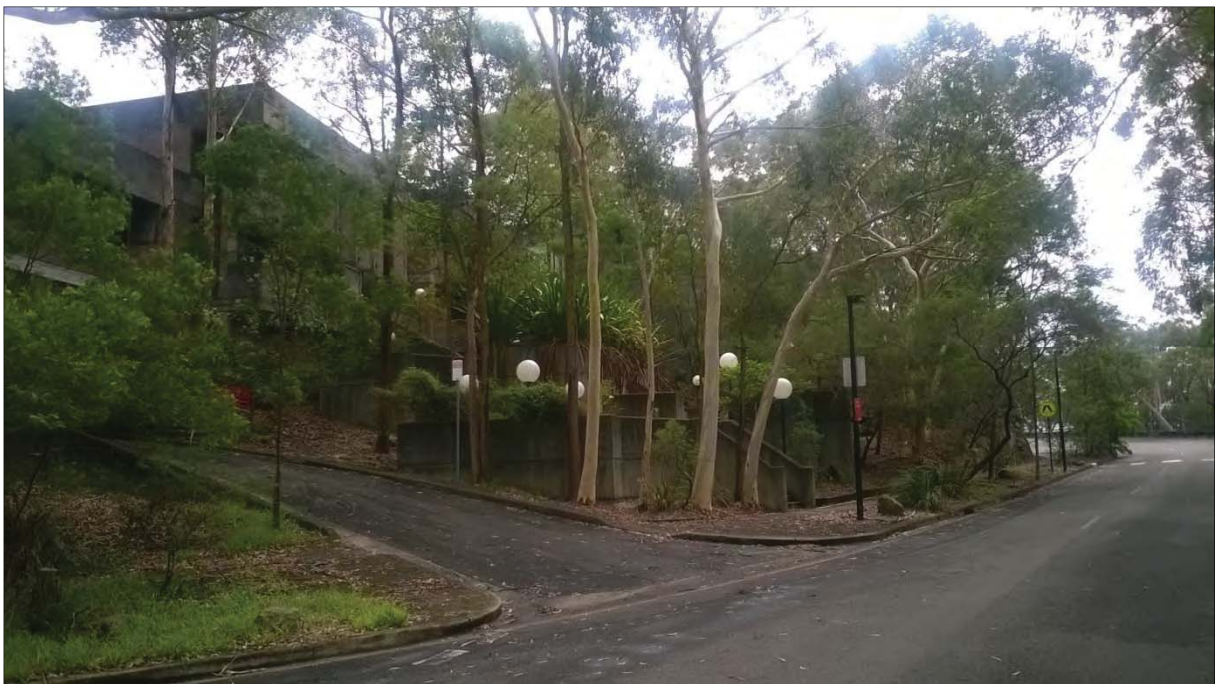
Plate 6: buildings and roadways in the eastern section of the site.
