Report on
Detailed Site (Contamination) Investigation

Proposed North Kellyville New Primary School
120-126 Hezlett Road, North Kellyville

Project 85998.01
August 2017

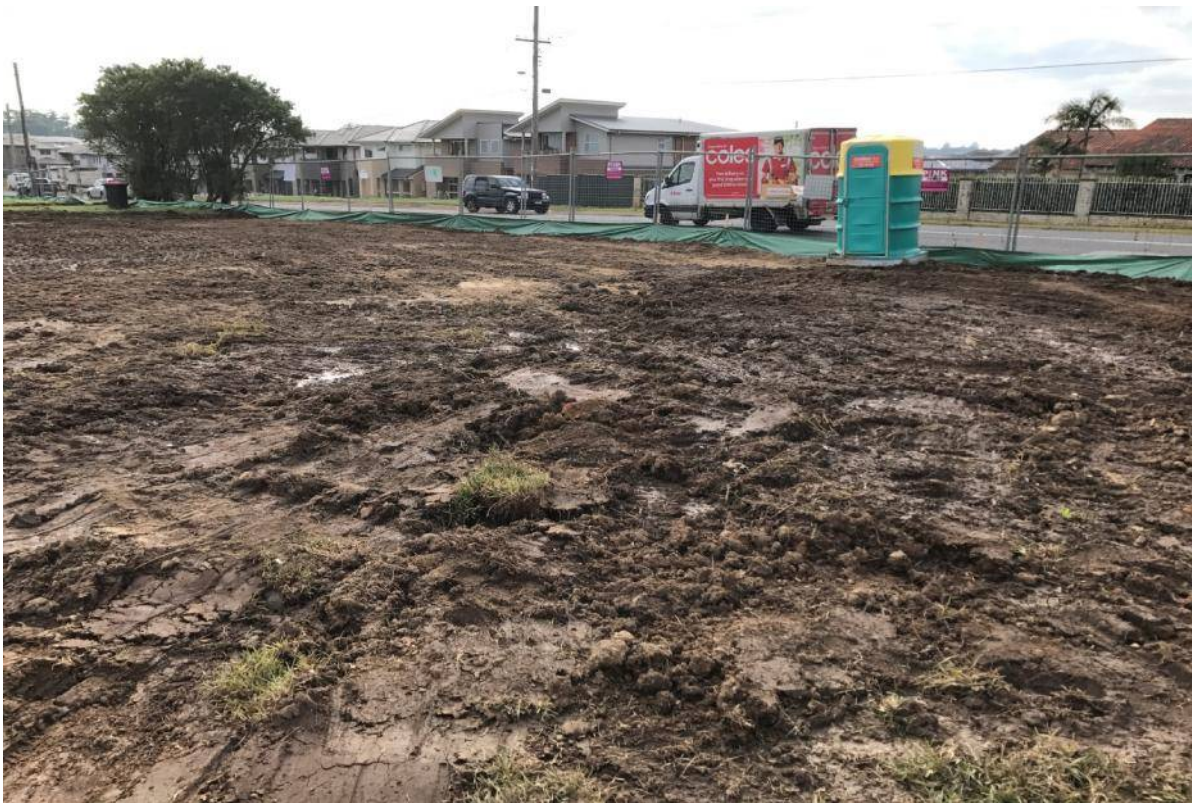
Photograph 1 - Cleared Structures to the East of site

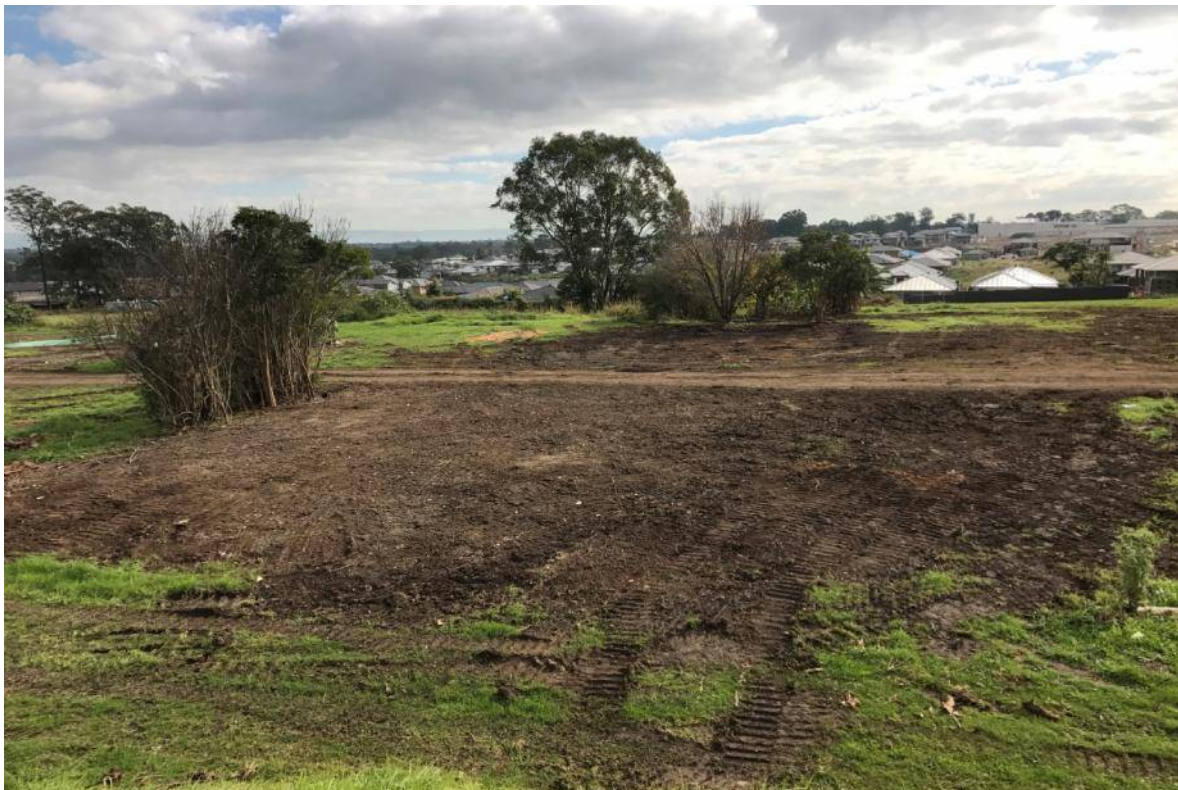
Photograph 2 - Cleared Structures Centre of site

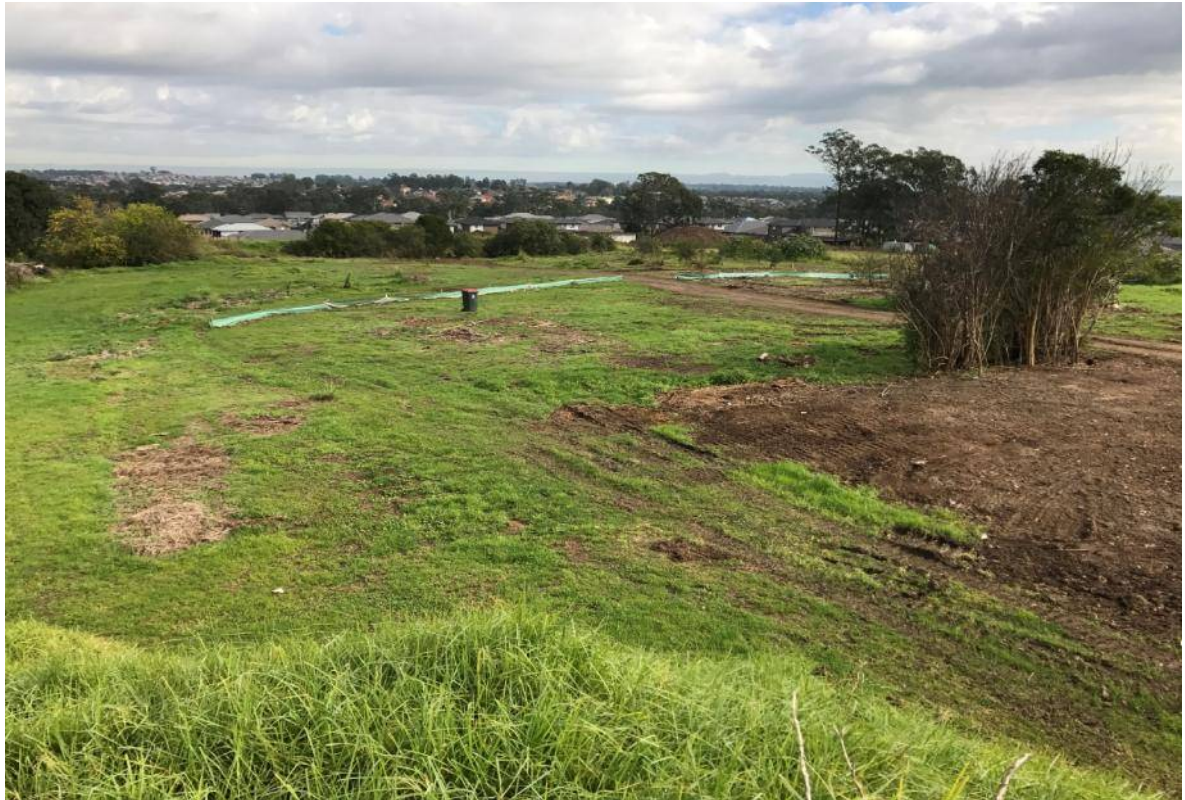
Photograph 3 - Vacant Site

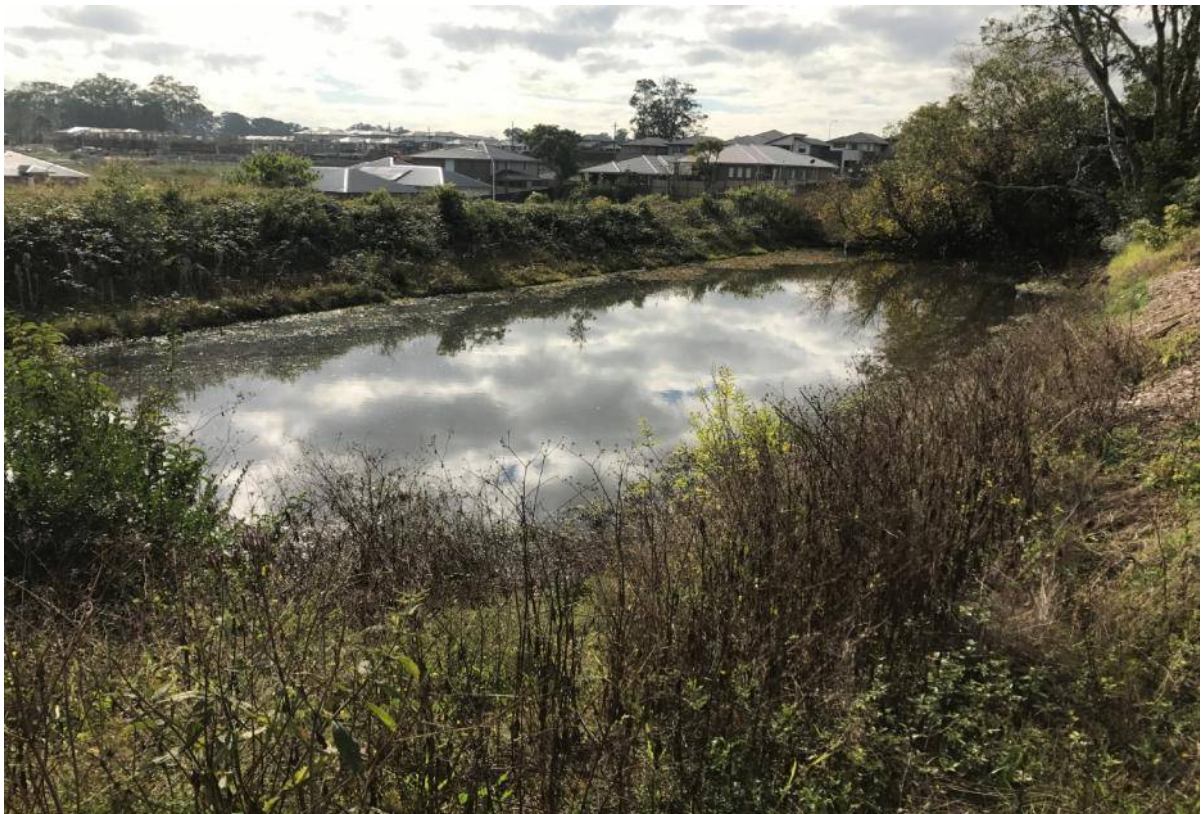
Photograph 4 - Onsite dam

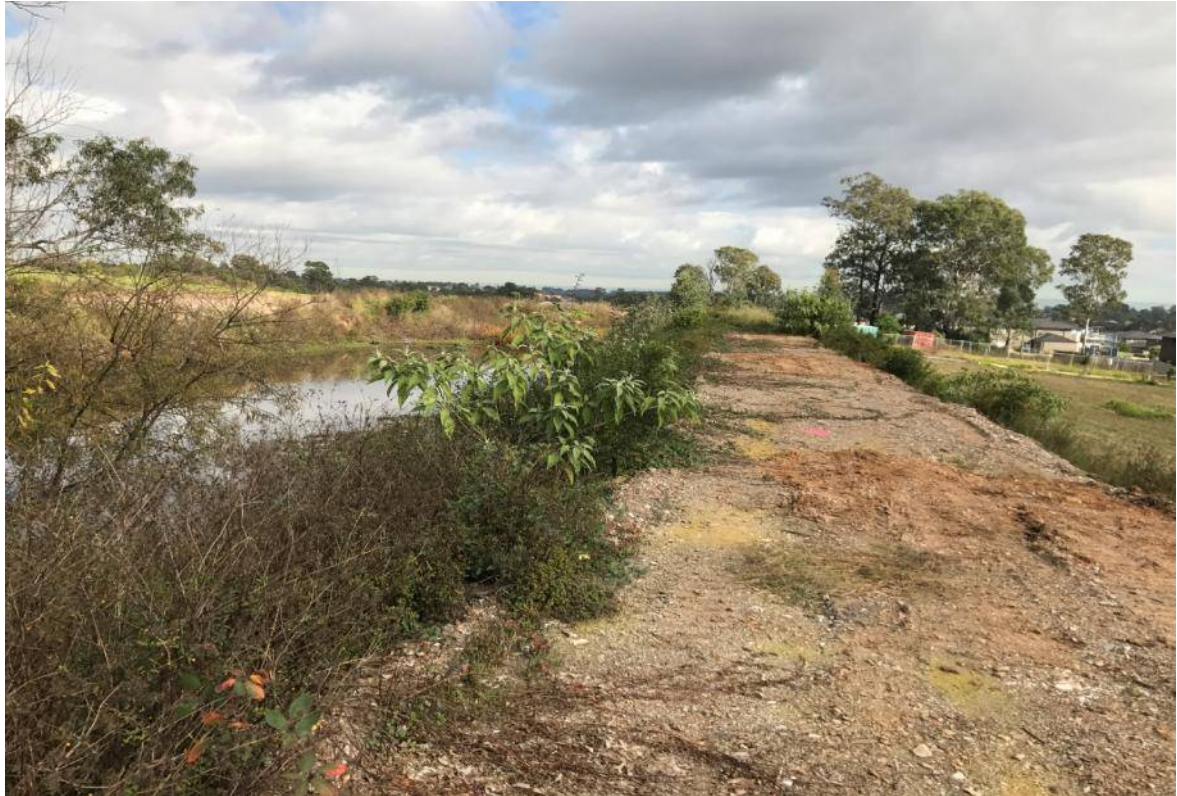
The northern boundary of the dam appeared to have been bunded up approximately three metres from the property immediately north of the site during the construction of the dam (Photograph 5). Bund materials observed consisted of shaly clay material which was consistent with natural material observed throughout the site. Potential asbestos containing material (ACM) was identified on the ground surface and sampled in a small area on the eastern edge of the dam, designated as AA on Drawing 2, Appendix A; however this was prior to asbestos removal and clearance by the asbestos assessor.

Photograph 5 - Bunded dam wall

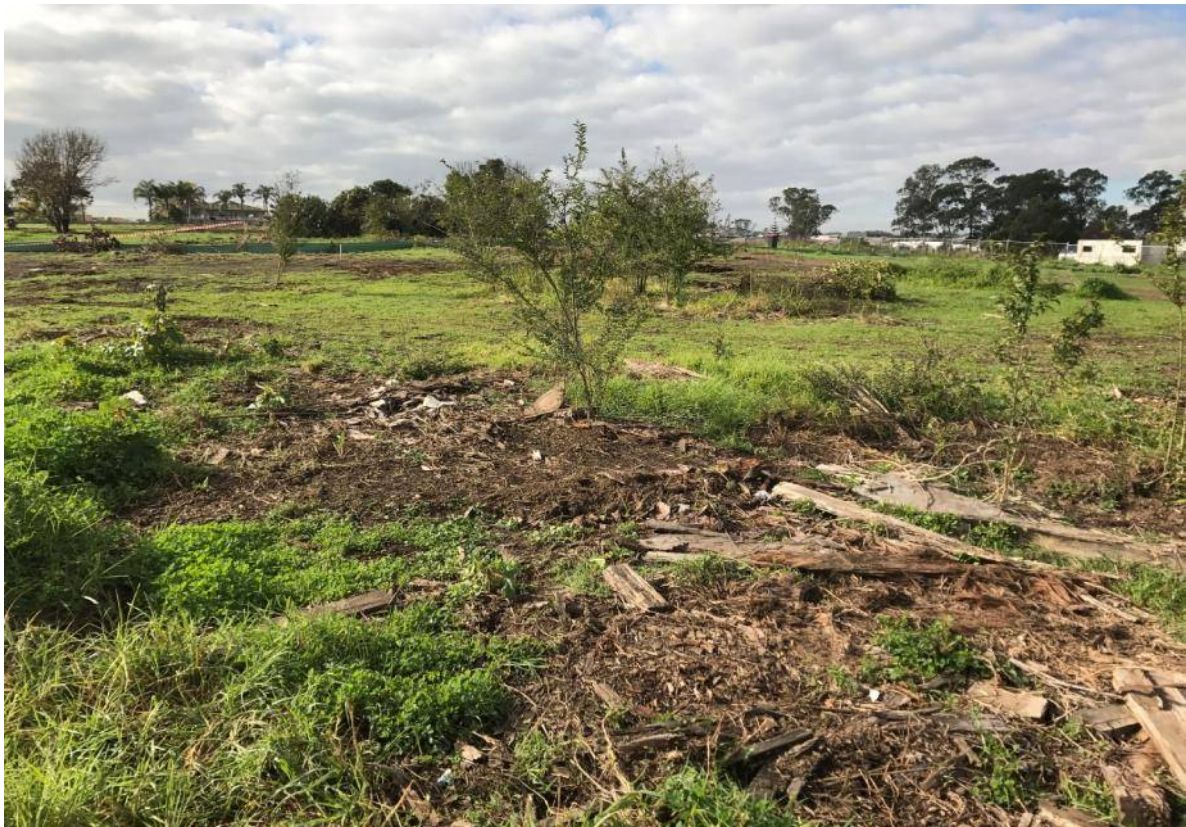
Building rubble and ACM were observed on the ground surface in these areas of the site after the clearance inspection had been conducted, as indicated in Drawing 2, Appendix A, as well as small stockpiles of mulch on the eastern boundary of the site (Photograph 6, 7 and 8).

Photograph 6 - Observed building material

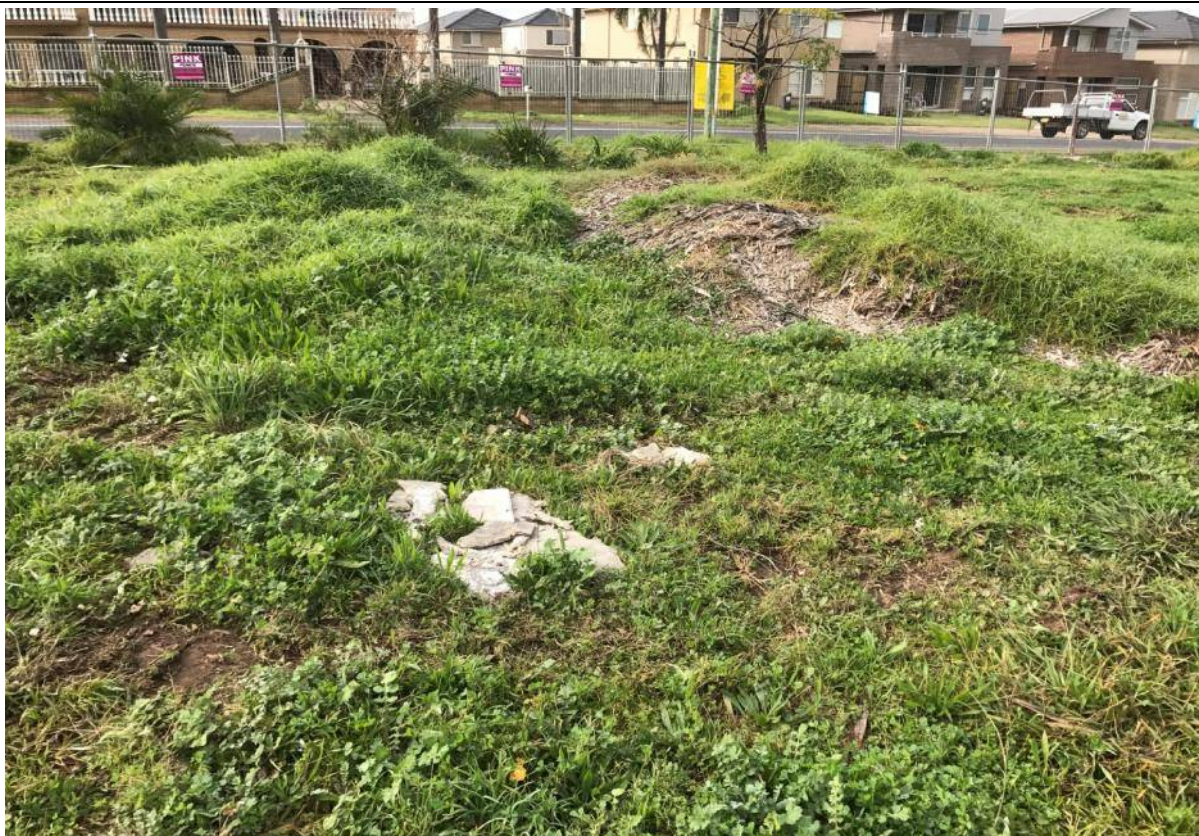
Photograph 7 - Mulch stockpiles and Observed Building Rubble

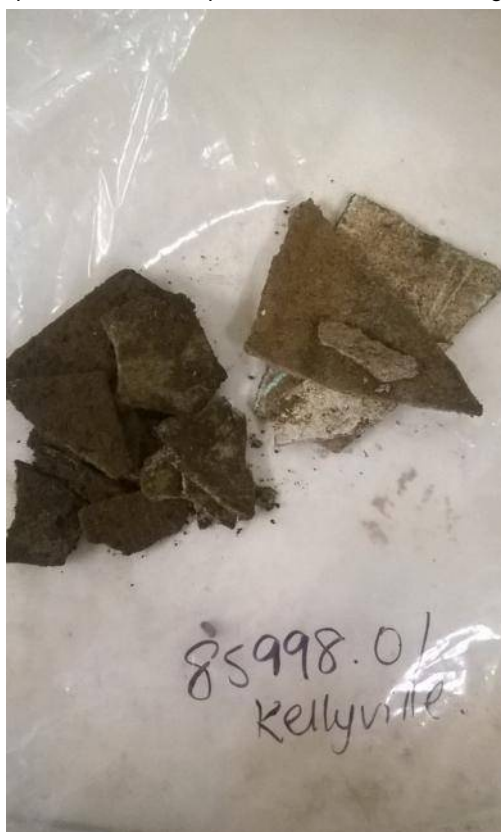
Photograph 8 - Observed Asbestos

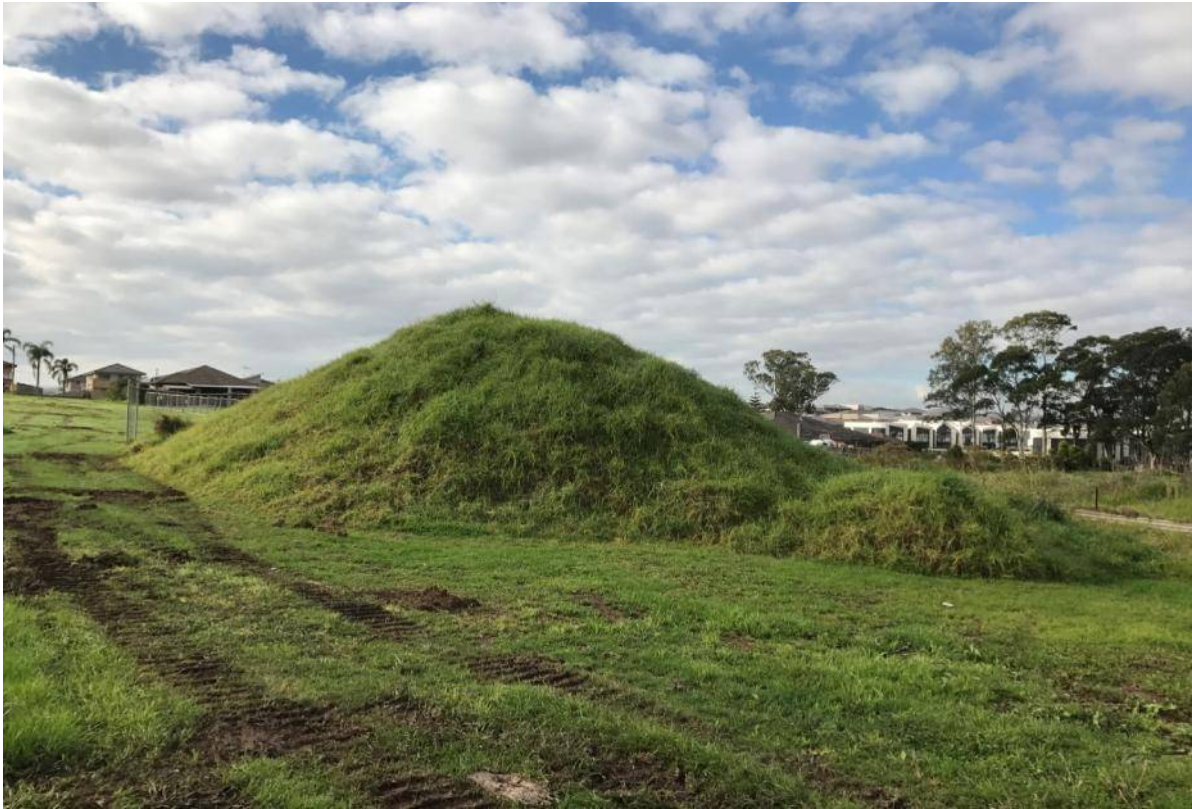
A grass covered stockpile was observed on the southern boundary adjacent to the previously demolished structure (Photograph 9) as shown on Drawing 2, Appendix A. DP undertook sampling of the stockpile at the request of the client. The stockpile was estimated at about 300 cubic metres.

Photograph 9 - Observed Stockpile

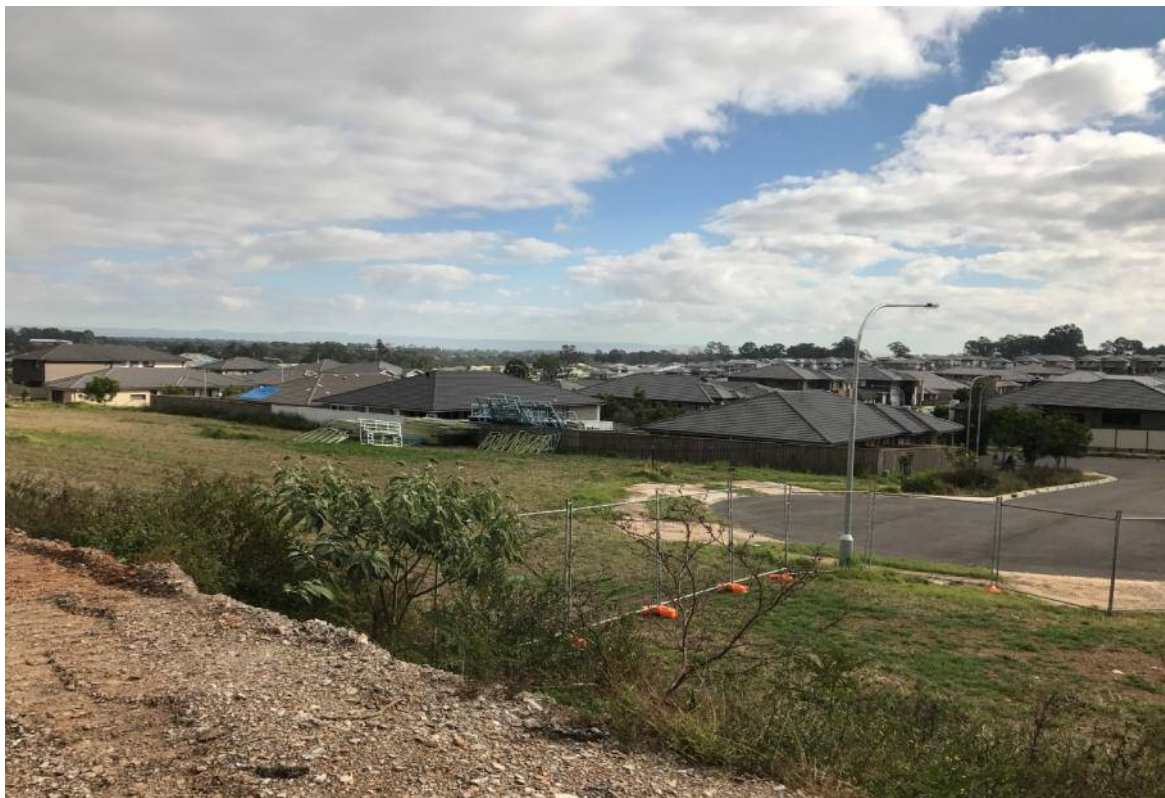
Photograph 10 - Surrounding Low Density Residential Developments
