Asbestos and Hazardous Materials Survey

Alexandria Park Community School,
Alexandria NSW 2015

10 February 2017

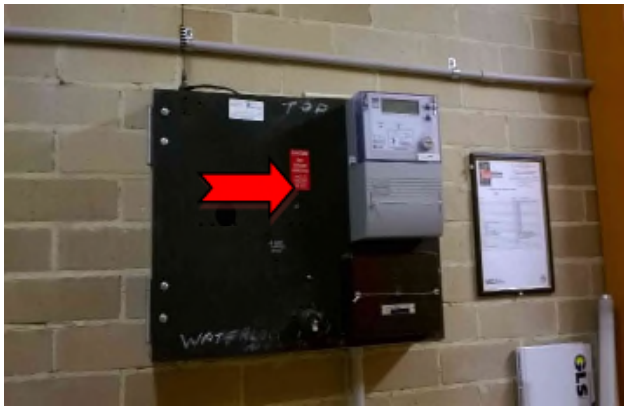
Photograph 1: Interior: Ground Floor; B00A R0027 – Main Switch Board – Suspected asbestos containing electrical backing board.

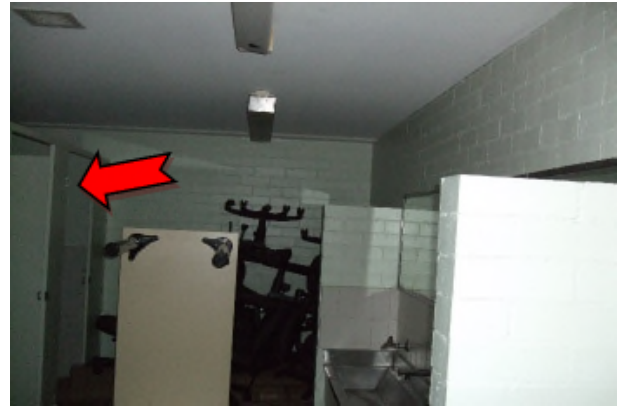
Photograph 2: Interior: Ground Floor; B00A R0028 – Girls Toilets – Asbestos containing fibre cement sheeting to the partition walls.

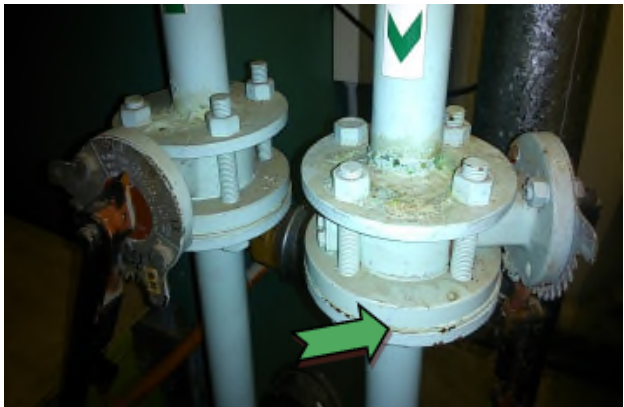
Photograph 3: Interior: First Floor; B00A R1007 – Plant – Non-asbestos containing gaskets to pipework.

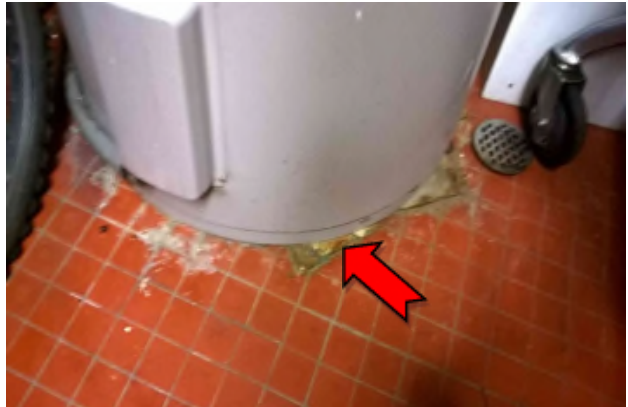
Photograph 4: Interior: Ground Floor; B00B R0021 – Laundry – Asbestos containing fibre cement to the packing below hot water heater.

- The exposed sections of the identified asbestos packers to the hot water heaters in rooms B00B – R2021 and B00C – R0063 need to be encapsulated, labelled as containing asbestos and maintained in a good condition if to remain in-situ;

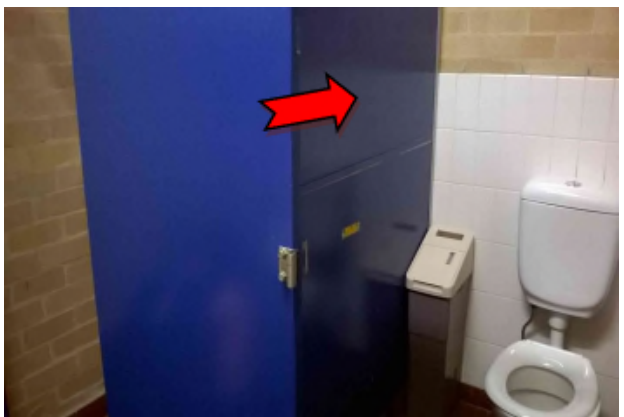
Photograph 5: Interior: Ground Floor; B00B R0034 – Girls Toilets – Asbestos containing fibre cement sheeting to the partition walls.

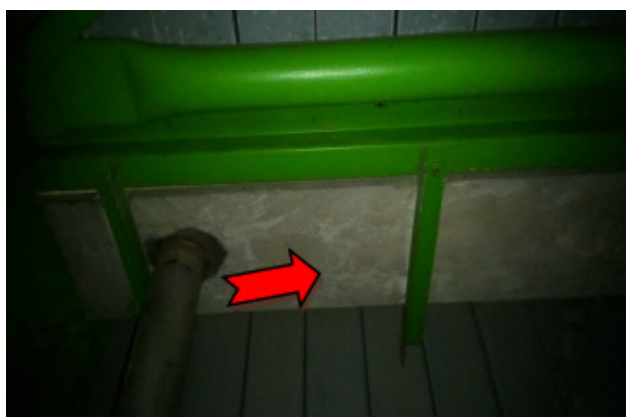
Photograph 6: Interior: Second Floor; B00B R2001 – Movement – Asbestos containing fibre cement sheeting to the compressed cement sheet ceiling panels.

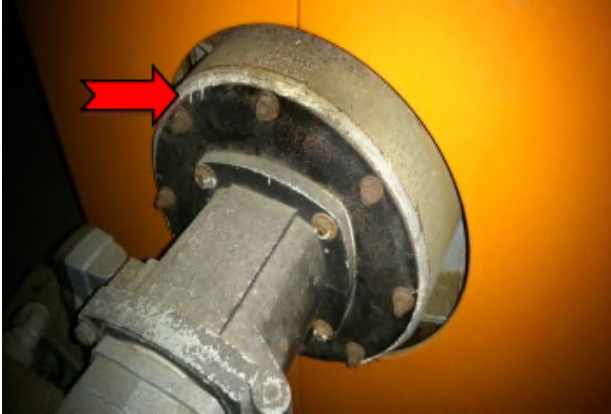
Photograph 7: Interior: Second Floor; B00B - R2002 – Plant – Asbestos containing rope gasket to boiler.

- The asbestos rope gasket to the boiler in the plant room (B00B – R2002) requires to be encapsulated, labelled as containing asbestos and maintained in its current condition if to remain in-situ. Eventual removal of this materials must be undertaken by a Class A (friable) asbestos removal contractor;

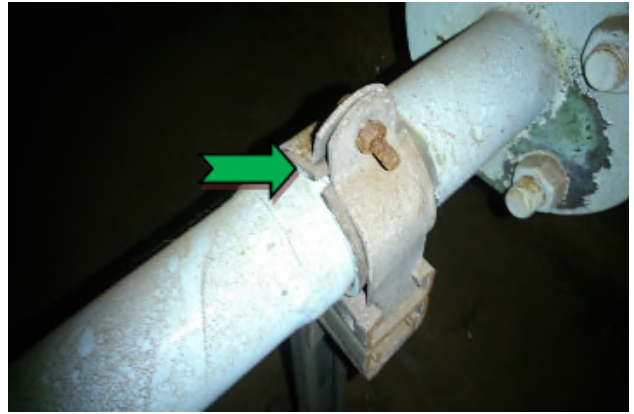
Photograph 8: Interior: Second Floor; B00B - R2002 – Plant – Non-asbestos containing bituminous collars to condenser water pipes.

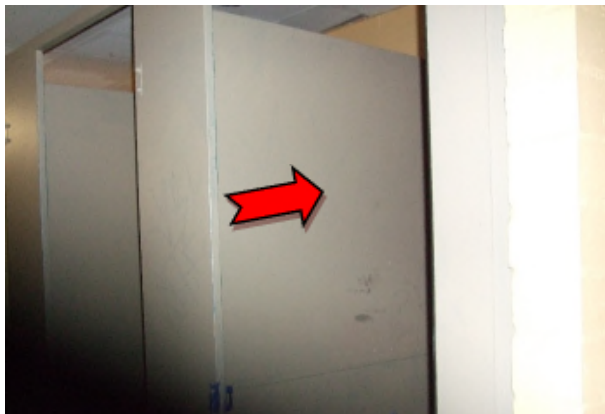
Photograph 9: Interior: Ground Floor; B00C – R0029 – Girls Toilets – Asbestos containing fibre cement sheeting to the partition walls.

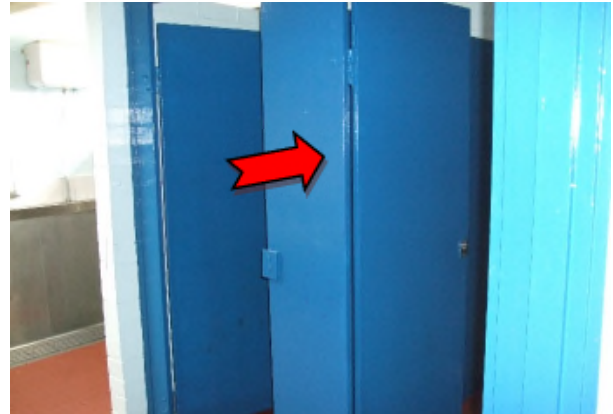
Photograph 10: Interior: Ground Floor; B00C – R0030 – Boys Toilets – Asbestos containing fibre cement sheeting to the partition walls.

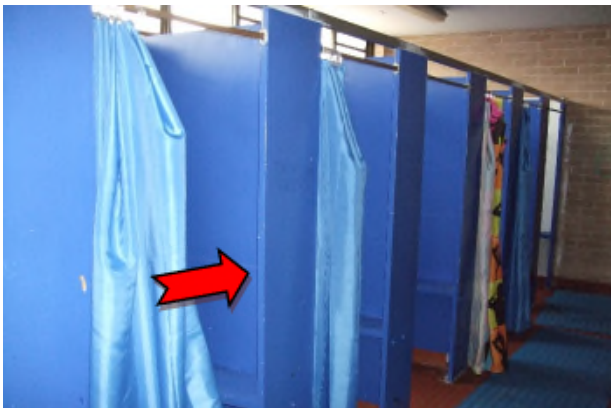
Photograph 11: Interior: Ground Floor; B00C – R0022 – Change – Asbestos containing fibre cement sheeting to the partition walls.

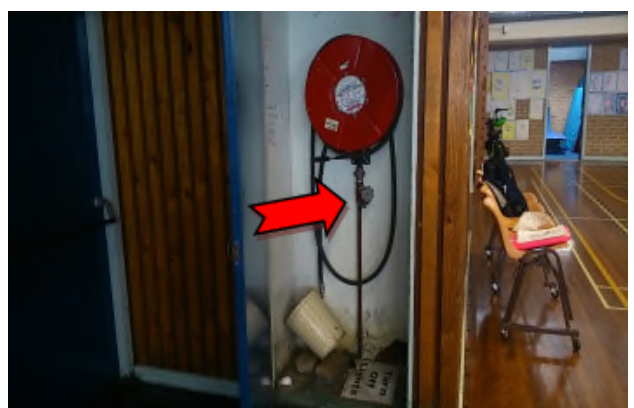
Photograph 12: Interior: Ground Floor; B00C – R0059 – Plant – Asbestos containing fibre cement sheeting to the rear wall.

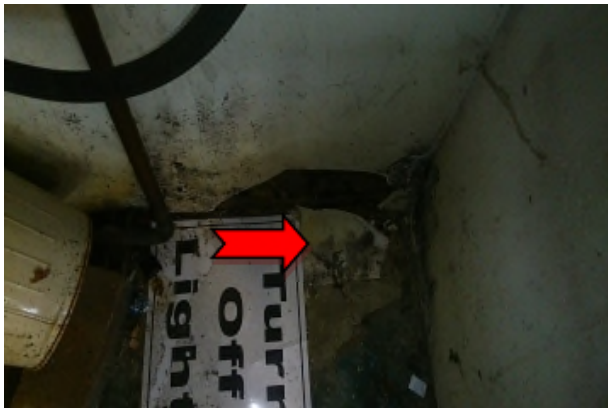
Photograph 13: Interior: Ground Floor; B00C – R0059 – Plant – Asbestos containing fibre cement debris associated with damaged rear wall.

- Access to the rear wall of the B00C - R0059 plant room needs to be restricted until the fibre cement debris identified at the base of the wall is removed under controlled non-friable asbestos removal conditions prior to refurbishment or demolition works by a Class B (non-friable) licensed asbestos removal contractor;

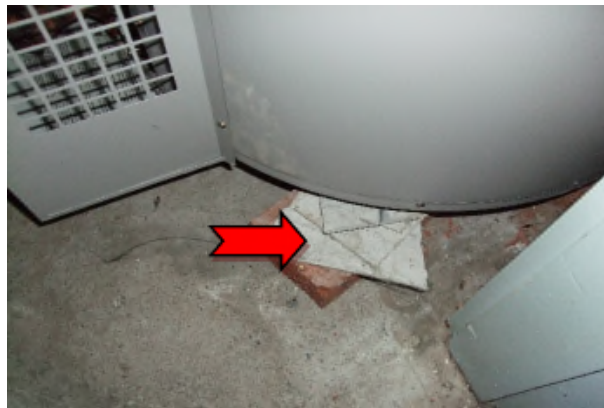
Photograph 14: Interior: Ground Floor; B00C – R0063 – Plant – Asbestos containing fibre cement to the packing beneath hot water heater.

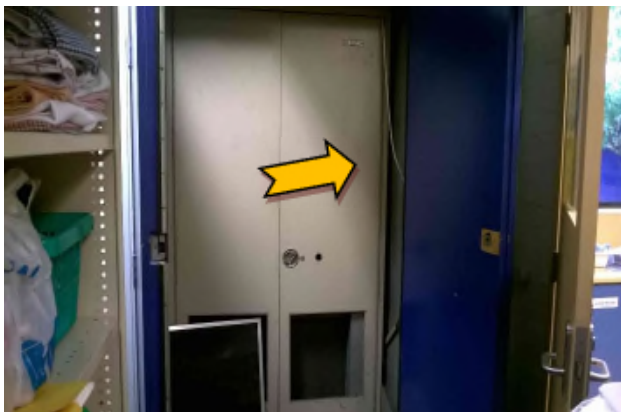
Photograph 15: Interior: Ground Floor; B00A R0057 – Plant – Suspected SMF containing wall insulation and ODS containing refrigerant to Chiller.

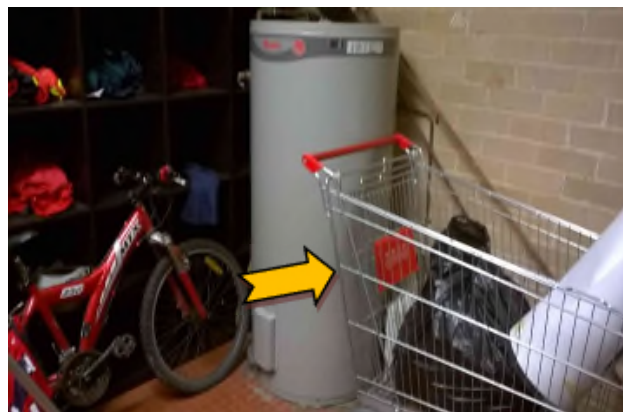
Photograph 16: Interior: Ground Floor; B00B R0021 – Laundry – Suspected SMF containing insulation to hot water heater.

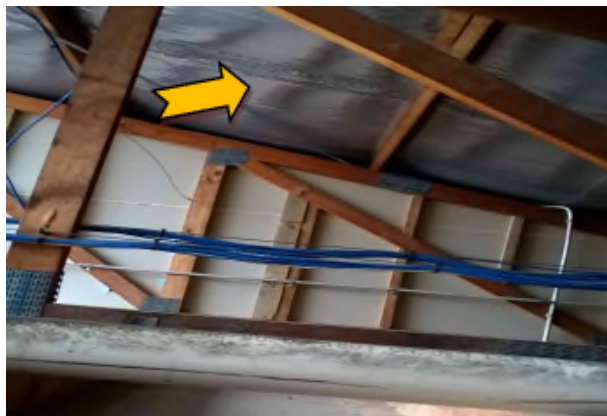
Photograph 17: Interior: Ground Floor; B00B – Suspected SMF containing sarking throughout ceiling space.

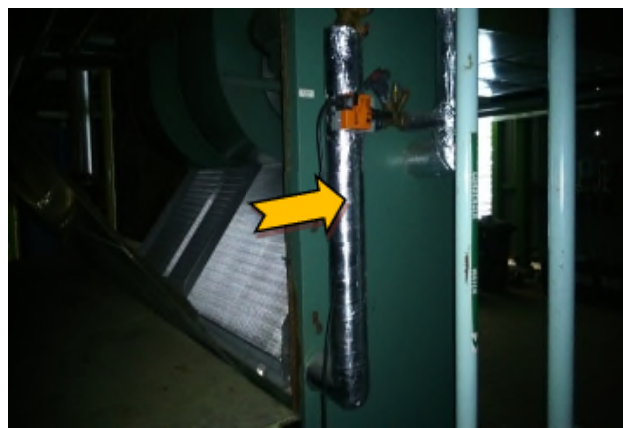
Photograph 18: Interior: Second Floor; B00B R2002 – Plant – Suspected SMF containing insulation to pipework.

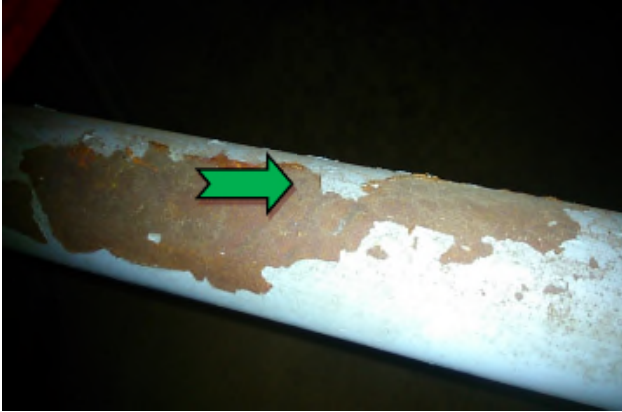
Photograph 19: Interior: Second Floor; B00B – R2002 – Plant – Non-lead containing paint to condenser water pipes.

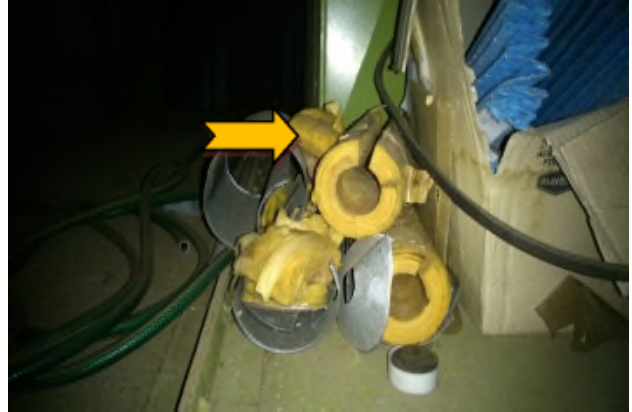
Photograph 20: Interior: Second Floor; B00B – R2002 – Plant – SMF containing loose pipe insulation.

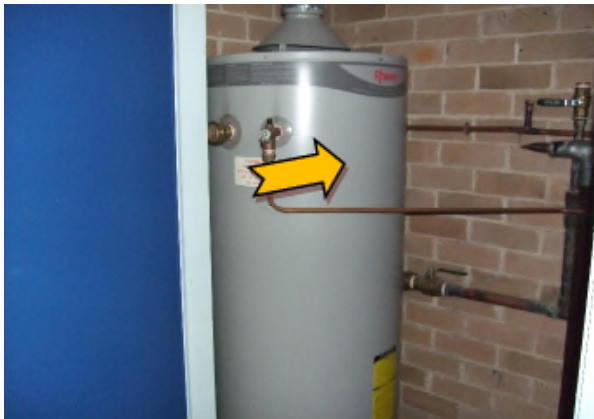
Photograph 21: Interior: Ground Floor; B00C R0060 – Plant – Suspected SMF containing insulation to hot water heater.

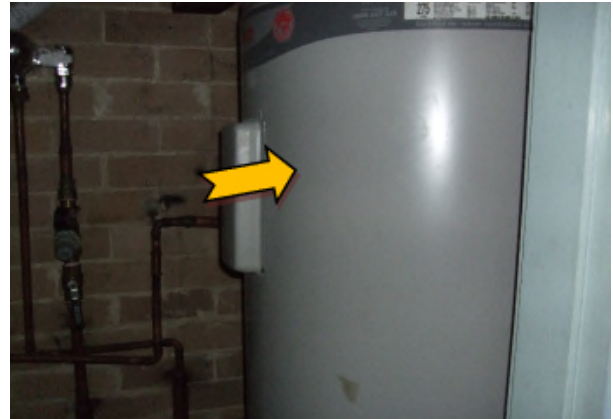
Photograph 22. Interior: Ground Floor; B00C R0063 – Plant – Suspected SMF containing insulation to hot water heater.

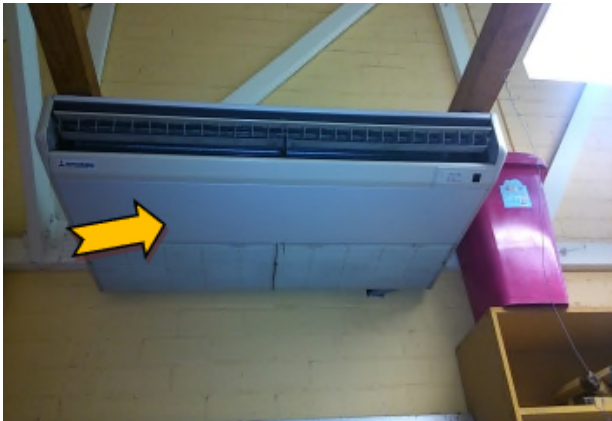
Photograph 23: Interior: Ground Floor; B00C – R0081 – Childcare Centre - Suspected ODS containing refrigerant to Mitsubishi AC Unit.
