**Tahmoor Coal Pty Ltd**

# QUARTERLY PROGRESS REPORT

**Myrtle Creek CMAP & Redbank Creek CMAP**

**June 2020**

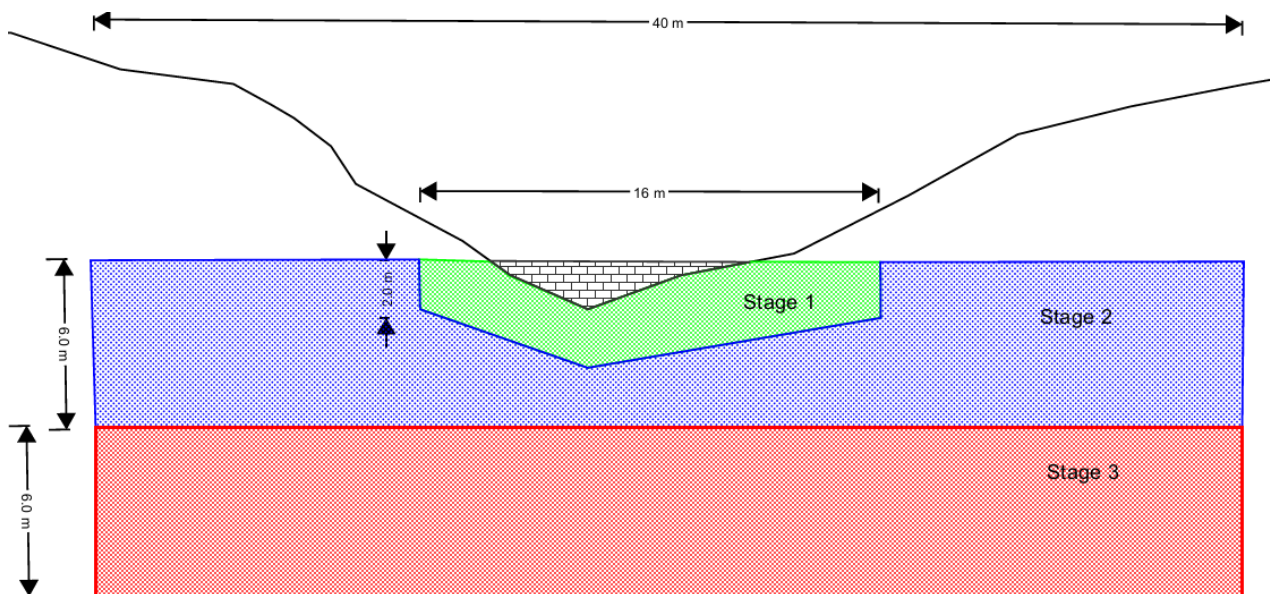
**Figure 11: Proposed grouting stages at Weir Pool / 26**

**Figure 11** illustrates the proposed grout stages at Weir Pool / 26. R9 is a level monitoring device in Weir Pool / 26. It will be used to measure PRR prior to and post remediation. It will also provide background data of pool behaviour prior to subsidence impacts.

- Stage 1 – Drill 16 m wide curtain to a depth of 2 m, with 0.5 m spacing and inject Spetec H100;
- Stage 2 – Drill 40 m wide curtain to a depth of 6 m with 2 m spacing and inject Spetec H100;
- Stage 3 – Drill 40 m wide curtain an additional 6 m depth with 2m spacing and inject Spetec H100.

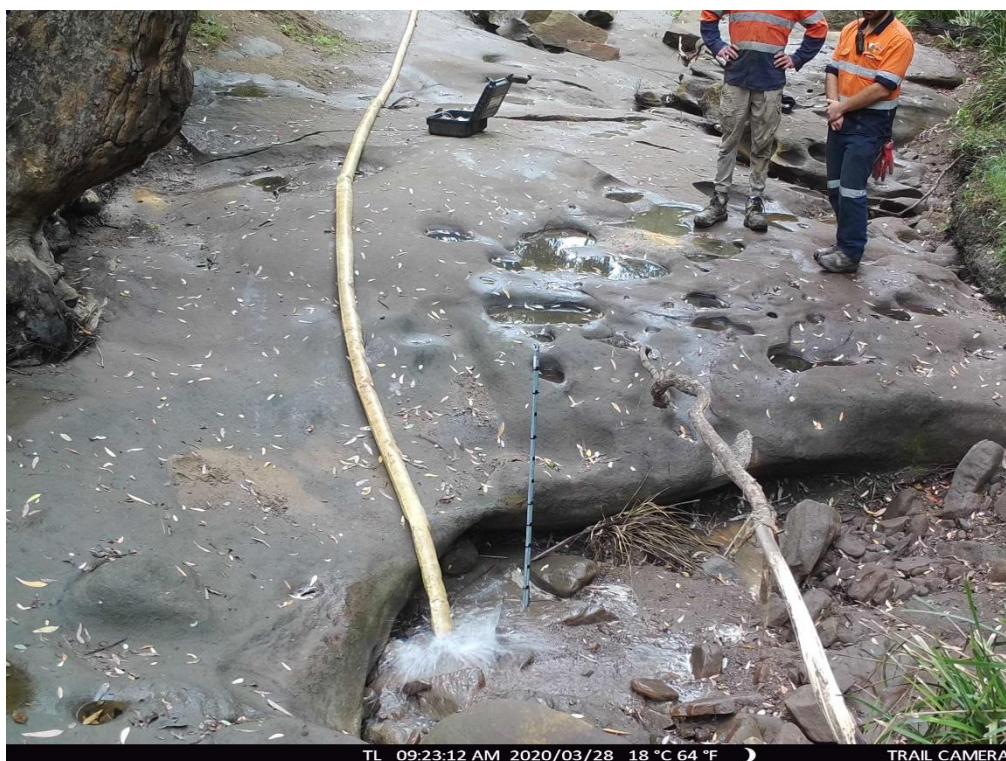
A baseline Pool Recession Test (PRT) was completed on the 30<sup>th</sup> of March 2020 prior to grout injection. The pool was filled with approximately 13000 L of water and then monitored to understand its existing retention. The 13 000L permeated through the rock bar immediately without any pooling.

*Image 1: Pumping begins*

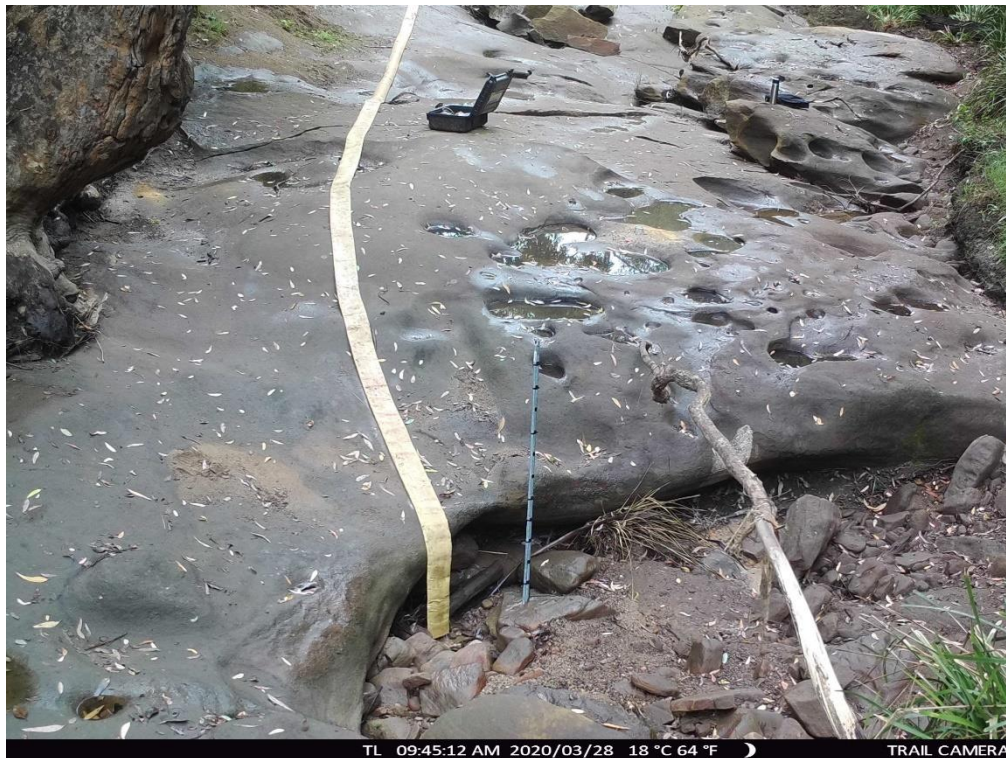
*Image 2: At the end of pumping*

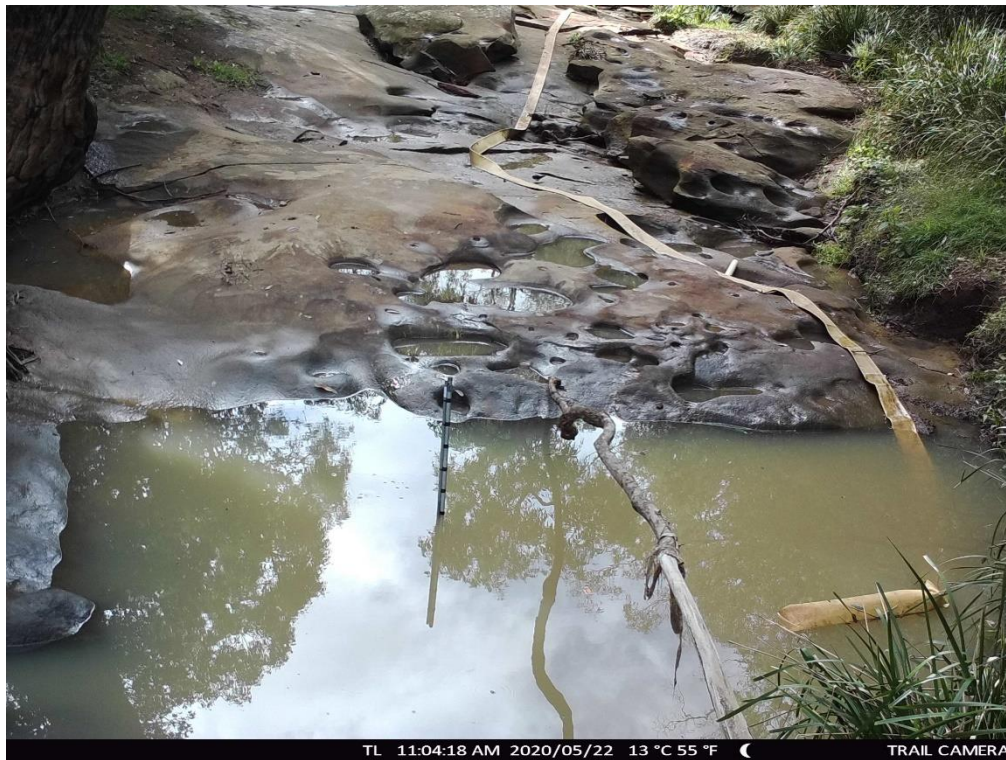
Prior to remediation the pool had no observable holding capacity. The works produced a holding time of 2.5 hrs as shown in Images 3 and 4.

*Image 3: Water stops flowing over rock bar*

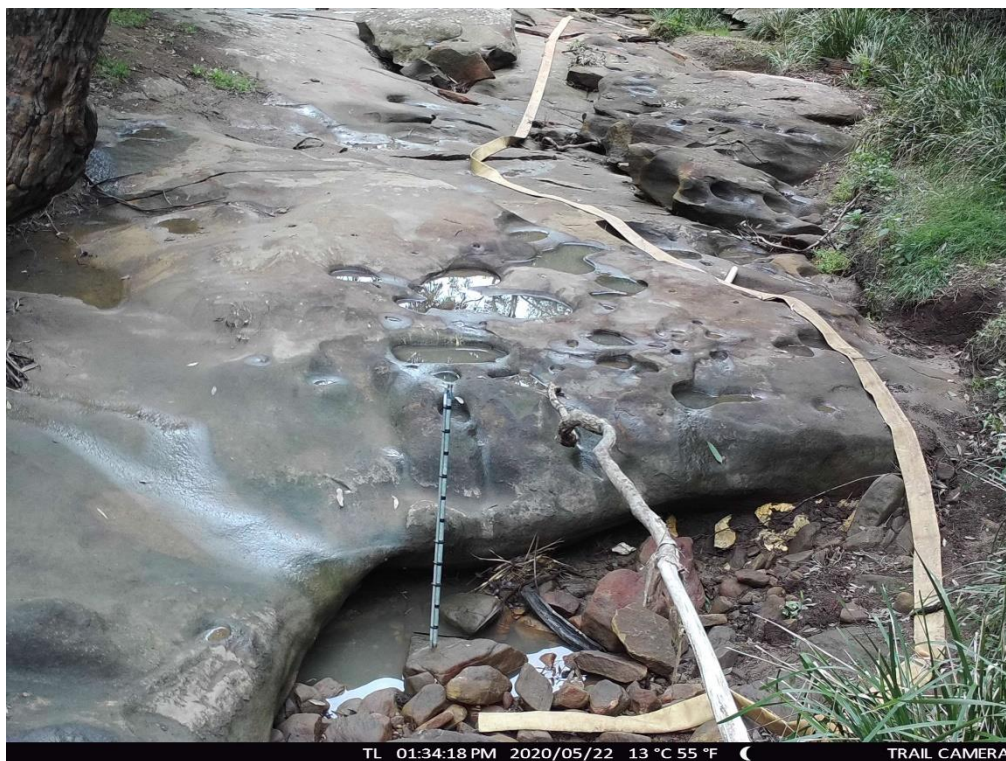
*Image 4: Water has drained from pool*

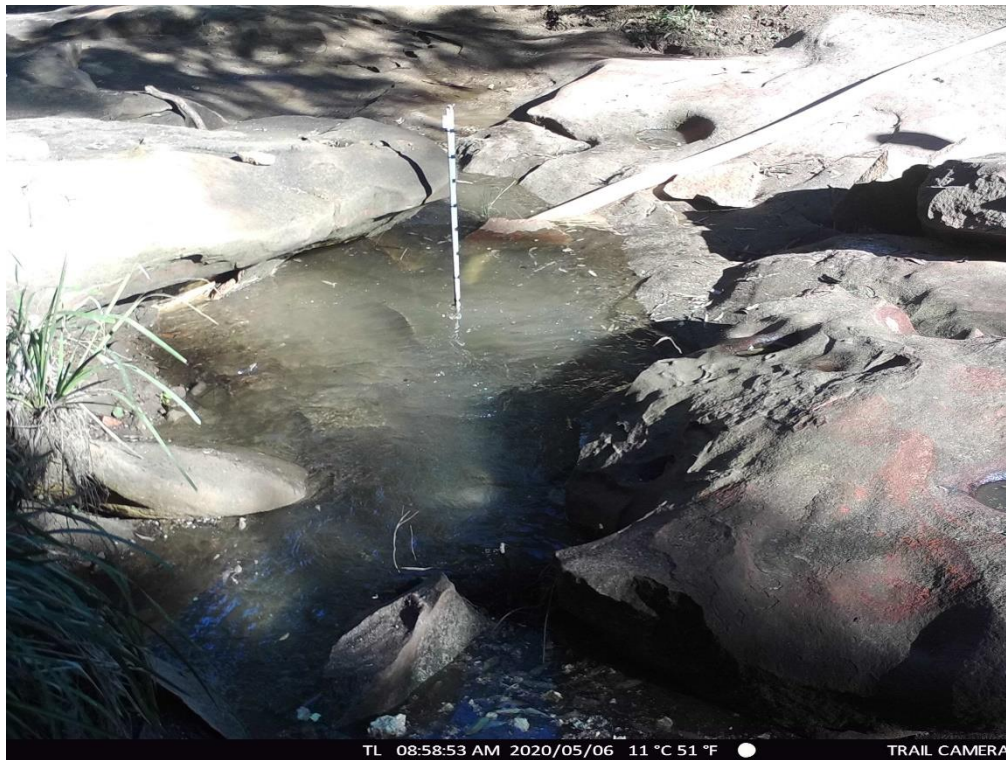
Pointe completed a Pool Recession Test (PRT) on the 6<sup>th</sup> May 2020 after completion of the works. The pool was filled with approximately 13000 L of water and time for it to recede was recorded. Prior to remediation the pool had no observable holding capacity. The test results show the pool receded 300 mm 75 minutes as shown in Images 1 and 2.

*Image 1: Filled with 13000 L*

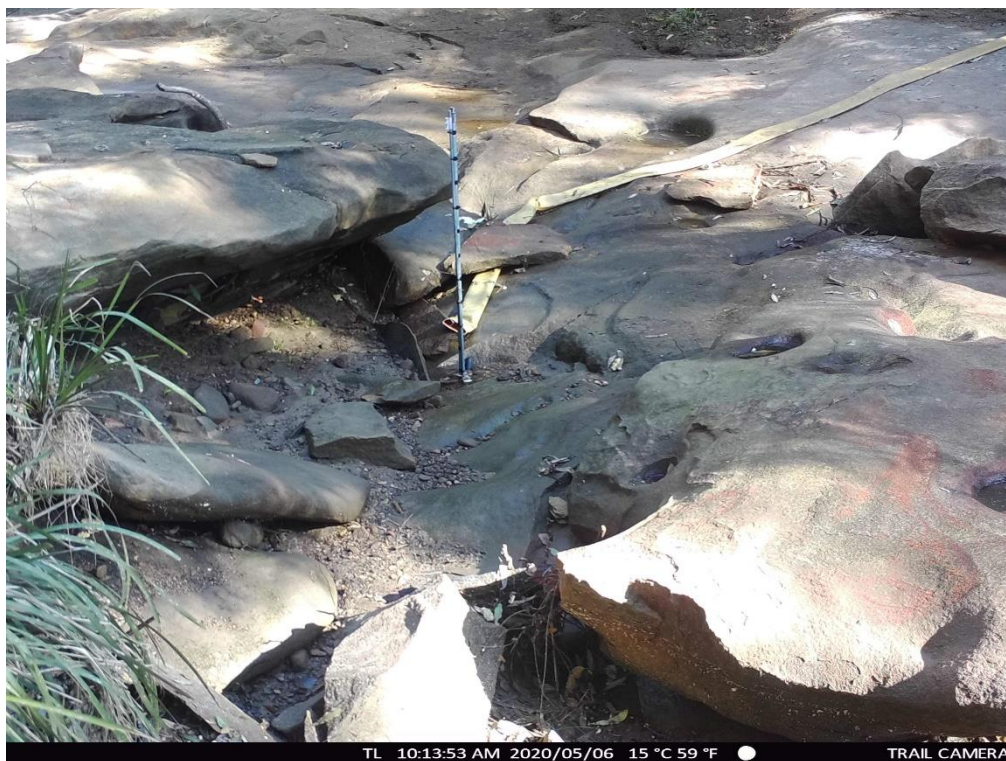
*Image 2: Water has drained from pool*

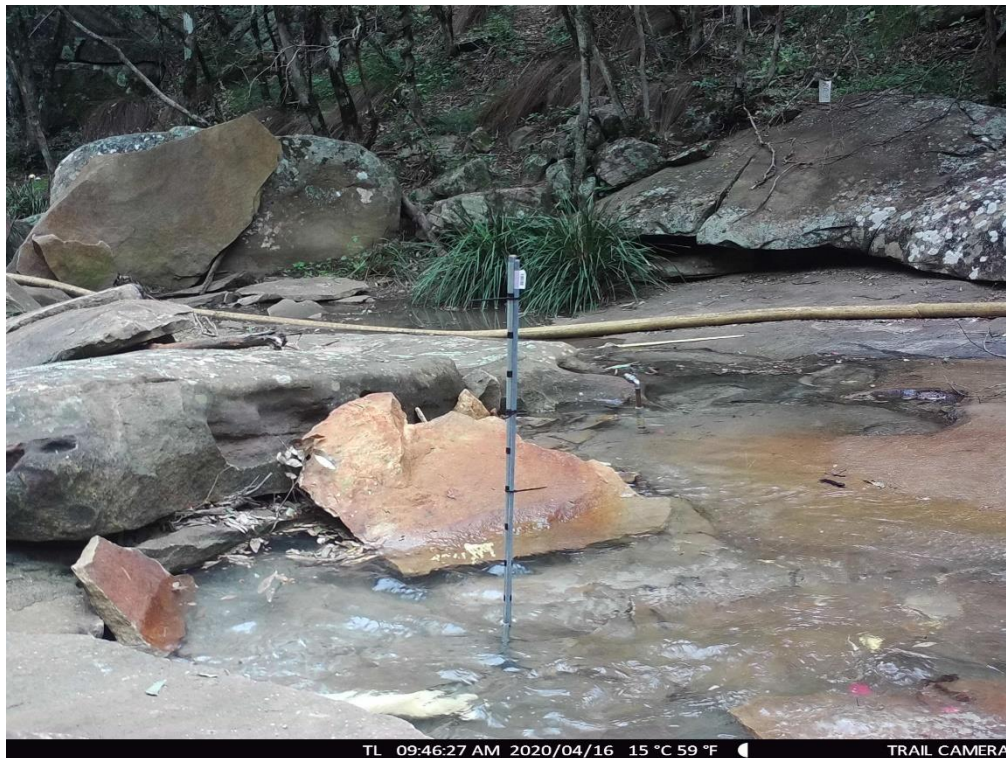
A baseline Pool Recession Test (PRT) was completed on the 16<sup>th</sup> of April 2020 prior to grout injection. The pool was filled with approximately 13000 L of water and then monitored to understand its existing retention. The 13 000L dissipated within 16 minutes, a 200 mm drop.

*Image 1: Water at the end of 13000L*

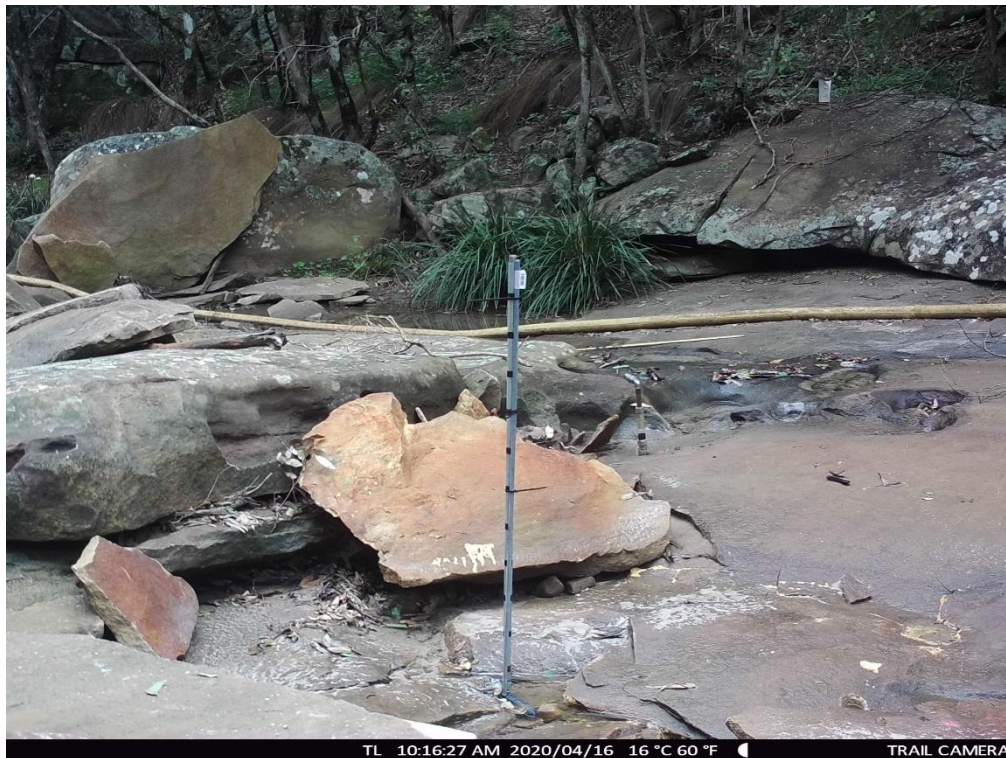
*Image 2: Water has drained from pool*

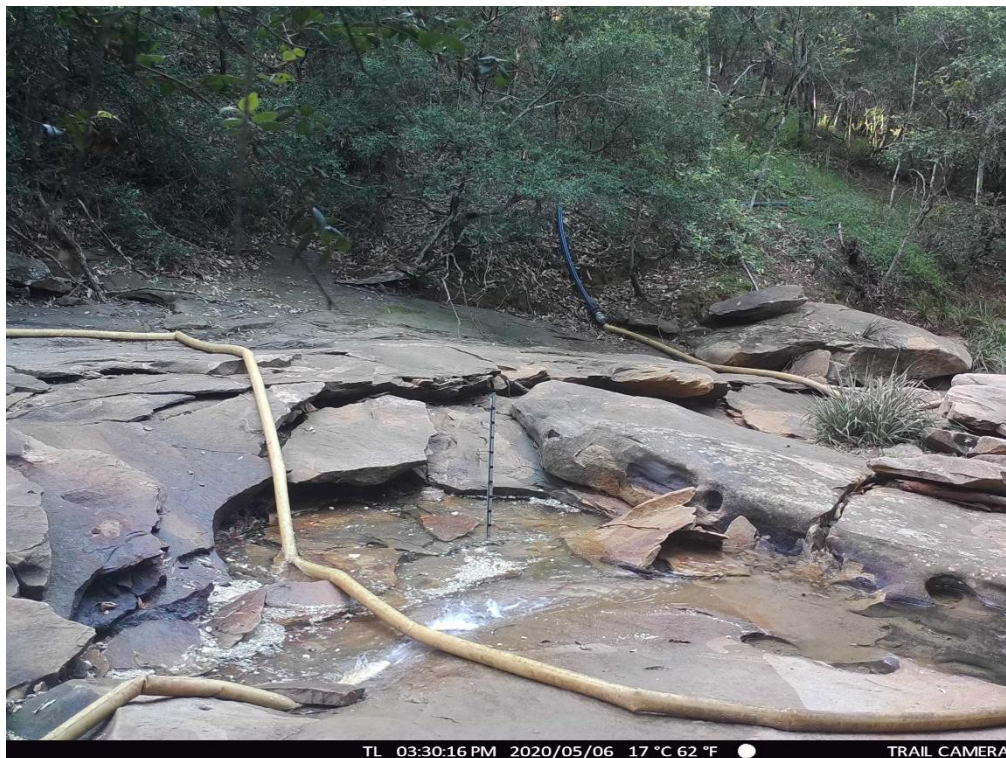
Pointe completed a Pool Recession Test (PRT) on the 6<sup>th</sup> May 2020 after completion of the works. The pool was filled with approximately 13000 L of water and time for it to recede was recorded. The pool retained water for 1.5 hours. The test results show an increase in holding time of 1.25 hours or greater than 5 times that of the pre works test, as shown in Images 3 and 4

*Image 3: Filled with 13000 L*

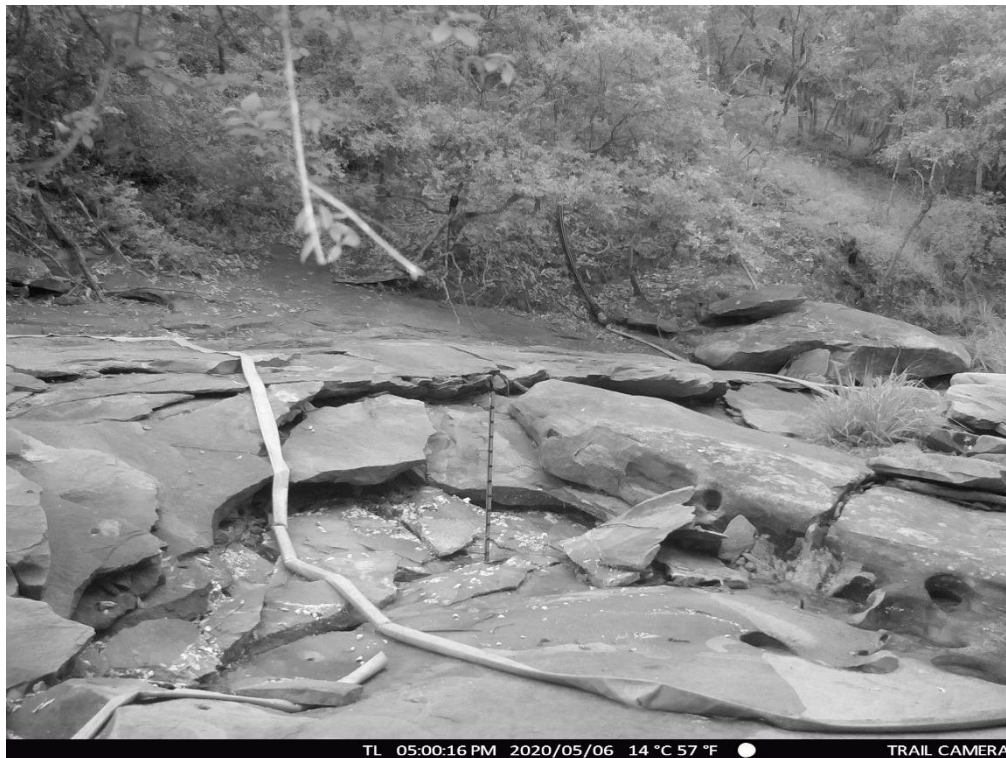
*Image 4: Water has drained from pool*

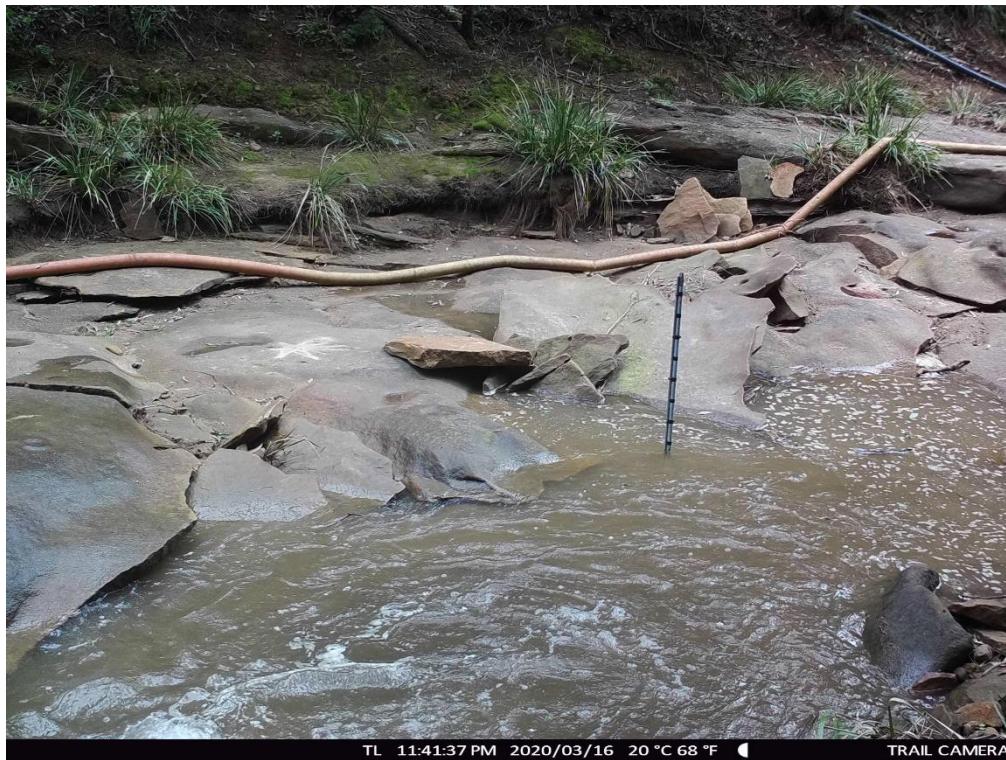
A baseline Pool Recession Test (PRT) was completed on the 17<sup>th</sup> of March 2020 prior to grout injection. The pool was filled with approximately 13000 L of water and then monitored to understand its existing retention. The 13 000L dissipated within 17 minutes, a 300 mm drop.

*Image 1: Water at the end of 13000L*

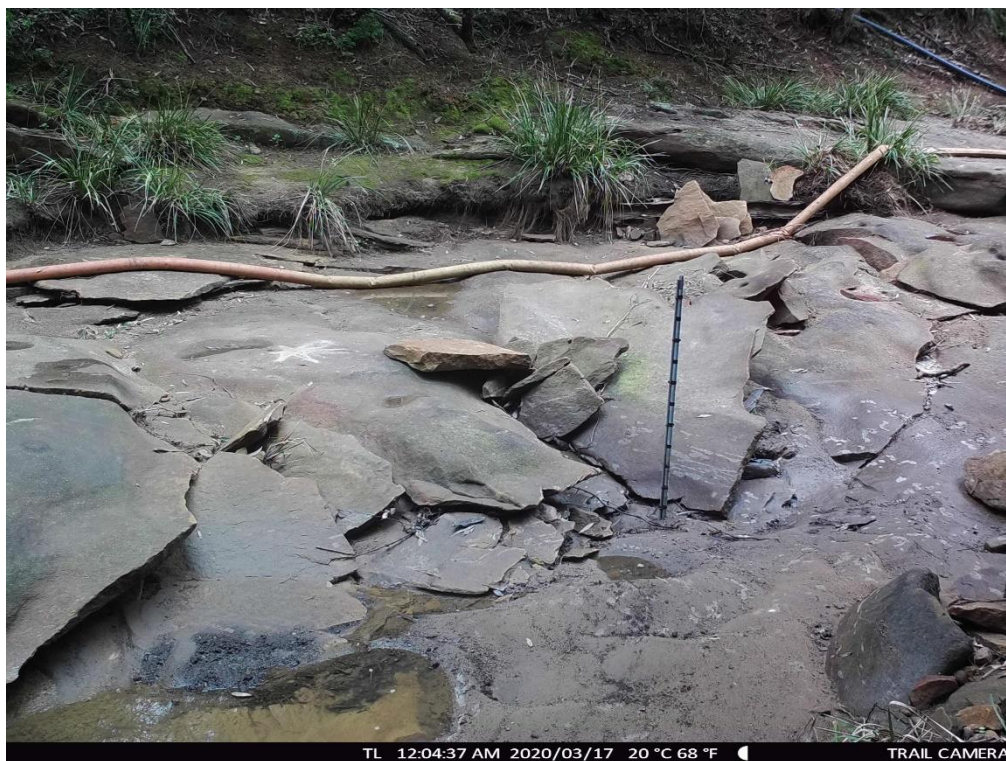
*Image 2: Water has drained from pool*

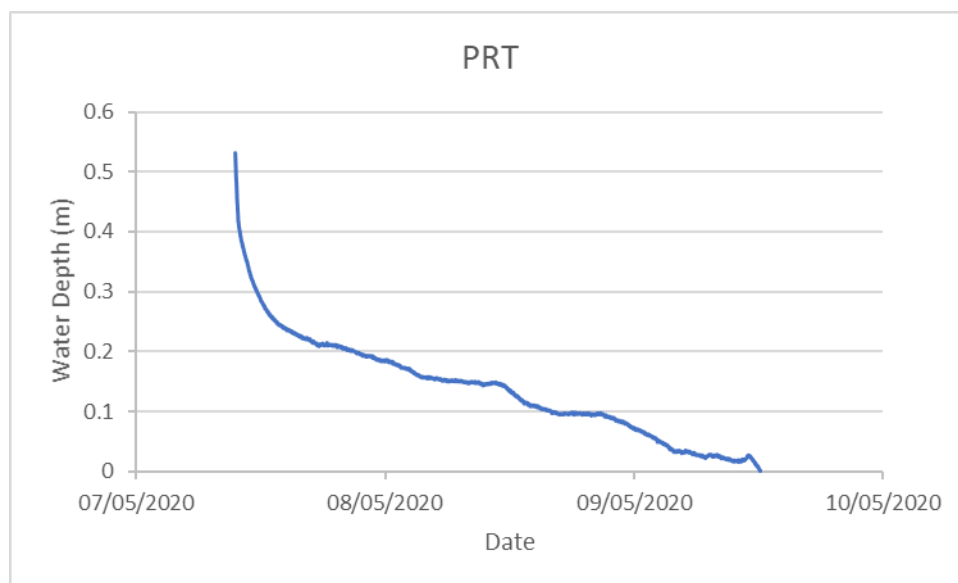
Pointe completed a Pool Recession Test (PRT) on the 7<sup>th</sup> May 2020 after completion of the works. The pool was filled with approximately 13000 L of water and time for it to recede was recorded. The pool retained water for 49 hours. The test results show an increase in holding time of 48.5 hours or greater than 200 times that of the pre works test as shown in Chart 1.

*Chart 1: Pool Recession Test Depth Over Time*

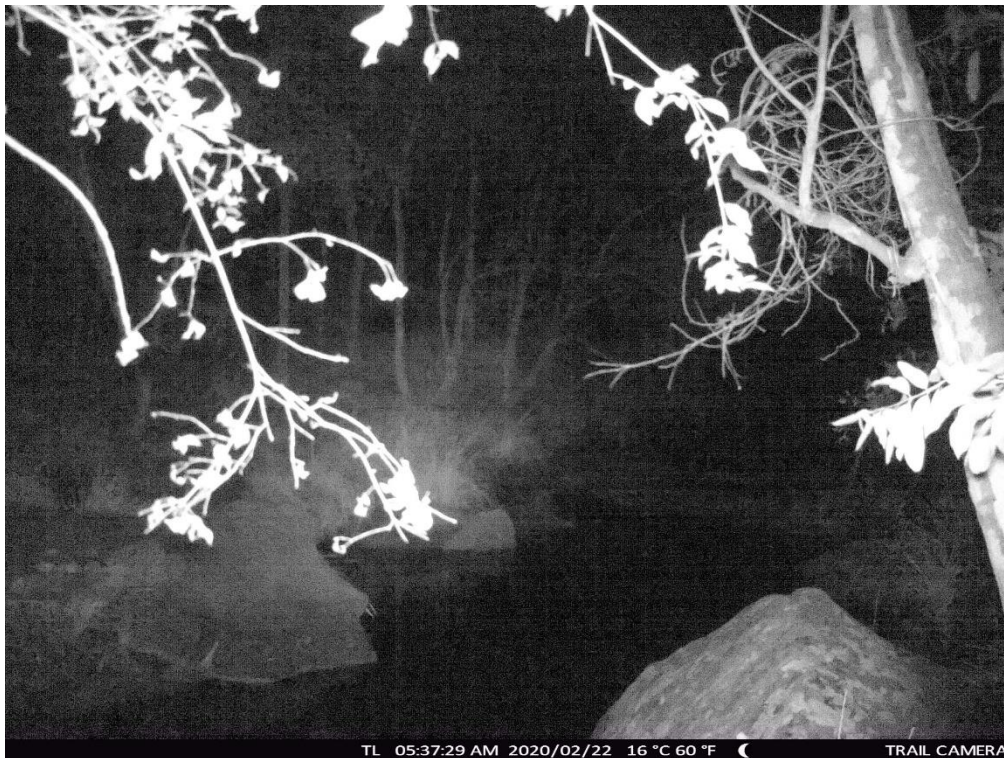
*Image 1: Water stops flowing over rock bar*

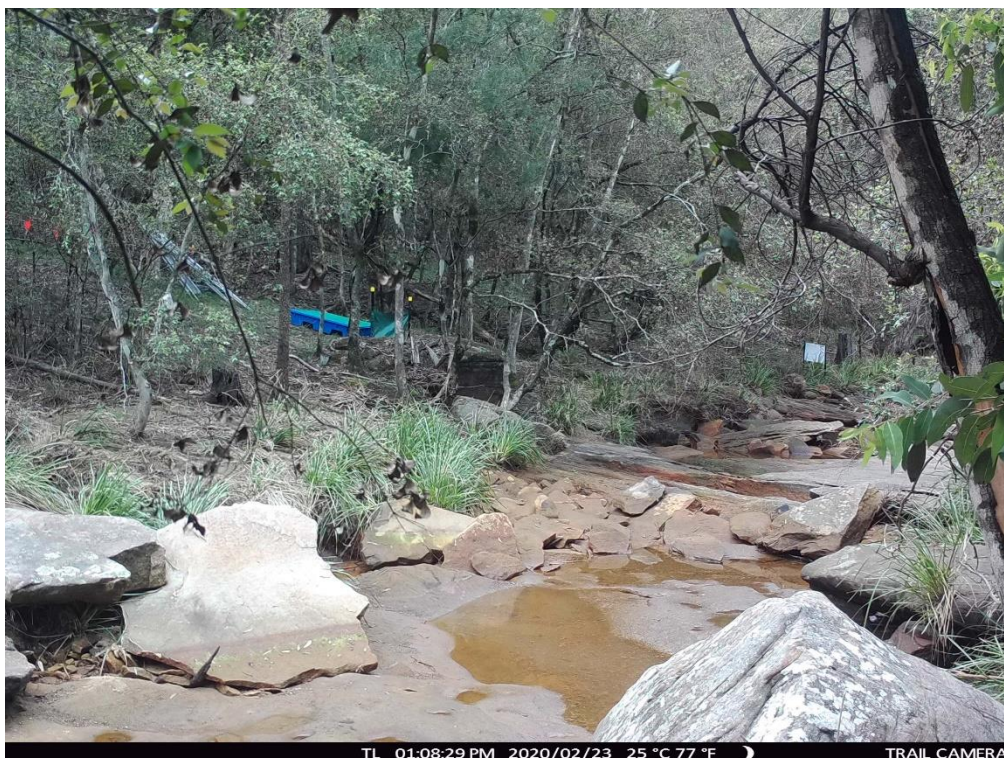
*Image 2: Water has drained from pool*

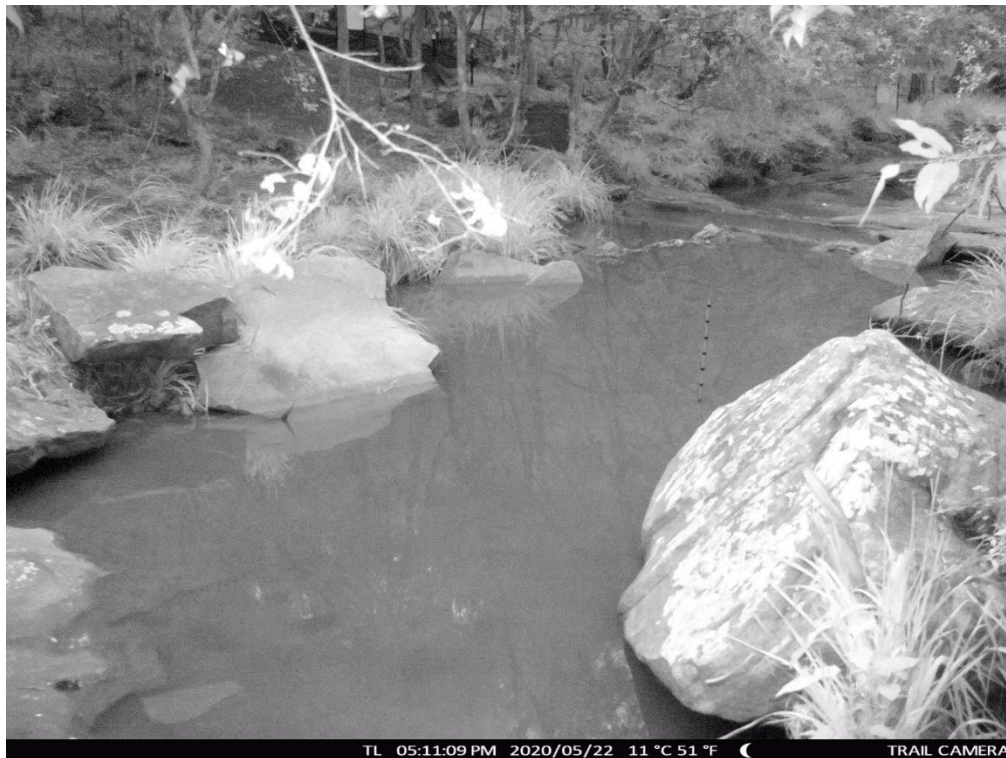
*Image 3: Water stops flowing over rock bar*

Visual observation during the works noted that water that had been previously surfacing just downstream of the rock bar no longer occurred.

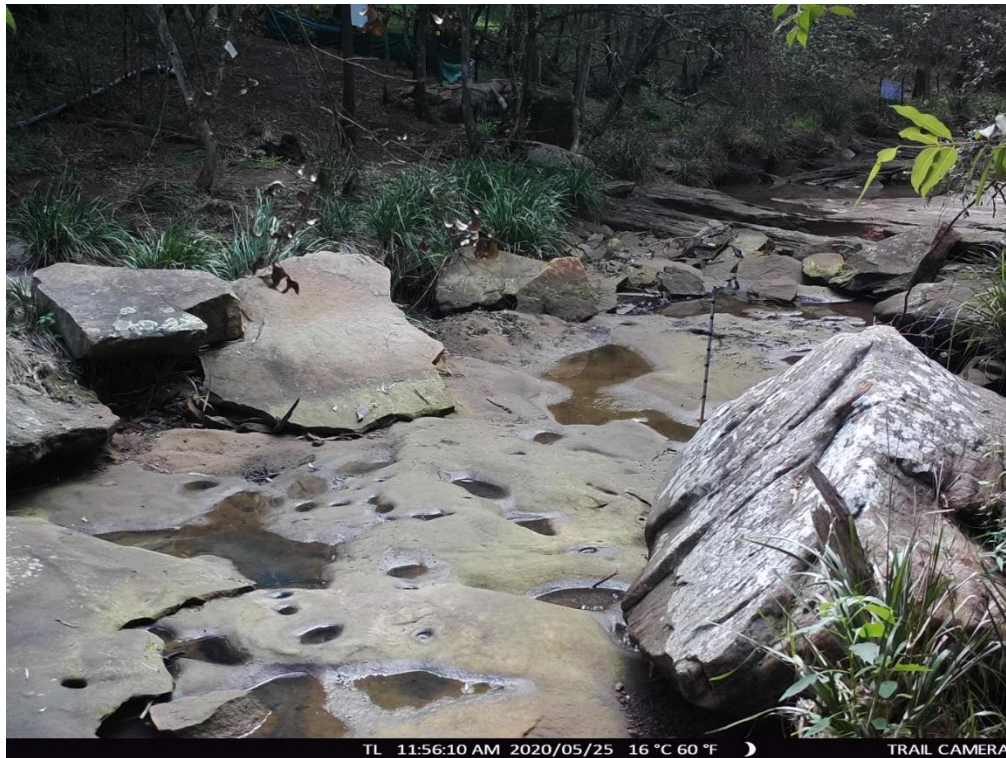
*Image 4: Water has drained from pool*
