Concept Design Road Safety Audit

**Hurlstone Agricultural High
School (Hawkesbury)
Londonderry Road, Vines Drive
and Southee Road**

Prepared for NSW Department of Education c/o Mace Australia Pty Ltd / 10 August
2018

161108 TAAE

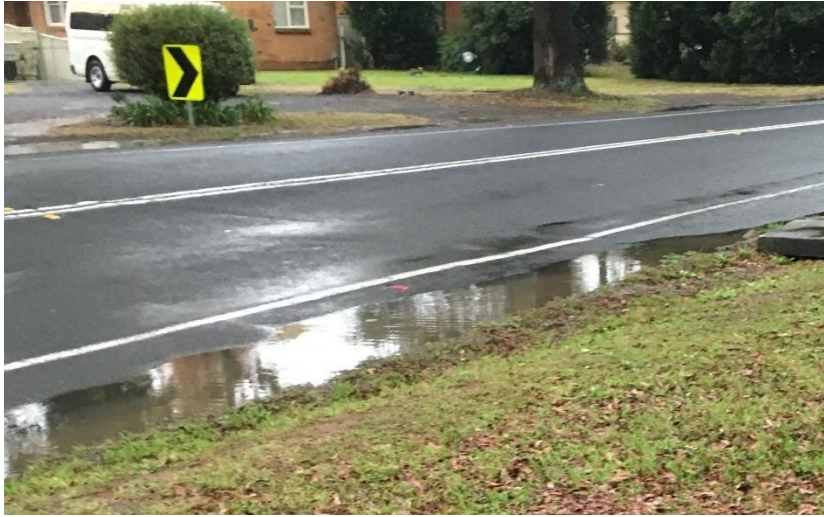
Item	Location	Identified Risks	Photographic Record	Frequency Severity Risk	Accept / Reject	Corrective Actions
INTERSECTIONS OF LONDONDERRY ROAD/VINES DRIVE AND LONDONDERRY ROAD/SOUTHEE ROAD						
1	Londonderry Road/Vines Drive	There is limited drainage located adjacent to Londonderry Road and Vines Drive. There is a risk that ponding water adjacent to the roadway may encroach the travel lane and result in vehicles aquaplaning and losing control. There is also a risk that drivers may swerve to avoid driving through water. These risks could lead to side impact or rear end collisions.

Improbable Minor Low	A	<p>Severe aquaplane risks are not considered to be evident at this location.</p> <p>Vines Drive consists of long straights and wide curves, providing good visibility of oncoming traffic in the event a vehicle is required to avoid water.</p> <p>Existing issue on external road is unlikely to be worsened by additional traffic.</p> <p>Operation is considered satisfactory.</p> <p>No further action.</p>

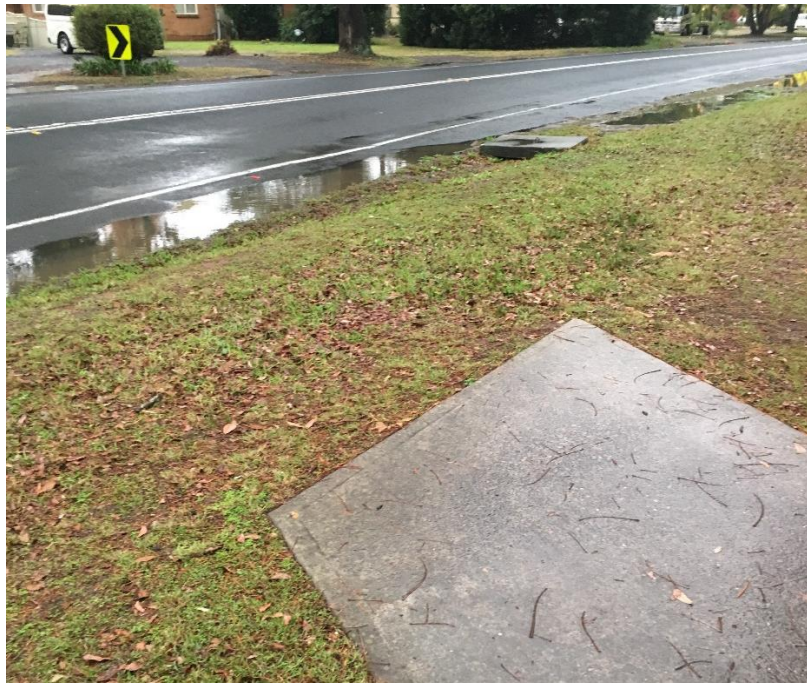
2	Vines Drive	A pedestrian path is provided on the eastern side of Vines Drive. The path does not continue and finishes approximately 1m from the road carriageway of Londonderry Road. This may result in pedestrians being lead to an uneven surface which may pose a trip hazard.

Improbable Limited Low	R	<p>Standard treatment for end of footpath onto flush and relatively flat grass surface.</p>

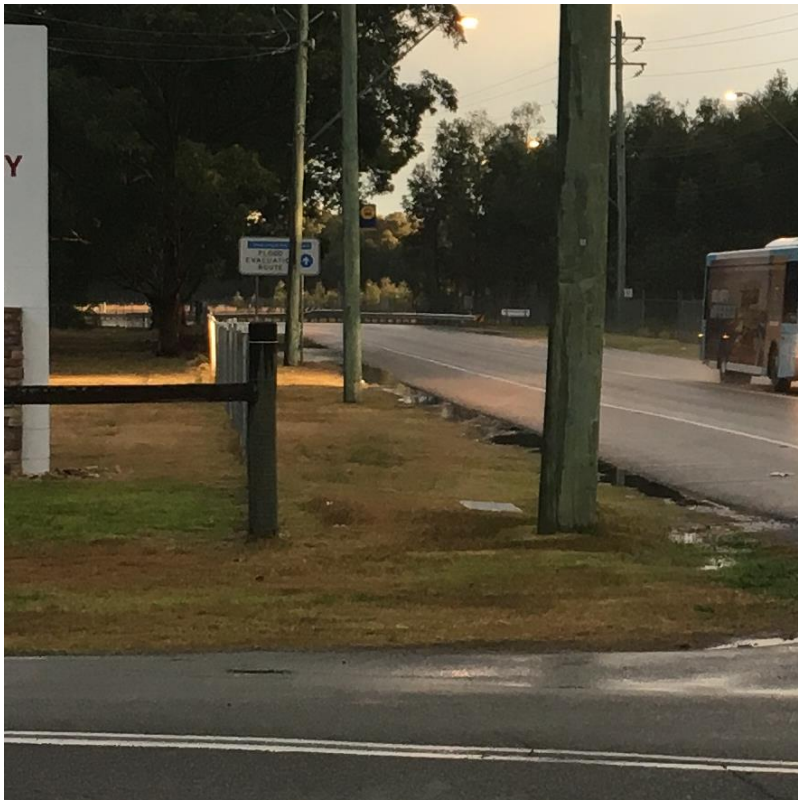
Item	Location	Identified Risks	Photographic Record	Frequency Severity Risk	Accept / Reject	Corrective Actions
3	Bus Stop on Londonderry Road	There is no safe pedestrian access provided to the bus stop on Londonderry Road. There is a risk that pedestrians may walk on the pavement to avoid uneven areas and ponding water resulting in collisions with passing vehicles. This risk may be increased once the proposed school is in operation as students may use this bus service.

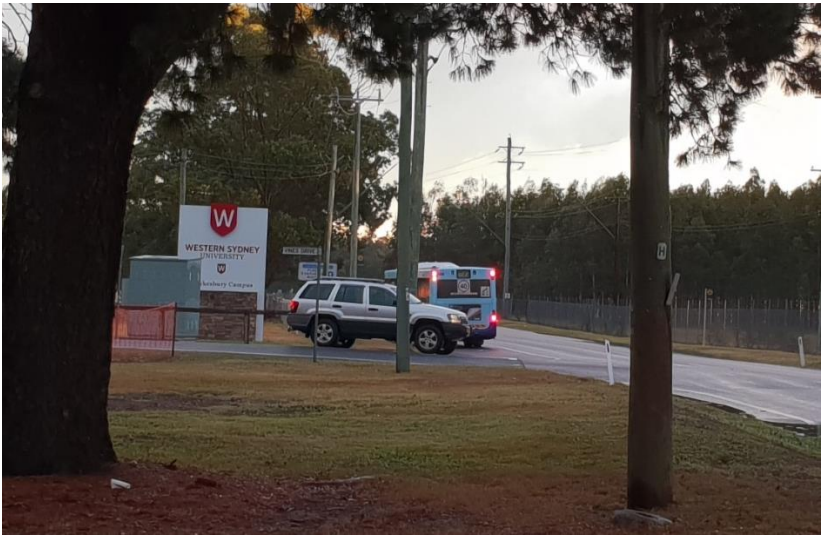
Improbable Serious Medium	A	As below.
4	Bus Stop on Londonderry Road	The existing bus stop on Londonderry Road is located 40m south of the intersection of Vines Drive and Londonderry Road. There is a risk that buses stopped to pick up passengers may impact sightlines for vehicles exiting Vines Drive and from those travelling northbound on Londonderry Road.

Improbable Serious Medium	A	<p>Vines Drive bus services operate very infrequently (2hrs morning, 1hrs evening). Closest services to school times are currently 8:15am, 10:10am, 2:10pm, 3:50pm which are outside school movement periods.</p> <p>While acknowledging timetables may change, low frequency of services not expected to result in issues.</p> <p>Additional usage of buses by school students is expected to be via dedicated school buses from within HAHS site.</p> <p>Operation is considered satisfactory.</p> <p>No further action.</p>

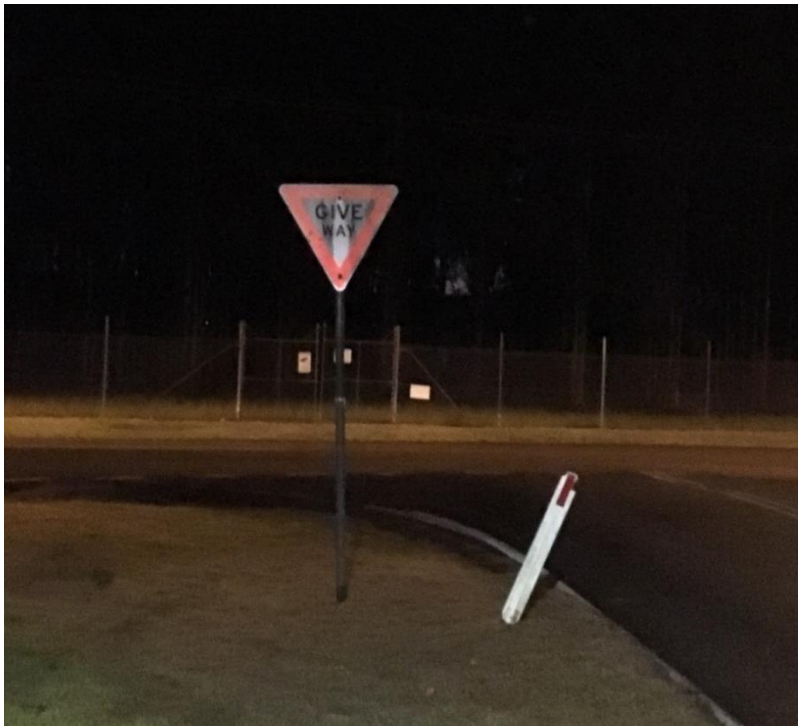
Item	Location	Identified Risks	Photographic Record	Frequency Severity Risk	Accept / Reject	Corrective Actions
5	Vines Drive	<p>Give-way signage located on Vines Drive at the intersection is faded and may be unclear to drivers. There is a risk that drivers may not be aware of the sign control on the intersection which may lead to side impact collisions.</p> <p>It is noted that the proposed design relocates this existing sign but does not replace it.</p>

<p>Improbable</p> <p>Serious</p> <p>Medium</p>	A	Sign to be replaced. (Action by Civil Engineer)
6	Vines Drive	<p>There is a no chevron board provided adjacent to the intersection on Vines Drive. There is a risk that during night or adverse weather conditions, the driver may not anticipate the terminating leg of the intersection and enter the through carriageway which may result in side impact collisions.</p>

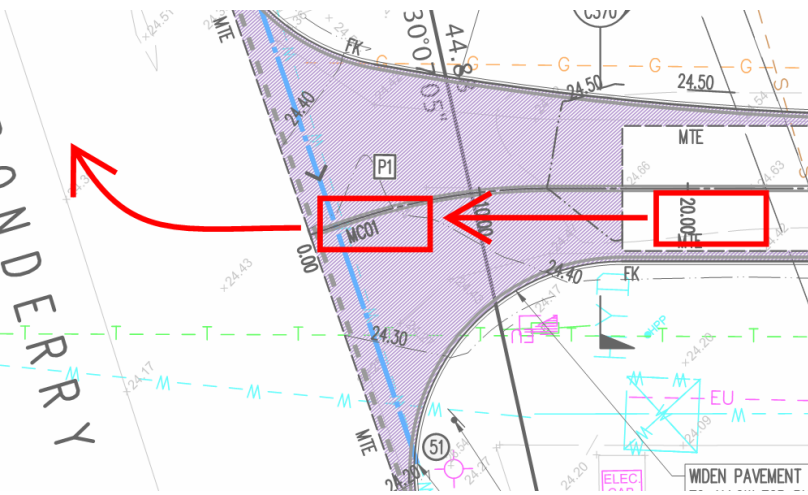
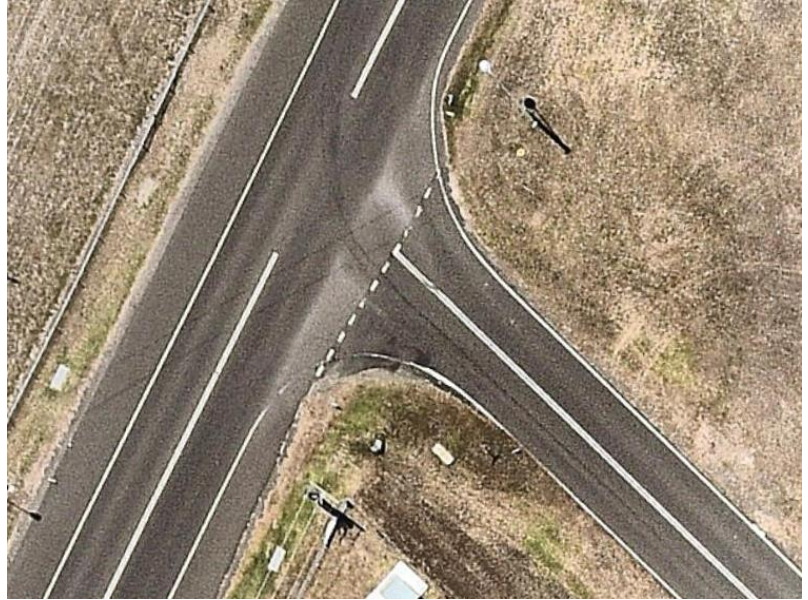
Item	Location	Identified Risks	Photographic Record	Frequency Severity Risk	Accept / Reject	Corrective Actions
9	Vines Drive	The proposed centreline of Vines Drive curves approximately 15m prior to the intersection with Londonderry Road. Drivers may tend to drive over the centreline when turning right onto Londonderry Road. This may lead to side swipe or side impact collisions. It is noted that the existing alignment does not have this curve.	<div>

</div> <div>Note: Second image shows the existing arrangement.</div>	Occasional Serious High	R	Proposed centreline of Vines Drive is perpendicular to Londonderry Road to ensure best visibility and act as a traffic calming measure. This alignment is also designed to ensure best turning manoeuvre for buses entering the site and avoid bus-car collisions.

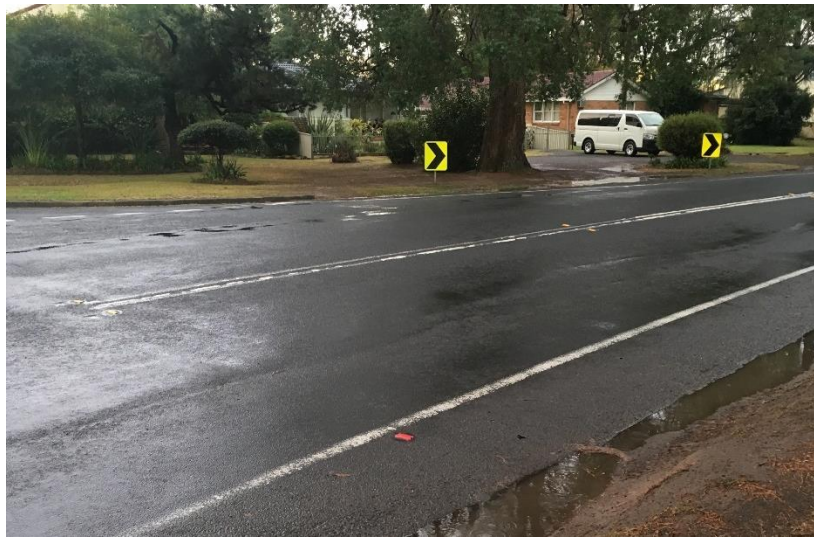
Item	Location	Identified Risks	Photographic Record	Frequency Severity Risk	Accept / Reject	Corrective Actions
10	Londonderry Road	The existing line marking for the centreline appears faded on Londonderry Road near the intersection with Southee Road. There is a risk that drivers may not be aware of the road alignment and may encroach into the oncoming traffic lane. This may lead to head on or side impact collisions.

Improbable Serious Medium	A	<i>Line marking can be renewed as part of line marking works at Vines Drive intersection.</i> <i>To be investigated with RMS during detailed design and approval process. (Action by Civil Engineer)</i>
11	Vines Drive	During night conditions there are no reflectors indicating the alignment of Vines Drive. There is a risk of vehicles not entering Vines Drive on the correct alignment or not travelling within their lane which may lead to head on or side swipe collisions.

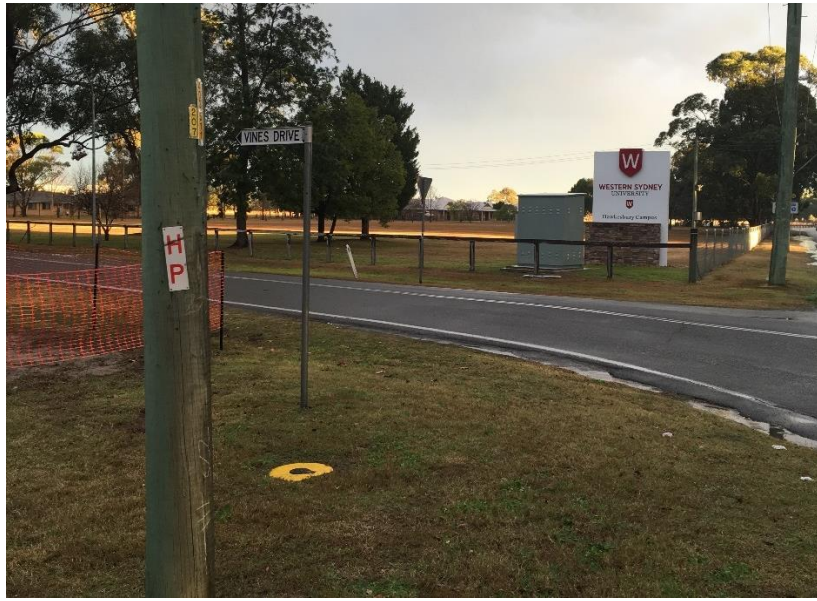
Item	Location	Identified Risks	Photographic Record	Frequency Severity Risk	Accept / Reject	Corrective Actions
12	Vines Drive	<p>The street signage of Vines Drive is located approximately 6m away from the Londonderry Road carriageway.</p> <p>There is a risk that the street sign may not be sighted by a passing motorist until late, resulting in sudden deceleration and possible rear end collisions.</p>

Occasional Minor Medium	R	<p><i>Vines Drive is private road to university which is utilised by regular users. New users are also alerted by significant University signage at intersection (visible in site photo).</i></p> <p><i>Additional site traffic for school will also be regular users.</i></p> <p><i>Signage for school to be investigated separately.</i></p>
13	Londonderry Road	<p>On the northern approach along Londonderry Road there is a raised concrete pit lid located adjacent to the southbound travelling lane. There is a risk that vehicles may hit this lid when passing a queued vehicle or swerve to avoid travelling near to this lid. This has the potential to result in side impact collisions.</p>
