ARBORICULTURAL ASSESSMENT AND TREE MANAGEMENT PLAN

**PICTON HIGH SCHOOL
480 ARGYLE STREET
PICTON, NSW 2571**

**REDEVELOPMENT AND
BUILDING ALTERATIONS AND
EXTENSION WORKS**

Addendum 19th October 2018

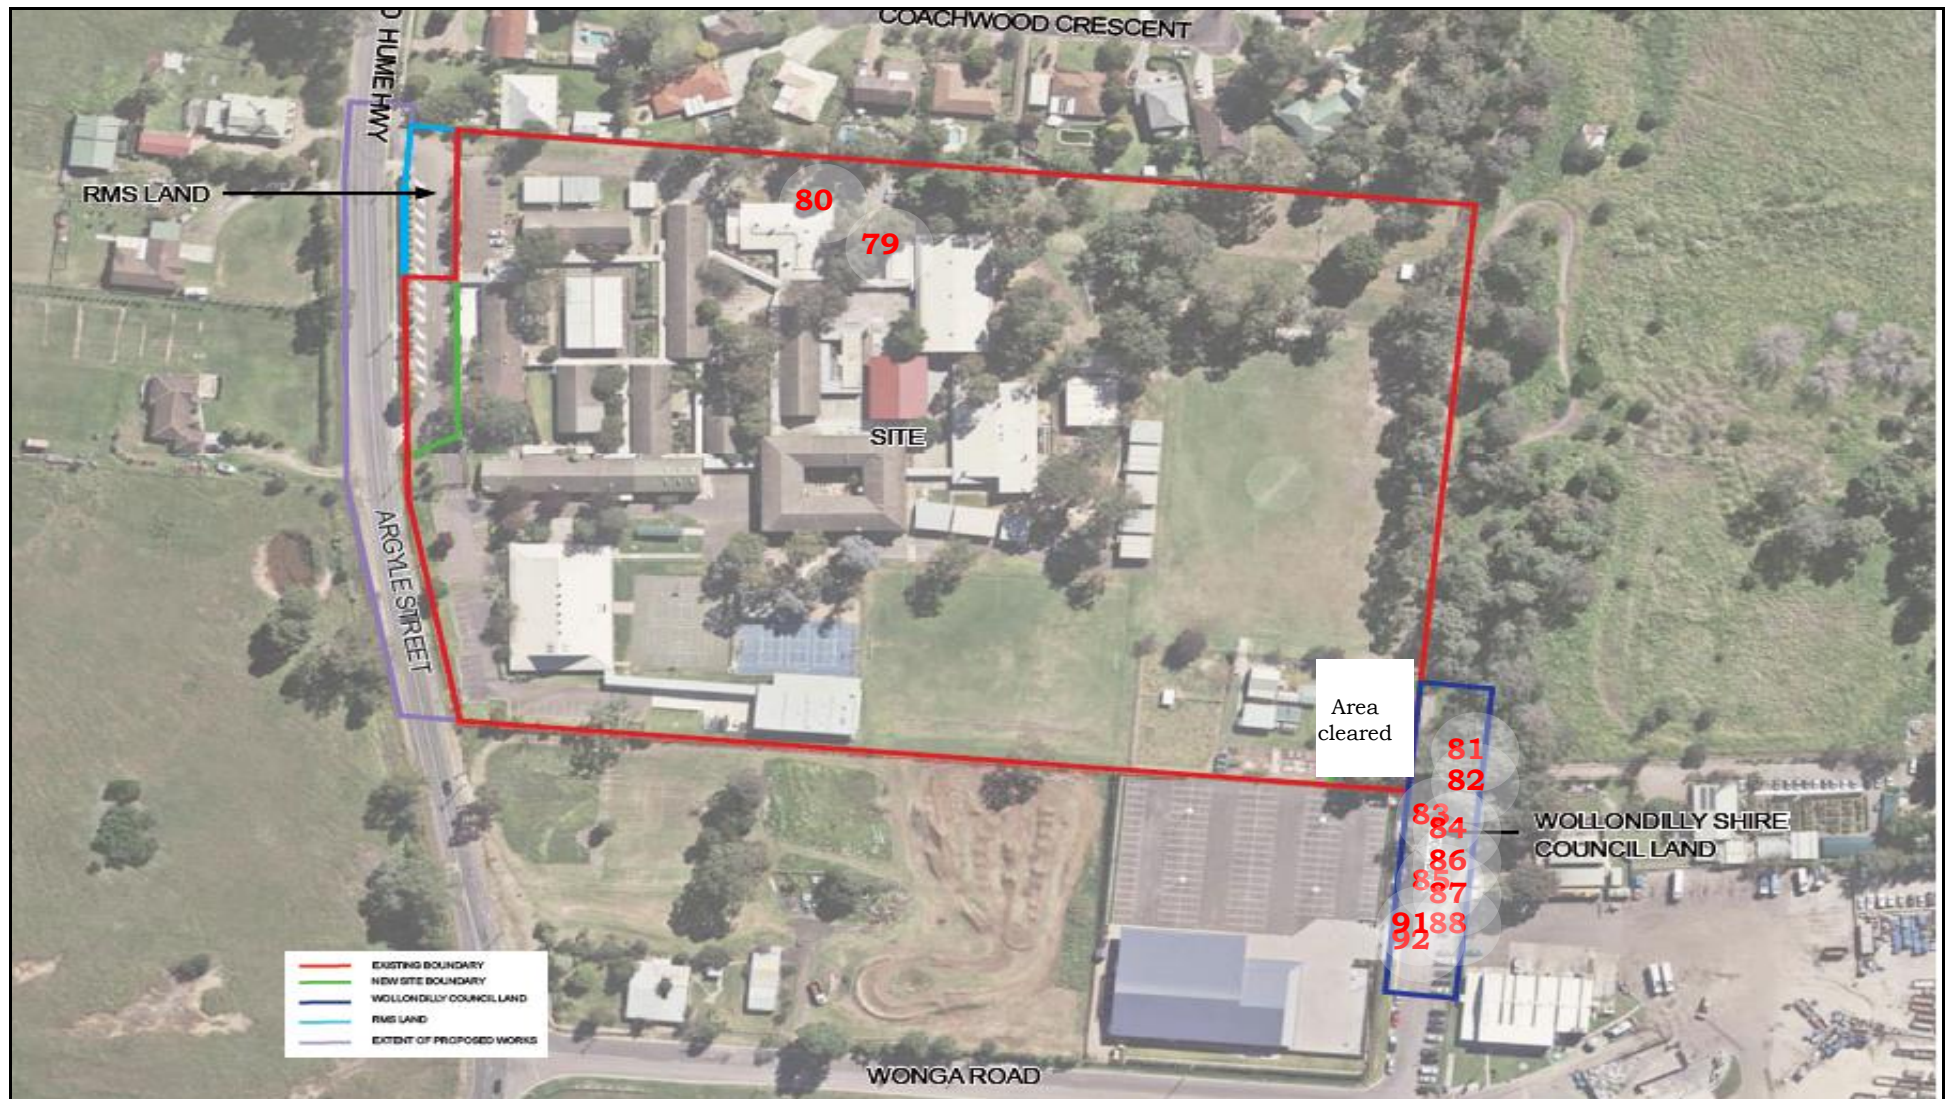
Figure 4 Shows the trees location that are required to be removed as part of the redevelopment works

Subject to Council process, approval is recommended for the removal of Fourteen-(14) trees based on their location to the proposed redevelopment works (trees 79 and 80) and accessway requirements (Trees 81 to 92) within Wonga Road for building materials.

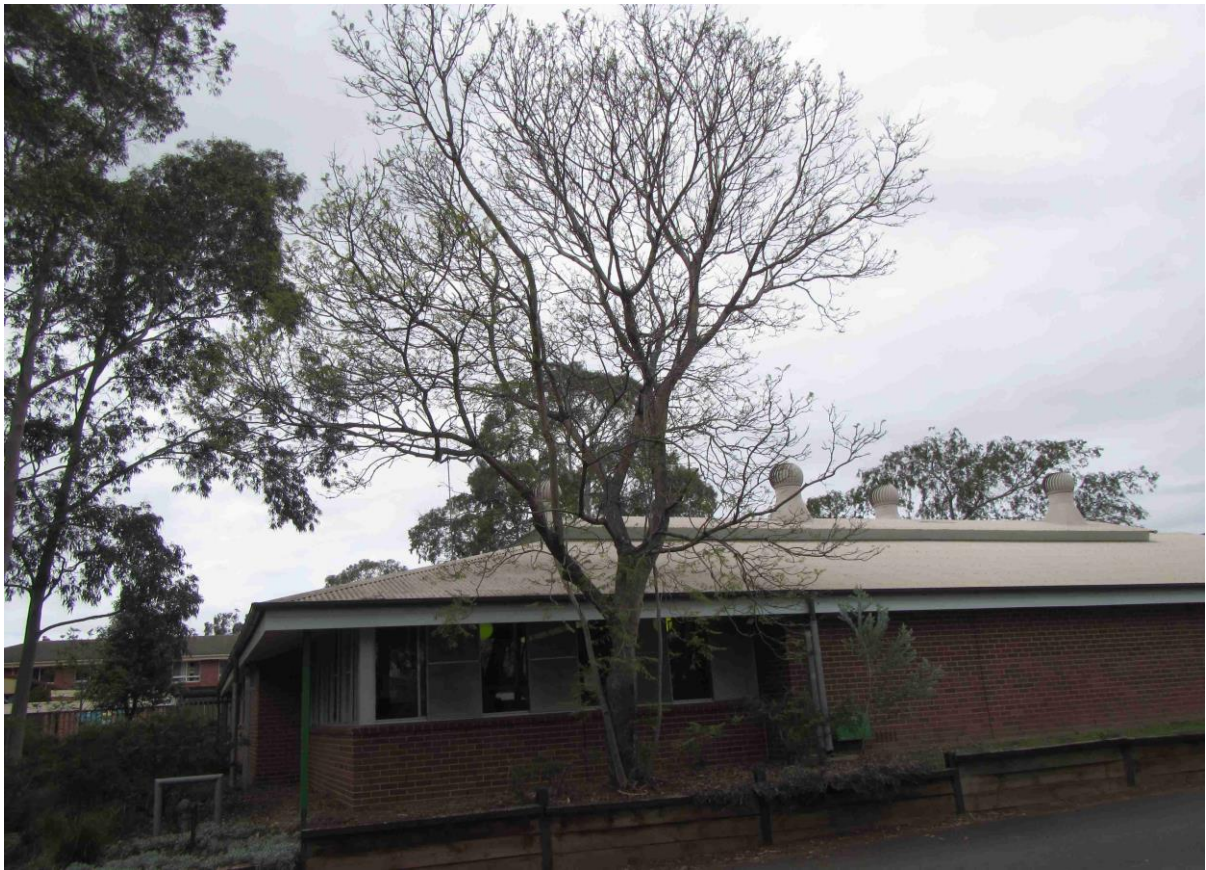
Figure 5 Shows Tree 80 that is required to be removed as part of the works.

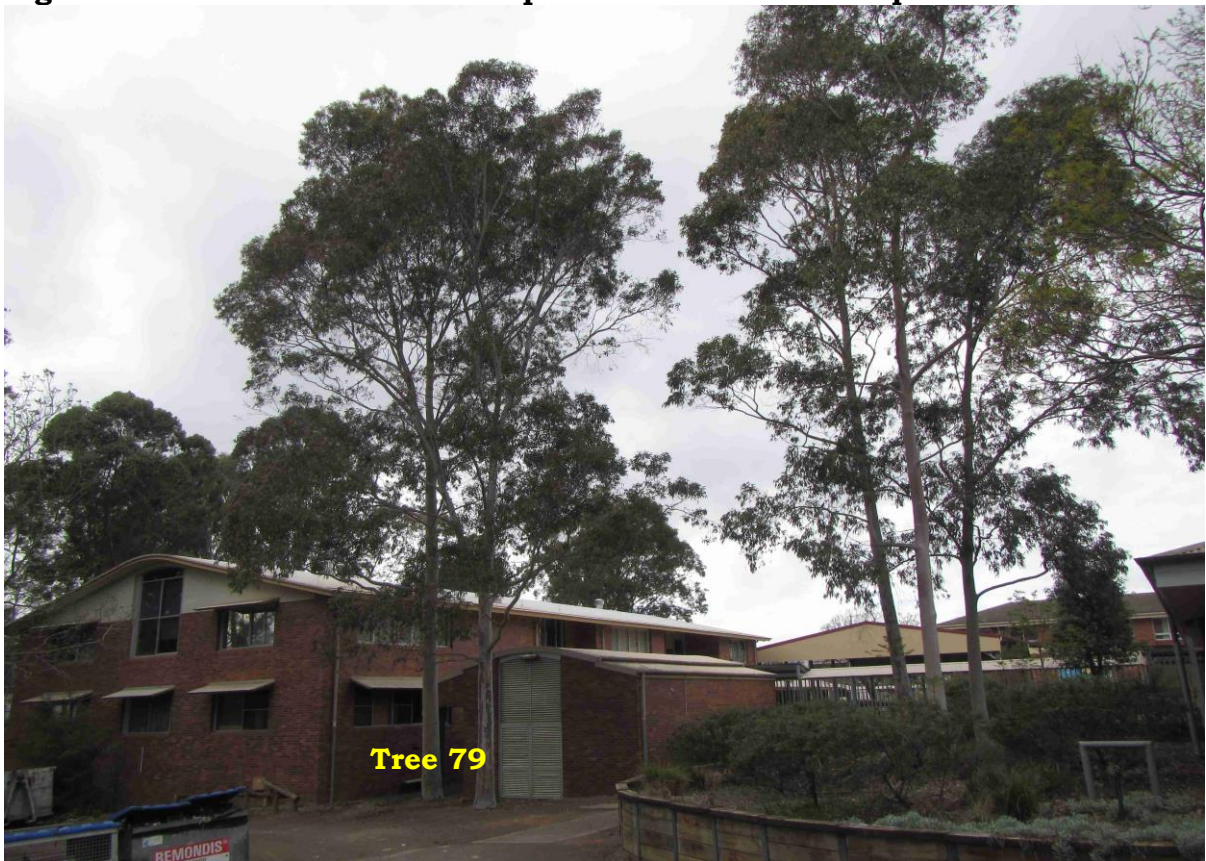
Figure 6 Shows Tree 79 from a distance with adjoining trees already approved to be removed.

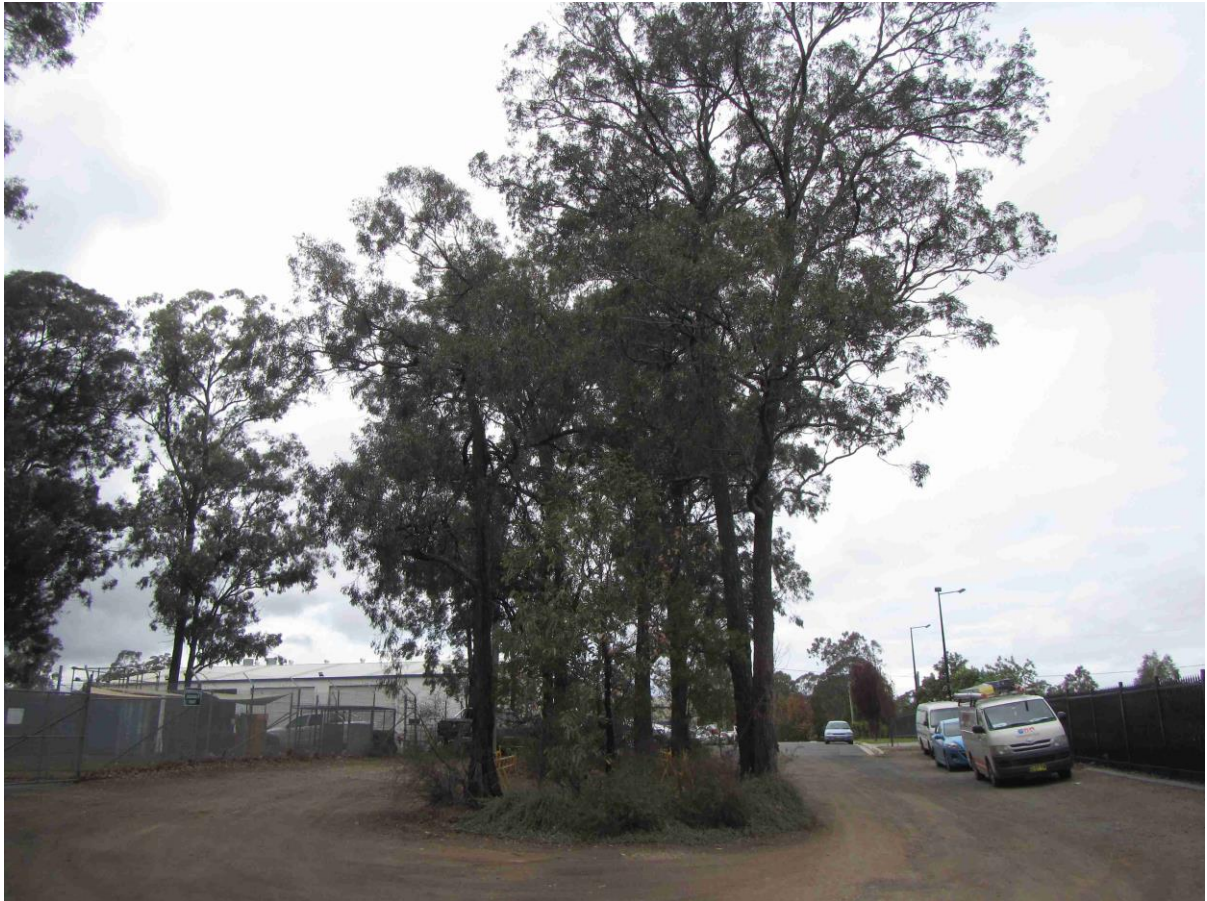
Figure 7 Shows a group of trees within Wonga Road, roadway that are required to be removed for vehicle access.

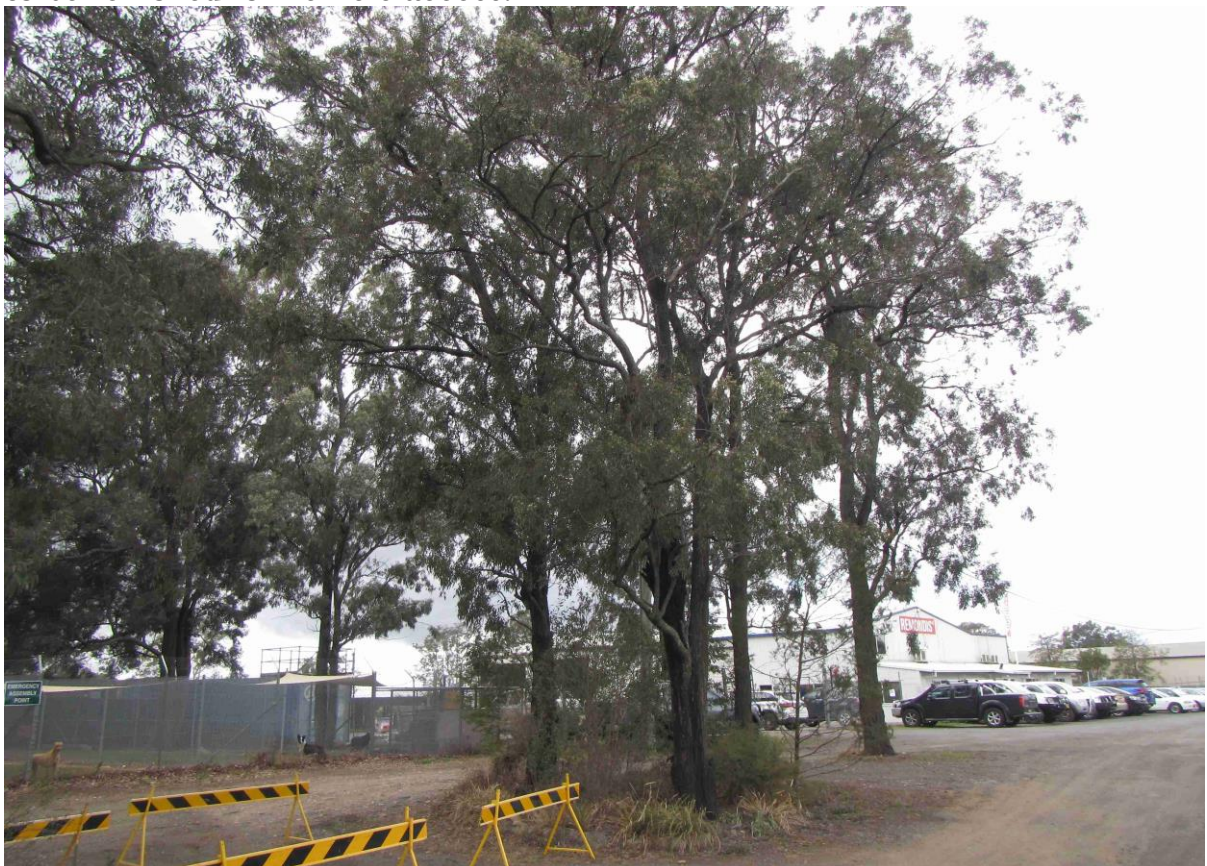
88	Narrow-leaved Ironbark <i>Eucalyptus crebra</i>	11m	410mm	N/A	N/A	Mature	Good to Fair	Good to Fair	3	Low	Low	No, tree is required to be removed for material/Transportation and delivery as its located within Wonga Road and replaced in the landscape upon completion.
89	Narrow-leaved Ironbark <i>Eucalyptus crebra</i>	11m	410mm	N/A	N/A	Mature	Good to Fair	Fair	4C	Low	Low	No, tree is required to be removed for material/Transportation and delivery as its located within Wonga Road and replaced in the landscape upon completion.
90	Narrow-leaved Ironbark <i>Eucalyptus crebra</i>	11m	410mm	N/A	N/A	Mature	Good to Fair	Good to Fair	4A	Low	Low	No, tree is required to be removed for material/Transportation and delivery as its located within Wonga Road and replaced in the landscape upon completion.

91	Narrow-leaved Ironbark <i>Eucalyptus crebra</i>	10m	390mm	N/A	N/A	Mature	Good to Fair	Good to Fair	4A	Low	Low	No, tree is required to be removed for material/Transportation and delivery as its located within Wonga Road and replaced in the landscape upon completion.
92	Narrow-leaved Ironbark <i>Eucalyptus crebra</i>	11m	400mm	N/A	N/A	Mature	Good to Fair	Good to Fair	3	Low	Low	No, tree is required to be removed for material/Transportation and delivery as its located within Wonga Road and replaced in the landscape upon completion.

Figure 8 Shows Trees 88 to 92 that are required to be removed.

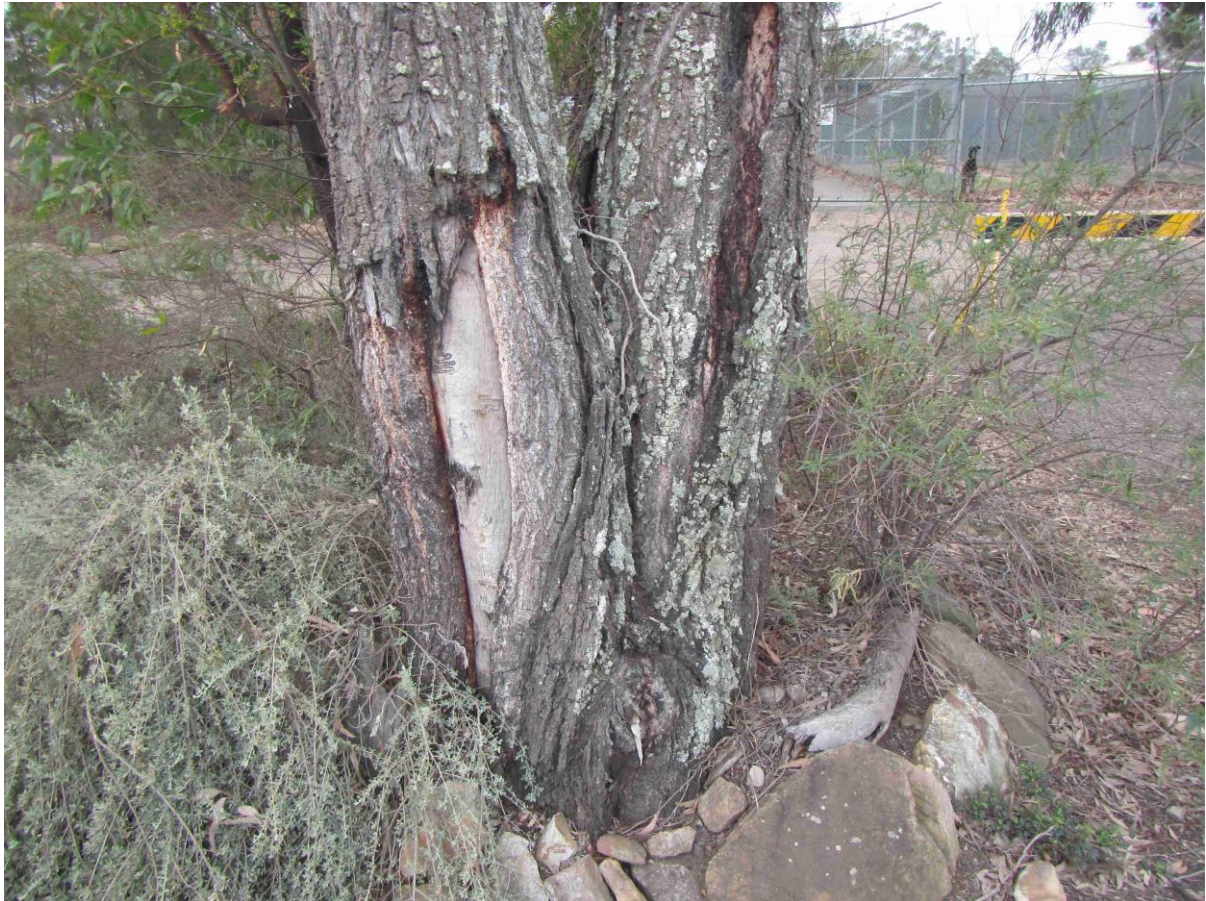
Figure 9 Shows typical open wound from mechanical damage to these trees.

WOUNDING: Generally, the wounds were located on the lower 2m of trees' trunk or on exposed roots. This suggests that the wounding may be a result of mechanical injury from landscape maintenance equipment. However, wounds were also noted higher up on the trunk and main branches. The likely cause of this wounding is branch failure, splitting or cracking during high wind events.

The primary effect of wounding is reduced translocation of water, minerals and sugars because of loss of bark, cambium and sapwood. Mechanical injury may also have implications for tree structure as the long-term effects of tree wounding is the potential development of decay. The long-term effects of tree wounding are the potential development of decay and loss of wood strength (Harris, Clark, Matheny, 1999).

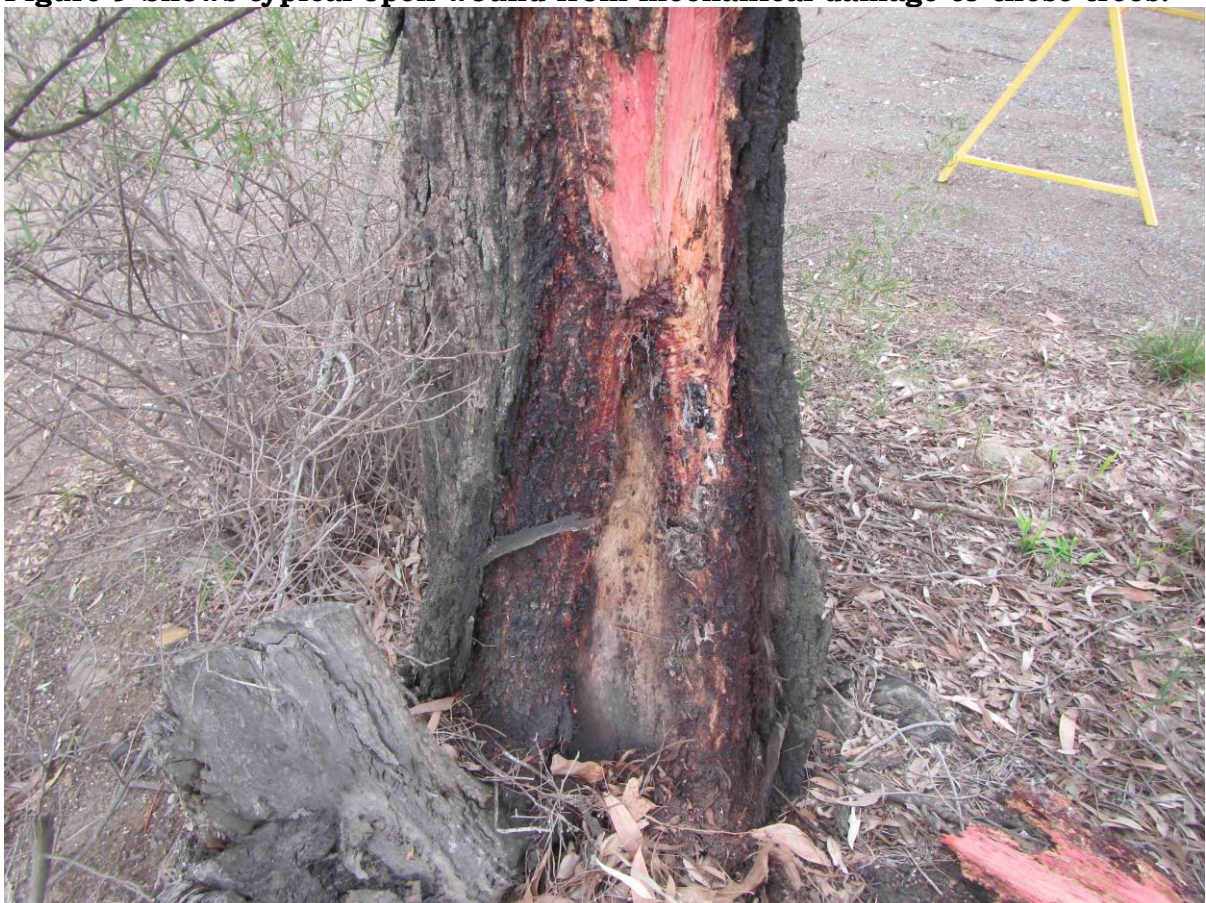
Figure 10 Shows again more mechanical damage to the lower trunk.

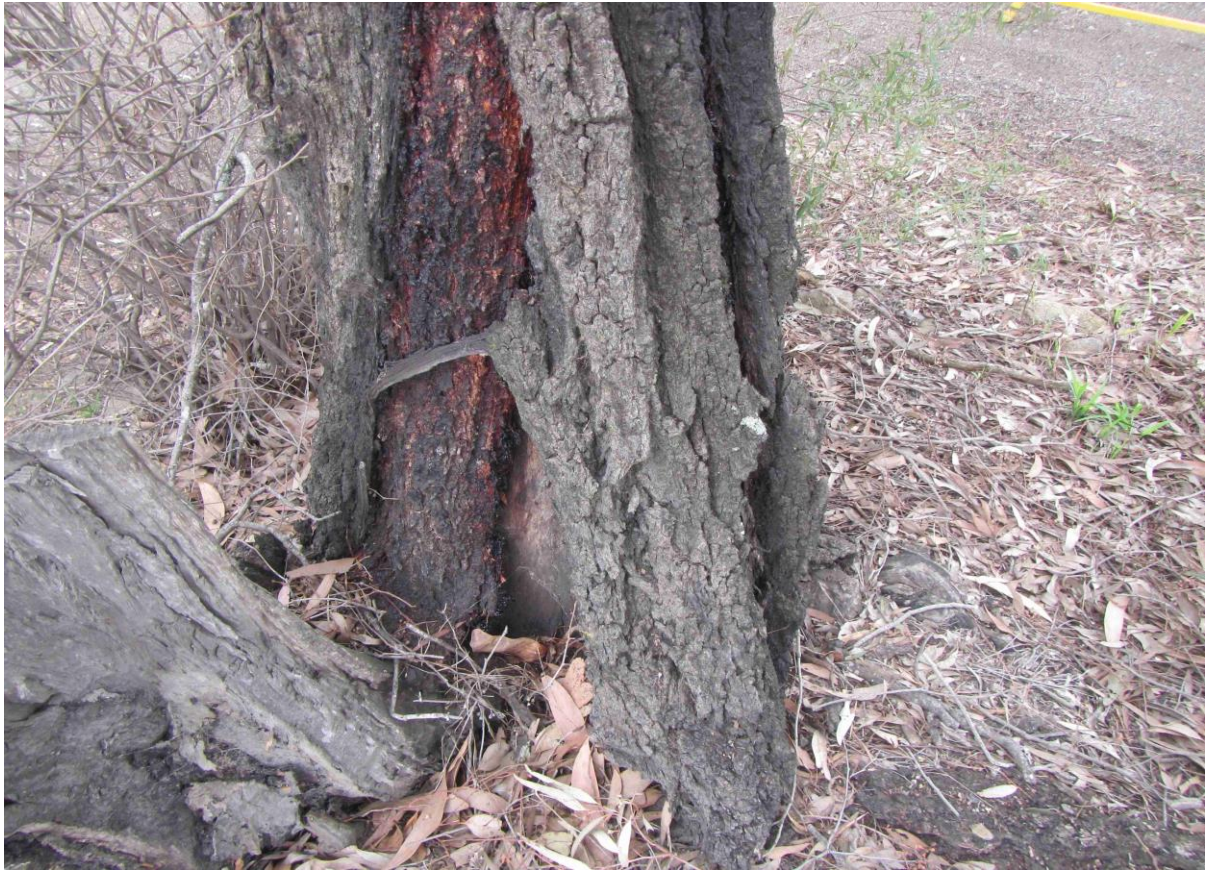
Figure 11 Shows mechanical and wound on the lower trunk.

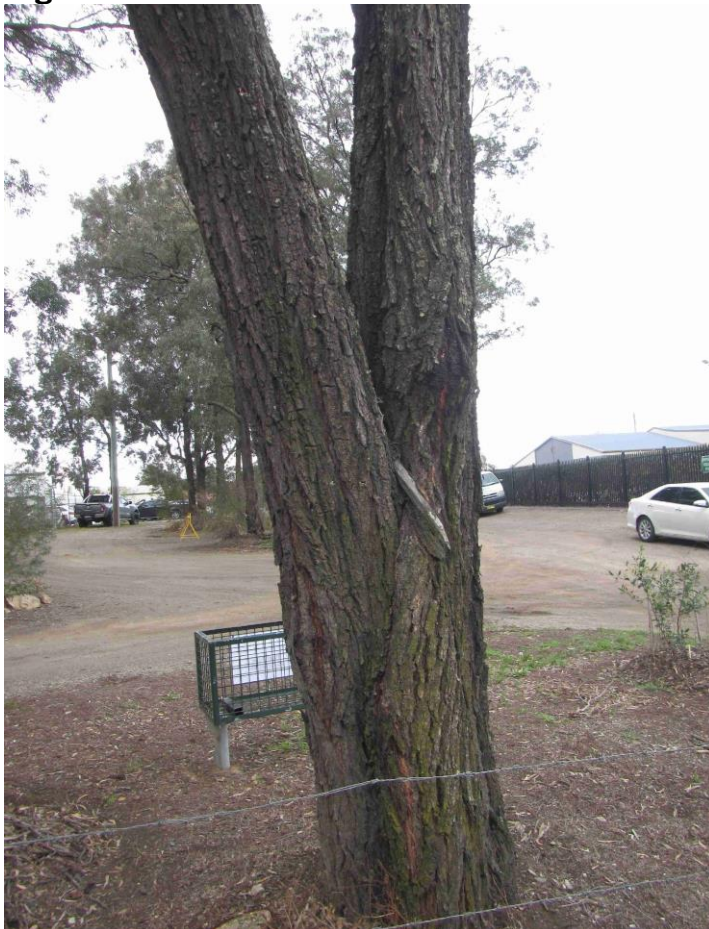
Figure 12 Shows the poor branch inclusion and structural weakness.

INCLUDED BRANCH JUNCTIONS: Included bark was noted on trees throughout the site. Included bark often forms when two branches or trunks grow together at sharply acute angles, producing a wedge of inward-rolling bark.

Junctions with included bark form weak attachments, as there is little connective tissue between the two stems. Although all co-dominant stems should be considered comparatively weak, co-dominant stems that have bark trapped in the union are significantly weaker than those that do not have bark included (Smiley, 2003). Tree failure can occur when the strength of wood is exceeded by a mechanical stress and/or is compromised by the presence of defects

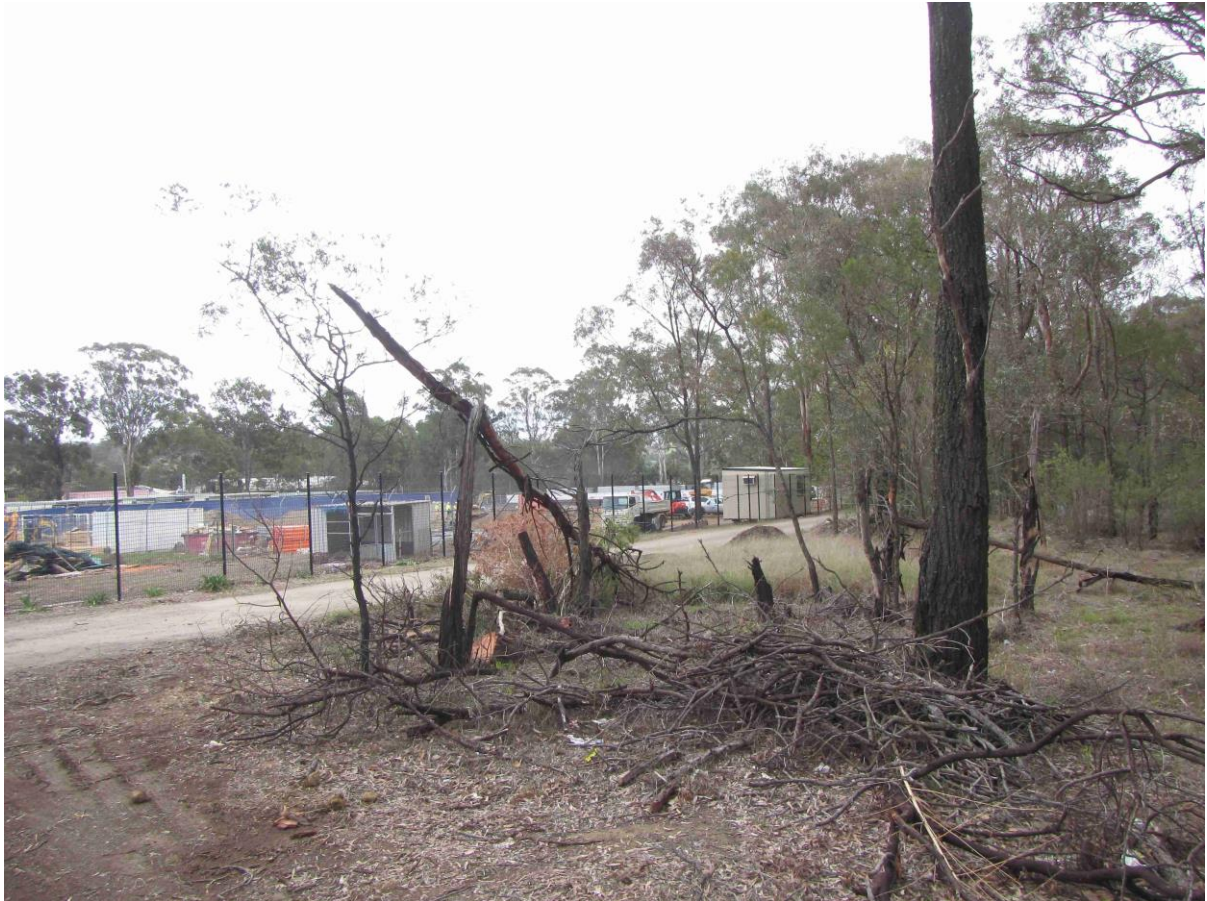
Figure 13 Shows dead acacias and minor grass to be removed.
