## Hazardous Building Materials Report

Picton High School  
480 Argyle Street  
Picton NSW 2571

Prepared for  
Billard Leece Partnership Pty Ltd

Project 35252.02  
June 2017

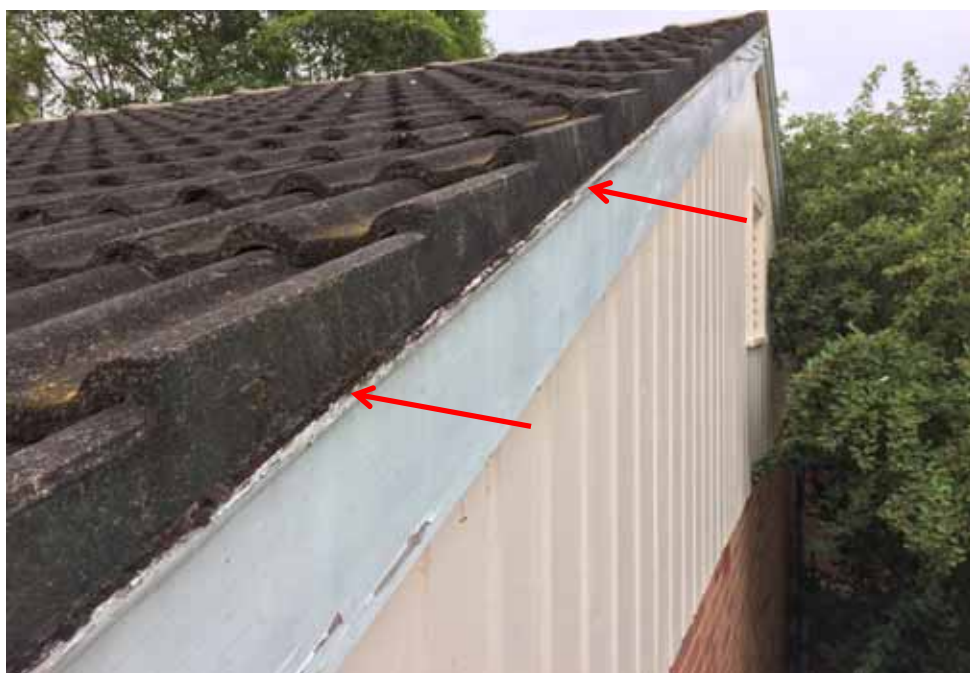
Photograph 1: Typical gable/roof verge linings (B00A-B00H).

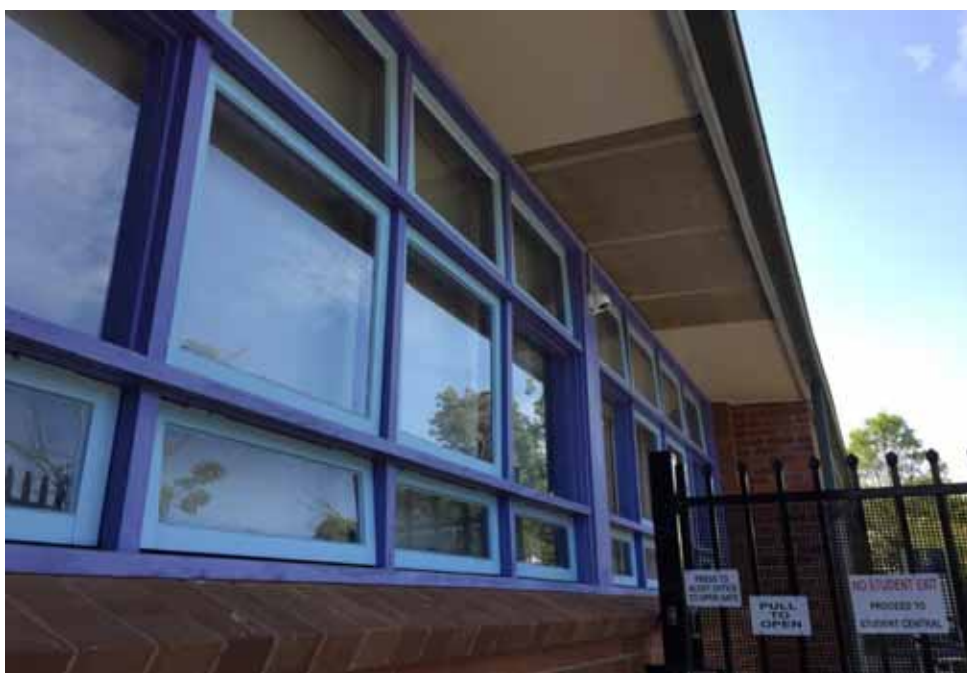
B00A, Exterior	Façade	Eave linings	Fibre cement sheeting	Refer previous sample S1	Asbestos detected	1	1	2	2	2	0	8	Low	40	sqm	2	Reinspect condition on a regular basis. Remove material prior to any significant disturbance (e.g. renovation, demolition or maintenance work).
B00A, Exterior & Interior	Façade/Rooms in general	Locations in general	Paints	Refer B00E-EXT-GABLE-LP	May contain lead	N/A	N/A	N/A	N/A	N/A	N/A	N/A	Low	Throughout	N/A	Similar 22	Lead concentrations >1% generally not detected in paint samples collected from buildings constructed circa 1958 (i.e. B00A-B00H) with exception of sample B00E-EXT-GABLE-LP (1.4% lead). Caution is however advised prior to significant disturbance of any paints that have not be sampled directly. Avoid disturbance of lead paints and implement controls to prevent exposure and dispersal during demolition. Waste contaminated with lead (including lead paint waste) from residential premises or educational or child care institutions is pre-classified as general solid waste (non-putrescible) under the NSW EPA Waste Classification Guidelines.

Photograph 2: B00A, eave linings

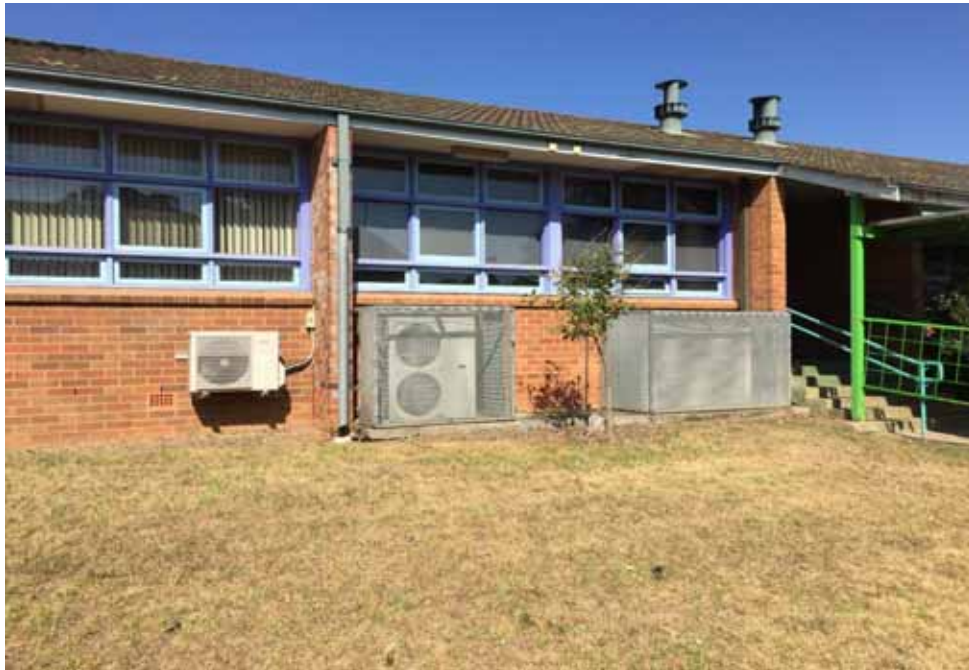
Photograph 3: B00A, AC units.

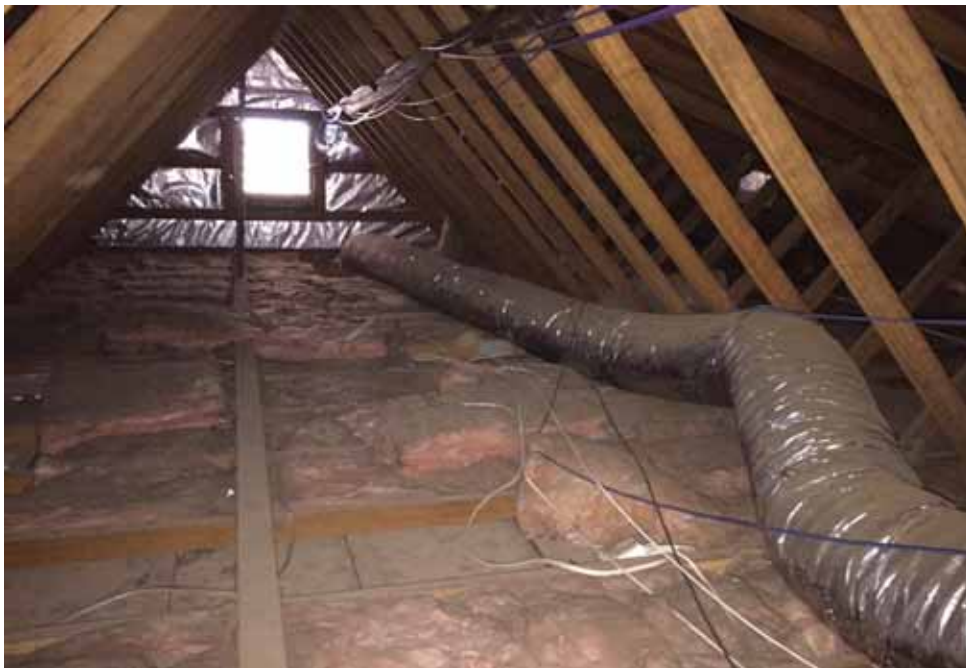
Photograph 4: B00A, Top of ceiling, insulation batts and air conditioning plant/duct work.

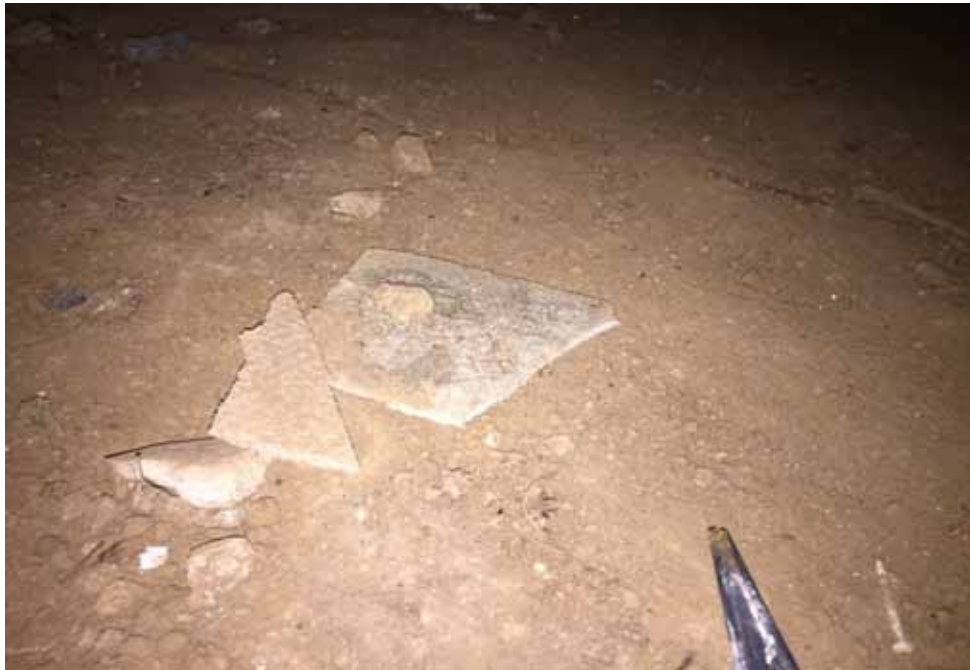
Photograph 5: B00A, subfloor, fibre cement debris.

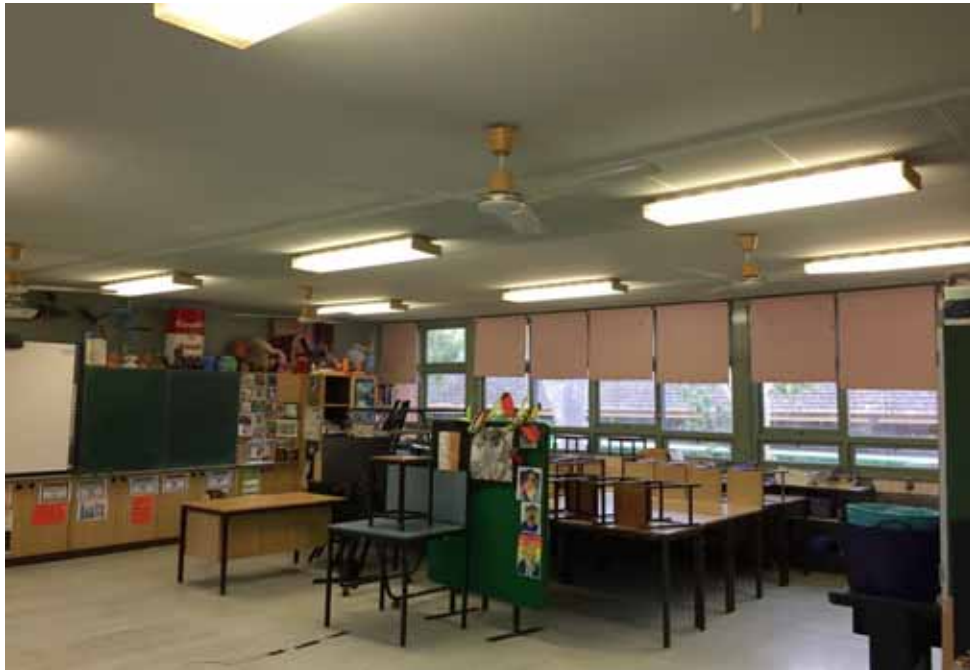
Photograph 7: Typical fluorescent light fittings and ceiling fans (B00A-B00H).

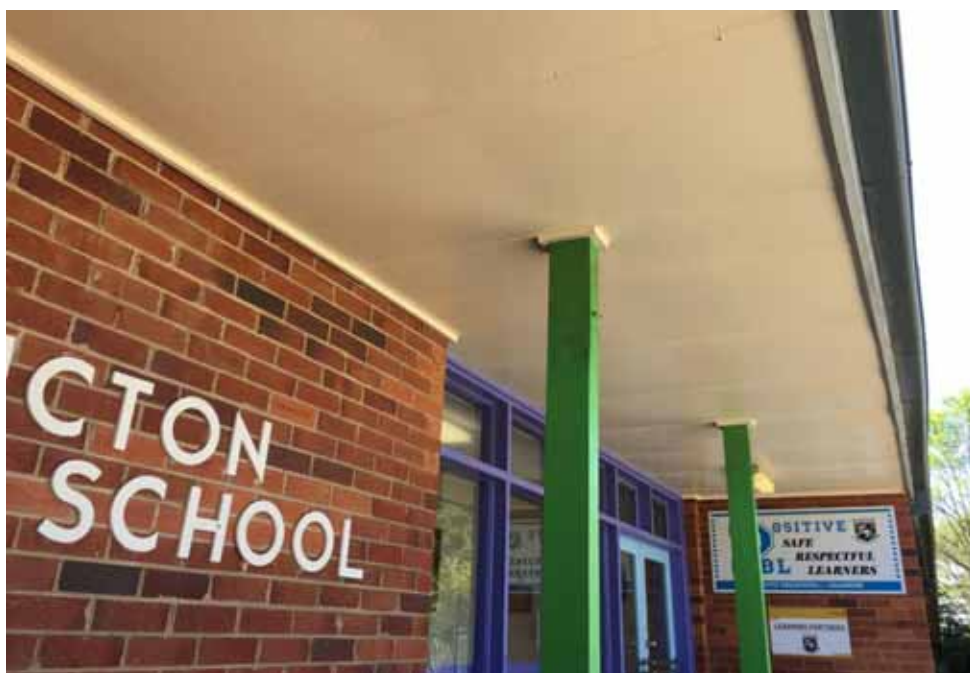
Photograph 9: B00A, R0016, ceiling.

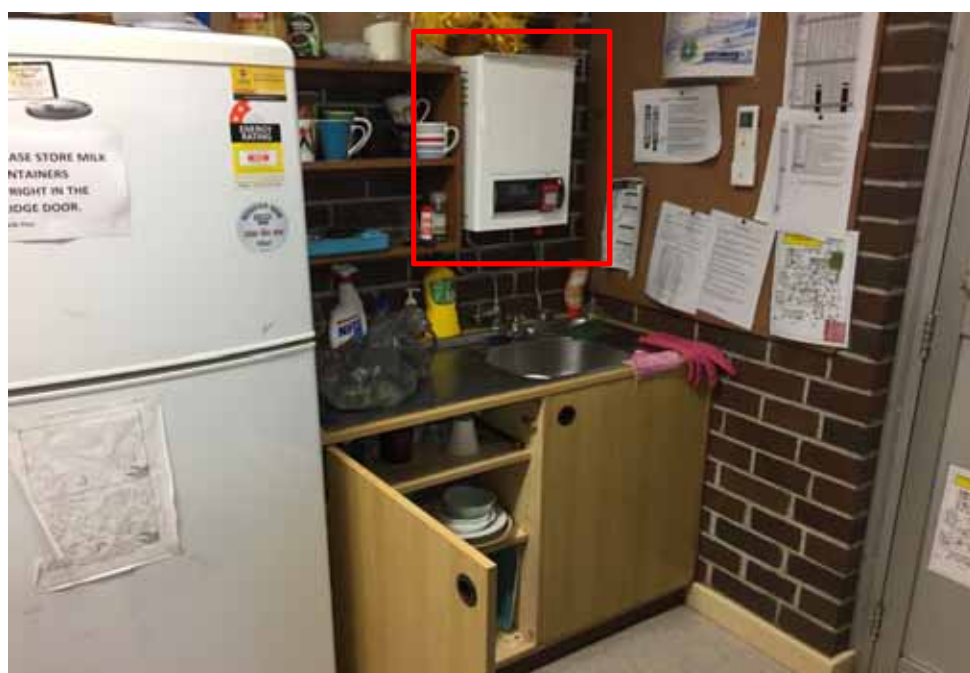
Photograph 10: Typical Zip boiling water unit

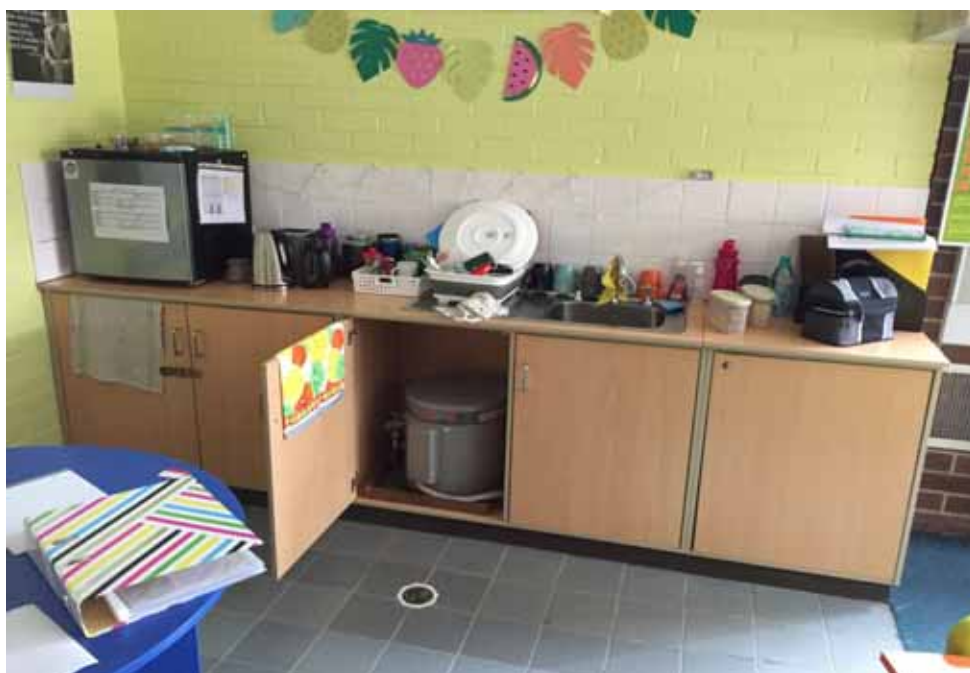
Photograph 11: Typical hot water unit

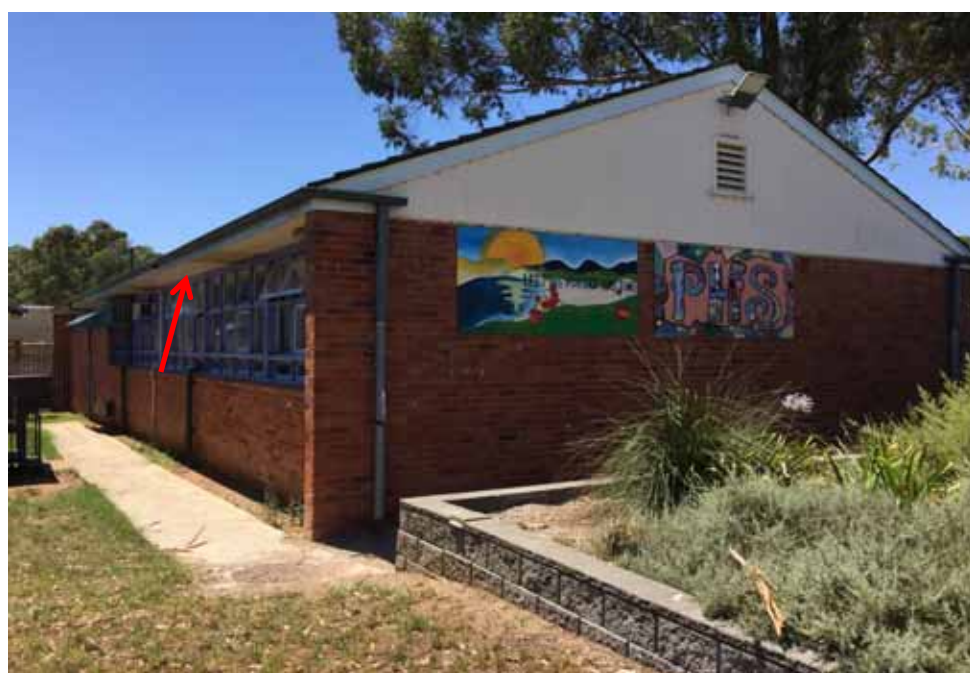
Photograph 12: B00B, exterior, eave lining.

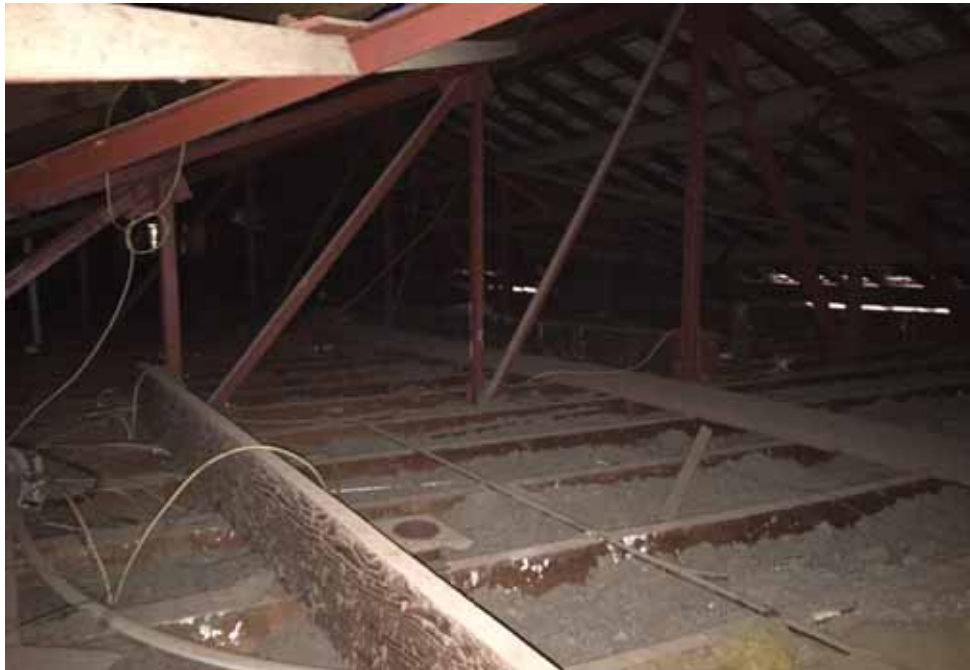
Photograph 13: B00B, ceiling void, loose fill insulation and settled dust.

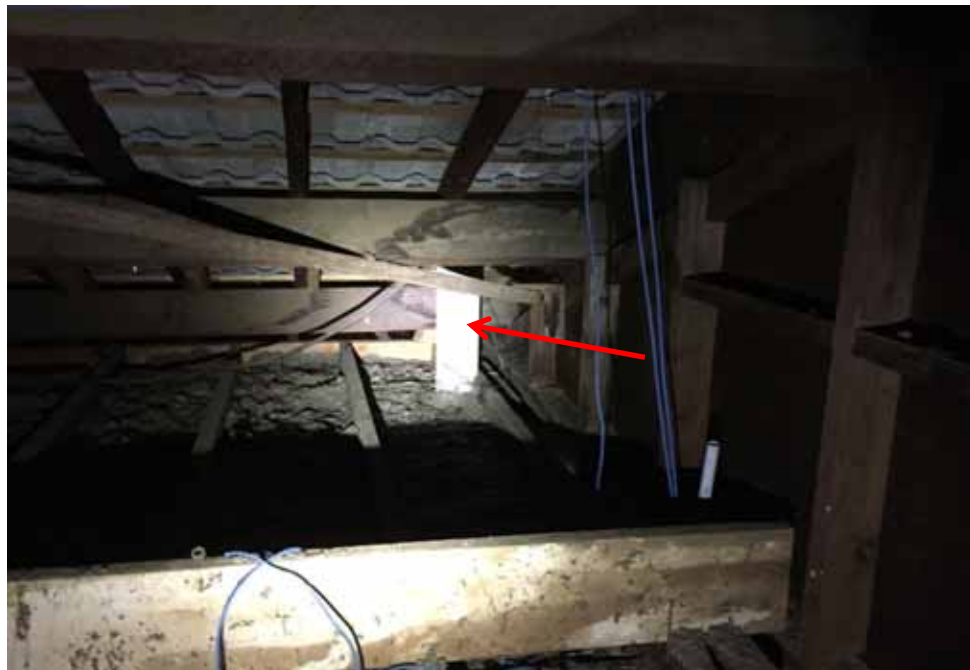
Photograph 14: Typical ceiling void (B00A-B00G), pipe work.

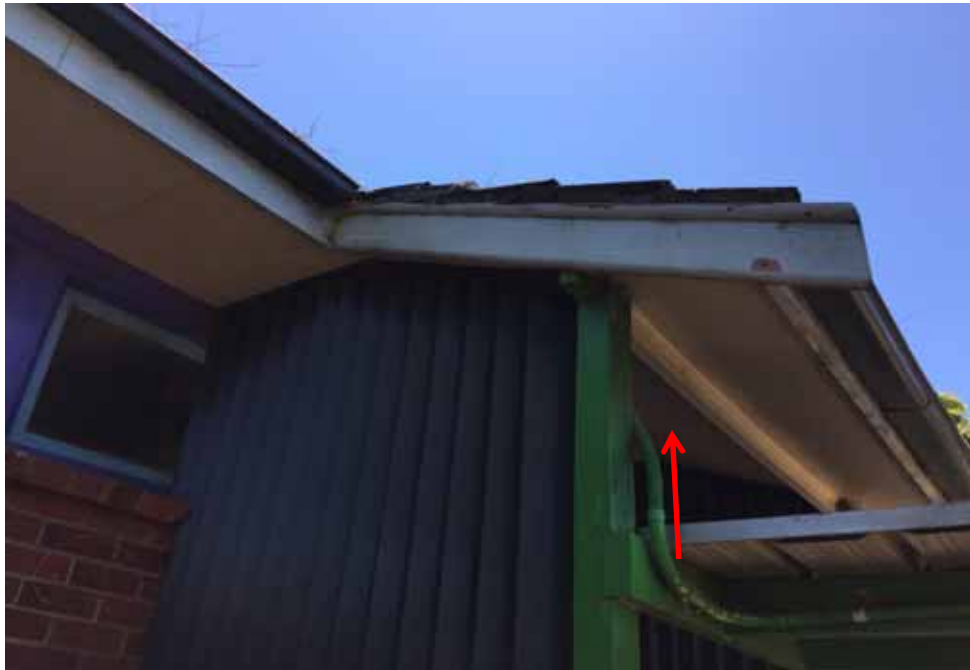
Photograph 15: B00B, R0009, ceiling lining.

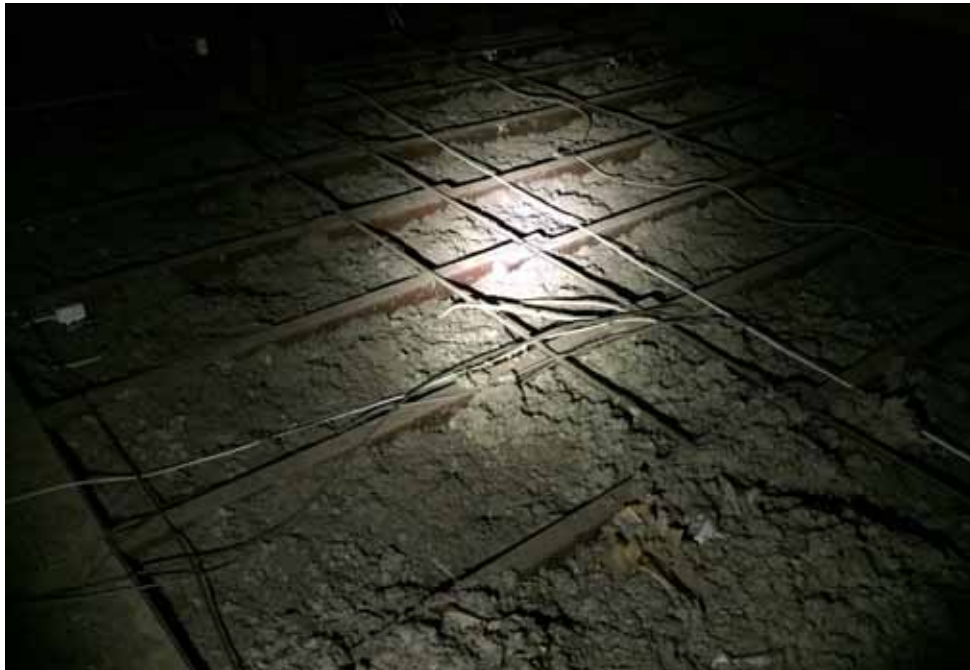
Photograph 17: B00C, ceiling void, loose fill insulation and settled dust.

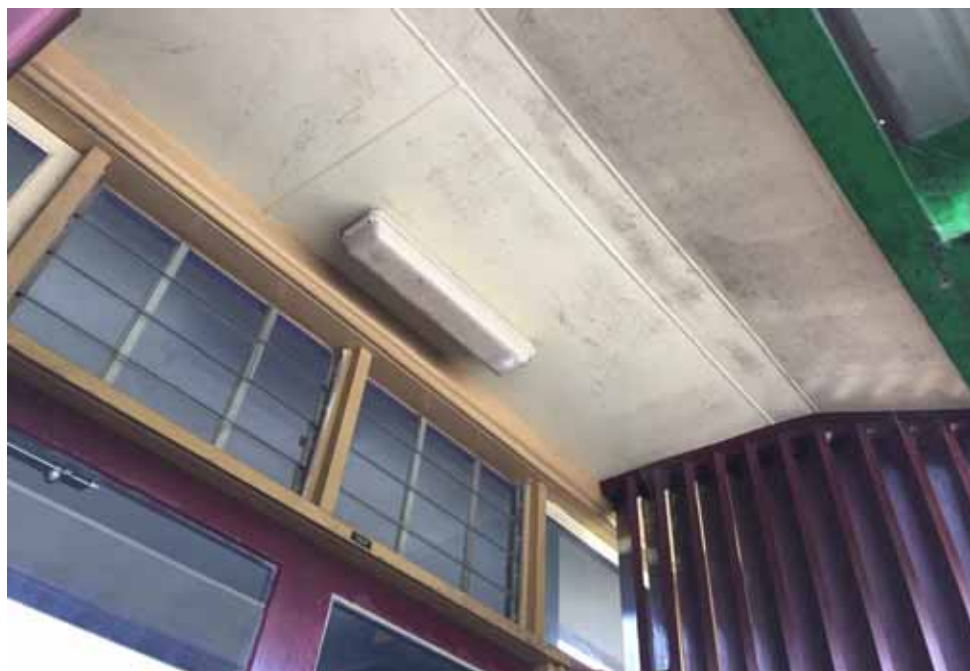
Photograph 18: B00C, R0005/R0012, ceiling lining.

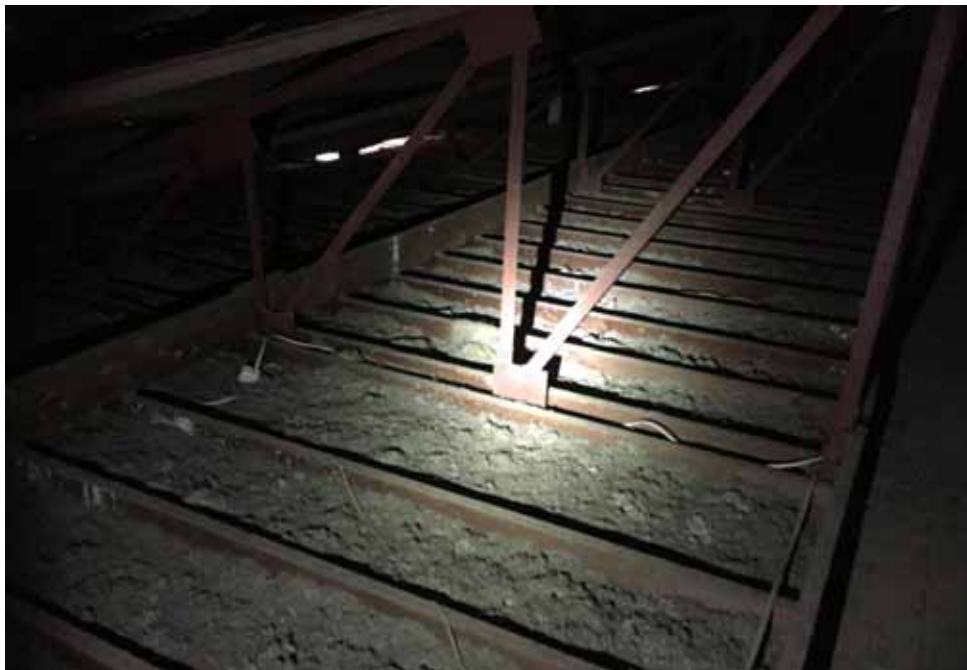
Photograph 20: B00D, ceiling cvaity, loose fill insulation, settled dust and pipe work.

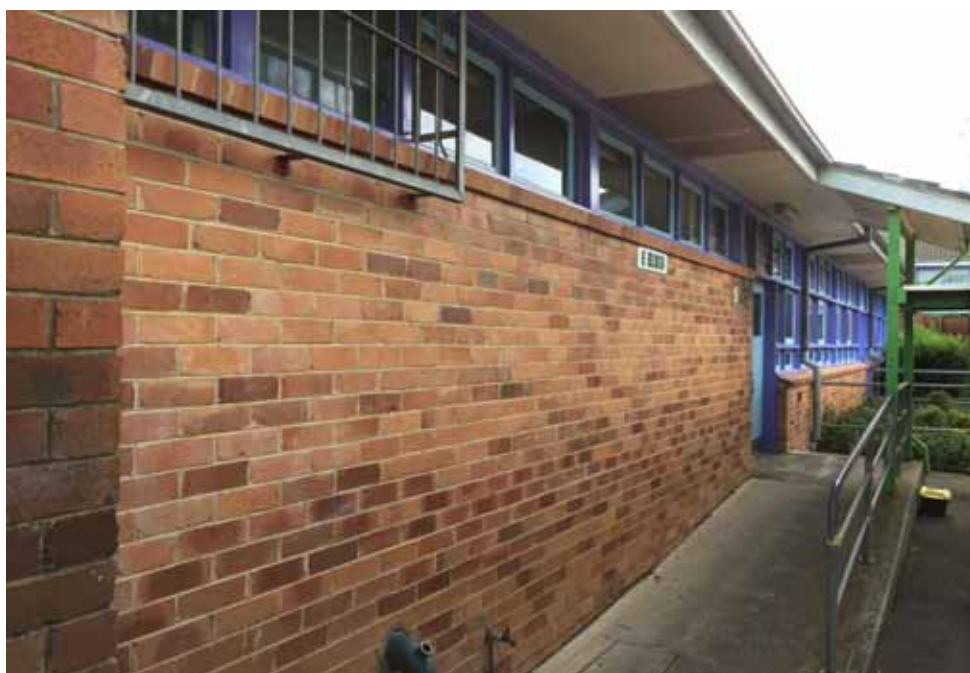
Photograph 21: B00E, eave linings.

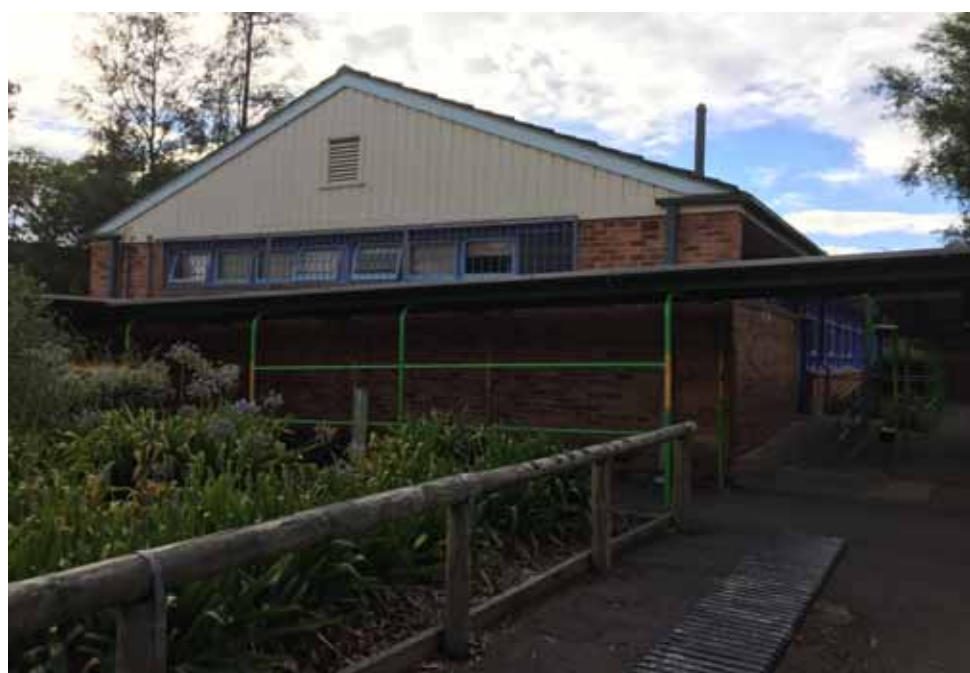
Photograph 22: B00E, gable, cream paint.

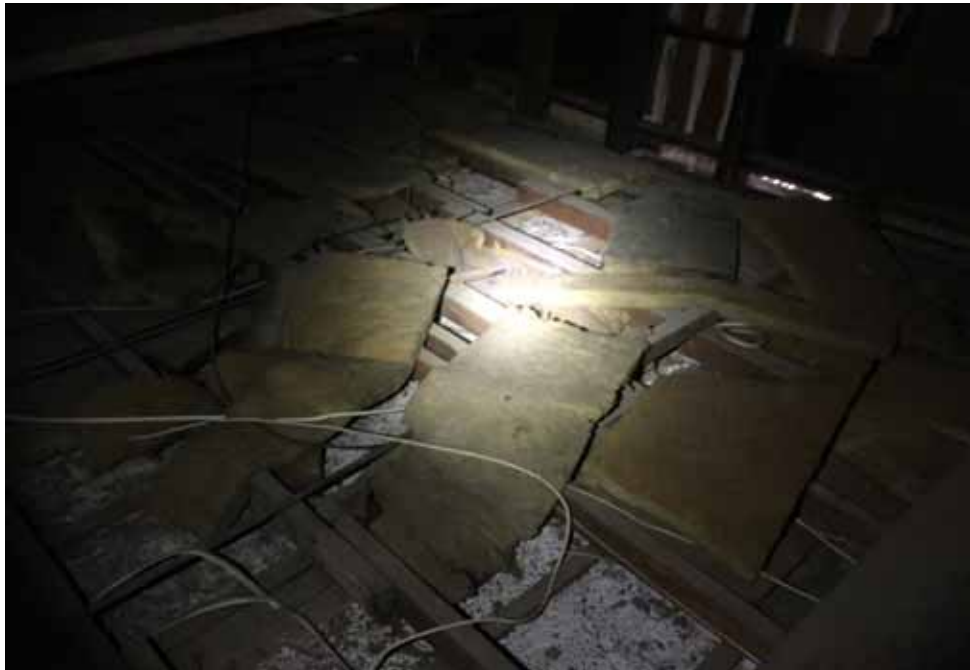
Photograph 23: B00E, ceiling cavity, insulation batts and settled dust.

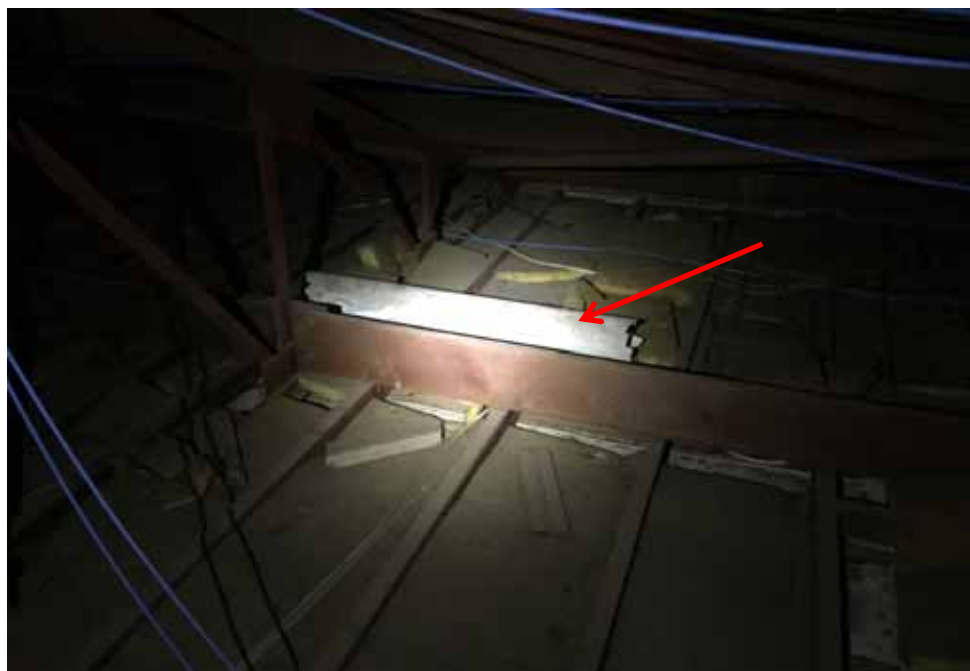
Photograph 24: B00E, ceiling cavity, dislodged pipe.

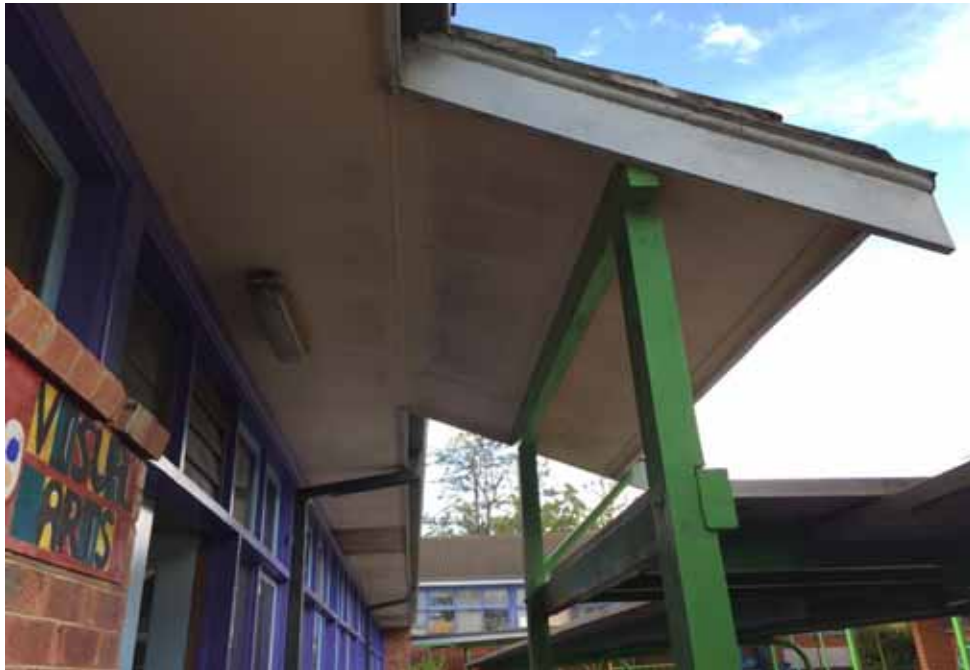
Photograph 25: B00E, R0010, ceiling lining.

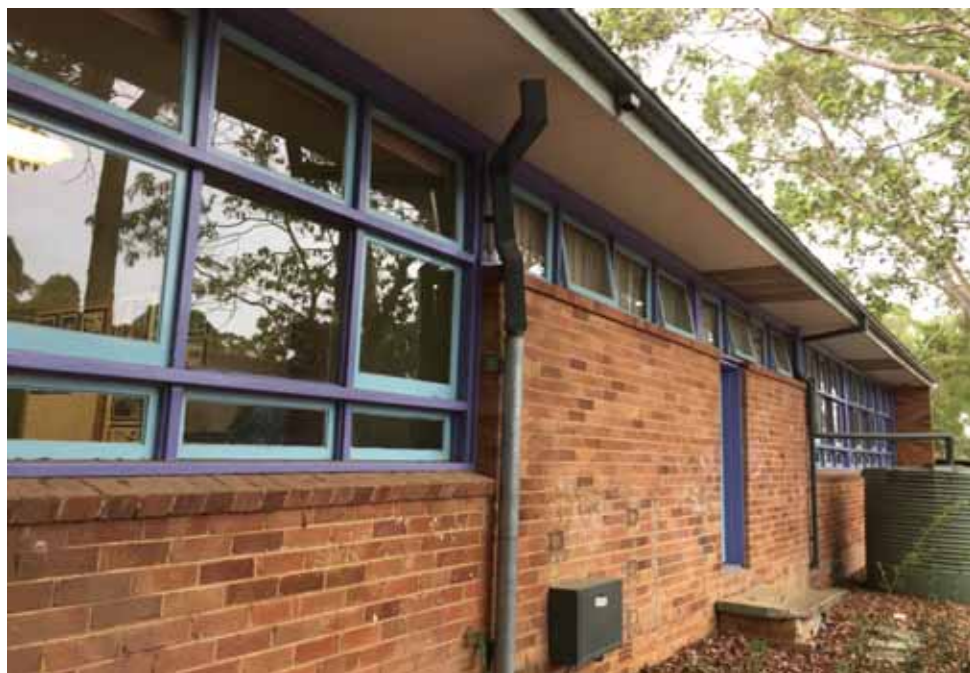
Photograph 26: B00F, eave linings.

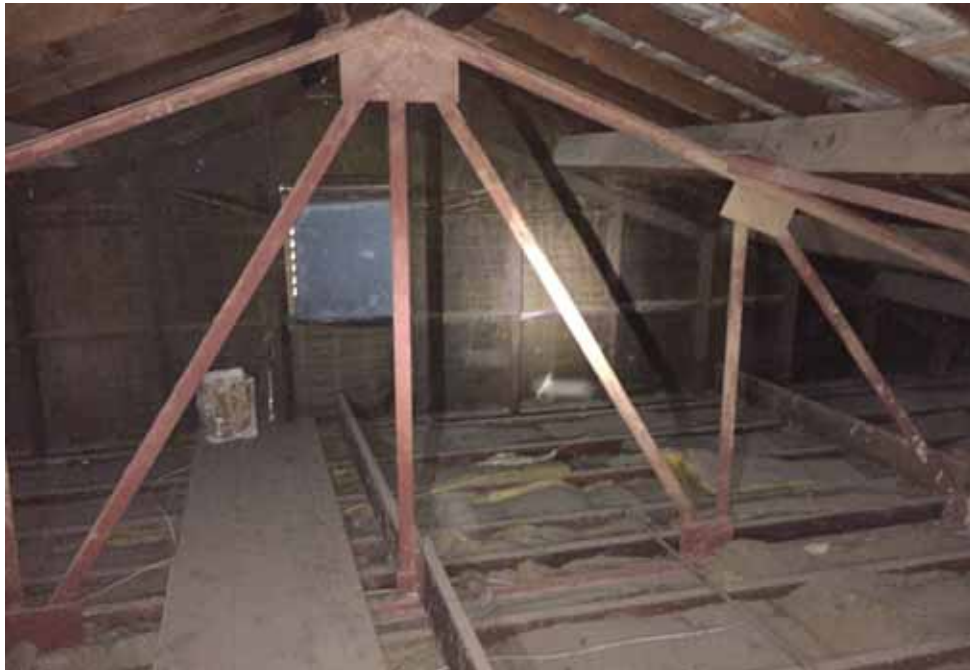
Photograph 27: B00F, ceiling cavity, insulation batts and settled dust.

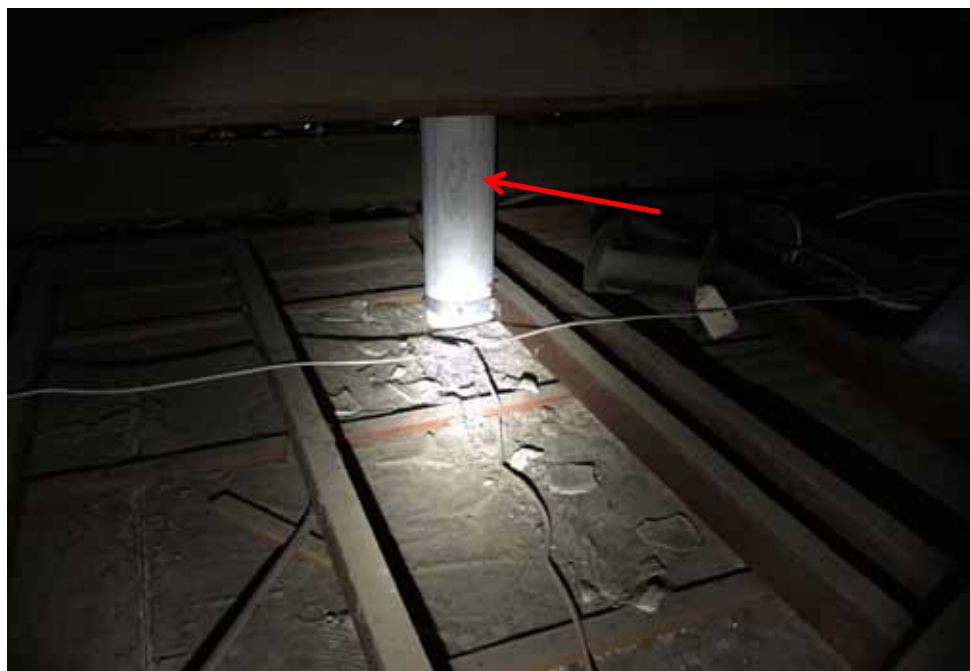
Photograph 28: B00G, ceiling cavity, settled dust and pipe work.

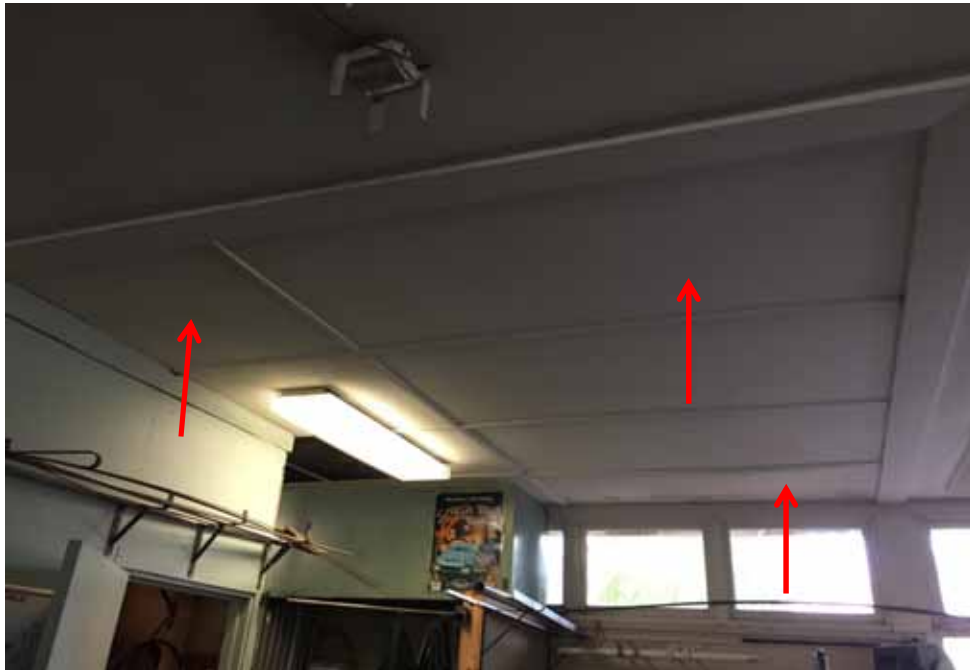
Photograph 29: B00G, R1021/R1022, ceiling lining.

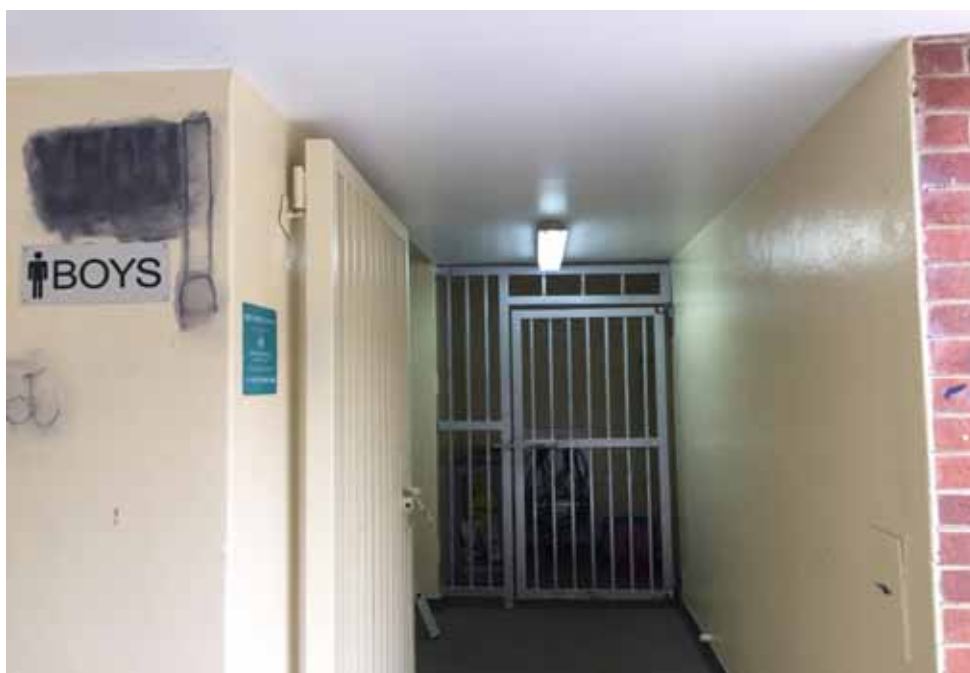
Photograph 31: B00H, R0023, ceiling lining.

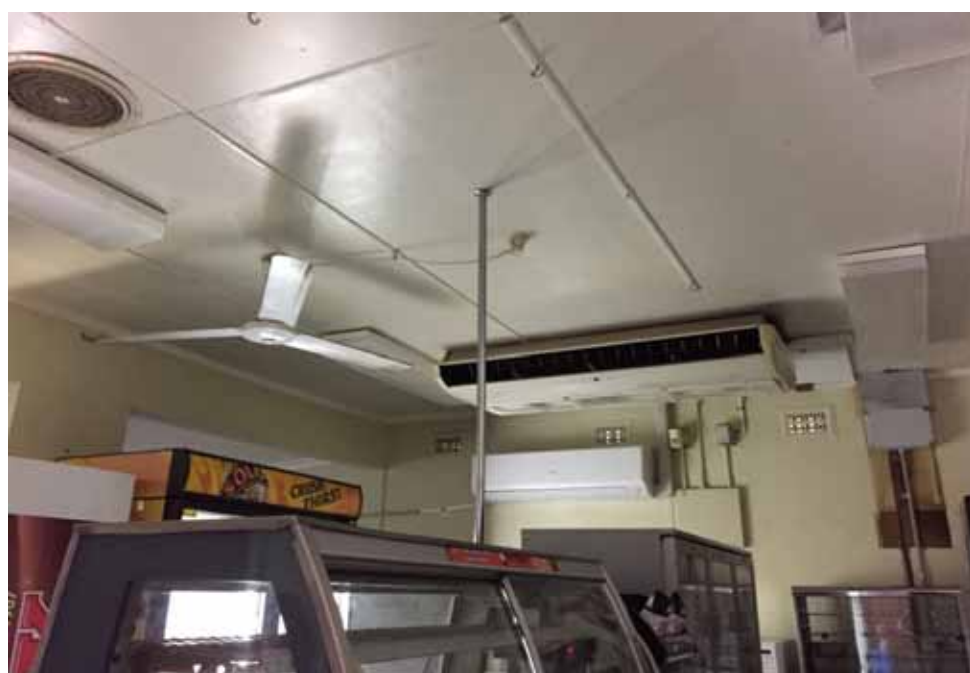
Photograph 32: B00H, R0016, ceiling lining.

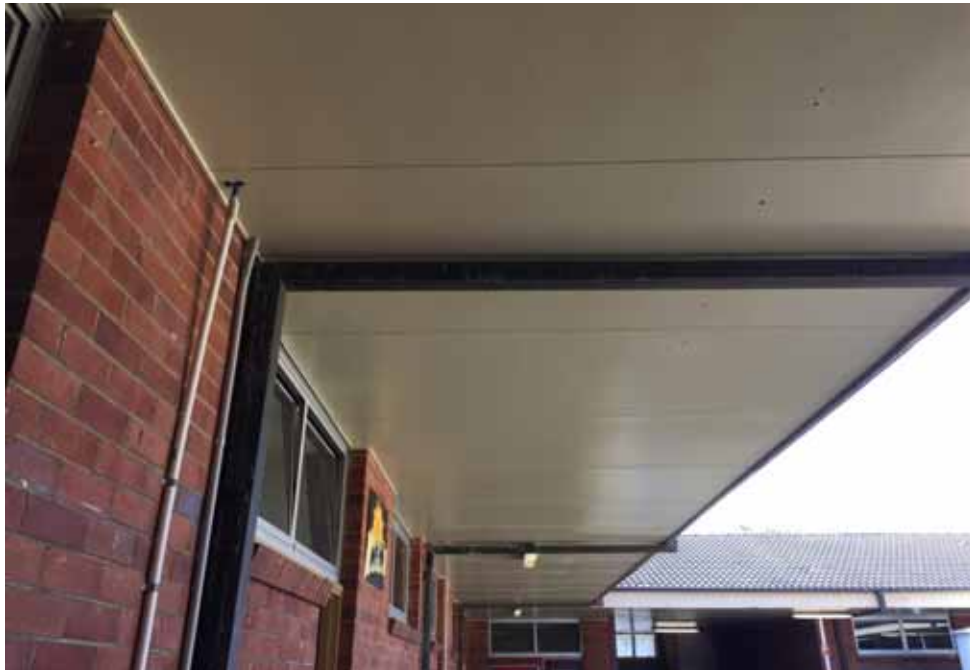
Photograph 33: B00I, eave linings.

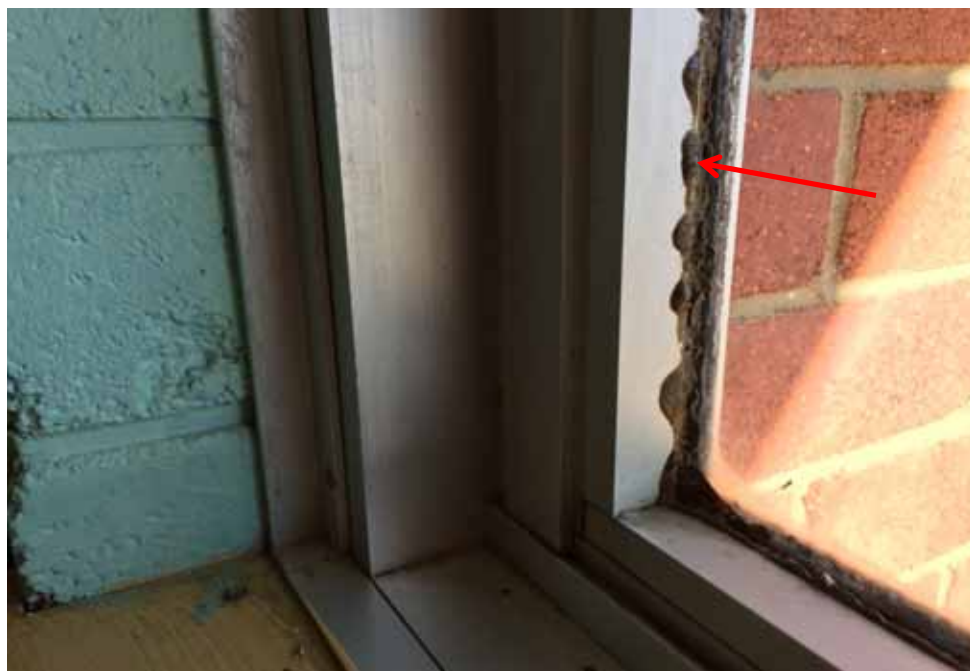
Photograph 34: B00I, typical window putty.

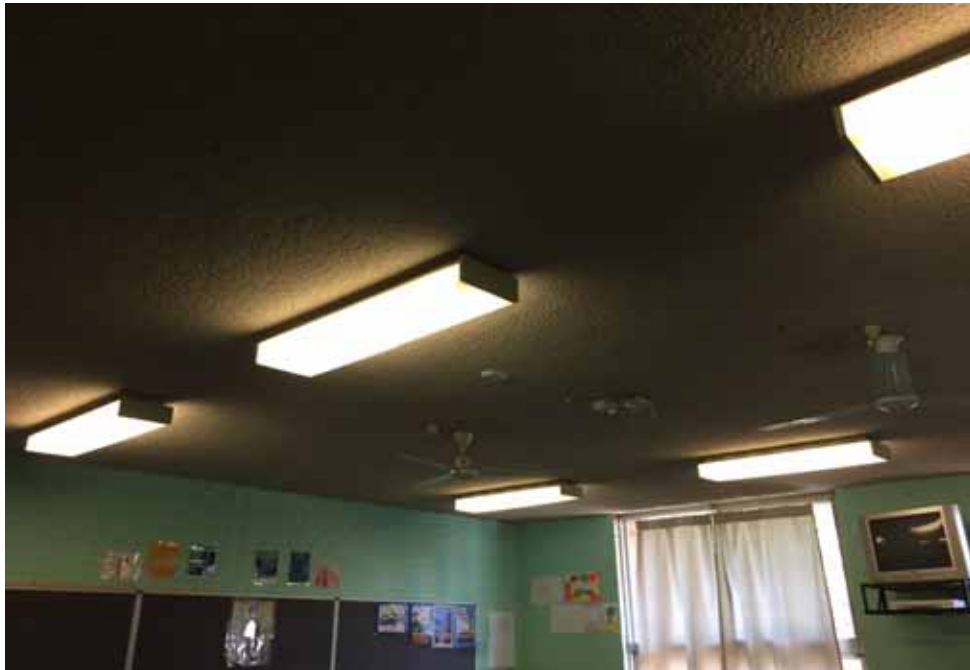
Photograph 35: B00I, Around rooms R1013-R1019, fluorescent lights and ceiling fans.

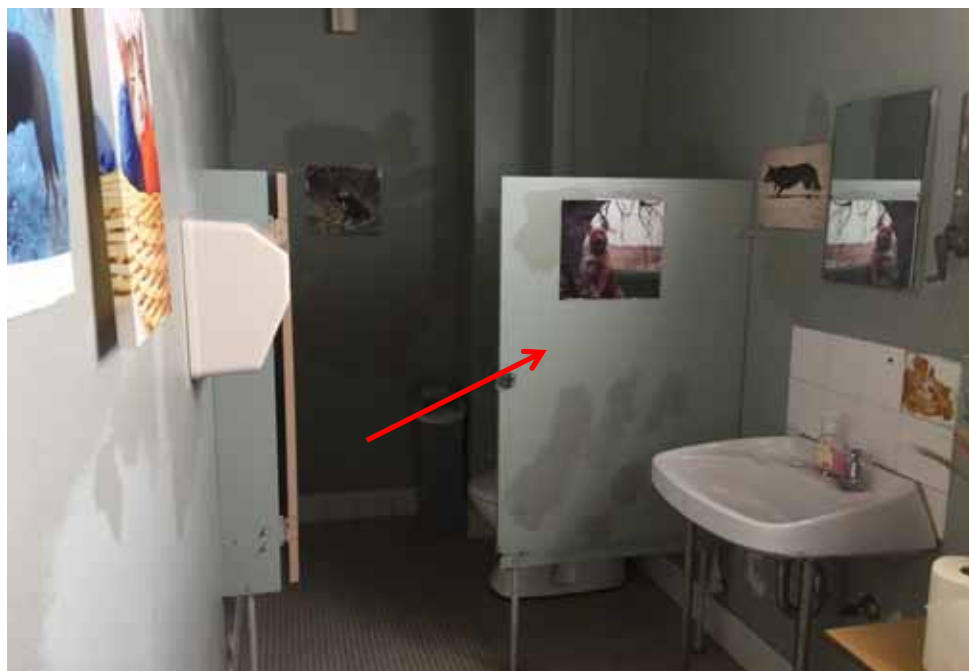
Photograph 38: B00I, R0010, partition wall.

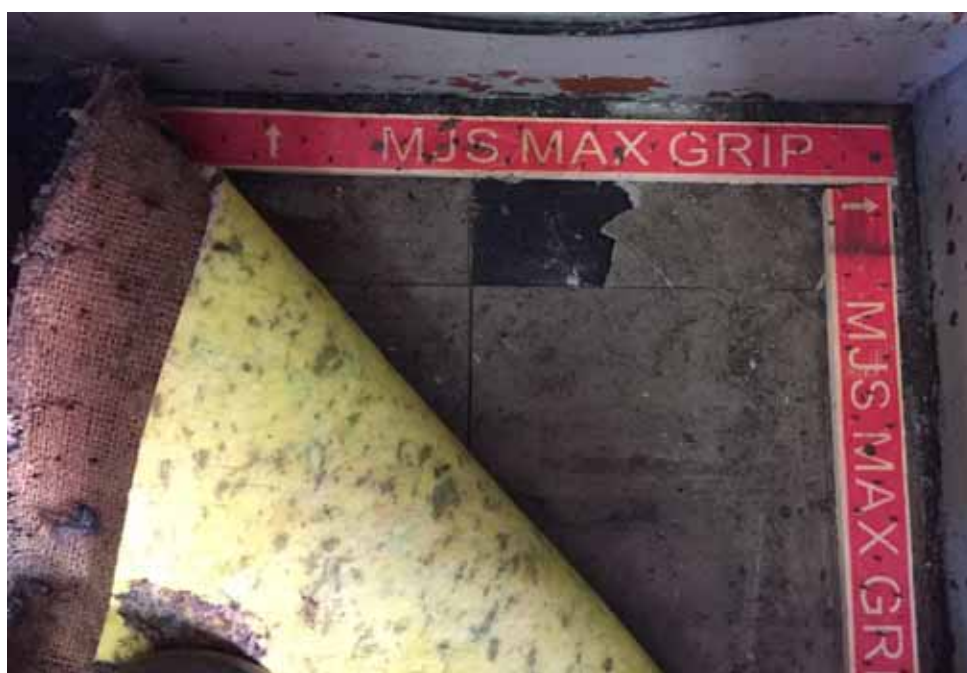
Photograph 40: B00I, typical grey vinyl tiles below carpet.

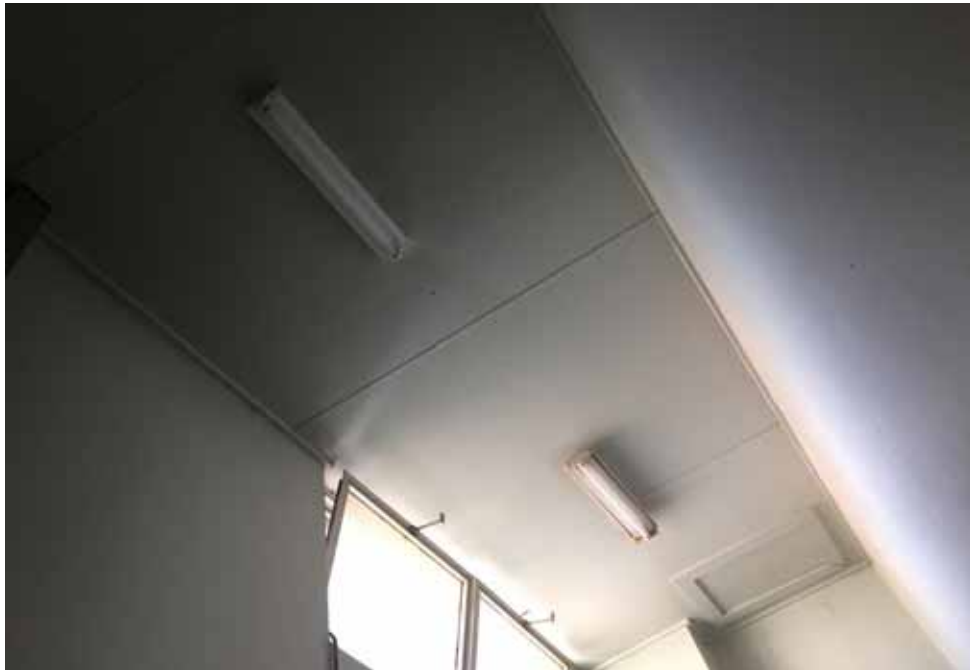
Photograph 41: B00I, R1012, ceiling lining.

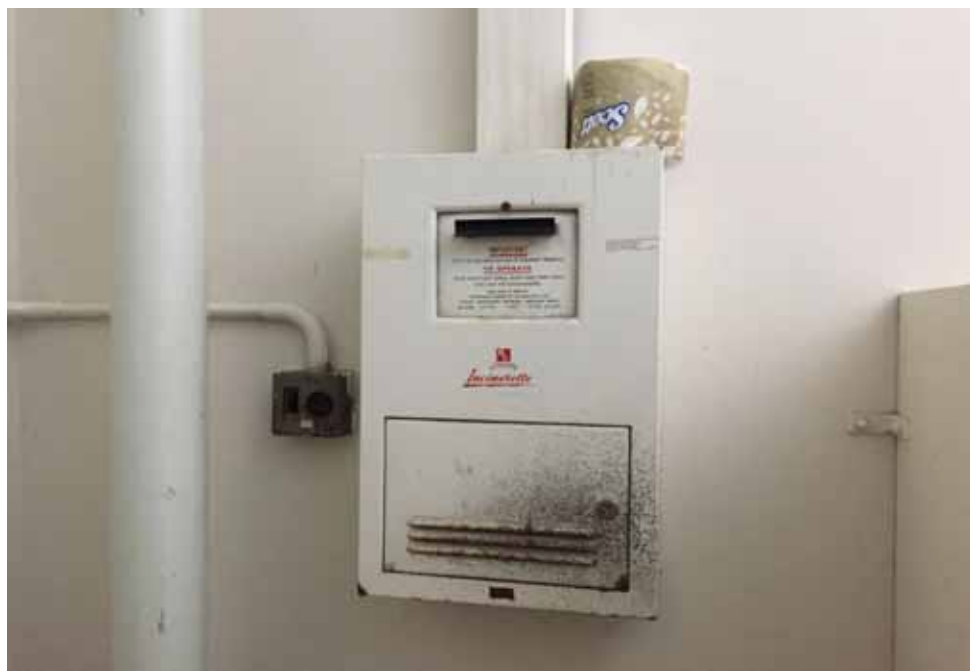
Photograph 42: B00I, R1012, incinerette.
