## Hazardous Building Materials Report

Picton High School  
480 Argyle Street  
Picton NSW 2571

Prepared for  
Billard Leece Partnership Pty Ltd

Project 35252.02  
June 2017

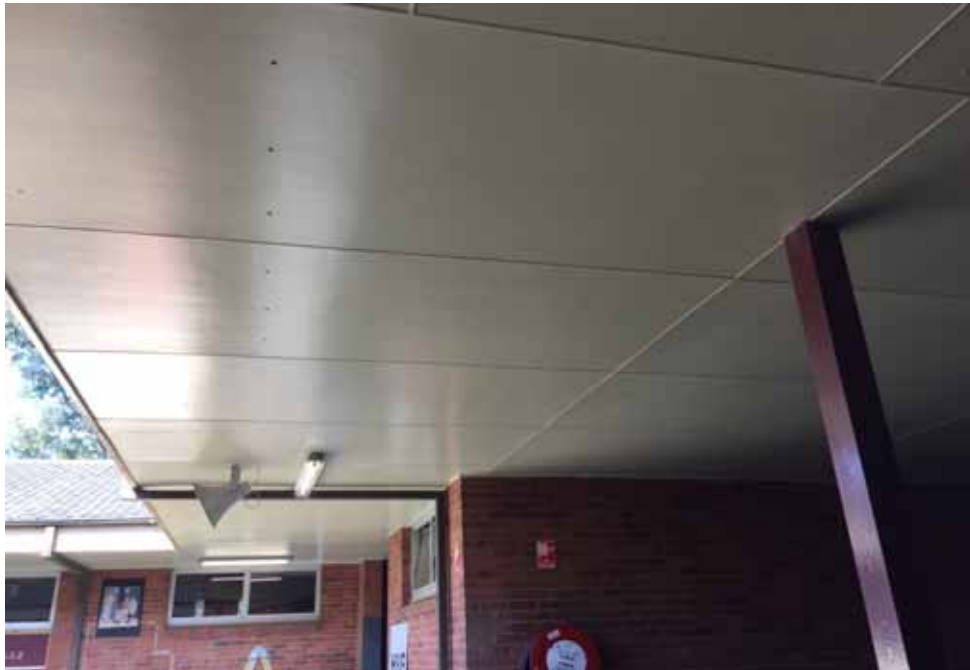
Photograph 43: B00I, R1022, ceiling lining.

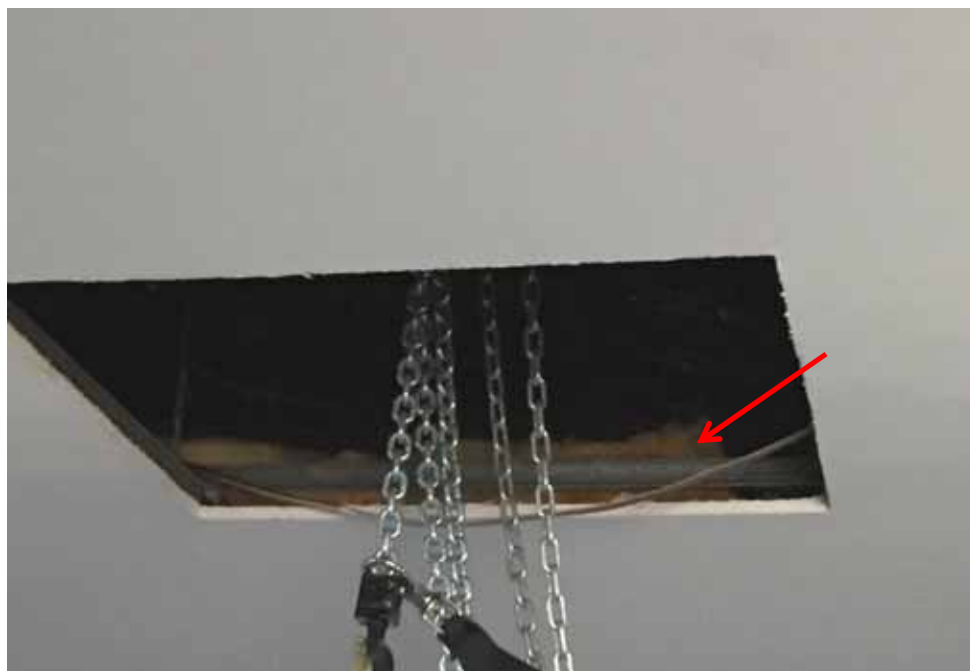
Photograph 44: B00K, ceiling cavity, insulation.

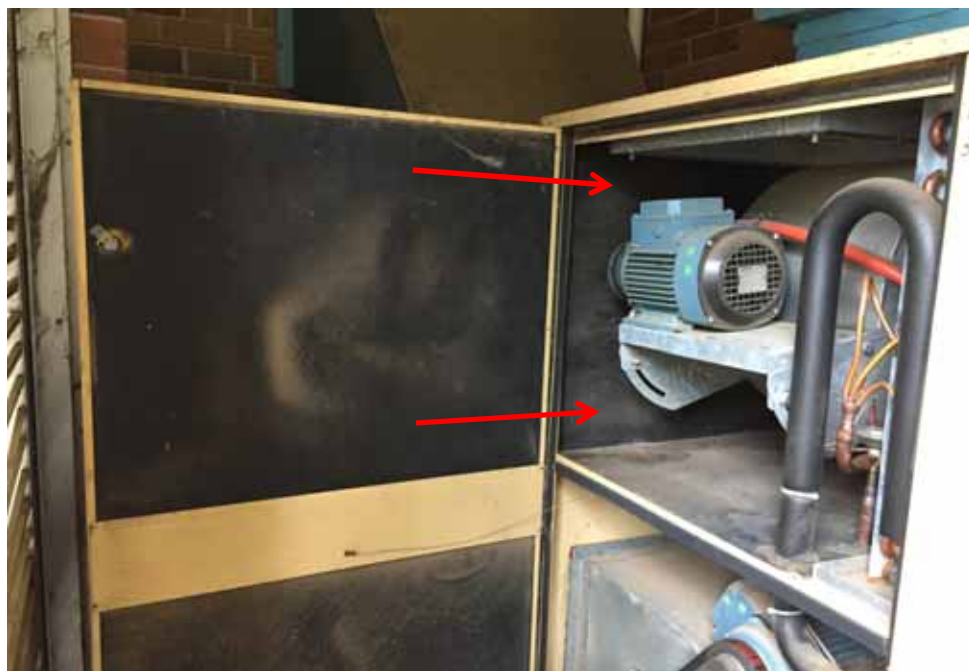
Photograph 46: B00K, R0004, Plant, heat pump and duct work.

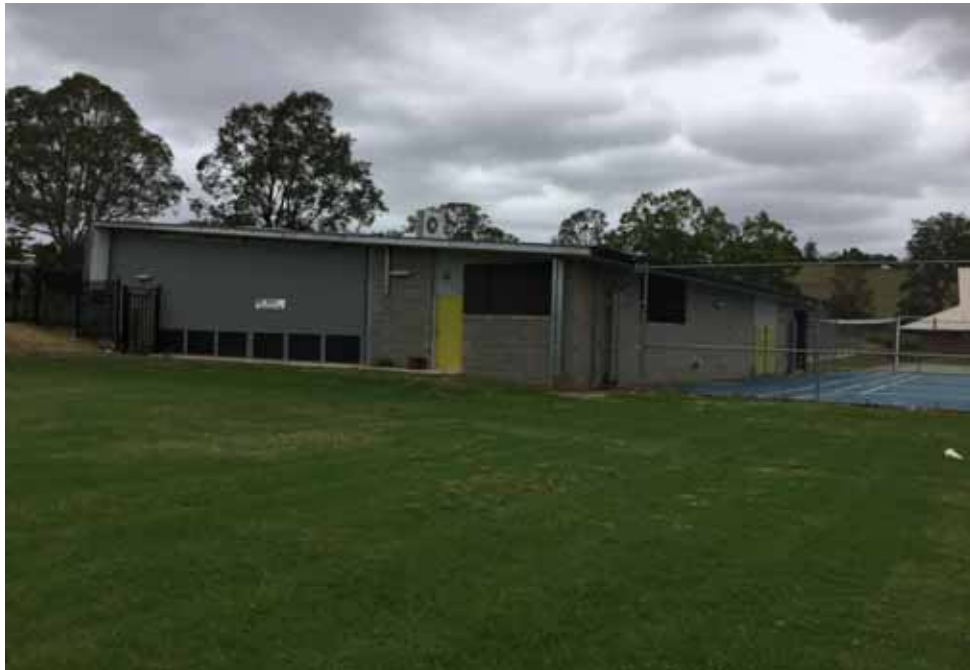
Photograph 51: B00O, exterior.

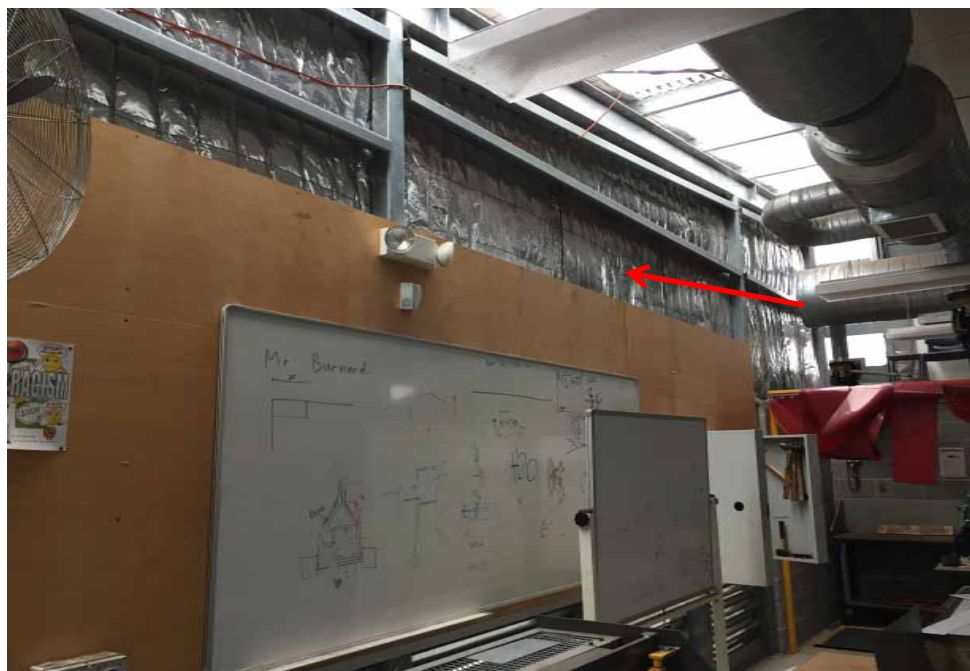
Photograph 52: B00O, interior, base of roof and walls, insulation behind sarking.

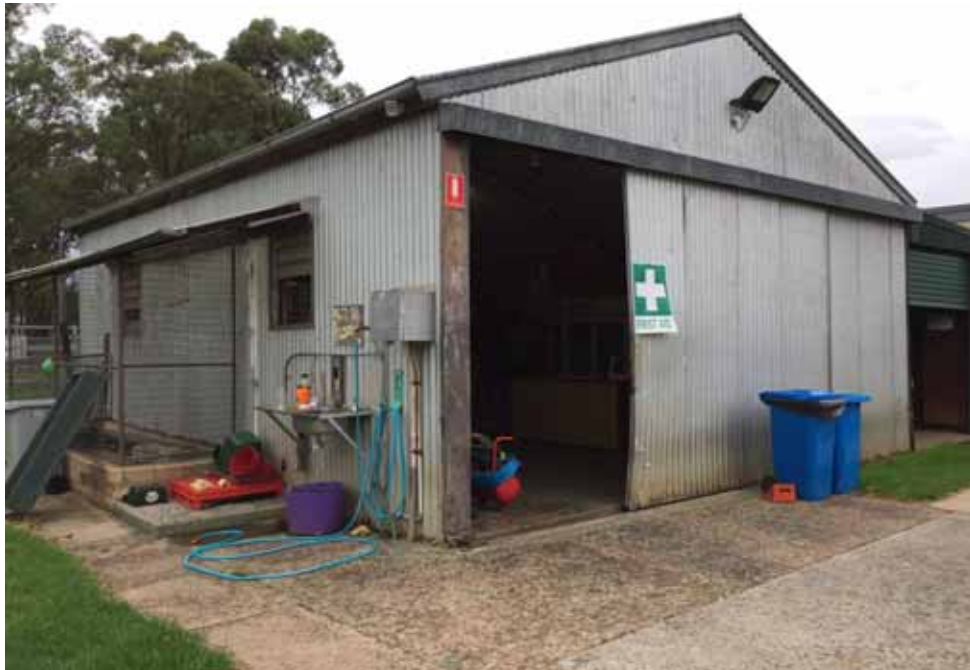
Photograph 53: B00P, exterior.

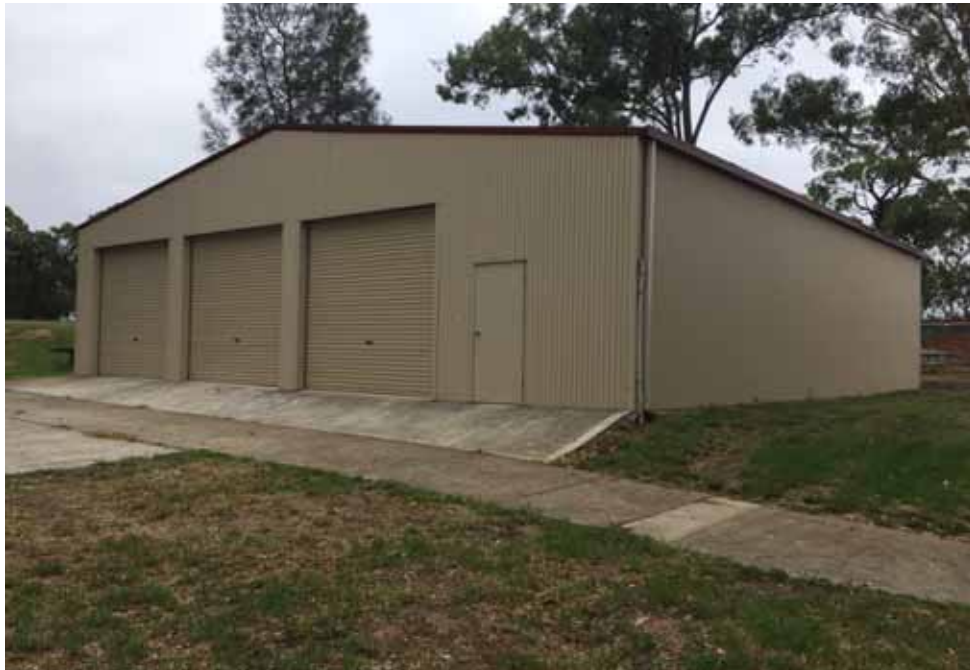
Photograph 55: Bus Shelter, exterior.

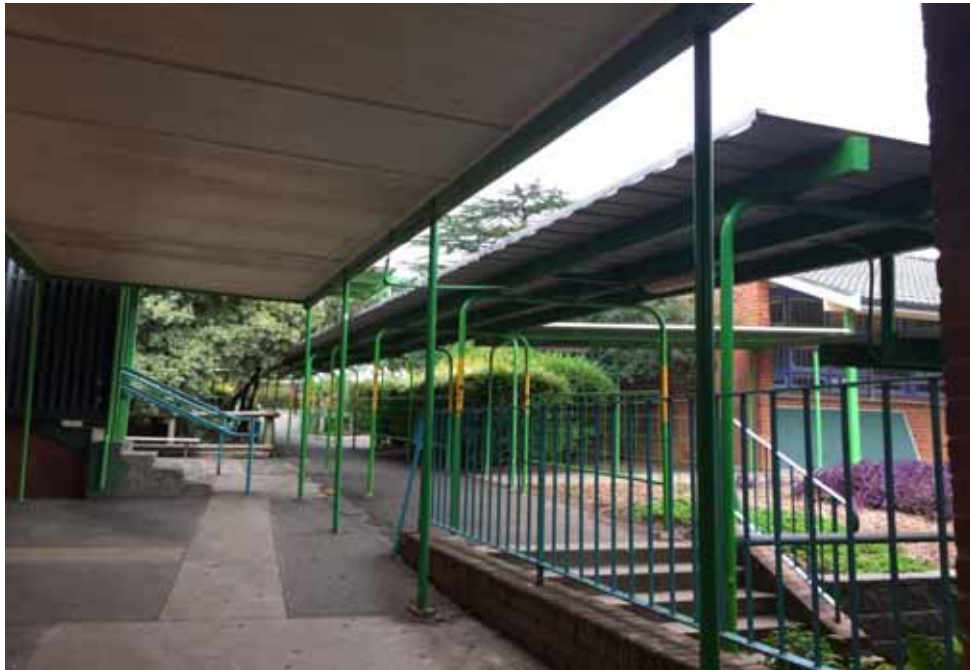
Photograph 57: Covered walkways, ceiling lining.

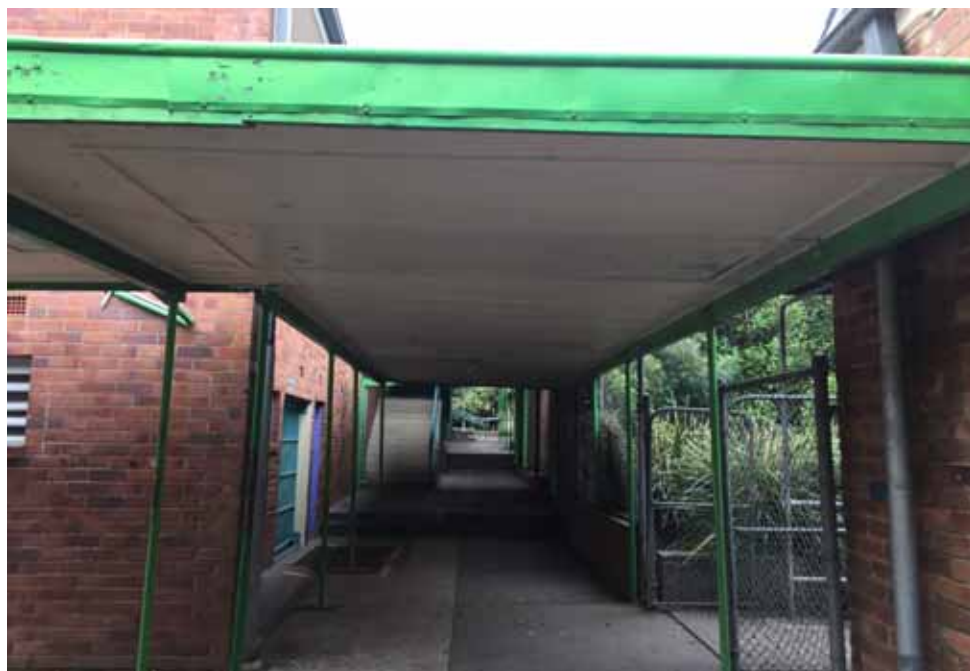
Photograph 58: Covered walkways, ceiling lining.

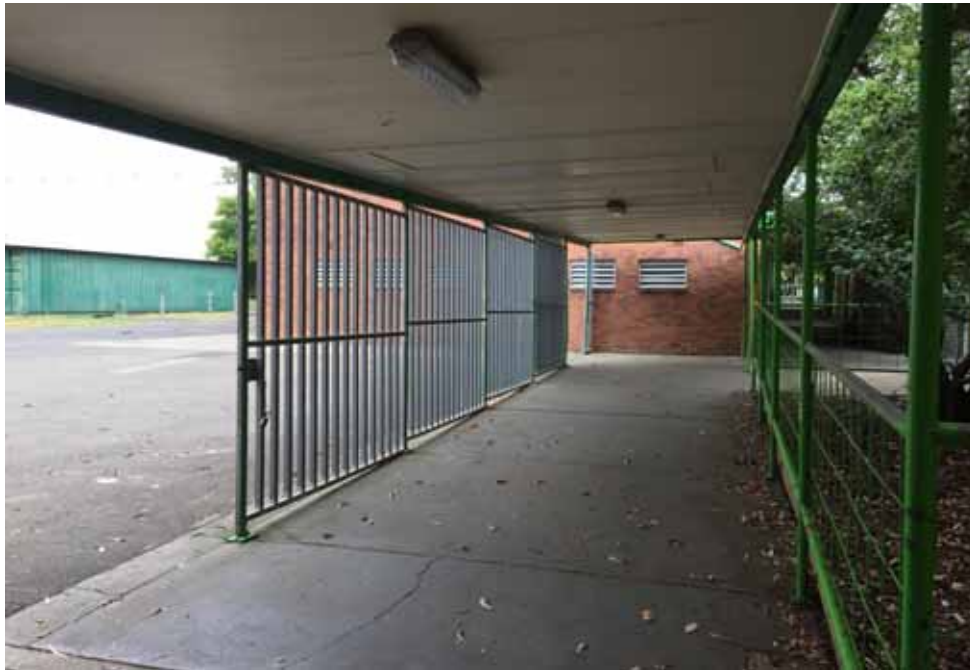
Photograph 59: Covered walkways, ceiling lining.

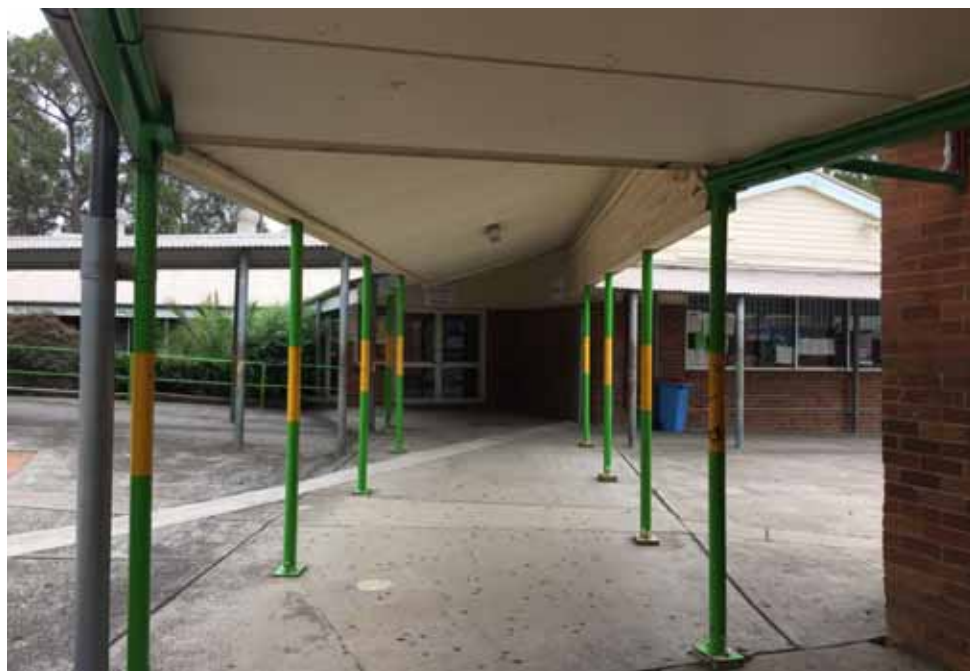
Photograph 60: Covered walkways, ceiling lining.
