# **WALSH BAY ARTS AND CULTURAL PRECINCT**

#### **HAZARDOUS MATERIALS ASSESSMENT FOR WHARF 2/3**

# Hazardous Materials Assessment Wharf 2/3 13A Hickson Road The Rocks NSW 2000

October 2011 - Rev01

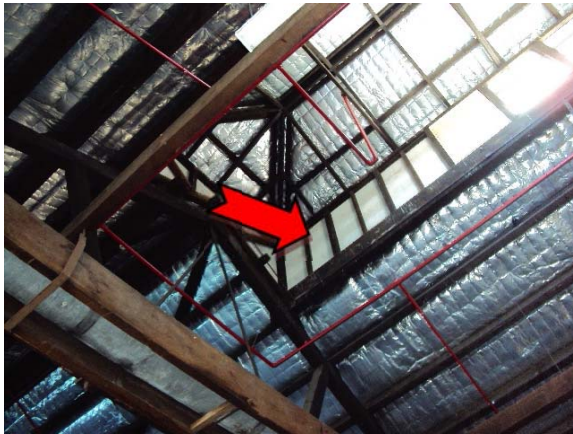
| Level / Area | Room & Location | Feature | Item Description | Hazard Type | Sample No. | Sample Status | Photo No. | Quantity | Condition | Friability | Disturb. Potential | Risk Status | Reinspect date | Control Priority | Recommendations & Comments |
|---|---|---|---|---|---|---|---|---|---|---|---|---|---|---|---|
| Exterior/Interior | Upper roof gables (north and south) | Infill panels | Fibre cement sheeting | Asbestos | Not sampled due to height | Suspected Positive | 1 | 4 x ~38m <sup>2</sup> | Good | Non-Friable | Low | Low | Oct-12 | P4 | Confirm Status, label as containing asbestos and maintain in good condition if to remain in-situ, remove under controlled bonded asbestos removal conditions prior to refurbishment or demolition works by an AS-2 (bonded) licensed asbestos removal contractor. |

**Photo 1.** Exterior/interior, upper roof gables (north and south), infill panels – suspected asbestos-containing fibre cement sheet

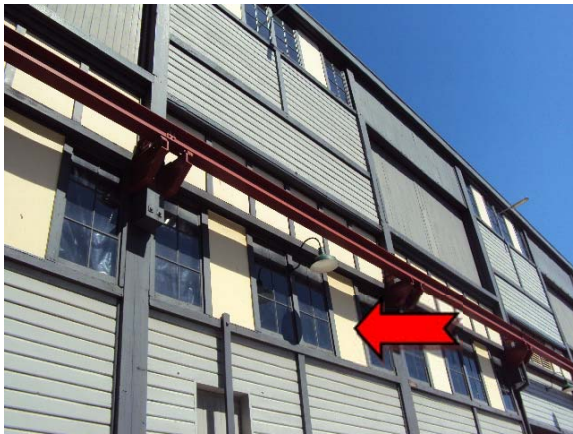
| Level / Area | Room & Location | Feature | Item Description | Hazard Type | Sample No. | Sample Status | Photo No. | Quantity | Condition | Friability | Disturb. Potential | Risk Status | Reinspect date | Control Priority | Recommendations & Comments |
|---|---|---|---|---|---|---|---|---|---|---|---|---|---|---|---|
| Exterior/Interior, level 1 | Throughout | Infill panels to windows | Fibre cement sheeting | Asbestos | Not sampled due to height | Suspected Positive | 3 | ~166m <sup>2</sup> | Good | Non-Friable | Low | Low | Oct-12 | P4 | Confirm Status, label as containing asbestos and maintain in good condition if to remain in-situ, remove under controlled bonded asbestos removal conditions prior to refurbishment or demolition works by an AS-2 (bonded) licensed asbestos removal contractor. |

**Photo 3.** Exterior/interior, throughout, infill panels – suspected asbestos-containing fibre cement sheeting

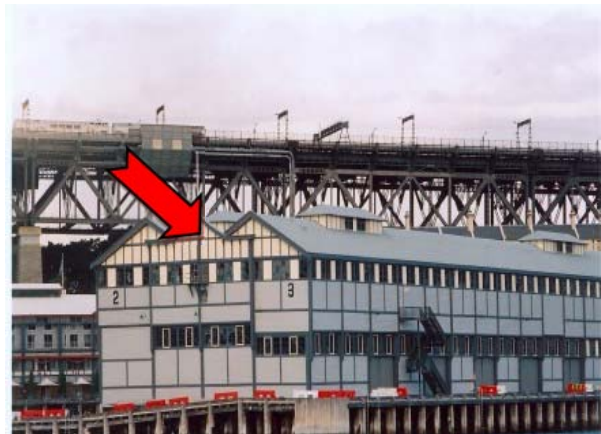
| Level / Area | Room & Location | Feature | Item Description | Hazard Type | Sample No. | Sample Status | Photo No. | Quantity | Condition | Friability | Disturb. Potential | Risk Status | Reinspect date | Control Priority | Recommendations & Comments |
|---|---|---|---|---|---|---|---|---|---|---|---|---|---|---|---|
| Exterior/Interior, level 1 | North wall | Gable infill | Fibre cement sheeting | Asbestos | Not sampled due to height | Suspected Positive | 4 | 4 x ~36m <sup>2</sup> | Good | Non-Friable | Low | Low | Oct-12 | P4 | Confirm Status, label as containing asbestos and maintain in good condition if to remain in-situ, remove under controlled bonded asbestos removal conditions prior to refurbishment or demolition works by an AS-2 (bonded) licensed asbestos removal contractor. |

**Photo 4.** Exterior/interior, level 1, north wall, gable infill panel – suspected asbestos-containing fibre cement sheeting

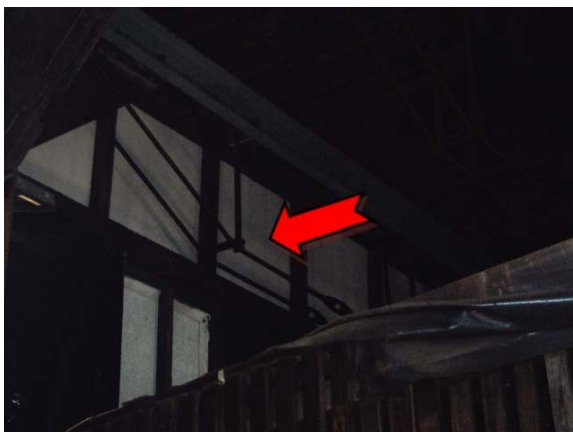
| Level / Area | Room & Location | Feature | Item Description | Hazard Type | Sample No. | Sample Status | Photo No. | Quantity | Condition | Friability | Disturb. Potential | Risk Status | Reinspect date | Control Priority | Recommendations & Comments |
|---|---|---|---|---|---|---|---|---|---|---|---|---|---|---|---|
| Exterior/Interior, ground level | Throughout | Infill panels to windows | Fibre cement sheeting | Asbestos | Not sampled due to height | Suspected Positive | 5 | ~240m <sup>2</sup> | Good | Non-Friable | Low | Low | Oct-12 | P4 | Confirm Status, label as containing asbestos and maintain in good condition if to remain in-situ, remove under controlled bonded asbestos removal conditions prior to refurbishment or demolition works by an AS-2 (bonded) licensed asbestos removal contractor. |

**Photo 5.** Interior, ground level, throughout, infill panels to windows – suspected asbestos-containing fibre cement sheeting

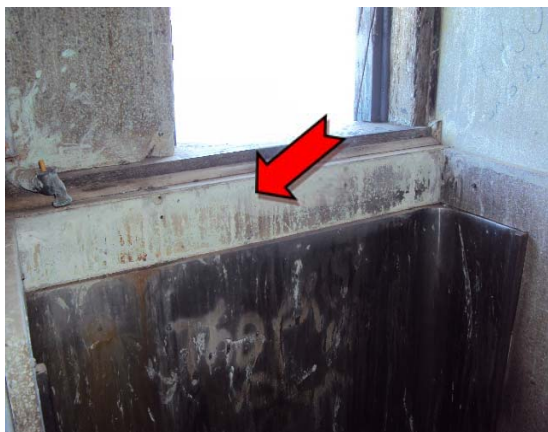
| Level / Area | Room & Location | Feature | Item Description | Hazard Type | Sample No. | Sample Status | Photo No. | Quantity | Condition | Friability | Disturb. Potential | Risk Status | Reinspect date | Control Priority | Recommendations & Comments |
|---|---|---|---|---|---|---|---|---|---|---|---|---|---|---|---|
| Interior, level 1 | North, toilet | Infill panels to window | Fibre cement sheeting | Asbestos | 50290-07-03 | Positive | 6 | ~2m <sup>2</sup> | Good | Non-Friable | Low | Low | Oct-12 | P4 | Encapsulate exposed sections, label as containing asbestos and maintain in good condition if to remain in-situ, remove under controlled bonded asbestos removal conditions prior to refurbishment or demolition works by an AS-2 (bonded) licensed asbestos removal contractor. |
| Interior, level 1 | North, toilet | Infill panels to urinal | Fibre cement sheeting | Asbestos | 50290-07-04 | Positive | 6 | ~3m <sup>2</sup> | Good | Non-Friable | Low | Low | Oct-12 | P4 | Encapsulate exposed sections, label as containing asbestos and maintain in good condition if to remain in-situ, remove under controlled friable asbestos removal conditions prior to refurbishment or demolition works by an AS-1 (friable) licensed asbestos removal contractor. |

**Photo 6.** Interior, level 1, north toilet, infill panels to urinal and windows – asbestos-containing fibre cement sheeting

- Encapsulate the asbestos-containing fibre cement infill panels to the urinal and windows, located on Level 1 within the northern toilet block as soon as practicable. The asbestos removal works should be conducted by an appropriately licensed asbestos removal contractor (i.e. AS-1 friable or AS-2 bonded) under controlled asbestos removal working conditions.

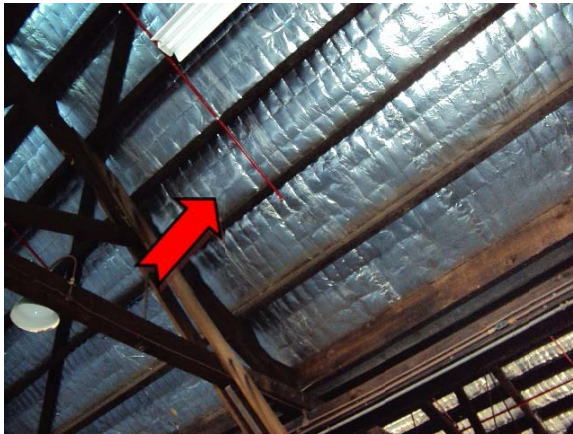
| Level / Area | Room & Location | Feature | Item Description | Hazard Type | Sample No. | Sample Status | Photo No. | Quantity | Condition | Friability | Disturb. Potential | Risk Status | Reinspect date | Control Priority | Recommendations & Comments |
|---|---|---|---|---|---|---|---|---|---|---|---|---|---|---|---|
| Interior, level 1 | Ceiling, throughout | Sarking | Insulation material | SMF | - | Suspected Positive | 7 | ~2,000m <sup>2</sup> | Good | Bonded | Low | Low | - | - | Maintain in good condition if to remain in-situ. Remove under controlled SMF conditions as per Code of Practice for the Safe Use of Synthetic Mineral Fibres [NOHSC: 2006 (1990)]. |

**Photo 7.** Interior, level 1, ceiling throughout, sarking – suspected SMF-containing insulation material

- SMF materials should be maintained in good condition as per the *National Code of Practice for the Safe Use of Synthetic Mineral Fibres* [NOHSC:2006(1990)].

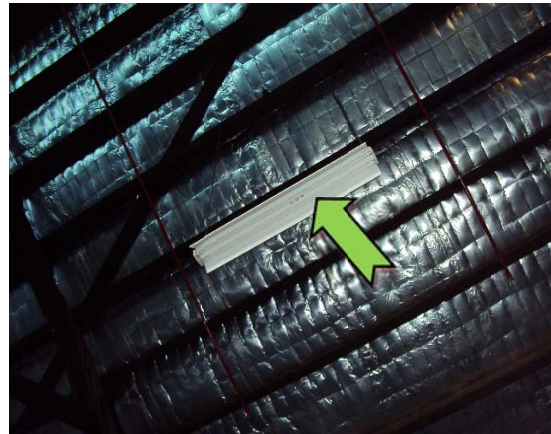
**Photo 8.** Interior, level 1, ceiling throughout, double tube fluorescent light fittings – suspected PCB-containing capacitors

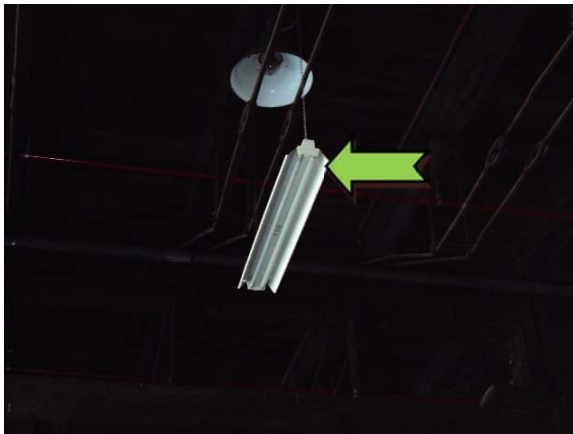
**Photo 9.** Interior, ground level, ceiling throughout, double tube fluorescent light fittings – suspected negative for the presence of PCB-containing capacitors

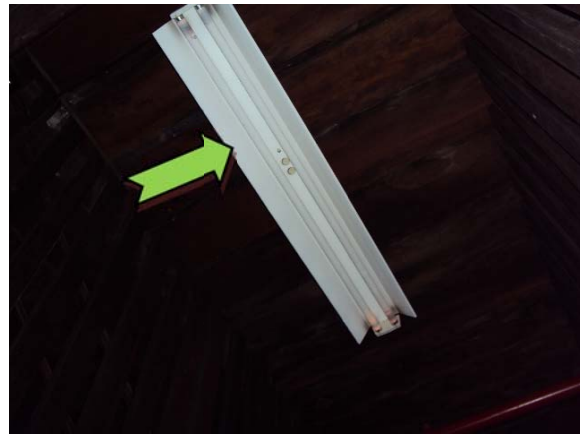
**Photo 10.** Interior, ground level, central, northern stairwell, ceiling throughout, double tube fluorescent light fittings – suspected negative for the presence of PCB-containing capacitors

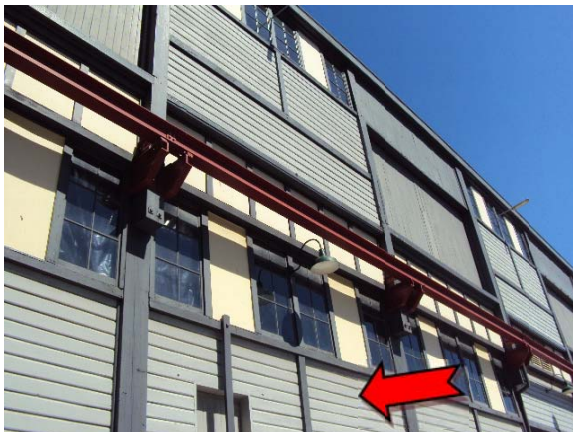
| Level / Area | Room & Location | Feature | Item Description | Hazard Type | Sample No. | Sample Status | Photo No. | Quantity | Condition | Friability | Disturb. Potential | Risk Status | Reinspect date | Control Priority | Recommendations & Comments |
|---|---|---|---|---|---|---|---|---|---|---|---|---|---|---|---|
| Exterior | Throughout | Timber features | White - lower coloured paint system | Lead Paint - Swab | - | Positive | 11 | ~20,000m <sup>2</sup> | Good | - | Low | Low | - | - | Maintain in current condition, over paint with a lead-free paint as part of ongoing maintenance. Remove under controlled conditions in accordance with AS 4361.2:1998 Guide to lead paint management prior to renovation or demolition works. |

**Photo 11.** Exterior, throughout, timber features – lead-containing white lower colour paint system

- Works that are likely to cause disturbance of LCP systems should be conducted under controlled conditions by a suitably qualified contractor. Dust suppression techniques should be utilized and works should be conducted in accordance with the requirements of AS 4361.2 1998 *Guide to lead paint management, Part 2: Residential and commercial buildings*.
