# **WALSH BAY ARTS AND CULTURAL PRECINCT**

#### **HAZARDOUS MATERIALS RE-ASSESSMENT FOR WHARF 4/5**

# Hazardous Materials Re-inspection Wharf 4-5, Hickson Road, Walsh Bay, NSW 2065

Preston Rowe Paterson New South Wales  
September 2012

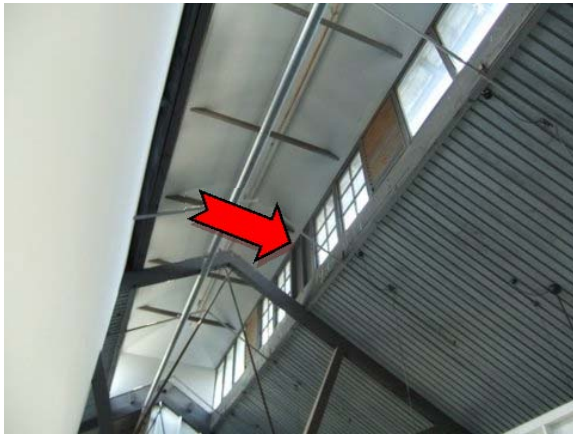
| Level / Area | Room & Location | Feature | Item Description | Hazard Type | Sample No. | Sample Status | Photo No. | Quantity | Condition | Friability | Disturb. Potential | Risk Status | Reinspect date | Control Priority | Recommendations & Comments |
|---|---|---|---|---|---|---|---|---|---|---|---|---|---|---|---|
| Level 4 interior | The loft | Window infill panels | Fibre cement sheeting | Asbestos | NAA Ref: 57607-02-10 | Positive | 1 | 2 units x ~2m <sup>2</sup> | Good | Non-Friable | Low | Low | Sep-17 | P4 | Maintain in good condition if to remain in-situ. Remove under controlled bonded asbestos removal conditions prior to refurbishment or demolition works by an Class B (bonded) licensed asbestos removal contractor. |

**Photo 1.** Level 4, interior, the loft, window infill panels – asbestos-containing fibre cement sheeting.

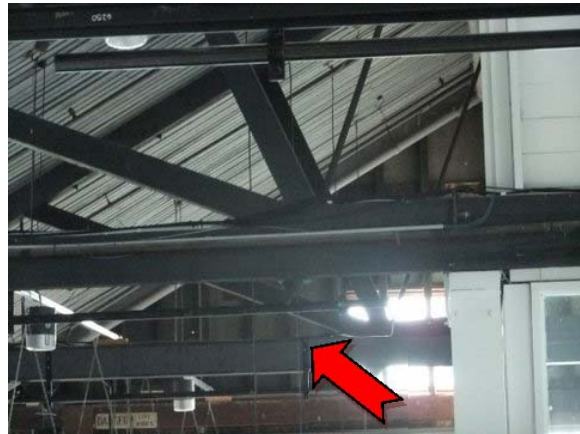
| Level / Area | Room & Location | Feature | Item Description | Hazard Type | Sample No. | Sample Status | Photo No. | Quantity | Condition | Friability | Disturb. Potential | Risk Status | Reinspect date | Control Priority | Recommendations & Comments |
|---|---|---|---|---|---|---|---|---|---|---|---|---|---|---|---|
| Level 3 interior | Restaurant | Gable Infill panels | Fibre cement sheeting | Asbestos | Not sampled due to height restrictions | Suspected Positive | 2 | ~20m <sup>2</sup> | Good | Non-Friable | Low | Low | Sep-17 | P4 | Confirm status, label as containing asbestos and maintain in good condition if to remain in-situ, remove under controlled bonded asbestos removal conditions prior to refurbishment or demolition works by an Class B (bonded) licensed asbestos removal contractor. |

**Photo 2.** Level 3, interior, restaurant, gable infill panels - suspected asbestos-containing fibre cement sheeting.

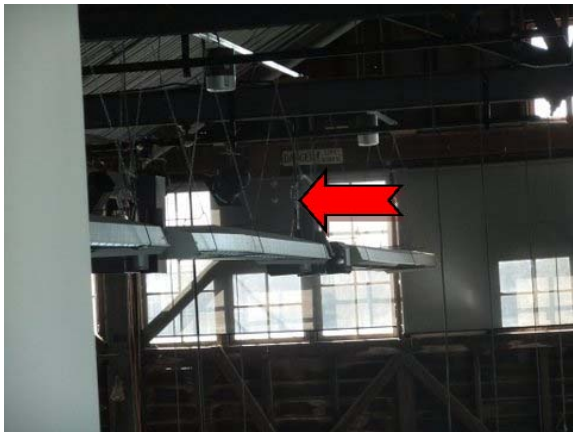
| Level / Area | Room & Location | Feature | Item Description | Hazard Type | Sample No. | Sample Status | Photo No. | Quantity | Condition | Friability | Disturb. Potential | Risk Status | Reinspect date | Control Priority | Recommendations & Comments |
|---|---|---|---|---|---|---|---|---|---|---|---|---|---|---|---|
| Level 3 interior | Restaurant | Infill panels under windows | Fibre cement sheeting | Asbestos | Same as NAA Ref: 57607-02-10 | Assumed Positive | 3 | 2 units x ~2m <sup>2</sup> | Good | Non-Friable | Low | Low | Sep-17 | P4 | Maintain in good condition if to remain in-situ. Remove under controlled bonded asbestos removal conditions prior to refurbishment or demolition works by an Class B (bonded) licensed asbestos removal contractor. |

**Photo 3.** Level 3, interior, restaurant - asbestos-containing infill panels under windows.

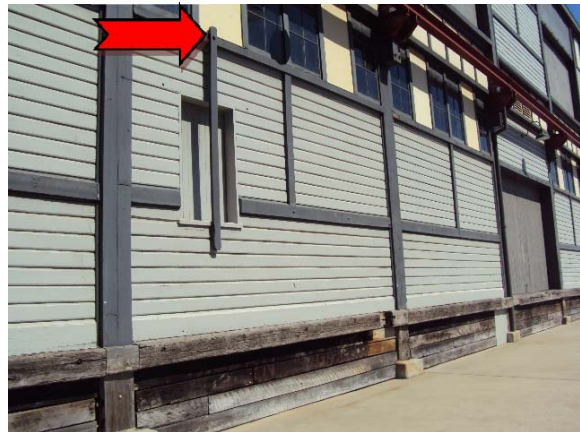
| Level / Area | Room & Location | Feature | Item Description | Hazard Type | Sample No. | Sample Status | Photo No. | Quantity | Condition | Friability | Disturb. Potential | Risk Status | Reinspect date | Control Priority | Recommendations & Comments |
|---|---|---|---|---|---|---|---|---|---|---|---|---|---|---|---|
| All levels interior/exterior | Throughout | Infill panels around windows | Fibre cement sheeting | Asbestos | NAA ref: 57607-02-07 | Positive | 4 | ~400m <sup>2</sup> | Good | Non-Friable | Low | Low | Sep-17 | P4 | Maintain in good condition if to remain in-situ. Remove under controlled bonded asbestos removal conditions prior to refurbishment or demolition works by an Class B (bonded) licensed asbestos removal contractor. |

**Photo 4.** All levels, throughout, external and internal - asbestos containing infill panels around windows

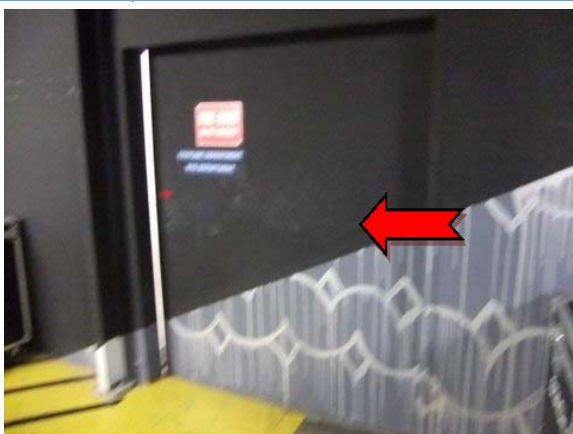
| Level / Area | Room & Location | Feature | Item Description | Hazard Type | Sample No. | Sample Status | Photo No. | Quantity | Condition | Friability | Disturb. Potential | Risk Status | Reinspect date | Control Priority | Recommendations & Comments |
|---|---|---|---|---|---|---|---|---|---|---|---|---|---|---|---|
| Level 3 interior | Costume department | Fire door - large | Fire door core | SMF | - | Suspected Positive | 5 | 1 unit | Good | Un-bonded | Low | Low | - | - | Maintain in good condition if to remain in-situ. Remove under controlled SMF conditions as per Code of Practice for the Safe Use of Synthetic Mineral Fibres [NOHSC: 2006 (1990)]. |

**Photo 5.** Level 3, interior, costume department, SMF-containing fire door core

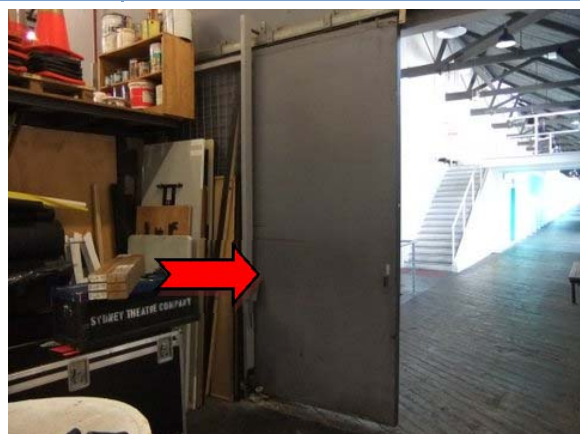
| Level / Area | Room & Location | Feature | Item Description | Hazard Type | Sample No. | Sample Status | Photo No. | Quantity | Condition | Friability | Disturb. Potential | Risk Status | Reinspect date | Control Priority | Recommendations & Comments |
|---|---|---|---|---|---|---|---|---|---|---|---|---|---|---|---|
| Level 3 interior | Workshop, entrance | Fire door - large | Fire door core | SMF | - | Suspected Positive | 6 | 1 unit | Good | Un-bonded | Low | Low | - | - | Maintain in good condition if to remain in-situ. Remove under controlled SMF conditions as per Code of Practice for the Safe Use of Synthetic Mineral Fibres [NOHSC: 2006 (1990)]. |

**Photo 6.** Level 3, interior, workshop entrance, SMF-containing fire door core

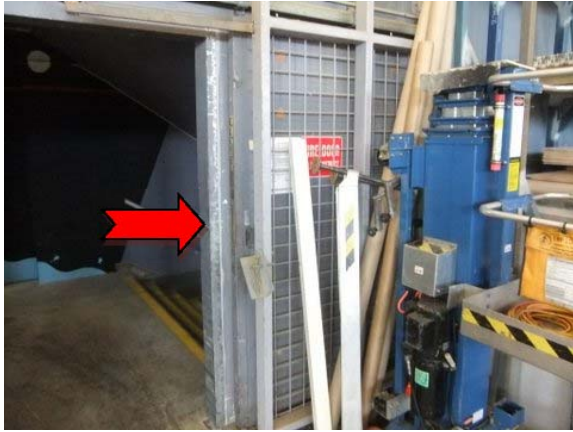
| Level / Area | Room & Location | Feature | Item Description | Hazard Type | Sample No. | Sample Status | Photo No. | Quantity | Condition | Friability | Disturb. Potential | Risk Status | Reinspect date | Control Priority | Recommendations & Comments |
|---|---|---|---|---|---|---|---|---|---|---|---|---|---|---|---|
| Level 3 interior | Workshop, fire tunnel | Fire door - single | Fire door core | SMF | - | Suspected Positive | 7 | 2 units | Good | Un-bonded | Low | Low | - | - | Maintain in good condition if to remain in-situ. Remove under controlled SMF conditions as per Code of Practice for the Safe Use of Synthetic Mineral Fibres [NOHSC: 2006 (1990)]. |

**Photo 7.** Level 3, interior, fire tunnel, SMF-containing fire door core

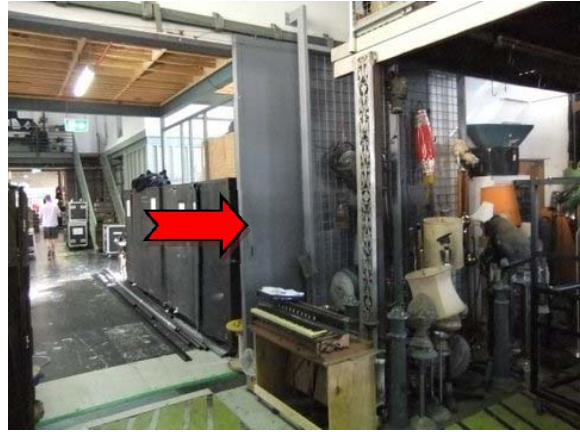
| Level / Area | Room & Location | Feature | Item Description | Hazard Type | Sample No. | Sample Status | Photo No. | Quantity | Condition | Friability | Disturb. Potential | Risk Status | Reinspect date | Control Priority | Recommendations & Comments |
|---|---|---|---|---|---|---|---|---|---|---|---|---|---|---|---|
| Level 3 interior | Prop room | Fire door - large | Fire door core | SMF | - | Suspected Positive | 8 | 1 unit | Good | Un-bonded | Low | Low | - | - | Maintain in good condition if to remain in-situ. Remove under controlled SMF conditions as per Code of Practice for the Safe Use of Synthetic Mineral Fibres [NOHSC: 2006 (1990)]. |

**Photo 8.** Level 3, interior, prop room – SMF-containing fire door core.

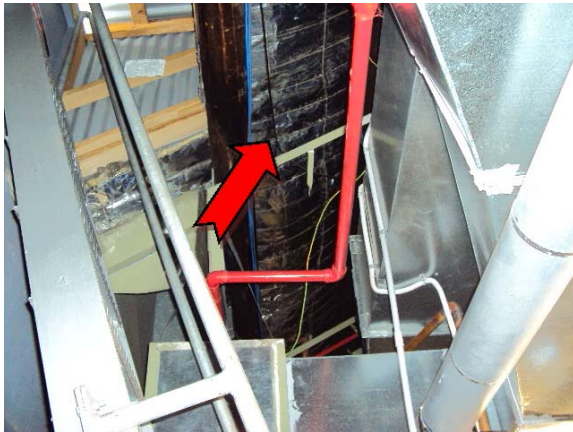
| Level / Area | Room & Location | Feature | Item Description | Hazard Type | Sample No. | Sample Status | Photo No. | Quantity | Condition | Friability | Disturb. Potential | Risk Status | Reinspect date | Control Priority | Recommendations & Comments |
|---|---|---|---|---|---|---|---|---|---|---|---|---|---|---|---|
| All levels interior | Throughout | Ceiling | Sarking insulation | SMF | - | Suspected Positive | 9 | ~500m <sup>2</sup> | Good | Bonded | Low | Low | - | - | Maintain in good condition if to remain in-situ. Remove under controlled SMF conditions as per Code of Practice for the Safe Use of Synthetic Mineral Fibres [NOHSC: 2006 (1990)]. |

**Photo 9.** All levels, throughout, ceiling - suspected SMF sarking insulation

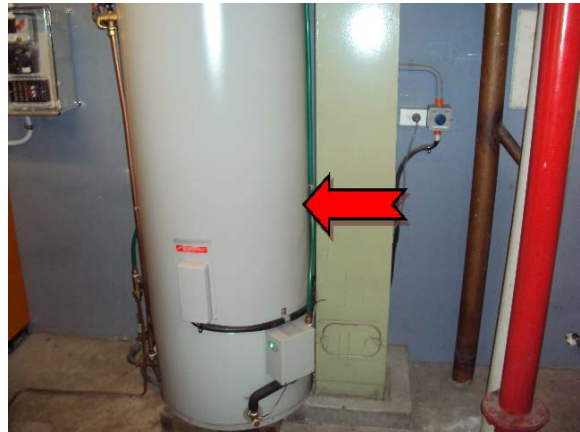
| Level / Area | Room & Location | Feature | Item Description | Hazard Type | Sample No. | Sample Status | Photo No. | Quantity | Condition | Friability | Disturb. Potential | Risk Status | Reinspect date | Control Priority | Recommendations & Comments |
|---|---|---|---|---|---|---|---|---|---|---|---|---|---|---|---|
| All levels interior | Throughout | Hot water heater | Insulation material - internal | SMF | - | Suspected Positive | 10 | ~15 units | Good | Bonded | Low | Low | - | - | Confirm status, maintain in good condition if to remain in-situ. Remove under controlled SMF conditions as per Code of Practice for the Safe Use of Synthetic Mineral Fibres [NOHSC: 2006 (1990)]. |

**Photo 10.** All levels, throughout, hot water heaters - suspected internal SMF insulation
