Arboricultural Impact Assessment

Cnr O'Connell Street and Eels Place, Parramatta
Proposed Parramatta Leagues Club Hotel Development
Prepared for Parramatta Leagues Club

Prepared 15 November 2018

Revised 28 November 2018

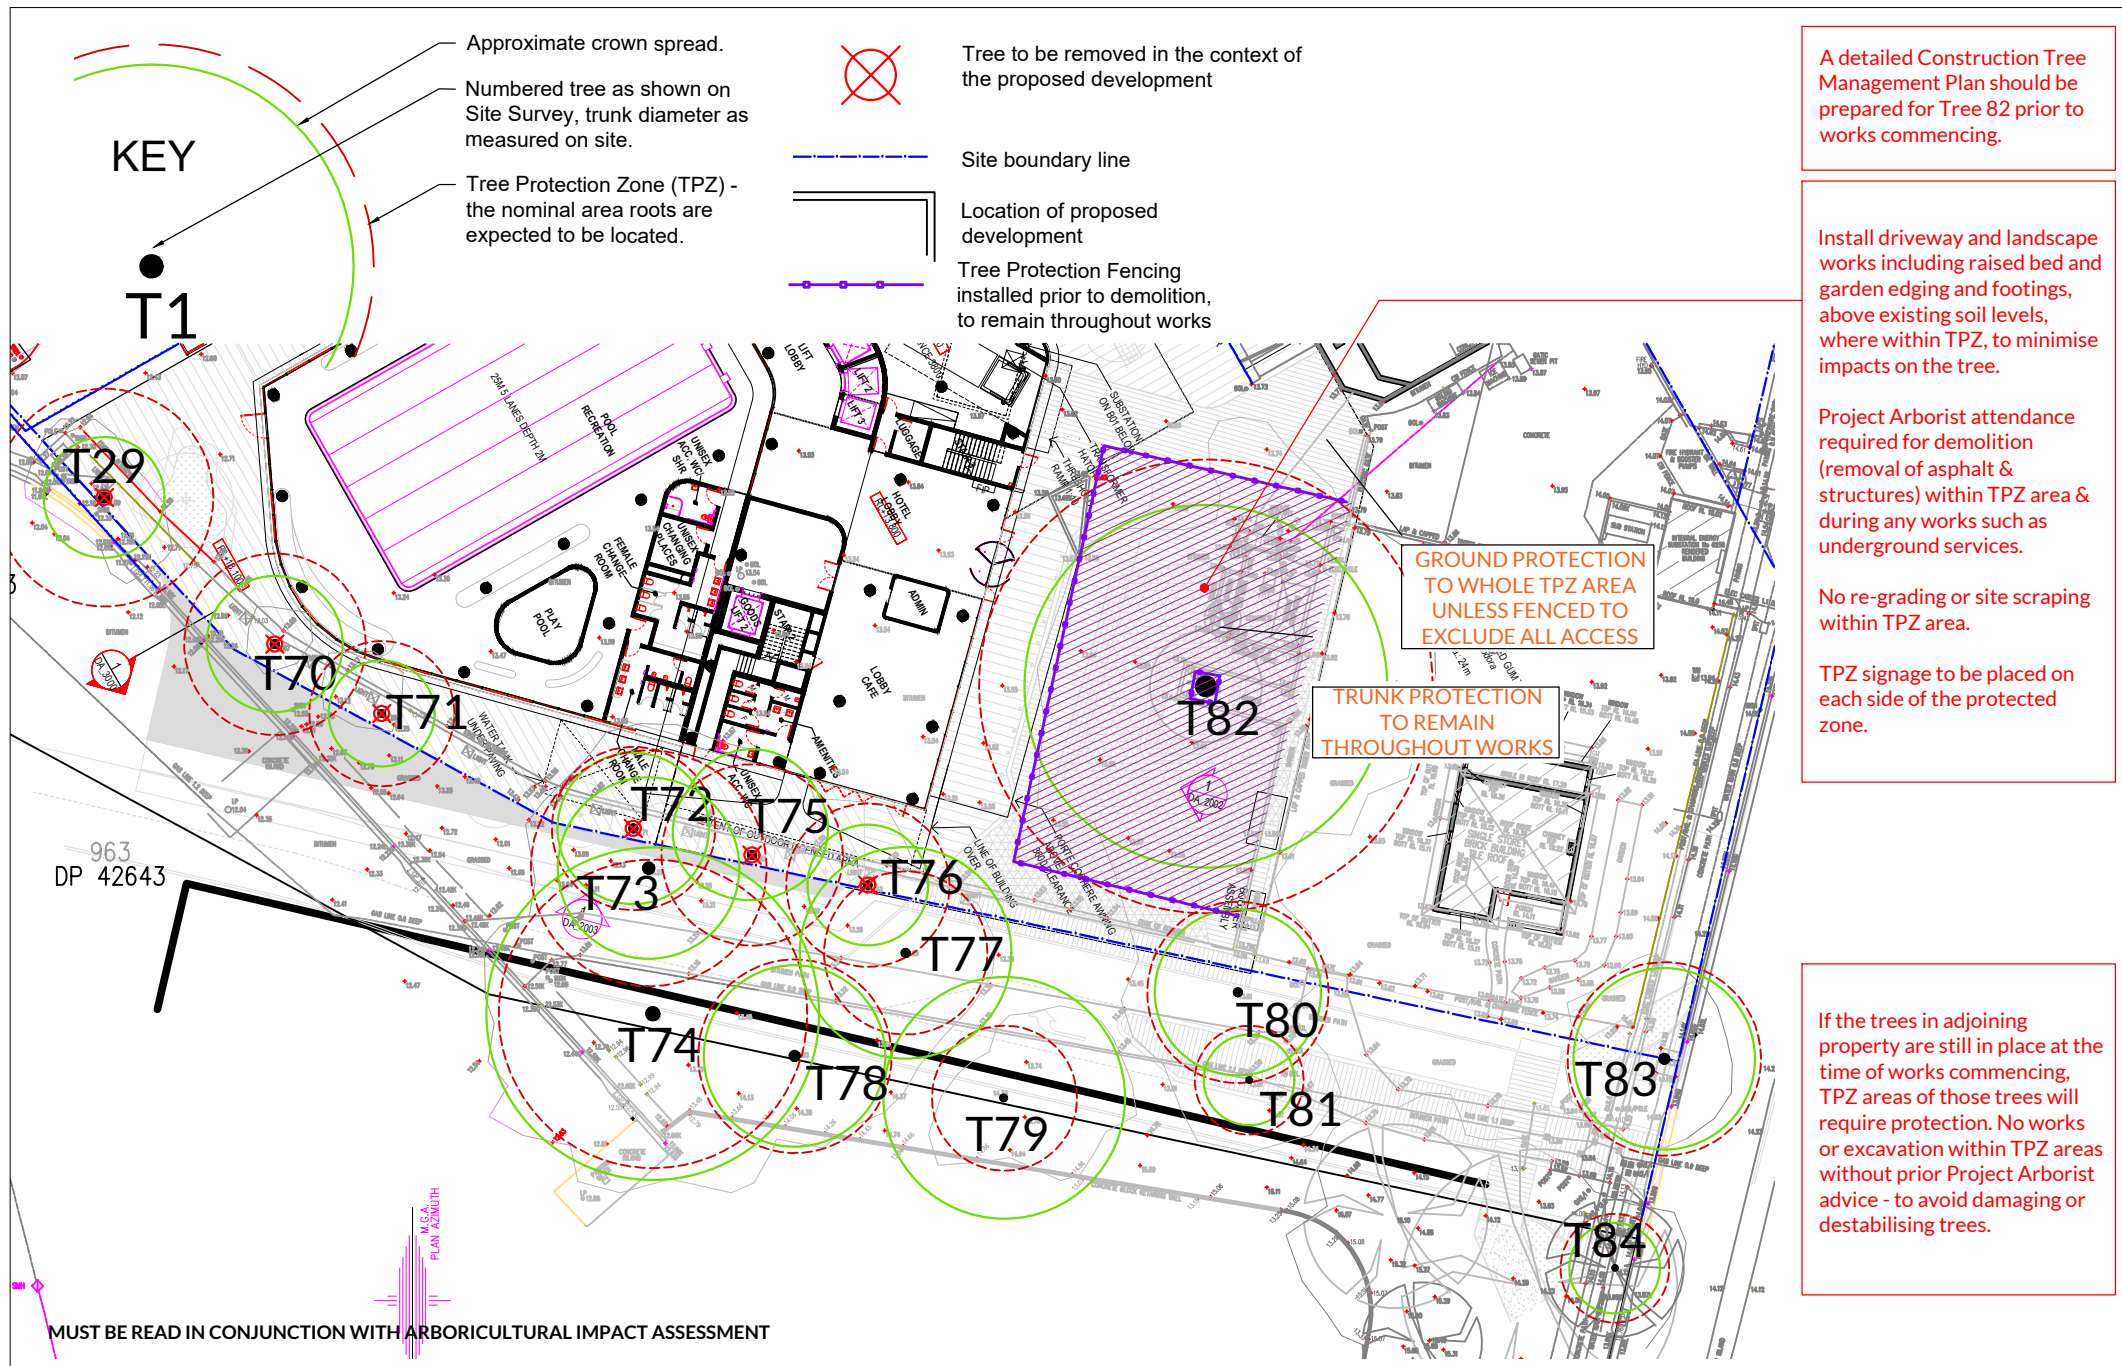
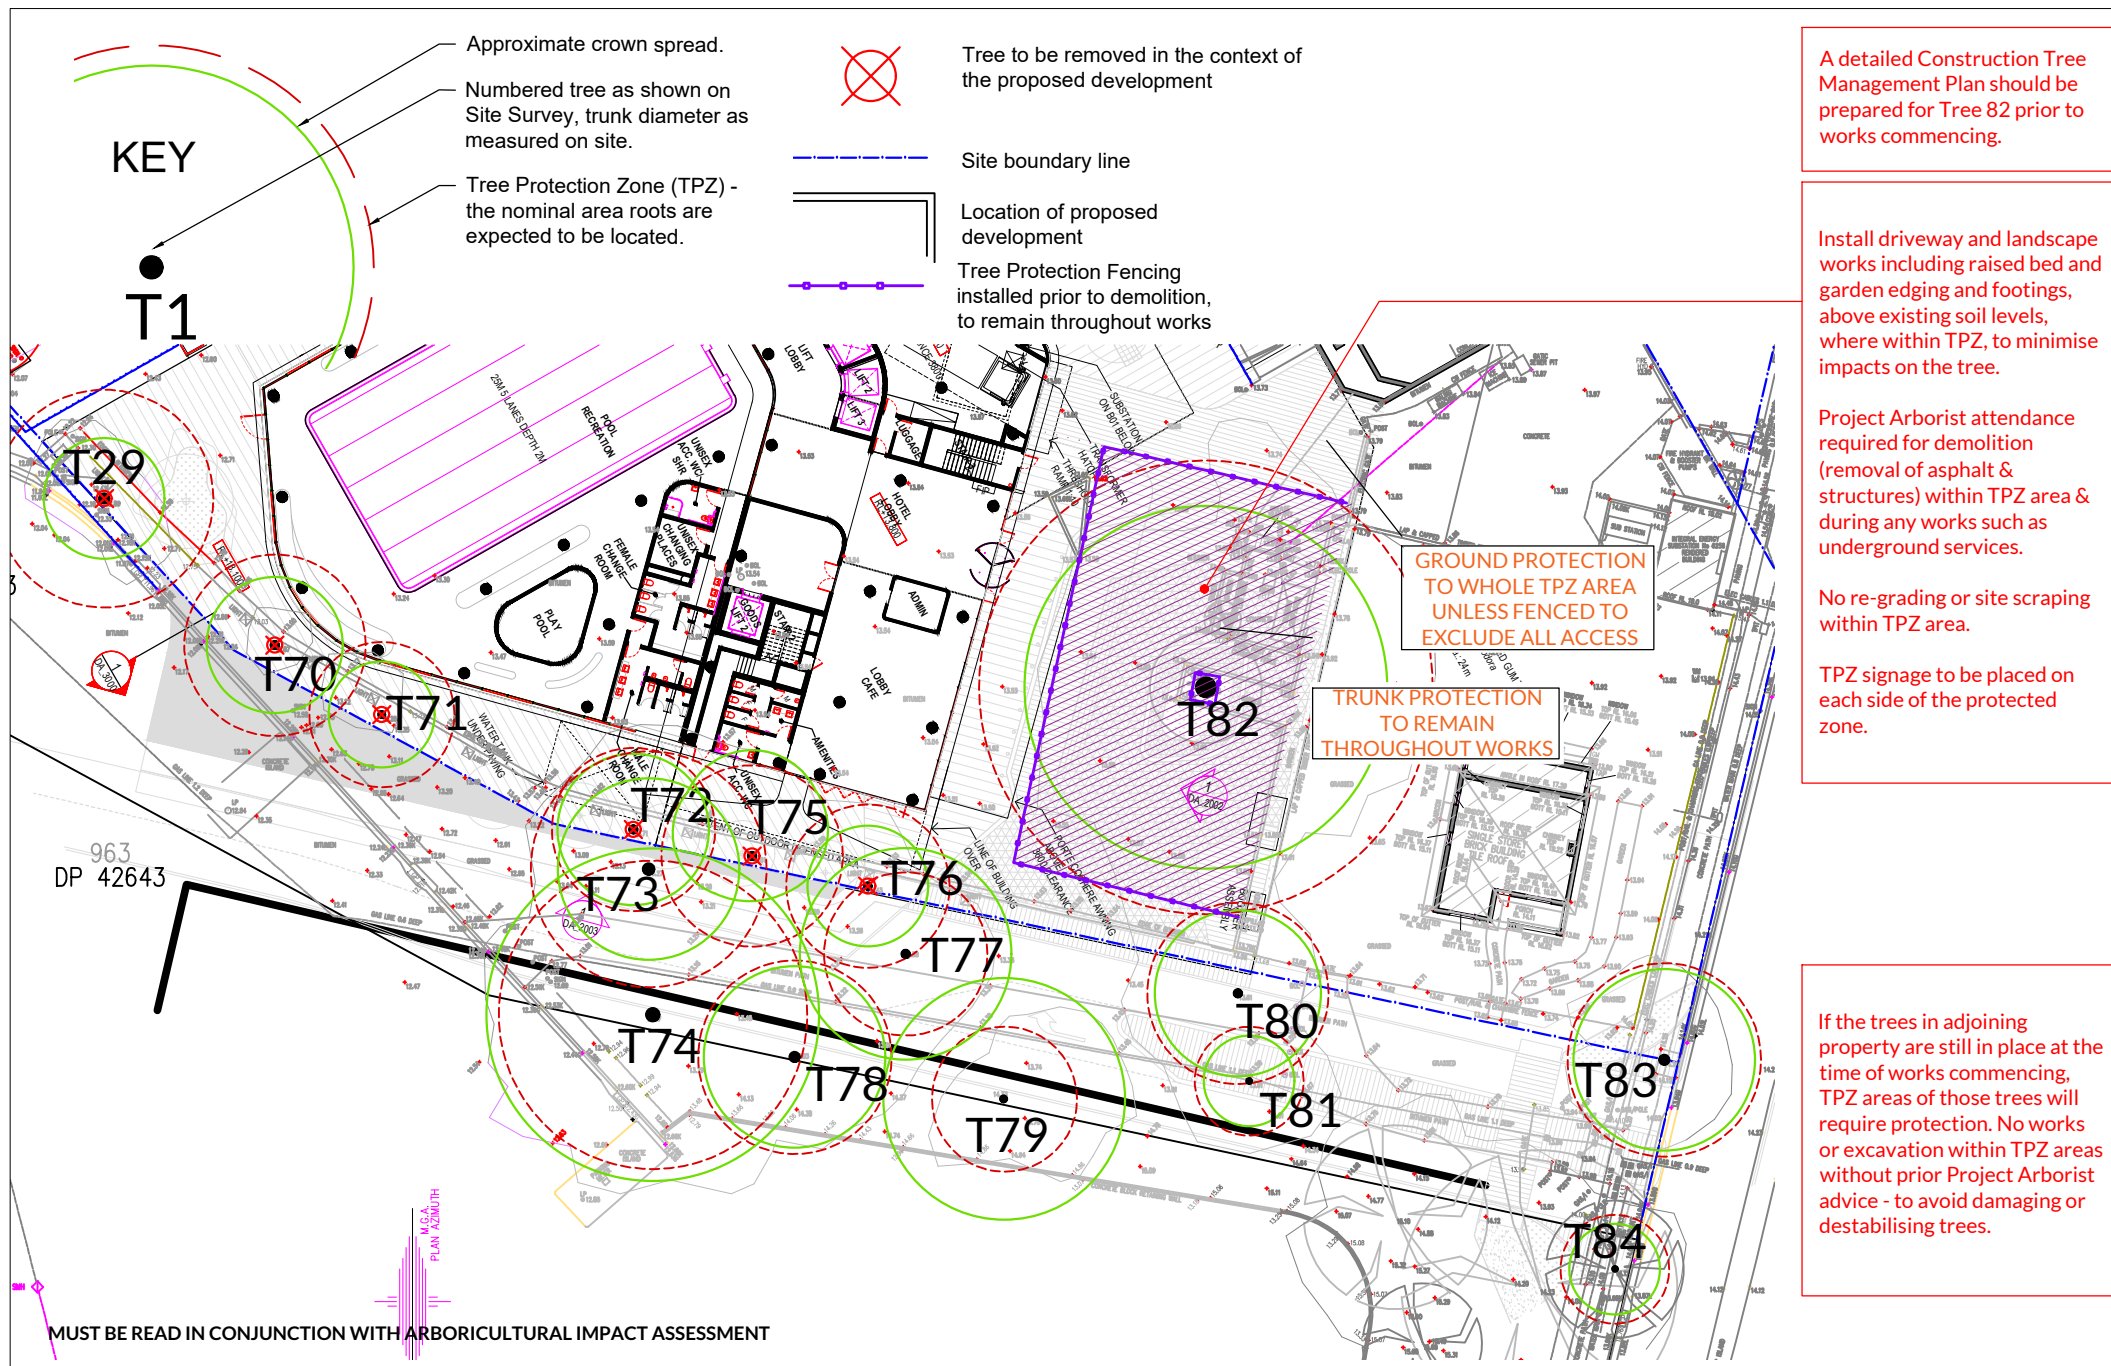
PARRAMATTA LEAGUES CLUB HOTEL						TREE PROTECTION PLAN					
				PROPOSED HOTEL DEVELOPMENT						SCALE	DATE	PROJECT			
										1:500 @ A4	DA	T - 01			
						APP PTY LTD		JB		28-11-18		REVISION			
												D

A detailed Construction Tree Management Plan should be prepared for Tree 82 prior to works commencing.

Install driveway and landscape works including raised bed and garden edging and footings, above existing soil levels, where within TPZ, to minimise impacts on the tree.

Project Arborist attendance required for demolition (removal of asphalt & structures) within TPZ area & during any works such as underground services.

No re-grading or site scraping within TPZ area.

TPZ signage to be placed on each side of the protected zone.

If the trees in adjoining property are still in place at the time of works commencing, TPZ areas of those trees will require protection. No works or excavation within TPZ areas without prior Project Arborist advice - to avoid damaging or destabilising trees.
