Appendix C

001 – Cranbrook Building Photographs

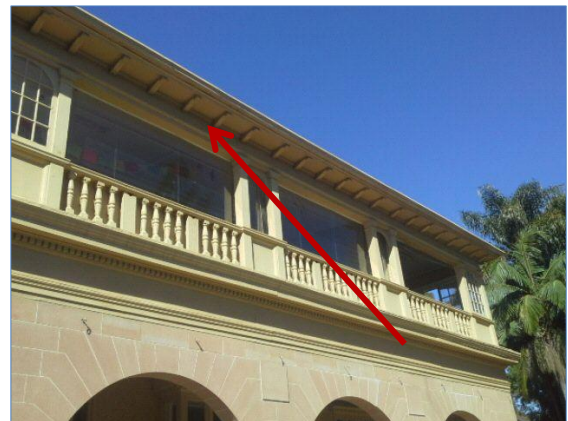
Photograph 06: North elevation - Presumed asbestos cement eave lining

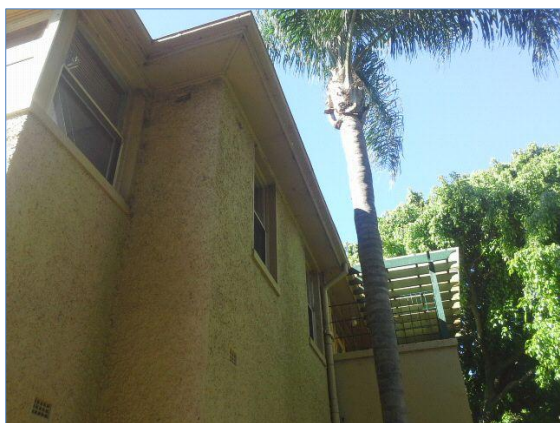
Photograph 07: West elevation - Asbestos cement eave lining

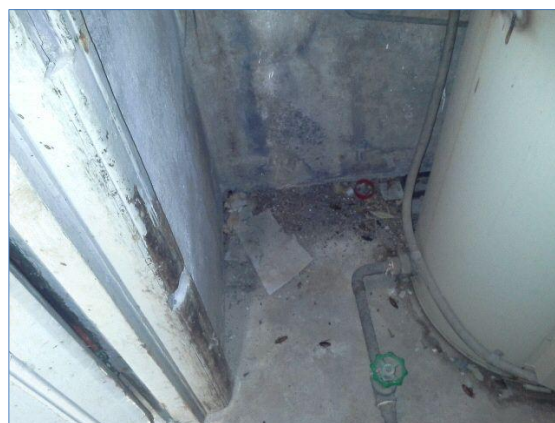
Photograph 12: Hot water cupboard 2.28 - Fibre cement sheeting on ground surface North West corner

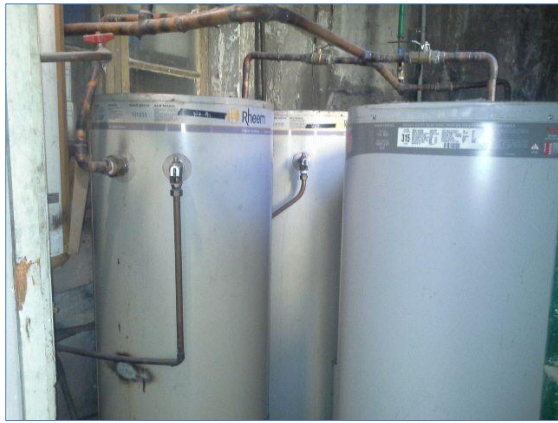
Photograph 13: Hot water cupboard 2.28 - SMF containing hot water units

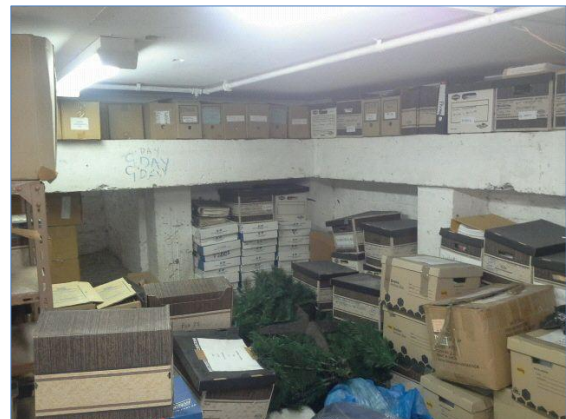
Photograph 18: Basement - White paint throughout

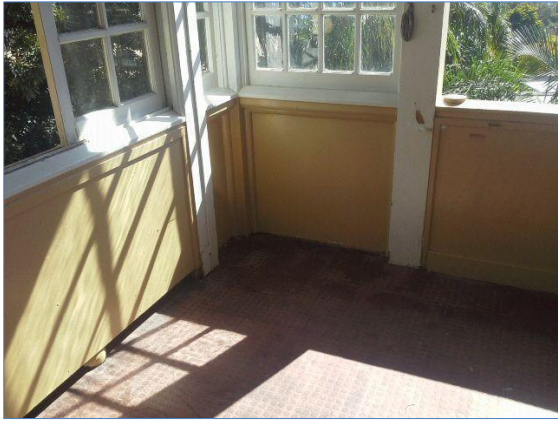
Photograph 19: Balcony 3.1 - Presumed asbestos cement infill panels to north and east walls

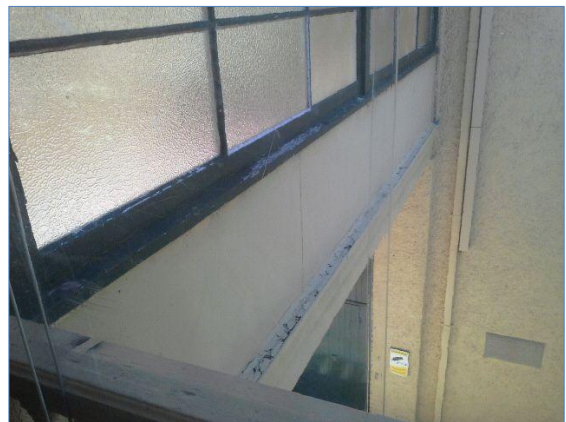
Photograph 23: Bridge 3.54 - Fibre cement south and west wall lining/cladding

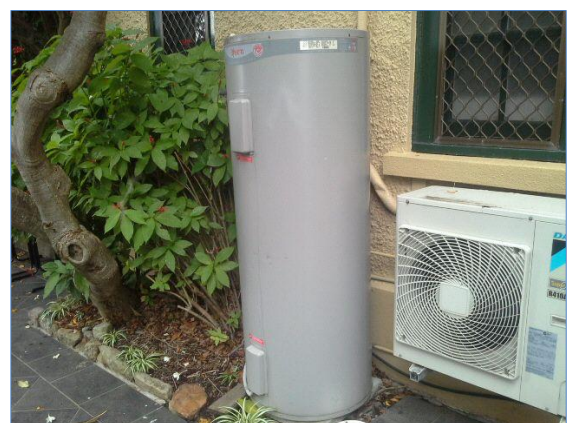
Photograph 06: North grounds - SMF containing hot water unit

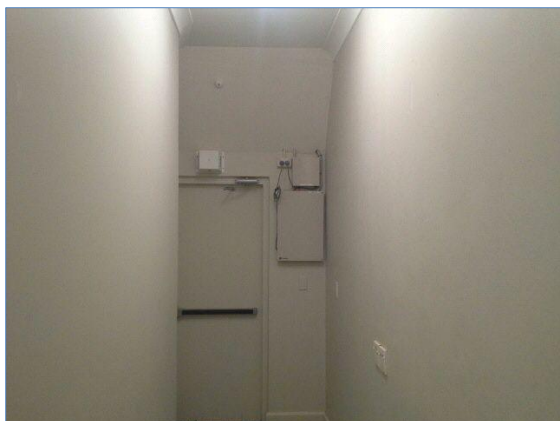
Photograph 07: Level 1 - Grey paint system to walls

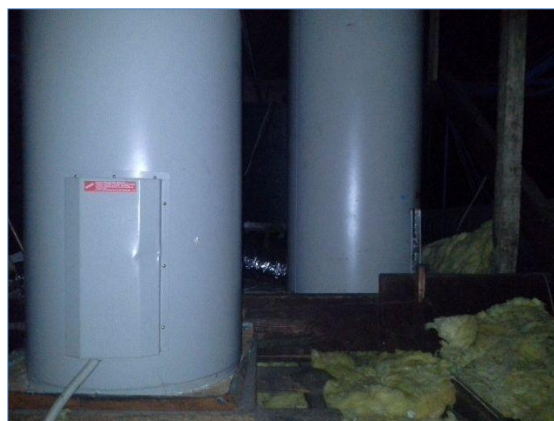
Photograph 12: First floor roof space - SMF containing hot water units

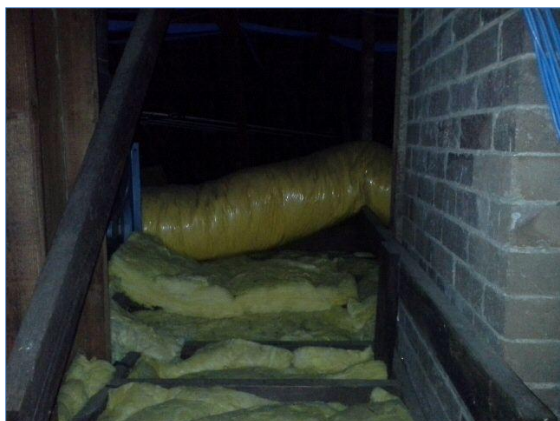
Photograph 13: First floor roof space - SMF insulating batts throughout and SMF insulated air handling ducts

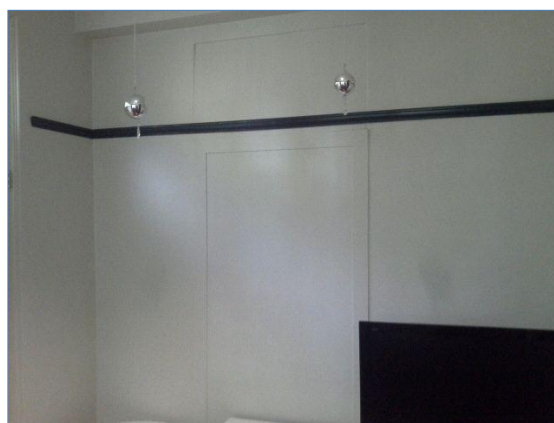
Photograph 16: Ground floor room 1.17 - Fibre cement infill panels in location of old door

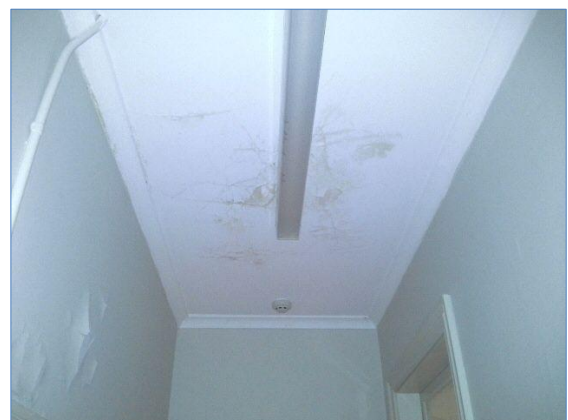
Photograph 06: Ground floor - White paint to ceilings

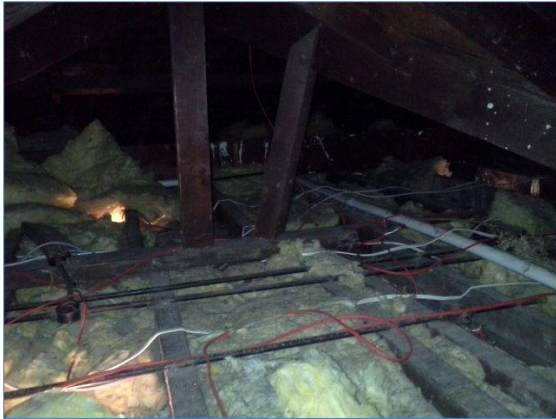
Photograph 07: Ceiling space - SMF insulating batts throughout roof space

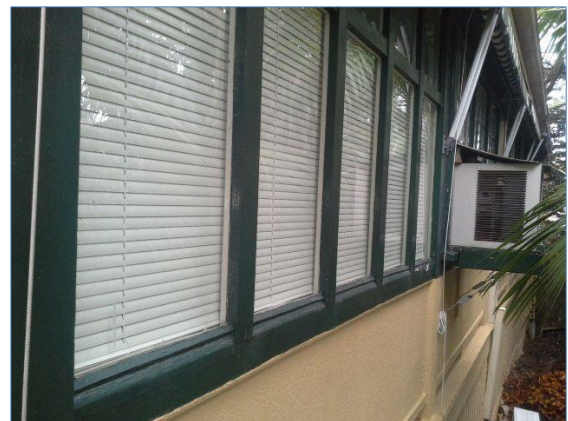
Photograph 12: Throughout - Window putty

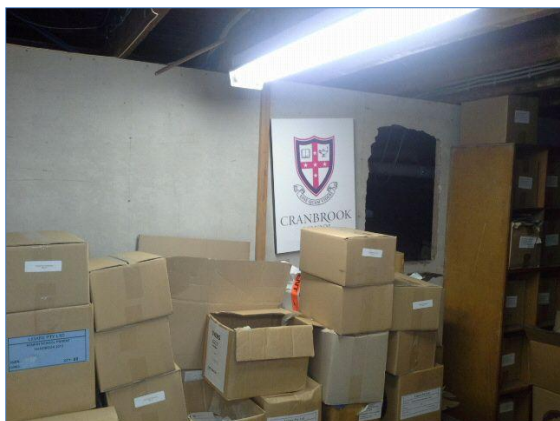
Photograph 13: Basement store 1.2 - Fibre cement south wall lining

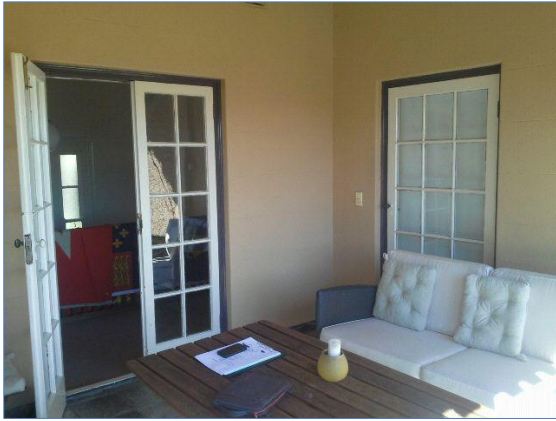
Photograph 07 : External perimeter - Cream lead based paint to walls, White lead based paint to doors and windows, Purple lead based paint to door frames and window sills

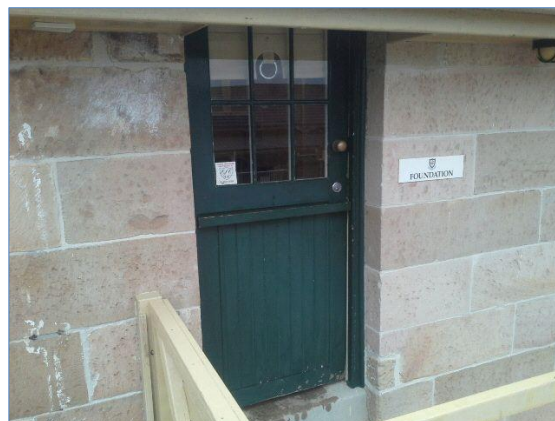
Photograph 04: Green paint to doors and frames

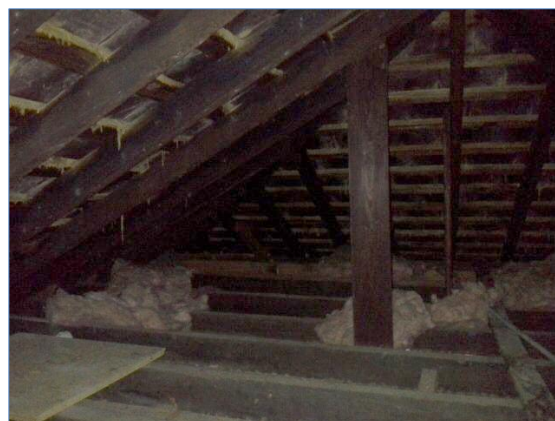
Photograph 06: Level 01 Foundation office 2.8, Ceiling space - SMF insulating batts throughout

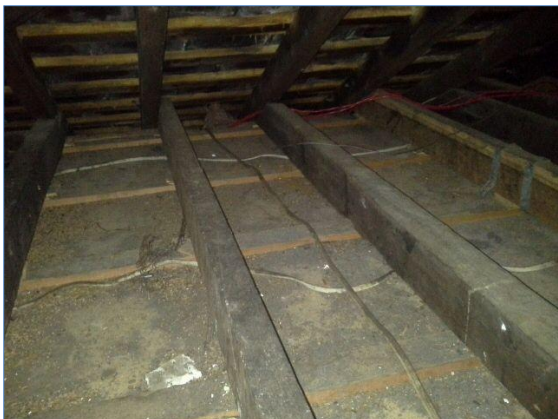
Photograph 07: Level 1 meeting room 2.4, ceiling space - Lead contaminated dust throughout ceiling space

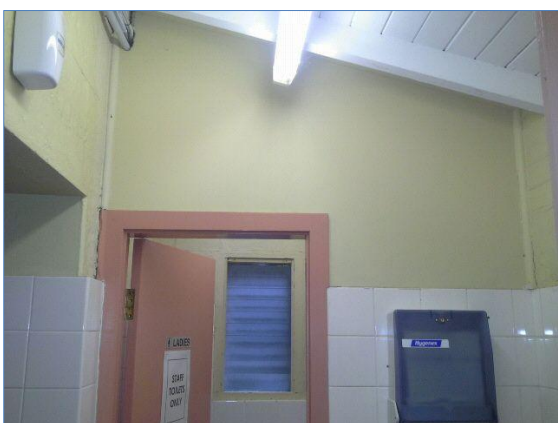
Photograph 09: Ground toilets - Fibre cement partition wall lining

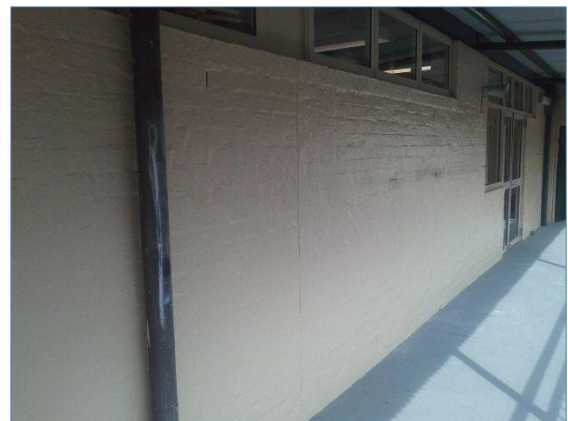
Photograph 06: External perimeter - Brick wall expansion gap mastic

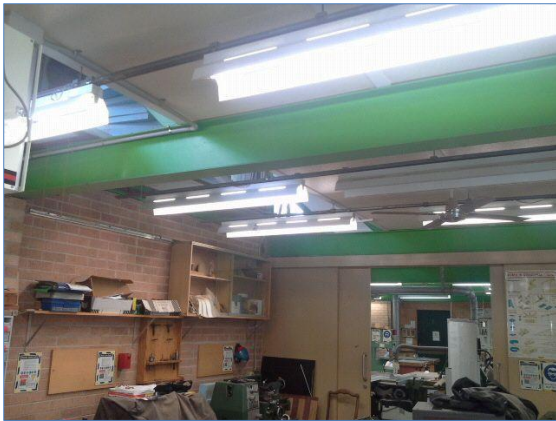
Photograph 07: Level 03 - Green paint to ceiling metal I beams

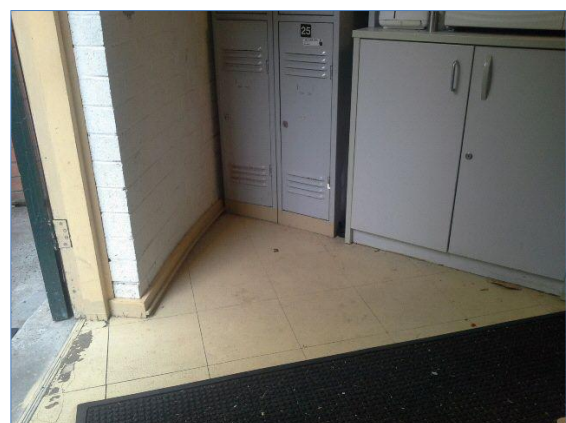
Photograph 12: Room 2.8 – Cream asbestos vinyl floor tiles throughout

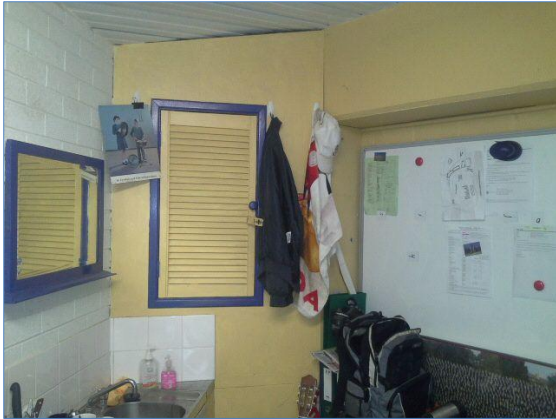
Photograph 13: Room 2.8 - Fibre cement south wall lining surrounding cupboard

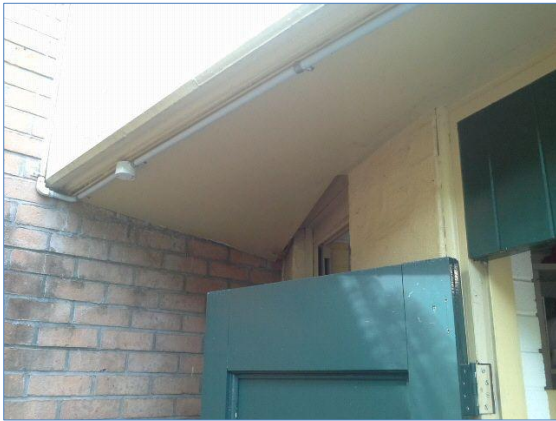
Photograph 14: Landing outside of room 2.8 - Fibre cement awning lining

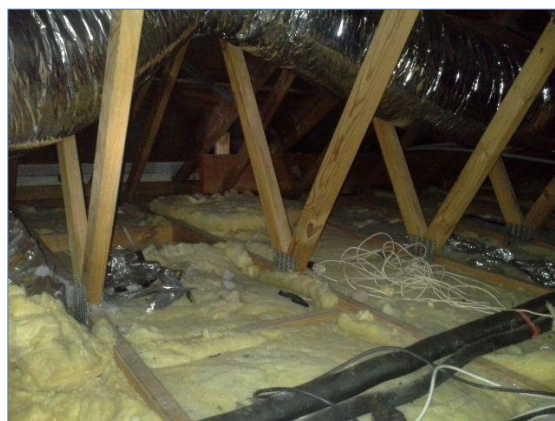
Photograph 06: Level 4 ceiling space - SMF insulating batts throughout

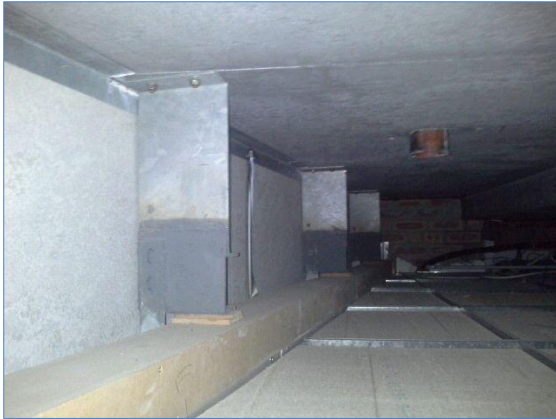
Photograph 07: Level 03 Room 3.12 - Fibre cement infill panels above northern windows above suspended ceiling

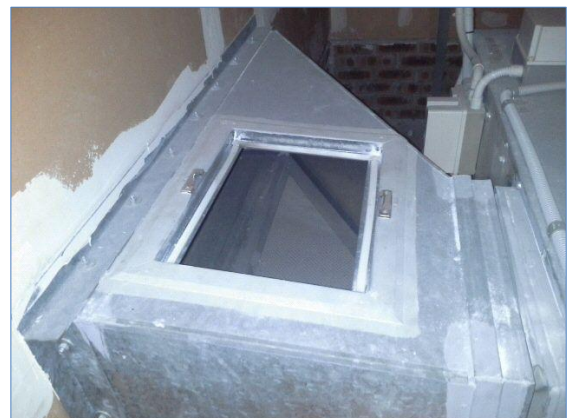
Photograph 12: Level 03 Office of the head master wing- SMF insulation within air handling ducts within ceiling space

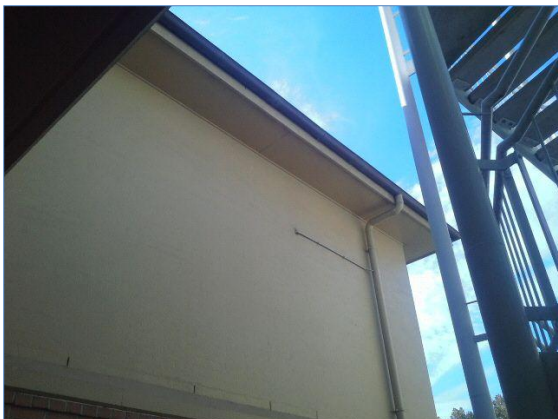
Photograph 13: Level 03 head master office wing external perimeter - Fibre cement eave lining

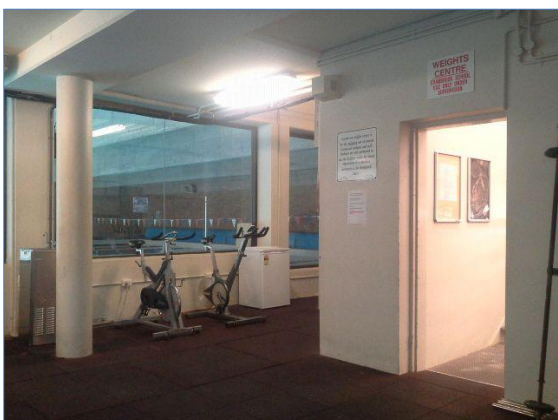
Photograph 15: Level 01 Weights area - White paint system to walls, columns and ceilings

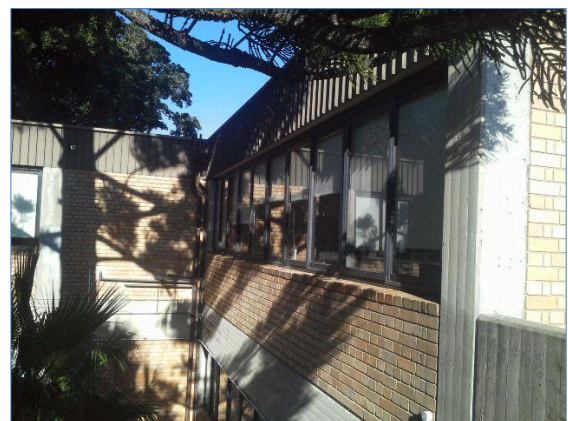
Photograph 06: Level 5 external south elevation - Presumed asbestos cement eave lining

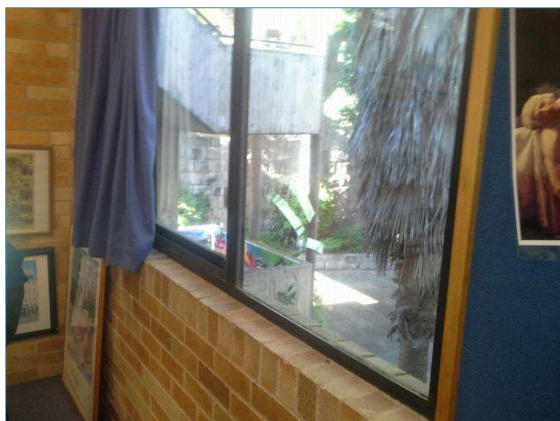
Photograph 07: Throughout Senior School Building - Asbestos window putty

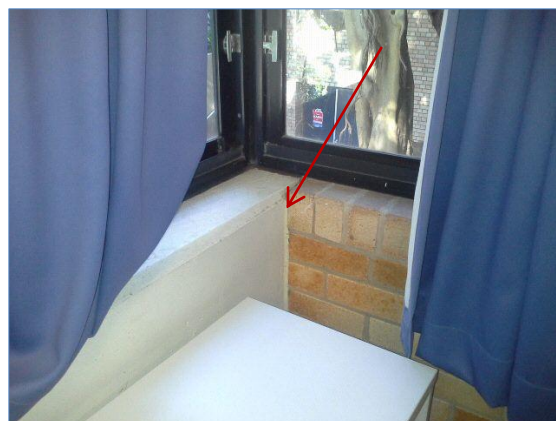
Photograph 12: Level 4 throughout - Brown expansion gap mastic between brickwork and concrete

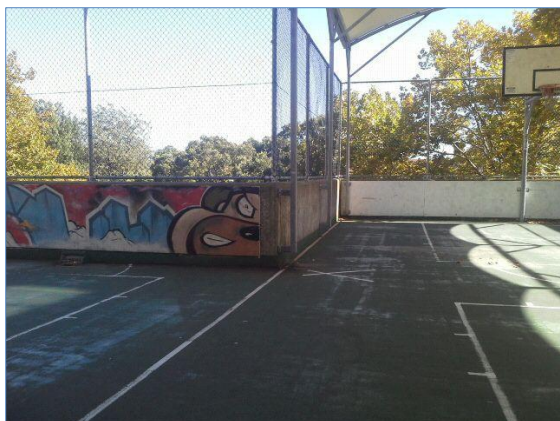
Photograph 13: Level 03 Terrace 3.21 - Fibre cement wall panelling

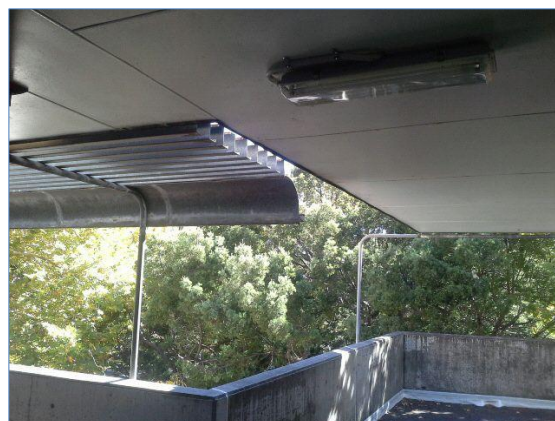
Photograph 18: Level 2 external corridor to Woodward terrace - Fibre cement awning lining

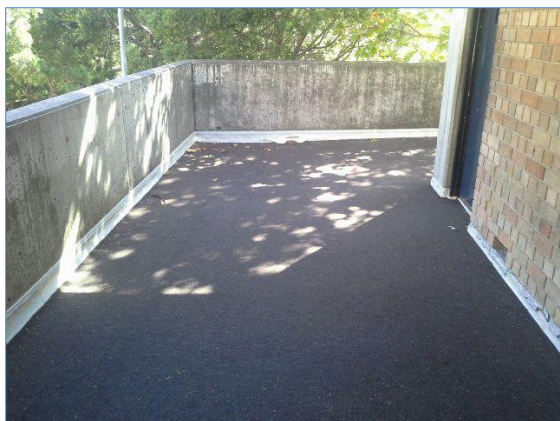
Photograph 19: Level 2 northern terraces - Waterproofing membrane

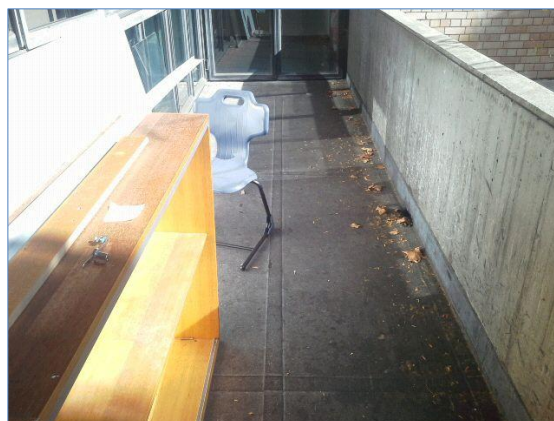
Photograph 24: Level 1 balcony 1.26 - Asbestos containing bituminous membrane floor covering

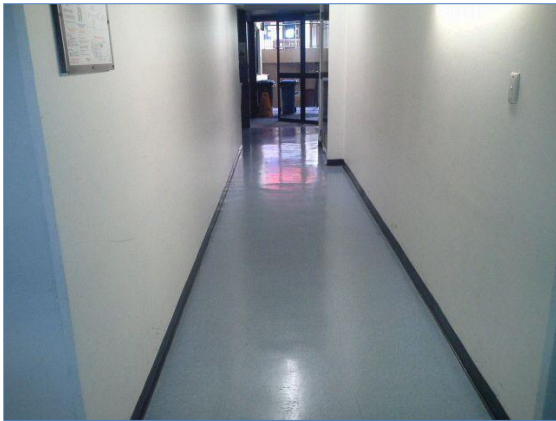
Photograph 25: Level 1 corridors throughout:
Blue asbestos vinyl tiles under vinyl sheeting

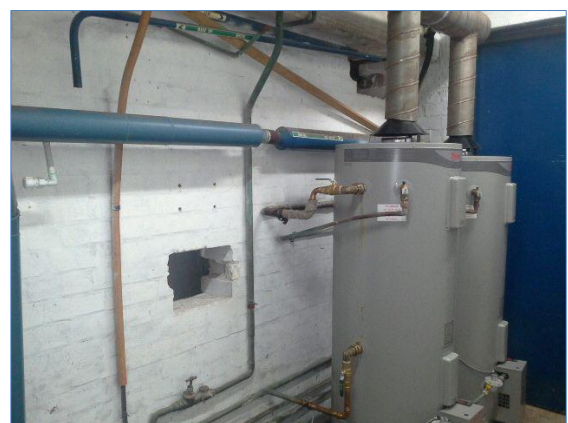
Photograph 30: Level 1 pool heater room 1.7-
SMF insulation to hot water units and pipes

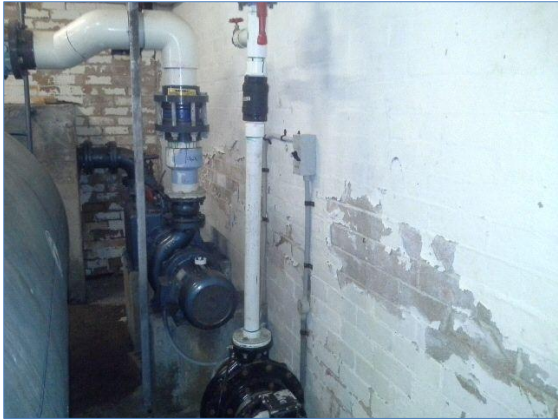
Photograph 31: Level 1 pool treatment room 1.8 - Flaking paint to walls

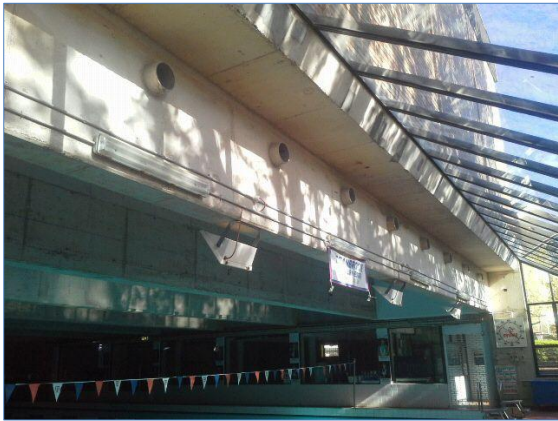
Photograph 32: Swimming pool 1.31 - Asbestos cement conduits fixed within northern most bulkhead

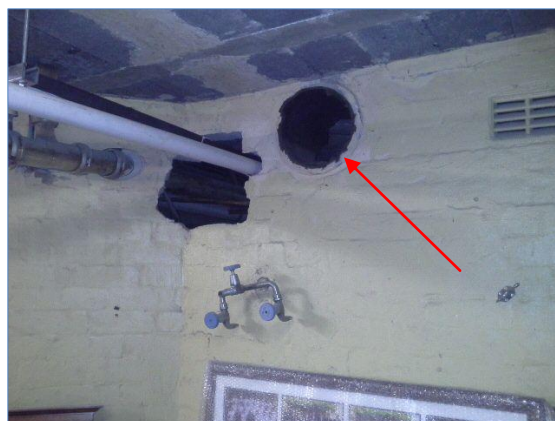
Photograph 06: Level 1 Store MB1.17 asbestos pipe

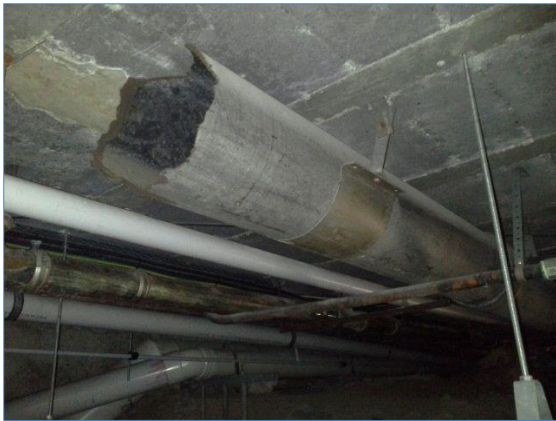
Photograph 07: Level 1 void west of Store MB1.7 - Broken asbestos pipe

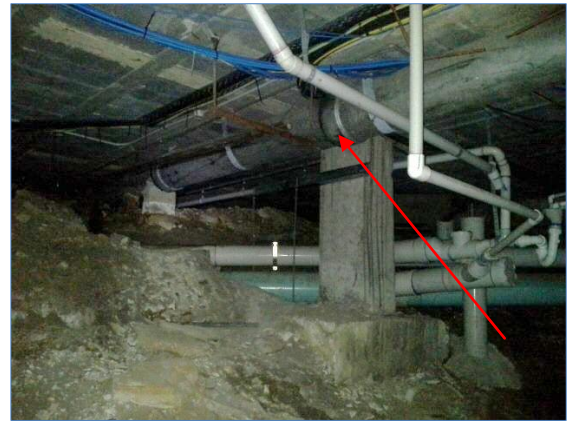
Photograph 10: Void south of store MB1.10 - Asbestos pipe

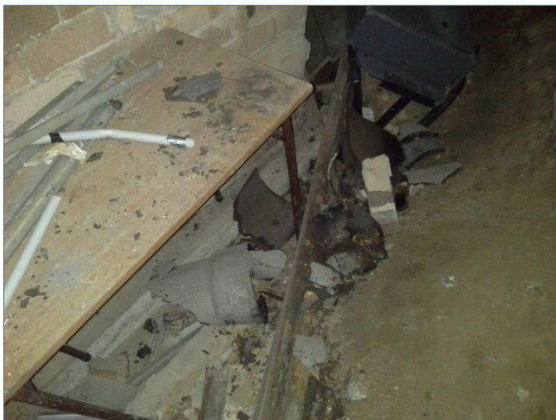
Photograph 08: Void west of Store MB1.7 - Broken asbestos pipe debris on ground surface

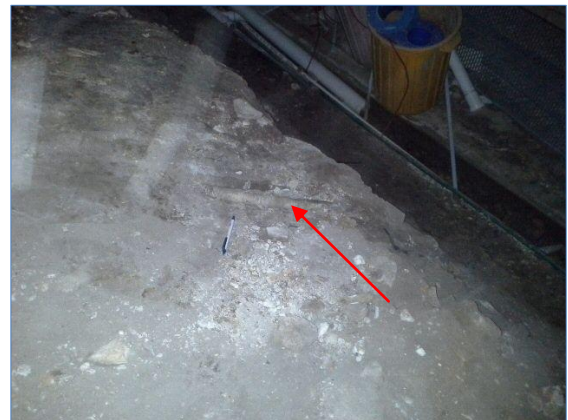
Photograph 11: Level 1 void South of store MB1.10 - Redundant pipe with asbestos rope insulation

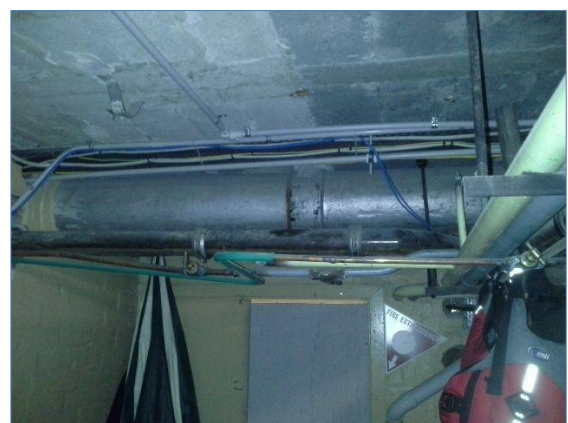
Photograph 12: Level 1 Store MB1.10 - Asbestos pipe

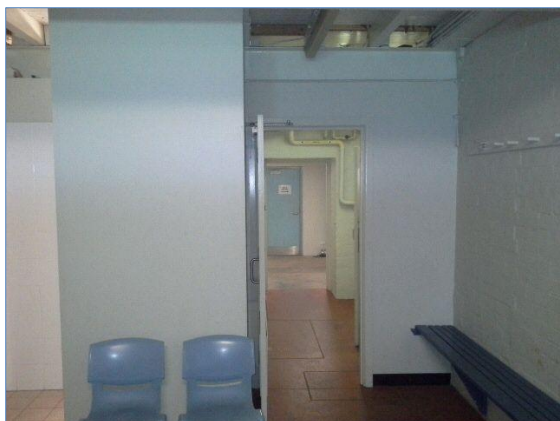
Photograph 13: Level 1 change room G1.15 and shower G1.16 - Fibre cement partition wall lining

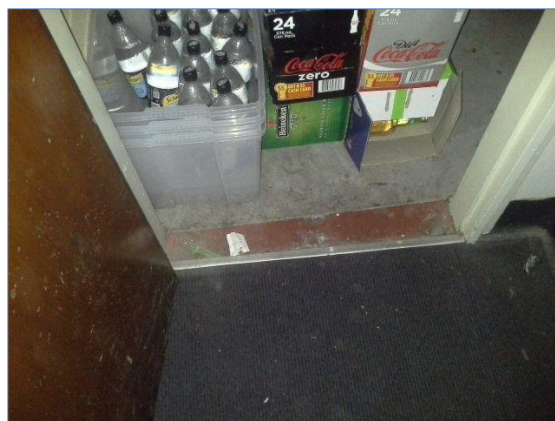
Photograph 18: Common room - Red vinyl floor tiles under carpet

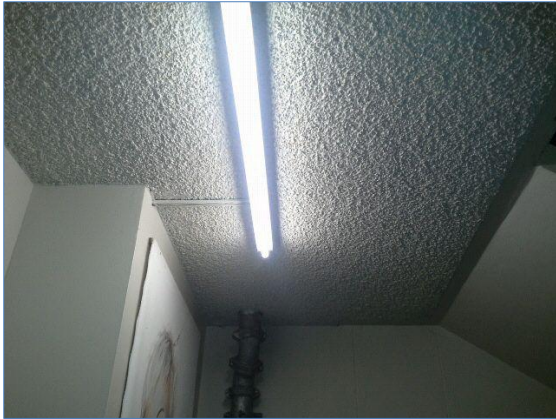
Photograph 19: Stairwell entrance - Vermiculite coating to soffit

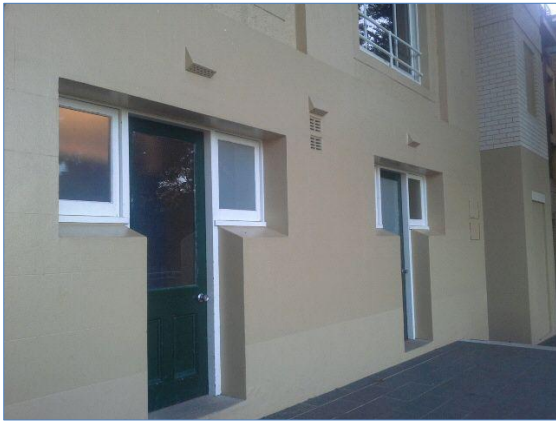
Photograph 20: Exterior - Cream paint to walls, White paint to windows, and Green paint to doors

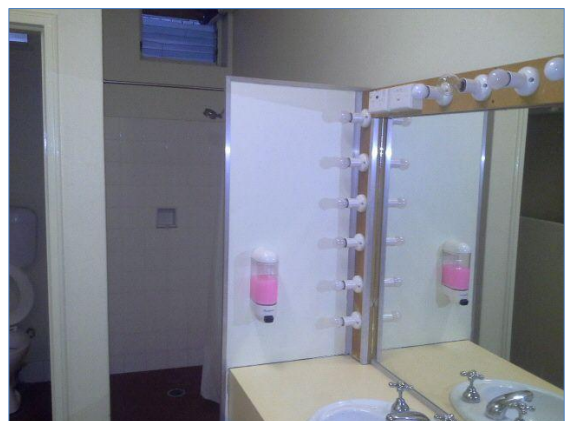
Photograph 06: Basement change room 1.10 - Compressed fibre cement vanity partition

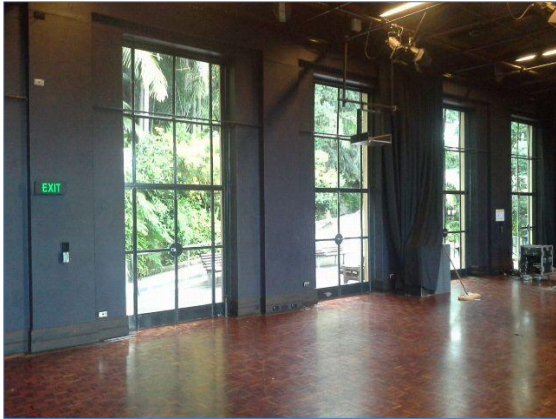
Photograph 07: Ground level hall - Black paint system to walls

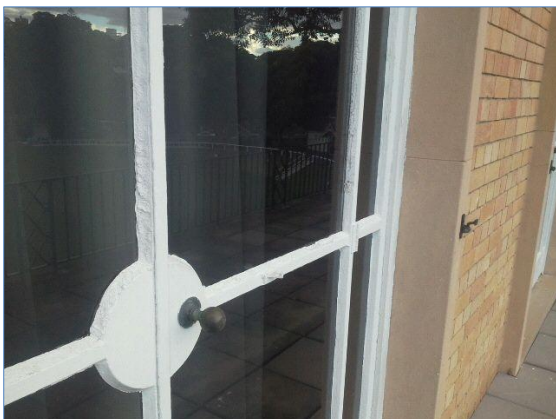
Photograph 09: Ground floor External - Putty between metal window and door frames and glass pane.

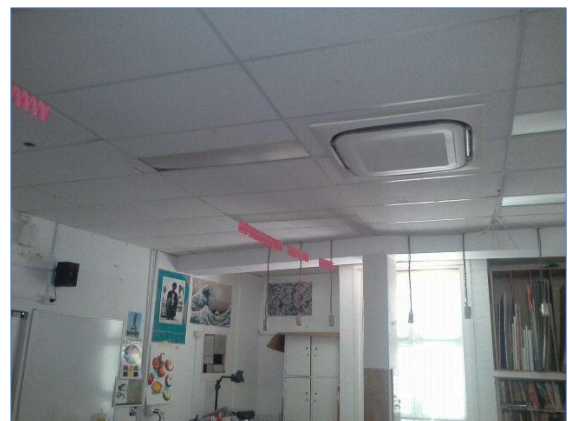
Photograph 06: Studio 3 - 2.5 - SMF containing suspended ceiling tiles

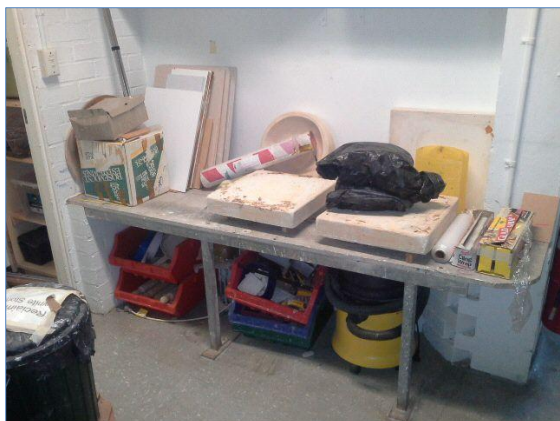
Photograph 07: Studio 3 - 2.5 - Compressed asbestos cement bench in south east corner of room

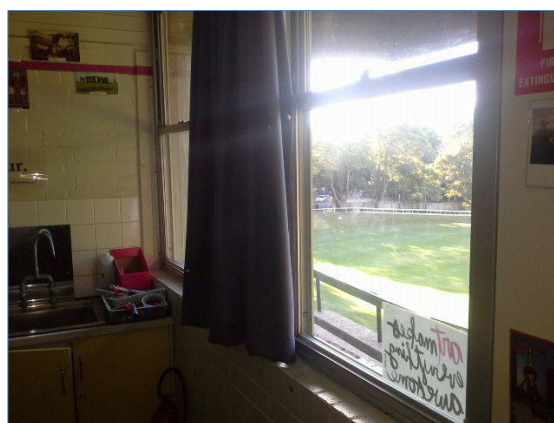
Photograph 12: Studio 4 - 1.2 - Putty between aluminium window frame and glass pane

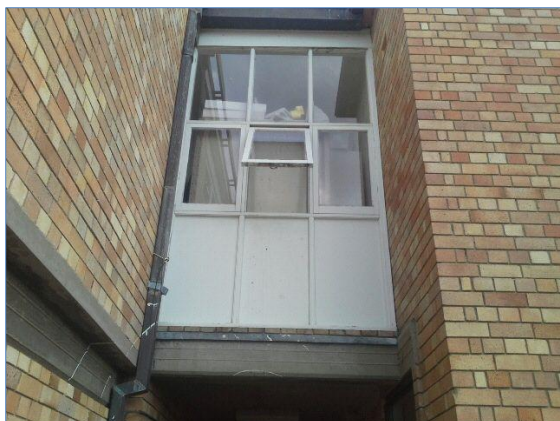
Photograph 13: Level 2 room 2.6 - Fibre cement infill panels under windows. Asbestos bituminous membrane below flooring. Sheeting can be seen entering under bricks

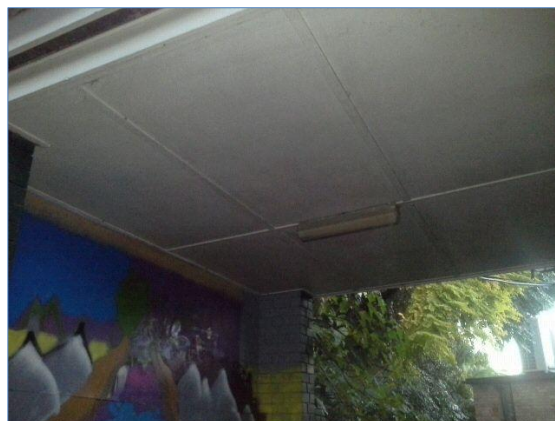
Photograph 14: South entrance - Asbestos cement awning lining

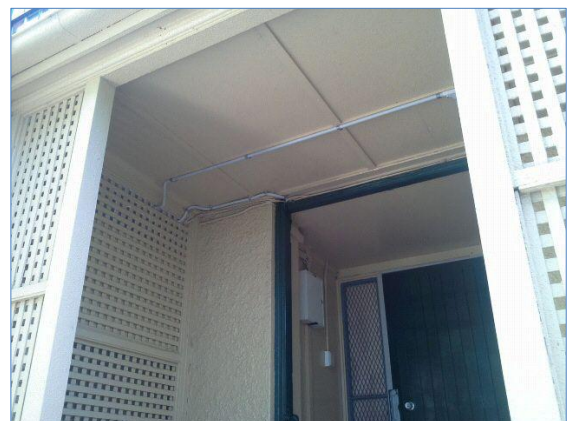
Photograph 06: East entrance - Asbestos cement awning lining

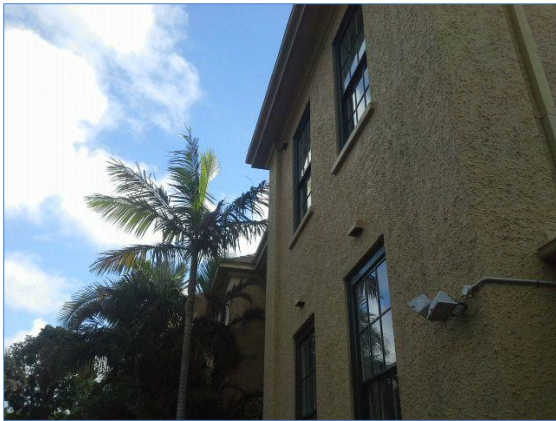
Photograph 07: External perimeter - Asbestos cement eave lining

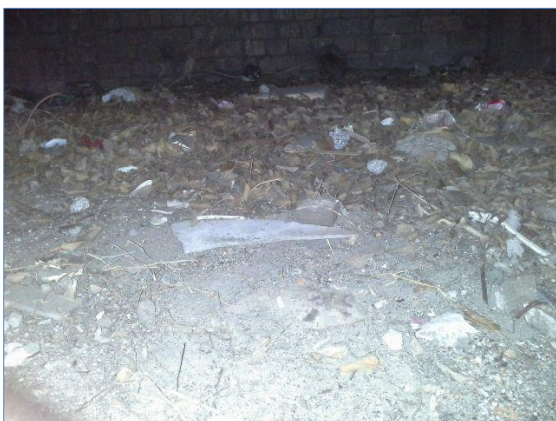
Photograph 09: Foundation space below offices 1.3 & 1.4 - Asbestos cement debris throughout

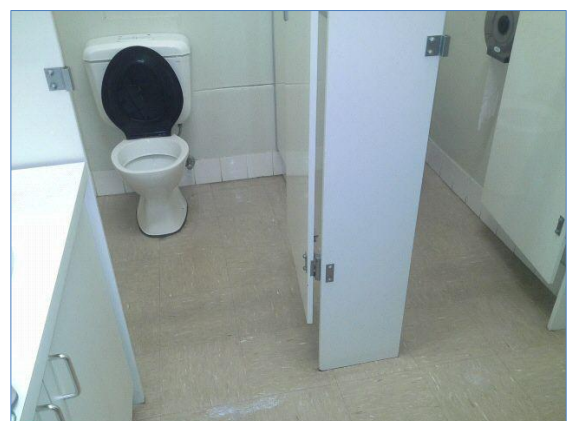
Photograph 12: Level 1 Ladies 2.10 - Vinyl floor tiles and fibre cement toilet partitions

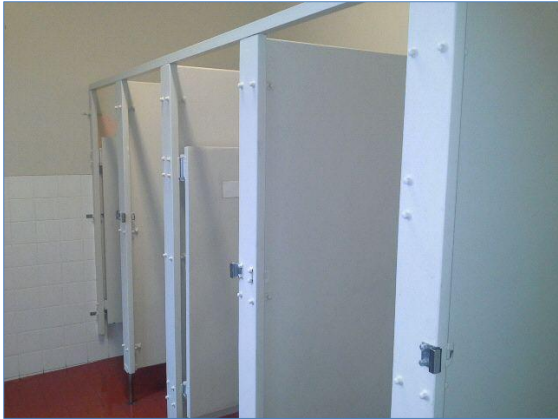
Photograph 13: Ground floor boys toilet 1, 2A – cement like toilet partitions

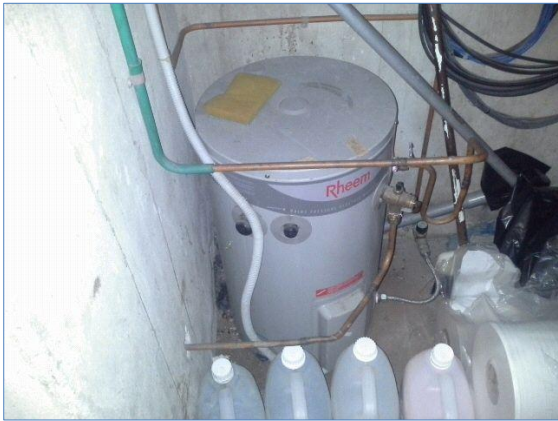
Photograph 14: Ground floor under stairs cupboard accessed from male toilet 1.9 - SMF insulation within hot water unit

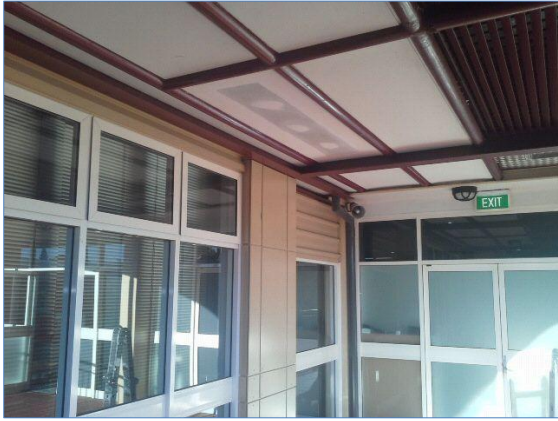
Photograph 02: Level 4 access balcony Fibre cement eaves and compress Fibre cement wall cladding

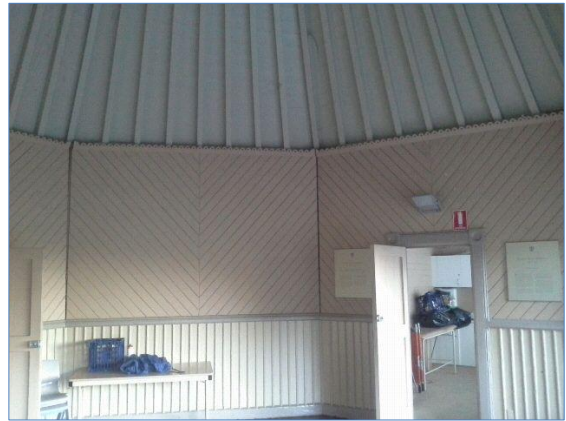
Photograph 04: John Saunders Pavilion - Green paint to ceiling and eaves, Tan paint to upper walls, Cream paint to lower walls, Mauve paint to door frame, skirting boards and trim.
