**ST. JOSEPH'S COLLEGE**  
**Visual Arts and John Healy Fitness Centre Buildings**  
**MARK STREET, HUNTERS HILL**  
**NSW**

**HAZARDOUS MATERIAL INSPECTION REPORT**

**MARCH 2018**

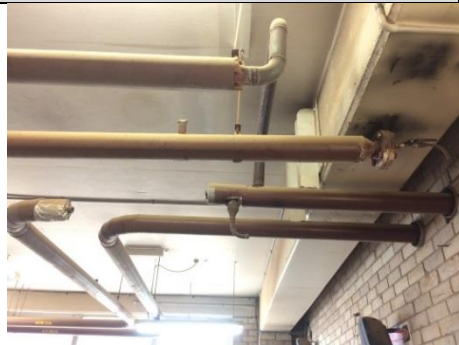
Asbestos containing material with a moderate risk rating has been identified in the gaskets located on the ground floor John Healy Fitness Centre hot water laundry pipes on ceiling which are not in use. These are a moderate risk rating due to their friable nature and fair condition.

| Sample # | Sample Date | Specific location | Material | Extent (m <sup>2</sup> ) | Type | Condition | Exposure Risk | Refer Identical material | Result | Overall risk rating | Comments | Reinspection Due | Photo |
|---|---|---|---|---|---|---|---|---|---|---|---|---|---|
| 10722 A1 | 15/01/2018 | Ground Floor John Healy Fitness Centre hot water laundry pipes on ceiling (not in use) | Gaskets | All gaskets | Friable | Fair | Low | - | Chrysotile Asbestos Detected | Moderate | Moderate corrosion helping to deteriorate gasket condition. Encapsulate the gasket and inspect the condition annually | | |

Damaged ACM should be managed through isolation, removal or encapsulation as soon as possible. Prior to refurbishment of the building, damaged sections of asbestos should be repaired or replaced to prevent disturbance during renovations. Should the building be due for demolition all ACM should be removed prior to the works commencing.

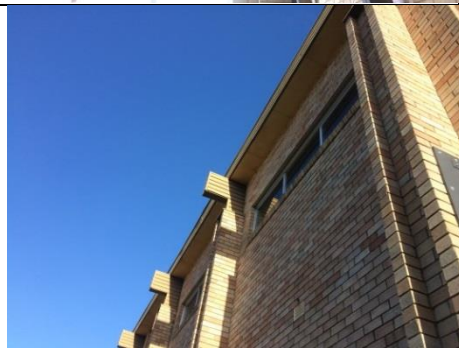
| Sample # | Sample Date | Specific location | Material | Extent (m <sup>2</sup> ) | Type | Condition | Exposure Risk | Refer Identical material | Result | Overall risk rating | Comments | Reinspection Due | Photo |
|---|---|---|---|---|---|---|---|---|---|---|---|---|---|
| 10722 A2.1 | 15/01/2018 | First Floor John Healy Fitness Centre exterior | External soffits | All external soffits | Non-friable | Good | Low | - | Presumed to contain Chrysotile Asbestos As detected in sample 10722 A2, analysed in original survey | Very low | Label and inspect the condition annually | | |

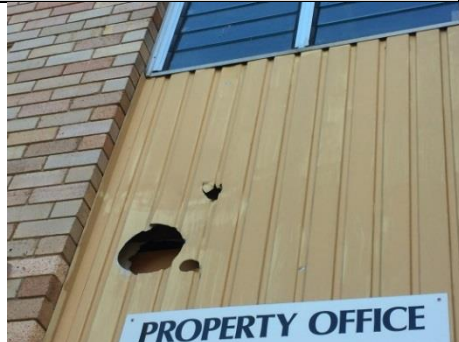
| Sample # | Sample Date | Specific location | Material | Extent (m <sup>2</sup> ) | Type | Condition | Exposure Risk | Refer Identical material | Result | Overall risk rating | Comments | Reinspection Due | Photo |
|---|---|---|---|---|---|---|---|---|---|---|---|---|---|
| 10722 A2.3 | 15/01/2018 | First Floor John Healey Fitness centre rear workshop fascia below window, behind metal cladding | Fibro sheet | 4 | Non-friable | Fair | Low | - | Presumed to contain Chrysotile Asbestos<br>As detected in sample 10722 A2, analysed in original survey | Very low | Encapsulate broken edges, label and reinspect annually | 15/01/2019 | |

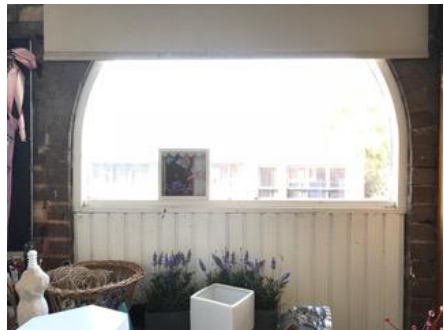
| Sample # | Sample Date | Specific location | Material | Extent (m <sup>2</sup> ) | Type | Condition | Exposure Risk | Refer Identical material | Result | Overall risk rating | Comments | Reinspection Due | Photo |
|---|---|---|---|---|---|---|---|---|---|---|---|---|---|
| - | 15/03/2018 | Visual Arts Building - Level 1 Eastern craft room - All window frames and boards below | White paint and undercoats | 10 | Non-Friable | Good | Low | The arts building - level 1 eastern Hallway and western room - window frames and surrounds | Positive for Lead Paint | Very Low | Implement appropriate controls, wear appropriate personal protective equipment (PPE), including respiratory protective equipment (RPE), and dispose of any waste residues appropriately if disturbed as part of refurbishment works. Maintain condition, reinspect annually | 15/03/2019 | |

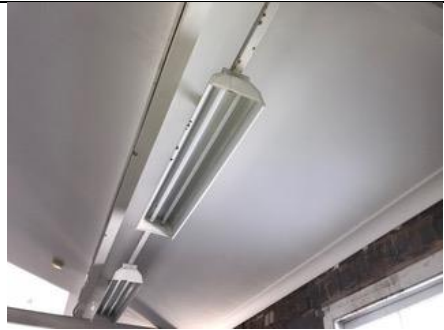
| Sample # | Sample Date | Specific location | Material | Extent (m <sup>2</sup> ) | Type | Condition | Exposure Risk | Refer Identical material | Result | Overall risk rating | Comments | Reinspection Due | Photo |
|---|---|---|---|---|---|---|---|---|---|---|---|---|---|
| 180309-P2 | 15/03/2018 | Visual Arts Building - Level 1 Eastern craft room - ceiling and cornice | White paint and undercoats | | | | | | | Negative for lead paint | | | |

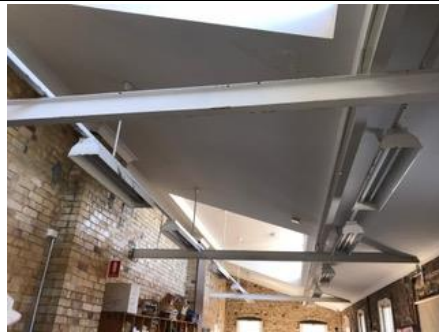
| Sample # | Sample Date | Specific location | Material | Extent (m <sup>2</sup> ) | Type | Condition | Exposure Risk | Refer Identical material | Result | Overall risk rating | Comments | Reinspection Due | Photo |
|---|---|---|---|---|---|---|---|---|---|---|---|---|---|
| - | 15/03/2018 | Visual Arts Building - Level 1 Eastern craft room - Roof steel beams | White paint and undercoats | 5 | Non-Friable | Good | Low | The arts building - level 1 eastern Hallway and western room- steal beams | Positive for Lead Paint | Very Low | Implement appropriate controls, wear appropriate PPE, including RPE, and dispose of any waste residues appropriately if disturbed as part of refurbishment works. Maintain condition, reinspect annually | 15/03/2019 | |

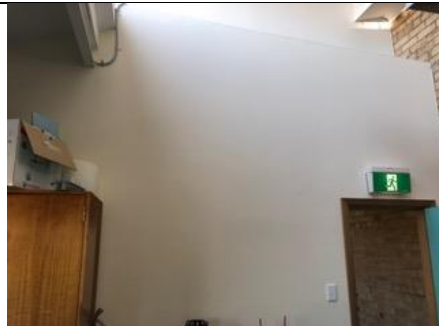
| Sample # | Sample Date | Specific location | Material | Extent (m <sup>2</sup> ) | Type | Condition | Exposure Risk | Refer Identical material | Result | Overall risk rating | Comments | Reinspection Due | Photo |
|---|---|---|---|---|---|---|---|---|---|---|---|---|---|
| 180309- P1 | 15/03/2018 | Visual Arts Building - level 1 eastern craft room - walls | Cream paint and undercoats | | | | | | Negative for lead paint | | | | |

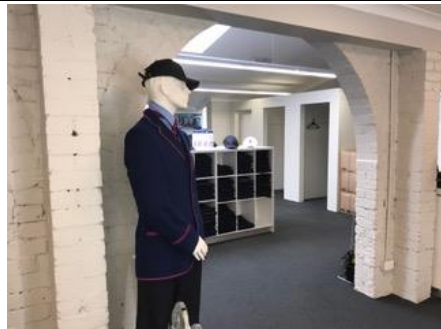
| Sample # | Sample Date | Specific location | Material | Extent (m <sup>2</sup> ) | Type | Condition | Exposure Risk | Refer Identical material | Result | Overall risk rating | Comments | Reinspection Due | Photo |
|---|---|---|---|---|---|---|---|---|---|---|---|---|---|
| - | 15/03/2018 | Visual Arts Building - ground floor - all masonry walls | Paint underlayers – various layers | All masonry walls | Non-Friable | Good | Low | - | Positive for Lead Paint | Very Low | Implement appropriate controls, wear appropriate PPE, including RPE, and dispose of any waste residues appropriately if disturbed as part of refurbishment works. Maintain condition, reinspect annually | 15/03/2019 | |

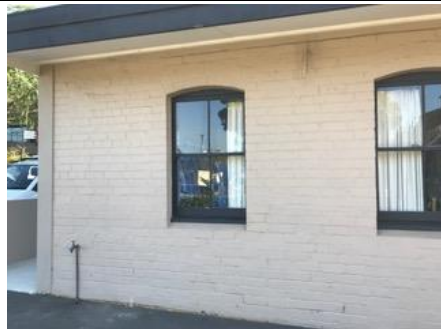
| Sample # | Sample Date | Specific location | Material | Extent (m <sup>2</sup> ) | Type | Condition | Exposure Risk | Refer Identical material | Result | Overall risk rating | Comments | Reinspection Due | Photo |
|---|---|---|---|---|---|---|---|---|---|---|---|---|---|
| - | 15/03/2018 | Visual Arts Building - External masonry wall | Paint underlayers – various layers | All masonry walls | Non-Friable | Good | Low | - | Positive for Lead Paint | Very Low | Implement appropriate controls, wear appropriate PPE, including RPE, and dispose of any waste residues appropriately if disturbed as part of refurbishment works. Maintain condition, reinspect annually | 15/03/2019 | |

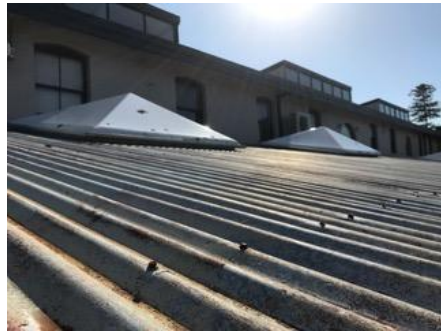
| Sample # | Sample Date | Specific location | Material | Extent (m <sup>2</sup> ) | Type | Condition | Exposure Risk | Refer Identical material | Result | Overall risk rating | Comments | Reinspection Due | Photo |
|---|---|---|---|---|---|---|---|---|---|---|---|---|---|
| - | 15/03/2018 | Visual Arts Building - roof | Residual paint – various layers | All roof | Non-Friable | Poor | Low | - | Positive for Lead Paint | Very Low | Implement appropriate controls, wear appropriate PPE, including RPE, and dispose of any waste residues appropriately if disturbed as part of refurbishment works. Maintain condition, reinspect annually | 15/03/2019 | |

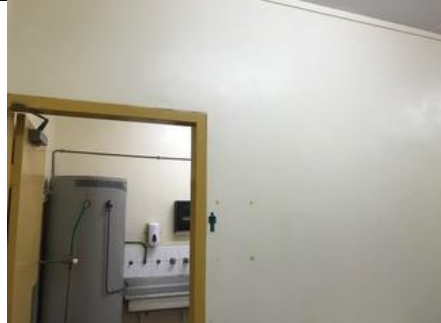
| Sample # | Sample Date | Specific location | Material | Extent (m <sup>2</sup> ) | Type | Condition | Exposure Risk | Refer Identical material | Result | Overall risk rating | Comments | Reinspection Due | Photo |
|---|---|---|---|---|---|---|---|---|---|---|---|---|---|
| 180309-P3 | 15/03/2018 | John Healy Fitness Centre - Ground floor Facilities amenities, ladies' toilet and first aid room | White paint underlayers | All walls | Non-Friable | Good | Low | - | Not lead paint but 0.46% lead detected in sample | Very Low | Wear appropriate PPE, including RPE if works involving abrasion or the potential to generate dust are required. Maintain condition, reinspect annually | 15/03/2019 | |

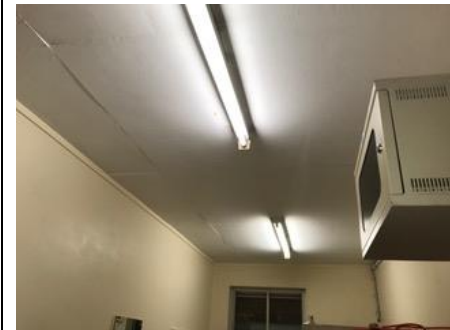
| Sample # | Sample Date | Specific location | Material | Extent (m <sup>2</sup> ) | Type | Condition | Exposure Risk | Refer Identical material | Result | Overall risk rating | Comments | Reinspection Due | Photo |
|---|---|---|---|---|---|---|---|---|---|---|---|---|---|
| - | 15/03/2018 | John Healy Fitness Centre – Ground floor Facilities amenities, ladies toilet, first aid room and workshop ceiling | Cream paint and undercoats | All ceilings | Non-Friable | Good | Low | - | Positive for Lead Paint | Very Low | Implement appropriate controls, wear appropriate PPE, including RPE, and dispose of any waste residues appropriately if disturbed as part of refurbishment works. Re-paint damaged areas maintain good condition, reinspect annually | 15/03/2019 | |

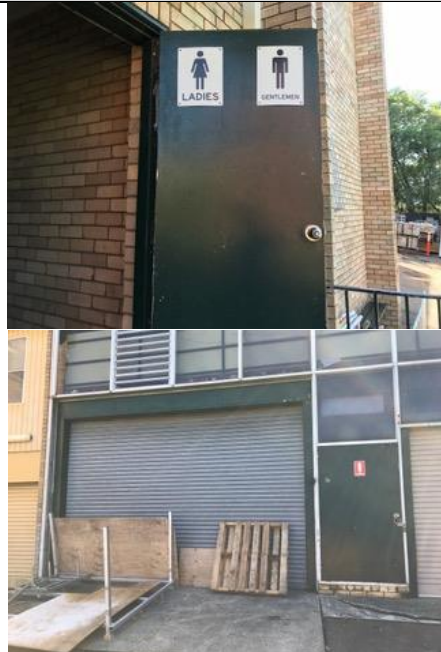
| Sample # | Sample Date | Specific location | Material | Extent (m <sup>2</sup> ) | Type | Condition | Exposure Risk | Refer Identical material | Result | Overall risk rating | Comments | Reinspection Due | Photo |
|---|---|---|---|---|---|---|---|---|---|---|---|---|---|
| 180309-P4 | 15/03/2018 | John Healy Fitness Centre – Ground floor Facilities main entrance door. | Green paint and undercoats | | | | | John Healy Fitness Centre Subfloor, access panel near amenities entrance and entrance to old workshop under PDHPE classroom | | | Negative for lead paint | | |

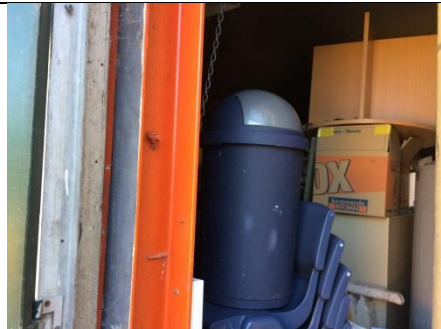
| Sample # | Sample Date | Specific location | Material | Extent (m <sup>2</sup> ) | Type | Condition | Exposure Risk | Refer Identical material | Result | Overall risk rating | Comments | Reinspection Due | Photo |
|---|---|---|---|---|---|---|---|---|---|---|---|---|---|
| 180309-P6 | 15/03/2018 | Old workshop under PDHPE classroom - steel structural members | Orange paint and underlayers | | | | | | | Negative for lead paint | | | |

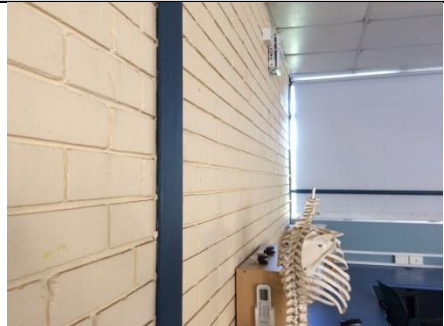
| Sample # | Sample Date | Specific location | Material | Extent (m <sup>2</sup> ) | Type | Condition | Exposure Risk | Refer Identical material | Result | Overall risk rating | Comments | Reinspection Due | Photo |
|---|---|---|---|---|---|---|---|---|---|---|---|---|---|
| 180309-P7 | 15/03/2018 | PDHPE classroom – structural steel and railings | Blue paint and undercoats | | | | | | Negative for lead paint | | | | |

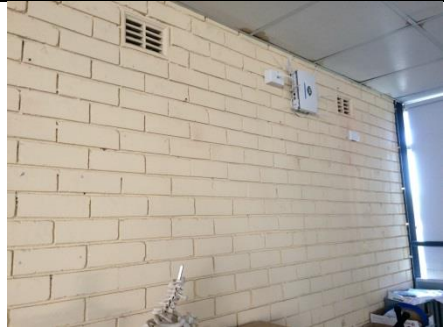
| Sample # | Sample Date | Specific location | Material | Extent (m <sup>2</sup> ) | Type | Condition | Exposure Risk | Refer Identical material | Result | Overall risk rating | Comments | Reinspection Due | Photo |
|---|---|---|---|---|---|---|---|---|---|---|---|---|---|
| 180309-P12 | 15/03/2018 | PDHPE classroom walls | Cream paint | | | | | | Negative for lead paint | | | | |

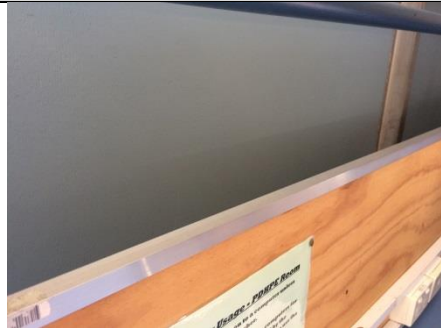
| Sample # | Sample Date | Specific location | Material | Extent (m <sup>2</sup> ) | Type | Condition | Exposure Risk | Refer Identical material | Result | Overall risk rating | Comments | Reinspection Due | Photo |
|---|---|---|---|---|---|---|---|---|---|---|---|---|---|
| 180309-P11 | 15/03/2018 | PDHPE classroom walls- wood panels below windows | Light blue paint | | | | | | Negative for lead paint | | | | |

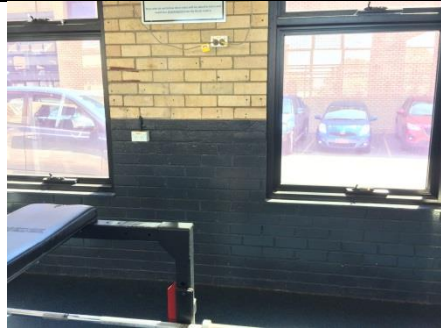
| Sample # | Sample Date | Specific location | Material | Extent (m <sup>2</sup> ) | Type | Condition | Exposure Risk | Refer Identical material | Result | Overall risk rating | Comments | Reinspection Due | Photo |
|---|---|---|---|---|---|---|---|---|---|---|---|---|---|
| 180309-P8 | 15/03/2018 | John Healy Fitness Centre - lower walls | Dark grey paint and underlayers | | | | | | Negative for lead paint | | | | |

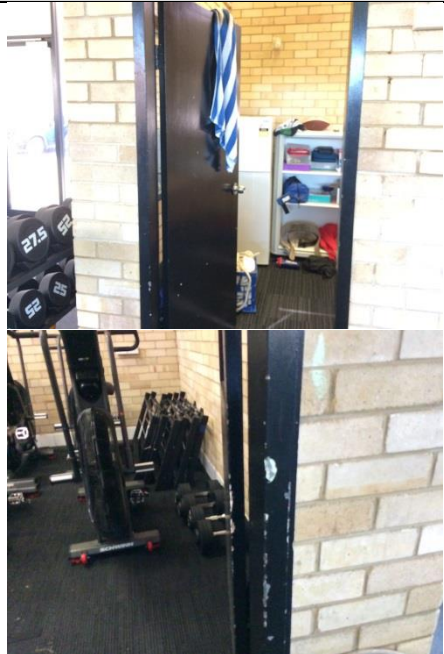
| Sample # | Sample Date | Specific location | Material | Extent (m <sup>2</sup> ) | Type | Condition | Exposure Risk | Refer Identical material | Result | Overall risk rating | Comments | Reinspection Due | Photo |
|---|---|---|---|---|---|---|---|---|---|---|---|---|---|
| 180309-P9 | 15/03/2018 | John Healy Fitness Centre - wooden doors and other woodwork | Black paint and underlayers | | | | | | Negative for lead paint | | | | |

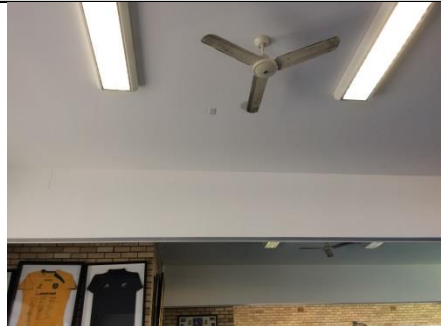
| Sample # | Sample Date | Specific location | Material | Extent (m <sup>2</sup> ) | Type | Condition | Exposure Risk | Refer Identical material | Result | Overall risk rating | Comments | Reinspection Due | Photo |
|---|---|---|---|---|---|---|---|---|---|---|---|---|---|
| 180309-P10 | 15/03/2018 | John Healy ceiling | White paint and undercoats | | | | | | Negative for lead paint | | | | |

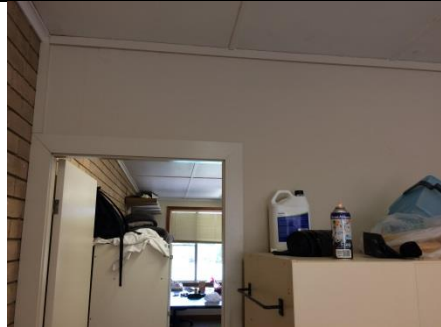
| Sample # | Sample Date | Specific location | Material | Extent (m <sup>2</sup> ) | Type | Condition | Exposure Risk | Refer Identical material | Result | Overall risk rating | Comments | Reinspection Due | Photo |
|---|---|---|---|---|---|---|---|---|---|---|---|---|---|
| 180309-P13 | 15/03/2018 | Cleaners room between John Healy Fitness Centre and PDPHE classroom - woodwork | Cream paint and undercoats | | | | | | Negative for lead paint | | | | |
| 180309-P14 | 15/03/2018 | Cleaners room between John Healy Fitness Centre and PDPHE classroom - walls | Cream paint and undercoats | | | | | | Negative for lead paint | | | | See photo above |

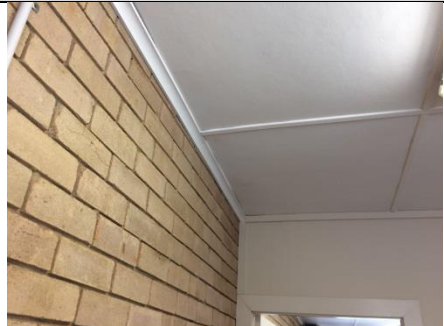
| Sample # | Sample Date | Specific location | Material | Extent (m <sup>2</sup> ) | Type | Condition | Exposure Risk | Refer Identical material | Result | Overall risk rating | Comments | Reinspection Due | Photo |
|---|---|---|---|---|---|---|---|---|---|---|---|---|---|
| 180309-P15 | 15/03/2018 | Cleaners room between John Healy Fitness Centre and PDPHE classroom - ceiling | White paint and undercoats | | | | | | Negative for lead paint | | | | |

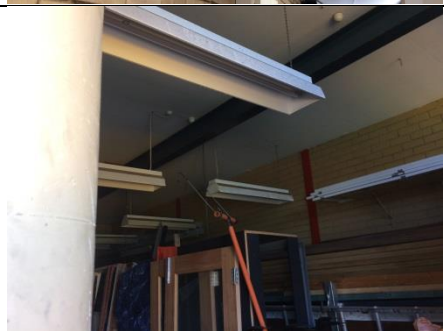
| Sample # | Sample Date | Specific location | Material | Extent (m <sup>2</sup> ) | Type | Condition | Exposure Risk | Refer Identical material | Result | Overall risk rating | Comments | Reinspection Due | Photo |
|---|---|---|---|---|---|---|---|---|---|---|---|---|---|
| 180309-P16 | 15/03/2018 | Old workshop below PDPHE classroom - walls and concrete columns | Cream paint and undercoats | | | | | | Negative for lead paint | | | | |

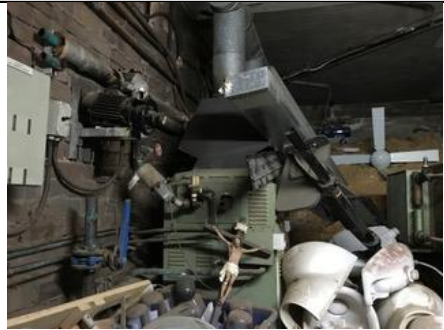
| Sample # | Sample Date | Specific location | Material | Extent (m <sup>2</sup> ) | Type | Condition | Exposure Risk | Refer Identical material | Result | Overall risk rating | Comments | Reinspection Due | Photo |
|---|---|---|---|---|---|---|---|---|---|---|---|---|---|
| | 15/03/2018 | John Healy Fitness Centre building subfloor undercroft in south western corner - Materials within disused boiler | Thermal insulation | Materials within | Friable | Good | Low | - | Presumed SMF | Low | Irritant to respiratory tract, eyes and skin. Appropriate PPE and RPE to be worn during disturbance of material | 15/03/2019 | |

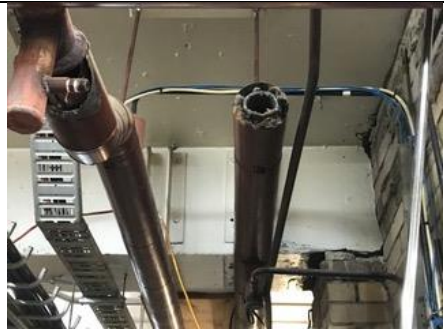
High risk SMF was located in the insulation of the hot water laundry pipes on the ceiling due to its friable nature, fair condition and moderate potential for exposure

| Sample # | Sample Date | Specific location | Material | Extent (m <sup>2</sup> ) | Type | Condition | Exposure Risk | Refer Identical material | Result | Overall risk rating | Comments | Reinspection Due | Photo |
|---|---|---|---|---|---|---|---|---|---|---|---|---|---|
| | 15/03/2018 | John Healy Fitness Centre building hot water laundry pipes on ceiling (not in use) | Thermal insulation | All pipe insulation | Friable | Fair | Moderate | - | Presumed mineral wool SMF | High | Irritant to respiratory tract, eyes and skin. All exposed SMF should be encapsulated, appropriate PPE and RPE to be worn during disturbance of material | 15/03/2019 | |

SMF is an irritant to the respiratory tract. All exposed SMF should be encapsulated, appropriate PPE and RPE to be worn during disturbance of material.

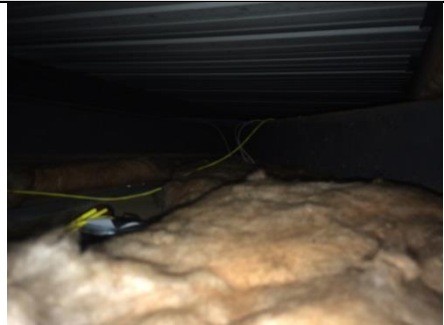
| Sample # | Sample Date | Specific location | Material | Extent (m <sup>2</sup> ) | Type | Condition | Exposure Risk | Refer Identical material | Result | Overall risk rating | Comments | Reinspection Due | Photo |
|---|---|---|---|---|---|---|---|---|---|---|---|---|---|
| | 15/03/2018 | PDHPE classroom - ceiling cavity | Thermal insulation | Unknown | Friable | Good | Low | - | Presumed modern SMF | Very Low | Maintain condition, reinspect annually | 15/03/2019 | |

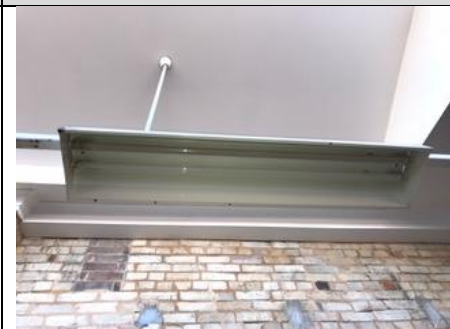
| Sample # | Sample Date | Specific location | Material | Extent (m <sup>2</sup> ) | Type | Condition | Exposure Risk | Refer Identical material | Result | Overall risk rating | Comments | Reinspection Due | Photo |
|---|---|---|---|---|---|---|---|---|---|---|---|---|---|
| | 15/03/2018 | Visual Arts Building - Level 1 Eastern craft room high level light fittings | Electrical components | All light fittings | Non-Friable | Good | Low | Hallway lights and ground floor uniform shop storeroom lights | Presumed PCB electrics | Very low | Based on appearance and assumed age of fittings. Maintain condition, reinspect annually | 15/03/2019 | |

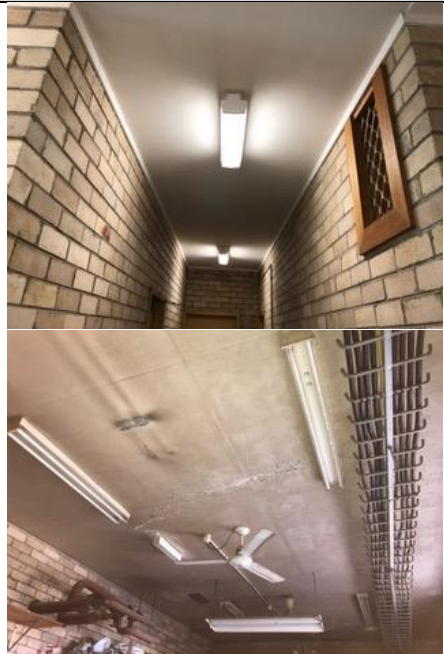
| Sample # | Sample Date | Specific location | Material | Extent (m <sup>2</sup> ) | Type | Condition | Exposure Risk | Refer Identical material | Result | Overall risk rating | Comments | Reinspection Due | Photo |
|---|---|---|---|---|---|---|---|---|---|---|---|---|---|
| | 15/03/2018 | John Healy Fitness Centre - ground floor light fittings except in Facilities office | Electrical components | Unknown | Non-Friable | Good | Low | - | Presumed PCB electrics | Very low | Based on appearance and assumed age of fittings. Maintain condition, reinspect annually | 15/03/2019 | |

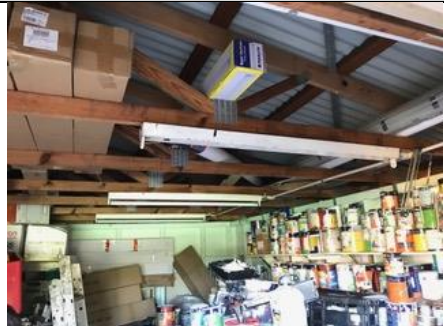
| Sample # | Sample Date | Specific location | Material | Extent (m <sup>2</sup> ) | Type | Condition | Exposure Risk | Refer Identical material | Result | Overall risk rating | Comments | Reinspection Due | Photo |
|---|---|---|---|---|---|---|---|---|---|---|---|---|---|
| | 15/03/2018 | Shed on Luke St, east of PDHPE classroom building – High level light fittings | Electrical components | Unknown | Non-Friable | Good | Low | - | Presumed PCB electrics | Very low | Based on appearance and assumed age of fittings. Maintain condition, reinspect annually | 15/03/2019 | |

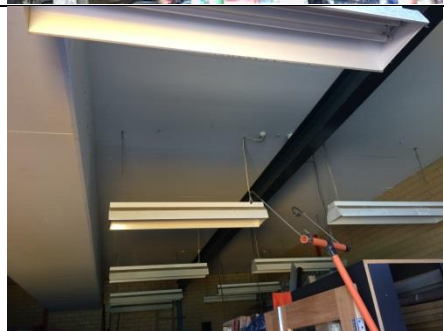
| Sample # | Sample Date | Specific location | Material | Extent (m <sup>2</sup> ) | Type | Condition | Exposure Risk | Refer Identical material | Result | Overall risk rating | Comments | Reinspection Due | Photo |
|---|---|---|---|---|---|---|---|---|---|---|---|---|---|
| | 15/03/2018 | Old workshop below PDHPE classroom - High level light fittings | Electrical components | Unknown | Non-Friable | Good | Low | - | Presumed PCB electrics | Very low | Based on appearance and assumed age of fittings. Maintain condition, reinspect annually | 15/03/2019 | |

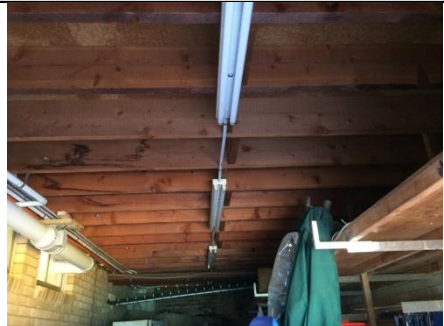
| Sample # | Sample Date | Specific location | Material | Extent (m <sup>2</sup> ) | Type | Condition | Exposure Risk | Refer Identical material | Result | Overall risk rating | Comments | Reinspection Due | Photo |
|---|---|---|---|---|---|---|---|---|---|---|---|---|---|
| | 15/03/2018 | Basketball court storage garage under cleaners' room. | Electrical components | Unknown | Non-Friable | Good | Low | - | Presumed PCB electrics | Very low | Based on appearance and assumed age of fittings. Maintain condition, reinspect annually | 15/03/2019 | |

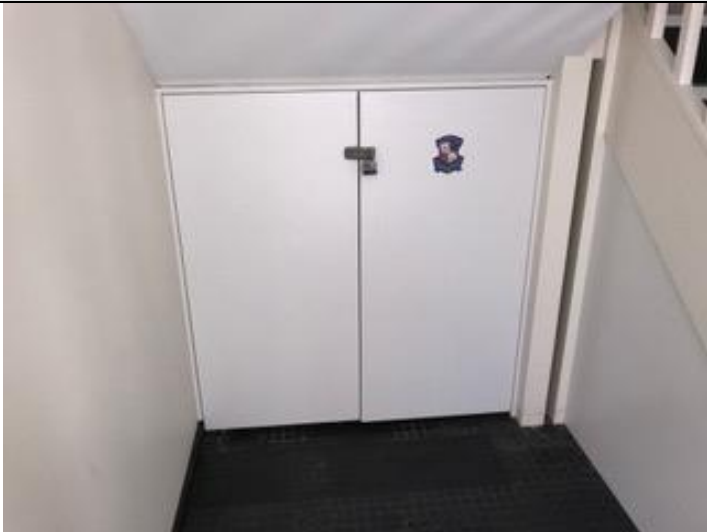
| LOCATION | REASON | PHOTO |
|---|---|---|
| Interior arts building under stairs | Padlocked with no available key | |

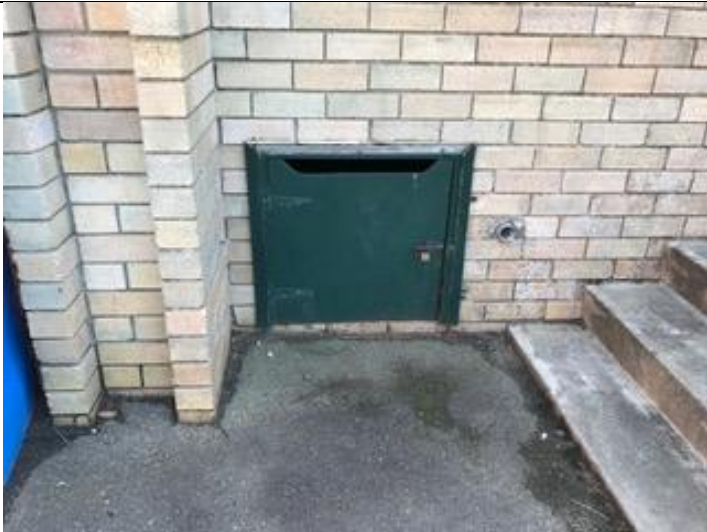
| LOCATION | REASON | PHOTO |
|---|---|---|
| John Healy Fitness Centre subfloor access left of amenities entrance | Padlocked with no available key | |

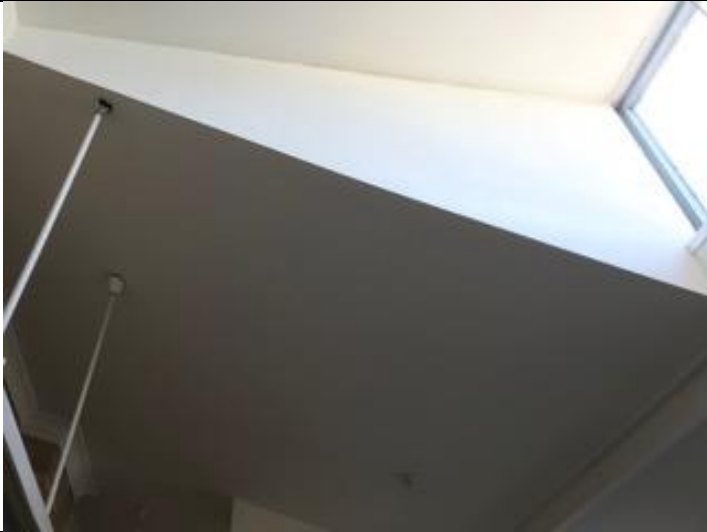
| LOCATION | REASON | PHOTO |
|---|---|---|
| The Arts Building - level 1 hall way ceiling cavity | No manhole or roof access | |
