Report on
Contaminated Land Preliminary Site Investigation

Proposed Hospital Upgrade
Bowral & District Hospital, Mona Road, Bowral

Prepared for
Health Infrastructure

Project 89199.01
September 2016

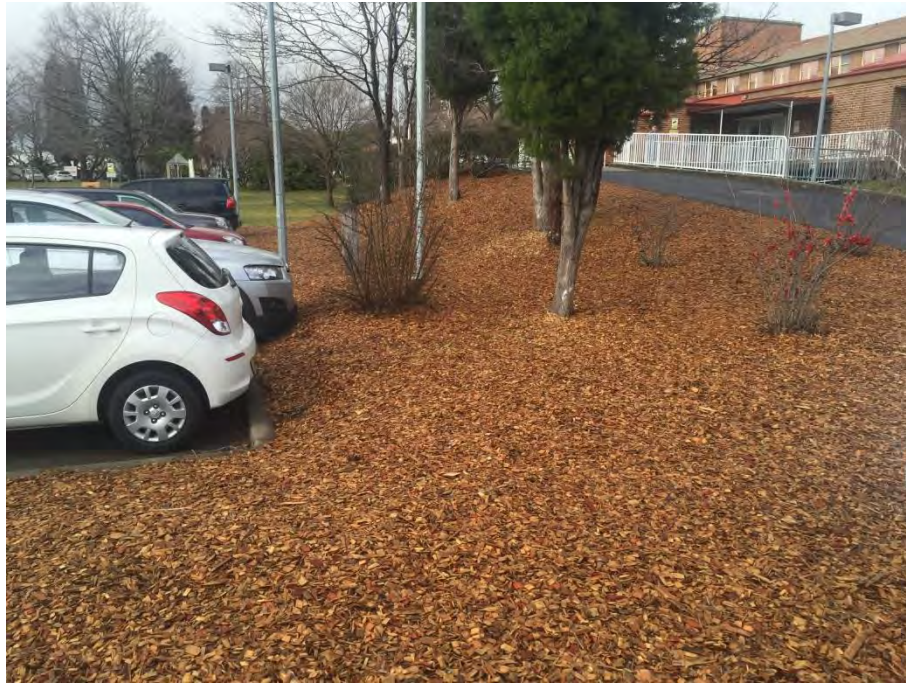
- A batter potentially containing filling was observed adjacent to the southern extent of the car park as highlighted on Drawing 1, Appendix B and shown in Photograph 3, Appendix C;

Photograph 3 – View of batter adjacent to northern car park with potential filling

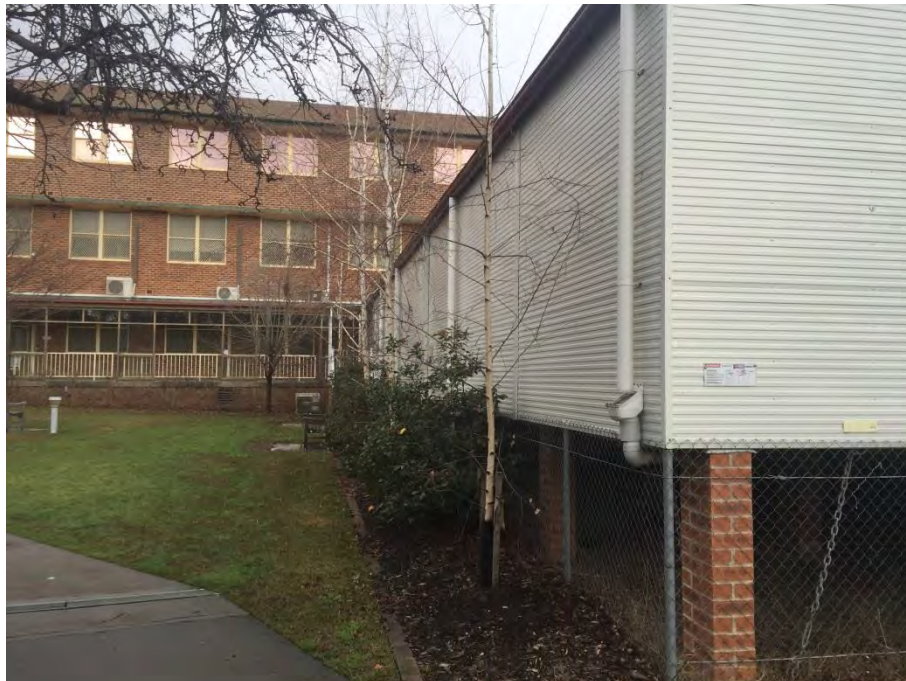
Photograph 4 – General view of hospital buildings

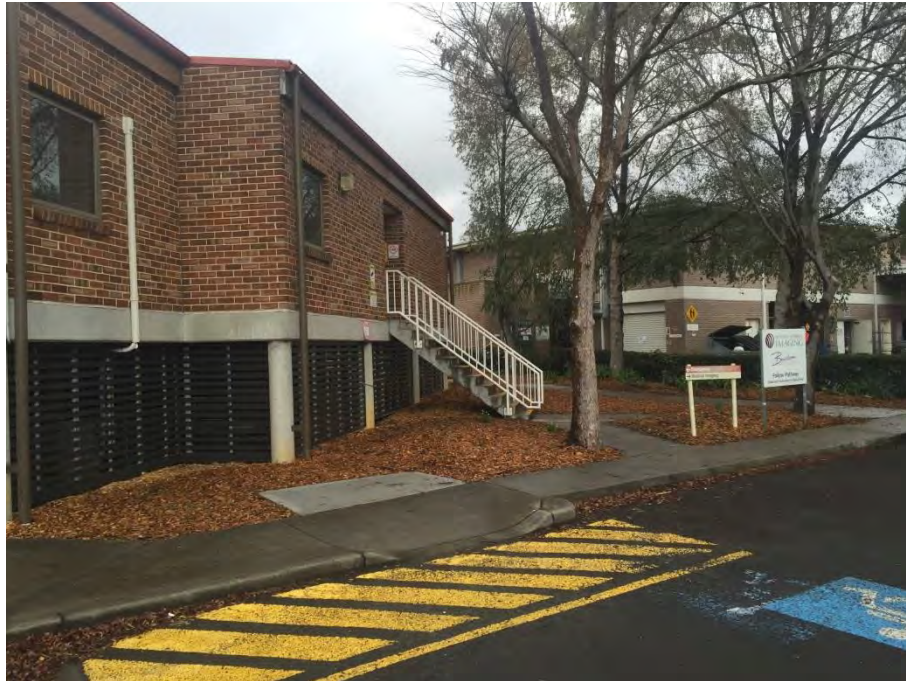
Photograph 5 – General view of hospital buildings

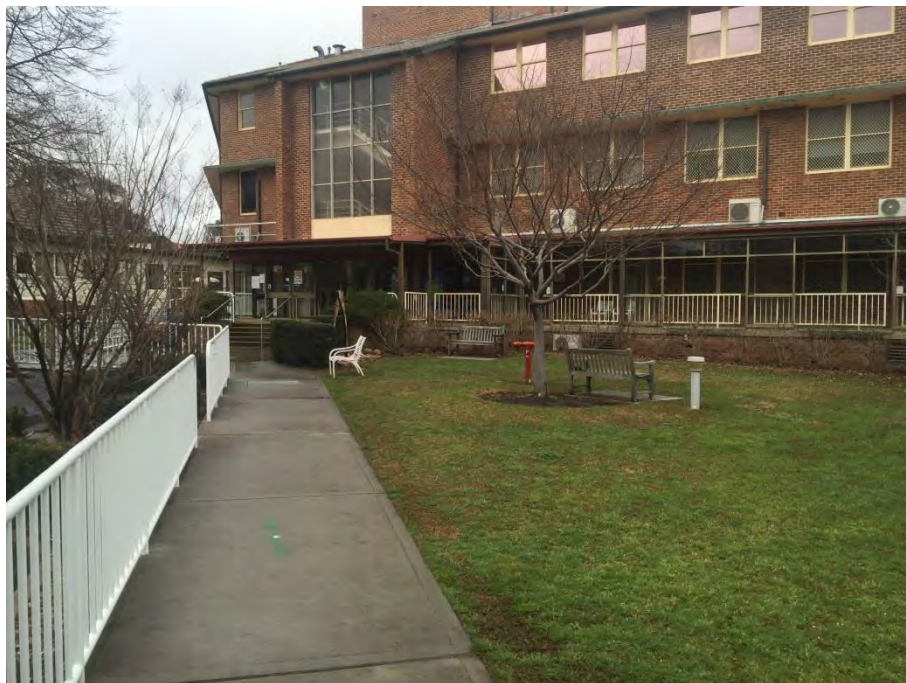
Photograph 6 – General view of hospital buildings

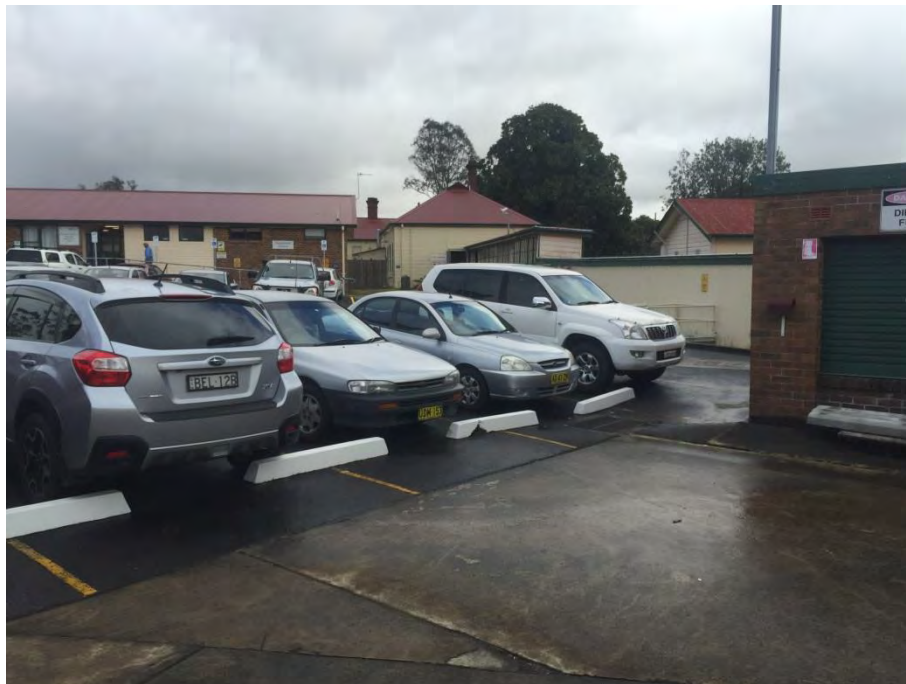
Photograph 7 – View of southern car park

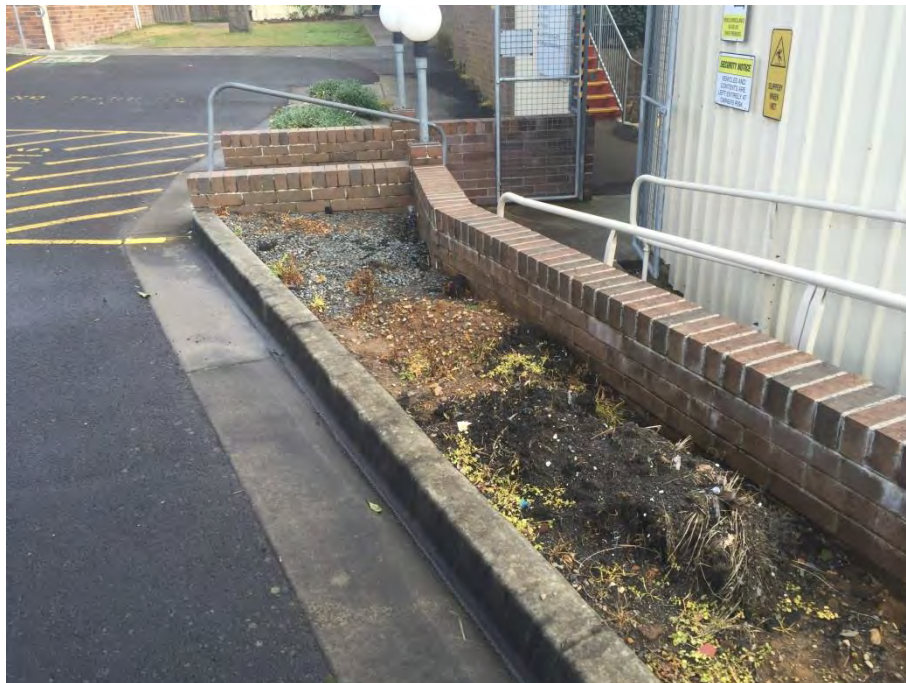
- The southern portion of the site included the following:
 - o An asphaltic concrete car park; refer to Photograph 7, Appendix C. Evidence that the car park platform had potentially been filled was observed on exposed edges of the car park; refer to Photograph 8, Appendix C;

Photograph 8 – Evidence of filling adjacent to southern car park

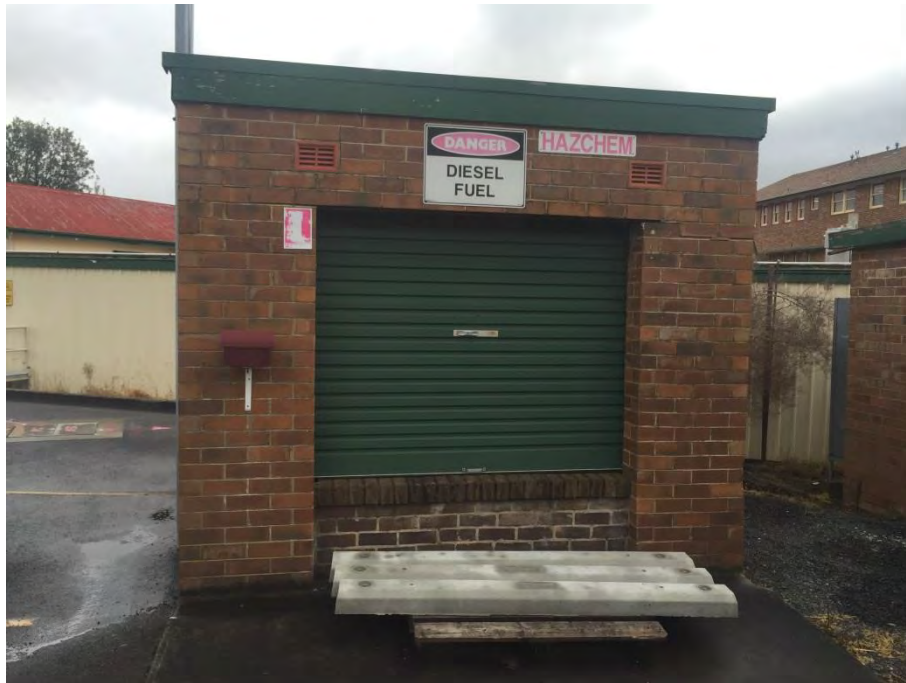
- o A brick building on a concrete slab base housing a diesel fuel storage tank; refer to Photograph 9, Appendix C. It is noted that access the building was not available to

determine the condition of the tank, however, no signs of contamination were observed surrounding the building;

Photograph 9 – View of diesel storage building
