01 Februray 2019
Document Ref: 20191973

**Subject: Arborist Report for Proposed Warnervale Primary School site, 75
Warnervale Road, Warnervale NSW.**

SULE (Safe Useful Life Expectancy) REPORT

**WARNER VALE ROAD
WANRNER VALE**

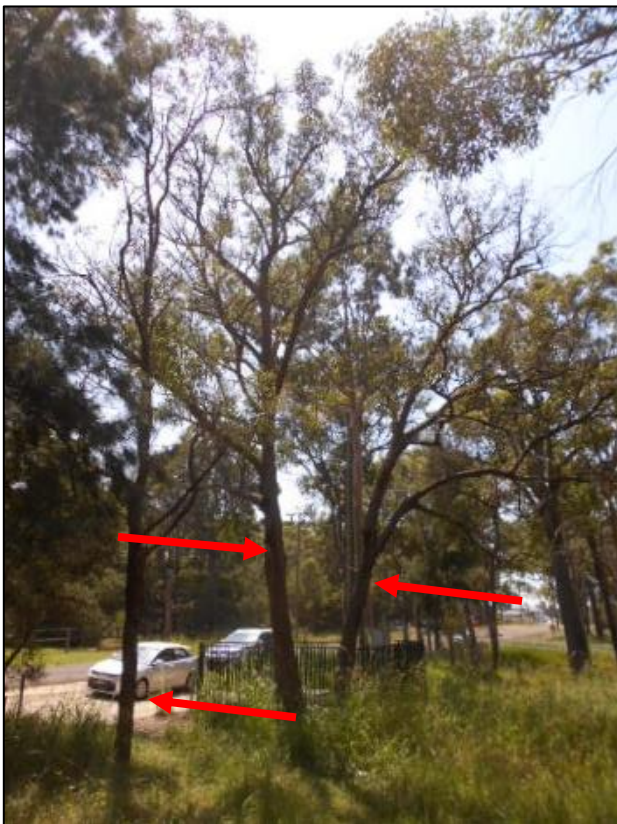
Tree No	Botanical Name Common Name	Age	HGT (m)	Canopy Spread NSEW(m)	DBH (m)	Structure	Health	Comments	SULE
1	<i>Eucalyptus resinifera</i> Red Mahogany	M	15	1211	250	Good	Good / Fair	Initial stage of decline. Dieback of small branches and twigs. Initial stage of decline Thinning of crown foliage No significant structural defects	3d
2	<i>Eucalyptus capitellata</i> Brown Stringybark	M	16	4654	440	Good / Fair	Fair	Initial stage of decline Thinning of crown foliage Initial stage of decline state of decline. Dead small & medium size branches & dieback of other branches Co-dominant trunks minor bark inclusion	3d
3	<i>Eucalyptus capitellata</i> Brown Stringybark	M	12	1922	400	Fair	Fair	Initial stage of decline Thinning of crown foliage Moderate state of decline. Numerous dead small & medium size branches & dieback of other branches Crown density < than 50% Poor habit & form Suppressed canopy orientated to the south Poor representative of the species	3b

Photo 11 – Tree Nos. 1, 2 & 3 initial state of decline and / or poor habit & form

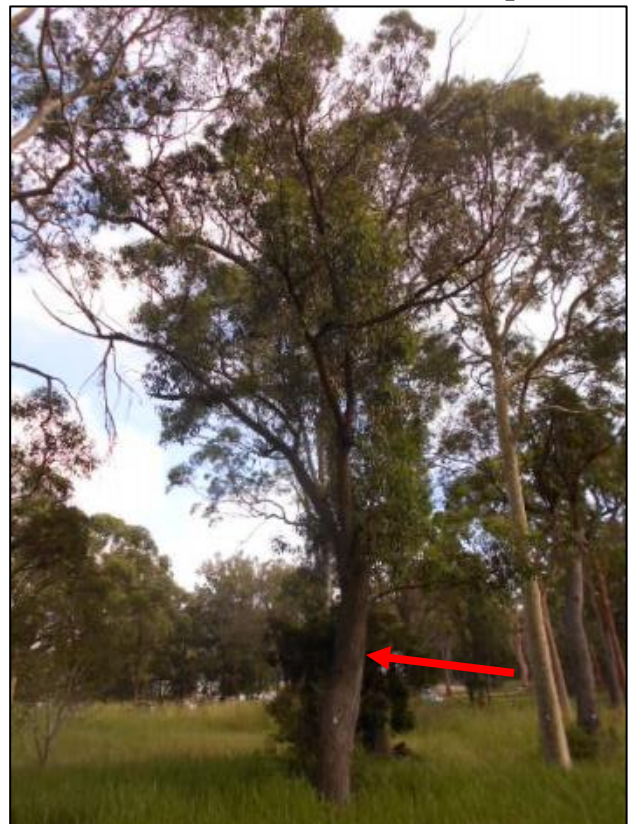
Photo 12 – Tree No. 21 displays relatively poor overall condition

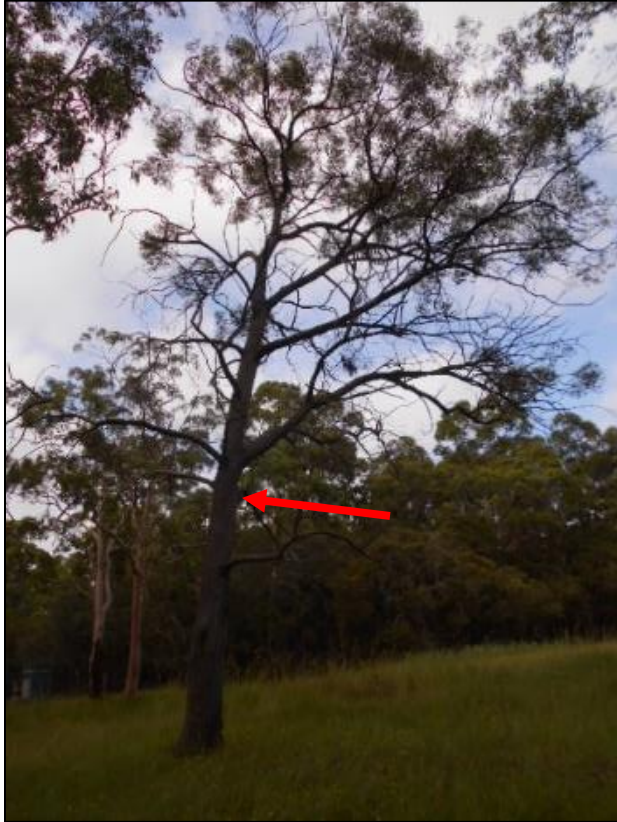
25	<i>Angophora costata</i> Smooth barked Apple	M	14	5546	330	Good	Good	No significant structural defects Dieback of some small to medium size branches but no significant signs of decline	1b
26	<i>Eucalyptus capitellata</i> Brown Stringybark	M	18	3528	600	Good / Fair	Poor	Advanced state of decline Dieback of small, medium & large branches Crown density < than 50%	4a
27	<i>Corymbia maculata</i> Spotted Gum	M		6635	490	Good	Good	No significant signs of dieback or decline No significant structural defects Minor borer damage to trunk Sap flow may indicate the presence of borers	2d

Photo 13 – Tree No. 26 Advanced state of decline and / or poor habit & form

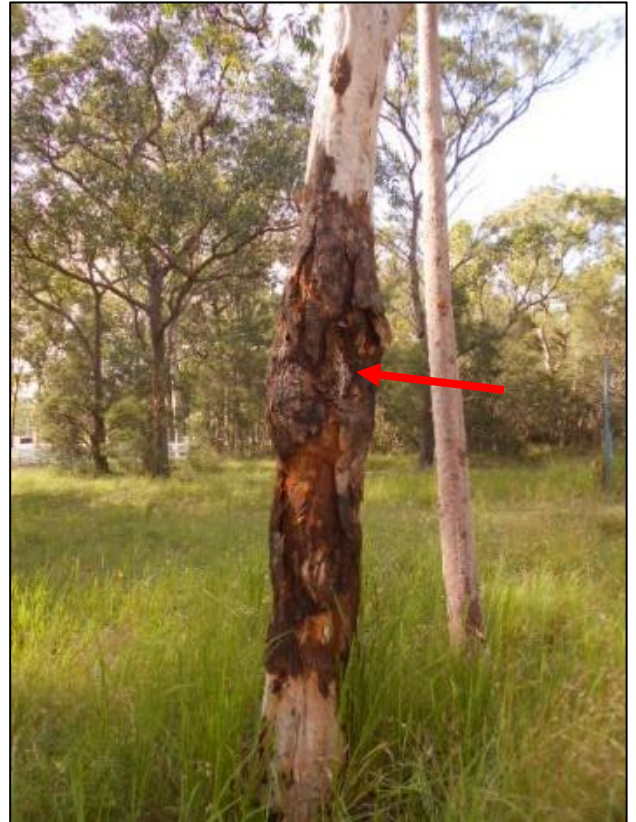
**Photo 14 – Tree No. 45
Major structural defect**

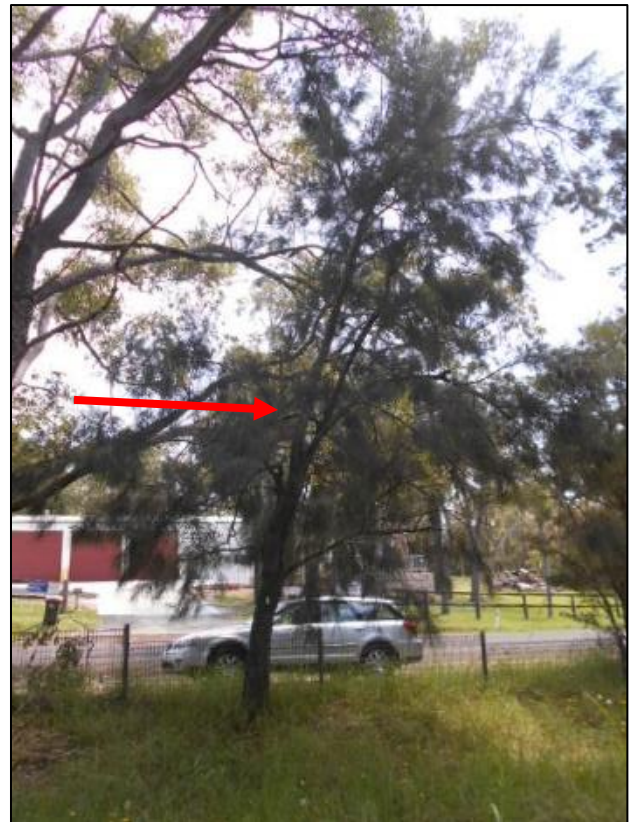
61	<i>Casuarina glauca</i> Swamp Oak	M	16	5533	450	Good	Good	No significant signs of dieback or decline No significant structural defects	1b
62	<i>Eucalyptus resinifera</i> Red Mahogany	M	18	7777	540	Good	Good / Fair	Initial stage of decline state of decline. Dead small & medium size branches & dieback of other branches No significant structural defects	2d
63	<i>Corymbia maculata</i> Spotted Gum	M	28	4664	870	Good / Fair	Good	No significant signs of dieback or decline Cavity in west facing leading scaffold at approx. 12m high	2d

Photo 16 – Tree No. 61 poor habit & form

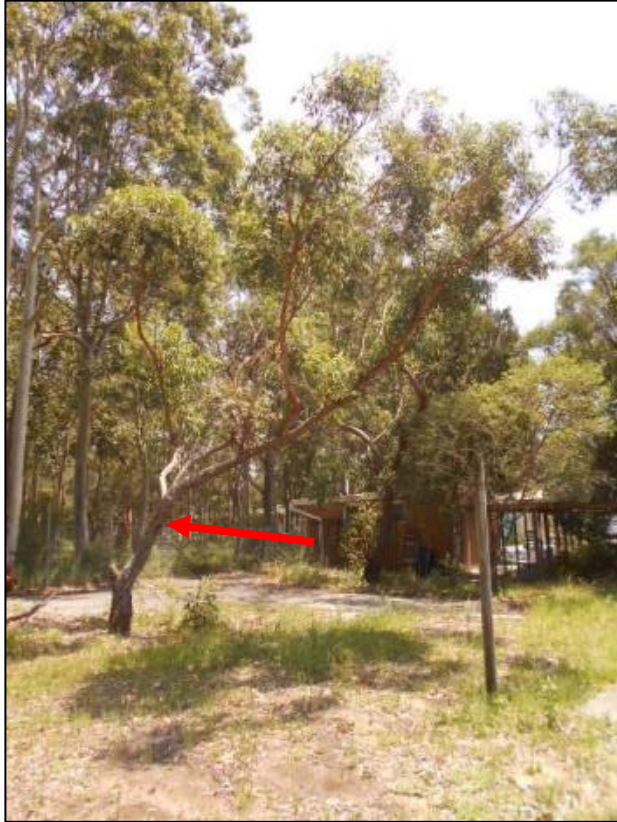
Tree No	Botanical Name Common Name	Age	HGT (m)	Canopy Spread NSEW(m)	DBH (m)	Structure	Health	Comments	SULE
64	<i>Eucalyptus botryoides</i> Southern Mahogany	S/M	7	2171	250	Poor	Good	No significant signs of dieback or decline Poor habit & form unbalanced crown orientated to the east	3b
65	<i>Eucalyptus botryoides</i> Southern Mahogany	M	10	3163	320	Good / Fair	Good / Fair	No significant structural defects Some dead small size branches but no significant signs of decline	2c
66	<i>Callistemon salignus</i> White Bottlebrush	S/M	8	3232	210	Good	Good	No significant signs of dieback or decline No significant structural defects	2d
67	<i>Lophostemon confertus</i> Brush Box	M	12	3242	320	Good	Good	No significant signs of dieback or decline No significant structural defects	1b
68	<i>Lophostemon confertus</i> Brush Box	M	12	4243	320	Good	Good	No significant signs of dieback or decline No significant structural defects	1b

Photo 17 – Tree No. 64 poor habit & form

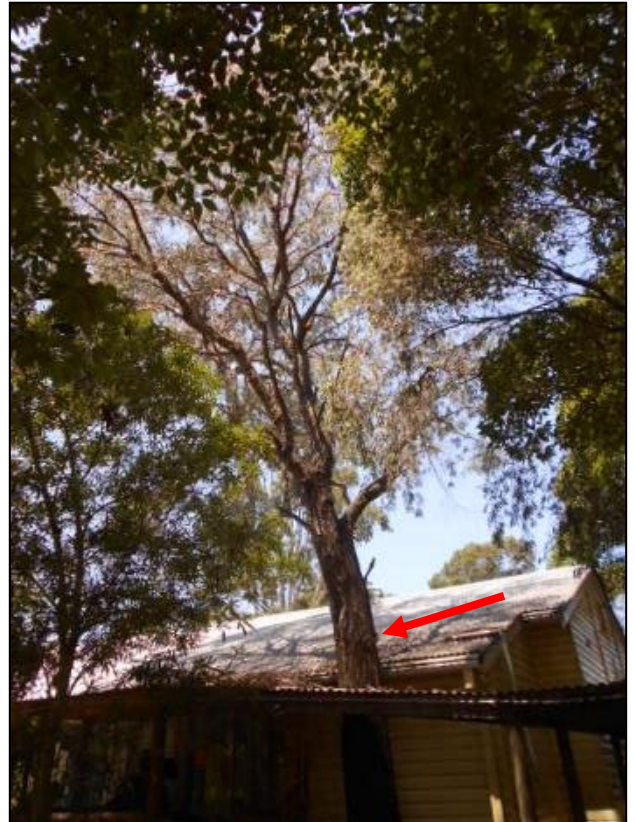
Tree No	Botanical Name Common Name	Age	HGT (m)	Canopy Spread NSEW(m)	DBH (m)	Structure	Health	Comments	SULE
74	<i>Eucalyptus nicholii</i> Nicholi	M	15	3462	530	Good	Good / Fair	No significant signs of dieback or decline No significant structural defects Not suitable to position for long term retention	3b
75	<i>Lophostemon confertus</i> Brush Box	S/M	12	2222	280	Good	Good	No significant signs of dieback or decline No significant structural defects	1b
76	<i>Banksia integrifolia</i> Coast Banksia	S/M	3	1111	170	Good	Good	No significant signs of dieback or decline No significant structural defects	2d
77	<i>Lophostemon confertus</i> Brush Box	S/M	10	2333	230	Good	Good	No significant signs of dieback or decline No significant structural defects	1b
78	<i>Leptospermum petersonii</i> Lemon-scented tea tree	M	5	2316	300	Fair	Good	No significant signs of dieback or decline Excessive end weight particularly on lower overextended branches Moderate lean Fair habit & form Suppressed canopy orientated to the west	3b

Photo 18 – Tree No. 74 Not suitable to position for long term retention

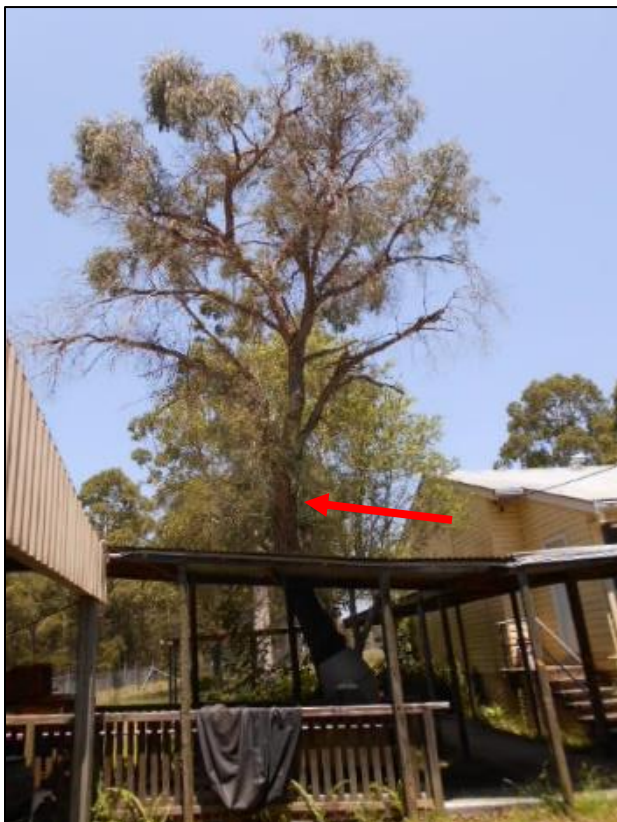
**Photo 19 – Tree No. Moderate state of decline
Not suitable to position for long term retention**

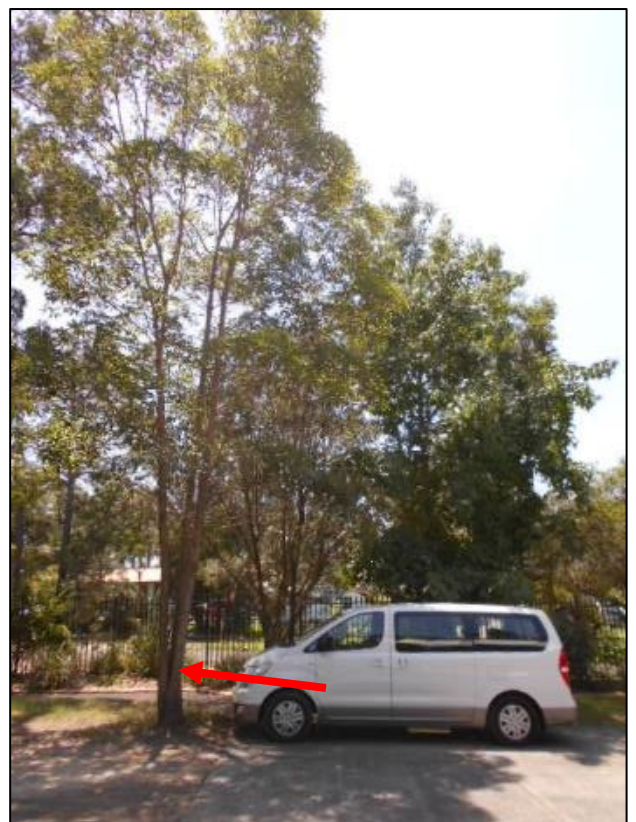
**Photo 20 – Tree No. 85
Moderate structural defects**

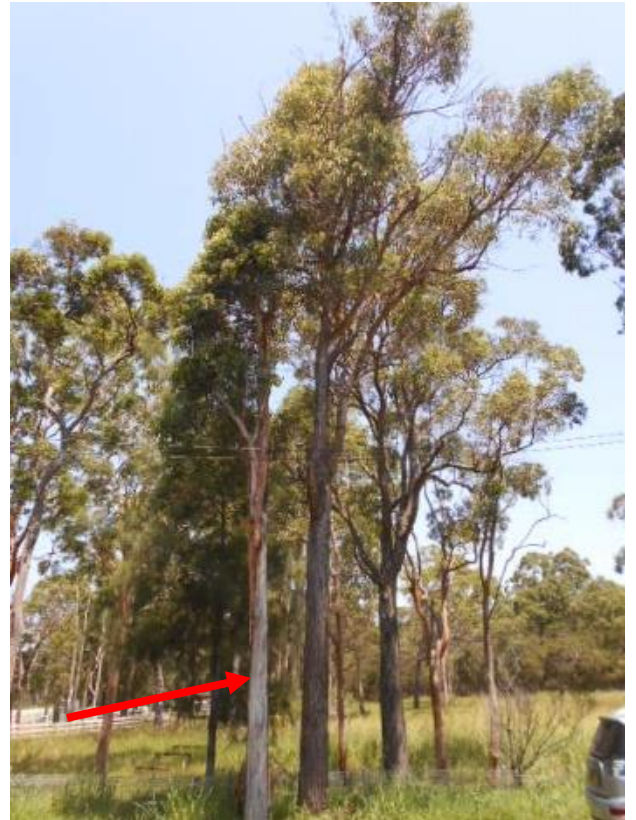
**Photo 22 – Tree No. 101
Major structural defects**

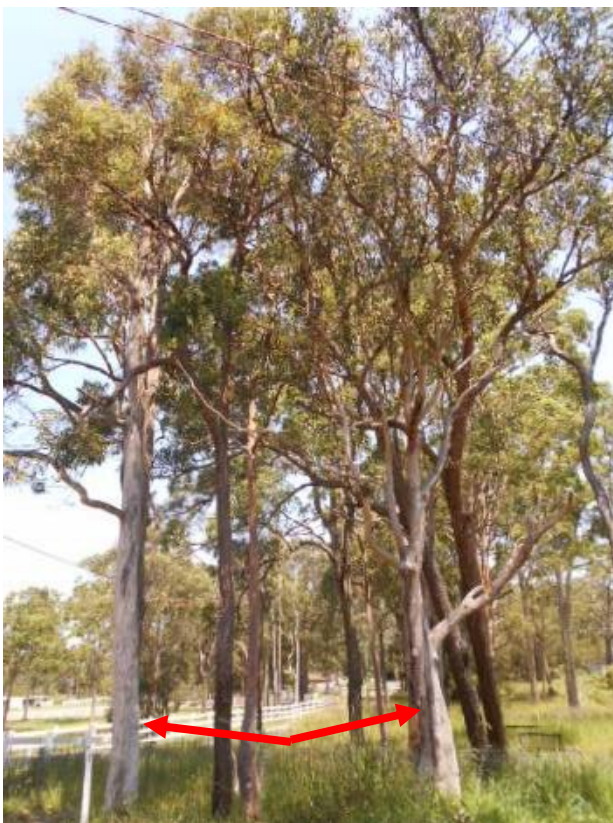
**Photo 23 – Tree No. 102 & 106
Dead trees**
